# **Cell 1 Regional Coastal Monitoring Programme Analytical Report 10: 'Full Measures' Survey 2017**

**North Tyneside Council**

**February 2018**

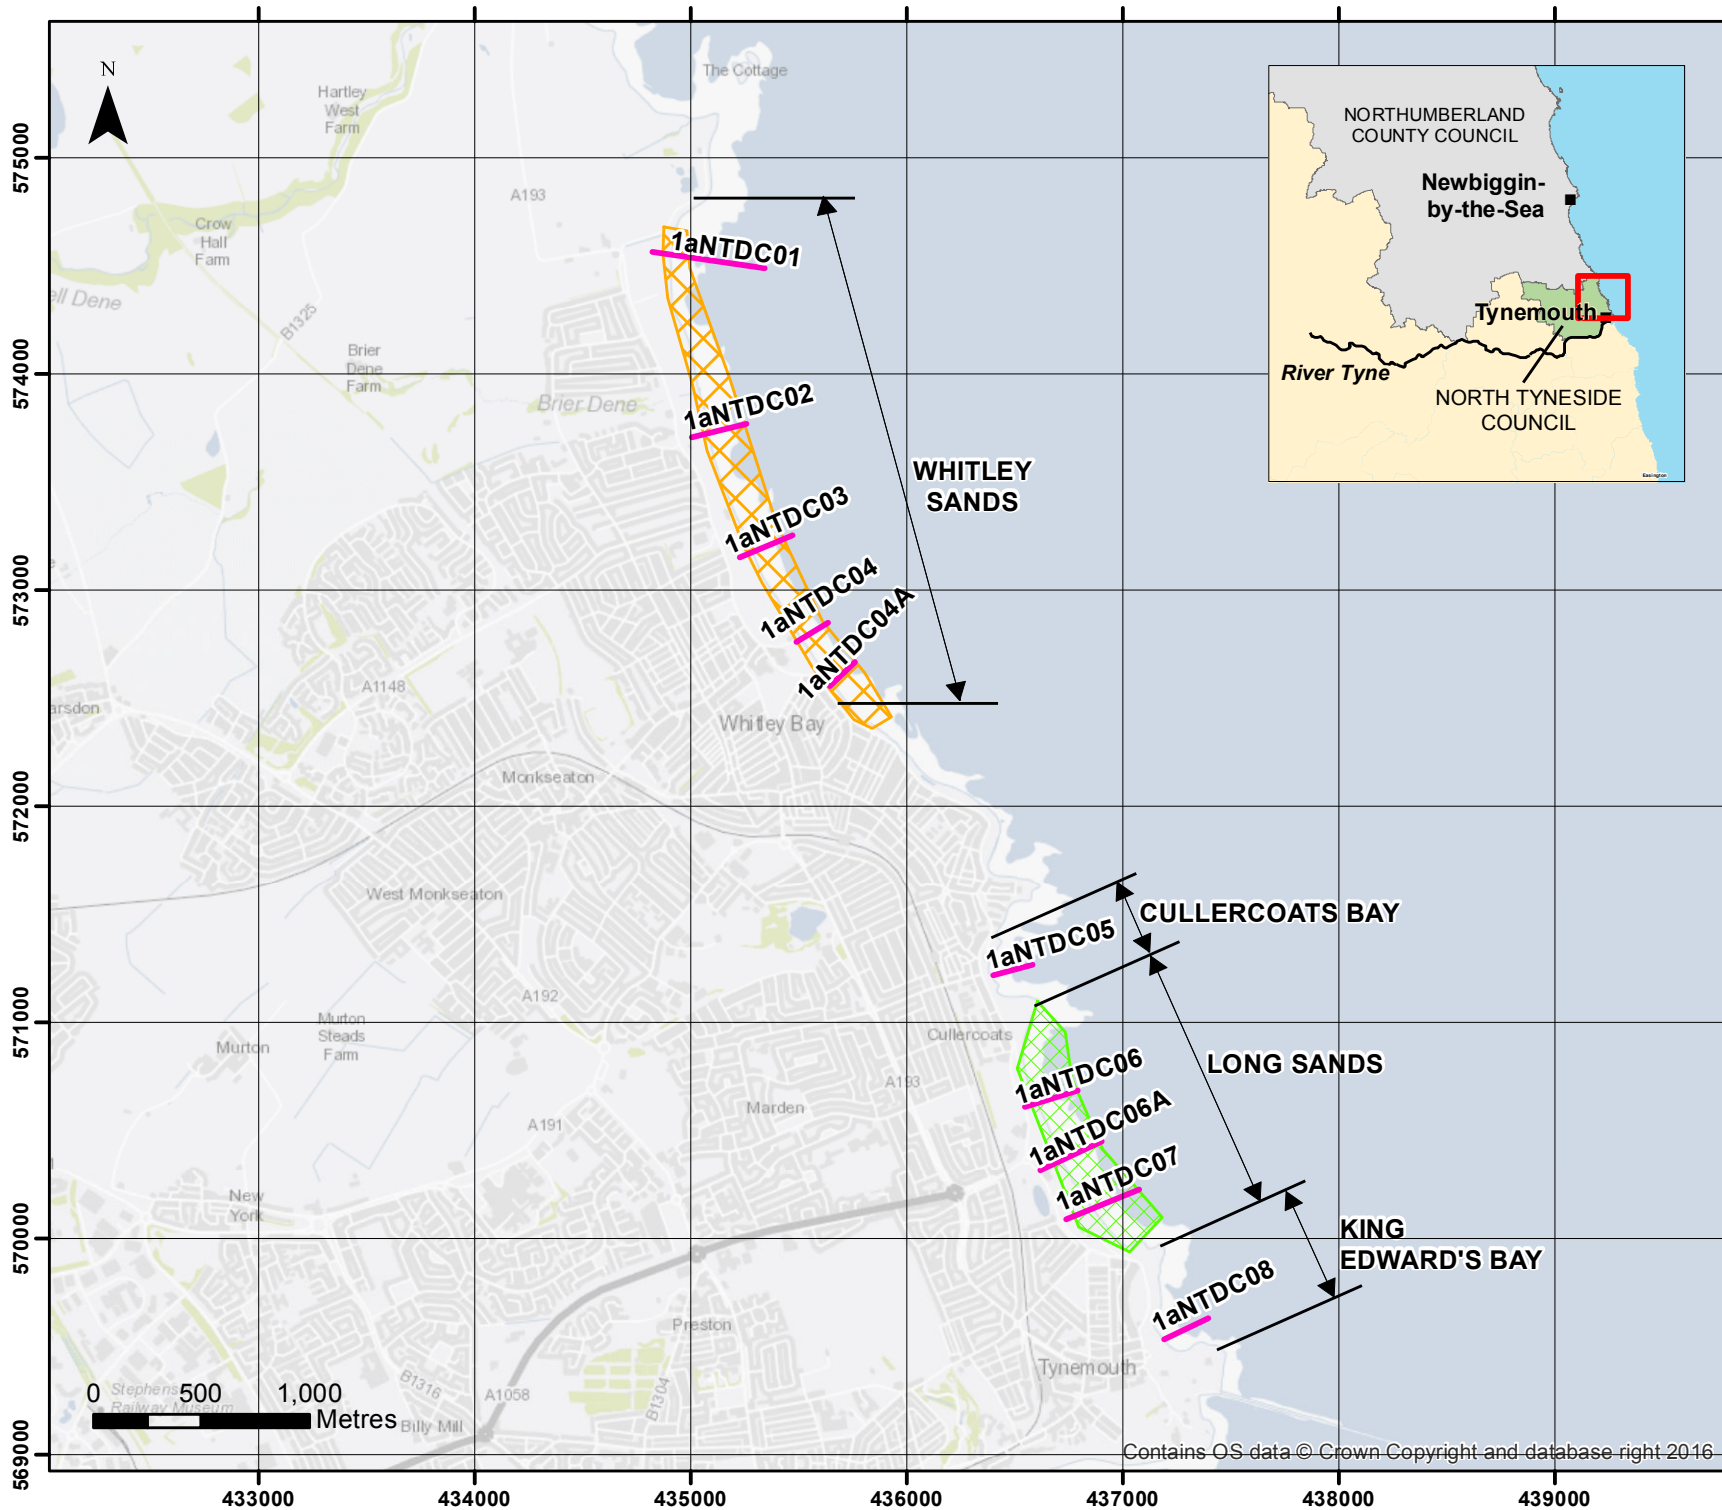
**Figure 2 - Map 1**

**SURVEY LOCATIONS**

**North Tyneside Council Frontage**

The location of these surveys is shown in Figure 1. The beach profiles and topographic surveys were undertaken between the 4<sup>th</sup> and 5<sup>th</sup> September, and 23<sup>rd</sup> and 24<sup>th</sup> October 2017. The weather conditions varied throughout the survey, details can be found in the surveyor's reports.

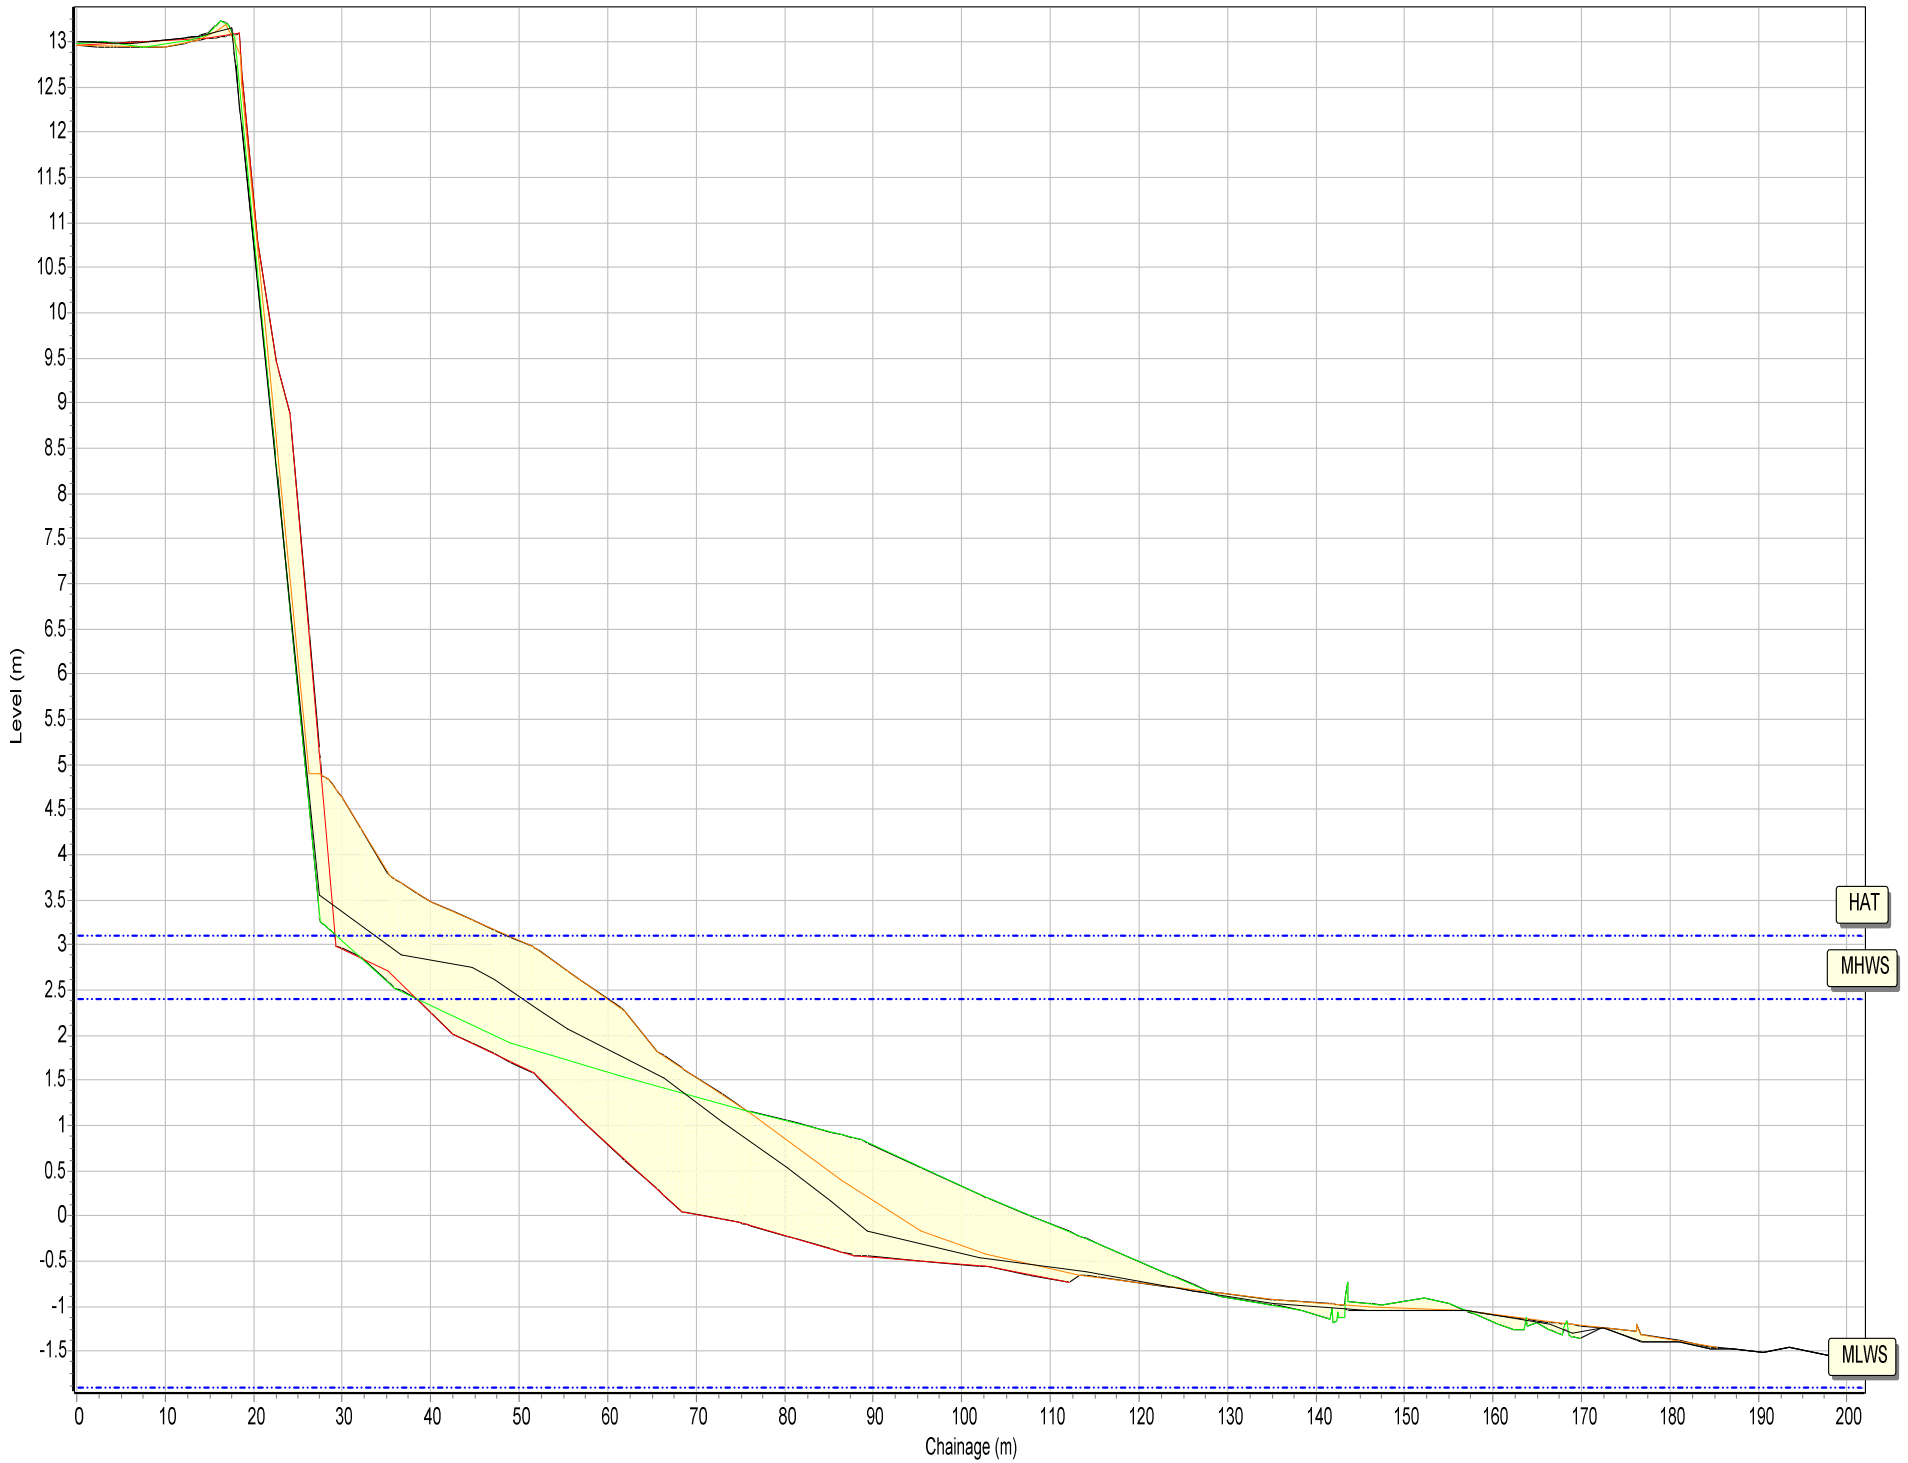
Beach Profiles: 1aNTDC01

Survey Date	Description of Changes Since Last Survey	Interpretation
5 <sup>th</sup> September 2017	<p><b>Beach Profiles:</b></p> <p>Whitley Sands is covered by five beach profile lines for the Full Measures survey (Appendix A). Four of these (1aNTDC01 to 1aNTDC04) were initially surveyed in April 2002 and were surveyed annually to 2009 (Full Measures, autumn 2009) and bi-annually thereafter. From March 2010 (Partial Measures, spring 2010) onwards, an additional beach profile line (NTDC04A) has been surveyed at the southern end of the frontage. All profiles were last surveyed in March 2017 for the Partial Measures survey.</p> <p><b>1aNTDC01</b> is located in the north of Whitley Sands, along the undefended cliffs immediately south of Trinity Road car park. There has been little change in the position of the cliff. Beach levels at the toe of cliff to chainage 70m have increased by up to 0.6m since the March 2017 survey, forming a small berm at chainage 45m. Between chainage 70m and 130m there has been erosion of up to 1.0m. Seawards of 130m chainage there has been little change. Overall the profile is at a relatively medium level compared to the range recorded from previous surveys.</p> <p>Profile <b>1aNTDC02</b> is located in the northern part of Whitley Sands. A seawall is present at the back of the beach. There has been significant accretion at the base of the seawall of 1.0m. Accretion, more typically up to 0.6m, has occurred between the seawall (chainage 50m) and chainage 112m. There has been erosion of up to 0.7m between chainage 112m and 165m, and the rock is exposed from 160m seawards. The profile is relatively medium- high on the upper and mid beach but low on the lower beach compared with the range recorded from previous surveys, resulting in a relatively steep profile.</p> <p>Profile <b>1aNTDC03</b> is located at the centre of Whitley Sands. There has been very little change from at the bottom of the seawall up to chainage 25m. Accretion of up to 0.8m has occurred between chainage 25m and 68m, covering up the previously exposed patches of boulders and forming a wide berm. From chainage 68m seawards there has been erosion of up to 0.8m, exposing a small section of rock at chainage 90m. The September 2017 profile is relatively low in the upper beach compared</p>	<p>Since the last survey, there has generally been accretion across the upper beach and erosion on the mid-lower beach.</p> <p><b>Longer term trends:</b> Beach levels are within the range seen in earlier surveys.</p>

- At Whitley Sands there has generally been accretion in the upper beach and erosion in the mid-lower beach. For the most part, the beach is at a medium level in the range recorded from previous surveys. There are no causes for concern.

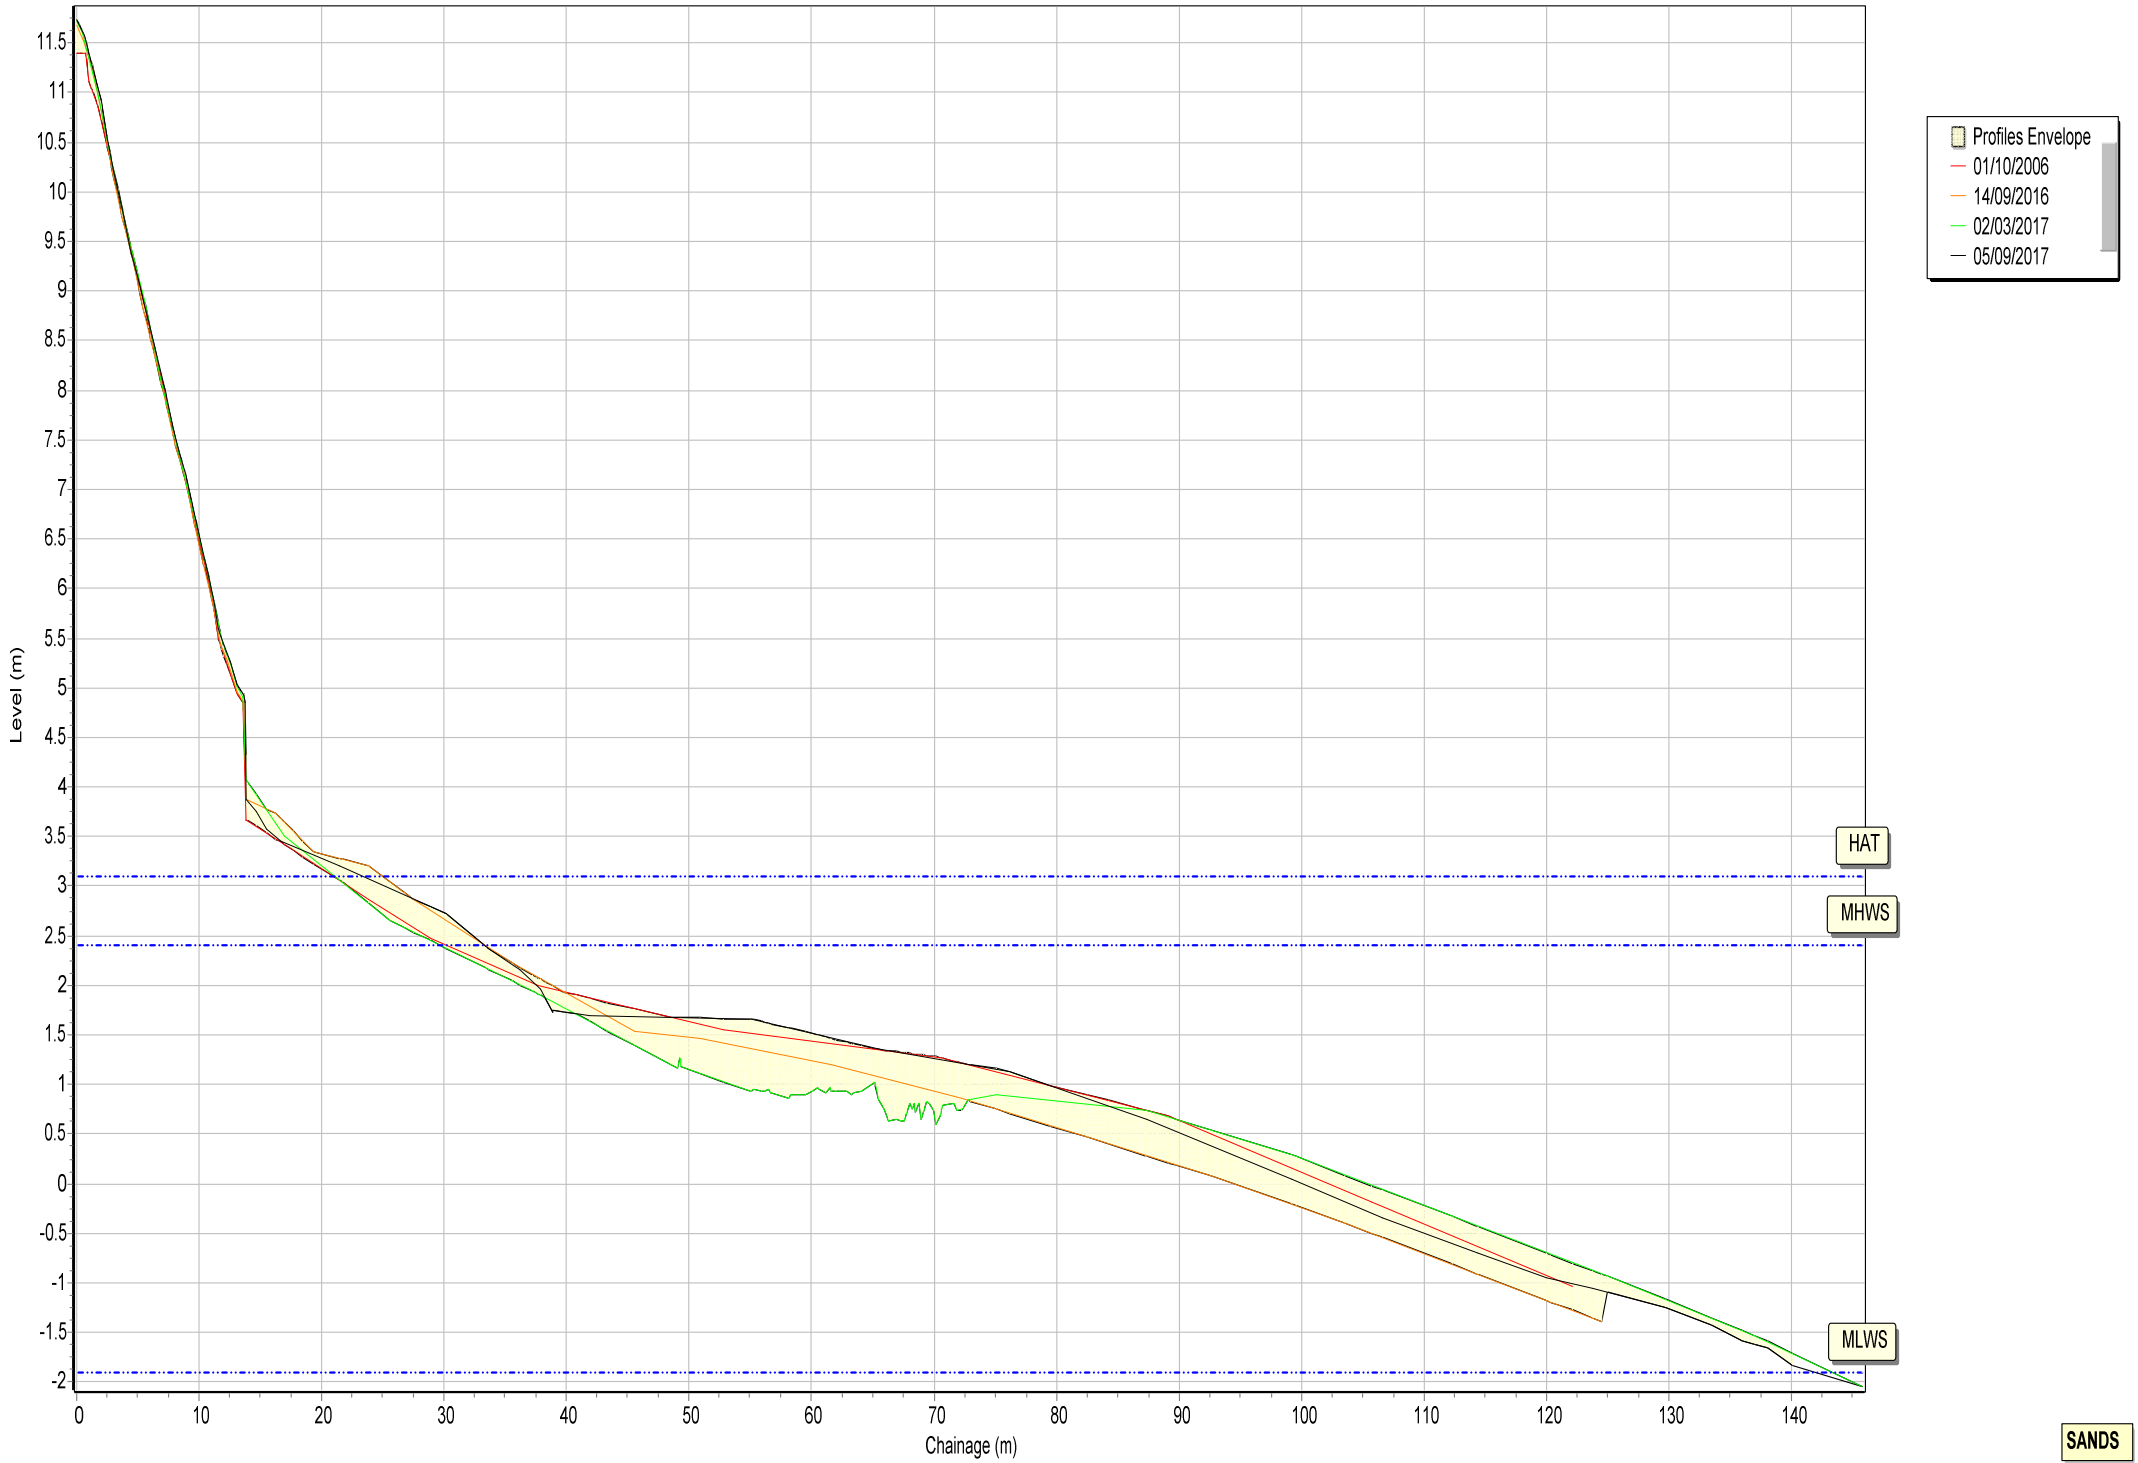
Beach Profiles: 1aNTDC04

Survey Date	Description of Changes Since Last Survey	Interpretation
	<p>to the range recorded from previous surveys, relatively high in the mid beach, and at a medium level in the lower beach.</p> <p>Profile <b>1aNDC04</b> is located in the southern part of Whitley Sands. There has been a small amount of erosion at the toe of the seawall (15m) of 0.2m. Between chainage 18m and 85m there has been varying amounts of accretion of up to 0.6m, covering up the previously exposed rocks. Seaward of 85m chainage there has been erosion of 0.2m. Overall the profile is in the middle of the range recorded from previous surveys.</p> <p>Profile <b>1aNDC04a</b> is located towards the southern end of Whitley Sands. There has been accretion at the toe of the seawall and to chainage 50m of up to 0.7m. From chainage 50m seawards there has been erosion of up to 0.4m. The rock platform is exposed from chainage 70m. Overall the profile is a medium level compared to the range recorded from previous surveys, though it is relatively low towards the toe of the beach.</p>

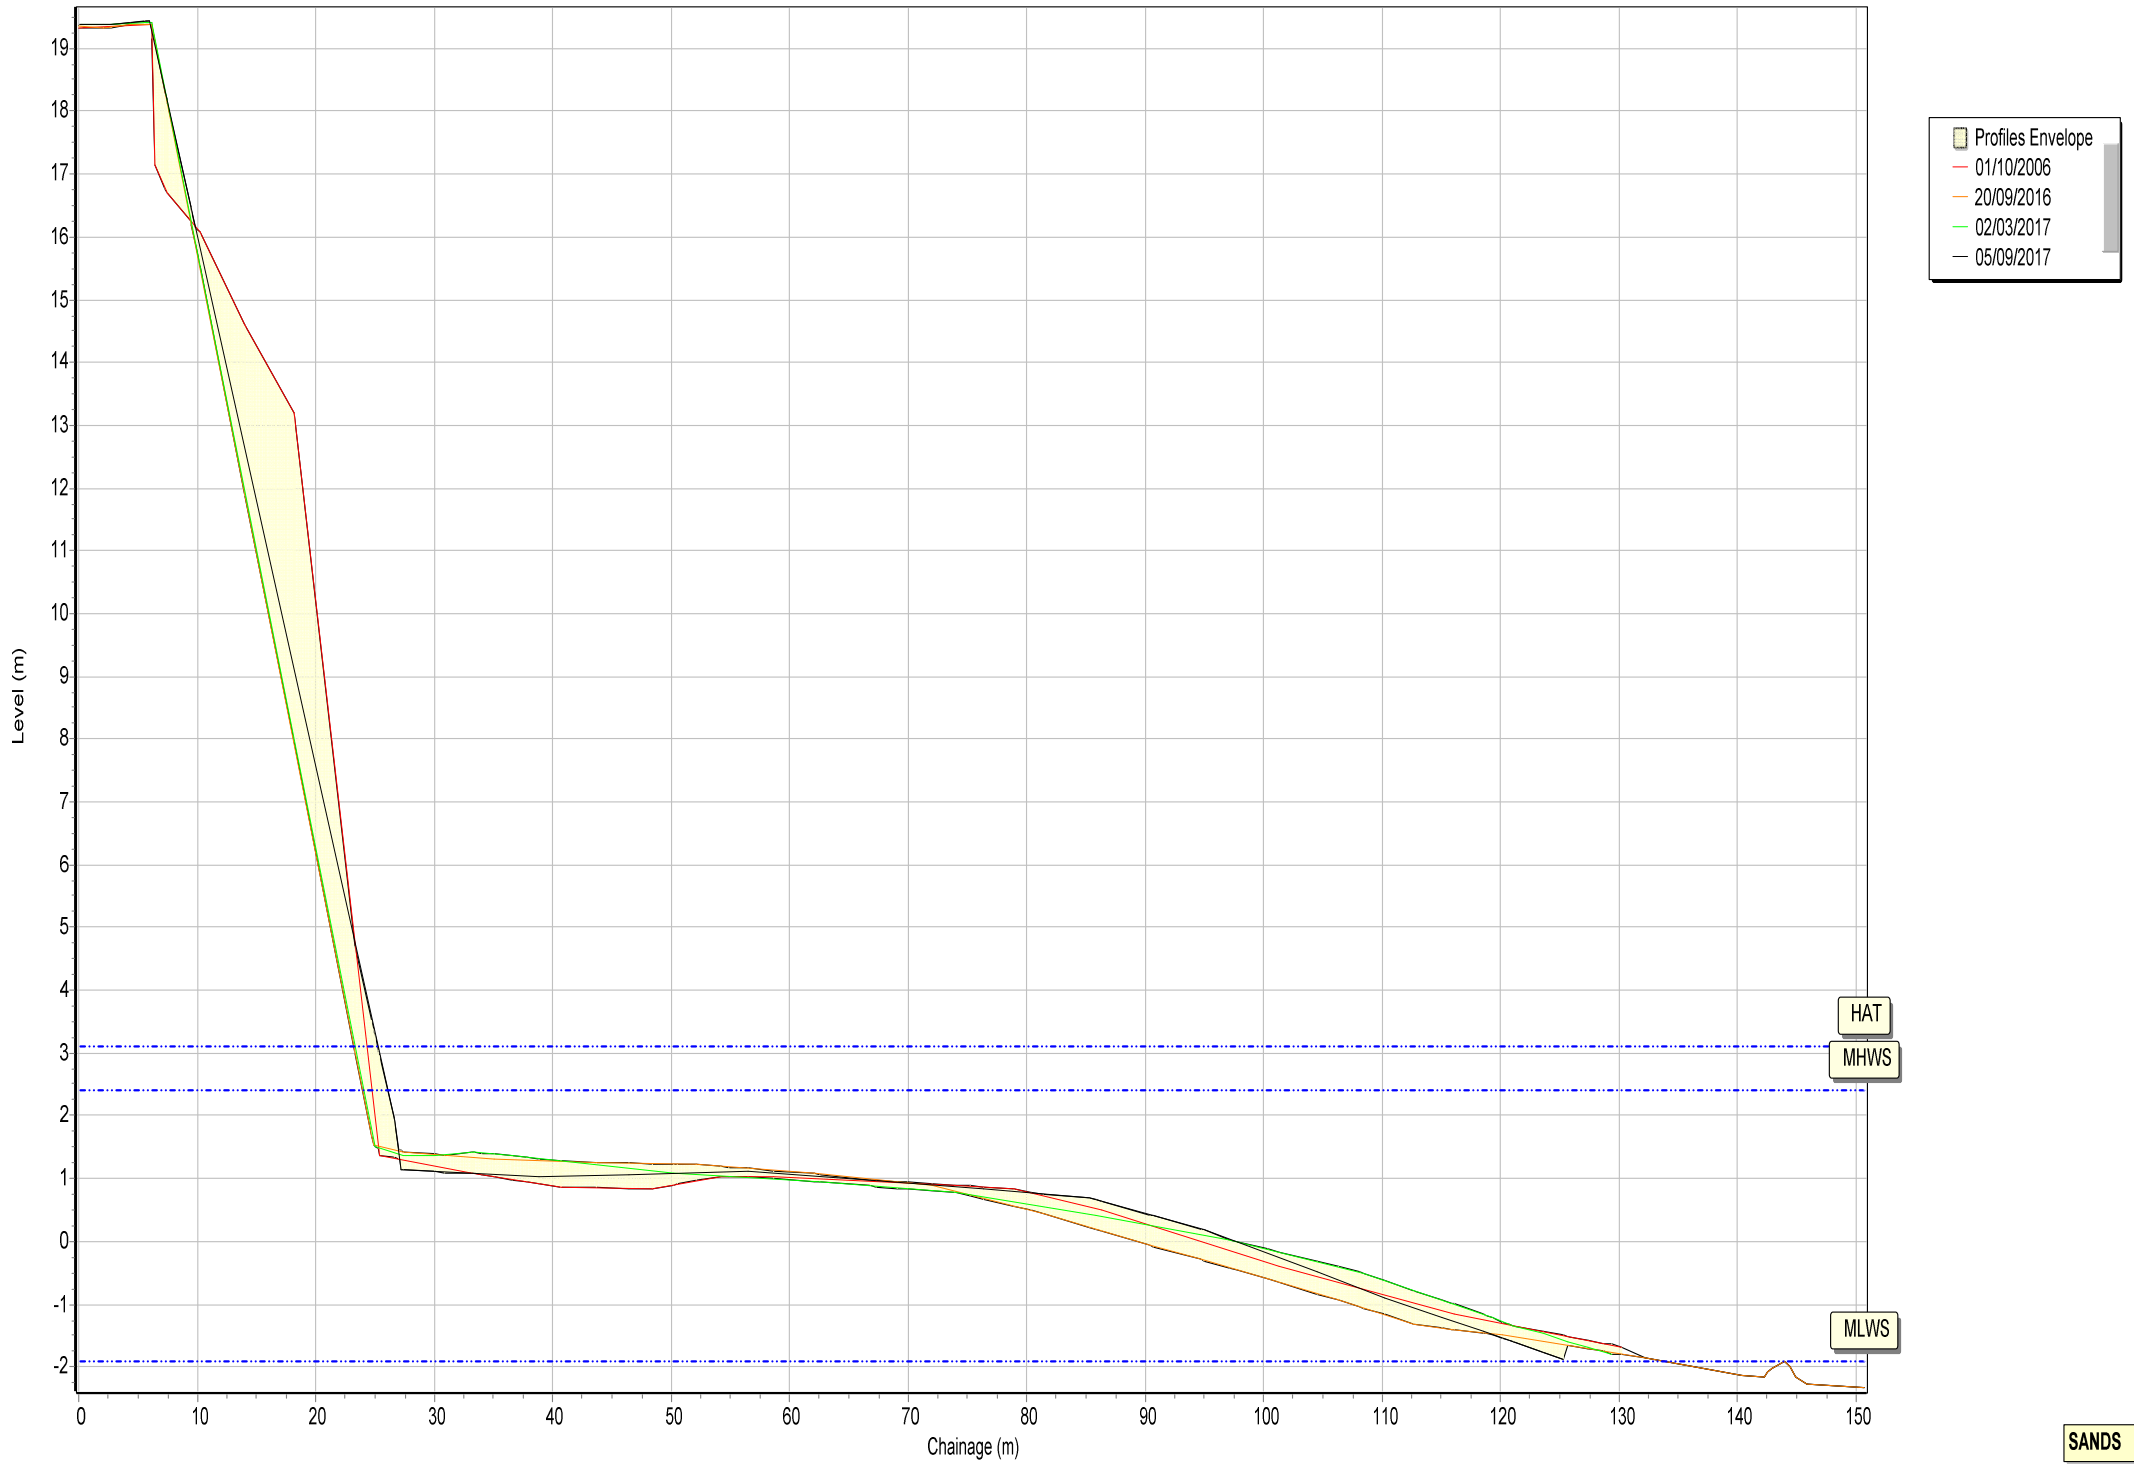
Beach Profiles: 1aNTDC05

Survey Date	Description of Changes Since Last Survey	Interpretation
5 <sup>th</sup> Septemebr 2017	<p><b>Beach Profiles:</b></p> <p>Cullercoats Bay is covered by one beach profile line for the Full Measures survey (Appendix A). This was surveyed annually each autumn between 2002 and 2009. From spring 2010 onwards, it has been surveyed bi-annually.</p> <p>At profile 1aNTDC05 the survey report notes '<i>cliff not measured at section 5 due to dangerous access</i>' as it has done in previous surveys. There has been erosion of up to 0.3m at the toe of the cliff to chainage 50m. Between chainage 50m and 98m there has been accretion typically less than 0.2m. Seawards of chainage 98m there has been erosion of up to 0.3m. The September 2017 profile is at a medium level on the upper beach compared to the range recorded from previous surveys, the highest on record in the middle beach (chainage 80m to 95m) and at a relatively low level at the toe of the beach.</p>	<p>As in previous surveys access to the cliff has not been possible.</p> <p>The data shows only limited change, less than <math>\pm 0.3\text{m}</math>, related to short-term patterns of sediment movement.</p> <p><b>Longer term trends:</b> The amount of change is low and the profile is within the past range. The upper beach is currently high, whereas the lower beach is at its lowest level and a bar seen in earlier surveys is absent.</p>

- The surveyor noted that there was construction ongoing on the promenade at profiles 1aNTDC03 and 1aNTDC04A.
- At profile 1aNTDC05 the cliff was not measured due to access problems. Access to this profile is noted to have been dangerous in previous Partial Measures and Full Measures reports, and it is recommended that the beach profile should start at the cliff toe and that the cliff be monitored using the aerial survey data.
- At Tynemouth Long Sands (profiles 1aNTDC06, 1aNTDC06A and 1aNTDC07) there was no access to the dunes in the middle of the profile due to seed protection fences. This means it has not yet been possible to monitor the effectiveness of the dune stabilisation scheme

It is recommended that the beach profile at 1aNTDC05 in Cullercoats Bay should start at the cliff toe and that the cliff be monitored using the aerial survey data.

- At Cullercoats Bay, at profile 1aNTDC05, there has been little change and there are no causes for concern.
- At Tynemouth Long Sands, the recorded profiles are within the previously recorded range with berm building processes dominating and present no cause for concern. The topographic survey is dominated by accretion, particularly in the upper and mid beach, with erosion at the toe of the beach.

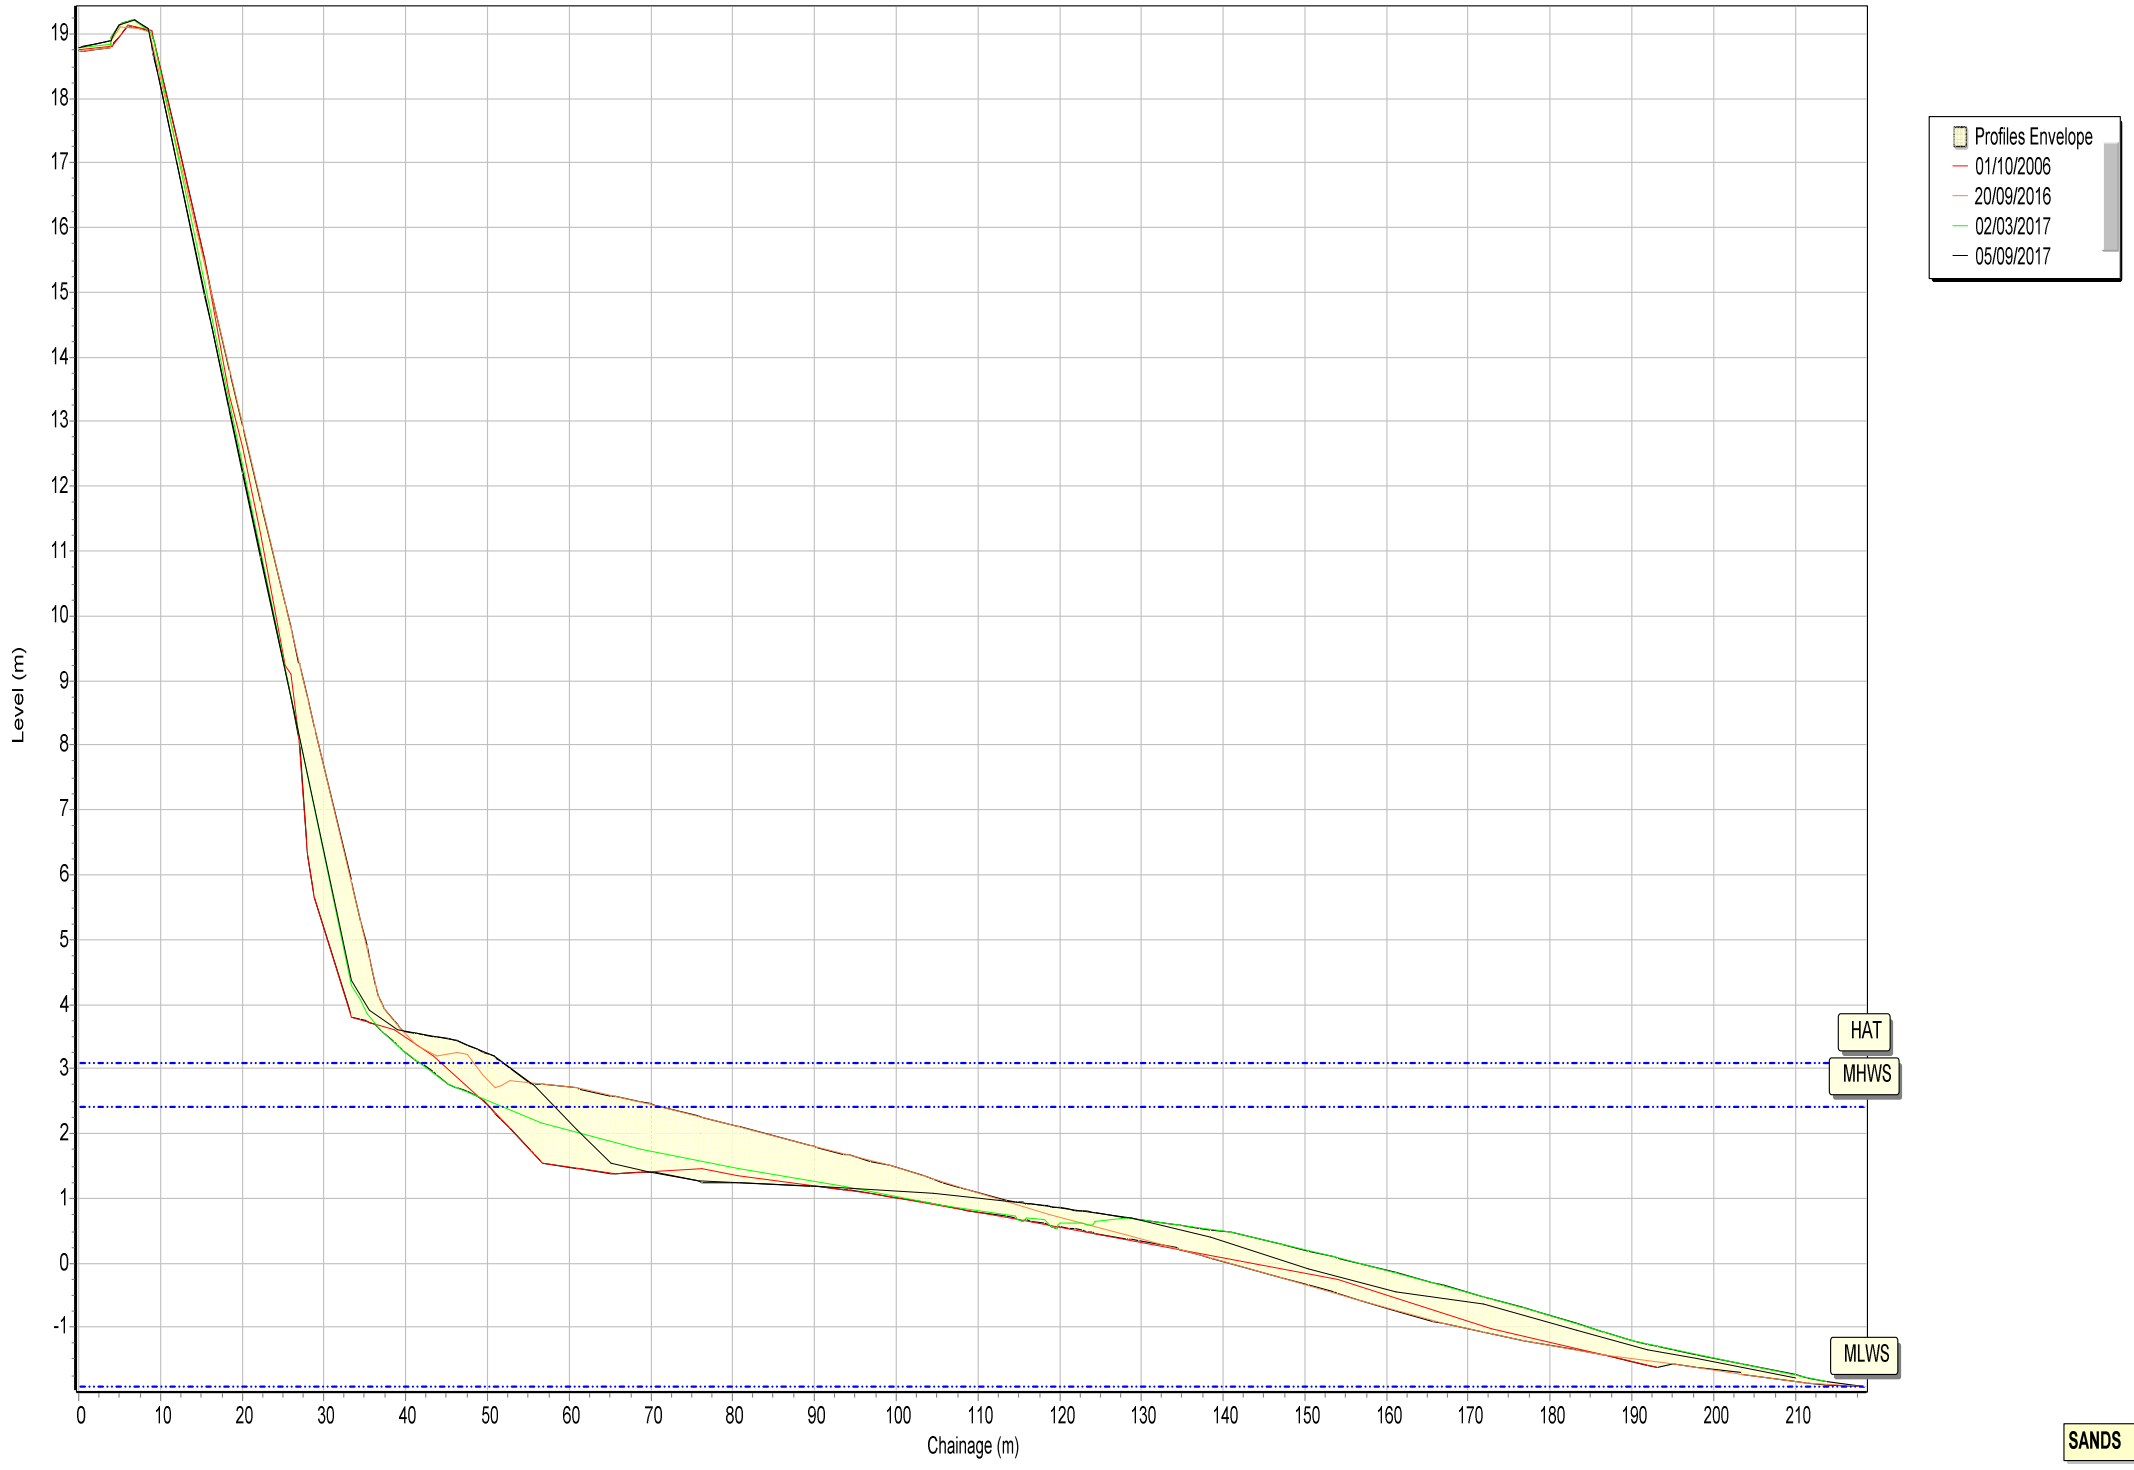
Beach Profiles: 1aNTDC06

Survey Date	Description of Changes Since Last Survey	Interpretation
5 <sup>th</sup> September 2017	<p><b>Beach Profiles:</b></p> <p>Tynemouth Long Sands is covered by three beach profile lines for the Full Measures survey (Appendix A). Profiles 1aNTDC06 and 1aNTDC07 were initially surveyed annually each autumn between 2002 and 2009. A third profile, 1aNTDC06A, was then added in the centre of the frontage. From spring 2010 (Partial Measures) onwards, all profiles have been surveyed bi-annually.</p> <p><b>1aNTDC06</b> is located approximately 150m south of the access ramp towards the north of the bay. The top of the cliff has not changed since the last survey, however, the remainder of the cliff profile cannot be reviewed due to lack of data points in the profile plot as the survey report notes '<i>no access to middle of section 6 due to seed protection fences</i>'. The beach profile starts at c.35m chainage and shows accretion over the upper beach of up to 0.6m. From chainage 60m to 95m this changes to erosion of up to 0.3m, before reverting to accretion of 0.2m from chainage 95m to 130m. The end of the profile from 130m to 210m shows erosion of &lt;0.2m. Overall the profile is generally at a medium level compared to the range recorded from previous surveys, with the exception of chainage 65m to 85m (area of upper beach erosion) where the levels are the lowest on record.</p> <p>At profile <b>1aNTDC06A</b>, the dune-cliff face has not significantly changed in form or position. As with section 6, the survey report notes '<i>no access to middle of section 6a due to seed protection fences</i>'. There has been very little change from the toe of the dunes at chainage 80m to chainage 110m. Between chainage 110m to 130m a small berm has formed through the accretion of 0.4m. The middle beach has been eroded by up to 0.5m between chainage 130m and 185m. A second wider berm has formed between chainage 175m and 230m through accretion of 0.4m. The lower beach seawards of chainage 235m has eroded by up to 0.7m. Overall the September 2017 profile is at a relatively medium level compared to the range recorded from the previous surveys, with the exception of the two berms which show the highest recorded levels in those areas.</p> <p>Profile <b>1aNTDC07</b> is located approximately 50m south of the access route through the dunes towards the southern end of the bay. The dune-cliff has not significantly changed in form or position since the last survey. As with section 6 and 6a, the survey report notes '<i>no access to middle of section 7 due to seed protection fences</i>'. The profile shows a similar pattern to profile <b>1aNTDC06A</b> with variable accretion and erosion and the formation of two berms. There has been a small amount of accretion</p>	<p>Since the last survey the dunes have retained the same form and position. The profiles generally show alternating sections of accretion and erosion, with the formation of berms in the upper and mid beach with some erosion in the mid beach as well as the lower beach.</p> <p><b>Longer term trends:</b> Overall, the beaches have retained a similar form but are towards the upper bound of the range of previous surveys, particularly in the foreshore.</p>

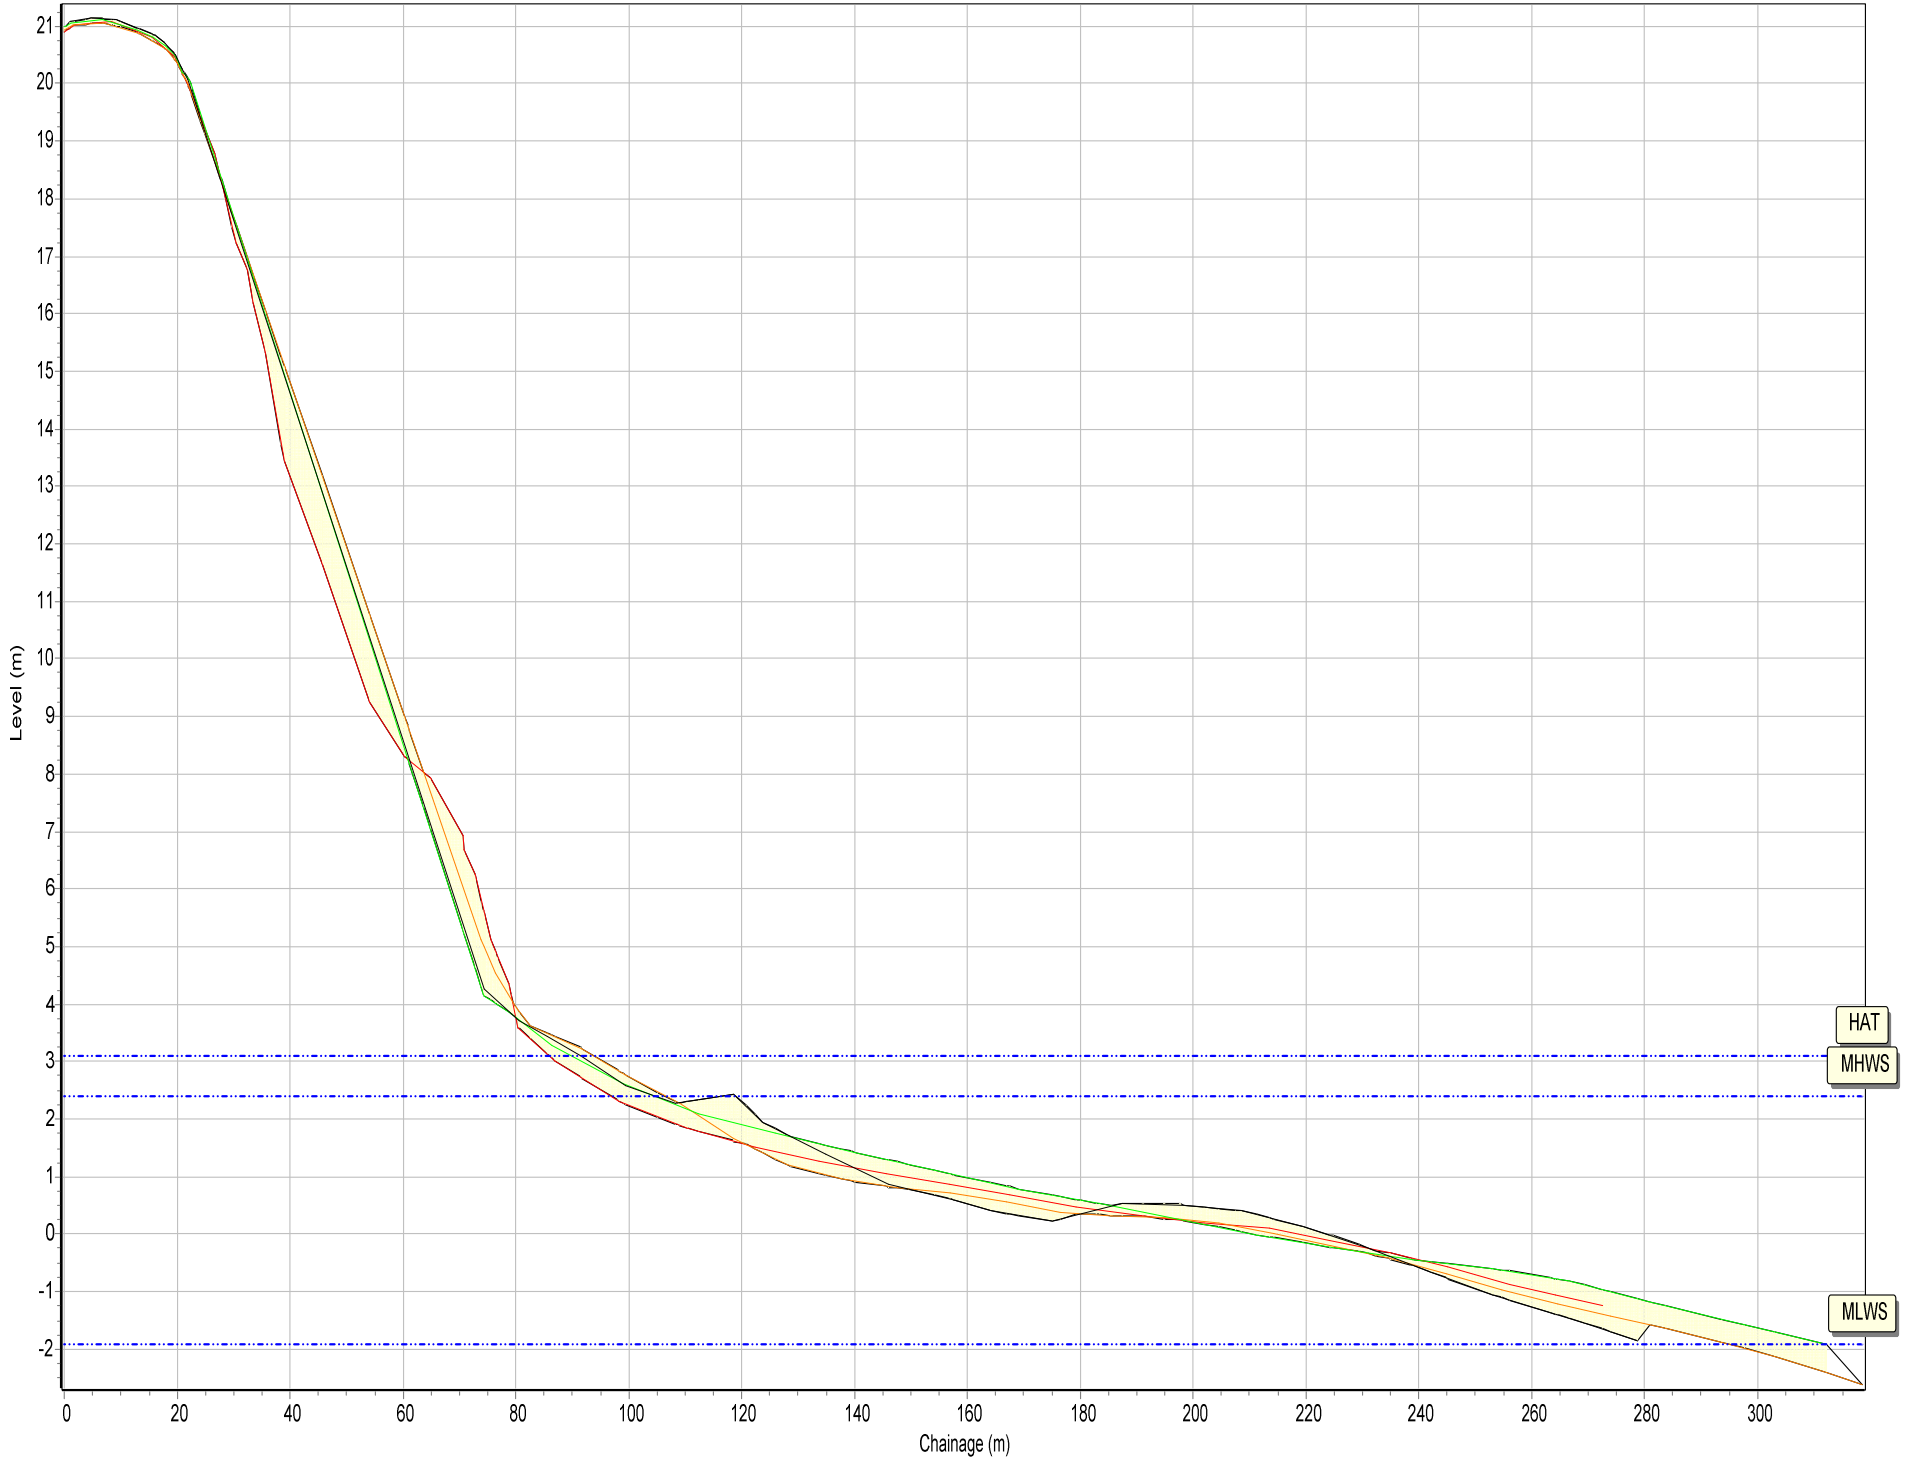
Beach Profiles: 1aNTDC06A

Survey Date	Description of Changes Since Last Survey	Interpretation
	<p>on the upper beach of less than 0.2m, with the formation of a small berm at chainage 145m through the accretion of 0.6m. There has been small amount of erosion of less than 0.1m between chainage 160m and 195m. A second wider berm has formed between chainage 195m and 245m through the accretion of 0.7m. Between chainage 245m and 300m there has been erosion of up to 0.4m. At the toe of the beach, seawards of chainage 300m there has been accretion of 0.2m.. Overall the September 2017 profile is at a relatively medium level compared to the range recorded from the previous surveys, except for the two berms which show the highest recorded levels in those areas.</p>	
<p><b>24<sup>th</sup> October 2017</b></p>	<p><b>Topographic Survey:</b></p> <p>The first survey was undertaken for the Full Measures survey in October 2010.</p> <p>Data from the current topographic survey have been used to create a digital ground model (DGM) (Appendix B – Map 2) using a Geographical Information System (GIS). A difference plot has also been produced by comparing the current DGM (Appendix B – Map 4) with that produced from the last topographic survey in March 2017.</p> <p>The difference plot shows that change since the last survey (Partial Measures, spring 2017) is patchy. The bay has clearly been dominated by accretion, particularly on the upper and mid beach, since the previous survey. The lower beach shows a thin band of erosion around most of the bay, with the greatest magnitude in the northern part of the bay. There are some patches of minor erosion in the mid beach, which ties up with what is seen in the profiles. The magnitude of change is relatively small for both the accretion and erosion across most of the bay with most of it less than <math>\pm 0.75\text{m}</math>.</p>	<p>The pattern shown in the difference plot corroborates the patterns identified in the profiles.</p>
