# **Cell 1 Regional Coastal Monitoring Programme Analytical Report 10: 'Full Measures' Survey 2017**

**North Tyneside Council**

**February 2018**

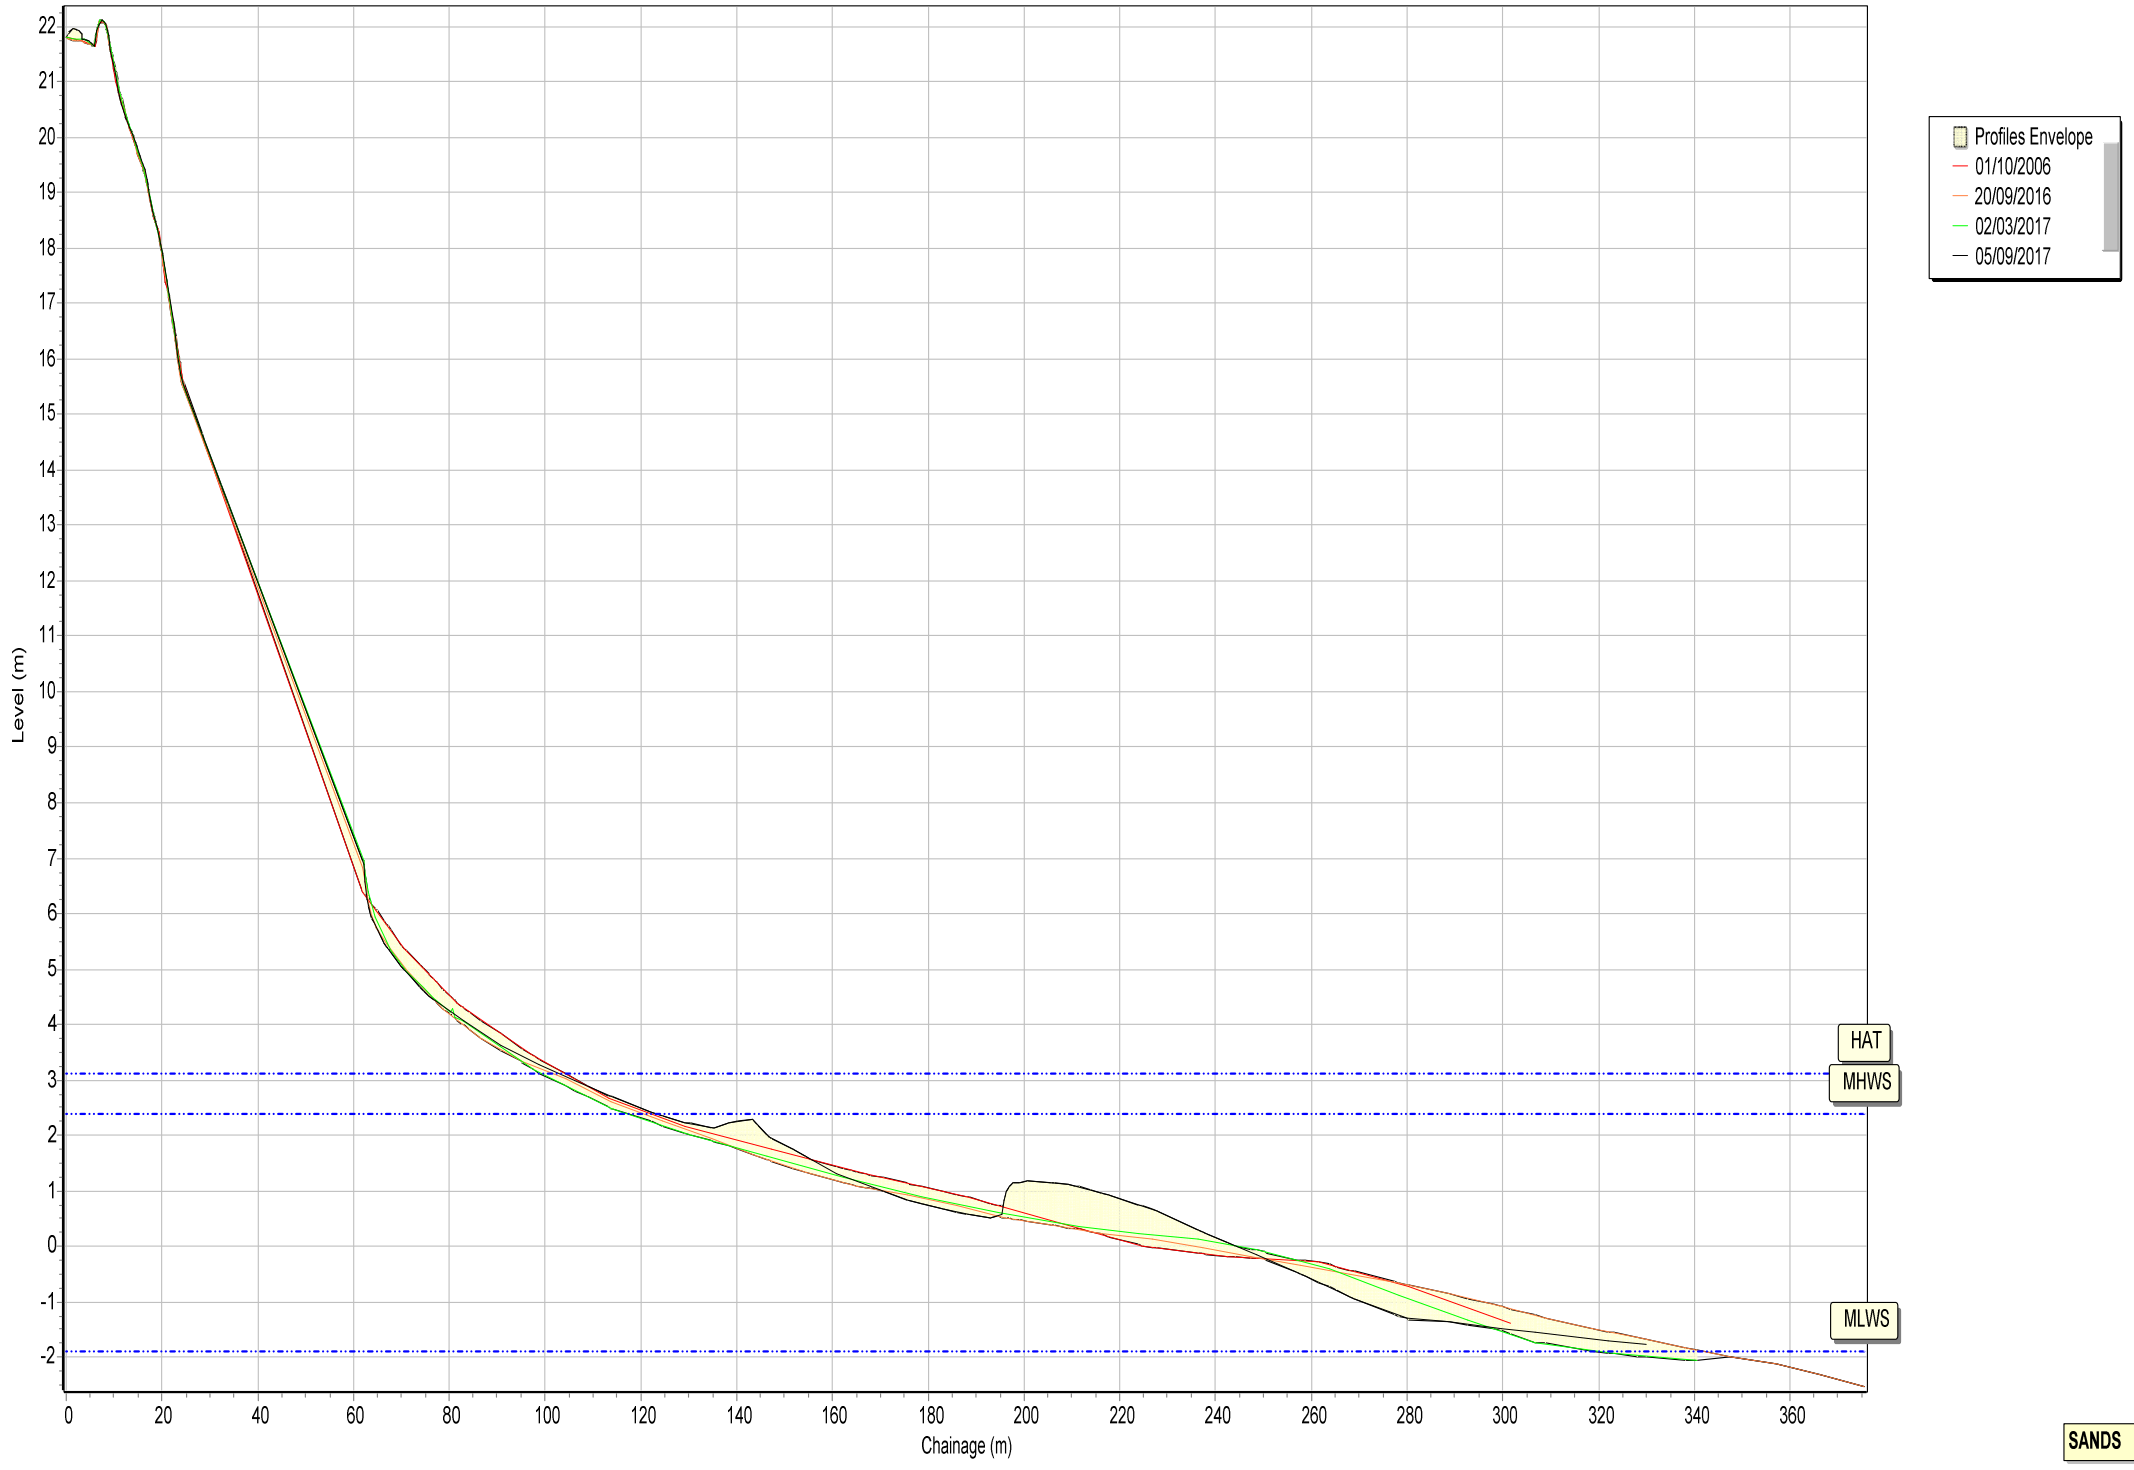
Beach Profiles: 1aNTDC07

Survey Date	Description of Changes Since Last Survey	Interpretation
5 <sup>th</sup> September 2017	<p><b>Beach Profiles:</b></p> <p>Tynemouth Long Sands is covered by three beach profile lines for the Full Measures survey (Appendix A). Profiles 1aNTDC06 and 1aNTDC07 were initially surveyed annually each autumn between 2002 and 2009. A third profile, 1aNTDC06A, was then added in the centre of the frontage. From spring 2010 (Partial Measures) onwards, all profiles have been surveyed bi-annually.</p> <p><b>1aNTDC06</b> is located approximately 150m south of the access ramp towards the north of the bay. The top of the cliff has not changed since the last survey, however, the remainder of the cliff profile cannot be reviewed due to lack of data points in the profile plot as the survey report notes '<i>no access to middle of section 6 due to seed protection fences</i>'. The beach profile starts at c.35m chainage and shows accretion over the upper beach of up to 0.6m. From chainage 60m to 95m this changes to erosion of up to 0.3m, before reverting to accretion of 0.2m from chainage 95m to 130m. The end of the profile from 130m to 210m shows erosion of &lt;0.2m. Overall the profile is generally at a medium level compared to the range recorded from previous surveys, with the exception of chainage 65m to 85m (area of upper beach erosion) where the levels are the lowest on record.</p> <p>At profile <b>1aNTDC06A</b>, the dune-cliff face has not significantly changed in form or position. As with section 6, the survey report notes '<i>no access to middle of section 6a due to seed protection fences</i>'. There has been very little change from the toe of the dunes at chainage 80m to chainage 110m. Between chainage 110m to 130m a small berm has formed through the accretion of 0.4m. The middle beach has been eroded by up to 0.5m between chainage 130m and 185m. A second wider berm has formed between chainage 175m and 230m through accretion of 0.4m. The lower beach seawards of chainage 235m has eroded by up to 0.7m. Overall the September 2017 profile is at a relatively medium level compared to the range recorded from the previous surveys, with the exception of the two berms which show the highest recorded levels in those areas.</p> <p>Profile <b>1aNTDC07</b> is located approximately 50m south of the access route through the dunes towards the southern end of the bay. The dune-cliff has not significantly changed in form or position since the last survey. As with section 6 and 6a, the survey report notes '<i>no access to middle of section 7 due to seed protection fences</i>'. The profile shows a similar pattern to profile <b>1aNTDC06A</b> with variable accretion and erosion and the formation of two berms. There has been a small amount of accretion</p>	<p>Since the last survey the dunes have retained the same form and position. The profiles generally show alternating sections of accretion and erosion, with the formation of berms in the upper and mid beach with some erosion in the mid beach as well as the lower beach.</p> <p><b>Longer term trends:</b> Overall, the beaches have retained a similar form but are towards the upper bound of the range of previous surveys, particularly in the foreshore.</p>

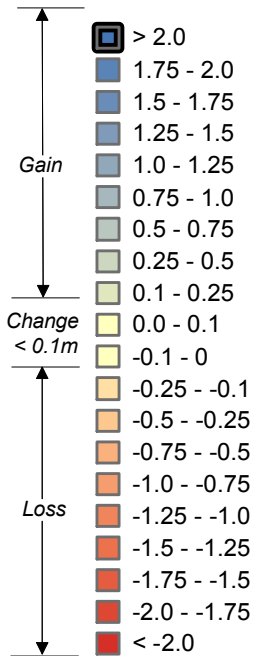
**Appendix B - Map 3**

<p><b>23<sup>rd</sup> October 2017</b></p>	<p><b>Topographic Survey:</b></p> <p>Whitley Sands is covered by an annual topographic survey, which commenced in October 2010.</p> <p>Data from the most recent topographic survey (Full Measures, autumn 2017) have been used to create a digital ground model (DGM) (Appendix B – Map 1) using a GIS. A difference plot has also been produced using the DGM (Appendix B – Map 3) produced from the last produced topographic survey (Full Measures, autumn 2016) and the present survey.</p> <p>The difference plot shows generally shore parallel changes. Overall accretion dominates the southern end and centre of the bay, with erosion being slightly more predominant in the north of the bay. The beach in the north shows erosion across the upper and mid beach, with little change on the lower beach. The centre of the bay shows erosion in the upper beach but accretion across the mid and lower beach. The beach at the southern end of the bay shows erosion on the upper beach, accretion in the mid beach, and patchy erosion on the lower beach.</p> <p>This is a comparison of annual surveys, rather than a biannual comparison like the beach profiles, and therefore the changes observed in the detailed profiles differ from this pattern of change in the bay as whole, indicating that much of this change is likely to have happened in the first six months since the previous survey.</p>	<p>The topographic survey indicates there to have been a movement of sediment towards the southern end of the bay. This is similar to the pattern recorded in the Autumn 2016 survey. In the autumn 2014 Full Measures survey there was a northerly movement of sediment recorded, suggesting the beach responds to storm directions that dominate over the monitoring period.</p>

**DIFFERENCE BETWEEN TOPOGRAPHIC SURVEYS**

Sept 2016 to Oct 2017

- The topographic survey indicates that sediment movements in Whitley Bay have, in general terms, 'reverted to type' with apparent sediment movement being towards the southern end of the bay.
