**Cell 1 Regional Coastal Monitoring Programme
Update Report 3: 'Partial Measures' Survey 2011**

North Tyneside Council

June 2011

^(*) The present report is **Update Report 3** and provides an analysis of the 2011 Partial Measures survey for North Tyneside Council's frontage. It is intended as a brief update of the key findings from this survey to maintain an understanding of ongoing changes.

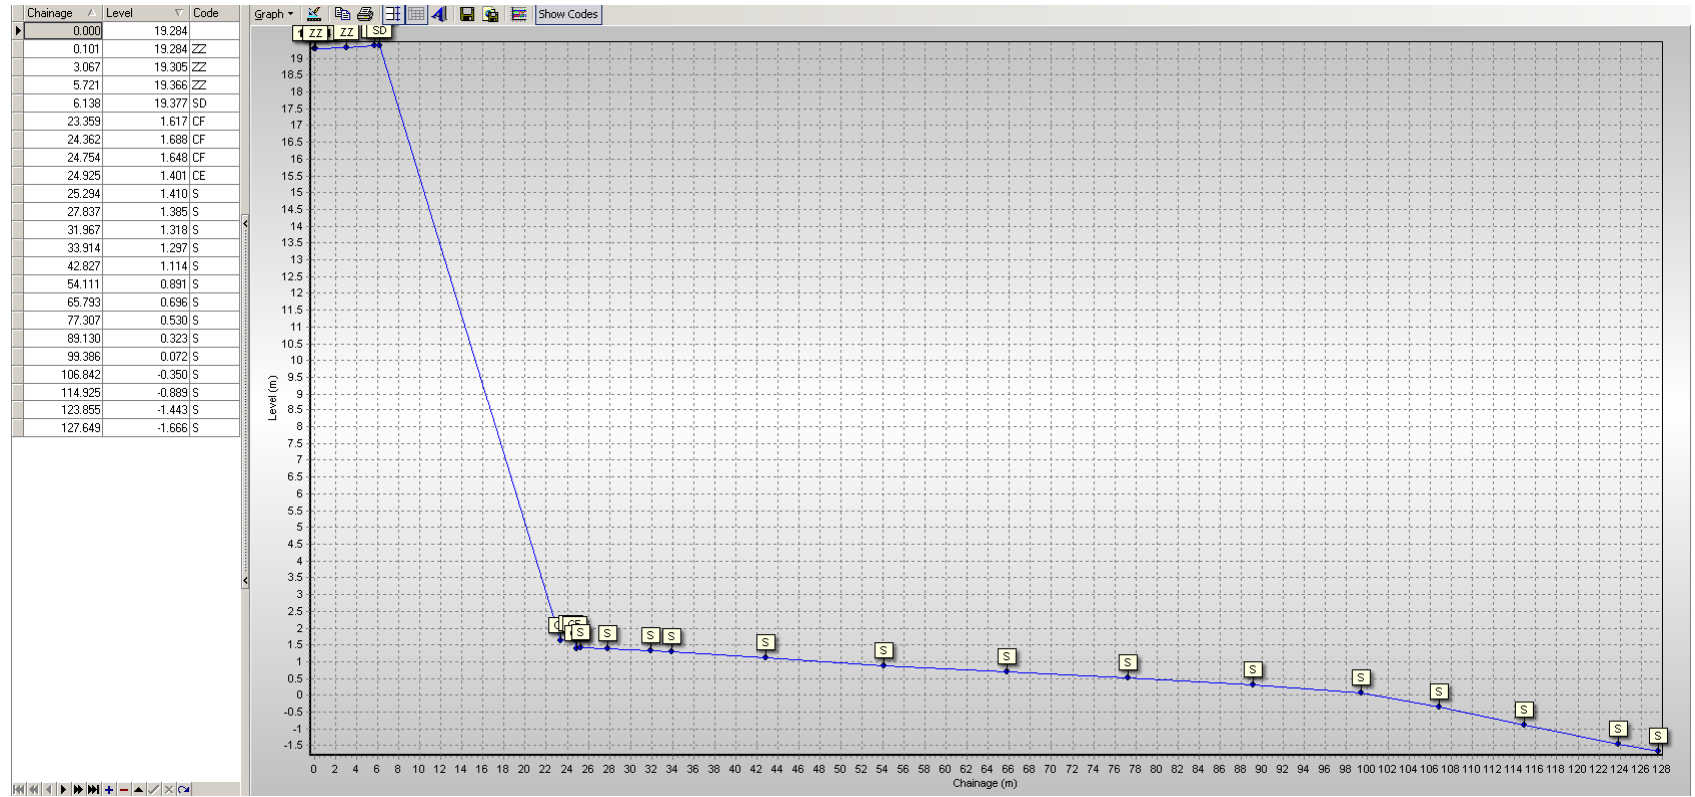
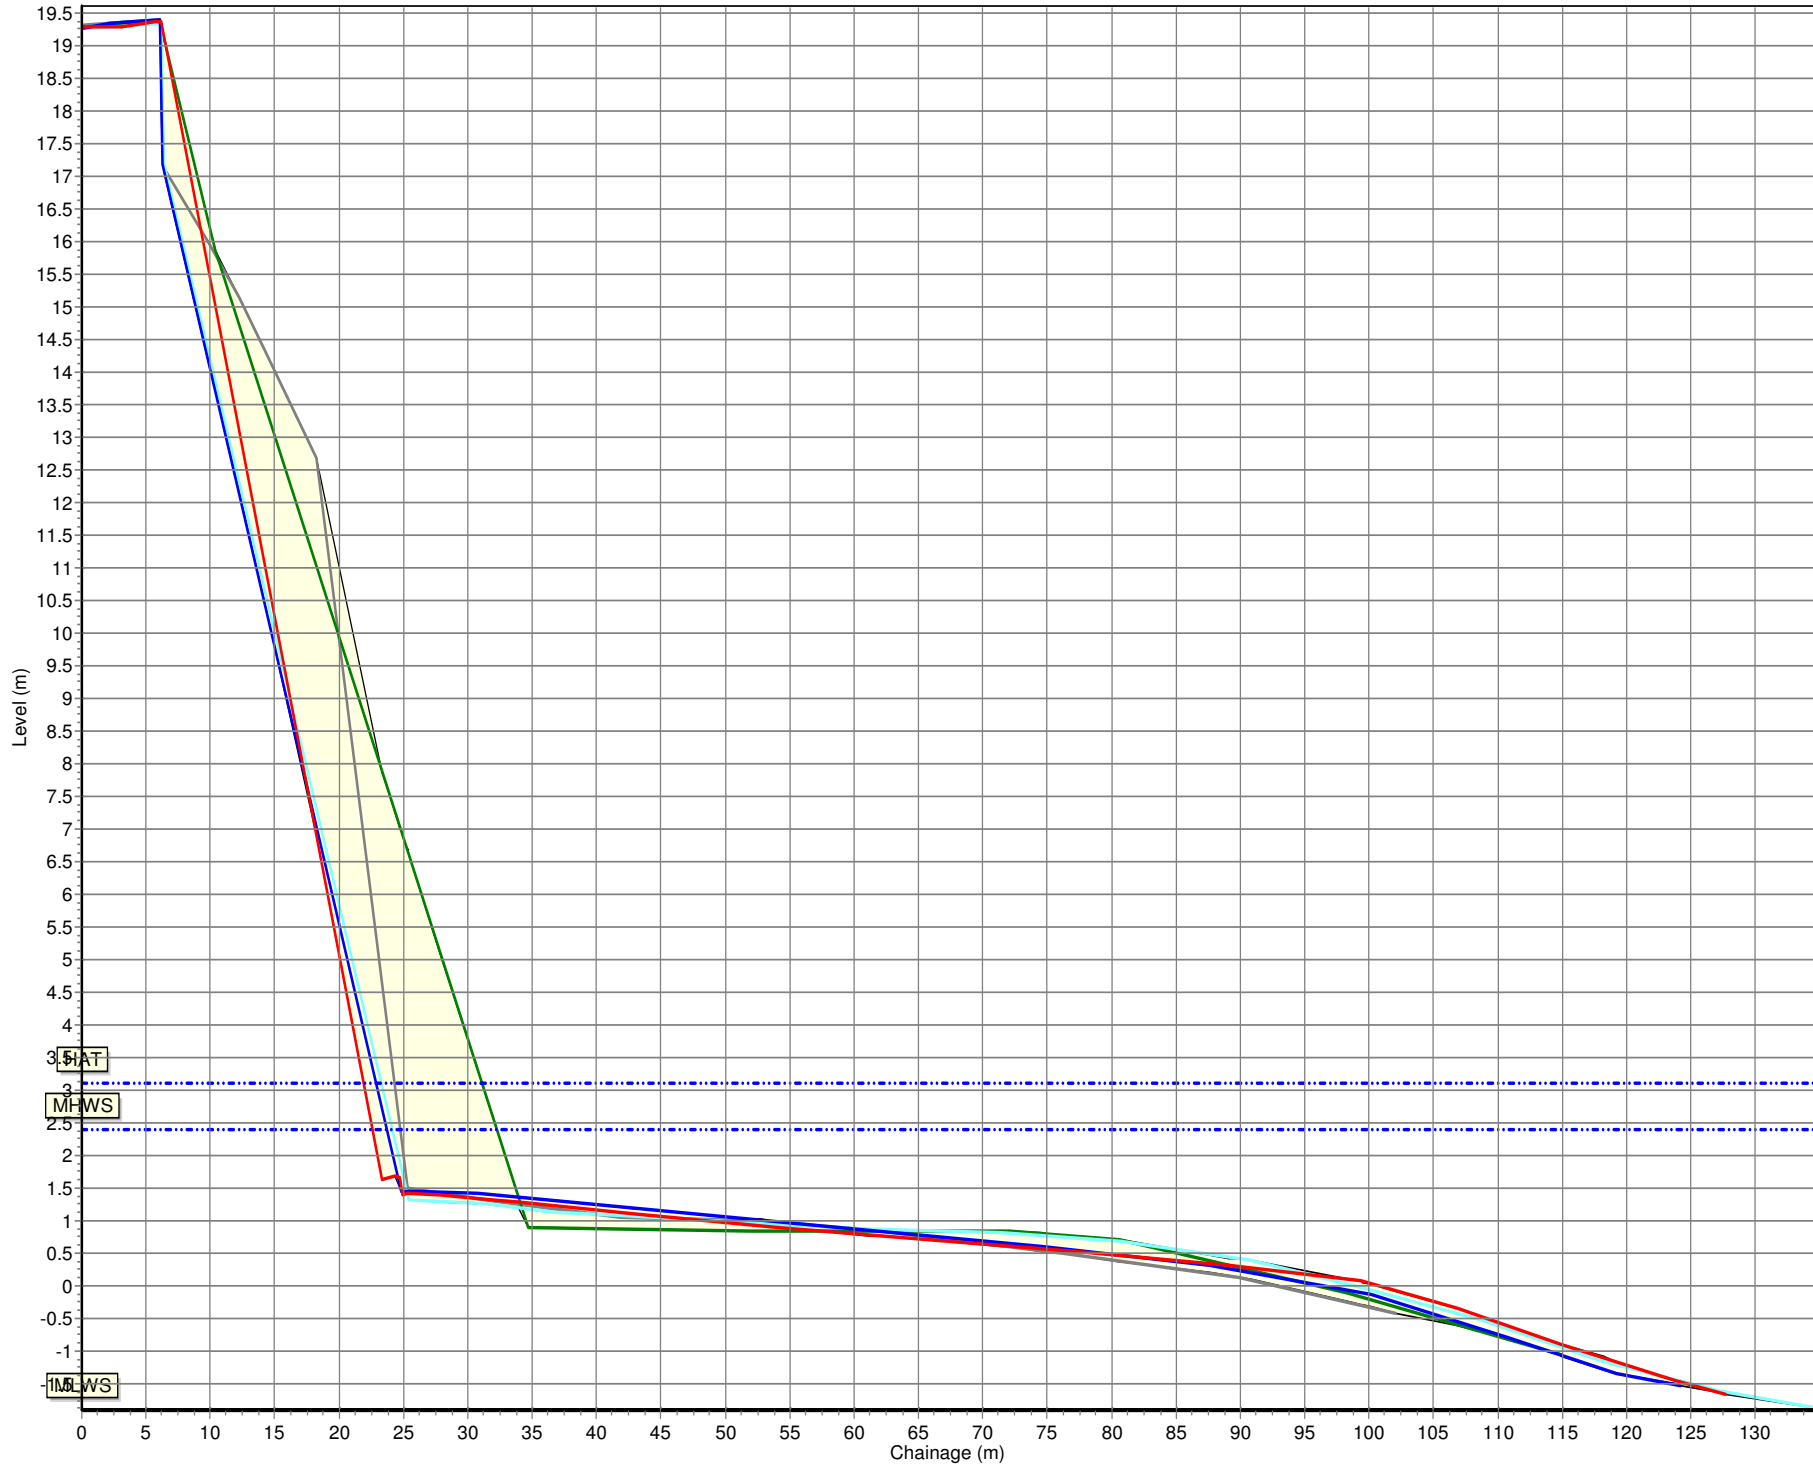
1aNTDC05 - 04/03/2011

Survey Date	Description of Changes Since Last Survey	Interpretation
03-2011	<p>Beach Profiles:</p> <p>Cullercoats Bay is covered by one beach profile line (Appendix A). This was surveyed annually each autumn between 2002 and 2009. From spring 2010 onwards, it has been surveyed 6-monthly.</p> <p>The cliff top position along NTDC05 has remained constant since surveys began in April 2002, but there are apparent changes at the toe of the cliff between September 2009 and March 2011. A section of cliff just above the toe appears to have slightly cut back. The foreshore levels remain similar to all previous surveys.</p>	<p>The surveyors report that the cliff top and large parts of the face have not been surveyed due to exposure. Instructions have been given to the surveyors at this profile not to attempt a cliff top or cliff face capture if conditions are unsafe. Therefore it is unclear whether the apparent cut back near the toe of the cliff is an actual change (i.e. notching at the cliff toe) or whether this is an artefact of the survey points. The next survey should clarify this situation. The foreshore levels remain highly stable as the beach is well sheltered by the Cullercoats piers.</p>

In Cullercoats Bay, the cliff face was not surveyed along profile NTDC05 due to high exposure on the day of the survey.

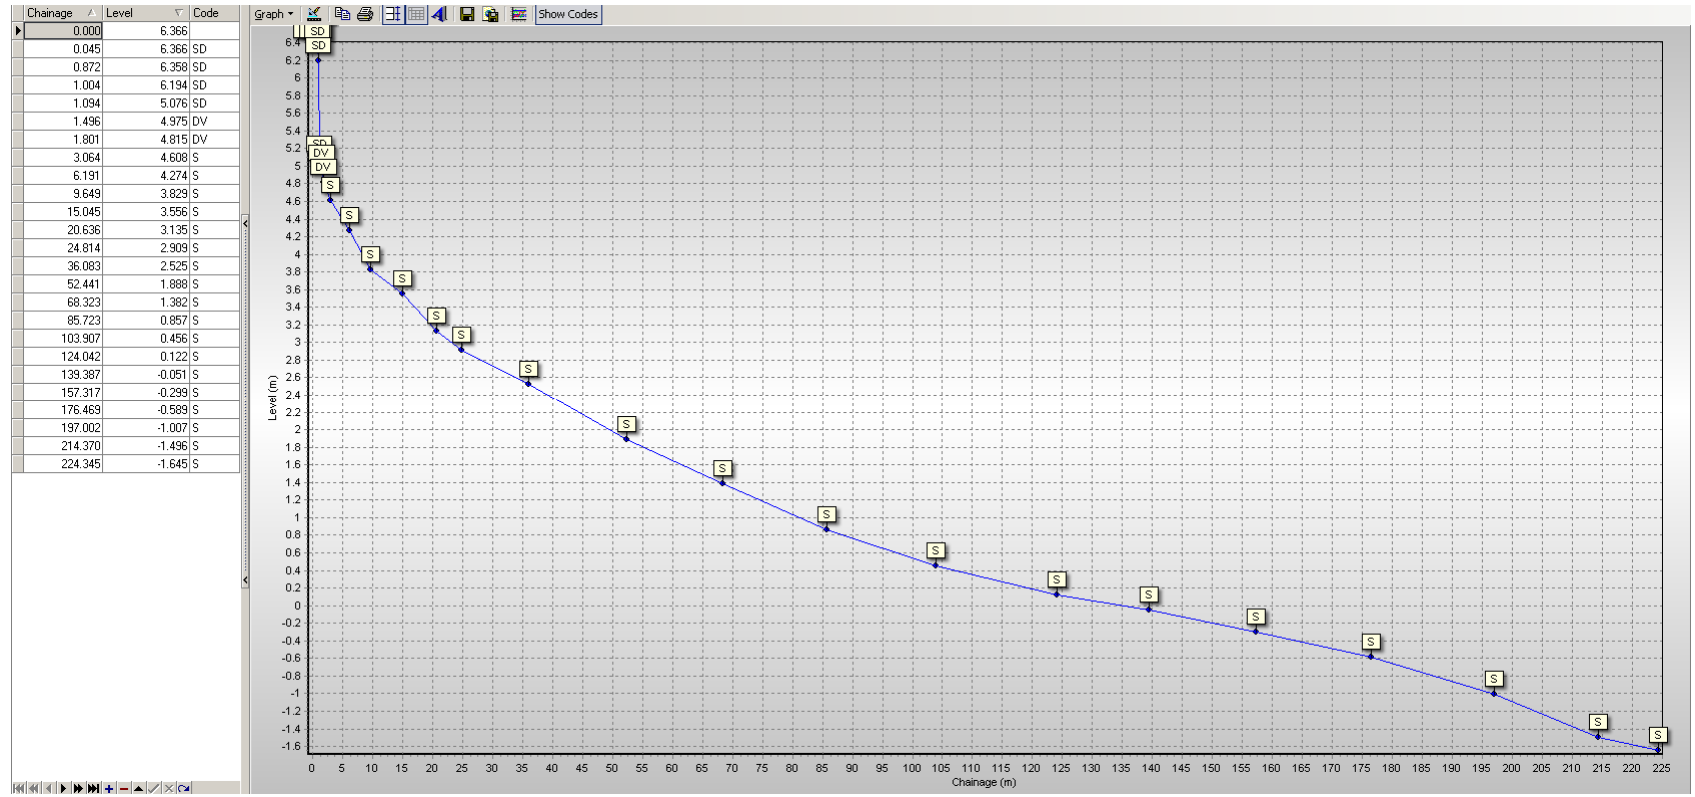
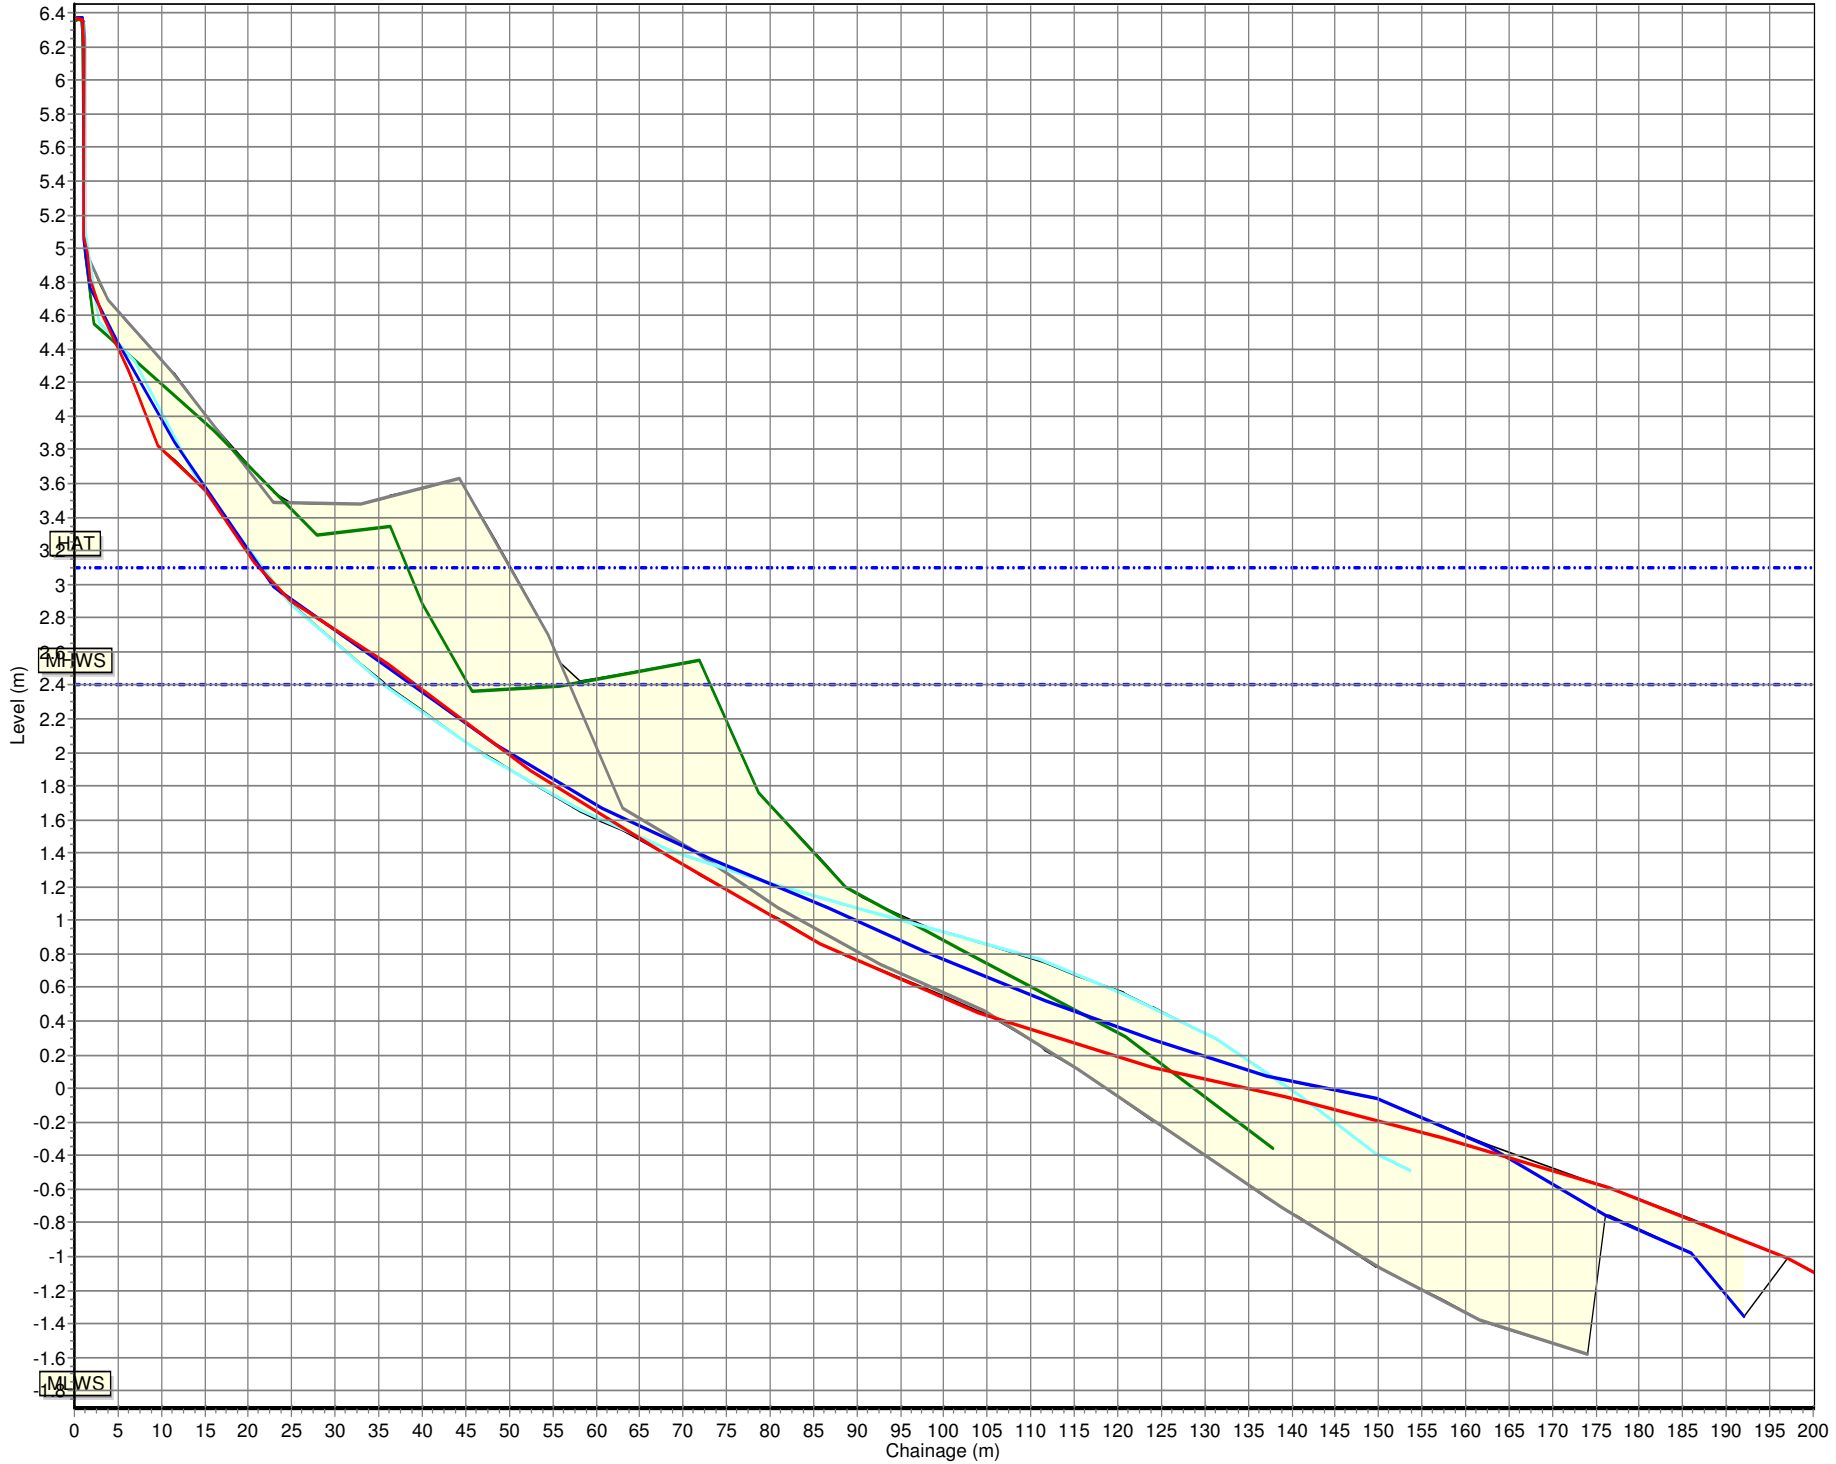
1aNTDC08 - 04/03/2011

Survey Date	Description of Changes Since Last Survey	Interpretation
03-2011	<p>Beach Profiles:</p> <p>King Edward's Bay is covered by one beach profile line (Appendix A). This was surveyed annually each autumn between 2002 and 2009. From spring 2010 onwards, it has been surveyed 6-monthly.</p> <p>Profile NTDC08 experienced a localised dip in beach level between chainages of 5-15m and more extensive lowering, by up to 0.2m seaward of a chainage of 50m. There were no berm features present along the profile.</p>	<p>King Edward's Bay has historically had a tendency to exhibit successive bermed and flat profile features, but the form of the profile remains similar in the September 2010 and March 2011 surveys, albeit with slight beach lowering along the upper beach to the latter date.</p>

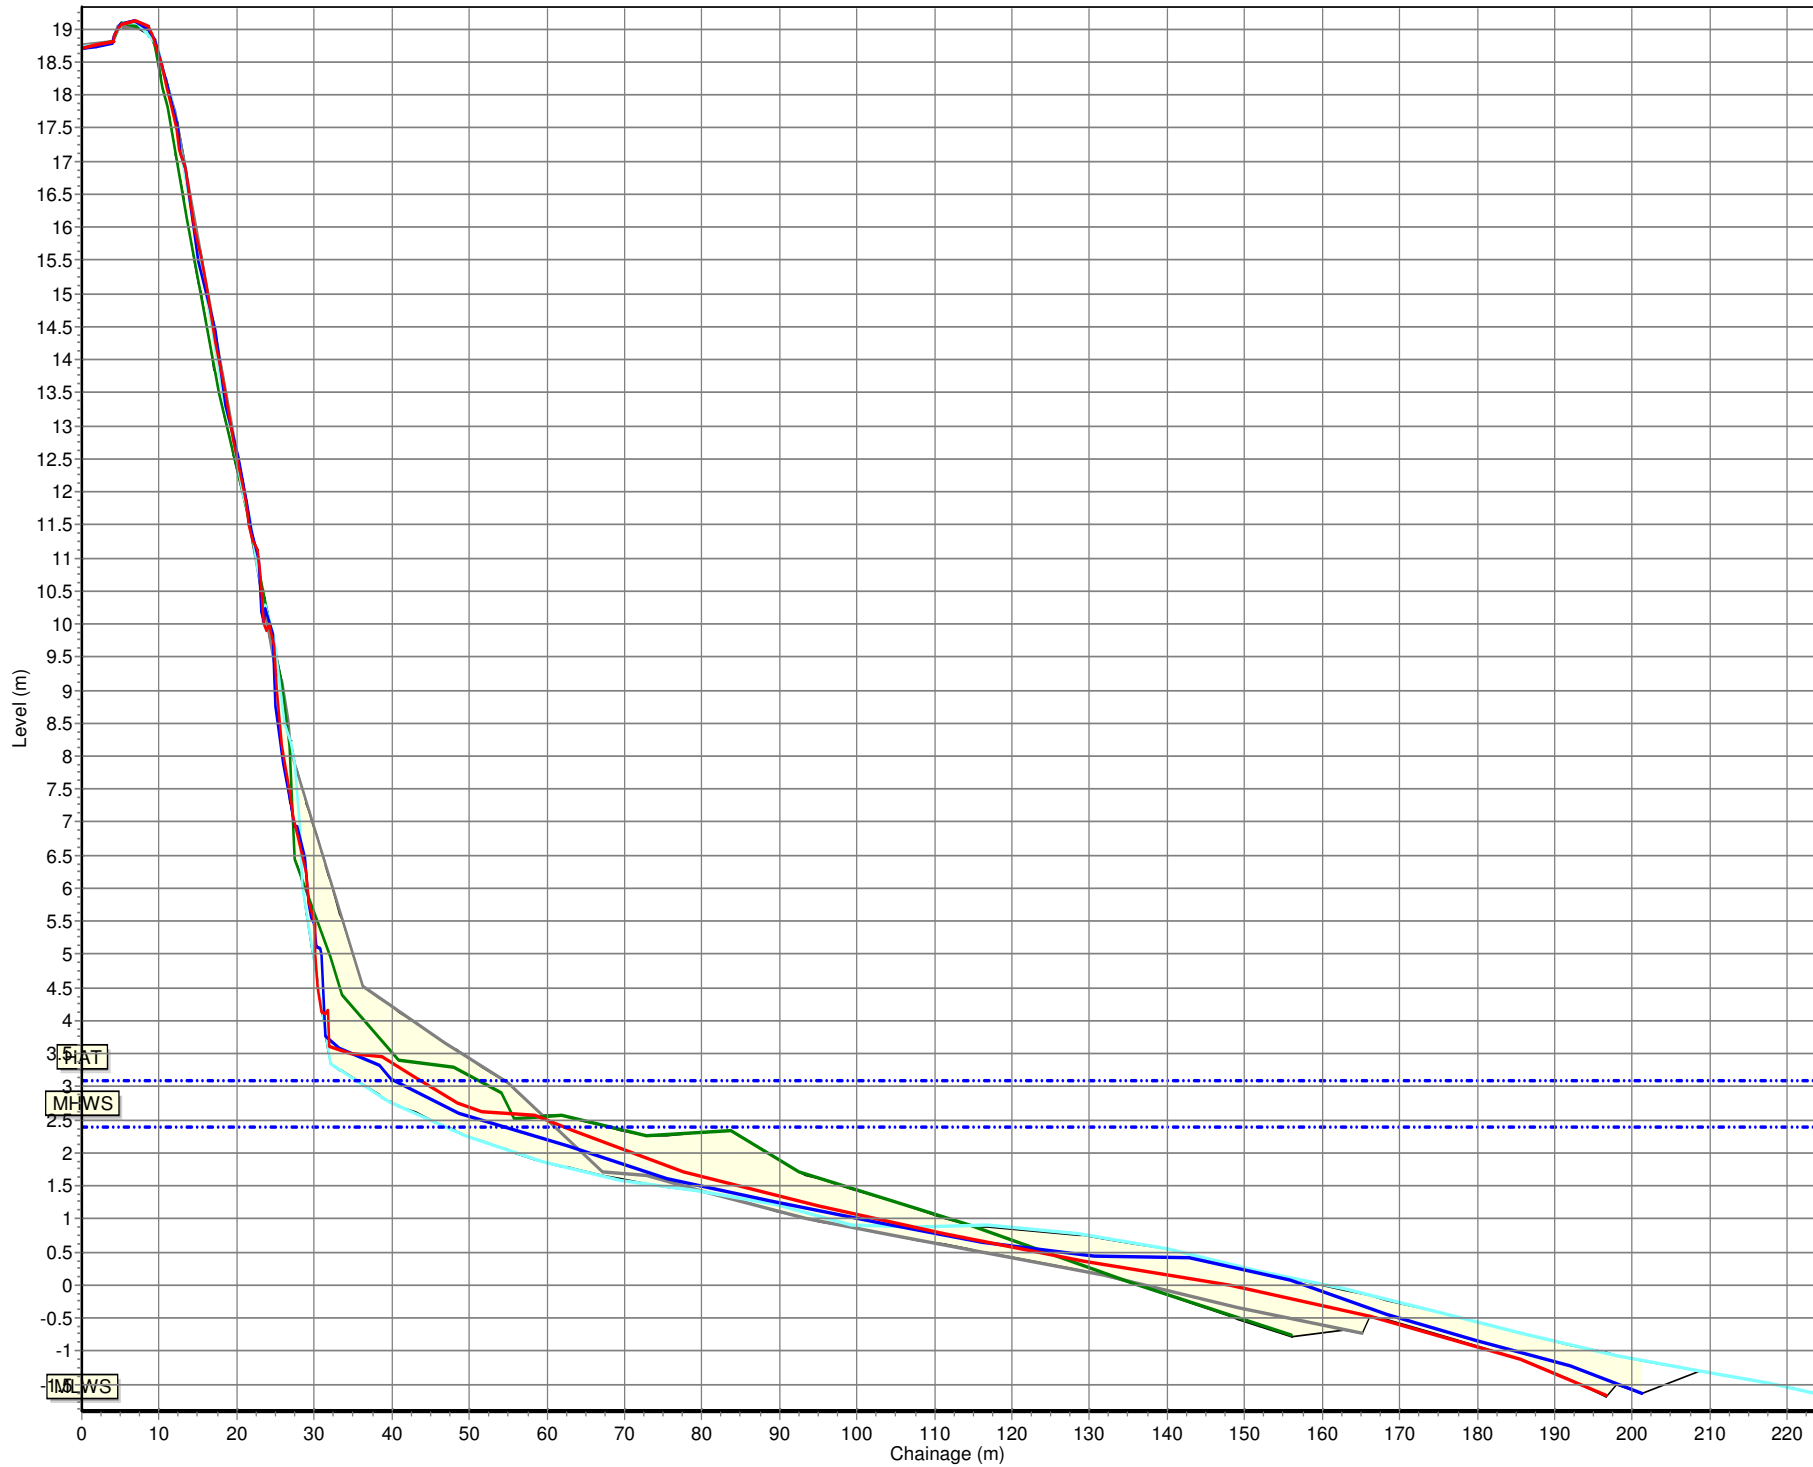
1aNTDC06 - 04/03/2011

- Slumping was observed in the dune face along part of Tynemouth Longsands (NTDC06), but here the dune toe has not eroded further landwards and the other profiles from Longsands reveal stable dune and beach formations.
