**Cell 1 Regional Coastal Monitoring Programme
Update Report 3: 'Partial Measures' Survey 2012**

North Tyneside Council

**North Tyneside Council
Final Report**

February 2013

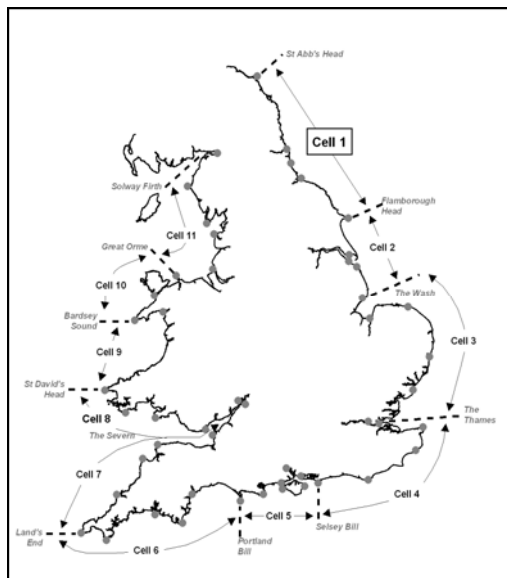
Figure 1 Sediment Cells in England and Wales

The Cell 1 Regional Coastal Monitoring Programme covers approximately 300km of the north east coastline, from the Scottish Border (just south of St. Abb's Head) to Flamborough Head in East Yorkshire. This coastline is often referred to as 'Coastal Sediment Cell 1' in England and Wales (Figure 1).

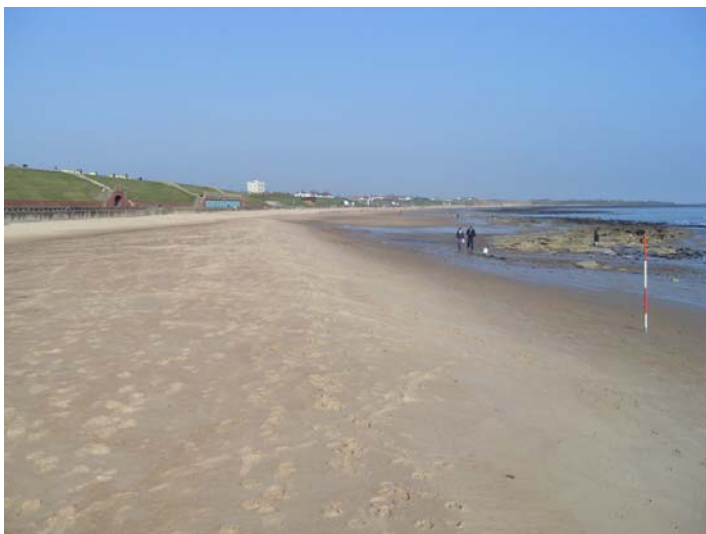
Plate 1 – Survey photograph 1aNTDC04_20120322_N5.JPG

Survey Date	Description of Changes Since Last Survey	Interpretation
	Profile 1aNTDC04a is located to the south of Whitley Sands. Since the last survey, beach levels at the toe of the seawall to a chainage of 40m (level of 1.2m) have increased by up to 1.5m. Seaward of 60m chainage to the rocky foreshore, beach levels have fallen by up to 1.2m.	To the south of Whitley Sand the increases are the largest observed. This suggests particularly significant storms over the winter have transported sediment into the system.
