**Cell 1 Regional Coastal Monitoring Programme
Update Report 6: 'Partial Measures' Survey 2014**

**North Tyneside Council
Final Report**

(*) The present report is **Update Report 6** and provides an analysis of the 2014 Partial Measures survey for North Tyneside Council's frontage.

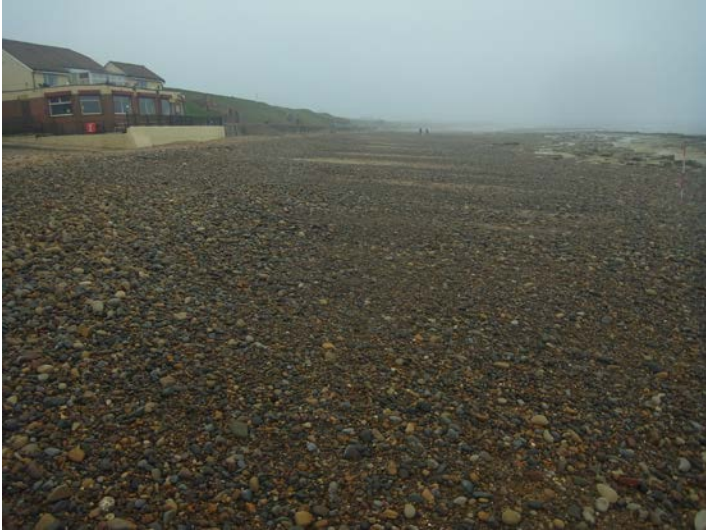
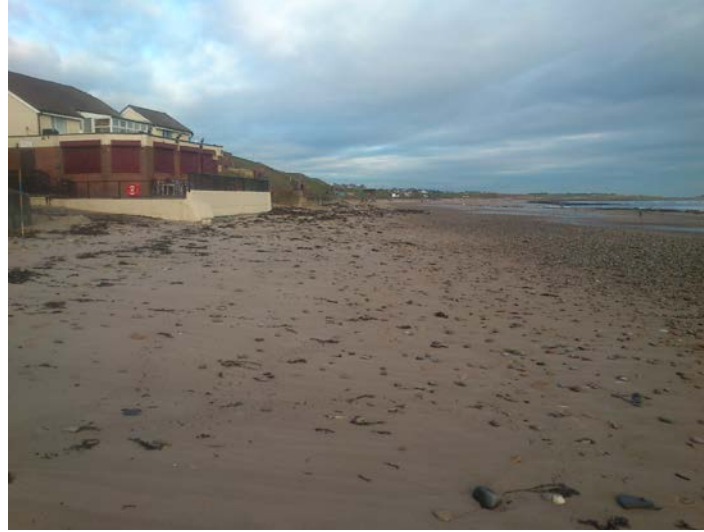
Survey Date	Description of Changes Since Last Survey	Interpretation
	<p>the survey photographs in Plates 1 and 2. The previous spring survey (Partial Measure 2013) also noted the presence of coarse shingle indicating that this may be a seasonal change.</p> <p>Profile 1aNTDC04a is located to the south of Whitley Sands. Beach levels have fallen across the profile by approximately 0.5m, with the exception of some sections seawards of 50m chainage where the underlying rock had previously been exposed and there was no loose material present to erode</p>

Plate 1 – Survey photograph 1aNTDC04_20140402_N14.JPG

Plate 2 – Survey photograph 1aNTDC04_20131017_N4.jpg

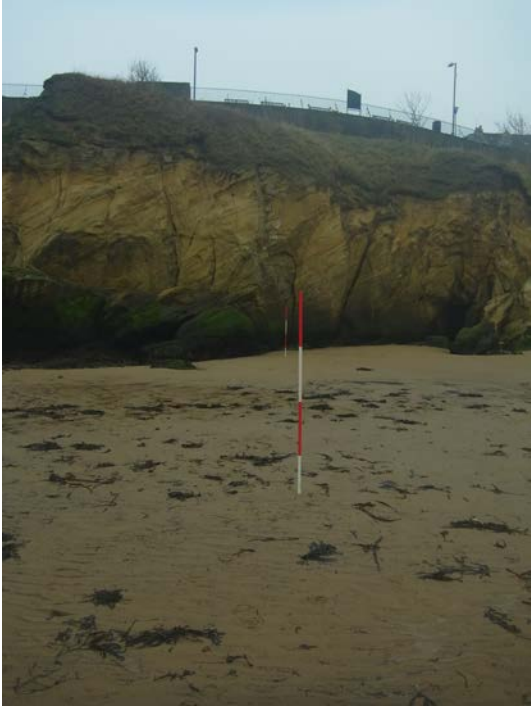
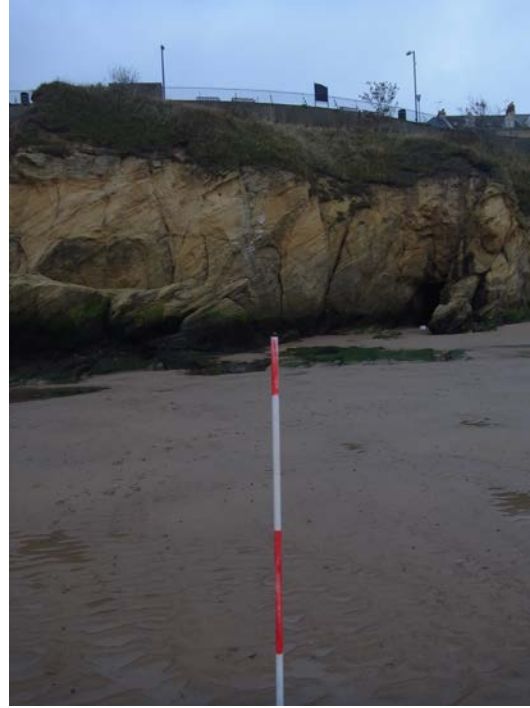
Survey Date	Description of Changes Since Last Survey	Interpretation
<p>Apr 2014</p>	<p>Beach Profiles:</p> <p>Cullercoats Bay is covered by one beach profile line for the Partial Measures survey (Appendix A). This was surveyed annually each autumn between 2002 and 2009. From spring 2010 onwards, it has been surveyed bi-annually. The last survey was the autumn 2013 Full Measures survey.</p> <p>The cliff top position along 1aNTDC05 has remained constant since surveys began in April 2002, but there have been apparent changes along the cliff face. The survey report notes '<i>cliff not measured at section 5 due to dangerous access</i>'. It is therefore likely that the changes observed are related to the survey technique used rather than actual change.</p> <p>From the cliff toe to a chainage of 48m beach levels have increased by almost 0.5m and the rock previously exposed (Full Measures 2013) now has a covering of sand (Plate 3 and Plate 4). Seaward of 48m chainage, beach levels have remained stable down to 95m chainage. Seawards of this the large toe berm observed in the previous survey (Full Measures, autumn 2013) is no longer present and the profile is now flatter with a drop in beach level of approximately 1.4m. Although the upper beach levels have increased slightly, visual observations indicate that the increase in area is likely to be smaller than the area of material lost from the toe berm. This suggests that storm waves may have moved this store of material further offshore. The berm was a new feature in the Full Measures 2013 survey and has not been observed in any other surveys. The profile has therefore returned to a similar form to those measured in spring 2013 and earlier.</p>	<p>As in previous surveys, the surveyors report that access to the cliff has not been possible.</p> <p>The upper beach has accreted to cover the underlying rock exposed in the previous survey. The berm previously observed at the toe of the beach is no longer present resulting in a significant reduction in level at the beach toe (up to 1.4m).</p> <p>Although the upper beach levels have increased slightly, visual observations indicate that the increase in area is likely to be smaller than the area of material lost from the toe berm. This suggests that storm waves may have moved this store of material further offshore.</p> <p>Longer term trends: The beach levels observed are within the bounds of previous surveys.</p>

Plate 3 – Survey photograph 1aNTDC05_20140403_Up3.JPG

Plate 4 – Survey photograph 1aNTDC05_20131018_Up3.jpg

At profile 1aNTDC05 the cliff was not measured due to dangerous access. Access to this profile is noted to have been dangerous in the previous partial measures and full measures reports, and therefore consideration should be given to changing the location of this survey.

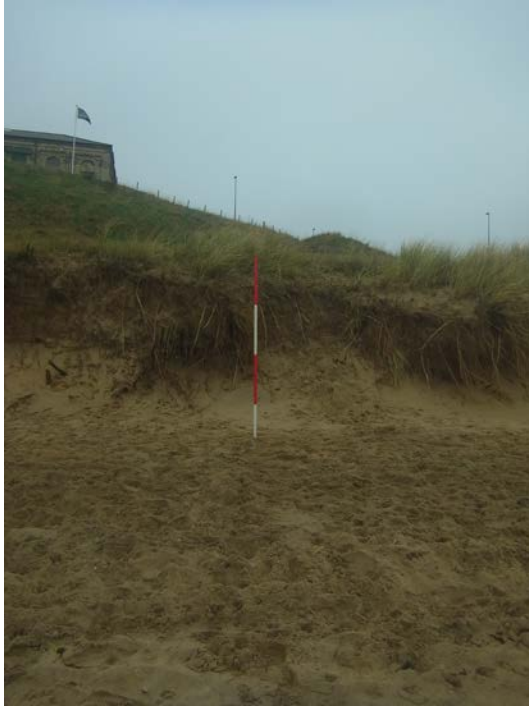
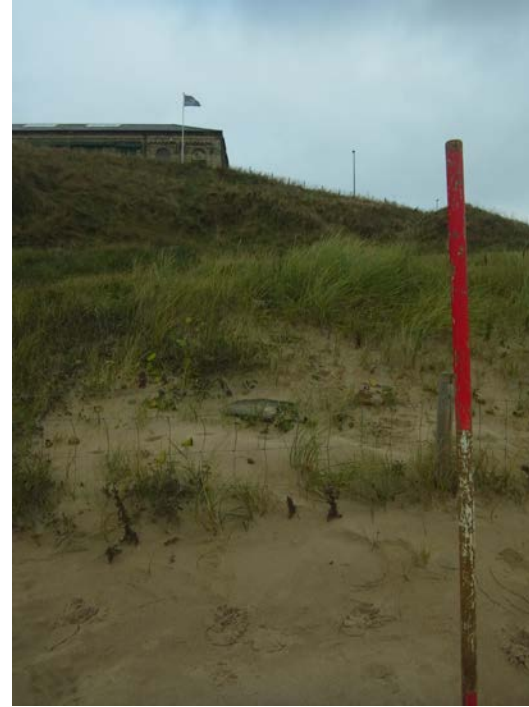
Survey Date	Description of Changes Since Last Survey	Interpretation
Apr 2014	<p>Beach Profiles:</p> <p>Tynemouth Long Sands is covered by three beach profile lines for the Partial Measures survey (Appendix A). Profiles 1aNTDC06 and 1aNTDC07 were initially surveyed annually each autumn between 2002 and 2009. A third profile, 1aNTDC06A, was later added in the centre of the frontage. From spring 2010 (Partial Measures) onwards, they have been surveyed bi-annually. The last survey was the autumn 2013 Full Measures survey.</p> <p>1aNTDC06 is located approximately 150m south of the access road/ramp towards the north of the bay. The profile for the dune-cliff face is limited due to a lack of data points in the profile plot. The survey report notes ‘<i>no access to middle of section 6 due to seed protection fences</i>’. The beach levels fluctuate across the profile with a small amount of erosion (<0.5m) on the upper beach and slight accretion on the middle of the profile. The beach toe has moved seawards slightly. Overall this has led to a smoother profile with no prominent berm features. The magnitude of change is in the order of 0.5m across the profile, suggesting a cross-shore movement of material.</p> <p>At profile 1aNTDC06A, the profile for the dune-cliff face is a straight line; a result of a lack of data points in the profile plot. This is explained by the note in the survey report; which states ‘<i>no access to middle of section 6A due to seed protection fences</i>’. The upper beach has eroded since the previous survey and the toe of the dunes has been cut back (see Plate 5 and Plate 6). The toe of the beach has accreted, indicating that material has been moved down the beach by storm waves over the winter period.</p> <p>Profile 1aNTDC07 is located approximately 50m south of the access route through the dunes towards the southern end of the bay. As with the other profiles the dune-cliff face is a straight line; a result of a lack of data points in the profile plot. As at 1aNTDC06A the upper beach has decreased slightly in level and the lower beach has increased, indicating movement of material down the beach by storm waves over the winter period.</p>	<p>At Tynemouth Long Sands, the dune-cliff face was not surveyed due to access constraints, but survey photographs suggest that erosion of the dunes has occurred, probably associated with the storm surge. Beach levels along the length of coastline here have fallen on the upper beach and increased on the lower beach. This indicates that material has been moved seawards by wave action over the winter period. At Profile 1aNTDC06A the toe of the dunes have been undercut, further indicating the impacts of storm waves and the storm surge experienced over the 2013/2014 winter period.</p> <p>Longer term trends: Overall, the beaches have retained a similar form and are within the bounds of previous surveys, although they are towards the lower bound. The exception is 1aNTD06A which exhibits the lowest levels recorded to date on the upper beach, from the toe of the dunes which have been undercut down to a chainage of 170m.</p>

Plate 5 – Survey photograph 1aNTDC06a_20140403_Up2.JPG

Plate 6 – Survey photograph 1aNTDC06A_20131018_Up1.JPG

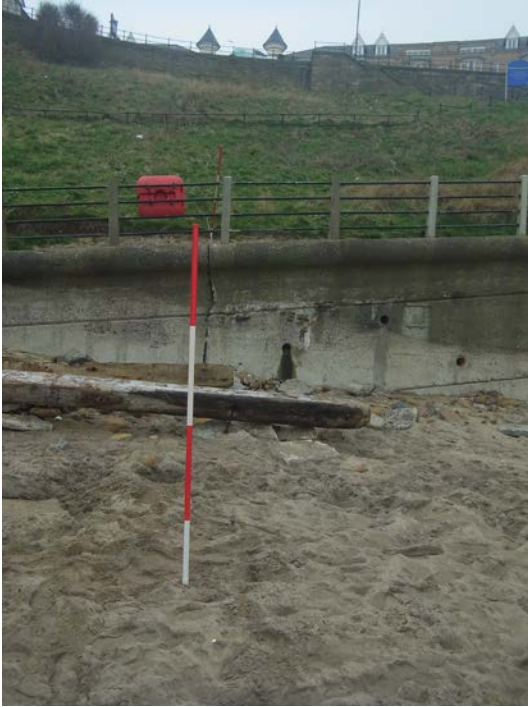
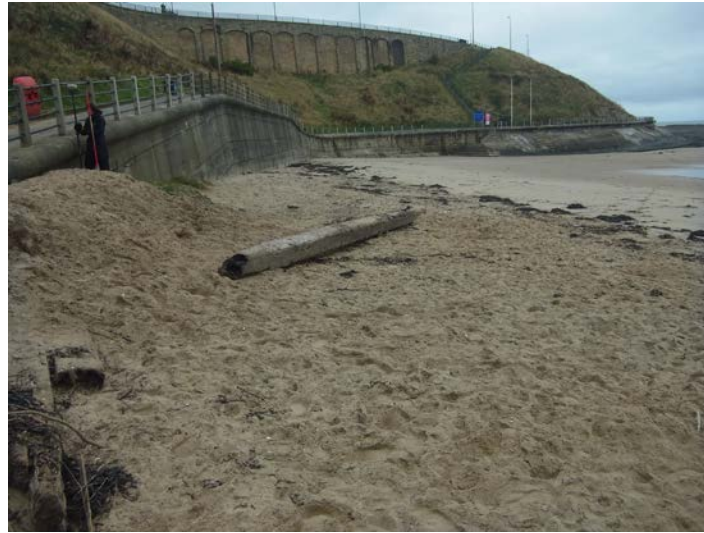
Survey Date	Description of Changes Since Last Survey	Interpretation
<p>Apr 2014</p>	<p>Beach Profiles:</p> <p>King Edward's Bay is covered by one beach profile line for the Full Measures survey (Appendix A). This was surveyed annually each autumn between 2002 and 2009. From spring 2010 onwards, it has been surveyed bi-annually. The last survey was the autumn 2013 Full Measures survey.</p> <p>At profile 1aNTDC08 beach levels have reduced considerably at the top of the profile (by over 1m) and it is noted in the survey report that the sand level is low at the base of the sea wall (Plate 7). At 18m chainage (just above HAT) a berm has developed resulting in an increase in beach level, peaking at an increase of 0.6m. Seawards of the berm the beach level has increased across the profile down to a chainage of 128m and a second berm has formed at about 0.8m elevation. Seawards of 128m the beach steepens compared to the previous measured profile. The change in beach form is likely to be the result of storm waves over the winter period eroding the top of the beach and moving material down the beach.</p>	<p>Since the last survey, the beach at King Edward's Bay beach has dropped significantly at the toe of the seawall. A berm has developed at around HAT and another smaller berm at around 0.8m elevation.</p> <p>Longer term trends: From the toe of the seawall (1m chainage) to about 18m chainage the beach levels are the lowest recorded to date by up to 0.6m. The remainder of the profile is, however, within the bounds of previous surveys, with historic surveys being both higher and lower when compared to present levels.</p>

Plate 7 – Survey photograph 1aNTDC08_20140403_Up2.JPG

Plate 8 – Survey photograph 1aNTDC08_20131018_N2.JPG.

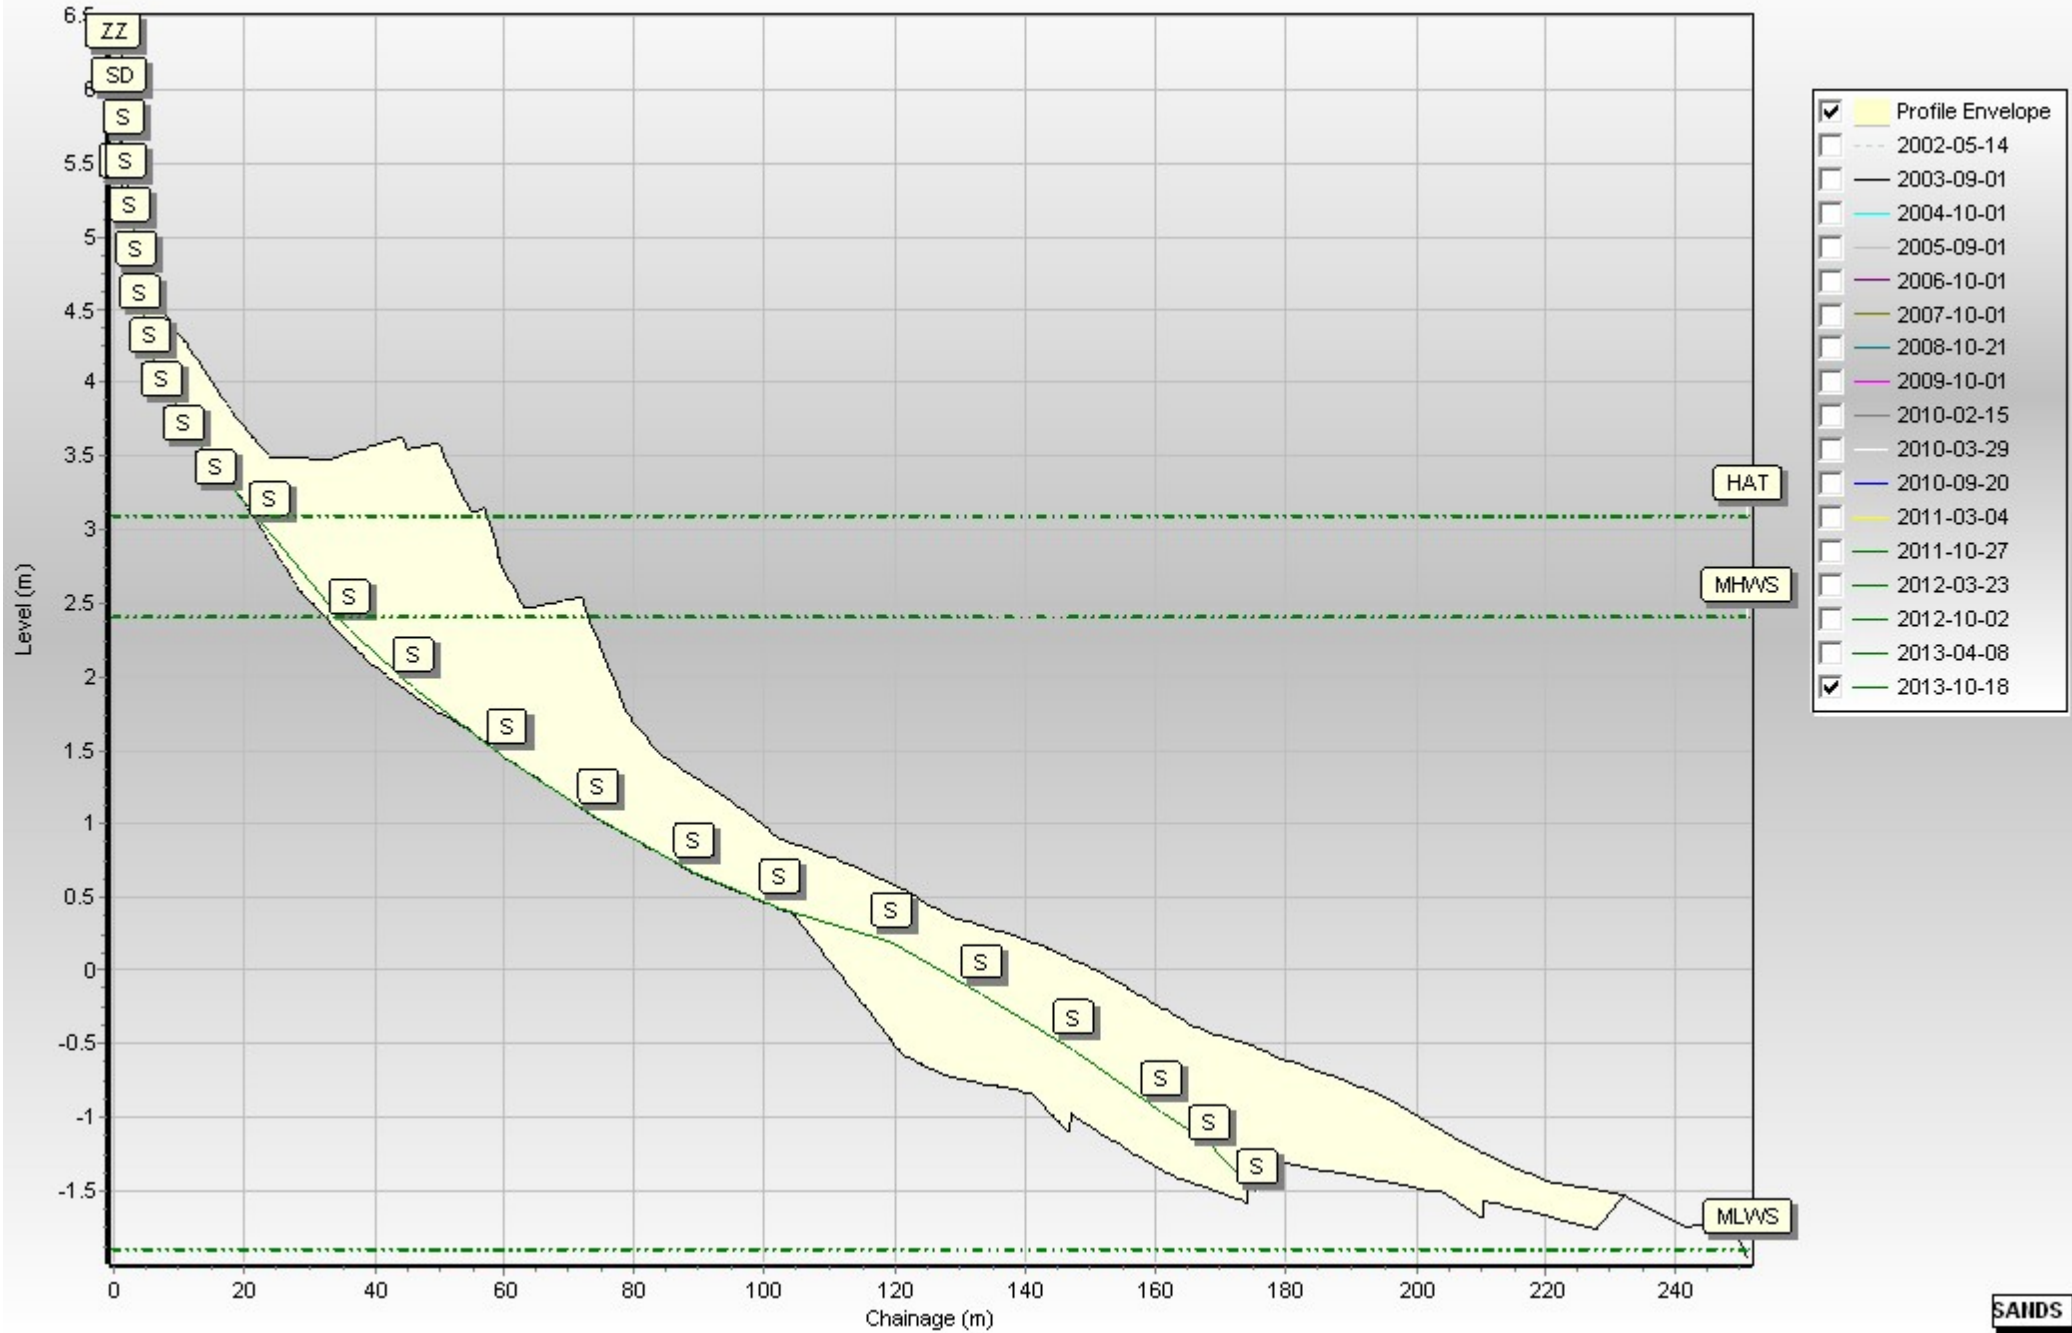
Profiles: 1aNTDC08

- Elsewhere along Tynemouth Long Sands, the recorded profiles and topographic survey present no causes for concern.
- At King Edward's Bay, the recorded profile is the lowest level recorded to date at the toe of the sea wall and across the upper 18m of the beach profile.
