**Cell 1 Regional Coastal Monitoring Programme
Update Report 10: 'Partial Measures' Survey 2018**

North Tyneside Council

May 2018

(*) The present report is **Update Report 10** and provides an analysis of the 2018 Partial Measures survey for North Tyneside Council's frontage.

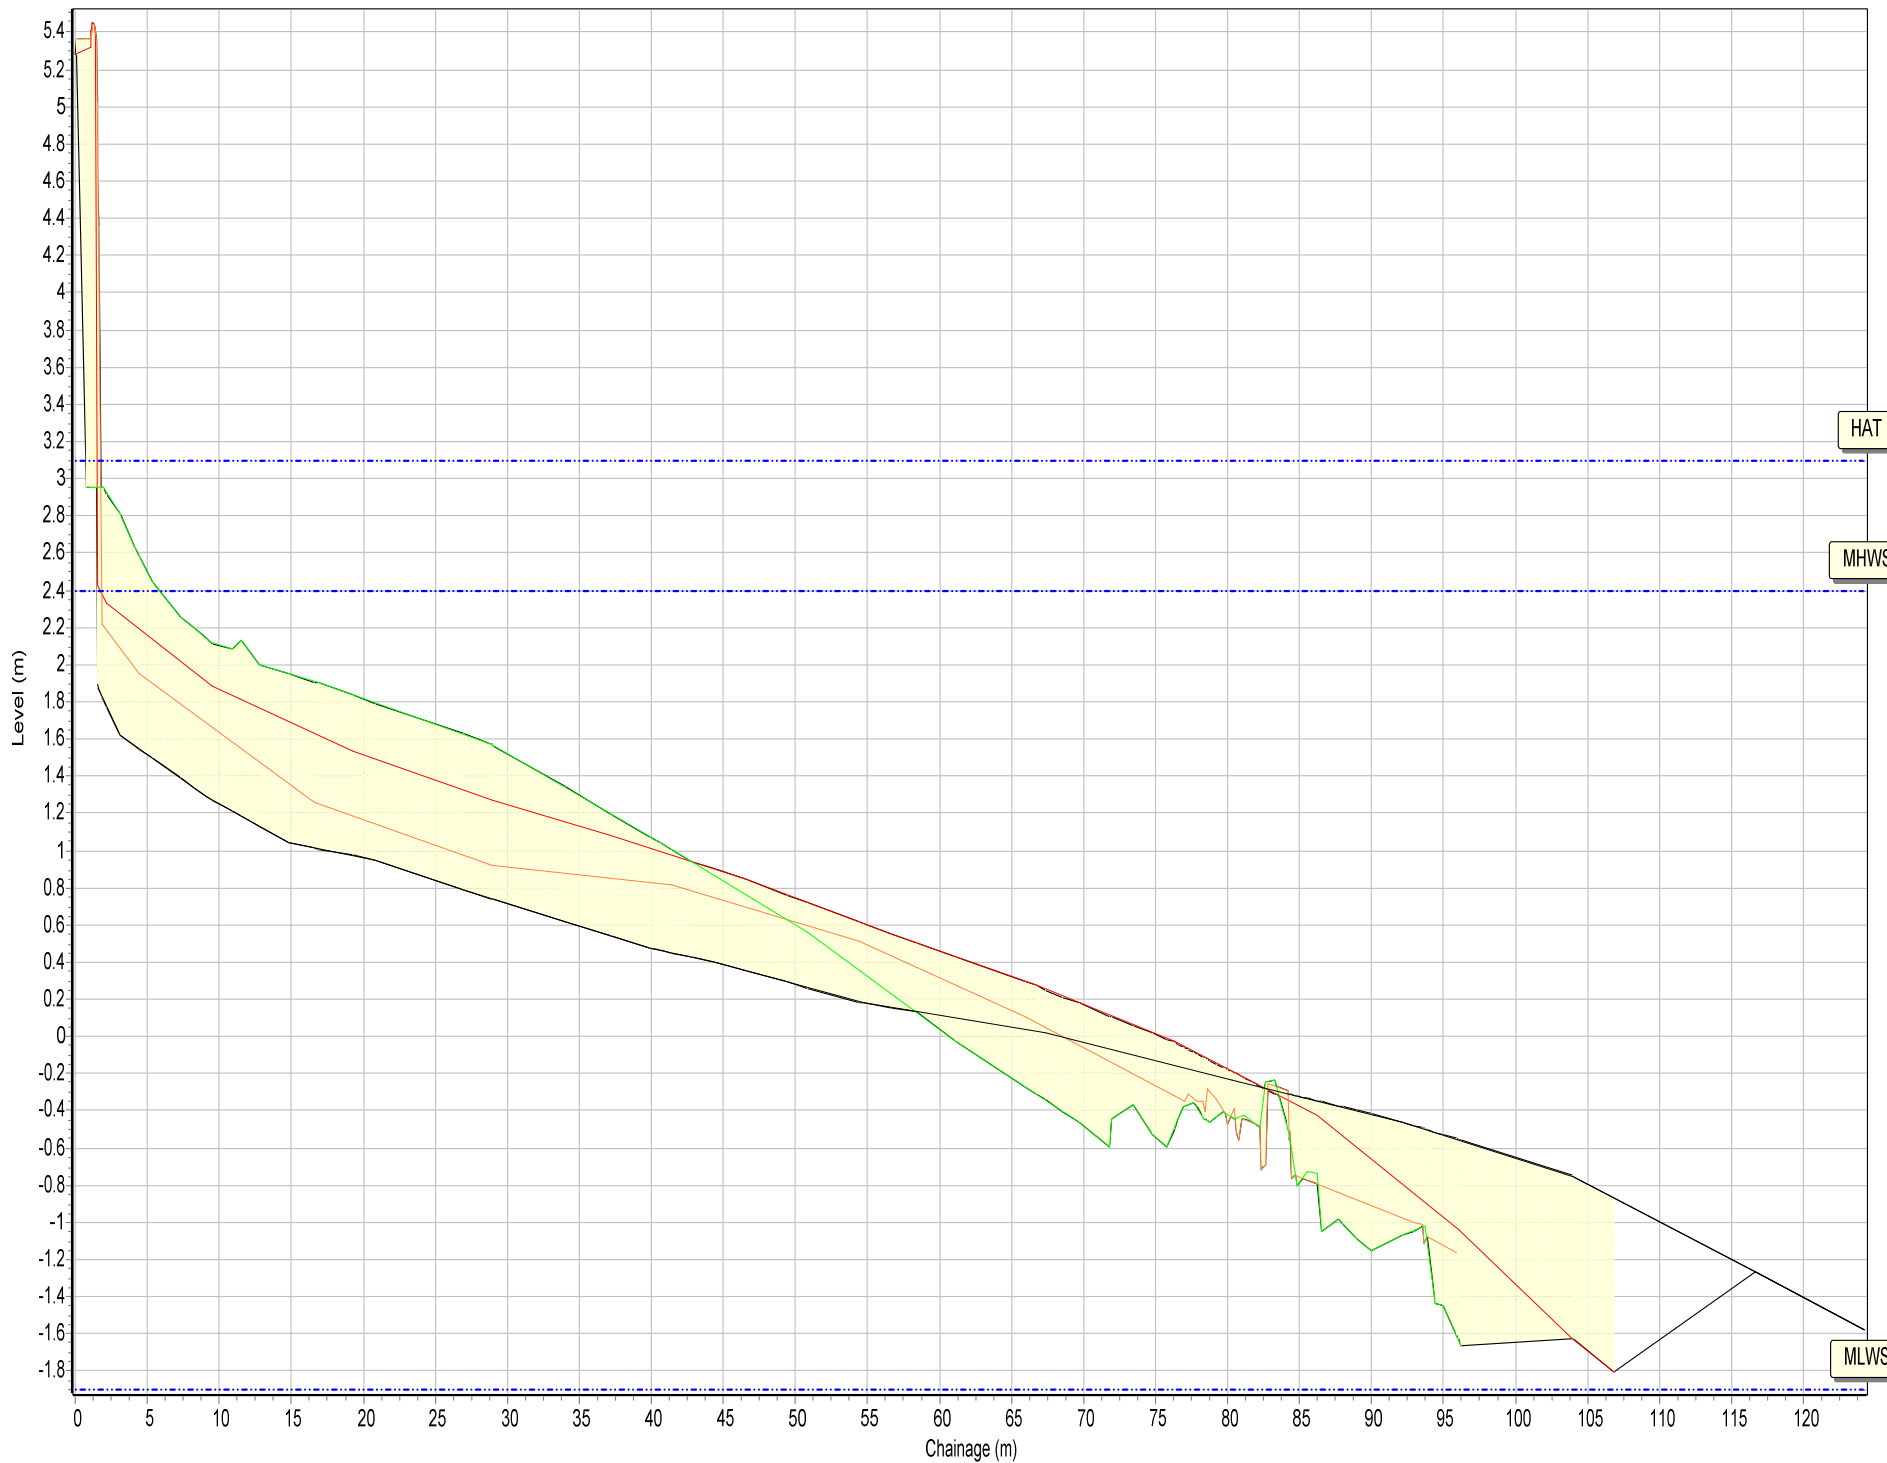
Beach Profiles: 1aNTDC04A

- Construction was however ongoing on the promenade at profile 1aNTDC04A.
- At profile 1aNTDC05 the cliff was not measured due to dangerous access. Access to this profile is noted to have been dangerous in the previous Partial Measures and Full Measures reports, and it is therefore recommended that the beach profile data should start at the cliff toe and the cliff position should be monitored from aerial survey data.
