## **Cell 1 Regional Coastal Monitoring Programme Update Report 12: 'Partial Measures' Survey 2020**

**North Tyneside Council**

**March 2020**

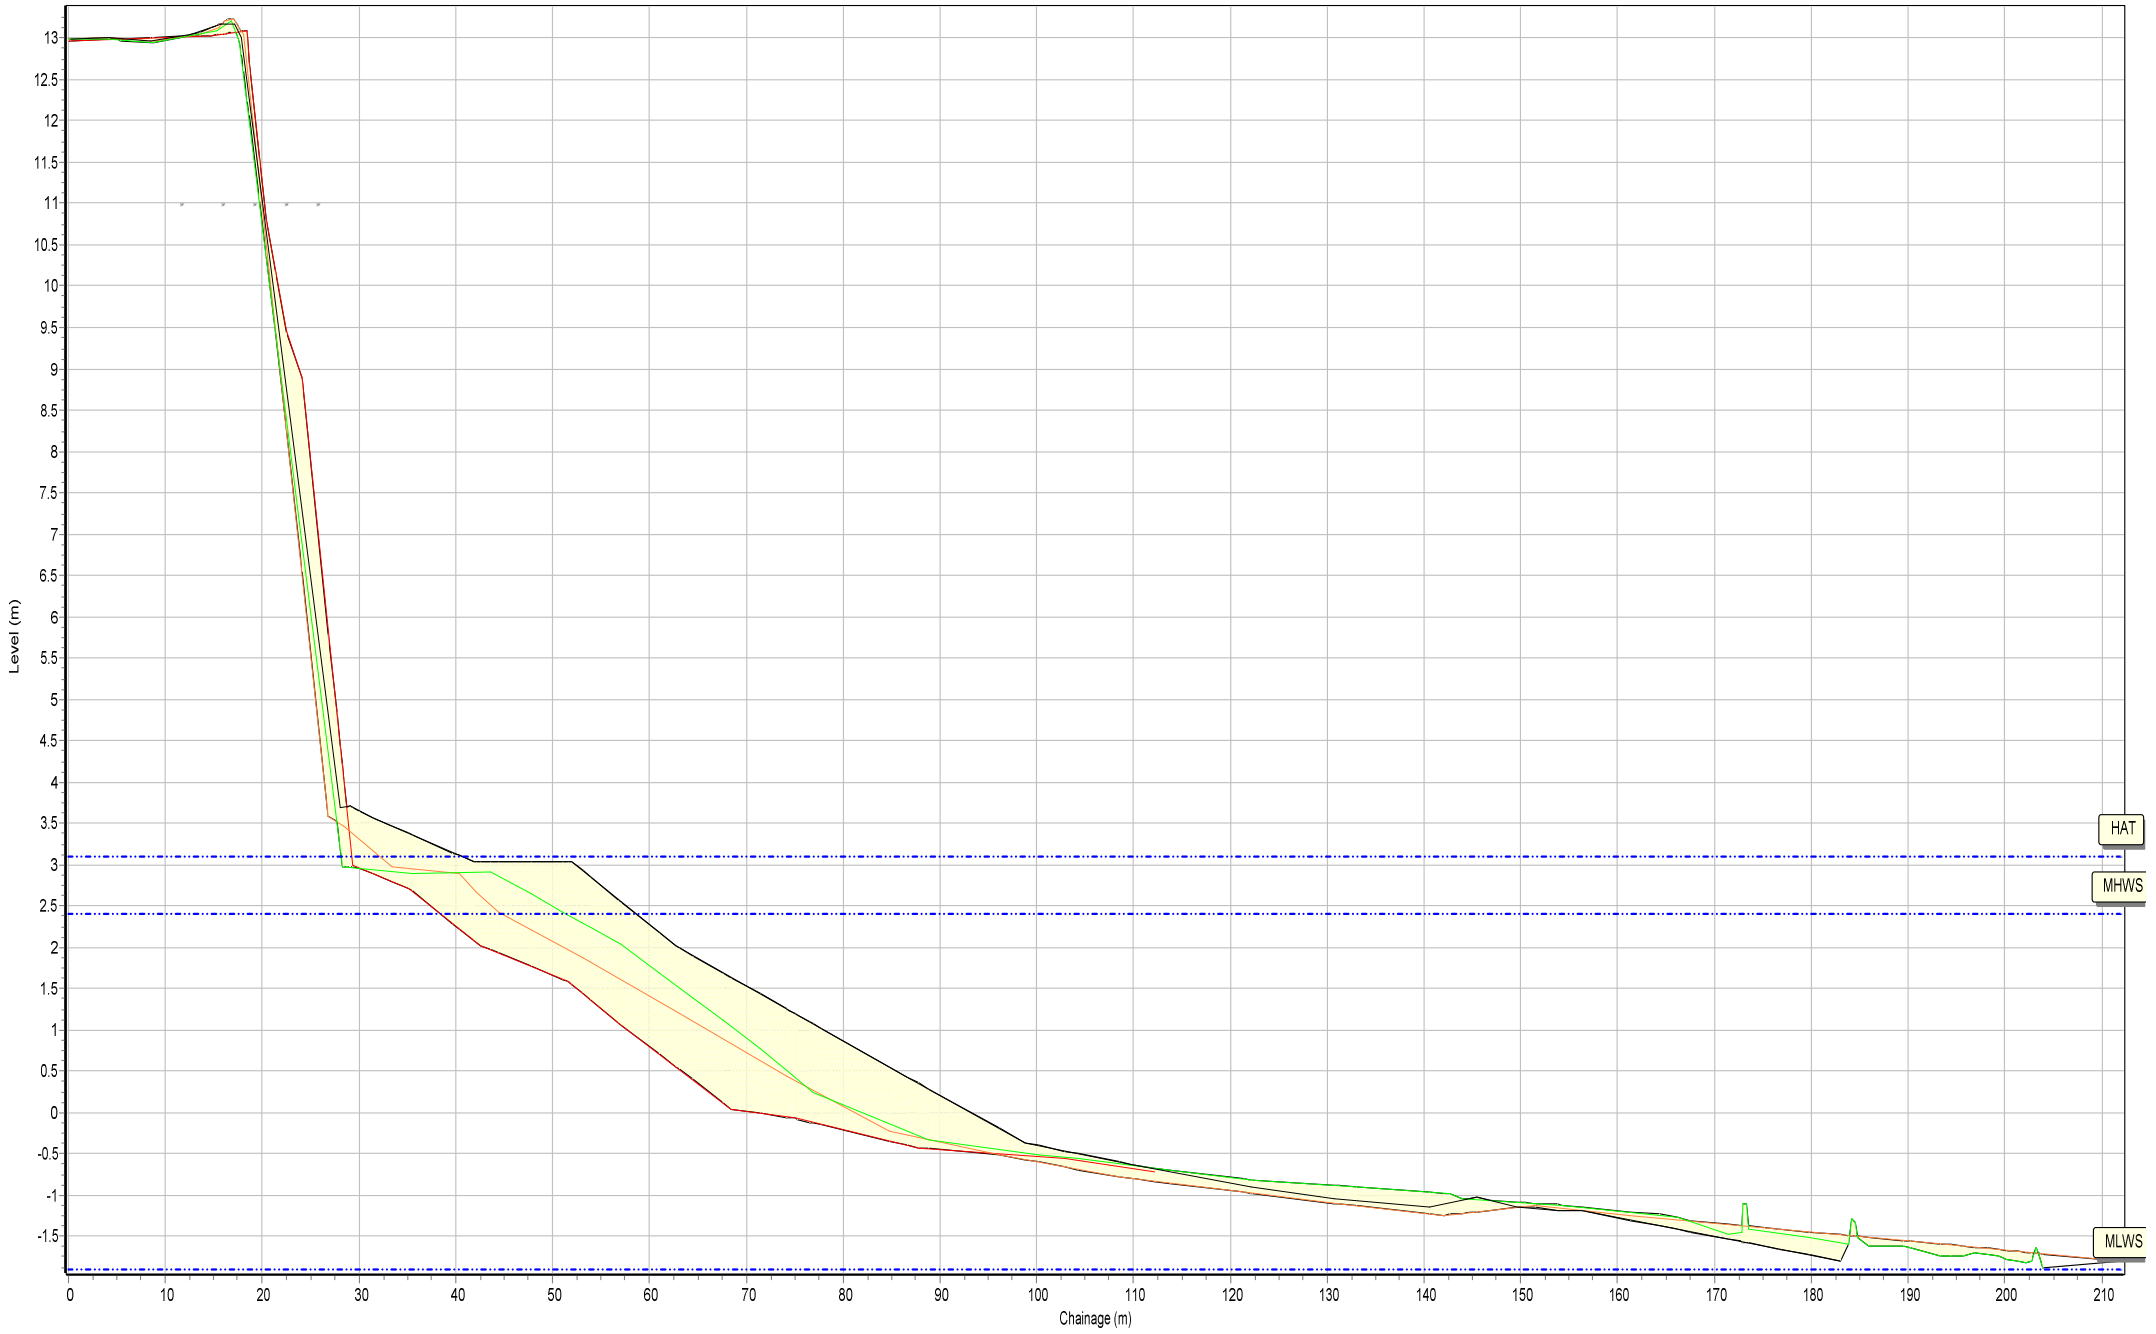
# Beach Profiles: 1aNTDC01

Survey Date	Description of Changes Since Last Survey	Interpretation
<p>9<sup>th</sup> – 10<sup>th</sup> Mar 2020</p>	<p><b>Beach Profiles:</b></p> <p>Whitley Sands is covered by five beach profile lines for the Partial Measures survey (Appendix A). Four of these (1aNTDC01 to 1aNTDC04) were initially surveyed in April 2002 and were then re-surveyed annually to 2009 (Full Measures, autumn 2009) after which time they have been surveyed bi-annually. From March 2010 (Partial Measures, spring 2010) onwards, an additional beach profile line (NTDC04A) has been surveyed at the southern end of the frontage for the same time periods listed above. All profiles were last surveyed in September 2019 for the Full Measures survey.</p> <p><b>1aNTDC01</b> is located in the north of Whitley Sands, along the undefended cliffs immediately south of Trinity Road car park. According to the survey report, the cliff was not measured due to dangerous access. There has been an accretion of up to 0.7m from the toe of the cliff across the upper and middle beach to chainage 110m. Seaward of 110m, the profile shows little change limited to 0.1m. Overall the profile is at a high level on the upper beach and a medium level on the middle and lower beach compared to the range recorded from previous surveys.</p> <p>Profile <b>1aNTDC02</b> is located towards the north of Whitley Sands. From the sea wall to 95m chainage the elevation of the beach has increased by up to 1.0m compared to the previous survey, creating a small berm at chainage 72m. From chainage 95m to the end of the survey the beach levels have decreased by up to 0.8m. The upper beach is at a high level compared to the range recorded from previous surveys, particularly between chainages 49-63m and 66-77m. The middle and lower beach are at a relatively low level compared to the range recorded from previous surveys.</p> <p>Profile <b>1aNTDC03</b> is located at the centre of Whitley Sands. Beach levels have risen between the sea wall and chainage 43m by up to 0.4m. Seawards of chainage 43m the beach level has dropped by up to 0.8m, exposing a rocky outcrop at chainage 75-90m. The toe of the beach has eroded by 0.35m. The upper beach is at a high level compared to the previous surveys, however the middle and lower beach are at a low level.</p>	<p>Since the last survey, beach levels at Whitley Sands have mostly accreted on the upper beach, with erosion dominating across the middle and lower beach.</p> <p><b>Longer term trends:</b></p> <p>The data show that profiles are mostly within the bounds of previous surveys.</p>

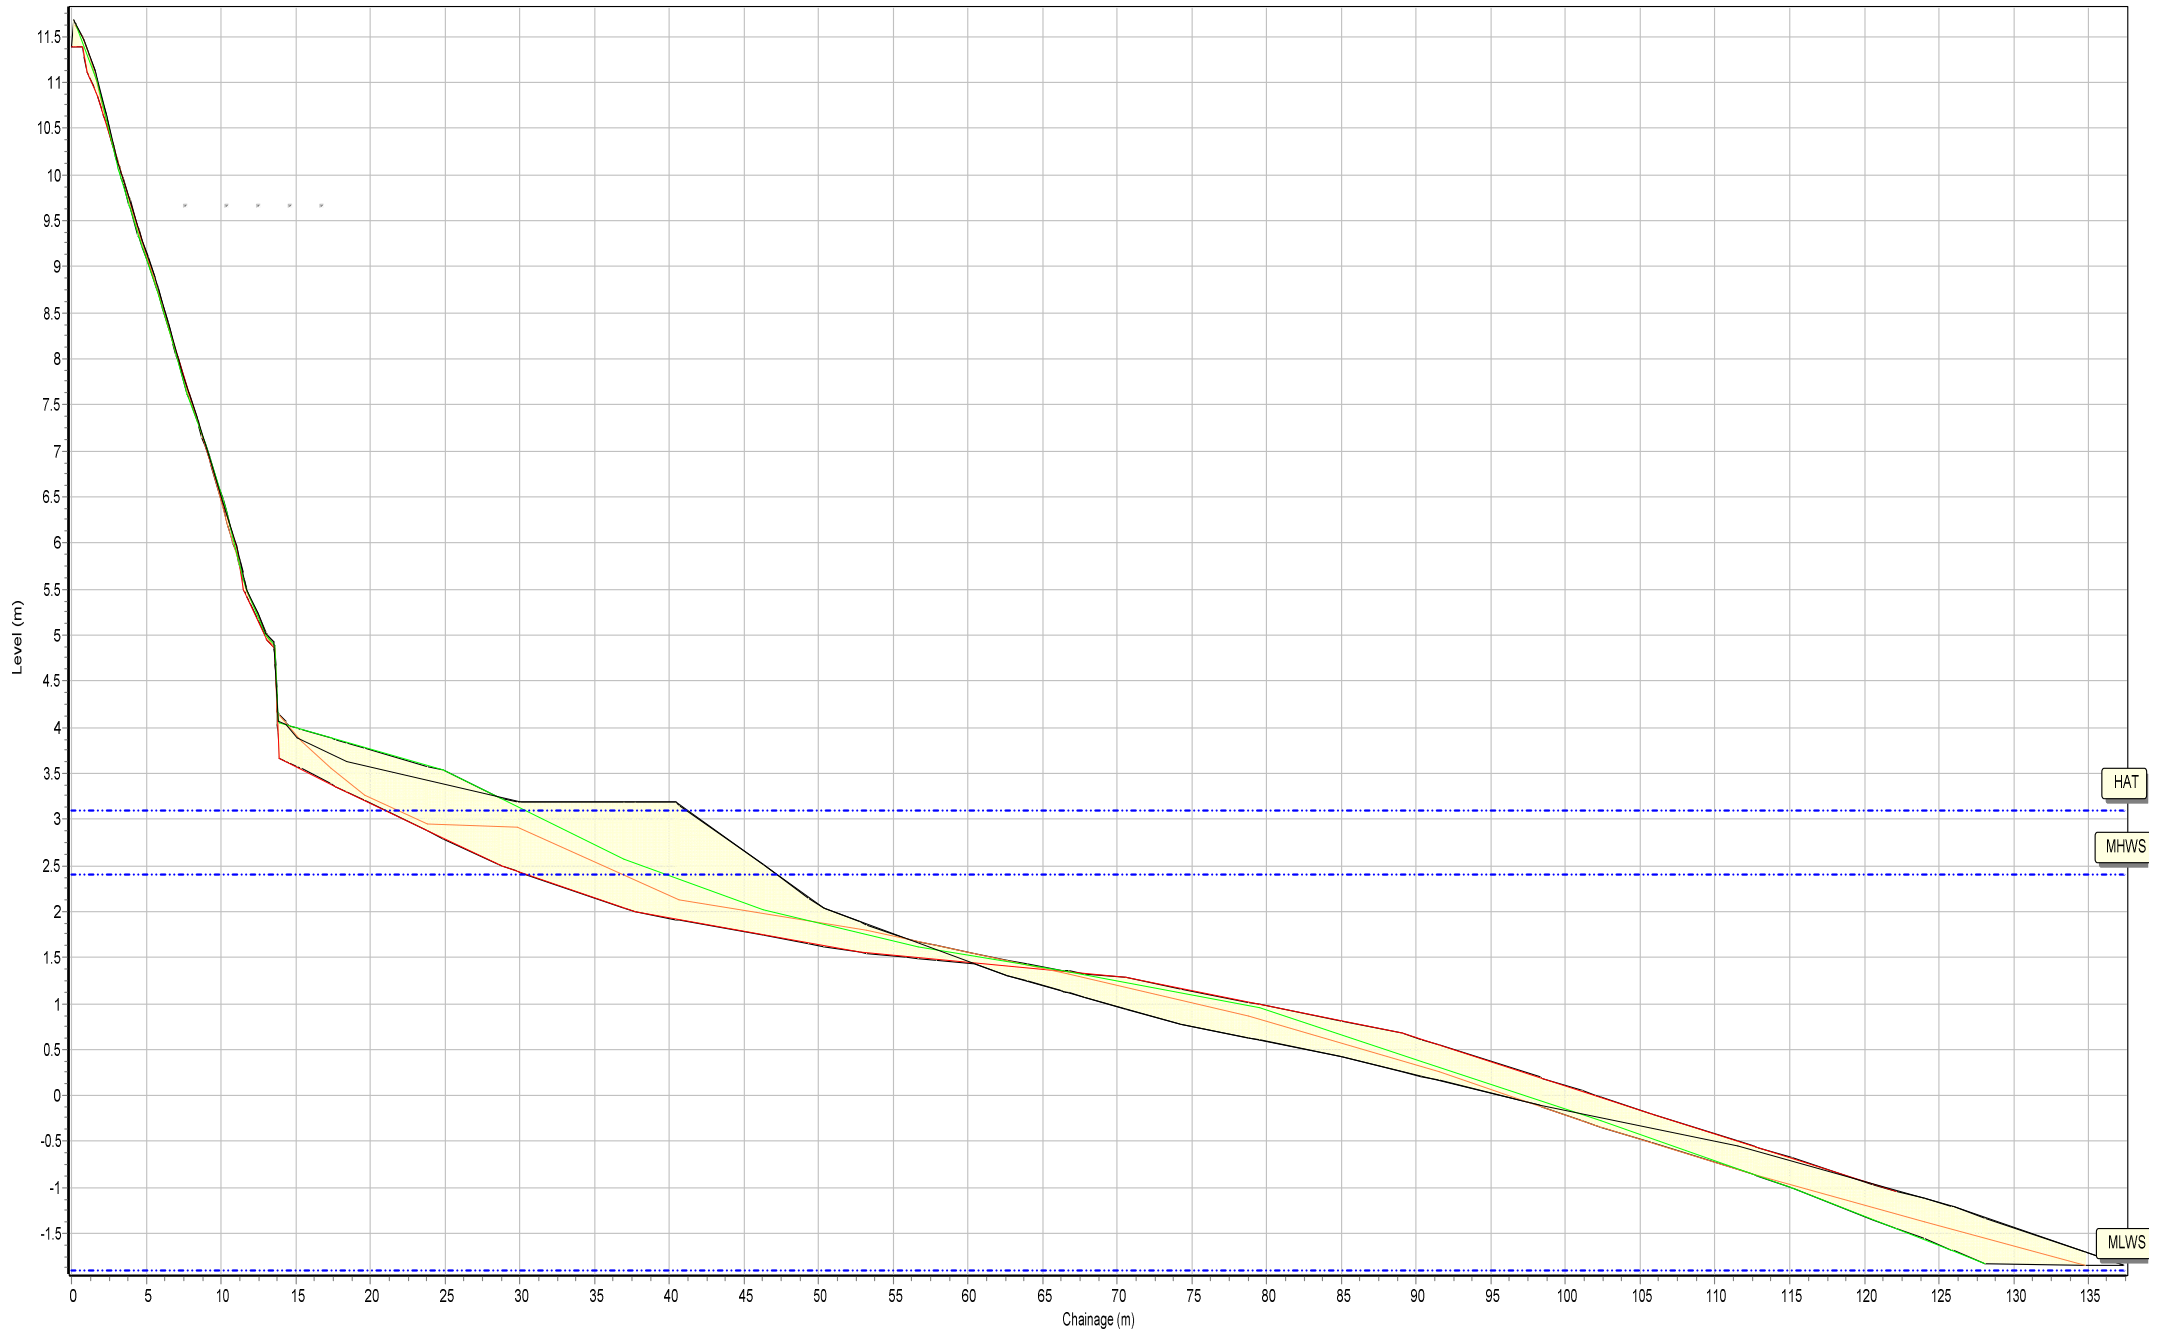
# Beach Profiles: 1aNTDC04

Survey Date	Description of Changes Since Last Survey	Interpretation
	<p>Profile <b>1aND04</b> is located to the south of Whitley Sands. There has been erosion between the base of the seawall and chainage 29m by up to 0.2m. The rest of the beach profile alternates between sections of erosion and accretion of <math>\pm 0.5</math>m. A small berm has formed at chainage 40m. Overall the upper beach is at a high level, particularly between chainages 29-45m which is at its highest level recorded since surveys began. The middle and lower beach are at a medium level compared to the range recorded from previous surveys.</p> <p>Profile <b>1aNTDC04a</b> is located to the south of Whitley Sands. A small section of the upper beach has accreted by up to 0.2m to chainage 12m. Seawards of chainage 12m there has been erosion of up to 0.6m, exposing the previously covered rocky shore platform between chainages 72m to 95m. The upper beach is relatively high level compared to the range recorded from previous surveys whilst the middle and lower beach are at a medium-low level.</p>

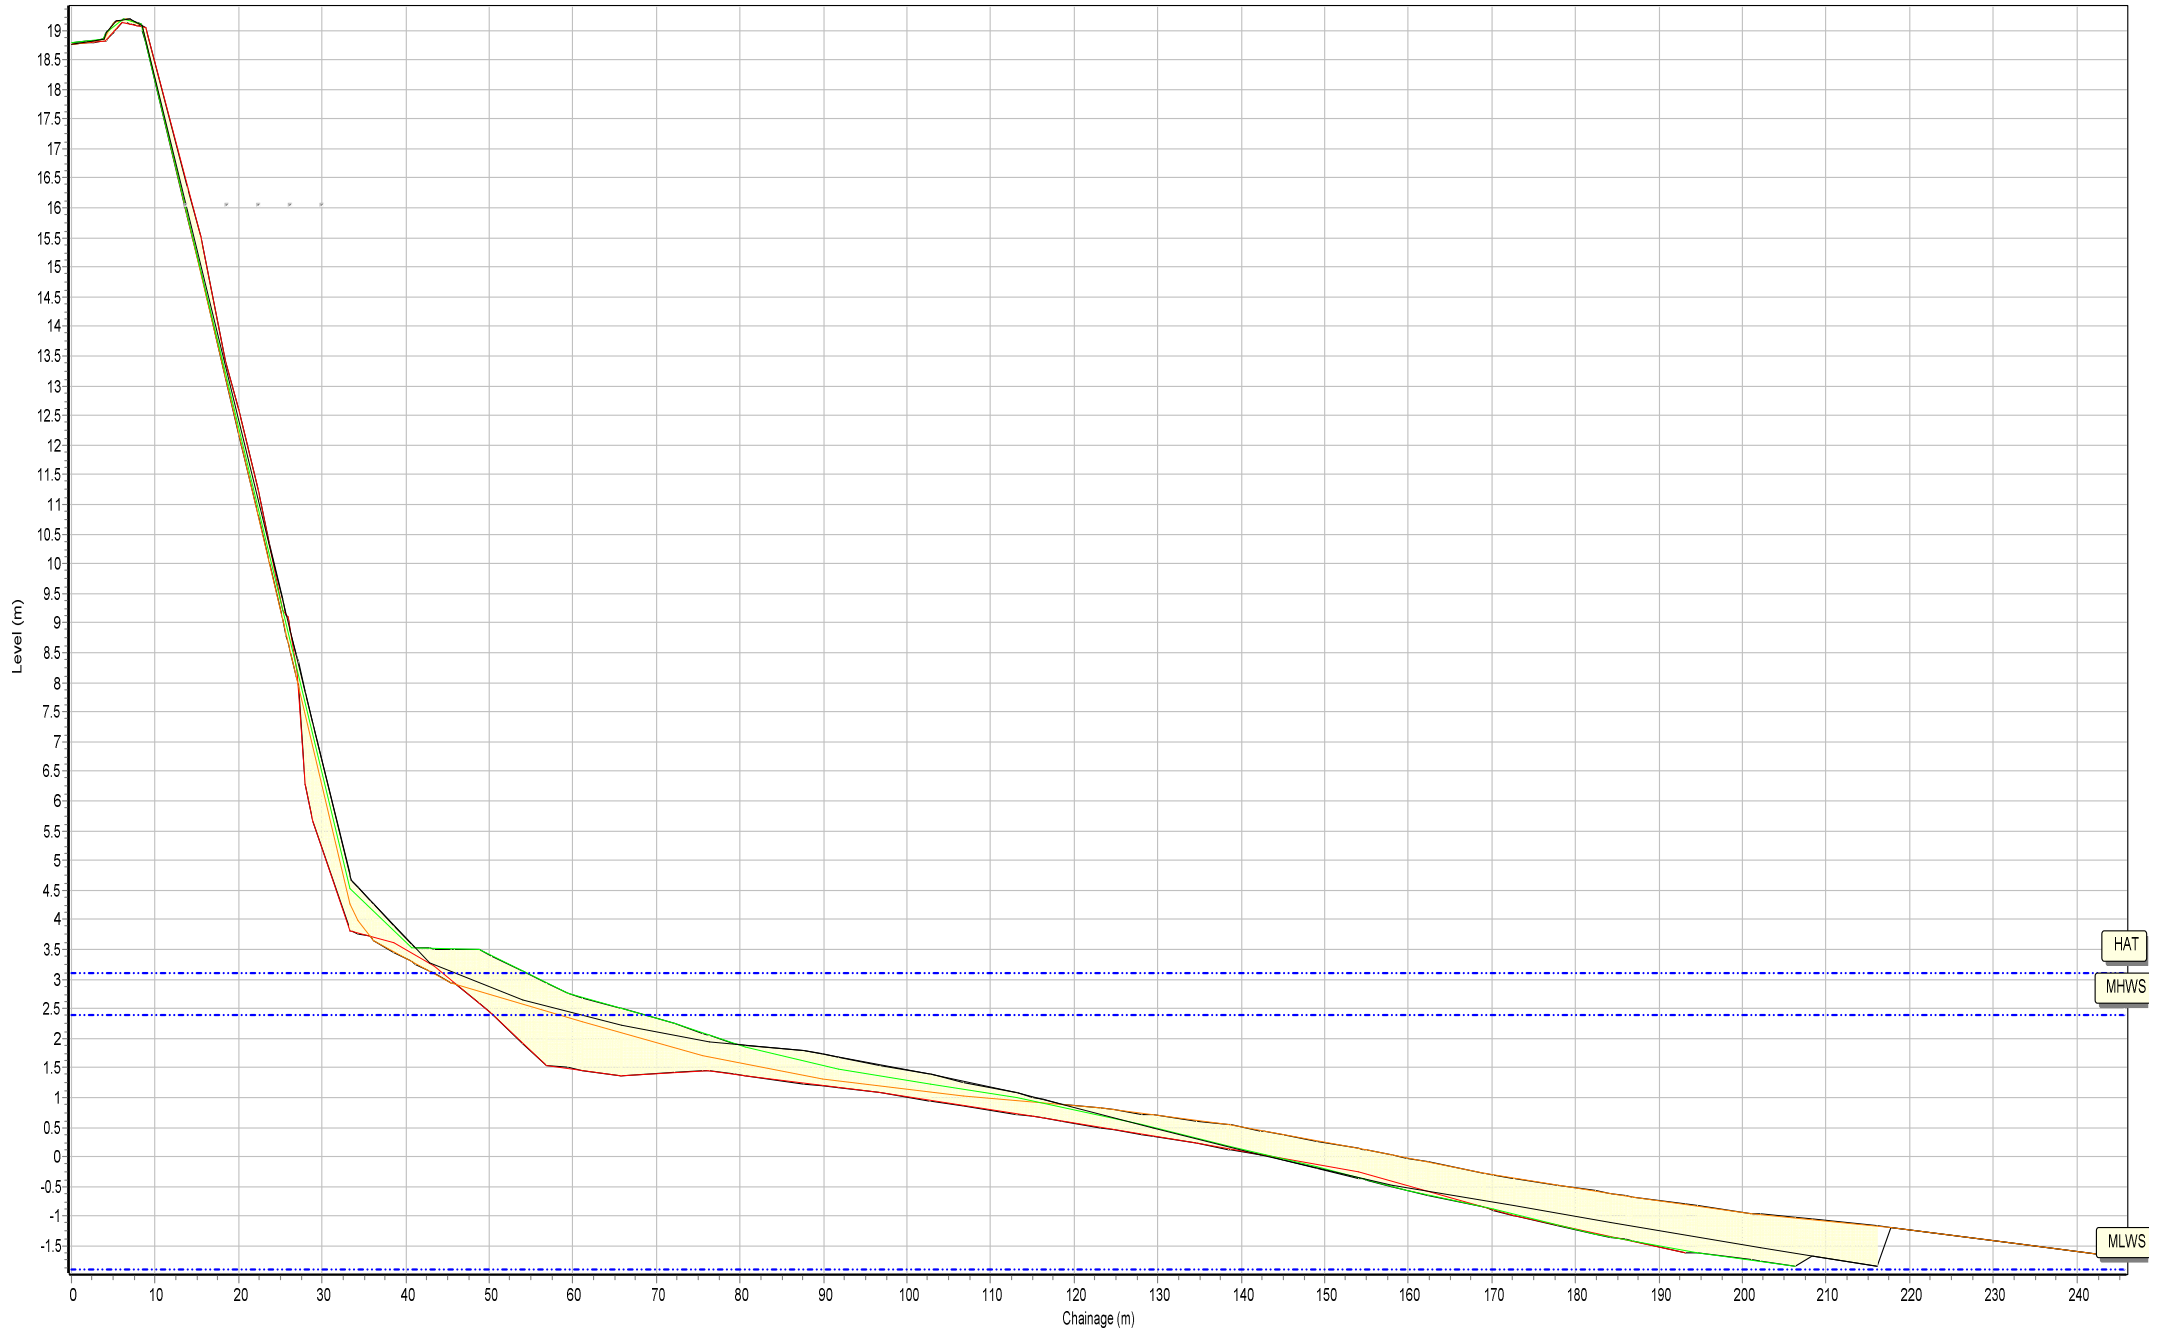
Beach Profiles: 1aNTDC06

Survey Date	Description of Changes Since Last Survey	Interpretation
<p>9<sup>th</sup> – 10<sup>th</sup> Mar 2020</p>	<p><b>Beach Profiles:</b></p> <p>Tynemouth Long Sands is covered by three beach profile lines for the Partial Measures survey (Appendix A). Profiles 1aNTDC06 and 1aNTDC07 were initially surveyed annually each autumn between 2002 and 2009. A third profile, 1aNTDC06A, was later added in the centre of the frontage. From spring 2010 (Partial Measures) onwards, they have been surveyed bi-annually. The last survey was the September 2019 Full Measures survey.</p> <p><b>1aNTDC06</b> is located approximately 150m south of the access road/ramp towards the north of the bay. The profile for the dune-cliff face is limited due to a lack of data points in the profile plot; the survey report for this monitoring period and previous survey reports have noted ‘<i>no access to middle of section 6 due to seed protection fences</i>’. There has been erosion from the toe of the dune-cliff to chainage 79m by up to 0.5m. Between chainages 79m and 125m there has been a small amount of accretion of up to 0.2m. Between chainages 125m and 155m there has been negligible change limited to <math>\pm 0.1</math>m. Seawards of chainage 155m there has been accretion of up to 0.2m. Overall the profile is at a medium level compared to the range recorded from previous surveys.</p> <p>At profile <b>1aNTDC06A</b>, the profile for the dune-cliff face is a straight line; a result of a lack of data points in the profile plot; the survey report for this monitoring period and previous survey reports have noted ‘<i>no access to middle of section 6A due to seed protection fences</i>’. There has been limited change across the upper and middle beach profile, up to <math>\pm 0.2</math>m. Overall the profile is at medium level compared to the range recorded from previous surveys.</p> <p>Profile <b>1aNTDC07</b> is located approximately 50m south of the access route through the dunes towards the southern end of the bay. As with the other profiles the dune-cliff face is a straight line; a result of a lack of data points in the profile plot. The survey report for this monitoring period and earlier reports note ‘<i>no access to middle of section 7 due to seed protection fences</i>’. The beach has seen very little change of <math>\pm 0.2</math>m from the toe of the dunes to the end of the profile. Overall the beach is at a relatively high level compared to the range recorded from previous surveys, particularly between chainages 85-11m which is at its highest recorded level.</p>	<p>At Tynemouth Long Sands, the dune-cliff face was not surveyed due to access constraints, but survey photographs suggest that wind-blown sand continues to accrete in the lee of the defences.</p> <p>Beach profile change has been relatively small over the winter/spring months and generally showing erosion of berms and creation of smoother concave profiles.</p> <p><b>Longer term trends:</b> Overall, the beaches have retained a similar form and are within the bounds of previous surveys.</p>

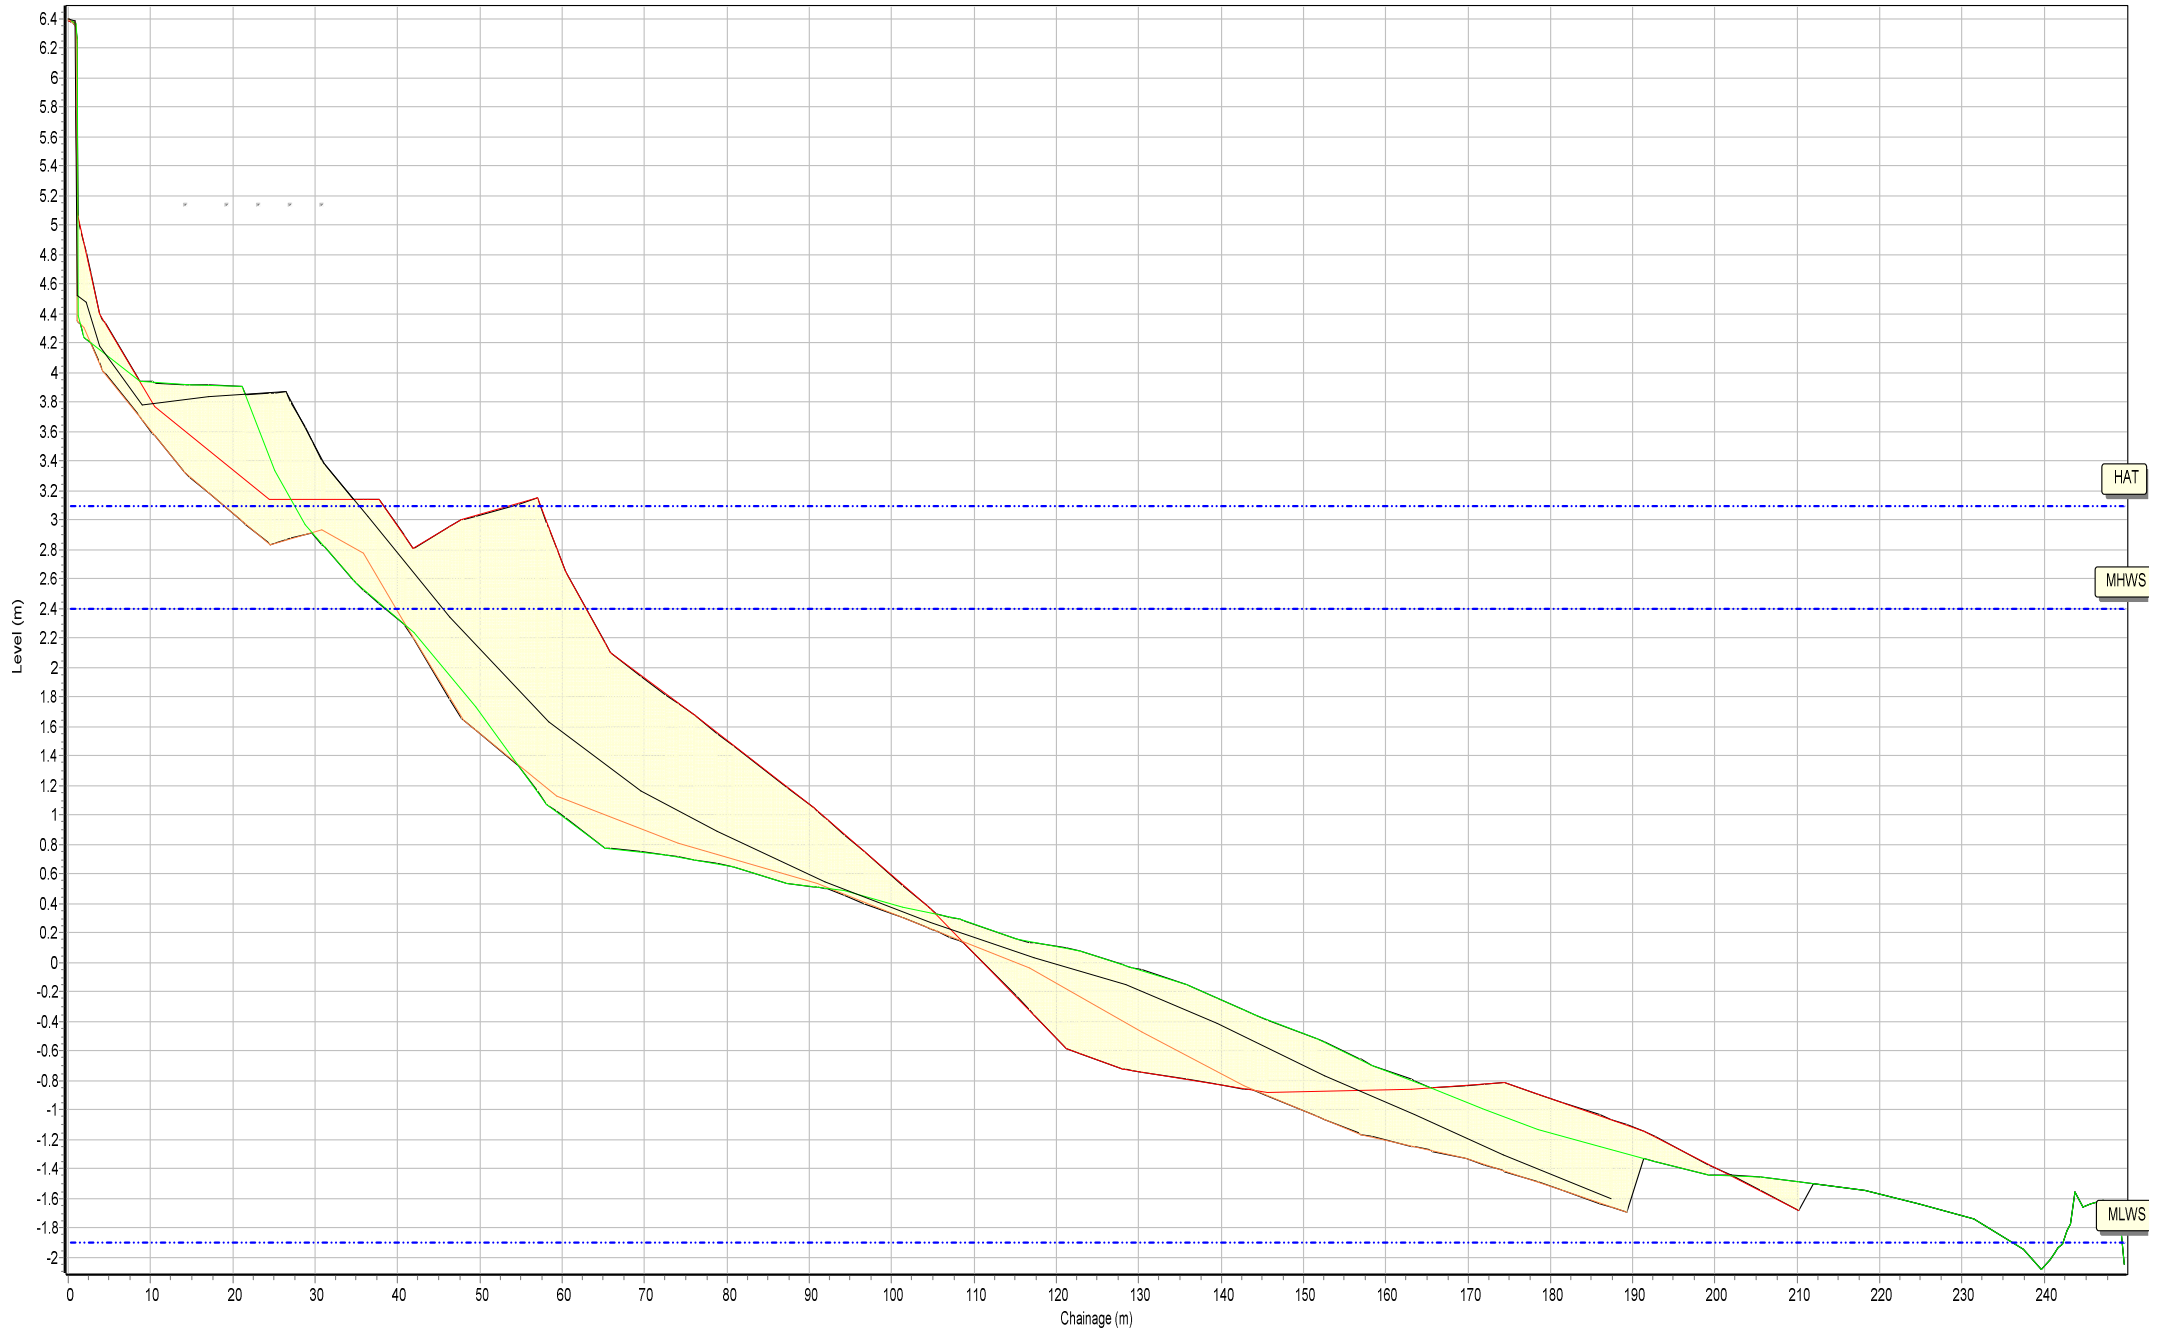
Beach Profiles: 1aNTDC08

Survey Date	Description of Changes Since Last Survey	Interpretation
<p>9<sup>th</sup> – 10<sup>th</sup> Mar 2020</p>	<p><b>Beach Profiles:</b></p> <p>King Edward's Bay is covered by one beach profile line for the Full Measures survey (Appendix A). This was surveyed annually each autumn between 2002 and 2009. From spring 2010 onwards, it has been surveyed bi-annually. The last survey was the September 2019 Full Measures survey.</p> <p>At profile <b>1aNTDC08</b> there has been movement of the upper beach berm further seaward by 6m. Seaward of chainage 98m there has been erosion of up to 0.2m. The beach toe has shortened by 64m. The upper beach is at a high level and the middle and lower beach are at a medium level compared to the range recorded from previous surveys.</p>	<p>Since the last survey, the beach at King Edward's Bay beach has seen little change, except the movement of an upper beach berm seaward by 6m.</p> <p><b>Longer term trends:</b> Changes recorded across the beach since the last survey are within the range of historical beach levels.</p>

- At King Edward's Bay, the upper beach berm has moved seaward by 6m, with change across the rest of the beach limited to  $\pm 0.2$ m. There are no causes for concern.
