**Cell 1 Regional Coastal Monitoring Programme  
Update Report 13: 'Partial Measures' Survey 2021**

(\*) The present report is **Update Report 13** and provides an analysis of the 2021 Partial Measures survey for North Tyneside Council's frontage.

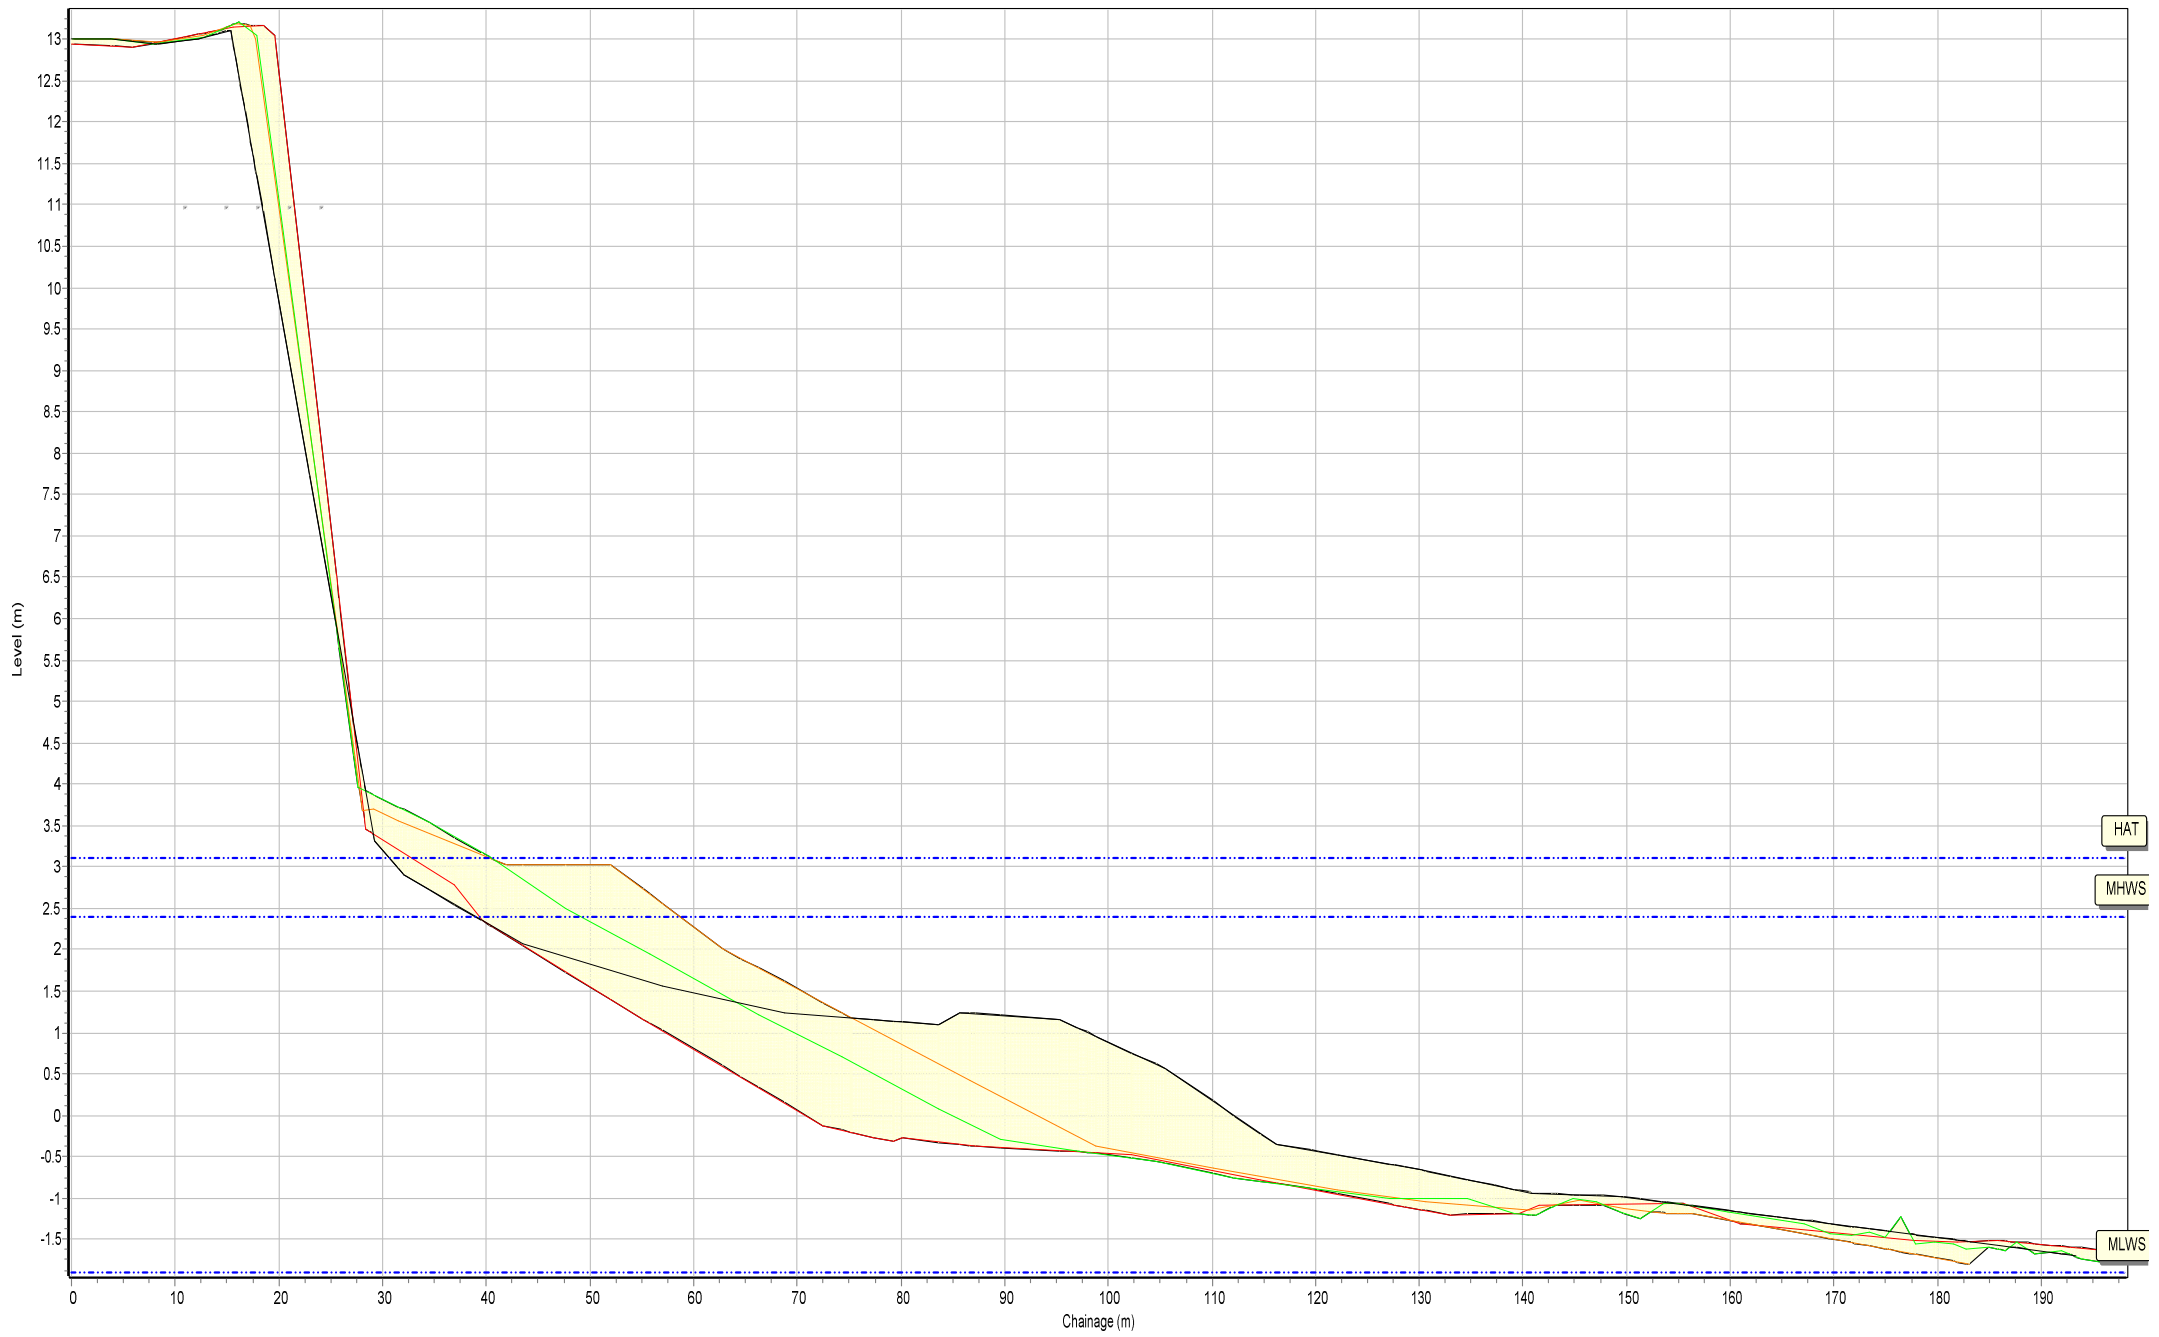
Beach Profiles: 1aNTDC01

Profiles Envelope 14/05/2002 10/03/2020 21/09/2020 04/03/2021

Survey Date	Description of Changes Since Last Survey	Interpretation
1 <sup>st</sup> -4 <sup>th</sup> Mar 2021	<p><b>Beach Profiles:</b></p> <p>Whitley Sands is covered by five beach profile lines for the Partial Measures survey (Appendix A). Four of these (1aNTDC01 to 1aNTDC04) were initially surveyed in April 2002 and were then re-surveyed annually to 2009 (Full Measures, autumn 2009) after which time they have been surveyed bi-annually. From March 2010 (Partial Measures, spring 2010) onwards, an additional beach profile line (NTDC04A) has been surveyed at the southern end of the frontage for the same time periods listed above. All profiles were last surveyed in September 2020 for the Full Measures survey.</p> <p><b>1aNTDC01</b> is located in the north of Whitley Sands, along the undefended cliffs immediately south of Trinity Road car park. According to the survey report, the cliff was not measured due to dangerous access and there was evidence of a rock fall. There has been lowering by up to 0.8m on the upper beach, from the toe of the cliff to chainage 64m. Seaward of chainage 64m, the profile shows accretion of up to 1.5m on the middle beach and 0.1m on the lower beach. Overall, the profile is at a medium level on the upper and lower beach and a high level on the middle beach compared to the range recorded from previous surveys.</p> <p>Profile <b>1aNTDC02</b> is located towards the north of Whitley Sands. From the sea wall to 126m chainage the elevation of the beach has decreased by up to 1.2m compared to the previous survey. From chainage 126m to the end of the survey, the beach levels have increased by up to 1.1m, forming a small berm at chainage 146m. The upper and middle beach are at a low level compared to the range recorded from previous surveys, particularly between chainages 102-122m which is at its lowest level recorded. The lower beach is at a high level compared to the range recorded from previous surveys, particularly between chainages 145-156m which is at its highest level recorded.</p> <p>Profile <b>1aNTDC03</b> is located at the centre of Whitley Sands. Beach levels have decreased between the sea wall across the upper and middle beach to chainage 83m by up to 1.0m. Seawards of chainage 83m, the beach level has risen by up to 0.9m, forming a small berm at chainage 95m. The upper and middle beach is at a low level compared to the range recorded from previous surveys, particularly</p>	<p>Since the last survey, beach levels in the north and centre of Whitley Sands have generally eroded across the upper to middle beach and accreted on the lower beach, exhibiting draw down of sediment from the upper to lower beach over winter. Beach levels in the south of Whitley Sands (1aNTDC04 and 1aNTDC04A) have eroded across the entire profile length.</p> <p><b>Longer term trends:</b></p> <p>The data show that profiles are generally within the bounds of previous surveys, however several sections experienced their highest (145-156m at 1aNTDC02) and lowest (102-122m at 1aNTDC02, 26-65m at 1aNTDC03 and 0-20m at 1aNTD04A) levels recorded.</p>

Survey Date	Description of Changes Since Last Survey	Interpretation
	<p>between chainages 26-65m which is at its lowest level recorded. The lower beach is at a high level.</p> <p>Profile <b>1aNDC04</b> is located to the south of Whitley Sands. There has been erosion between the base of the seawall and chainage 24m by up to 0.3m, switching to small section of accretion of up to 0.2m to chainage 29m, before switching to erosion across the rest of the beach profile. Erosion ranges from 0.6m on the middle beach, exposing some rocks at chainage 64m, to 0.4m on the lower beach. Overall, the beach is at a medium-low level compared to the range recorded from previous surveys.</p> <p>Profile <b>1aNTDC04a</b> is located to the south of Whitley Sands. The entire beach profile has lowered evenly by 1.0m, exposing the previously covered rocky shore platform between chainages 72m to 95m. The entire beach is at a low level compared to the range recorded from previous surveys, particularly between chainages 0-20m which is at its lowest level recorded.</p>

- At Whitley Sands, beach levels have generally lowered across the upper to middle beach and accreted on the lower beach in the north of the survey area and eroded across the beach profile in the south of the survey area. For the most part, the upper beach is at a high level across the bay, whilst middle to lower beach levels across the bay are at a medium-low level. Beach levels should continue to be monitored in the next survey to check for signs of recovery or further erosion.
