**Cell 1 Regional Coastal Monitoring Programme  
Analytical Report 2: 'Full Measures' Survey 2009**

**Durham County Council  
Final Report**

**March 2010**

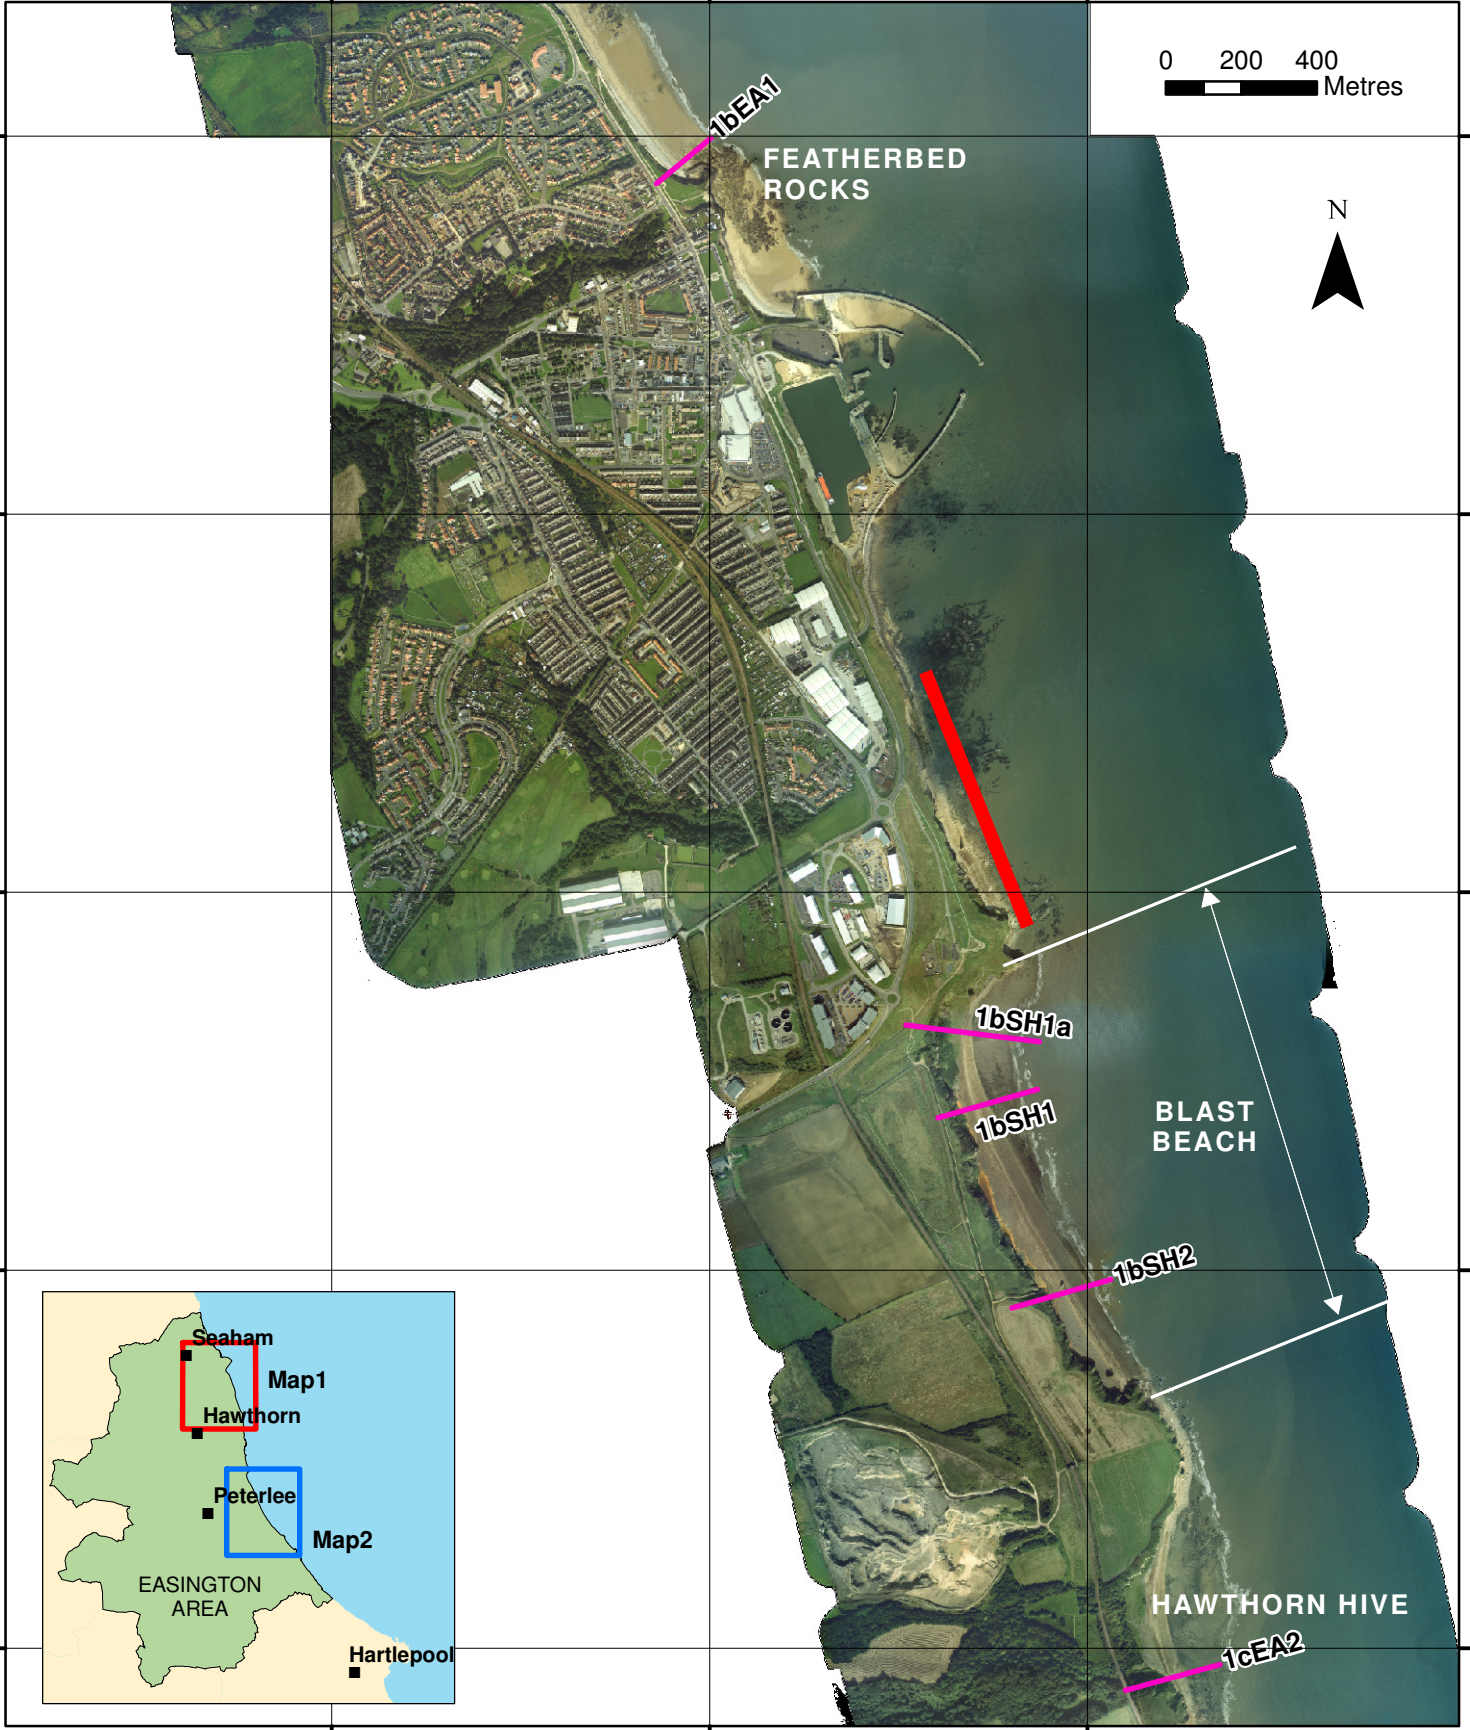
**Figure 2 - Map 1  
 Durham County Council Frontage**

The location of these surveys is shown in Figure 2. They have also previously been provided on a digital file which can be opened in Google Earth showing the locations of the surveys.

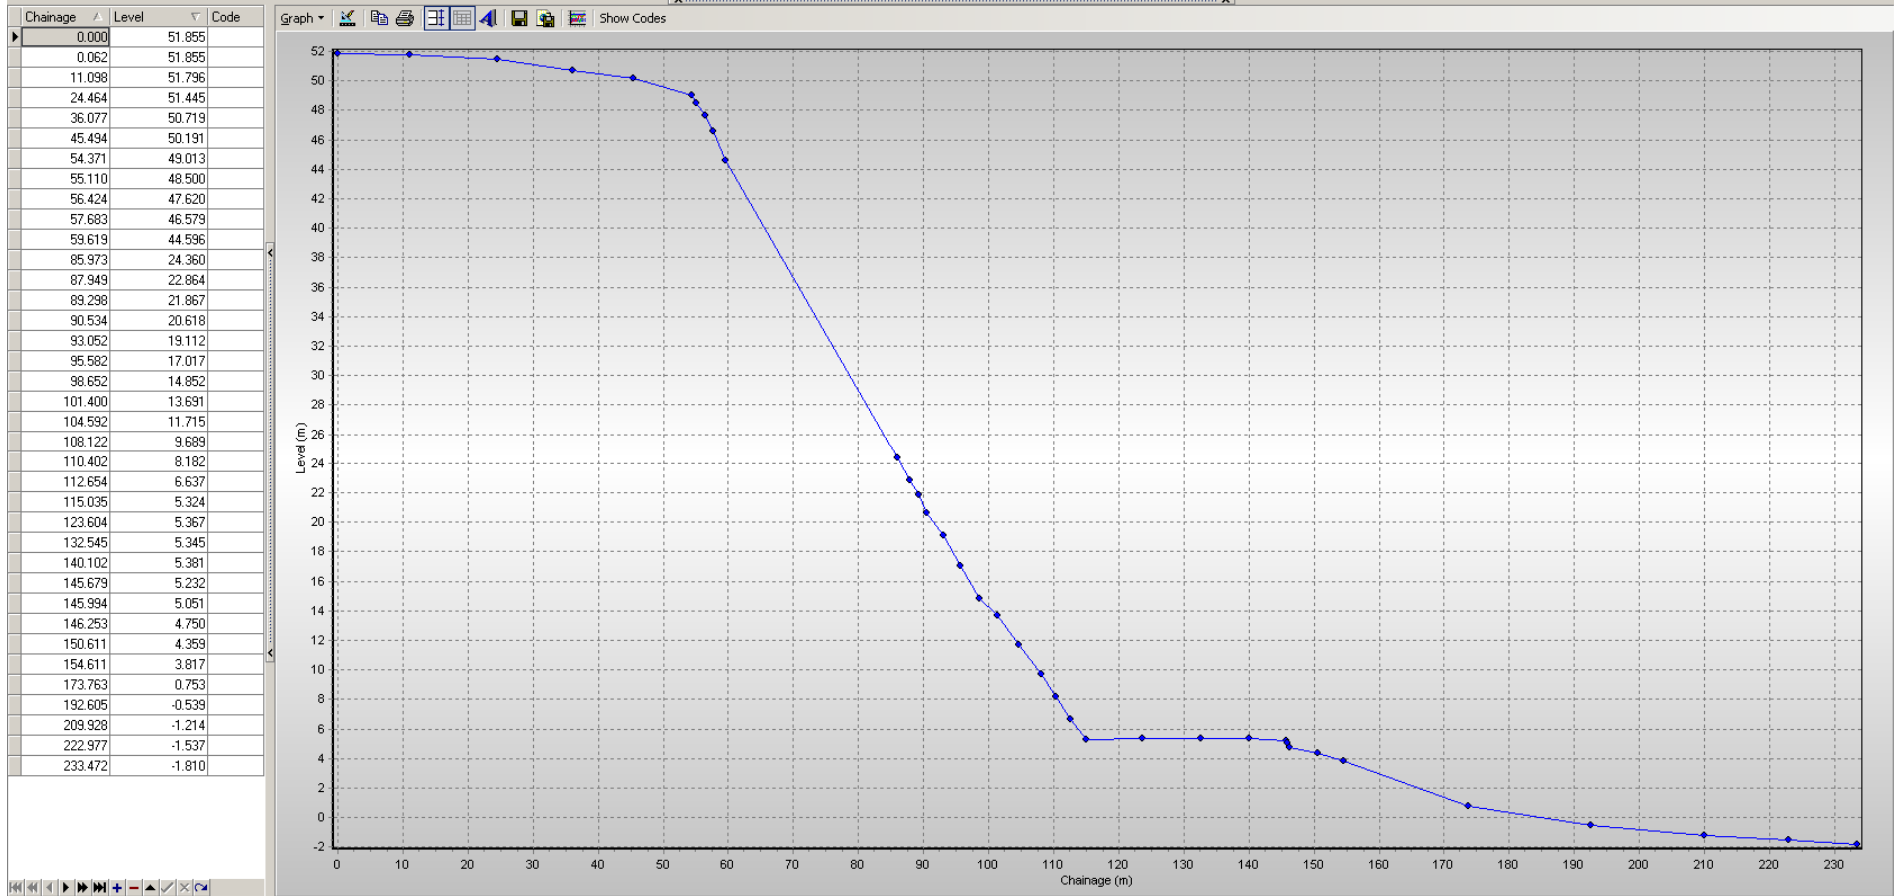
# 1bBH1 - 06/10/2009

Survey Date	Description of Changes Since Last Survey	Interpretation
10-2009	<p><b>Beach Profiles:</b></p> <p>Blackhall Colliery is covered by three beach profile lines (Appendix A).</p> <p>BH1 is located near Horden Point and shows no significant change since the previous survey, although there is a little accumulation of sediment at the cliff toe.</p> <p>BH2 exhibits no change in the cliff profile or upper beach, but the cliffed-edge of the spoil beach eroded landwards by approximately 1m.</p> <p>BH3 shows some apparent signs of minor movement in the cliff face, but the most notable change is the increase in the width and depth of the outlet channel of Castle Eden Burn, which crosses the profile.</p>	<p>The surveys show that the spoil beach along much of the Blackhall Colliery shore continues to provide effective protection to the backing cliffs. This spoil beach did, however, cut back at its seaward cliffed edge by around 1m.</p> <p>Despite notable changes in the width and depth of the outlet channel crossing BH3, there is no major corresponding change in foreshore elsewhere.</p>

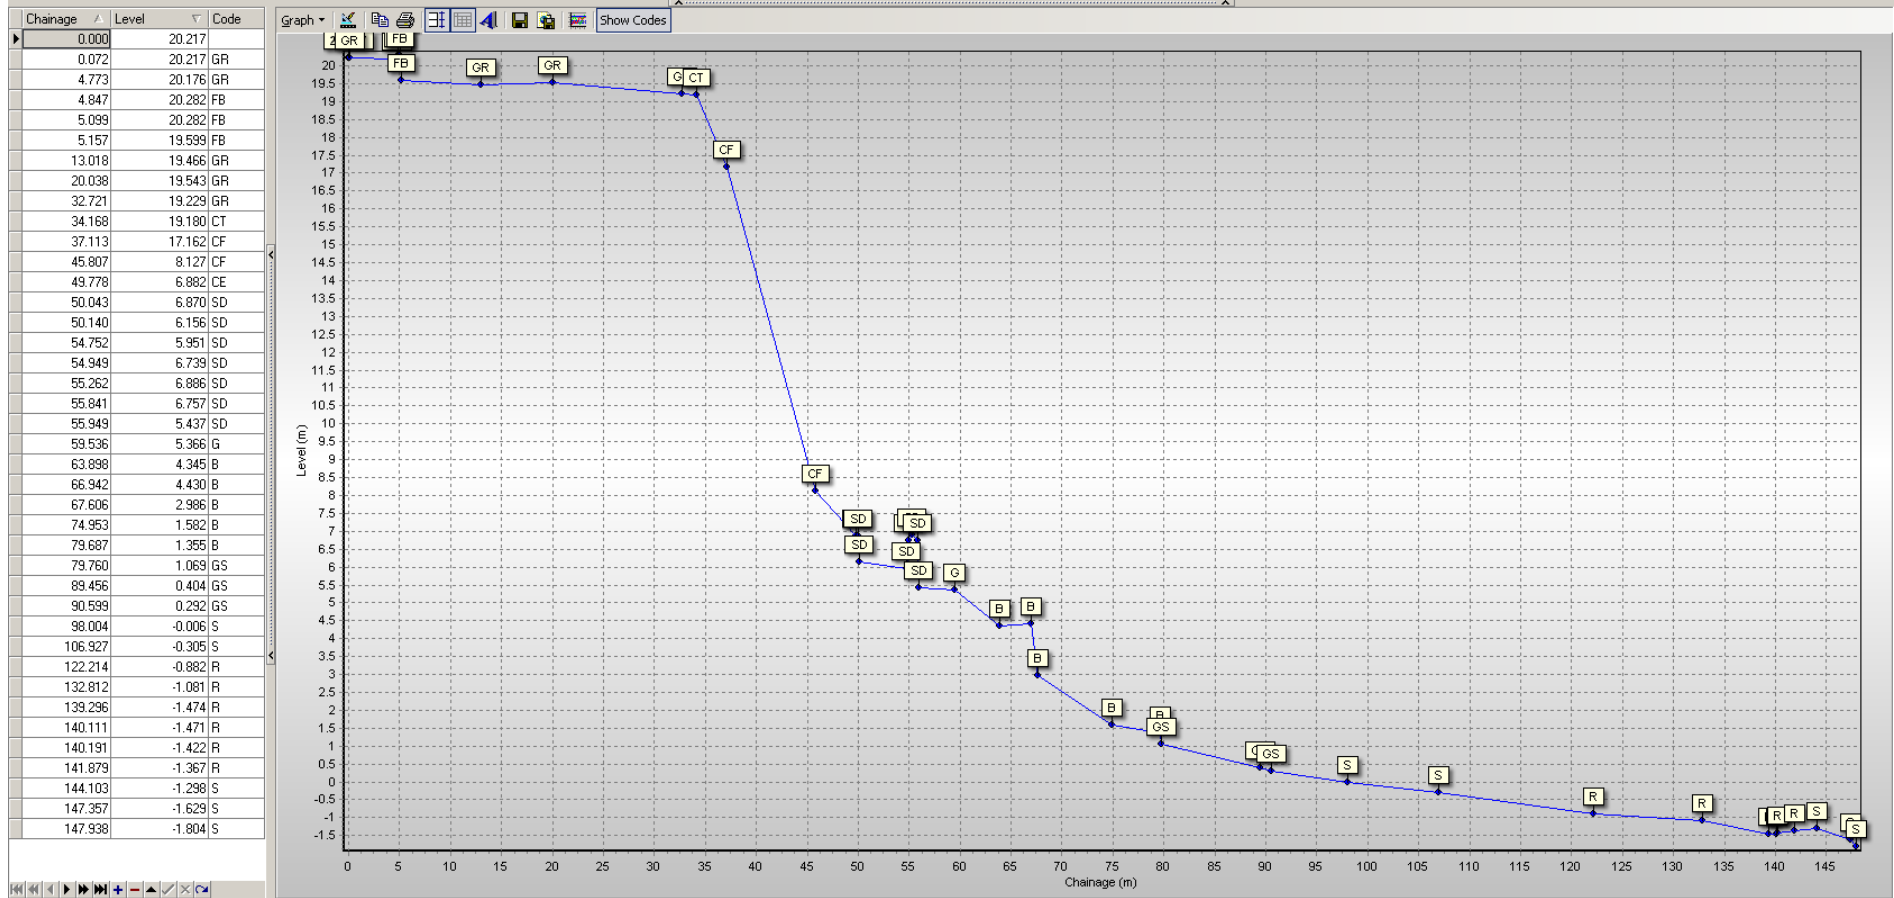
1bEA1

Survey Date	Description of Changes Since Last Survey	Interpretation
10-2009	<p><b>Beach Profiles:</b></p> <p>One beach profile line (EA1) is located at Featherbed Rocks (Appendix A). The profile line was relocated to its present position in March 2009. The profile extends across the cliff top, dipping slightly at the cliff edge to around 19mODN. It then drops down the cliff face to the toe of the cliff and then extends seawards across the promenade. The sea wall is then crossed, before the survey drops to beach level where a significant quantity of shingle has accumulated at the toe of the wall.</p>	<p>Through comparison of the March 2009 and current surveys, it is notable that a small degree of erosion has occurred from the shingle berm at the base of the sea wall down to around mean water level. This is considered to be typical of natural fluctuations along this profile.</p>

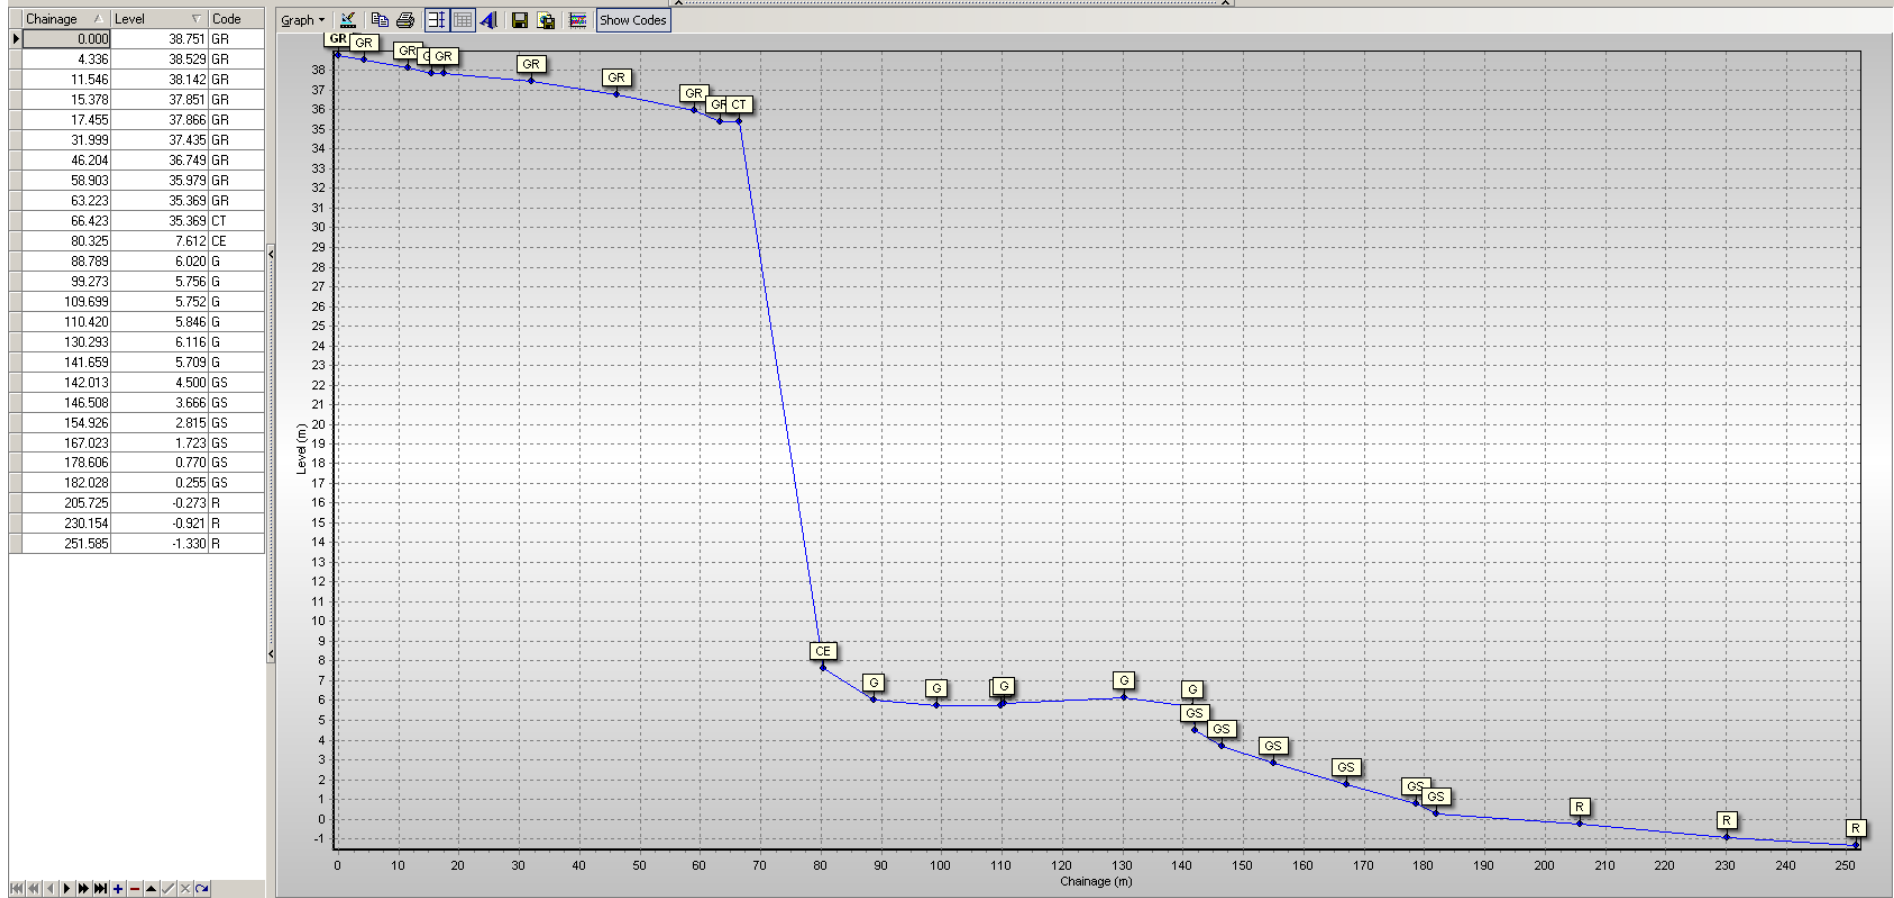
# 1bSH1a

Survey Date	Description of Changes Since Last Survey	Interpretation
10-2009	<p><b>Beach Profiles:</b></p> <p>Blast Beach is covered by three beach profile lines (Appendix A).</p> <p>Profile SH1a was added to the programme during the current Full Measures survey. It is located to the north of the previously-established SH1. All three profiles along Blast Beach exhibit similar forms, with a backing cliff, wide spoil beach with a distinct cliff at the seaward margin and a gravel and sand foreshore extending down to the low water mark.</p> <p>The width of the spoil beach along SH1a is around 60m, reducing to around 40m along SH1 and SH2.</p>	<p>Over the three successive surveys since November 2008, there does not appear to have been any landward recession to date of the margin of the spoil beach along the surveyed transects at SH1 and SH2. Further monitoring will identify the onset of any such processes.</p>

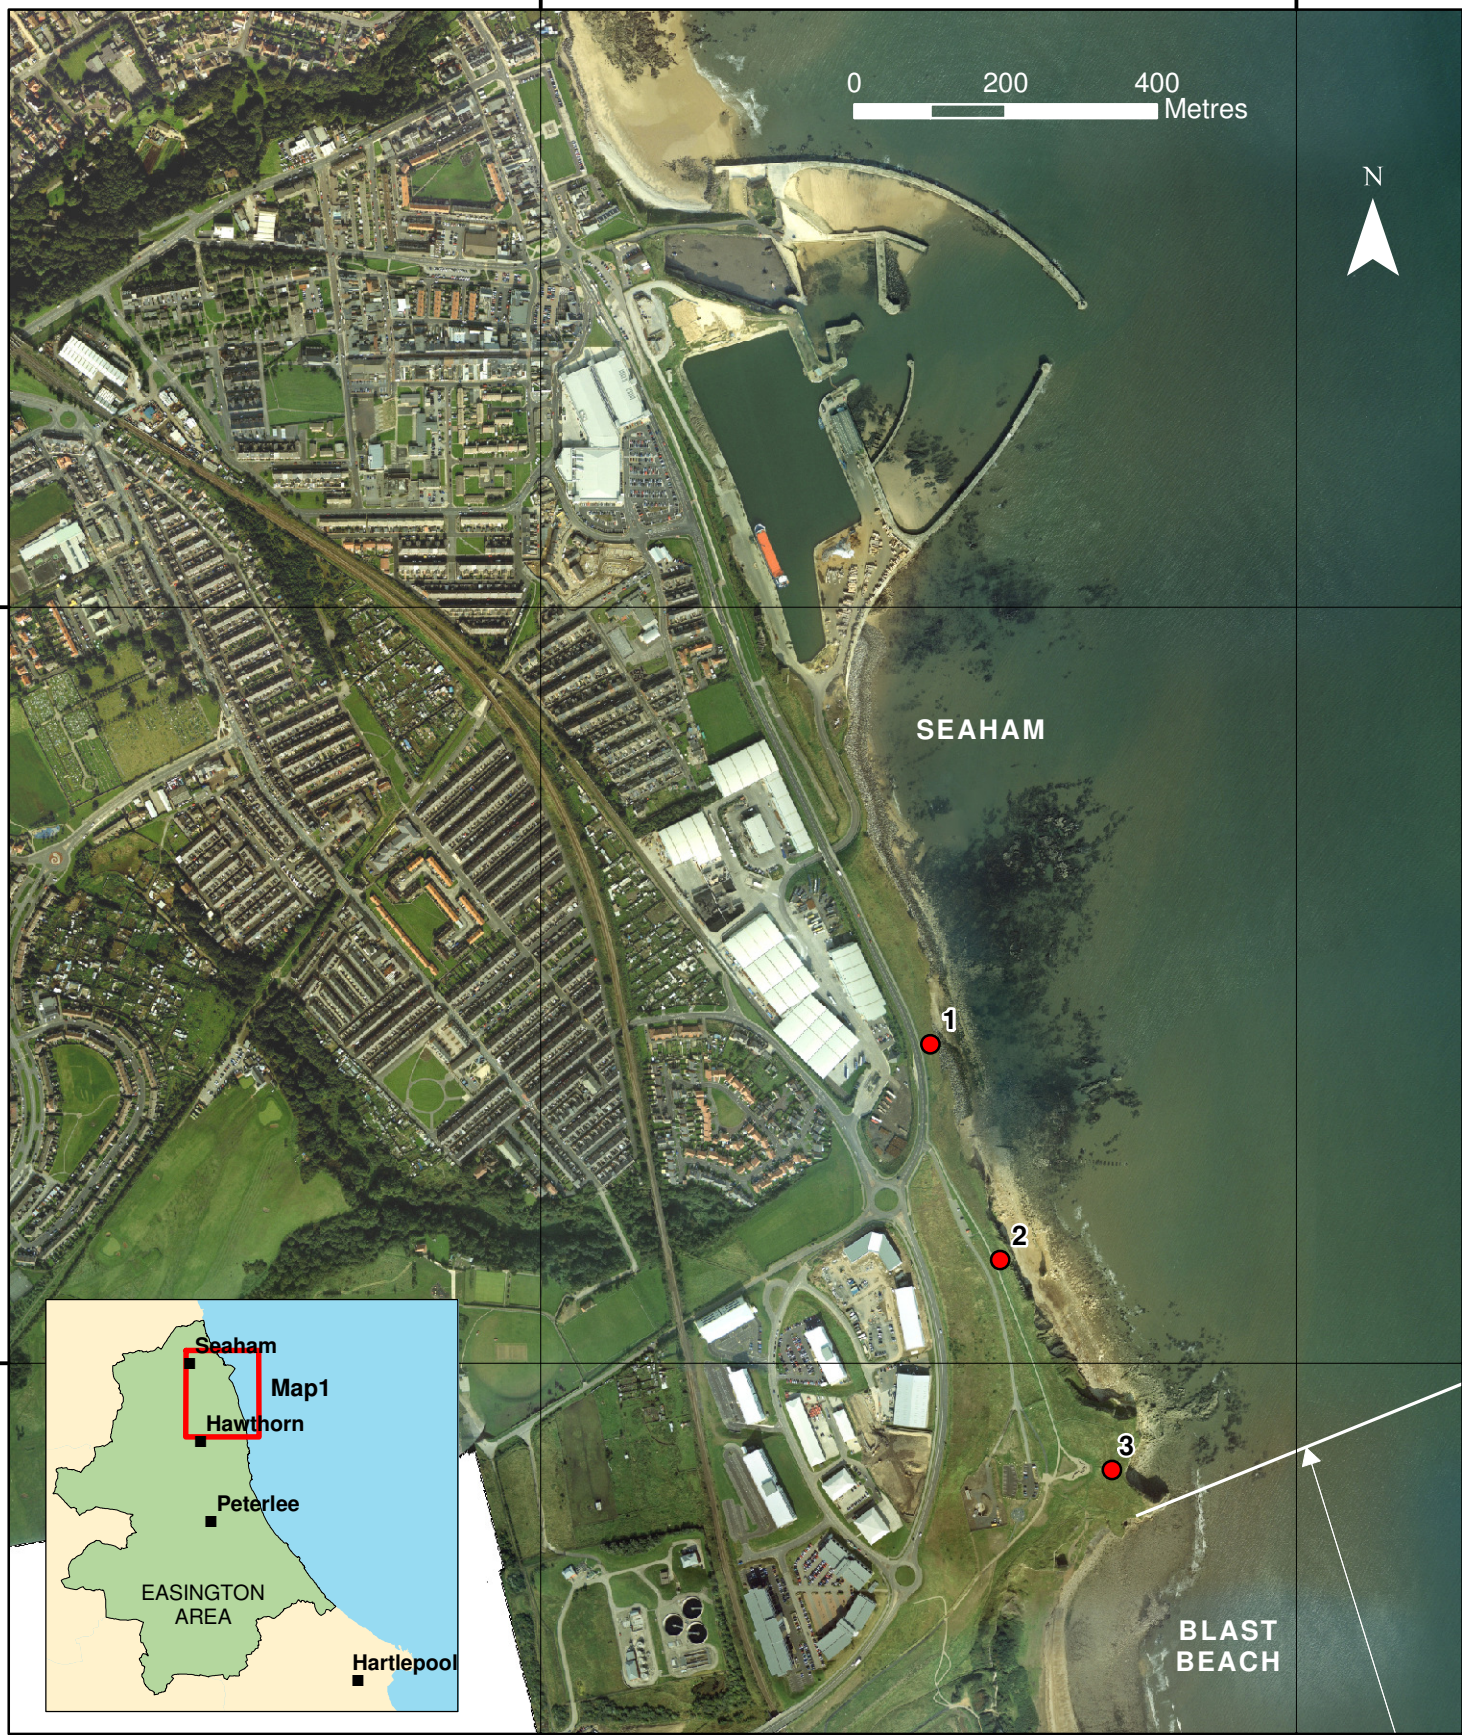
**Appendix B - Map 1  
 Durham County  
 Council Frontage**

Survey Date	Description of Changes Since Last Survey	Interpretation
10-2009	<p><b>Cliff Top Survey:</b></p> <p>Three ground control points have been established along the cliff top at Dawdon (Figure B1). The separation between any two points is nominally 300m. These cliff top surveys are intended to inform on erosion rates of the undefended sea cliffs extending south of the rock armour revetment to the south of Seaham Harbour. The cliff top surveys at Dawdon are undertaken bi-annually. Measurements are taken from a fixed ground control point along a fixed bearing to the edge of the cliff top.</p> <p>Appendix B provides information about the ground control points and results from between the 2008 (baseline) cliff top survey and the current survey. Future reports will show results from subsequent surveys and provide a means of assessing erosion since the baseline survey.</p>	<p>Overall, there has been recession along ground control points 1 and 3 by the order of 1m.</p> <p>Cliffs at ground control point 1 show ongoing change between successive surveys in November 2008, March 2009 and October 2009, whilst the change along ground control point 1 occurred between November 2008 and March 2009, with stability recorded since.</p> <p>No significant change has occurred along ground control points 1.</p>

Three ground control points have been established along the cliff top at Dawdon (Figure B1). The separation between any two points is nominally 300m. These cliff top surveys are intended to inform on erosion rates of the undefended sea cliffs extending south of the rock armour revetment to the south of Seaham Harbour.

The cliff top surveys at Dawdon are undertaken bi-annually. Measurements are taken from a fixed ground control point along a fixed bearing to the edge of the cliff top.
