**Cell 1 Regional Coastal Monitoring Programme
Analytical Report 9: 'Full Measures' Survey 2016**

Durham County Council

March 2017

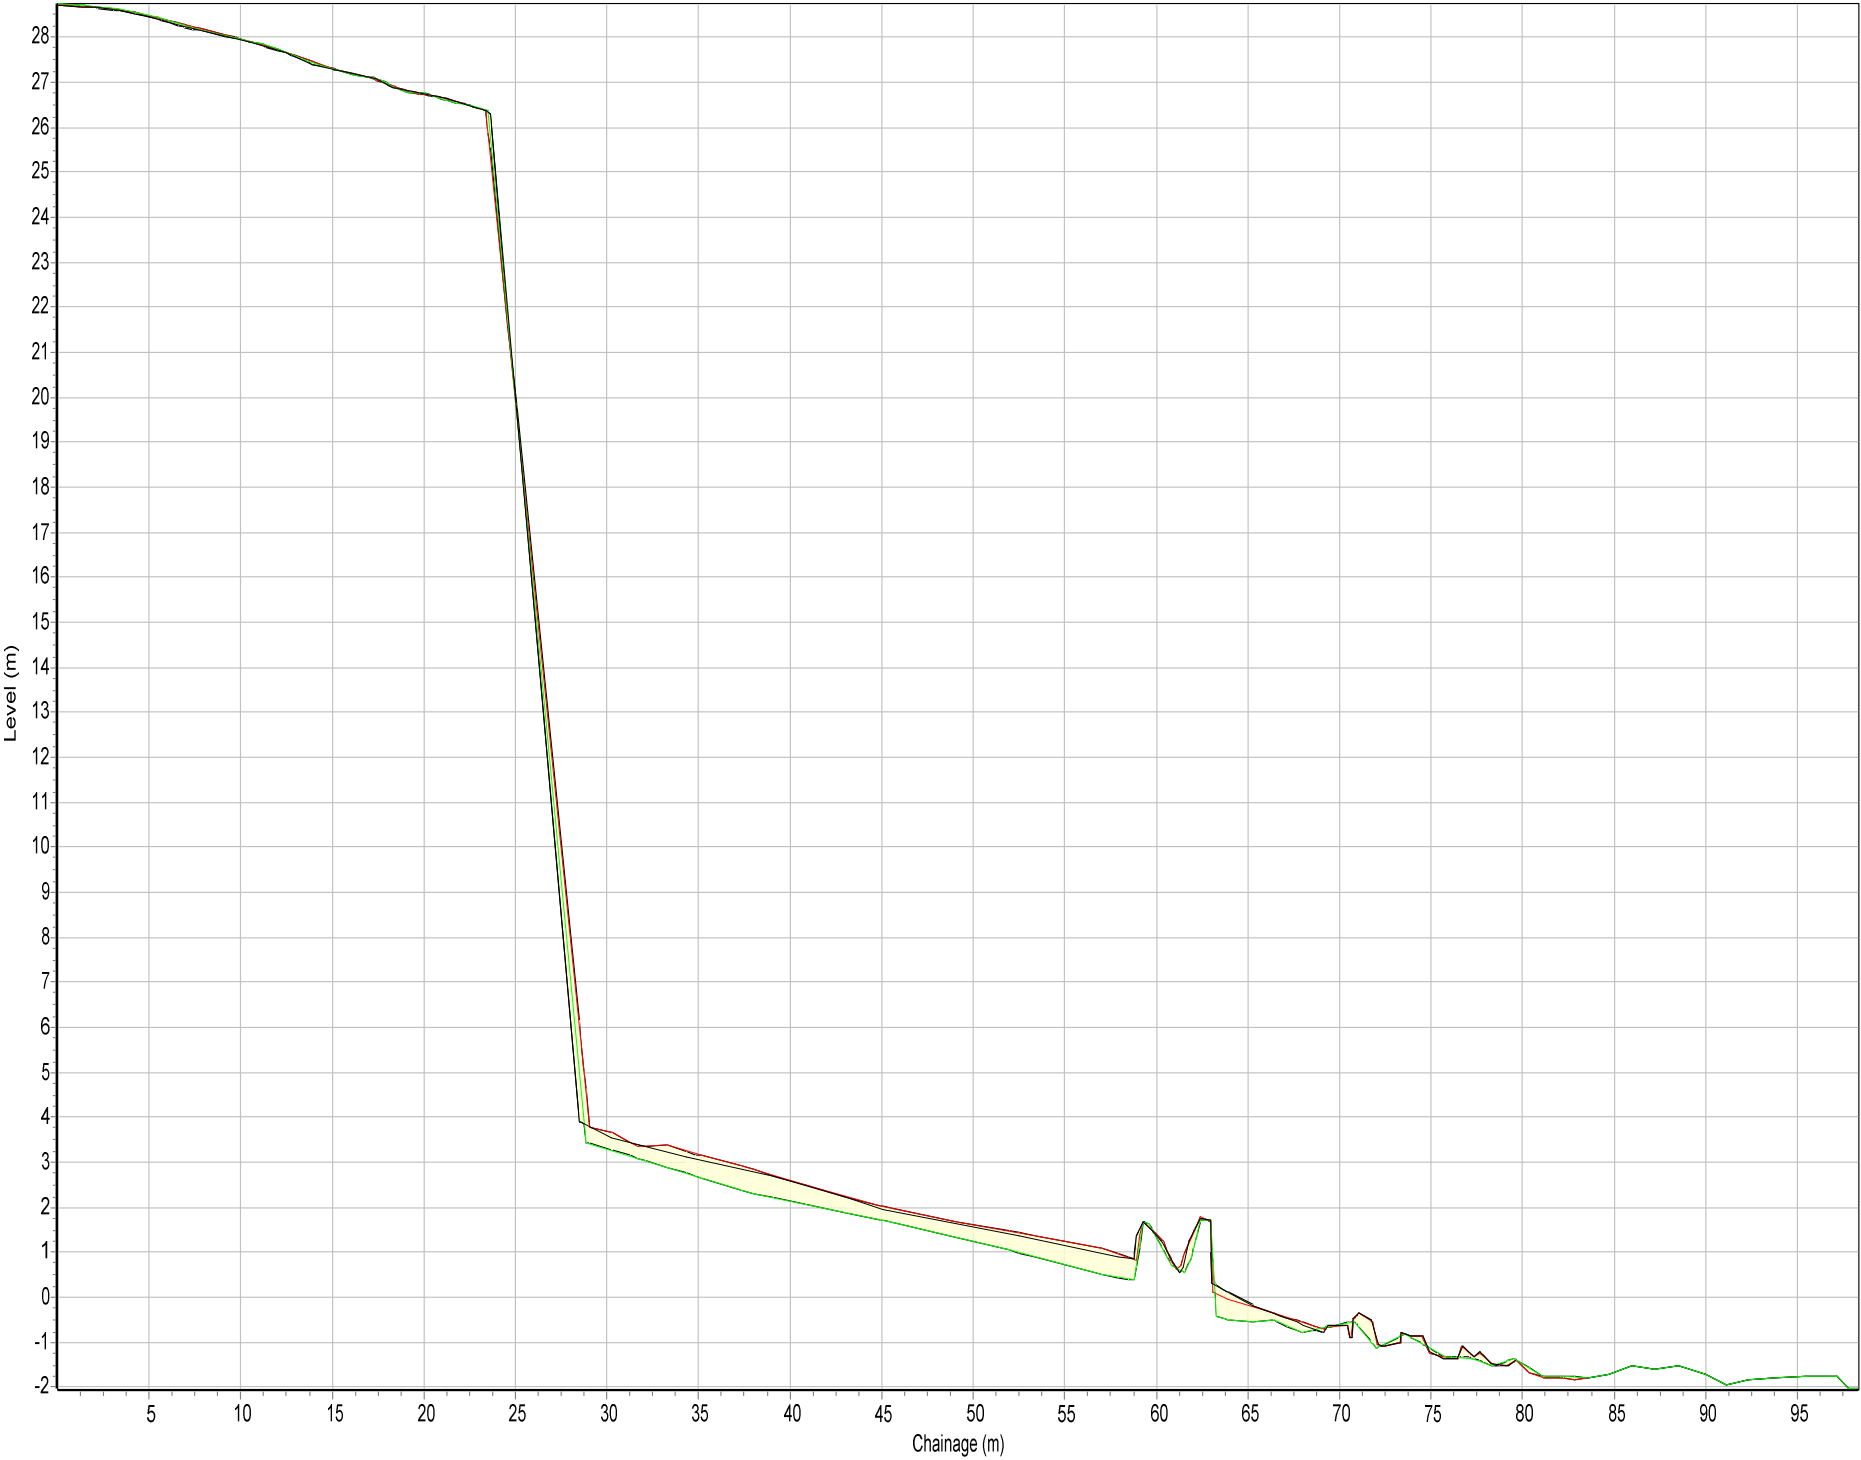
Beach Profiles: 1bSH1B

Survey Date	Description of Changes Since Last Survey	Interpretation
30 th September 2016	<p>Beach Profiles:</p> <p>Blast Beach is covered by four beach profile lines (Appendix A). All of the profiles along Blast Beach exhibit similar forms, with a rock cliff, wide colliery spoil beach with a distinct low cliff at its eroding seaward edge, and a mixed gravel and sand foreshore extending to MLW.</p> <p>Profile 1bSH1b was added to the programme during the Full Measures survey in October 2015. The profile is adjacent to the sewage works south of Seaham. The profile is cliff to 30m and then gravel beach between 30m and 60m chainage, which has shown some slight fluctuation in level over the last year but no long term change. There are two concrete blocks which have been upturned on the beach and are shown on the profiles as a protrusion in the profile between 60m and 65m chainage. The beach is visible again between 65m and 70m chainage. Below this point the rocks are exposed from 70m chainage to the end of the survey at 85m.</p> <p>Profile 1bSH1a was added to the programme during the Full Measures survey in September 2009. It is located to the north of the previously-established 1bSH1. The upper beach has a very similar profile to the previous year as far as the eroding face of the spoil deposit at 140m chainage. Between 140m chainage and 150m there has been little change in the beach profile since April 2016. From 150m to 160m chainage the beach levels have dropped by 1.5m and the crest in the beach has moved landward by 3m. Between 160m and 190m chainage the beach gradient has remained similar but the level has dropped by 1m over the summer of 2016. From 190m chainage and the end of the survey at 260m chainage the rocks are exposed at the bottom of the beach. The 2016 profile is towards the lower end of the range of previously recorded profiles, and is around 1 m lower than the autumn 2015 profile.</p> <p>Profile 1bSH1 is similar to all of the previous surveys to the beach crest at 75m. The mound present at the top of the beach in March 2015 between chainages 90m and 100m has reappeared and moved landwards by 10m. Between 90m and 145m the beach gradient has remained similar since October 2015 however the beach level has dropped by up to 1.2m (0.5m since April 2016). From 145m to the end of the survey at 160m chainage the rocks are exposed. The 2016 profile is towards the lower end of the range of previously recorded profiles.</p>	<p>The cliffs behind Blast Beach are currently inactive because they are fronted by colliery spoil. The crest of the spoil material on profiles 1bSH1 and SH1a has remained stable since 2009. Profile 1bSH2 has been progressively eroding since 2009, however has remained more stable since November 2014 showing accretion in the lower beach.</p> <p>The beaches at profiles 1bSH1b, 1bSH1a, and SH1 have all been subject to up to a 1.5m drop in beach level since the April 2016 survey. The beach at profile SH2 has shown an increase in level however. There has also been some change in the mid beach levels with formation of berms.</p> <p>Longer term trends: The sea cliffs will eventually reactivate as on-going erosion of the colliery spoil removes the protection it affords to the cliffs. This is most likely to occur at the southern end of the bay where the spoil is most rapidly eroding. The accumulating sediment seaward of the colliery spoil in the northern part of the bay will offer the cliffs more protection. However since the winter of 2014 there has been a reversal in the trend with erosion in the north of the bay and accretion in the south; this may yet be a short term change.</p>

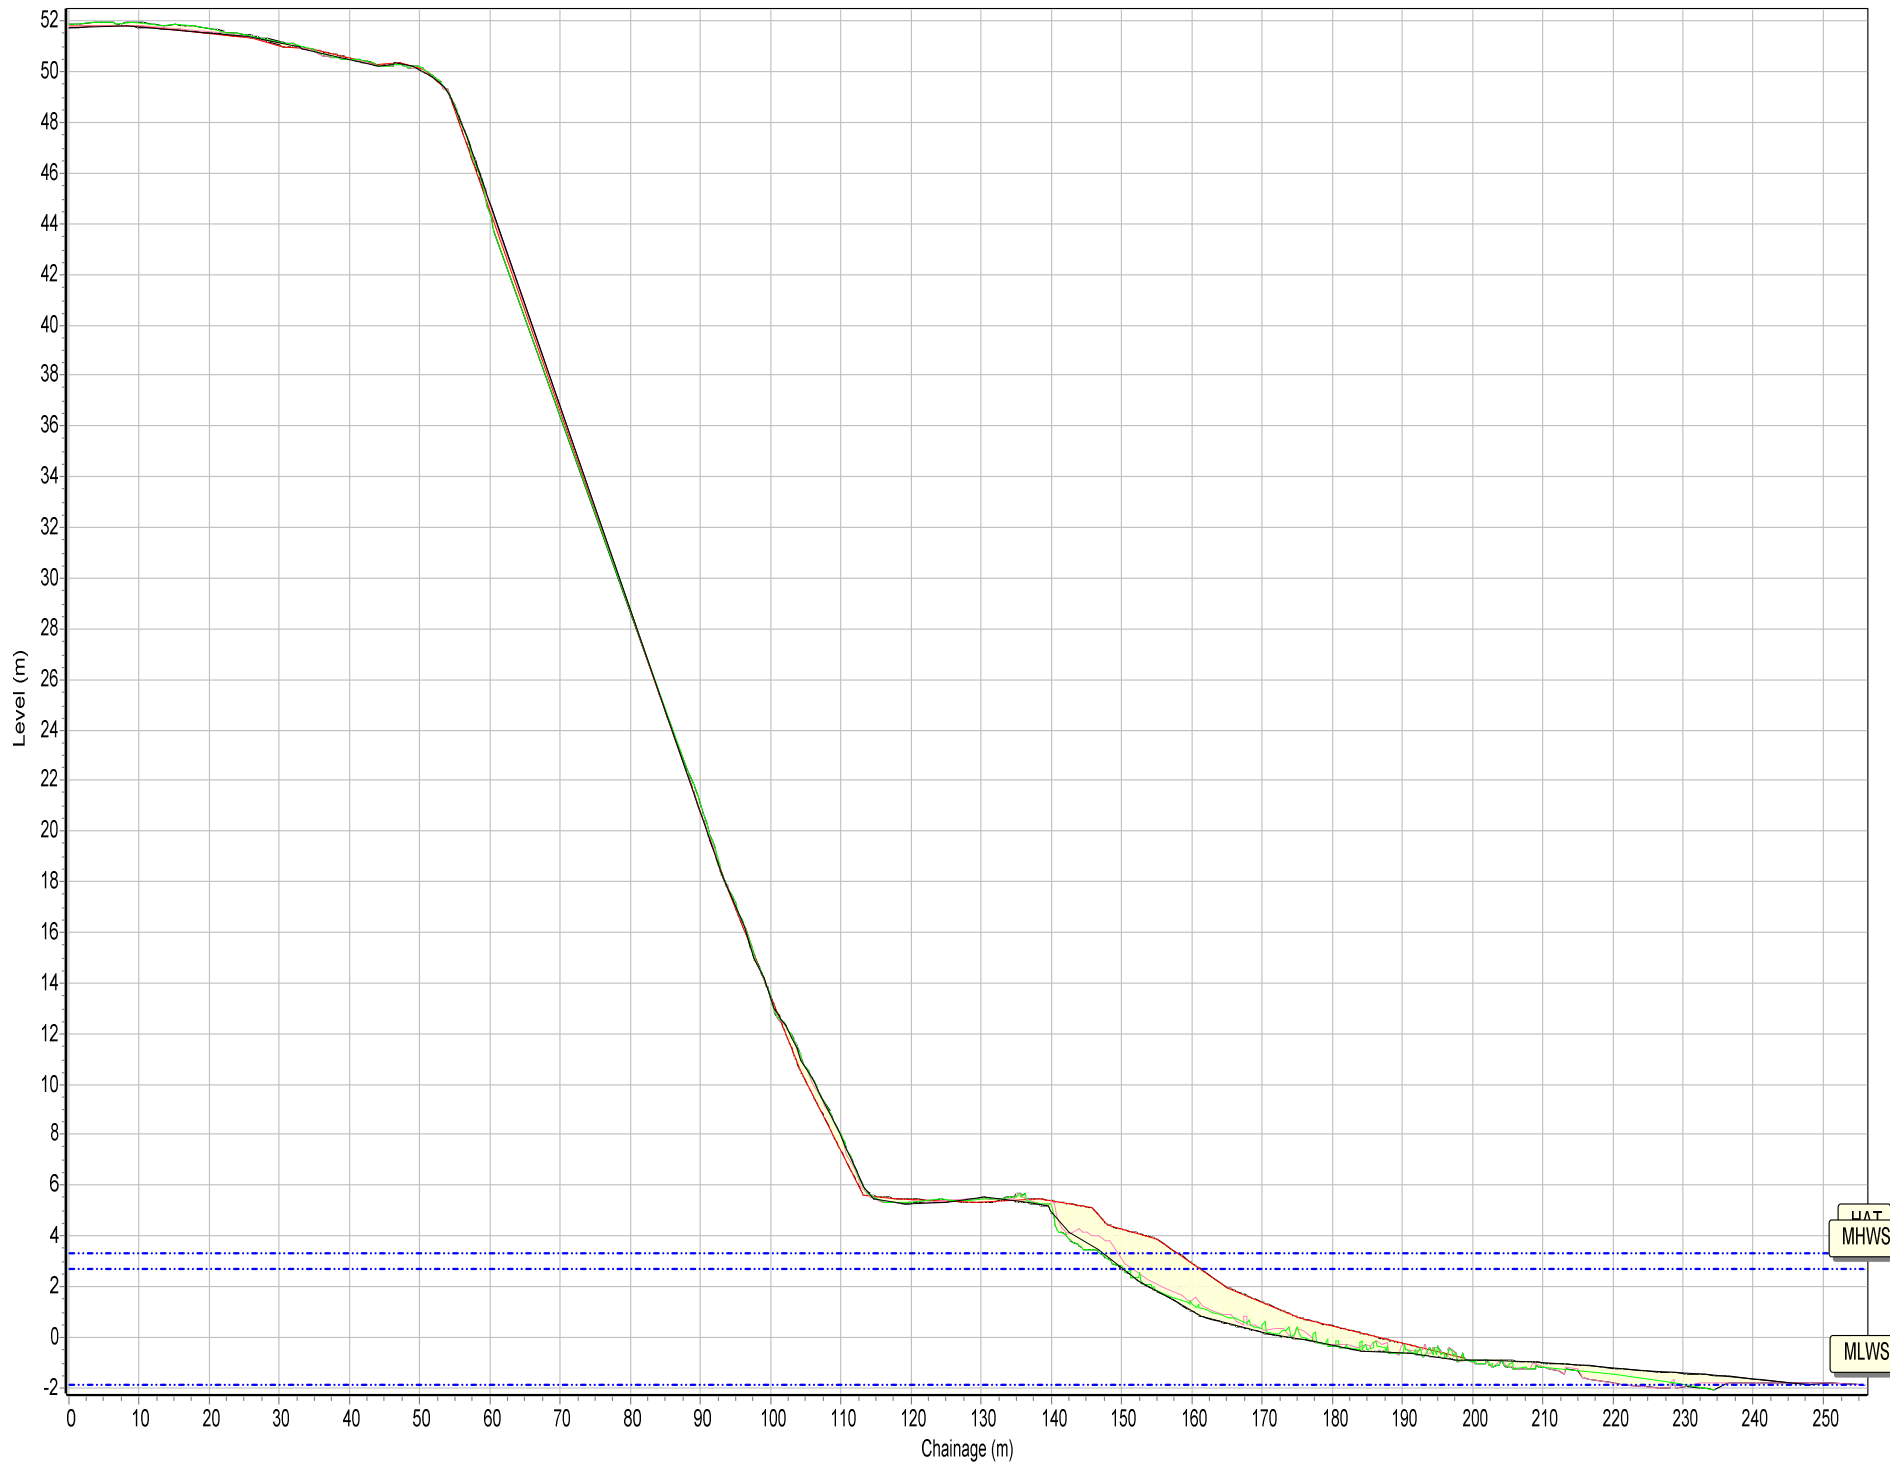
Beach Profiles: 1cBH1

Survey Date	Description of Changes Since Last Survey	Interpretation
25 th August 2016	<p>Beach Profiles:</p> <p>Blackhall Colliery is covered by three beach profile lines (Appendix A). As at Blast Beach, profiles are dominated by colliery spoil and exhibit similar forms with a rock cliff, wide spoil beach with a distinct cliff at the eroding face of the colliery spoil, and a gravel and sand foreshore that extends to MLW.</p> <p>1cBH1 is located near Horden Point and shows that the face of the colliery spoil has receded by a similar amount as in 2015 of around 0.5, much less than the 3m erosion, which happened in 2014. The eroding face at 140m chainage is steep. The overall gradient of the beach has changed becoming steeper, with an increase in beach levels of up to 0.4m from 140m chainage to 150m. From 155m to 175m chainage the beach level has dropped by 0.2m since October 2015, making it the lowest recorded levels in this section. From 175m to 200m chainage the cobble beach has remained stable, with an increase in sand levels from 200m to the end of the profile.</p> <p>Profile 1cBH2 exhibits no change in the cliff profile and the cliffed-edge of the spoil beach has remained stable since November 2014. There had been 2m of erosion since September 2013, but much less through 2015 and 2016. There is around c.43m of material from the eroding face at the back of the beach to the cliff toe. From 170m to 250m the beach gradient has reduced, with erosion of up to 0.4m between chainage 170m to 205m, and infilling of the profile by up to 1m between chainage 205m and 250m making the lower beach the highest recorded levels. At the bottom of the profile from chainage 250m the beach has remained stable.</p> <p>The profile 1cBH3 shows that since 2008 there has been episodic migration, infilling and scouring of the outflow of Castle Eden Burn, which crosses the profile. There has been limited recession of the landward bank of the channel, which is closer to the cliffs than in previous years. From the edge of the channel at 150m to 185m chainage there is a mound where the upper beach berm is. The top of the mound has moved landward by 5m. From 180m to 225m there has been erosion of up to 0.5m since October 2015. The lower beach is the lowest recorded level because of the progressive recession of this beach.</p>	<p>The more northerly two profiles at Blackhall Colliery show a similar trend with little change in the eroding face of the beach material following a large change in 2014.</p> <p>There have been some changes to the gradients of the profiles, with BH1 steepening whilst BH2 has flattened slightly, and BH3 has remained consistent.</p> <p>Longer term trends: The surveys show that the spoil beach along much of the Blackhall Colliery shore is progressively eroding but continues to protect the cliffs in the short term.</p>
