**Cell 1 Regional Coastal Monitoring Programme  
Update Report 2: 'Partial Measures' Survey 2010**

**Durham County Council  
Final Report**

**May 2010**

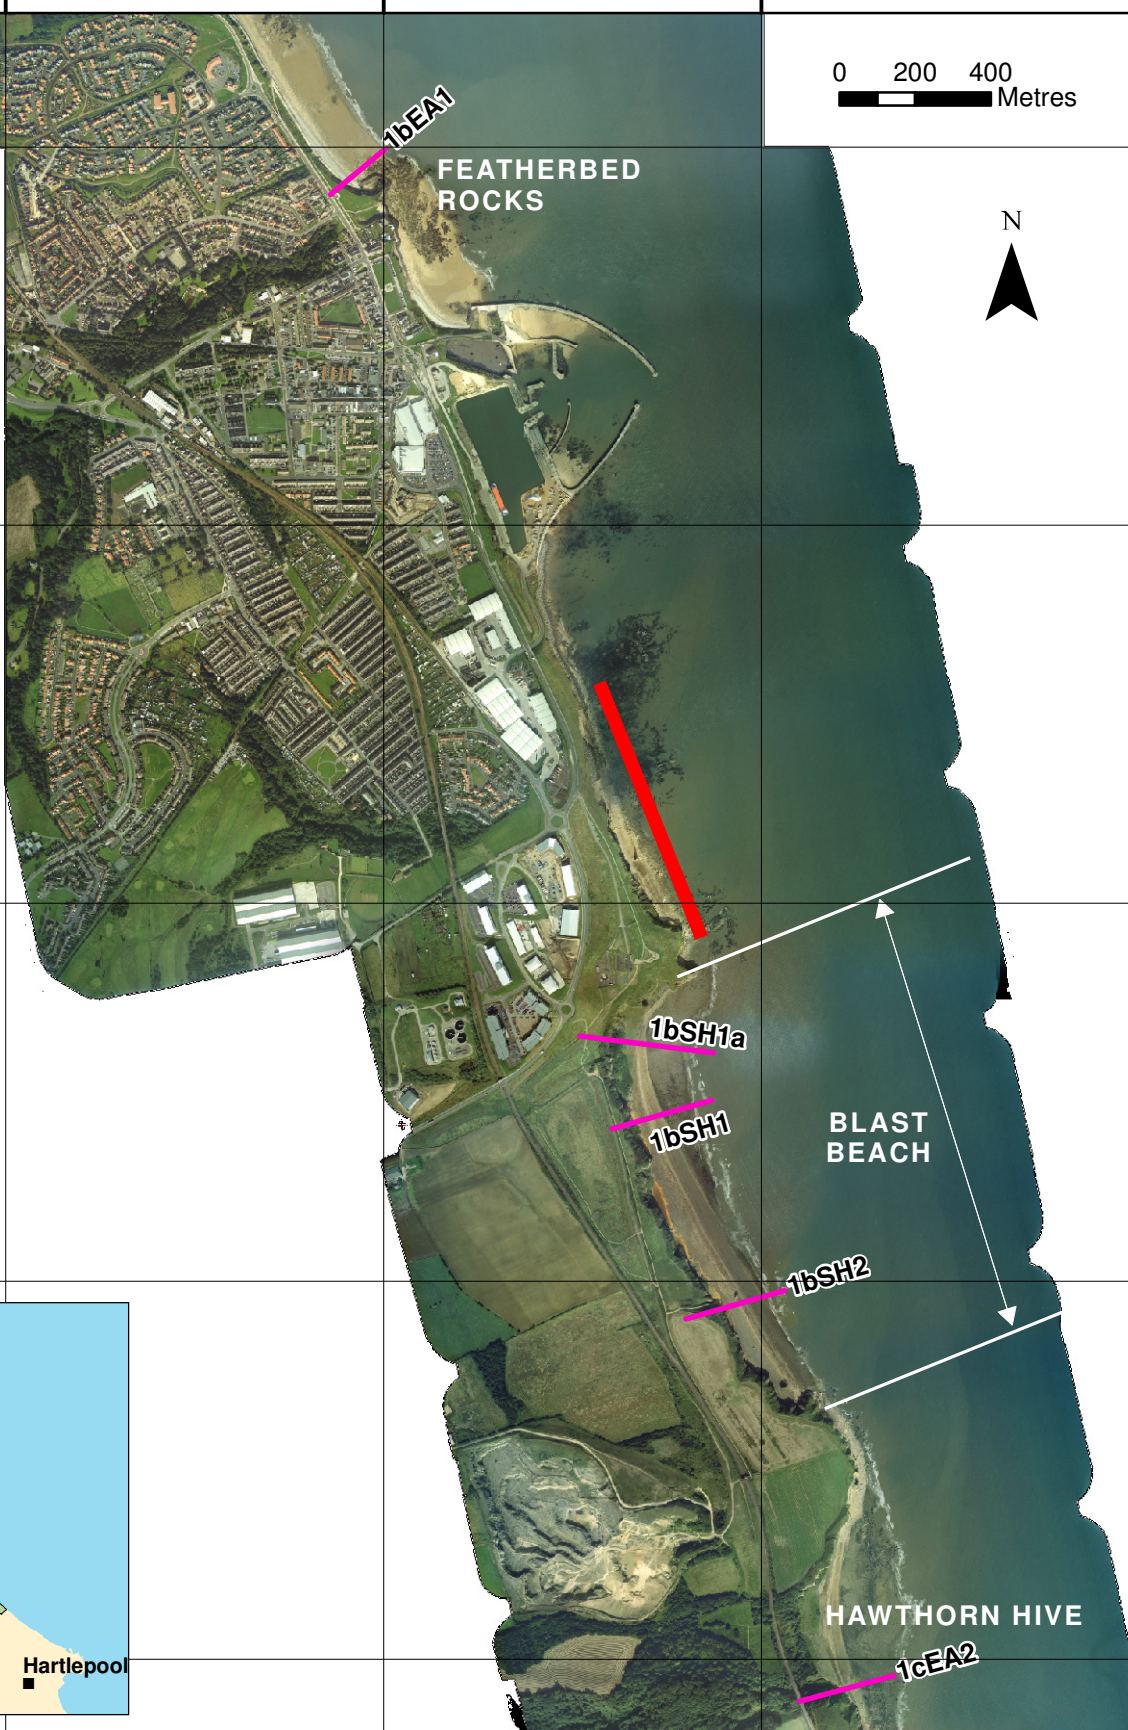
**Figure 1 - Map 1  
Durham County  
Council Frontage**

The location of these surveys is shown in Figure 1. They have also previously been provided on a digital file which can be opened in Google Earth showing the locations of the surveys.

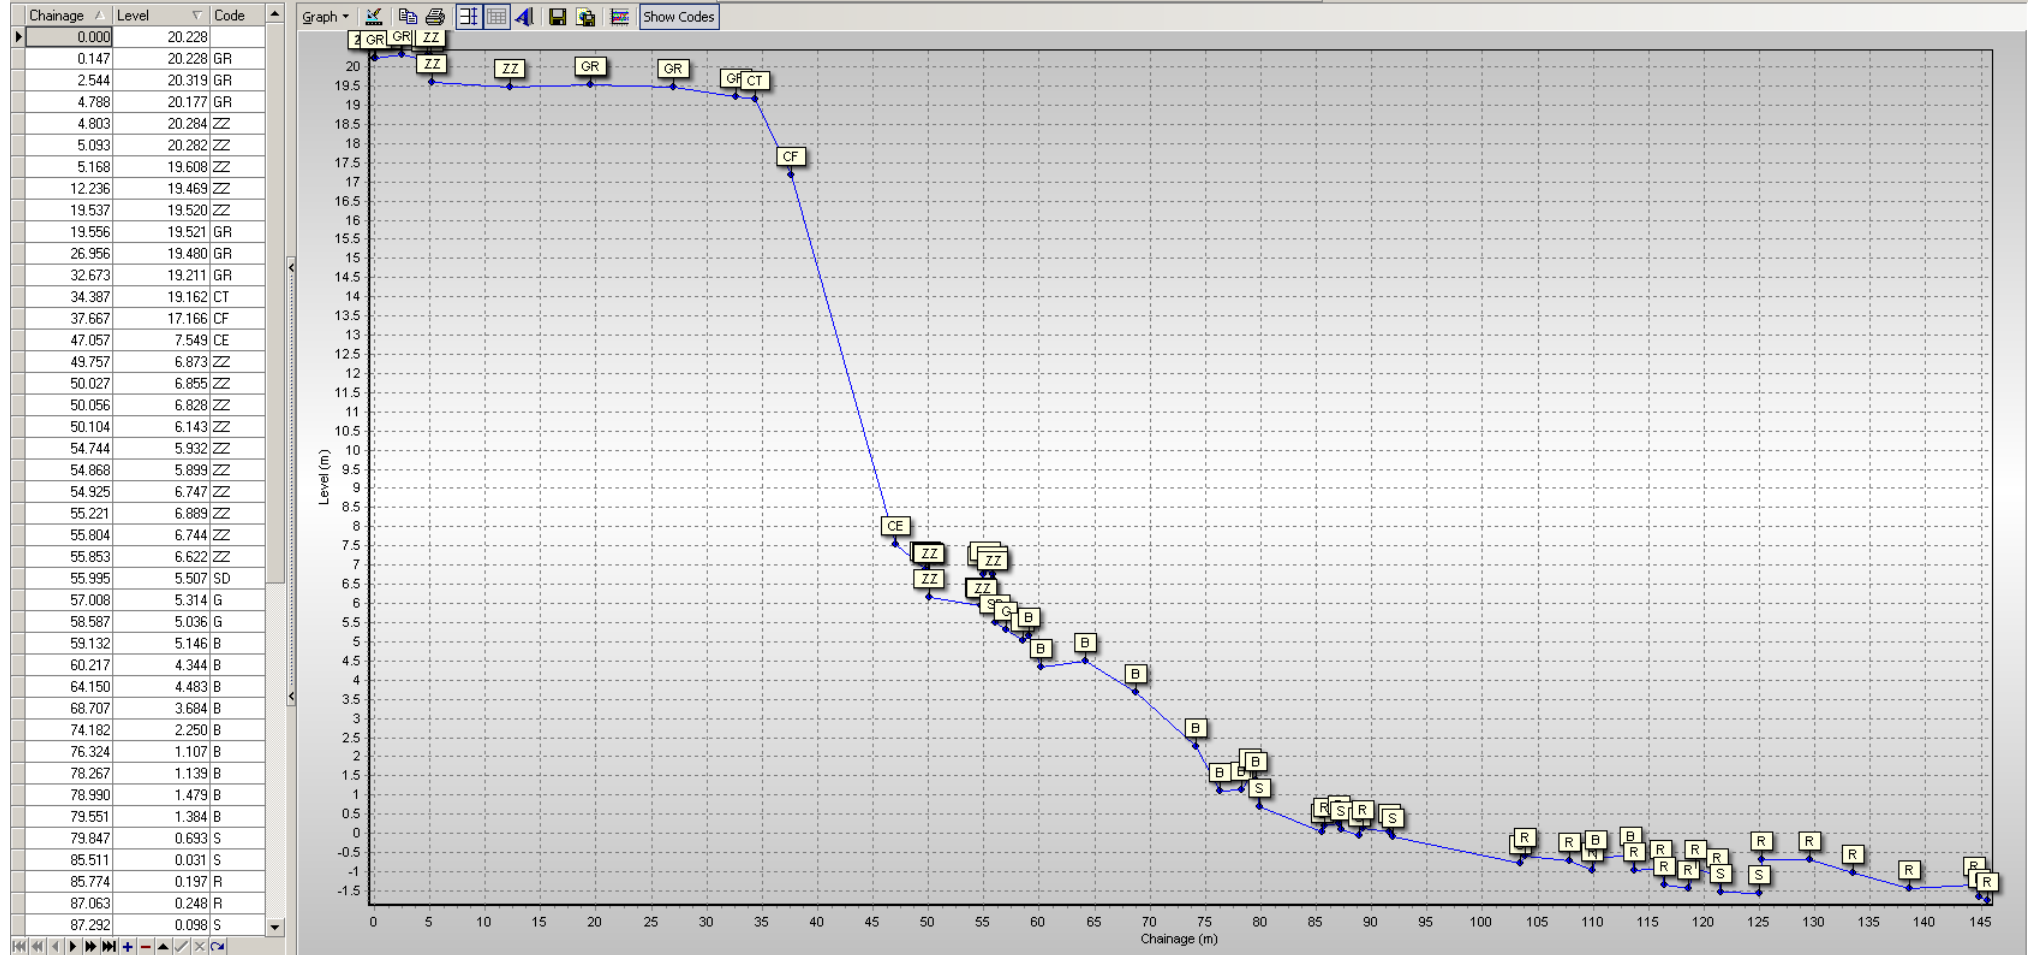
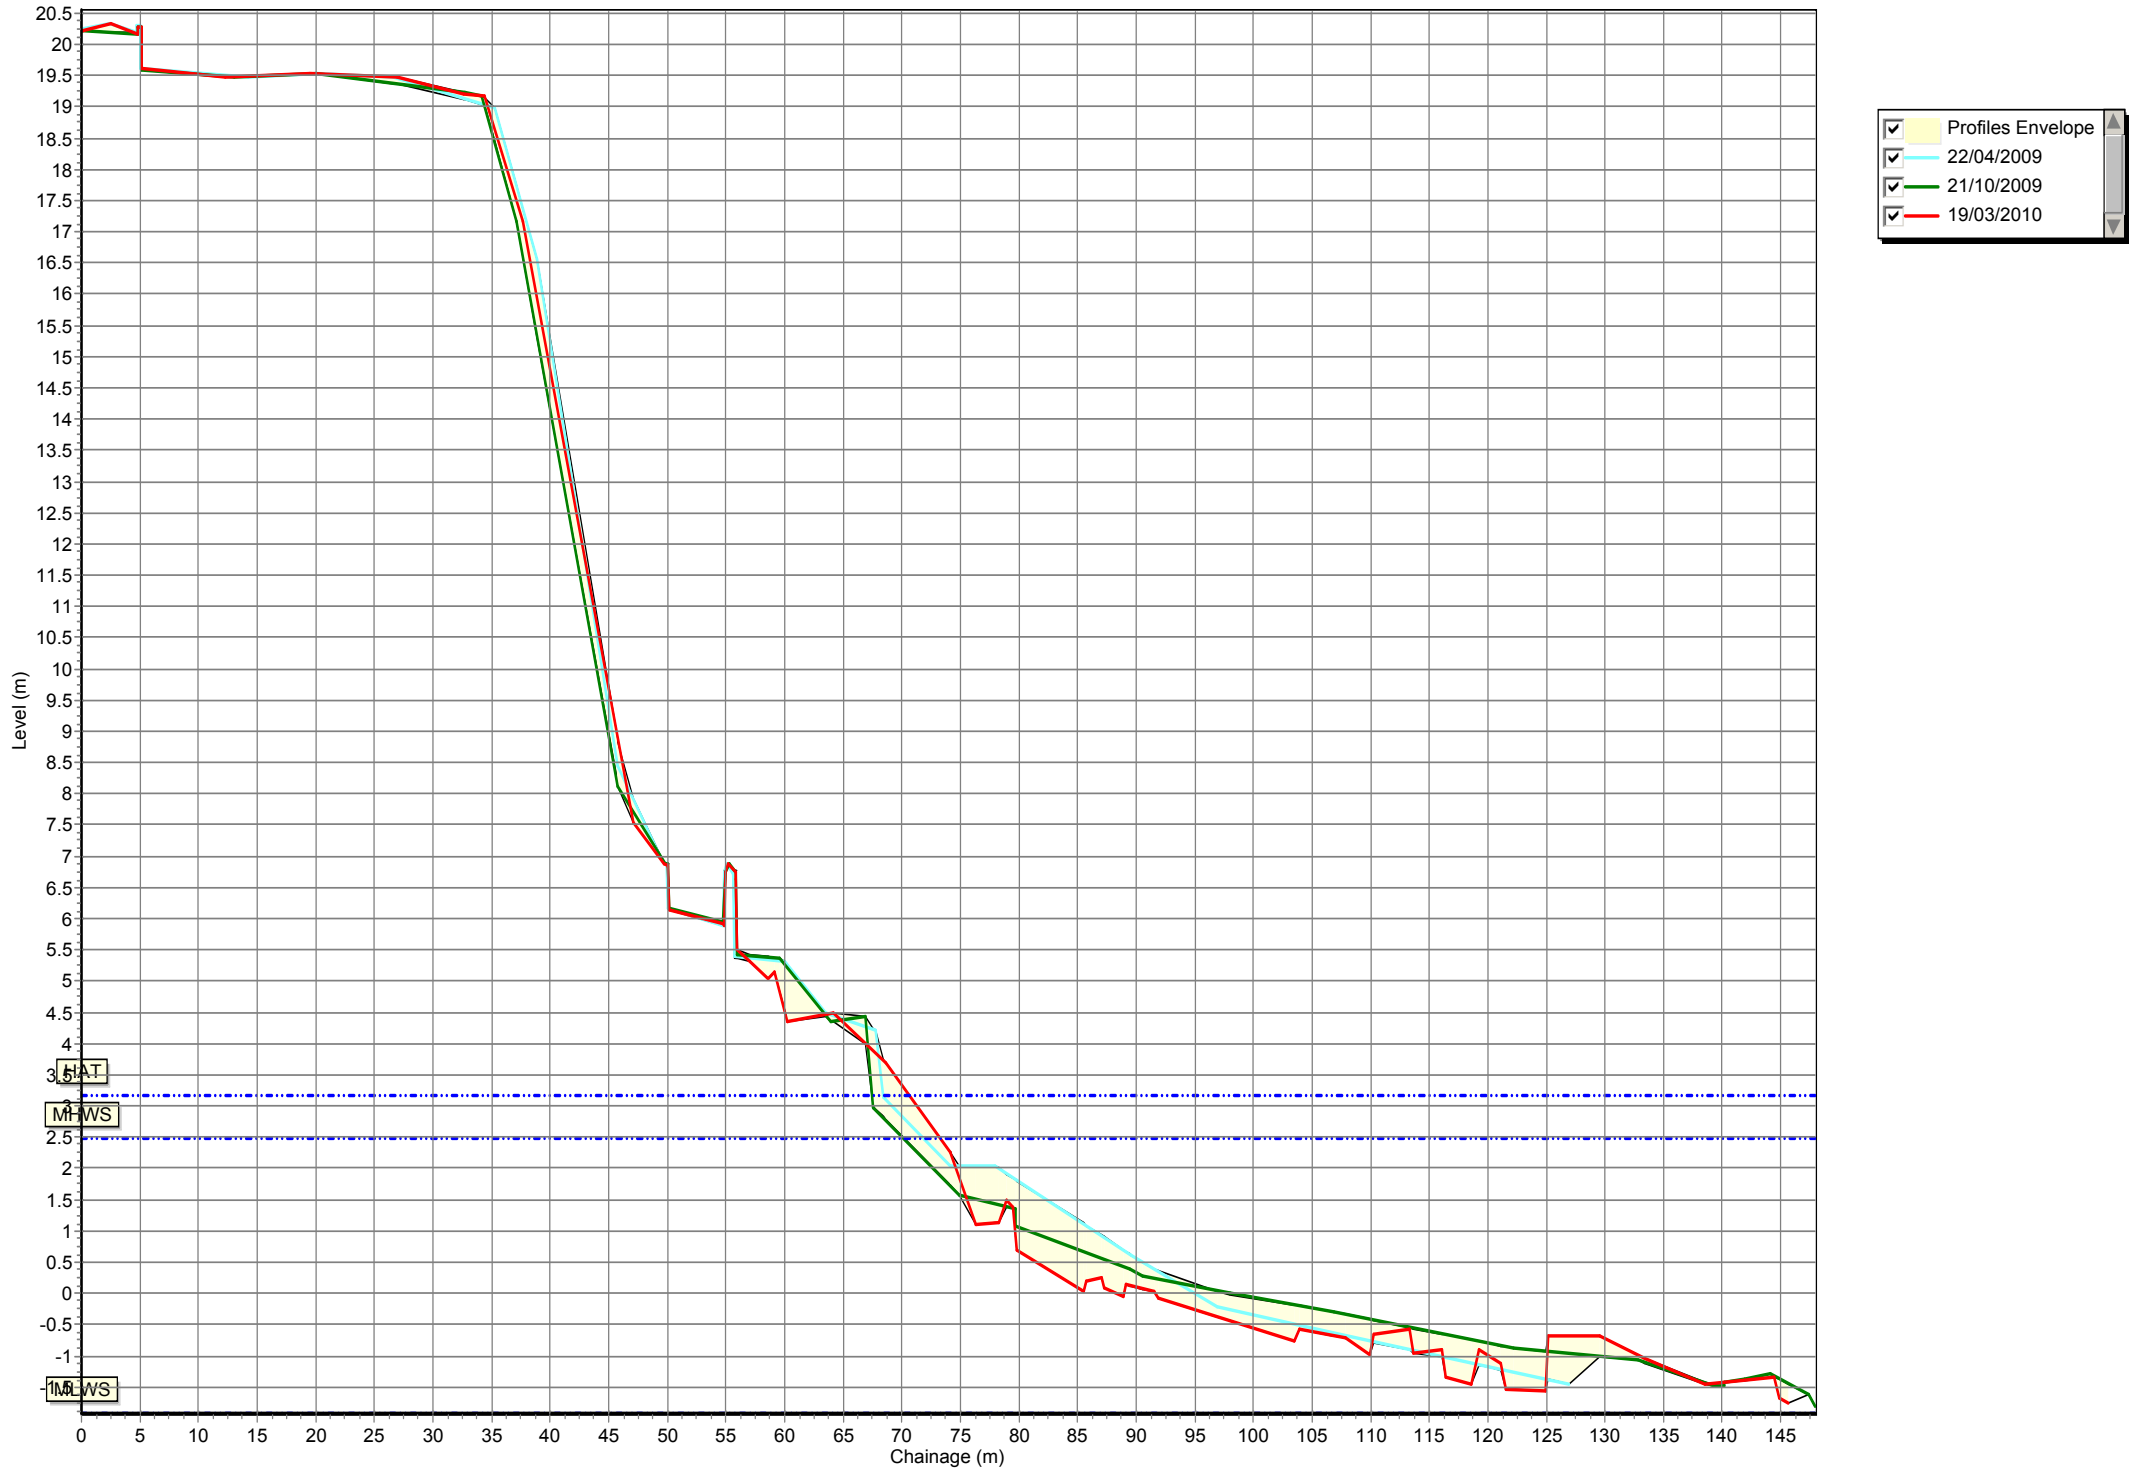
# Beach Profiles: 1bEA1

Survey Date	Description of Changes Since Last Survey	Interpretation
03-2010	<p><b>Beach Profiles:</b></p> <p>Featherbed Rocks is covered by one beach profile line (EA1) during the Partial Measures survey (Appendix A).</p> <p>The shingle berm, which previously had a quite distinct near-vertical seaward-facing edge around HAT and a 'ramped' profile between there and the toe of the sea wall, has been flattened, reducing beach levels just seaward of the toe of the wall by around 1m. Further seaward along the profile, the lowest beach levels since surveys began in April 2009 were recorded, exposing rock outcrops along the lower foreshore.</p>	<p>Whilst there has been a longer-term net tendency for accretion of shingle at this location, the March 2010 survey shows that erosion has occurred over the winter of 2009/2010. There appears to have been a net export of shingle from this profile, suggesting some drawdown and movement (temporarily) offshore. It is expected that over the summer of 2010 much of this material will return to shore and re-form the ramped profile characteristics of this site.</p>

- Despite the longer-term trend of accretion, the shingle along the foreshore at profile EA1 has been redistributed from the 'ramp' that built up at the toe of the sea wall and promenade. It is likely that this material has been (temporarily) washed offshore during the winter storms of 2009/2010.

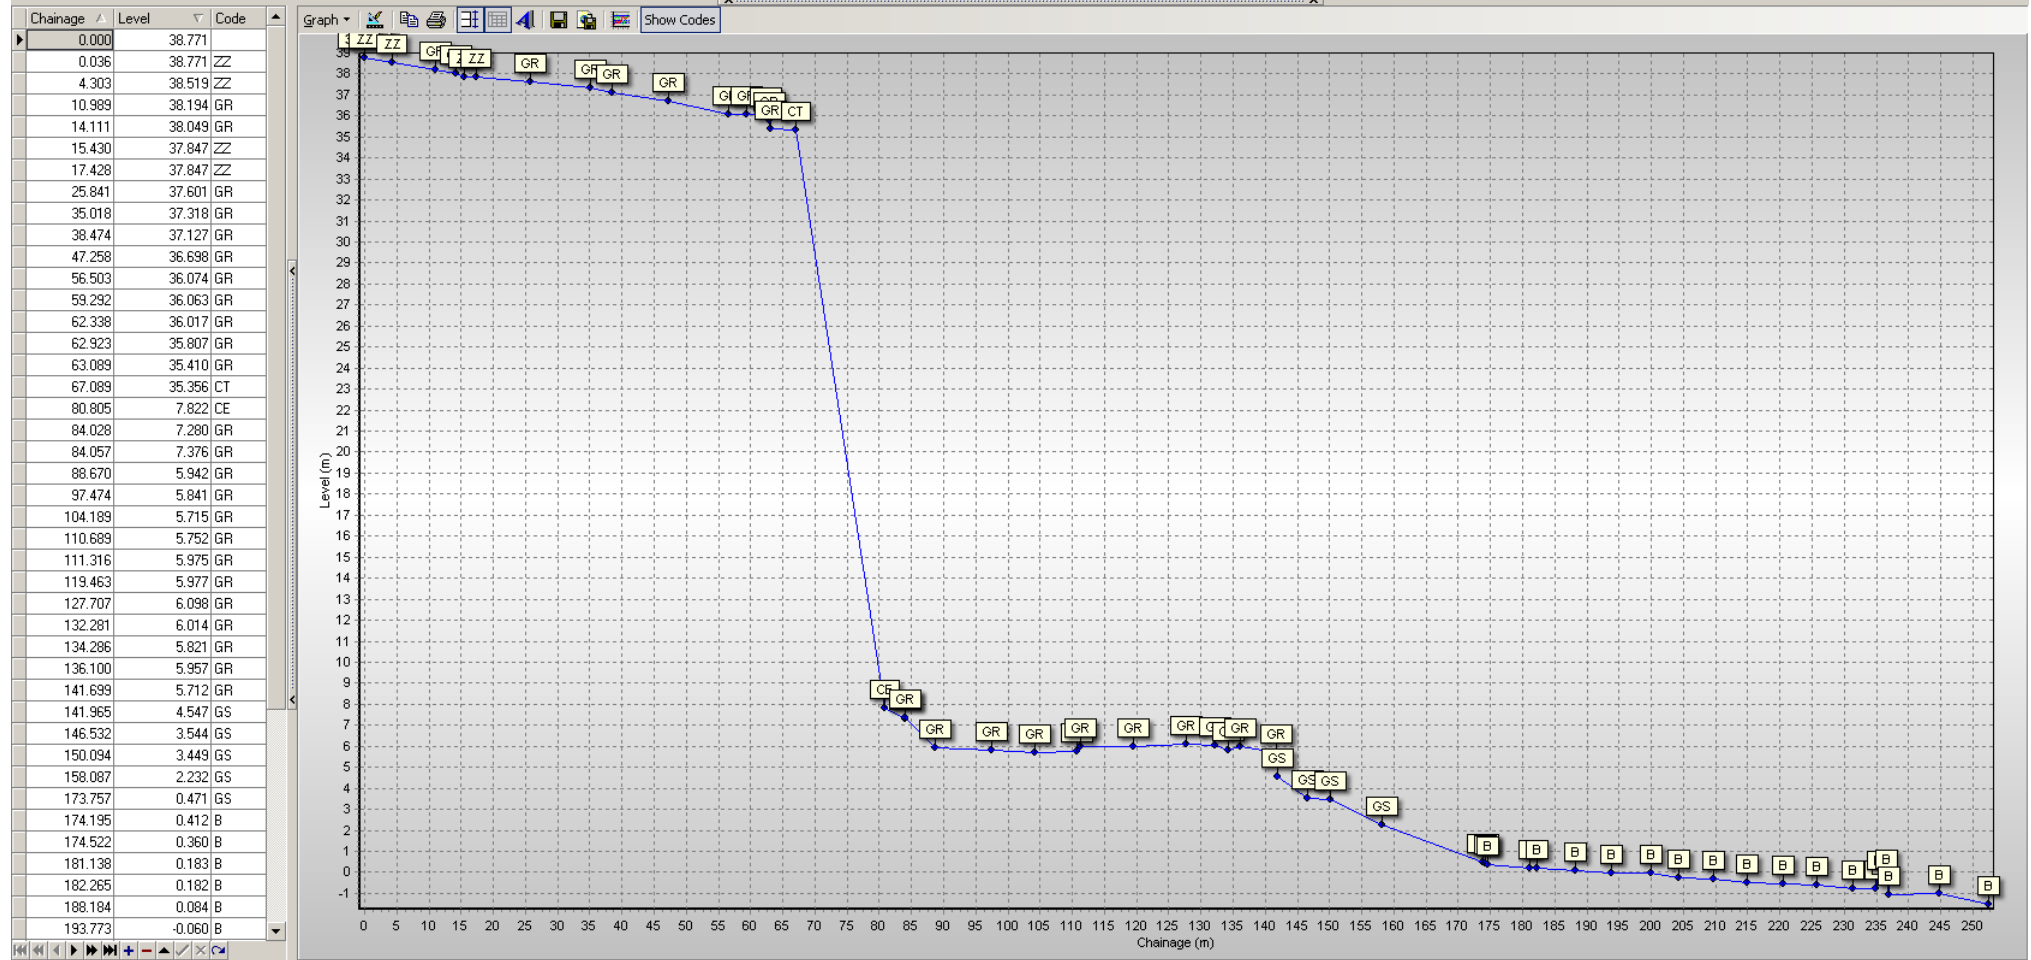
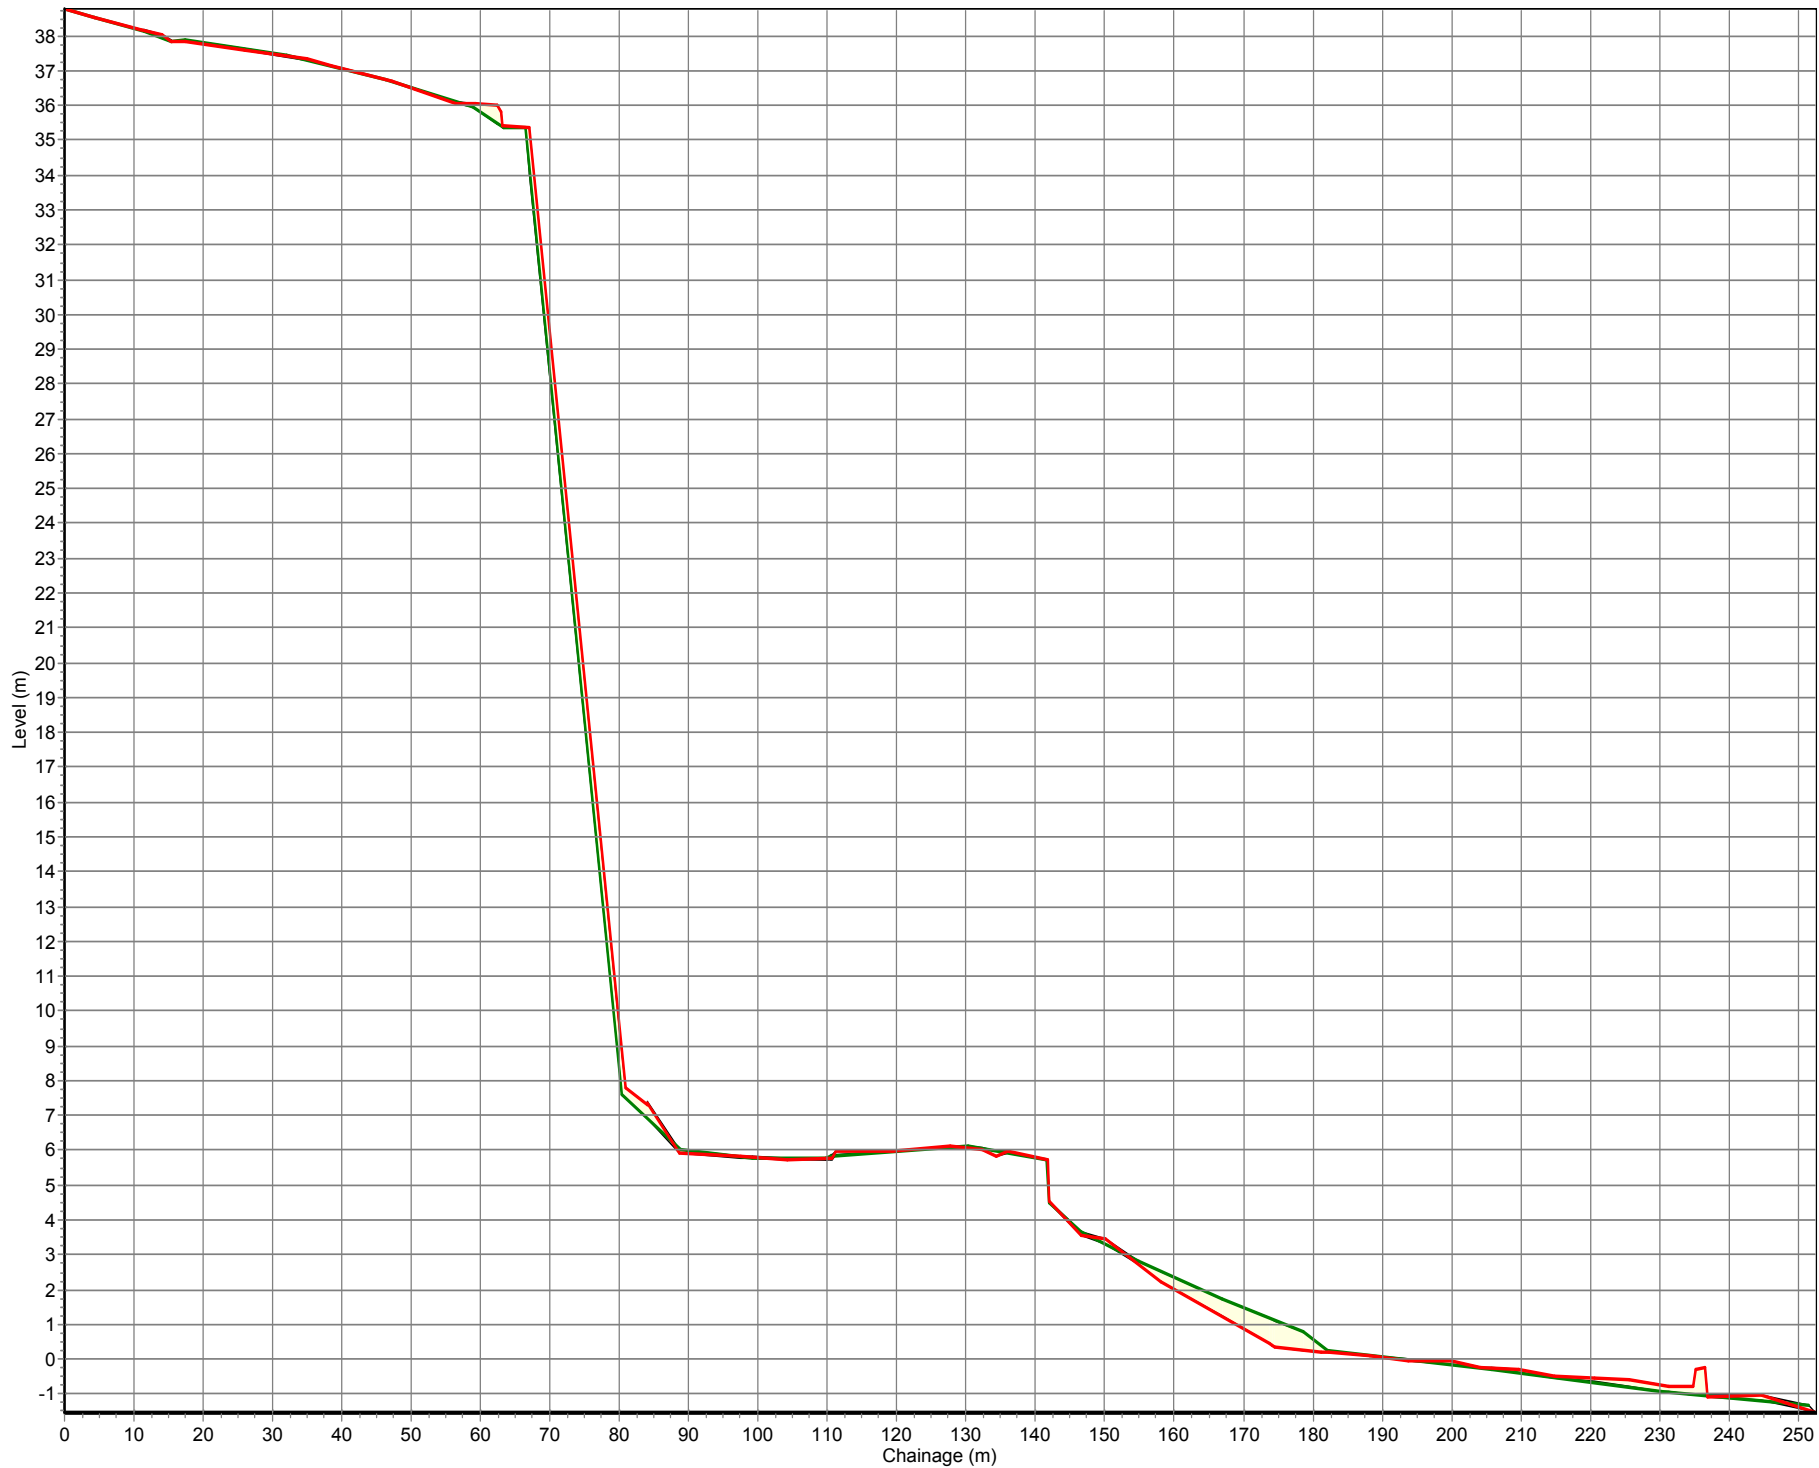
Beach Profiles: 1bSH1a

Survey Date	Description of Changes Since Last Survey	Interpretation
03-2010	<p><b>Beach Profiles:</b></p> <p>Blast Beach is covered by three beach profile lines during the Partial Measures survey (Appendix A). Two of these commenced in November 2008, with SH1a being added in October 2009.</p> <p>SH1a shows stability in the form, height and position of the vertical cliff-edge at the seaward face of the spoil beach. The backing wide spoil beach and cliffs remain stable, with minor changes in the foreshore causing only a modest reduction locally in beach levels.</p> <p>SH1 shows yet further accretion of sediment on the foreshore fronting the beach comprised of colliery spoil. This has raised beach levels here by up to a further 0.5m. The edge of the colliery spoil has not eroded.</p> <p>SH2 shows measurable erosion at the seaward face of the spoil beach, with the cliffed front edge cutting landwards by around 6.5m. There is now a reduce width of around 38m of spoil beach in front of the relic cliff. In addition to this, the foreshore has also lowered by up to 1m.</p>	<p>The previous trend identifying a small amount of redistribution of beach sediment from the southern frontage to the northern frontage appears to have continued, but now there has been measurable erosion of the colliery spoil beach along SH2.</p>

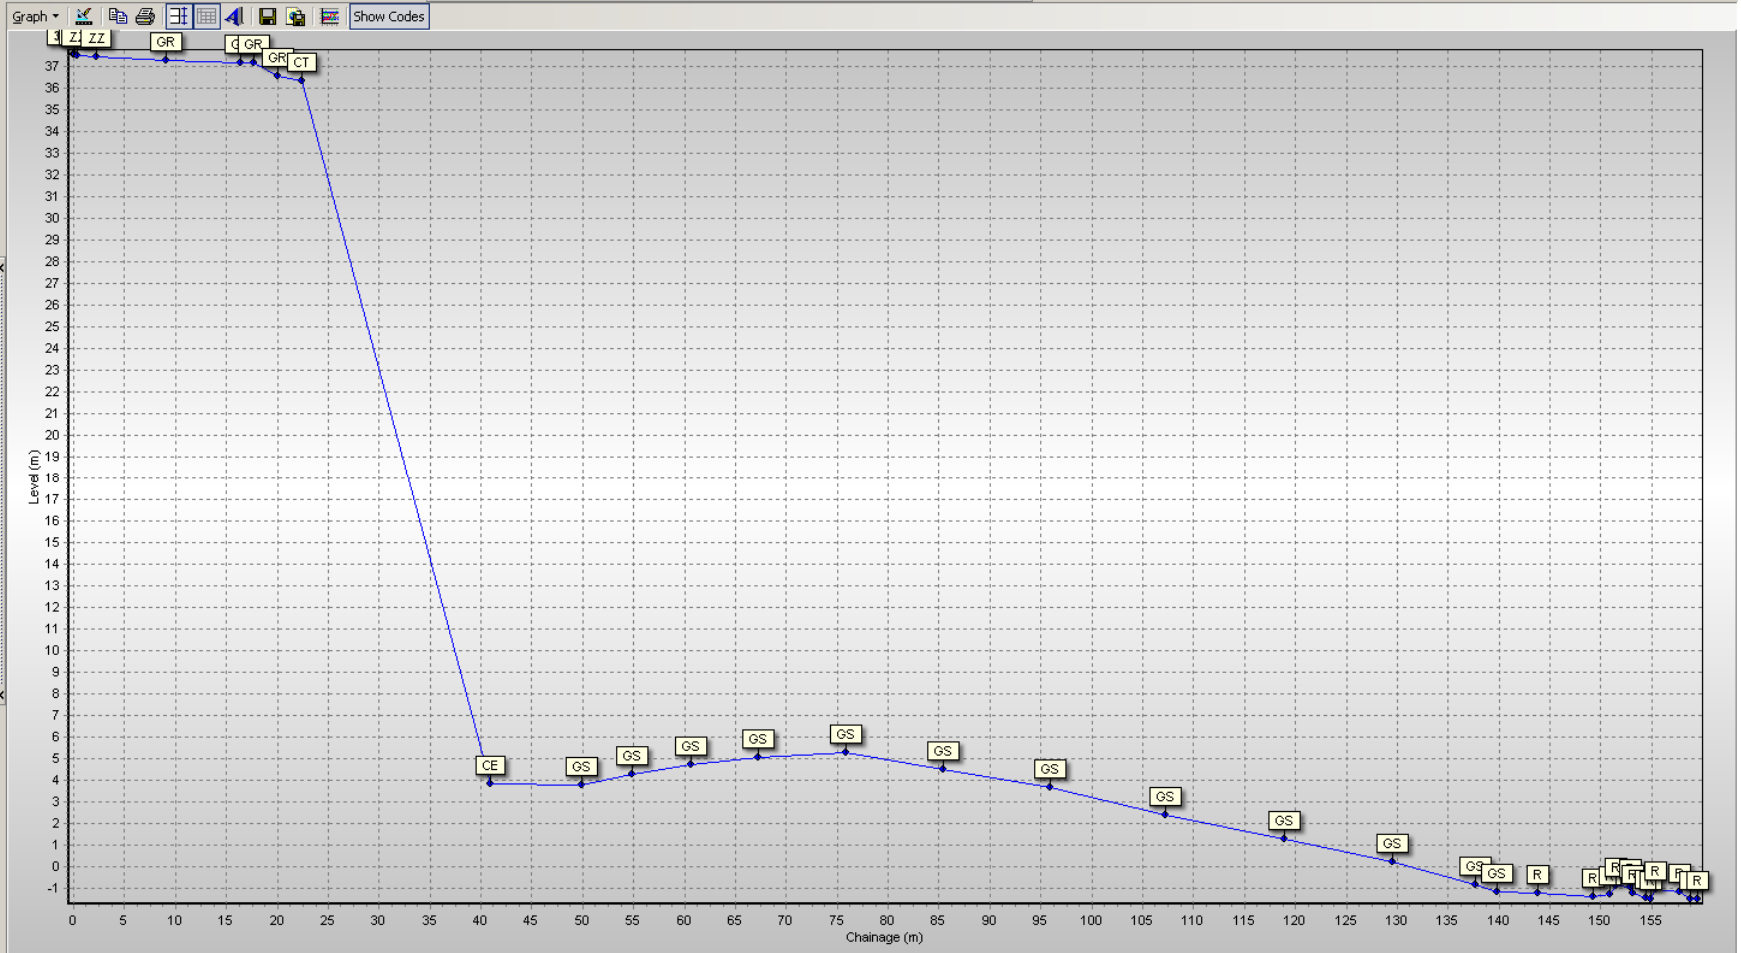
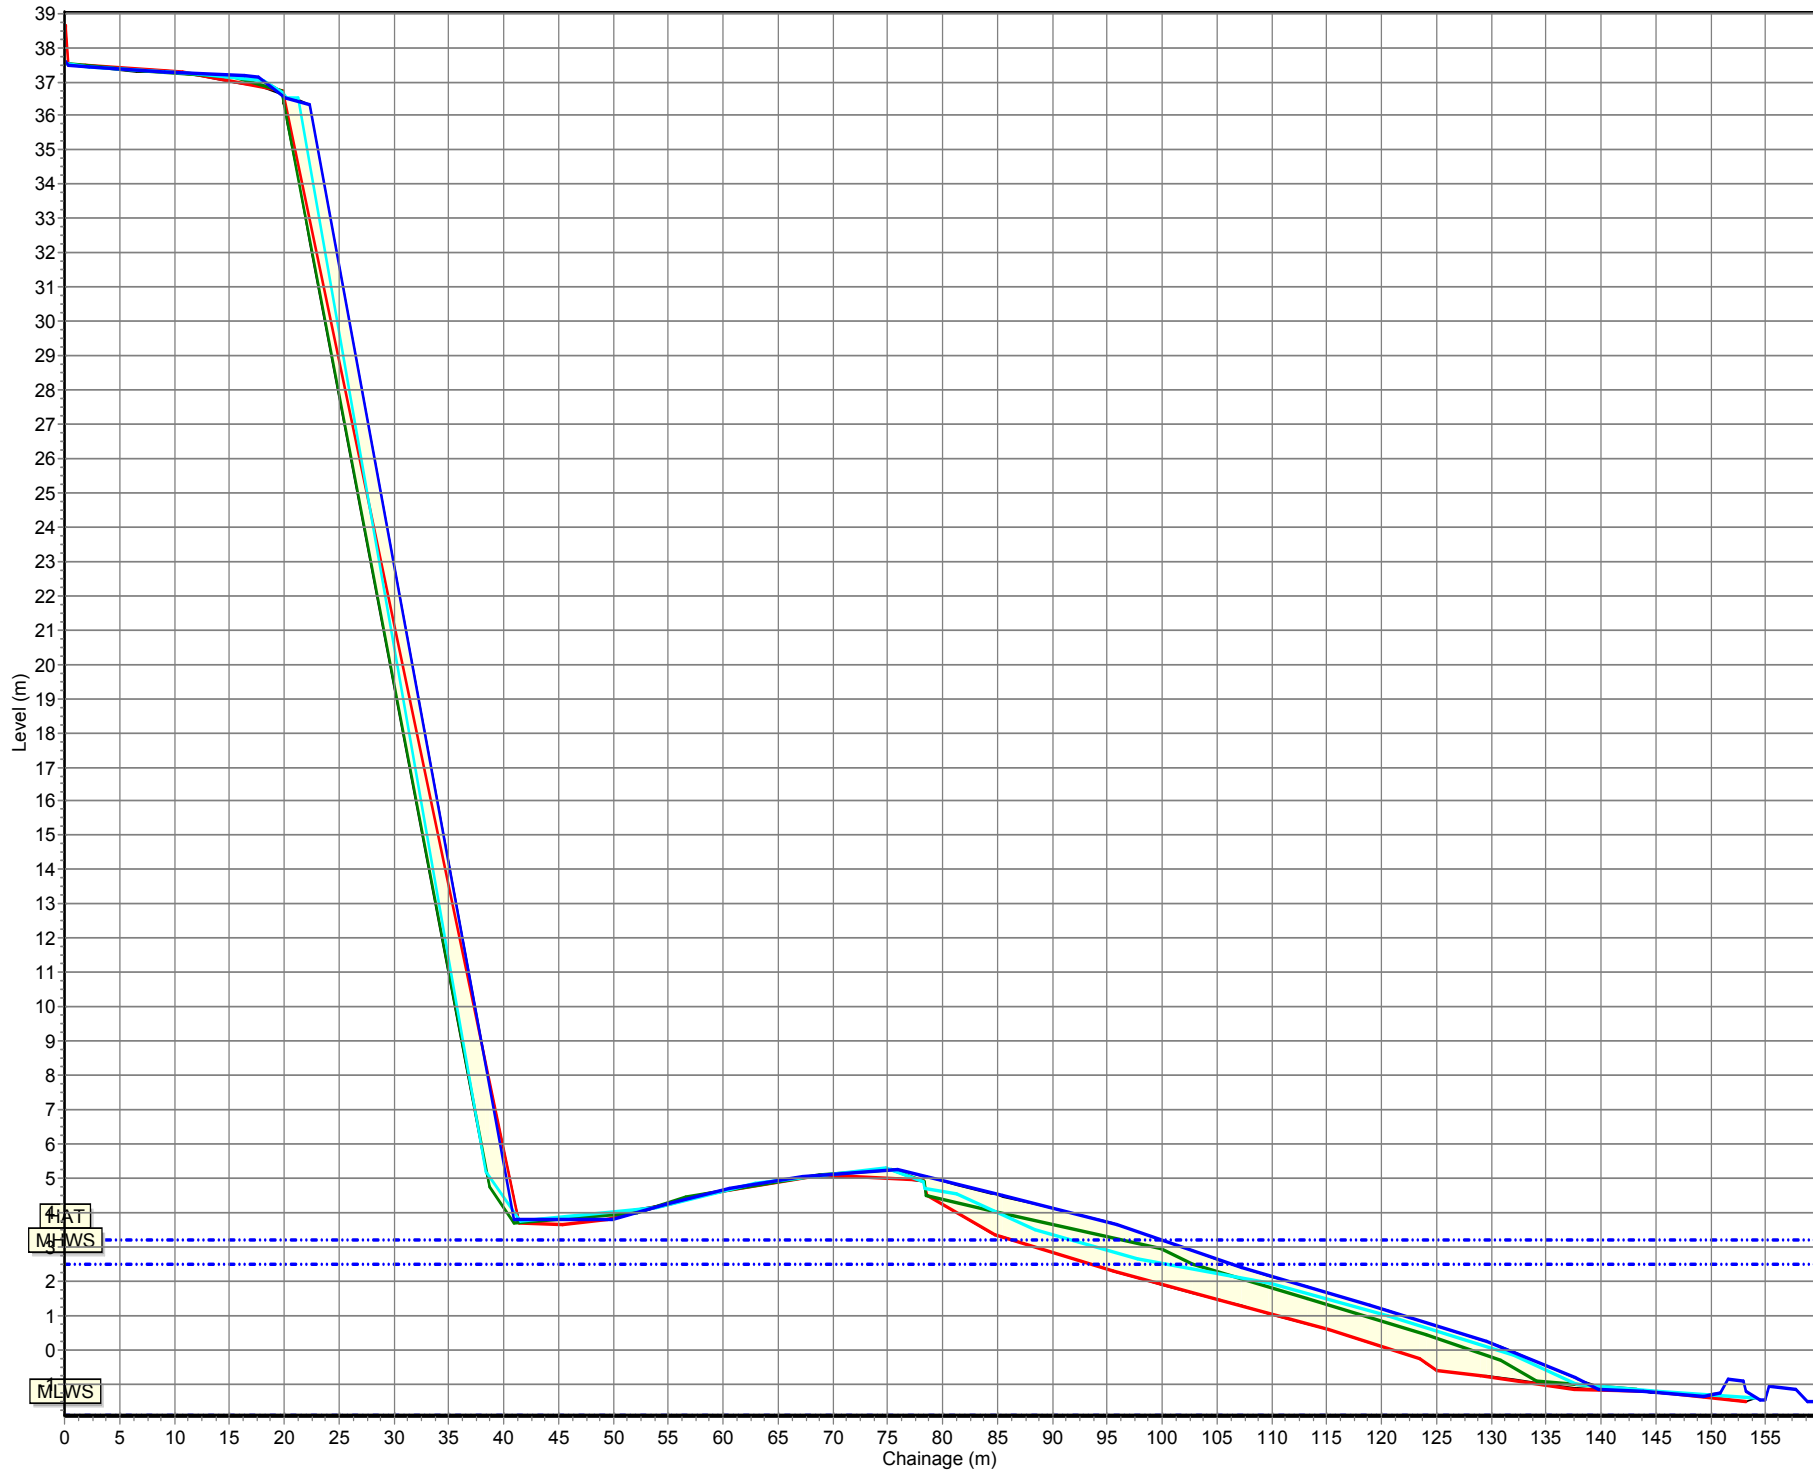
# Beach Profiles: 1bSH1

Beach profiles SH1, SH2 and EA2 extend across cliff tops, each with difficult access to the cliff edge. This has led to slightly different levels of detail being picked up in these difficult areas between successive surveys. This gives rise to minor 'apparent' changes in the cliff face or cliff top which are not true. However, once crossing the foreshore there are no such problems and the survey accuracy is restored.

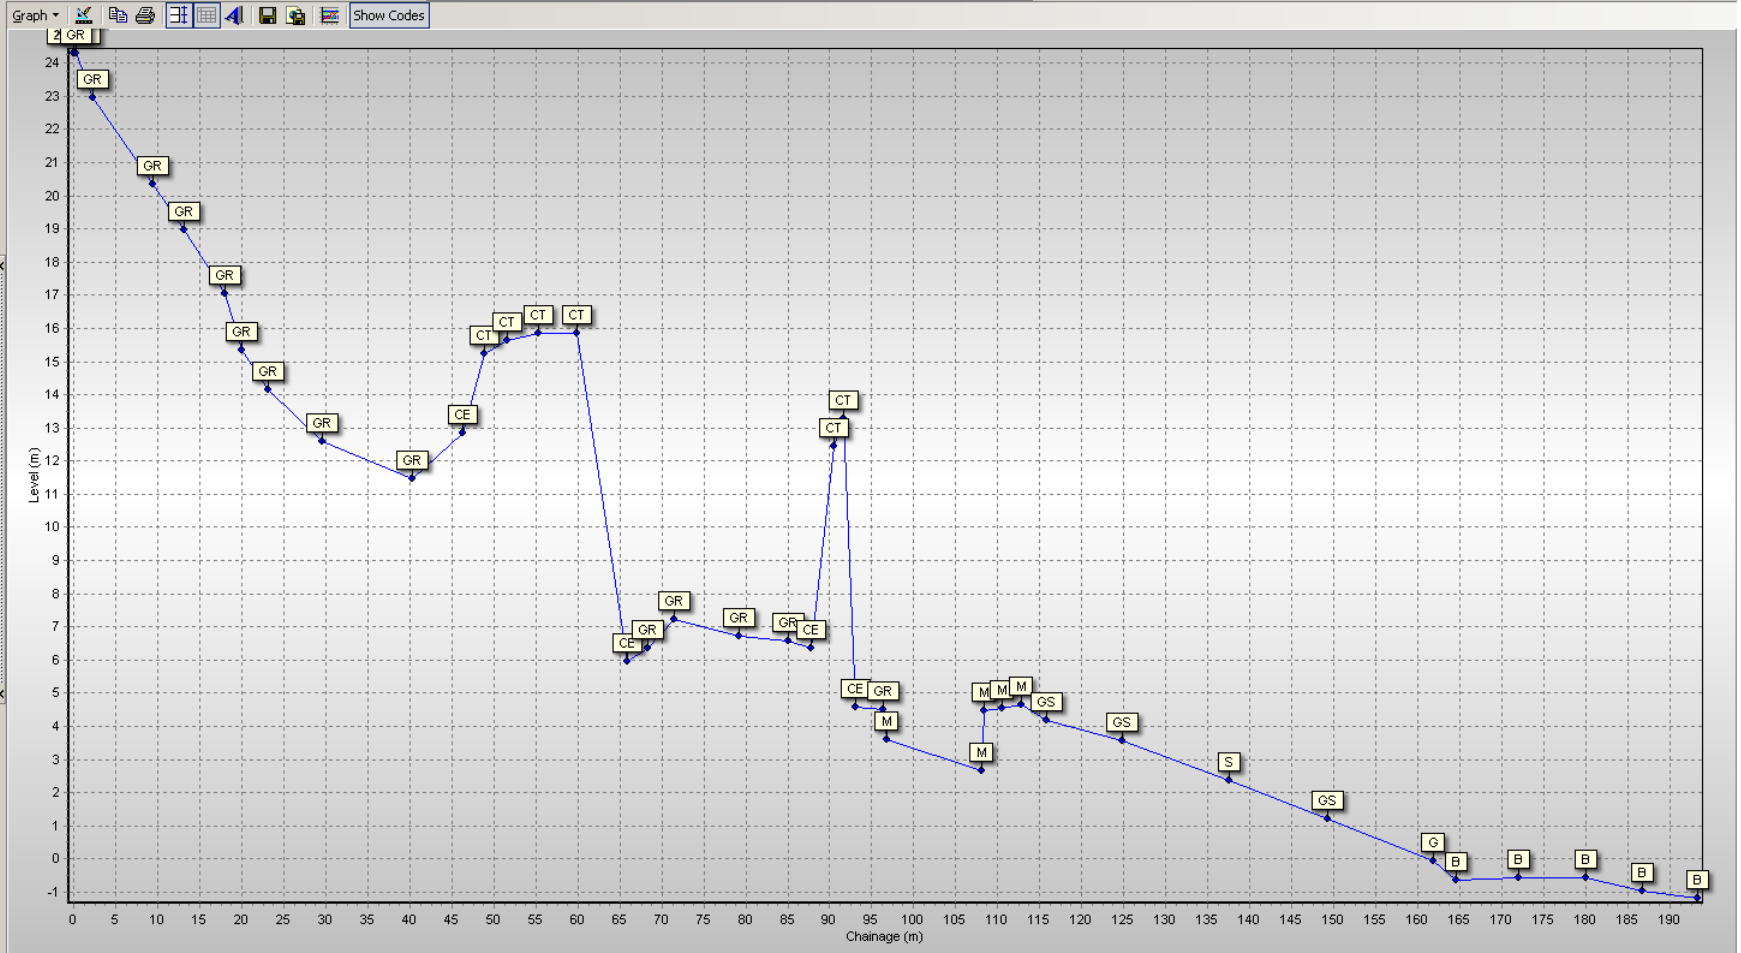
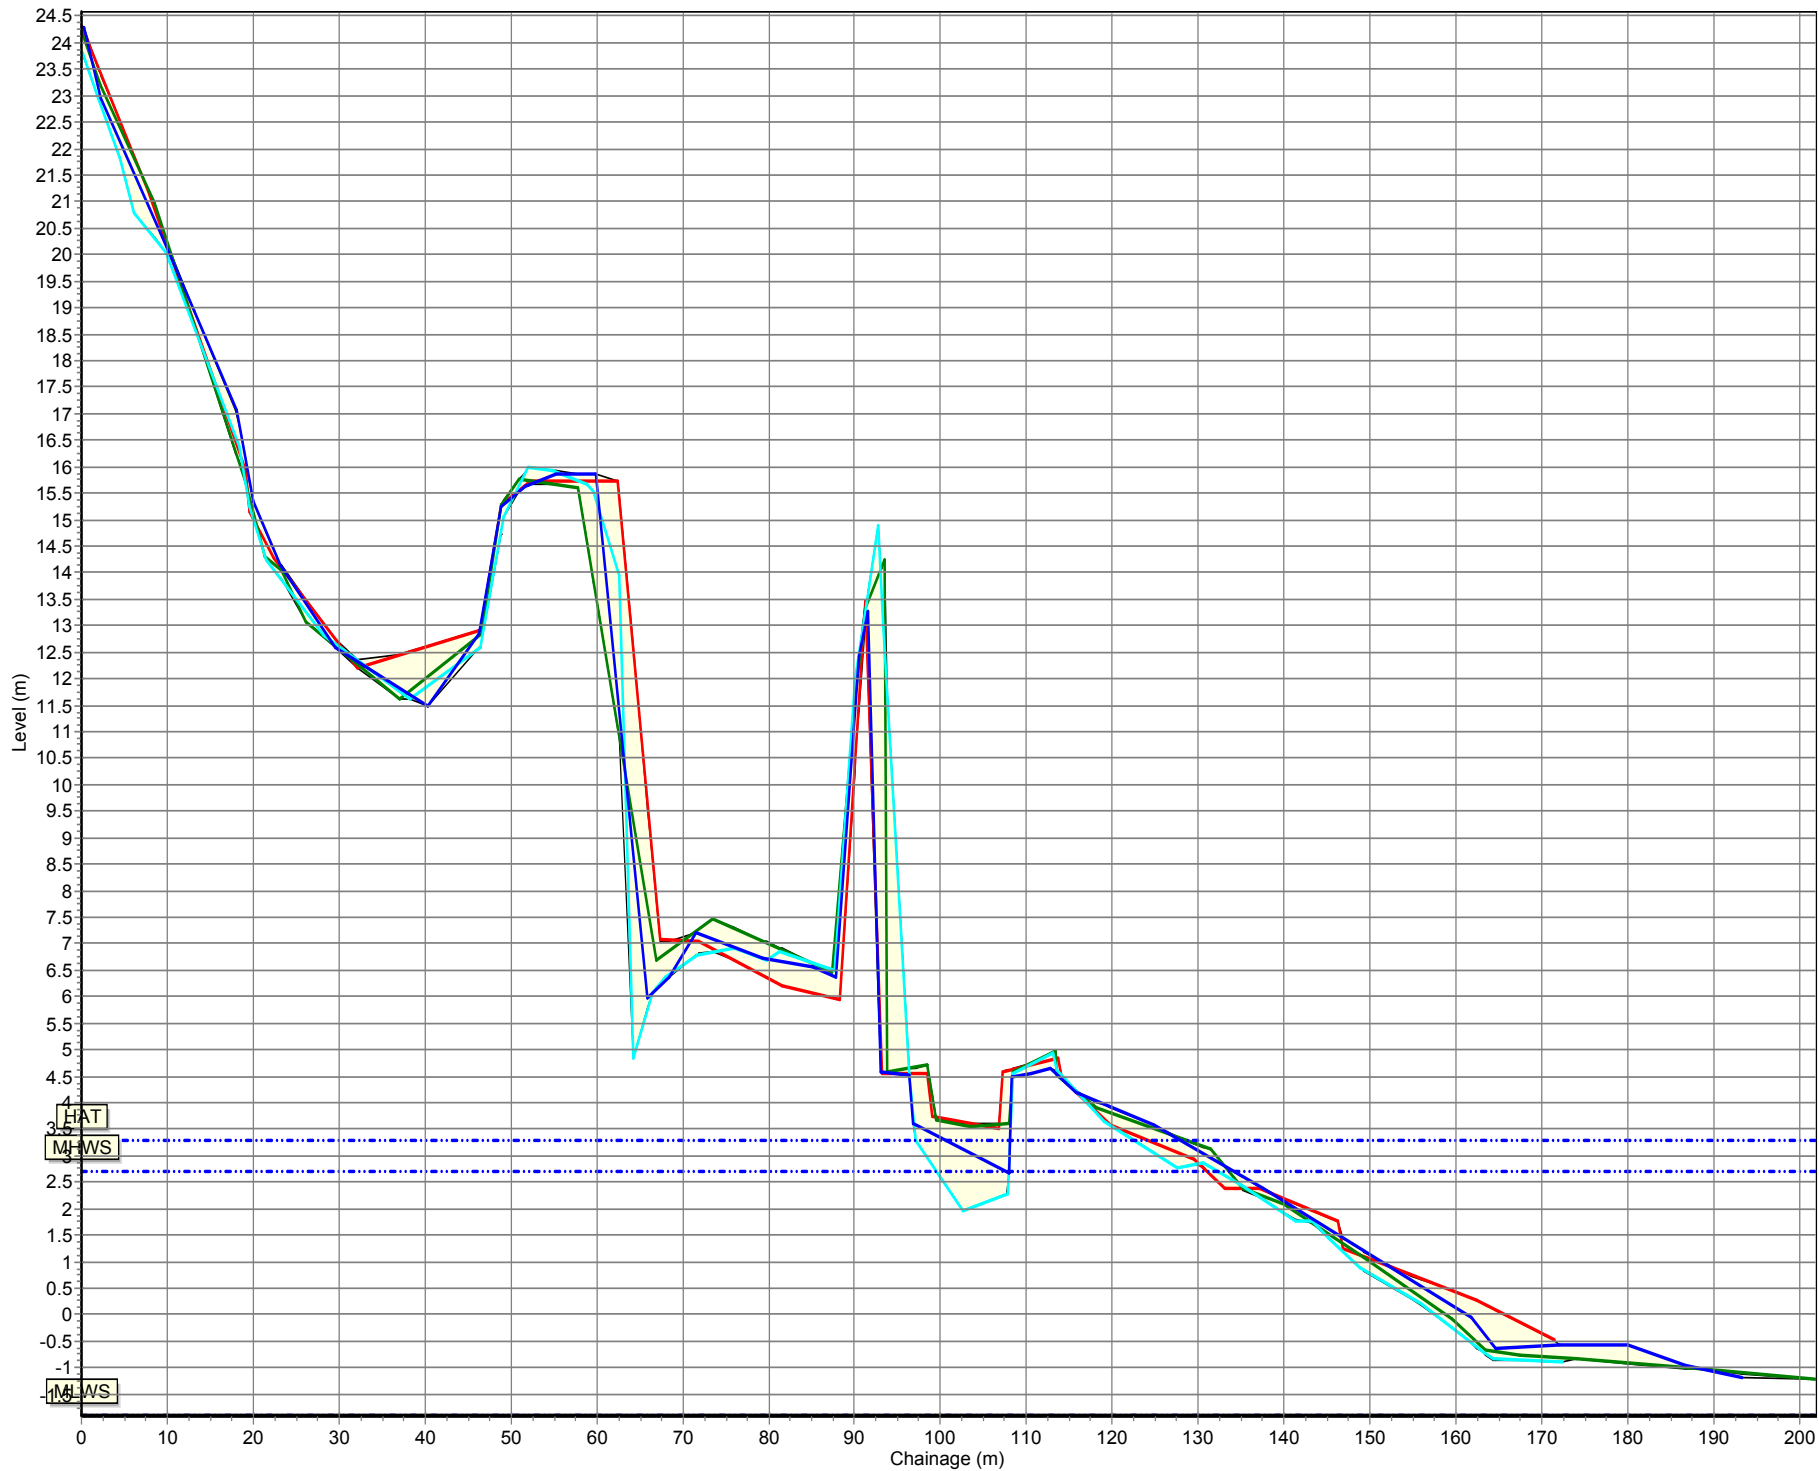
Beach Profiles: 1cEA2

Survey Date	Description of Changes Since Last Survey	Interpretation
03-2010	<p><b>Beach Profiles:</b></p> <p>Hawthorne Hive is covered by one beach profile line (EA2) during the Partial Measures survey (Appendix A).</p> <p>The foreshore has shown some modest accretion since October 2009, and levels are now generally mid-way between the envelope of previous surveys. The outlet channel of Hawthorne Hive remained in a relatively constant position (at this profile line).</p>	<p>The stability in the channel position resulted in modest accretion along the foreshore.</p>

- The outlet channel of Hawthorne Hive remained in a relatively constant position, enabling a modest amount of beach accretion.
