**Cell 1 Regional Coastal Monitoring Programme
Update Report 3: 'Partial Measures' Survey 2011**

Update Report 3
 'Partial Measures' Survey 2011

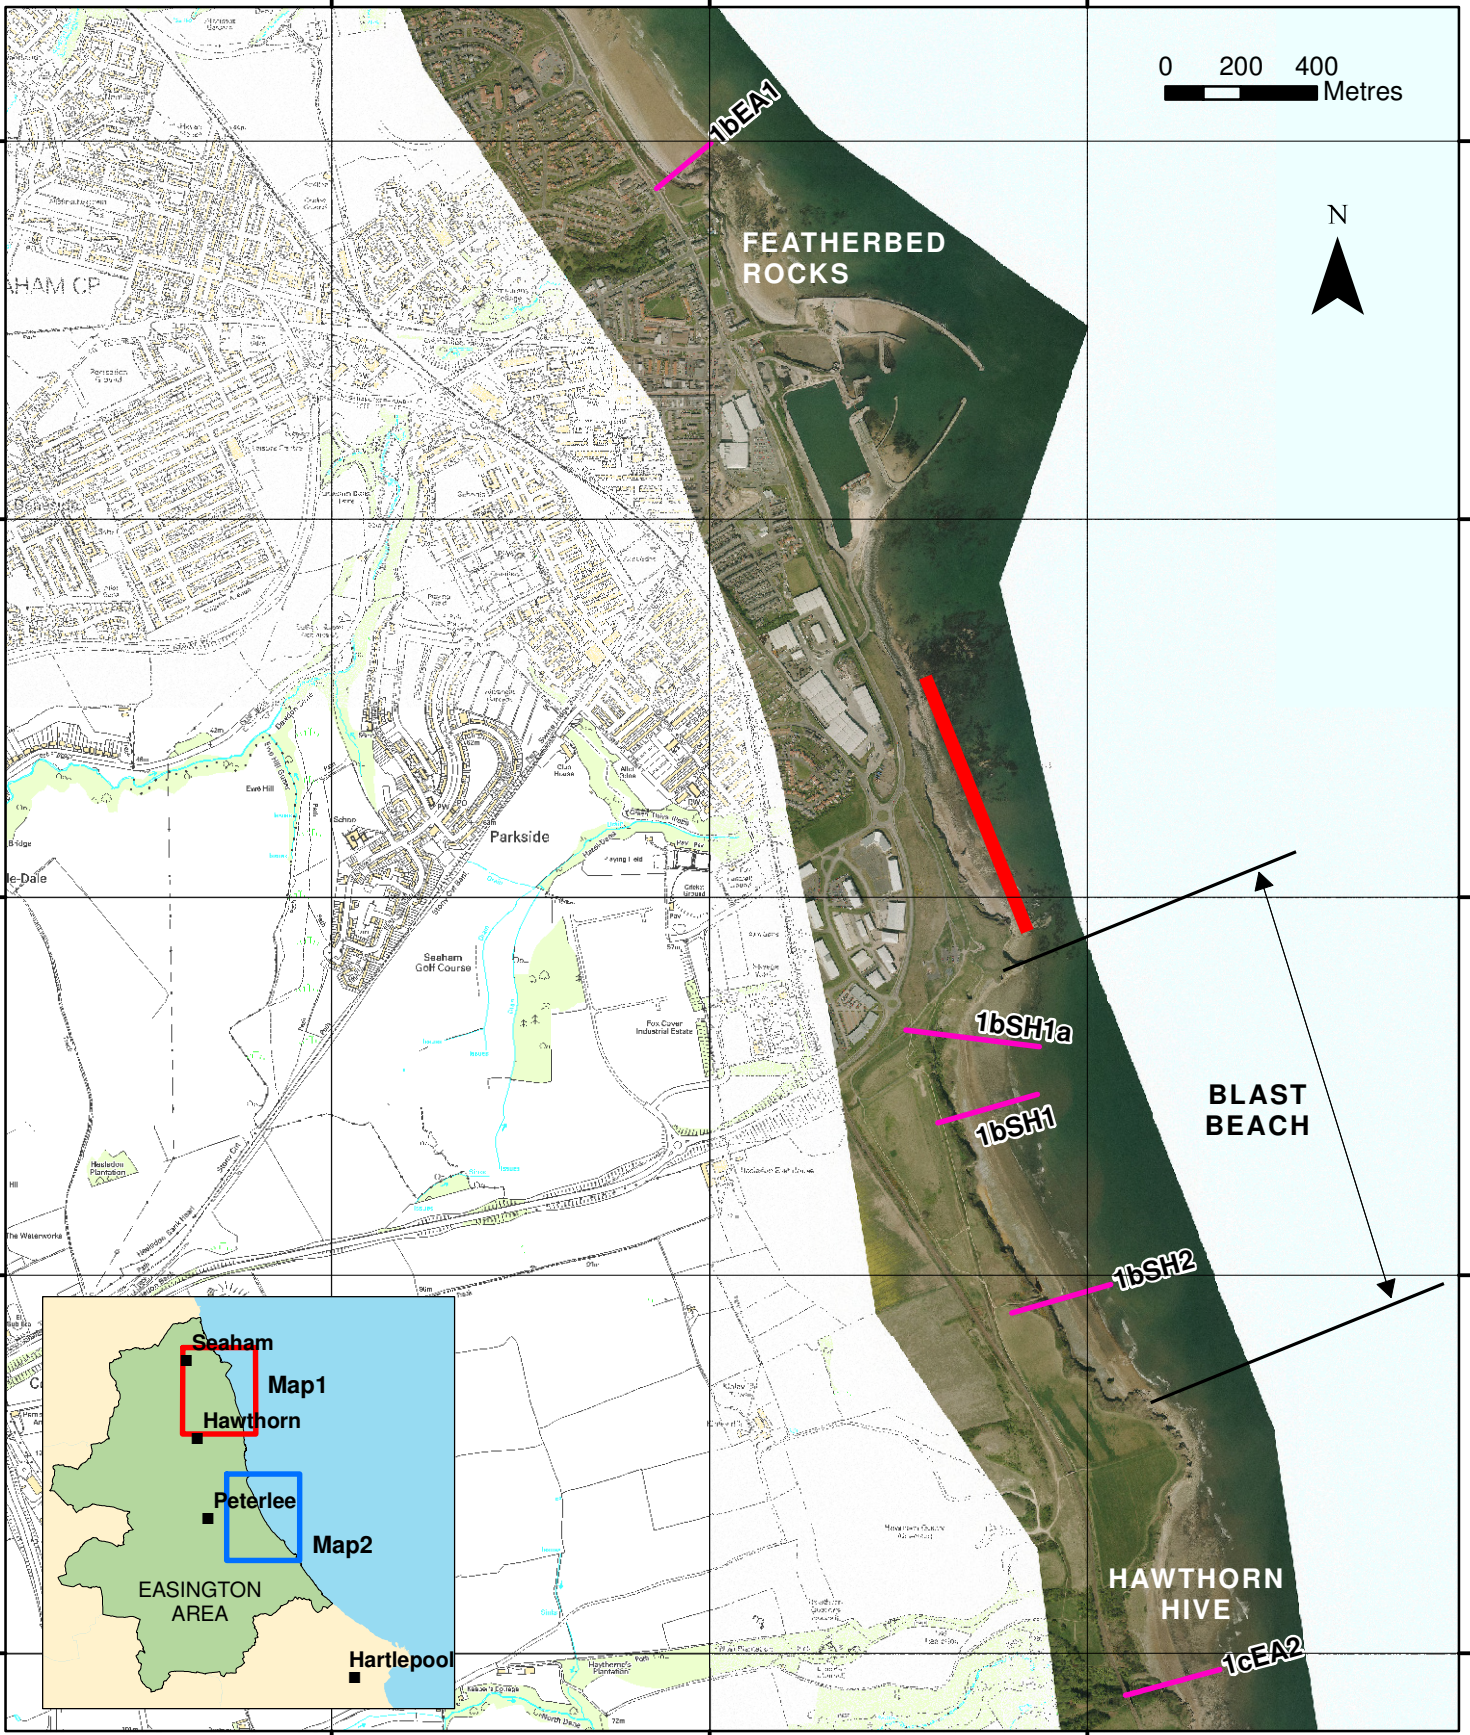
**Figure 1 - Map 1
 Durham County
 Council Frontage**

- Annual Profile
 - Bi-Annual Profile
 - 6 monthly Survey
 - Yearly Survey
 - 5 yearly Survey
 - Cliff Top Survey @ 50 centres
 - Cliff Top Survey @ 100 centres
 - Cliff Top Survey @ 300 centres
- (Indicative Survey Extents shown)*

The location of these surveys is shown in Figure 1. They have also previously been provided on a digital file which can be opened in Google Earth showing the locations of the surveys.

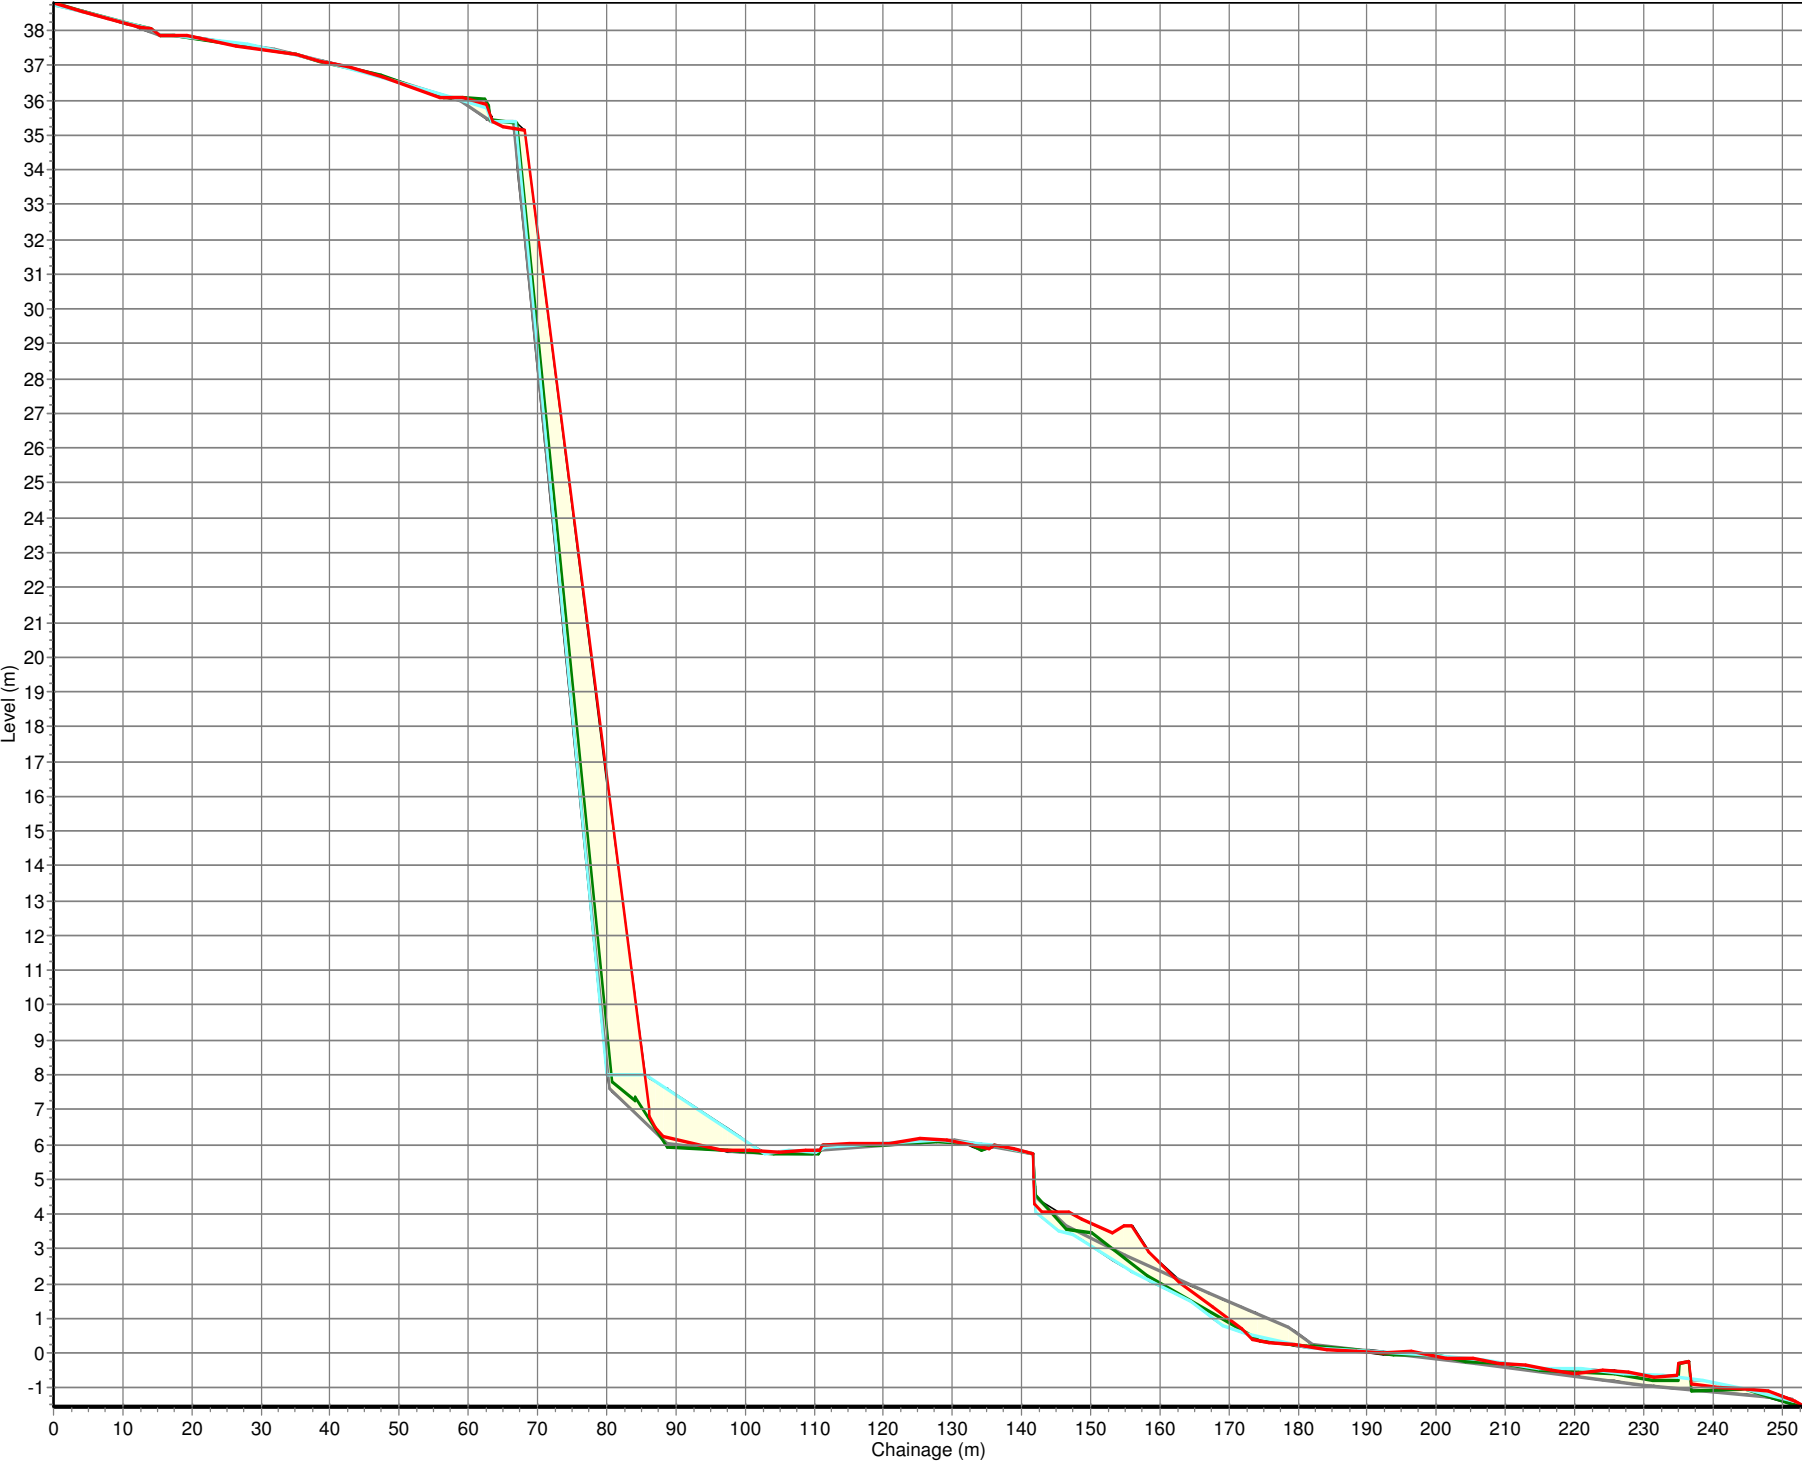
Beach Profiles: 1bSH1A

Survey Date	Description of Changes Since Last Survey	Interpretation
03-2011	<p>Beach Profiles:</p> <p>Blast Beach is covered by three beach profile lines during the Partial Measures survey (Appendix A). Two of these commenced in November 2008, with SH1a being added in October 2009.</p> <p>SH1a shows stable foreshore levels on the upper beach, with relatively high levels mid beach and stable levels along the lower, boulder-strewn foreshore. The cliff in the colliery spoil has remained stable at this transect.</p> <p>SH1 shows stable levels landward of the beach berm and relatively high levels seaward.</p> <p>SH2 shows stable levels landward of the beach berm and moderate levels seaward. The cliff in the colliery spoil does seem to have retreated landwards by around 3m.</p>	<p>There are no major concerns along Blast Beach, although the colliery spoil has cut back by around 3m along SH2.</p>

- Profiles Envelope
- 21/10/2009
- 19/03/2010
- 13/09/2010
- 18/03/2011

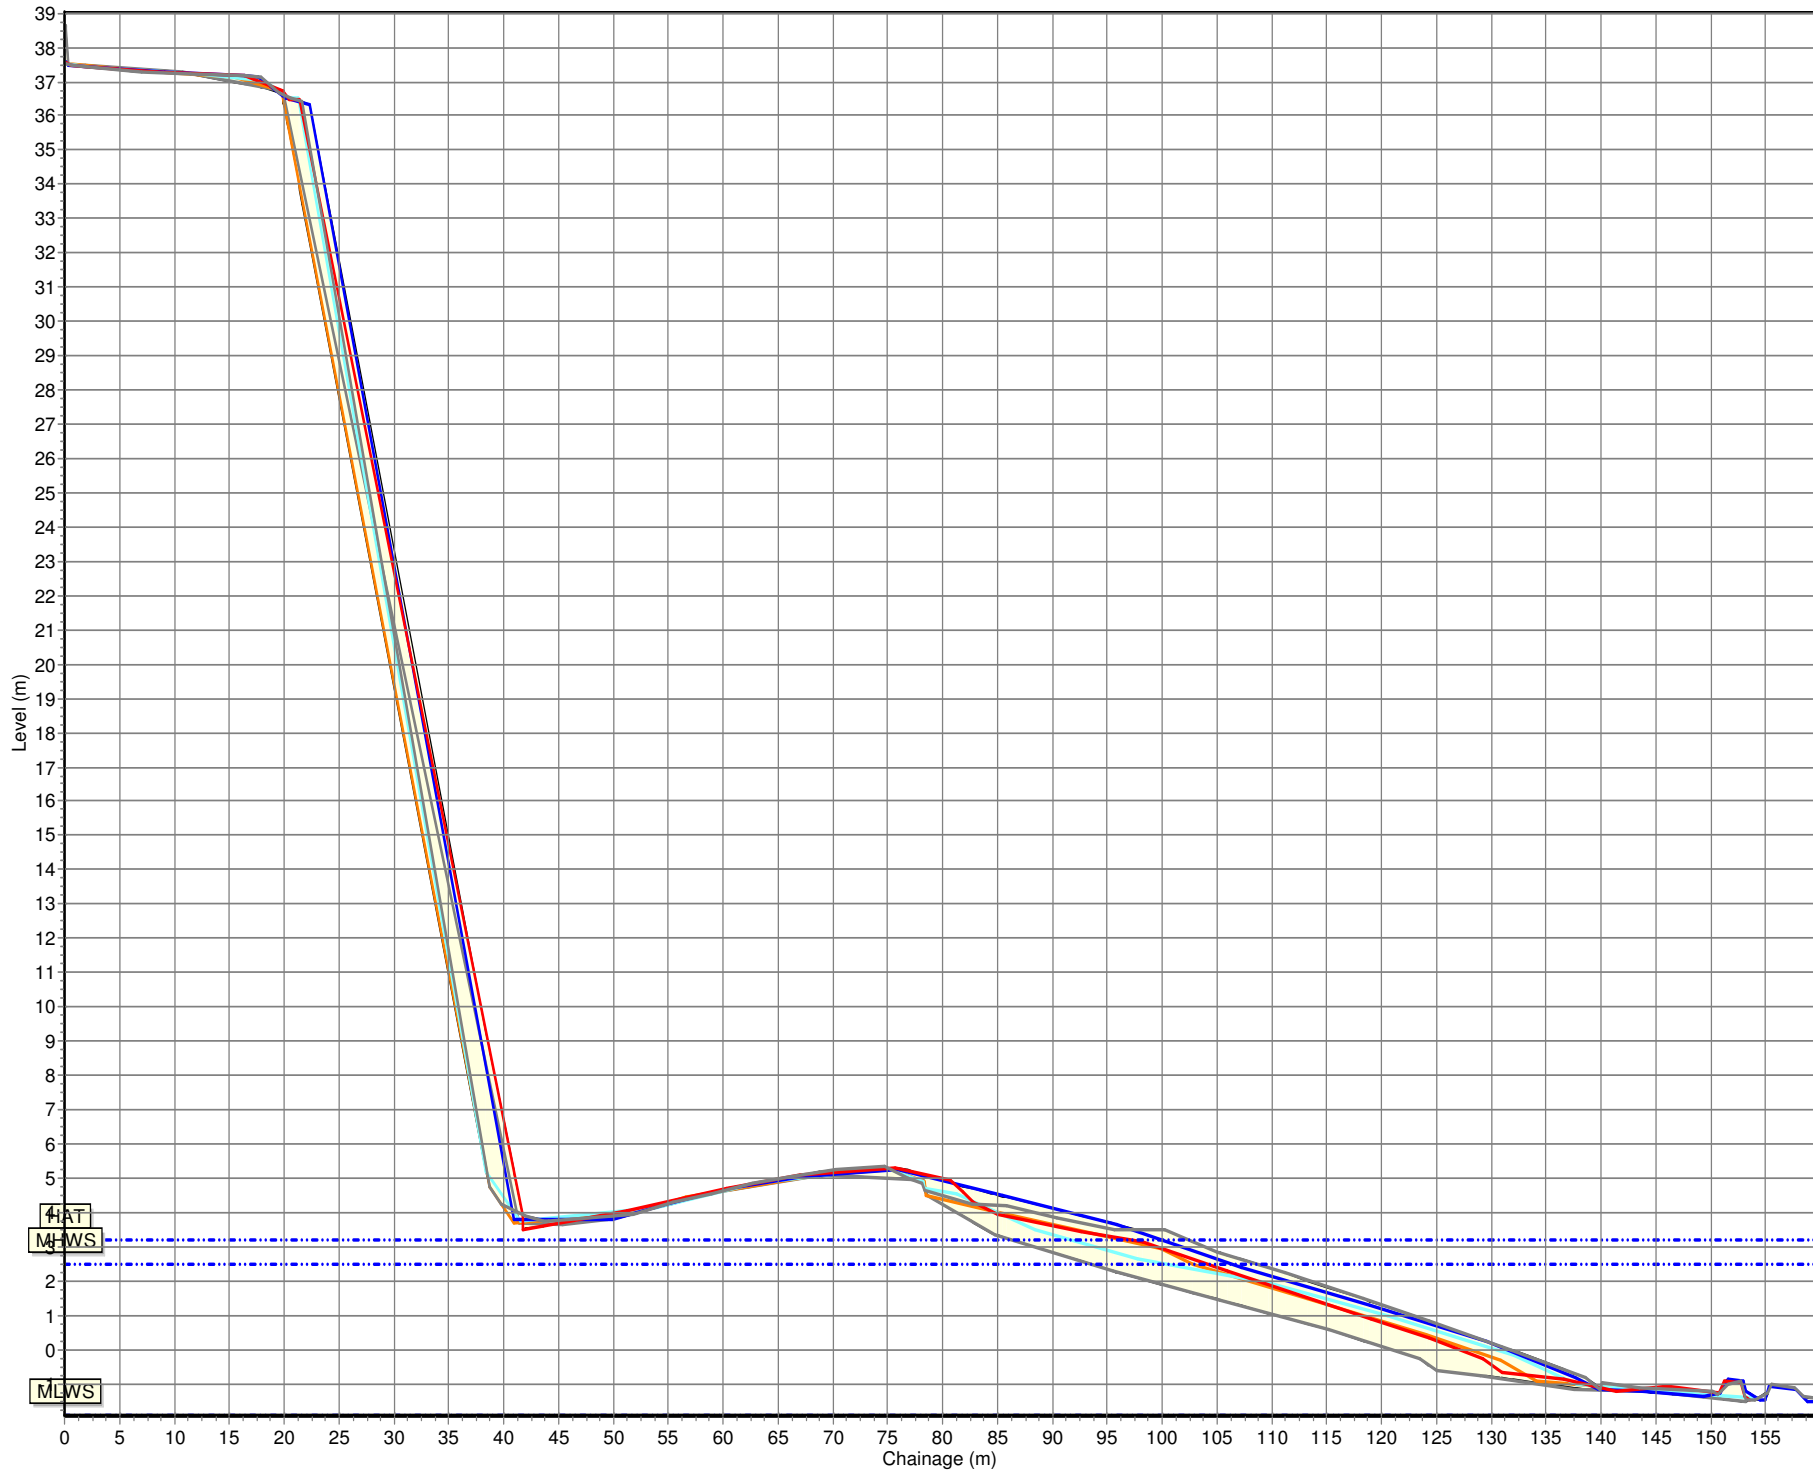
Beach Profiles: 1bSH1

- Profiles Envelope
- 25/11/2008
- 22/04/2009
- 21/10/2009
- 19/03/2010
- 13/09/2010
- 18/03/2011

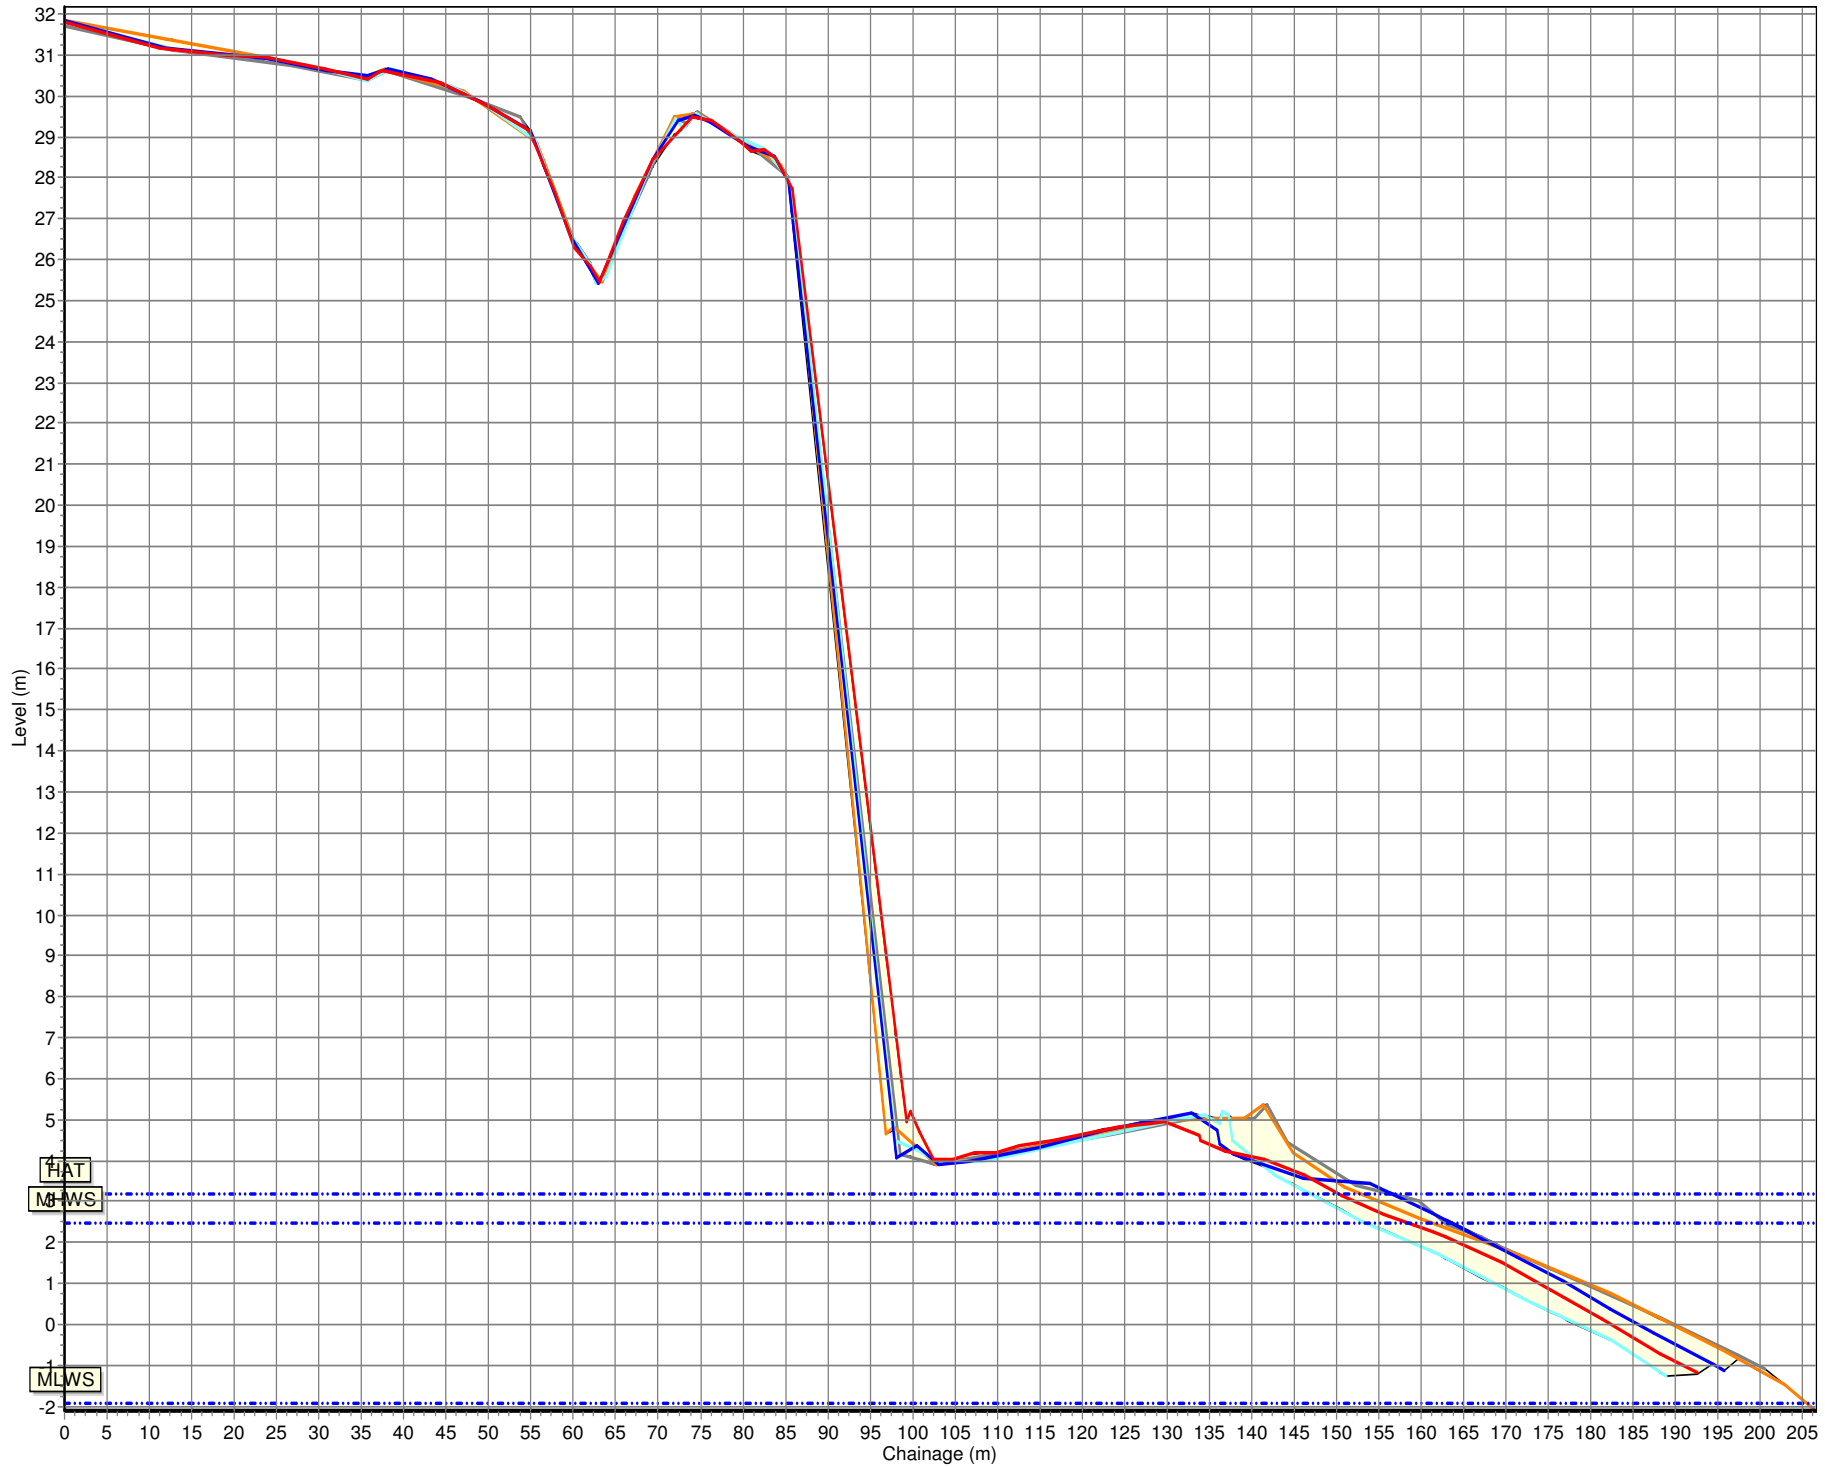
Beach Profiles: 1bSH2

- There are no major causes for concern, although the cut back of the colliery spoil along SH2 within Blast Beach was notable and the beach levels along EA2 at Hawthorne Hive were particularly low.

- Profiles Envelope
- 22/04/2009
- 21/10/2009
- 19/03/2010
- 13/09/2010
- 18/03/2011

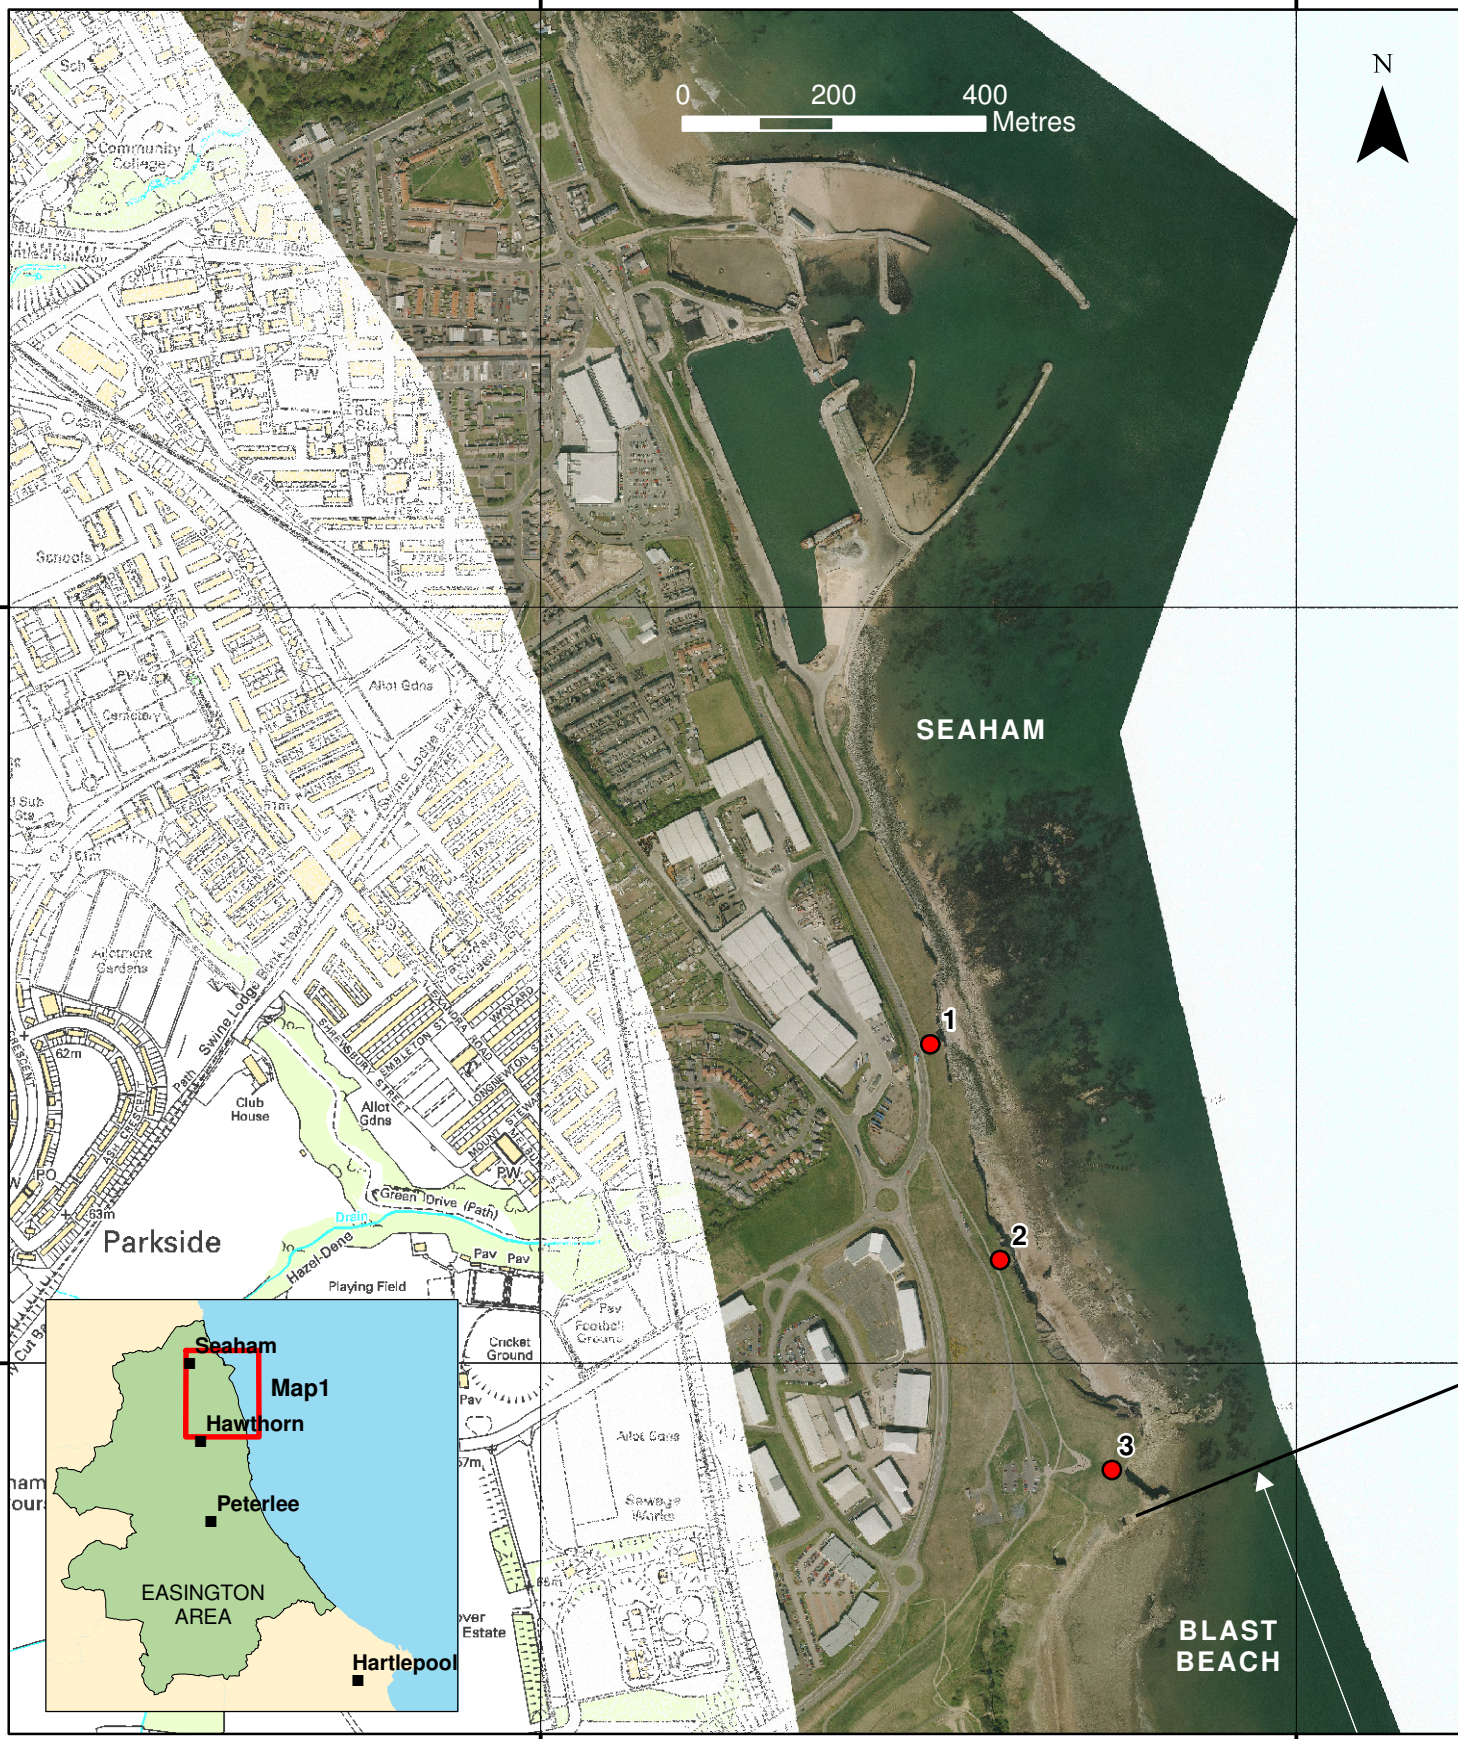
**Appendix B - Map 1
 Durham County
 Council Frontage**

Three ground control points have been established along the cliff top at Dawdon (Figure B1). The separation between any two points is nominally 300m. These cliff top surveys are intended to inform on erosion rates of the undefended sea cliffs extending south of the rock armour revetment to the south of Seaham Harbour.

The cliff top surveys at Dawdon are undertaken bi-annually. Measurements are taken from a fixed ground control point along a fixed bearing to the edge of the cliff top.

● Cliff Top Monitoring Points

Survey Date	Description of Changes Since Last Survey	Interpretation
03-2011	<p>Cliff Top Survey:</p> <p>Three ground control points have been established along the cliff top at Dawdon (Figure B1).</p> <p>The separation between any two points is nominally 300m. These cliff top surveys are intended to inform on erosion rates of the undefended sea cliffs extending south of the rock armour revetment to the south of Seaham Harbour. The cliff top surveys at Dawdon are undertaken bi-annually. Measurements are taken from a fixed ground control point along a fixed bearing to the edge of the cliff top.</p> <p>Appendix B provides results from the March 2011 survey showing the position from the ground control point to the edge of the cliff top along the defined bearing and changes since the November 2008 baseline survey.</p>	<p>At Point 1 there has been slight further erosion of the cliff top position, resulting in 0.9m erosion since surveys began in November 2008. There were no changes recorded along Points 2 and 3, which suggests that Point 2 remains stable and Point 3 has stabilised following recent erosion episodes.</p>
