**Cell 1 Regional Coastal Monitoring Programme  
Update Report 9: 'Partial Measures' Survey 2017**

**Durham Council**

**July 2017**

(\*) The present report is **Update Report 9** and provides an analysis of the 2017 Partial Measures survey for Durham Council's frontage.

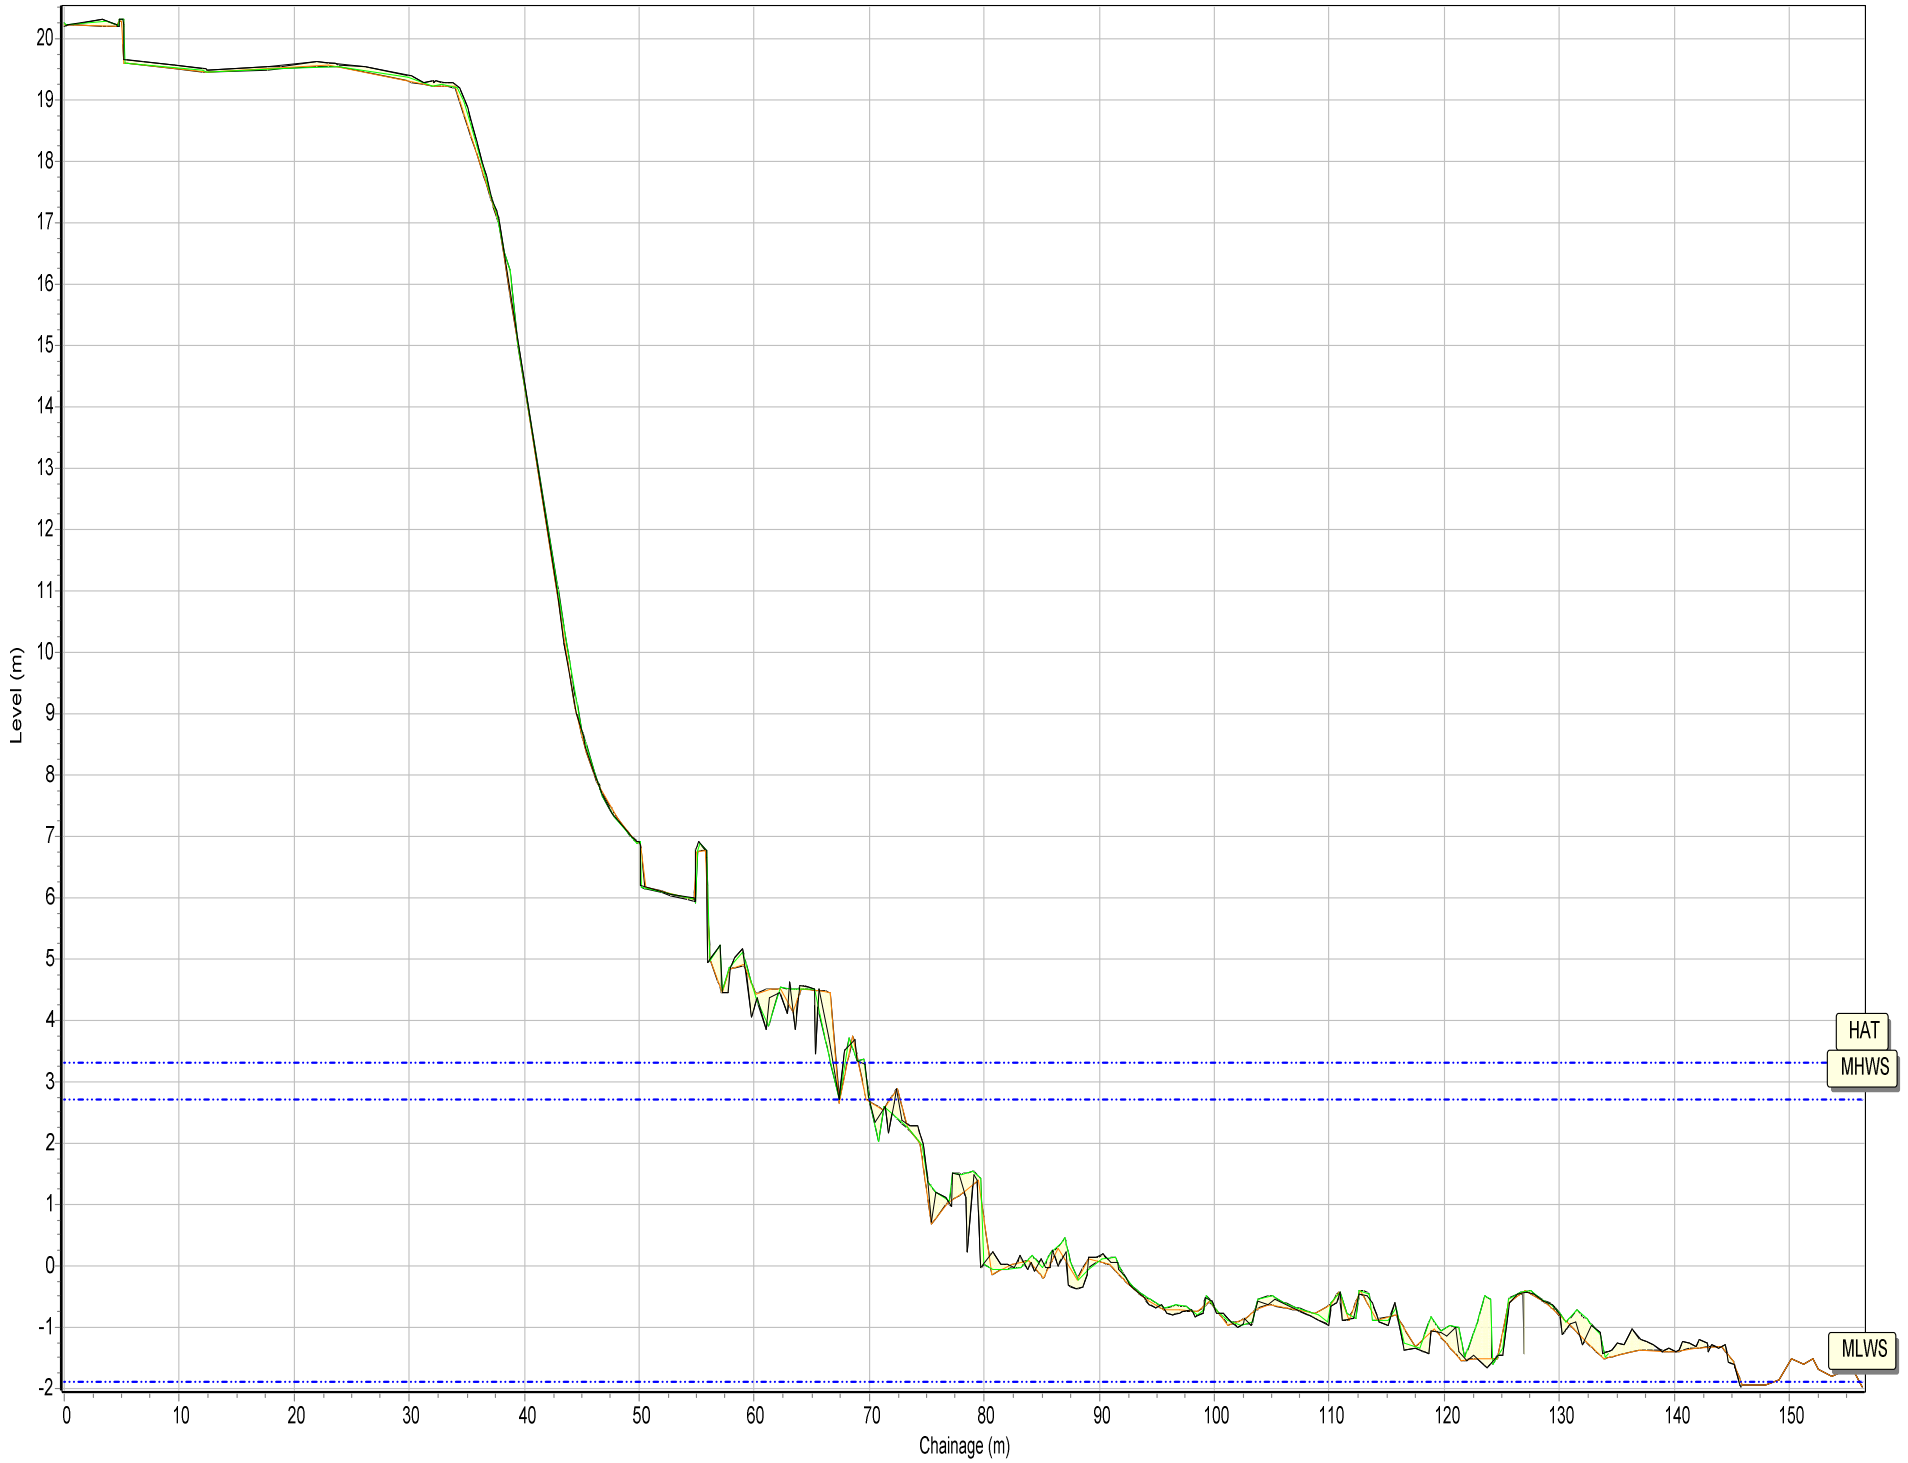
Beach Profiles: 1bEA1

Survey Date	Description of Changes Since Last Survey	Interpretation
<p><b>31<sup>st</sup> March 2017</b></p>	<p><b>Beach Profiles:</b></p> <p>Featherbed Rocks is monitored by one beach profile line (EA1) during the Partial Measures survey (Appendix A). The previous survey was September 2016.</p> <p>Profile 1bEA1 has changed very little to 55m chainage, which covers the cliff and promenade. The uneven profile at the base of the sea wall than earlier surveys between 55m and 80m is due to the rock armour. From 80m chainage to 85m chainage there is little change since September 2016 due to the rocks being exposed in both surveys. Beyond 85m there has been little change over the winter of 2016/17, the beach profiles reflect the rocky nature of the foreshore and that there is no beach over the shore platform.</p>	<p>The rocky nature of the foreshore means it is unlikely to undergo significant changes in morphology unless sediment is deposited. Previous monitoring indicates that a veneer beach tends to accumulate over the summer and is stripped off by winter storms, giving rise to small and localised changes in profile. The upper part of the profile, which covers the cliff promenade and rock armour remains unchanged, as does the lower part of the profile which covers the beach.</p> <p><b>Longer term trends:</b></p> <p>The level of the beach in March 2017 was comparable with the lowest beach levels recorded in March 2010, April 2013 and October 2013. The shore platform is exposed and as a result any apparent changes are likely to be due to differences in the survey point locations and the way that survey points are joined to show an interpolated surface.</p>

- The level of the beach at Featherbed Rocks in March 2017 was comparable with the lowest beach levels recorded in March 2010, April 2013 and October 2013. The shore platform is exposed on the lower beach

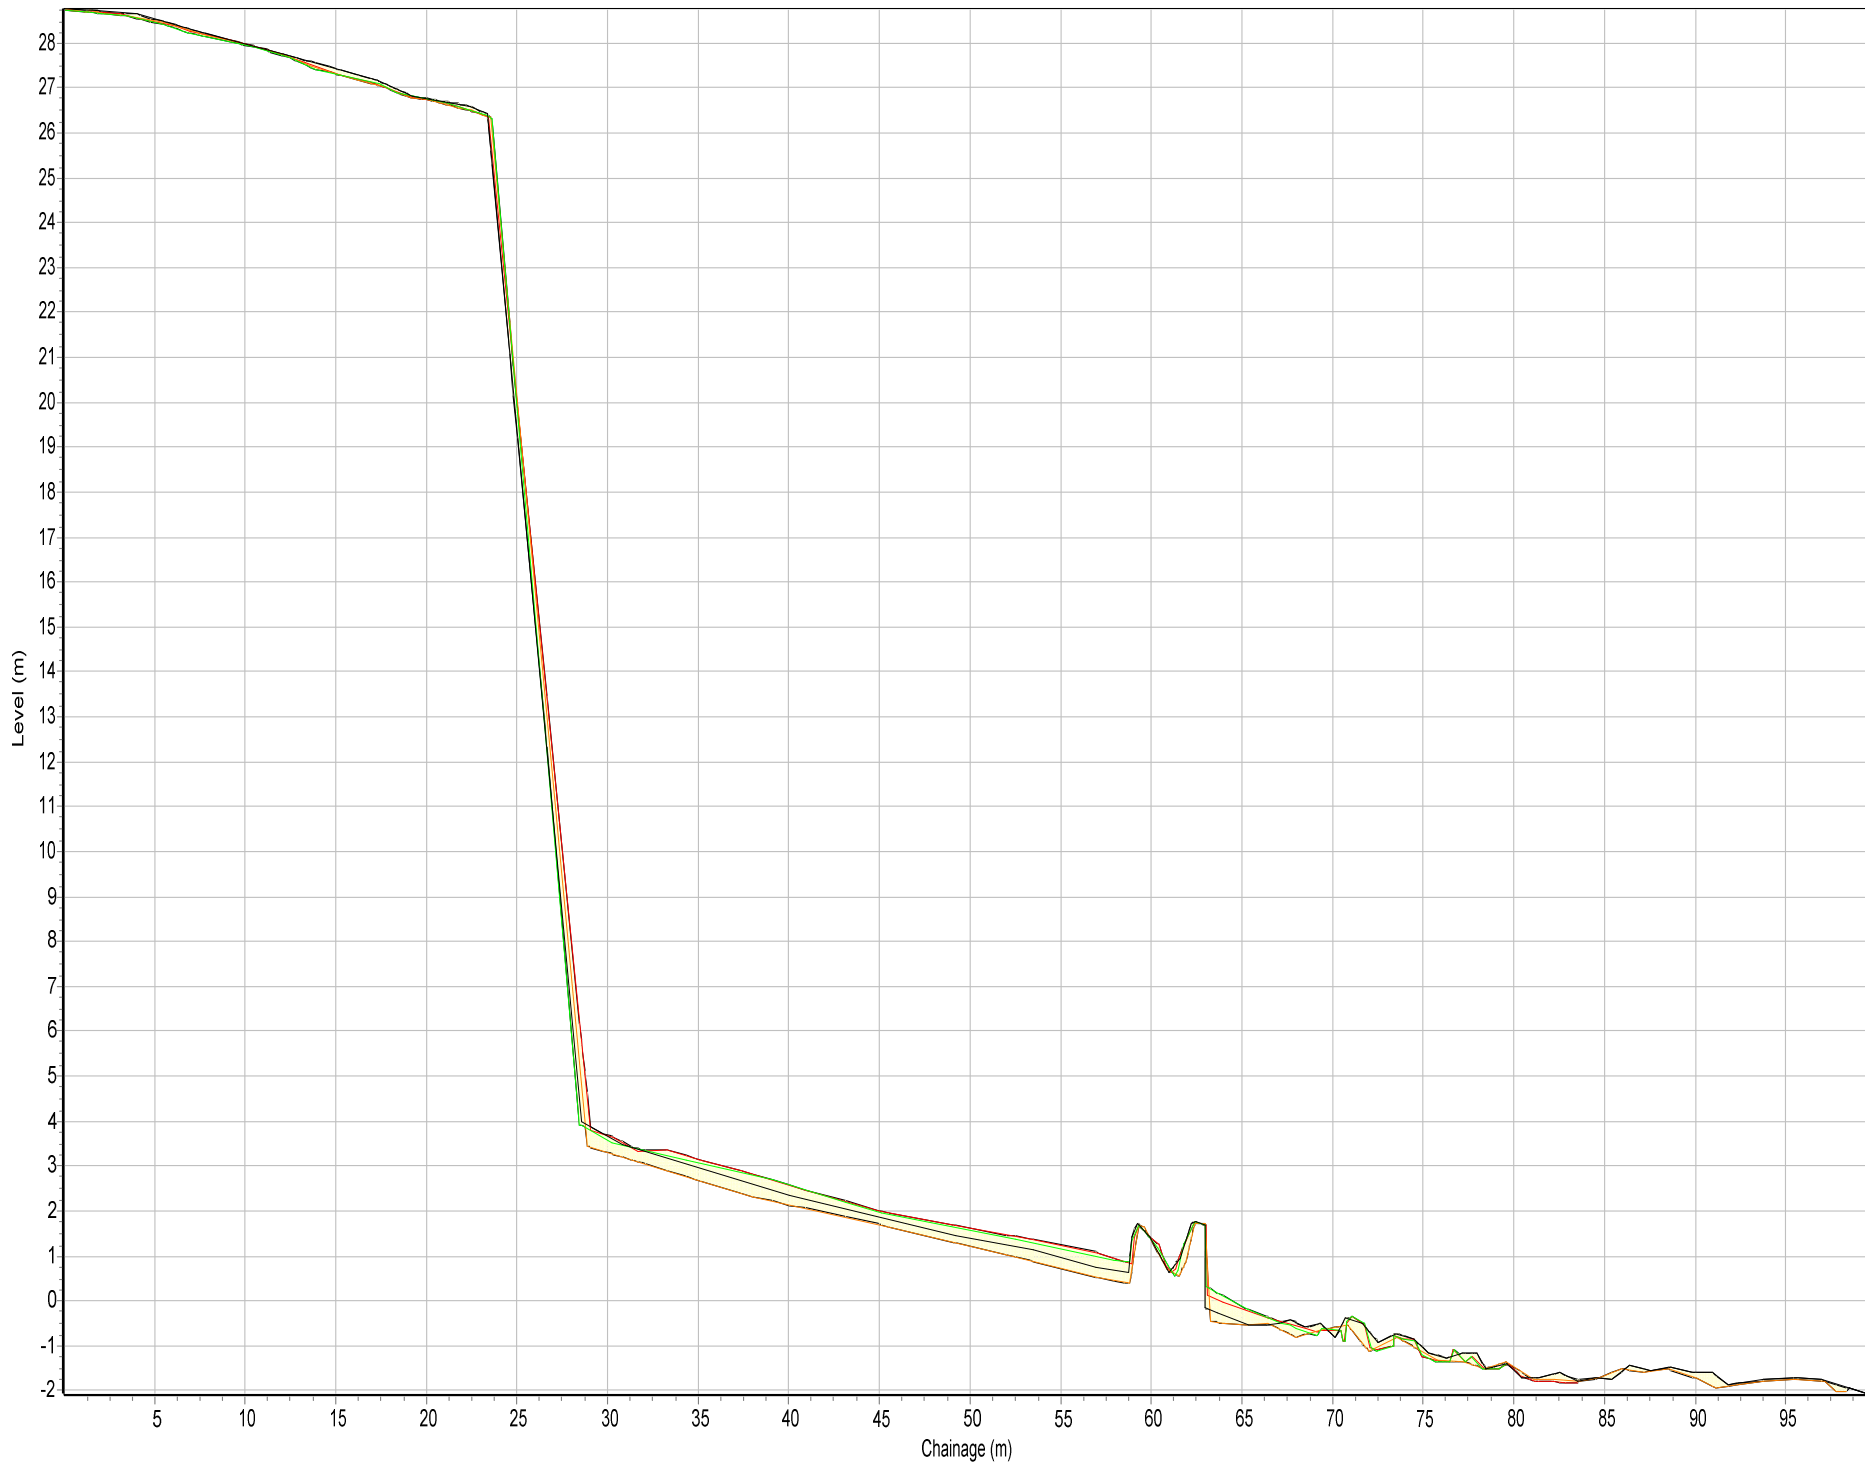
Beach Profiles: 1bSH1B

Survey Date	Description of Changes Since Last Survey	Interpretation
31 <sup>st</sup> March 2017	<p><b>Beach Profiles:</b></p> <p>Blast Beach is covered by four beach profile lines during the Partial Measures survey (Appendix A). Two of these commenced in November 2008, with 1bSH1a being added in October 2009, and 1bSH1b added in October 2015.</p> <p>Profile <b>1bSH1b</b> is adjacent to the sewage works south of Seaham. The profile is cliff to chainage 30m and then gravel beach between 30m and 60m chainage, which has shown a slight decrease in level of up to 0.2m since September 2016. There are two concrete blocks which have been upturned on the beach and are shown on the profiles as a protrusion in the profile between 60m and 65m chainage. The beach is visible again between 65m and 70m chainage, and has decreased in level by up to 0.2m. Below this point the rocks are exposed from 70m chainage to the end of the survey at 85m. Profile appears to show winter drawdown followed by summer build-up, however only two years of survey is available.</p> <p>At <b>1bSH1a</b> there has been a drop in level at the toe of the eroding face of the spoil at chainage 141m, leading to an increase in height of the face by approximately 0.6m. Two small berms have formed at chainage 145m and 150m. The beach level has dropped by up to 0.8m compared with the September 2016 survey, exposing 10m more rock on the beach. With the exception of the upper beach (chainage 140m to 155m) the beach level is the lowest recorded by the previous surveys.</p> <p>At <b>1bSH1</b> the beach crest previously stable at 75m has moved landwards by around 15m and dropped in height by up to 0.4m. The upper beach has flattened compared to the September 2016 survey with erosion of up to 0.7m between chainage 77m and 90m forming a depression, and the formation of a berm at chainage 97m, 1.4m above the Septemebr 2016 beach level. Beach levels from the berm to the exposed rock at chainage 130m have increased by 0.4m to 1.0m. Overall the beach levels are at a medium level compared to the range recorded from previous surveys, except for the berm which is the highest recorded level at that location, and the beach crest being in its most landwards position.</p> <p>At <b>1bSH2</b> the berm's crest has moved further landwards by around 10m and increased in height by up to 0.2m compared to the September 2016 survey. Between chainage 135m and the exposed rock at 190m there has been a drop in beach level by 0.2m to 0.6m. Overallt eh eback is at a medium level</p>	<p>Through the winter there has been erosion of the beach across the bay with the roll-back of beach features such as berm crests. However although 1bSH1 shows roll-back of the berm crest it also shows accretion across the rest of the beach. The profiles remained a similar gradient to the spring and autumn profiles.</p> <p>All the profiles show the beach level in the range of previous profiles, except where the berm crests have rolled back.</p> <p><b>Longer term trends:</b></p> <p>The beach at SH2 shows an overall pattern of erosion since October 2008. However, SH1 and SH1a show much more fluctuation in beach level, whereas SH2 is almost progressive recession.</p>

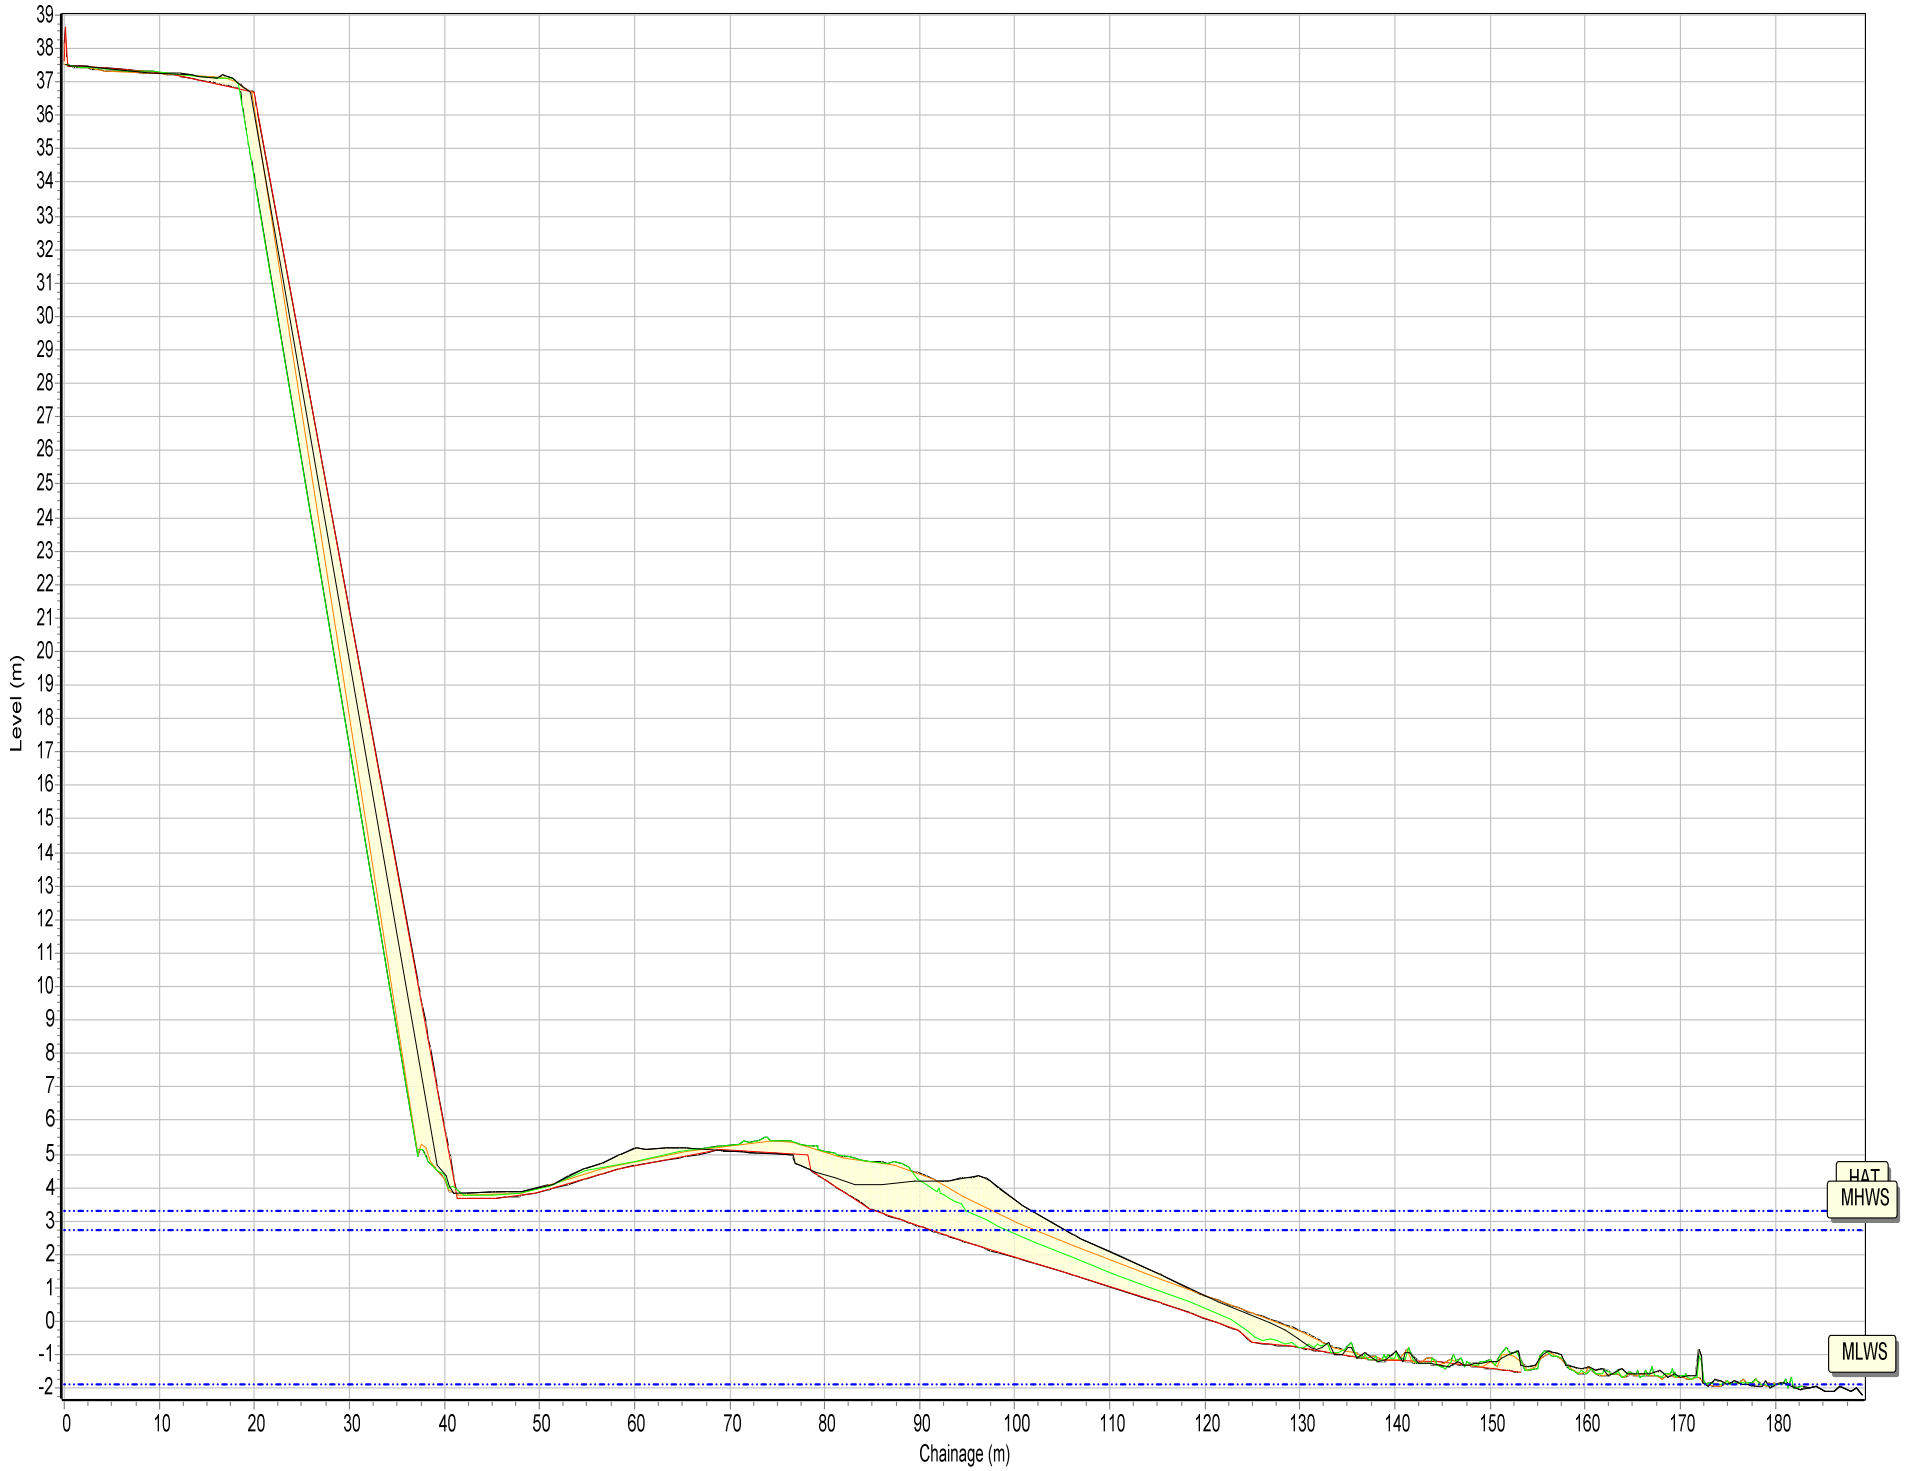
Beach Profiles: 1bSH1

- At Blast Beach colliery spoil still prevents the sea from actively eroding the cliffs. However, there have been significant changes in the beach profile. There is a periodic shift in the direction of sediment transport through the winter, this winter the profiles generally show erosion and roll-back.

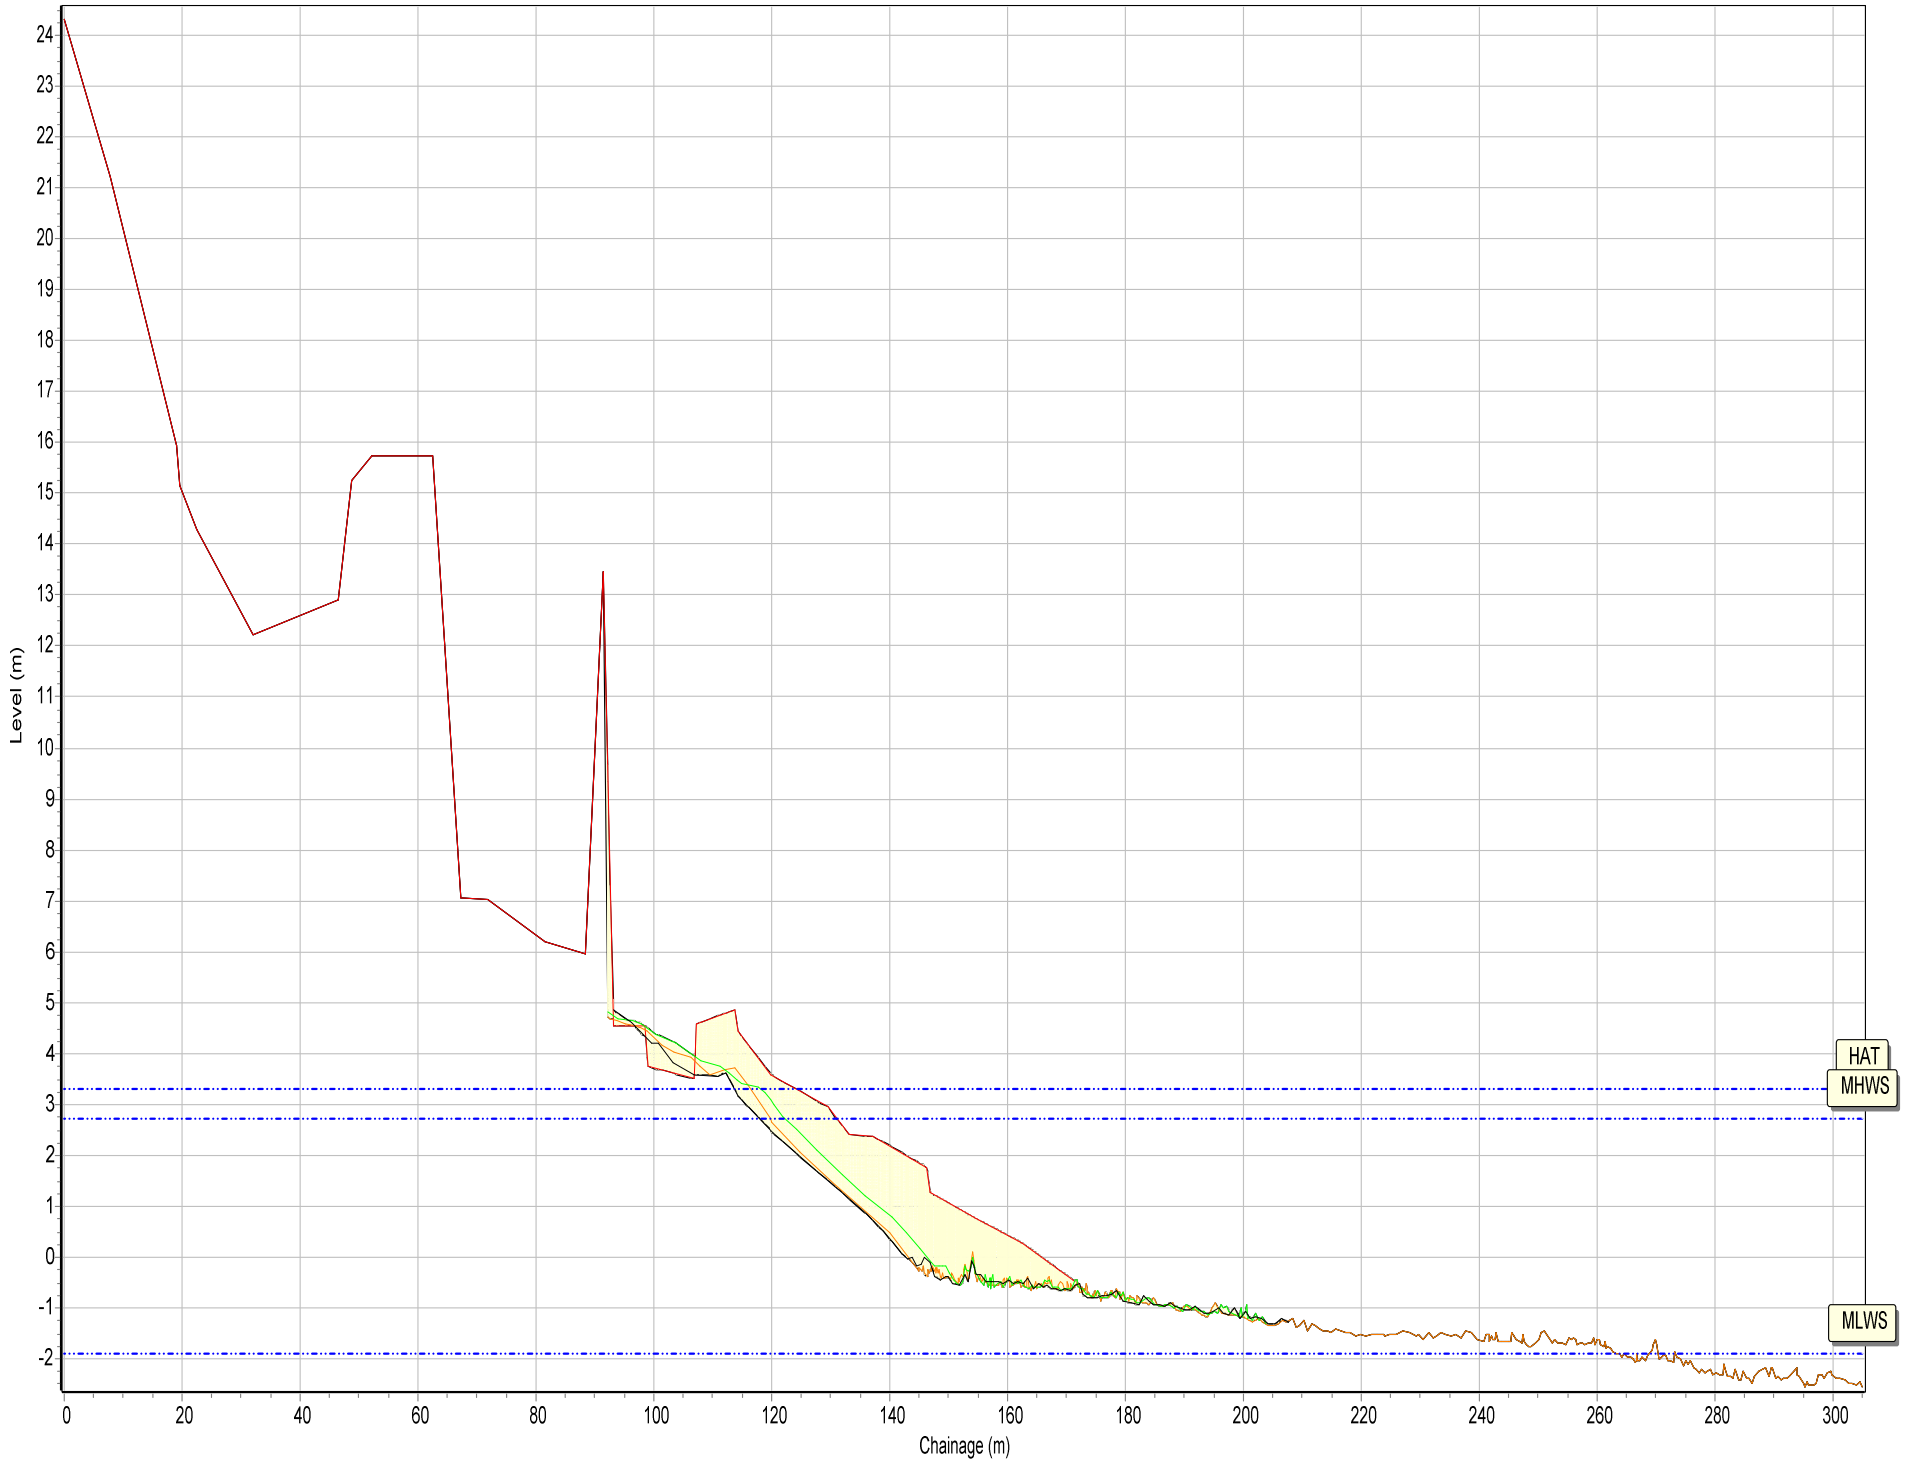
Beach Profiles: 1cEA2

Survey Date	Description of Changes Since Last Survey	Interpretation
<p><b>31<sup>st</sup> March 2017</b></p>	<p><b>Beach Profiles:</b></p> <p>Hawthorne Hive is covered by one beach profile line <b>1cEA2</b> during the Partial Measures survey (Appendix A). The survey report notes <i>“unable to measure start of Section EA2 as the vegetation has choked out the section line and route over cliff faces”</i> and therefore all surveys following October 2012 start at 95m chainage.</p> <p>Until the partial measures survey in April 2013, a channel was present between 95m and 105m chainage, but it has infilled.</p> <p>The majority of the beach, between 95m chainage and 145m chainage shows a drop in beach level of up to 0.5m compared to the September 2016 survey. The berm previously recorded at chainage 118m has moved landwards by around 5m and become more pronounced. From 145m chainage to the end of the survey at 260m chainage the boulders at the bottom of the beach remain exposed. Overall the beach remains at a medium level compared to the range recorded from previous surveys.</p>	<p>The beach has recovered since the low level in April and November 2014. The profile is in the middle of the range of previous profiles.</p> <p><b>Longer term trends:</b></p> <p>The profiles show the beach is undergoing progressive erosion.</p> <p>The infilling and incision of the channel seems to be an episodic process and is likely to reflect a combination of annual and seasonal variations in the flow of Hawthorn Burn and storm events which move sediment onshore to block the outflow of the burn.</p>

- At Hawthorn Hive the beach level was low in April and November 2014. The beach has now recovered slightly and is close to the middle of the previous range of results. However, it is likely that the long term trend of progressive erosion will continue on this profile.
