## **Cell 1 Regional Coastal Monitoring Programme Update Report 15: 'Partial Measures' Survey 2023**

**Durham County Council**

**May 2023**

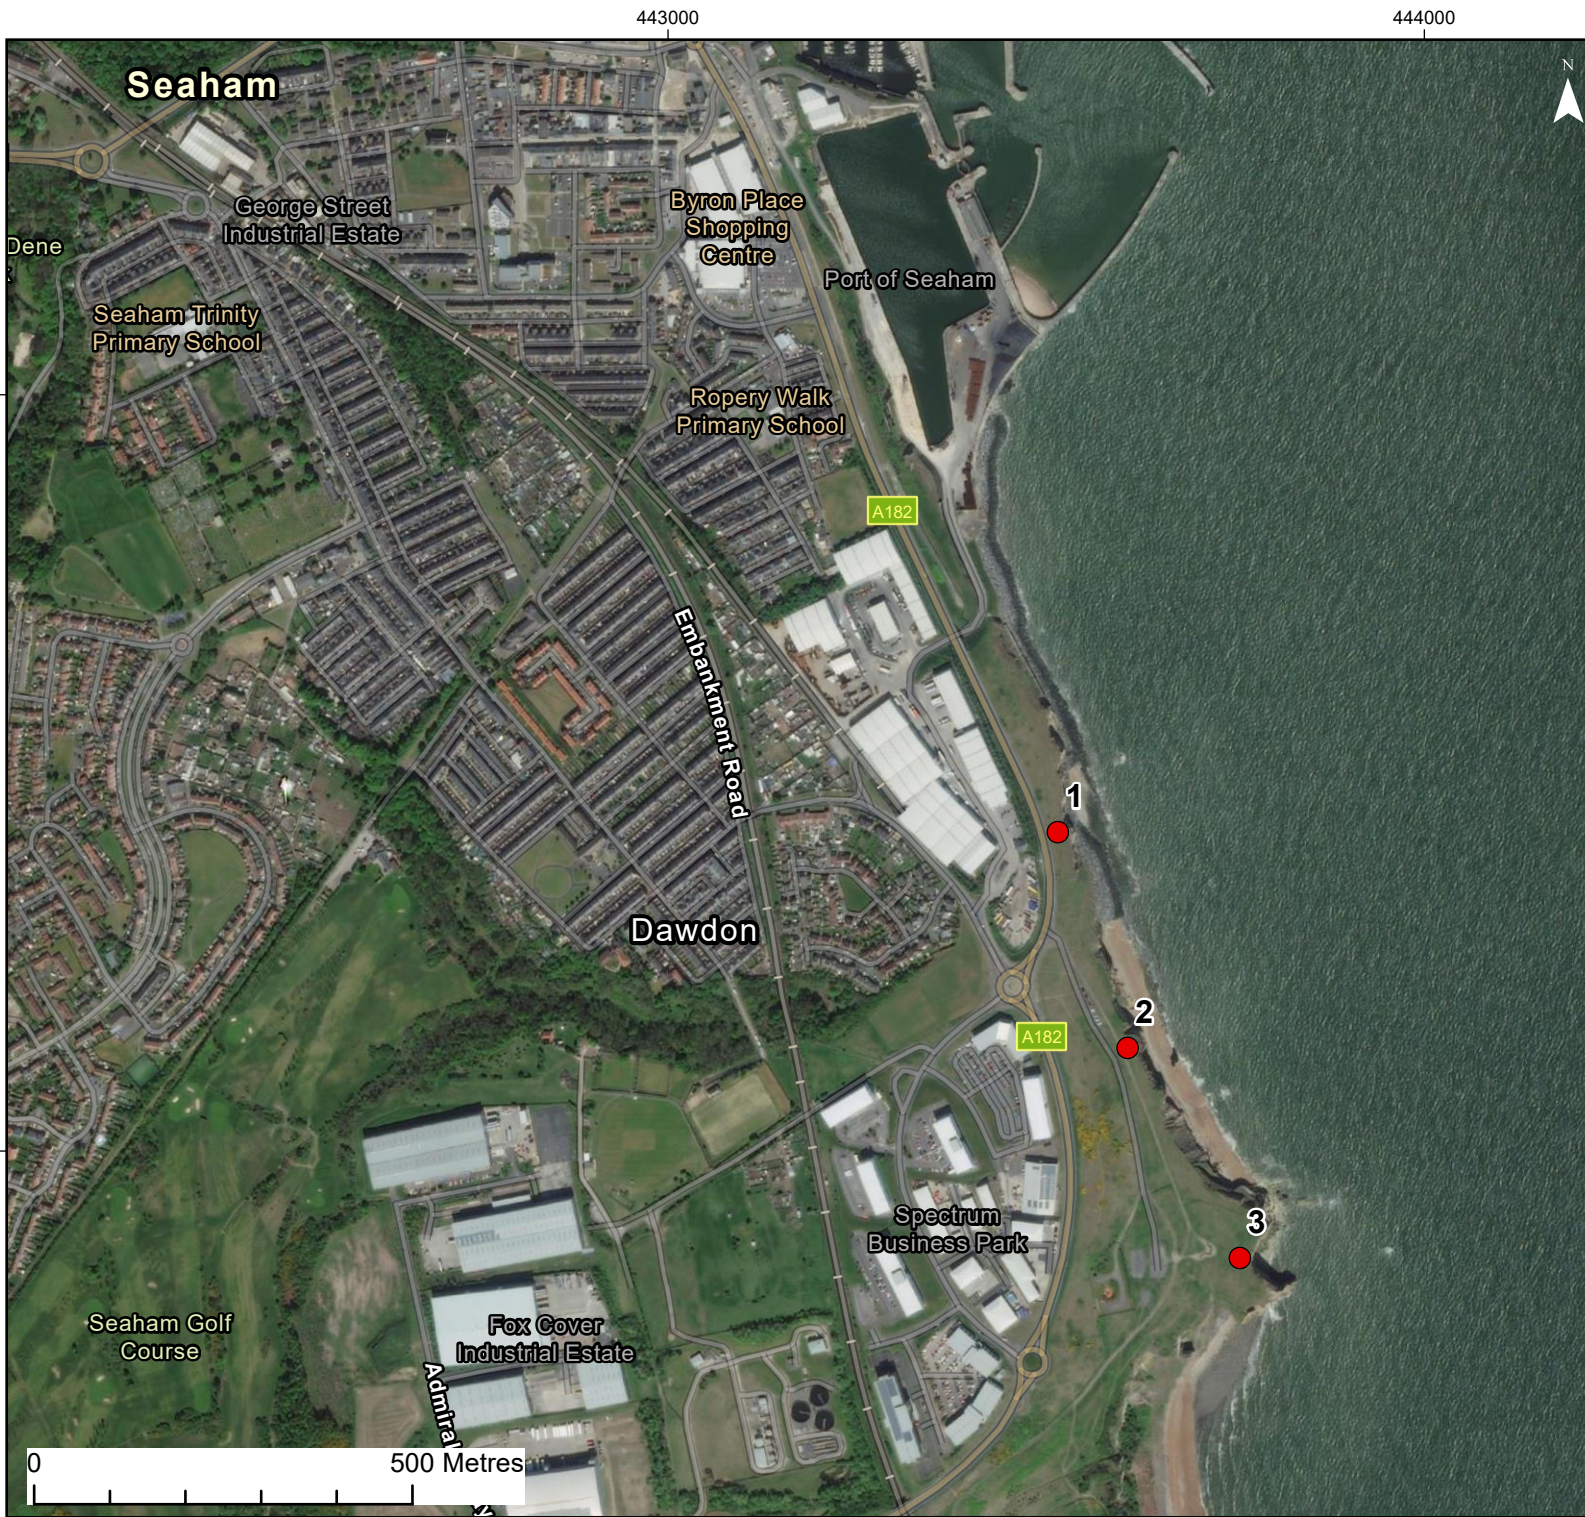
**Figure 3 - Map 1**

**SURVEY LOCATIONS**

- Cliff Top Survey Points

Three ground control points have been established at Dawdon (Figure B1). The maximum separation between any two points varies along the coast, reflecting the degree of risk from erosion.

The cliff top surveys at Dawdon are undertaken bi-annually. Measurements are taken from a fixed ground control point along a fixed bearing to the edge of the cliff top.

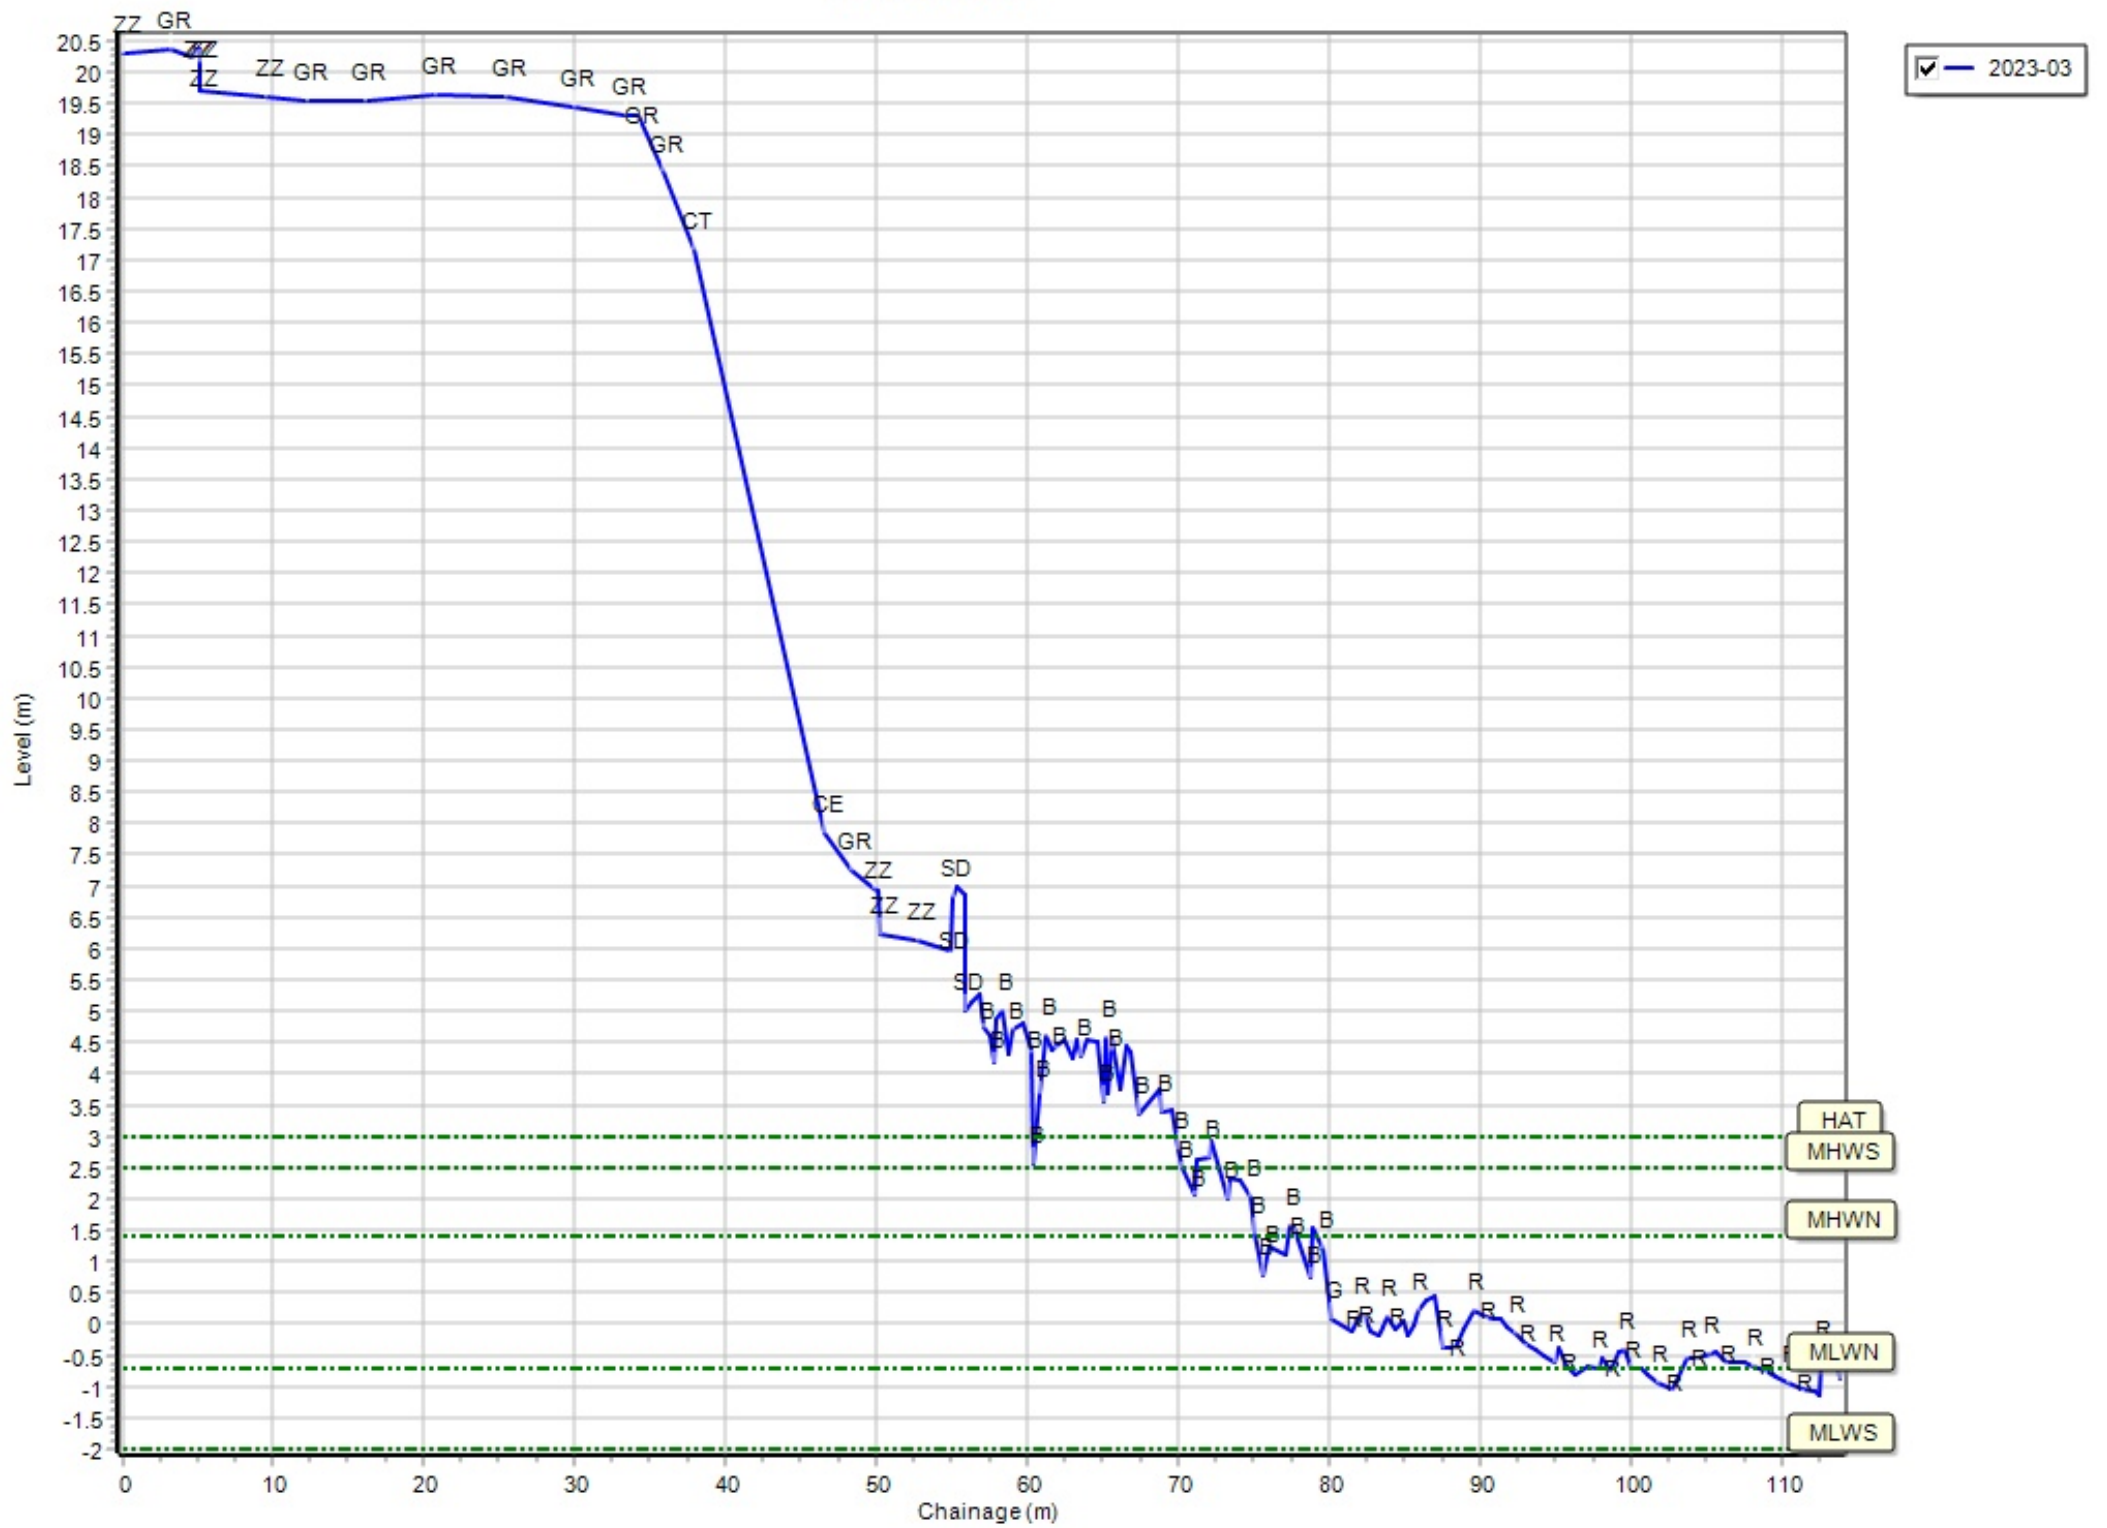
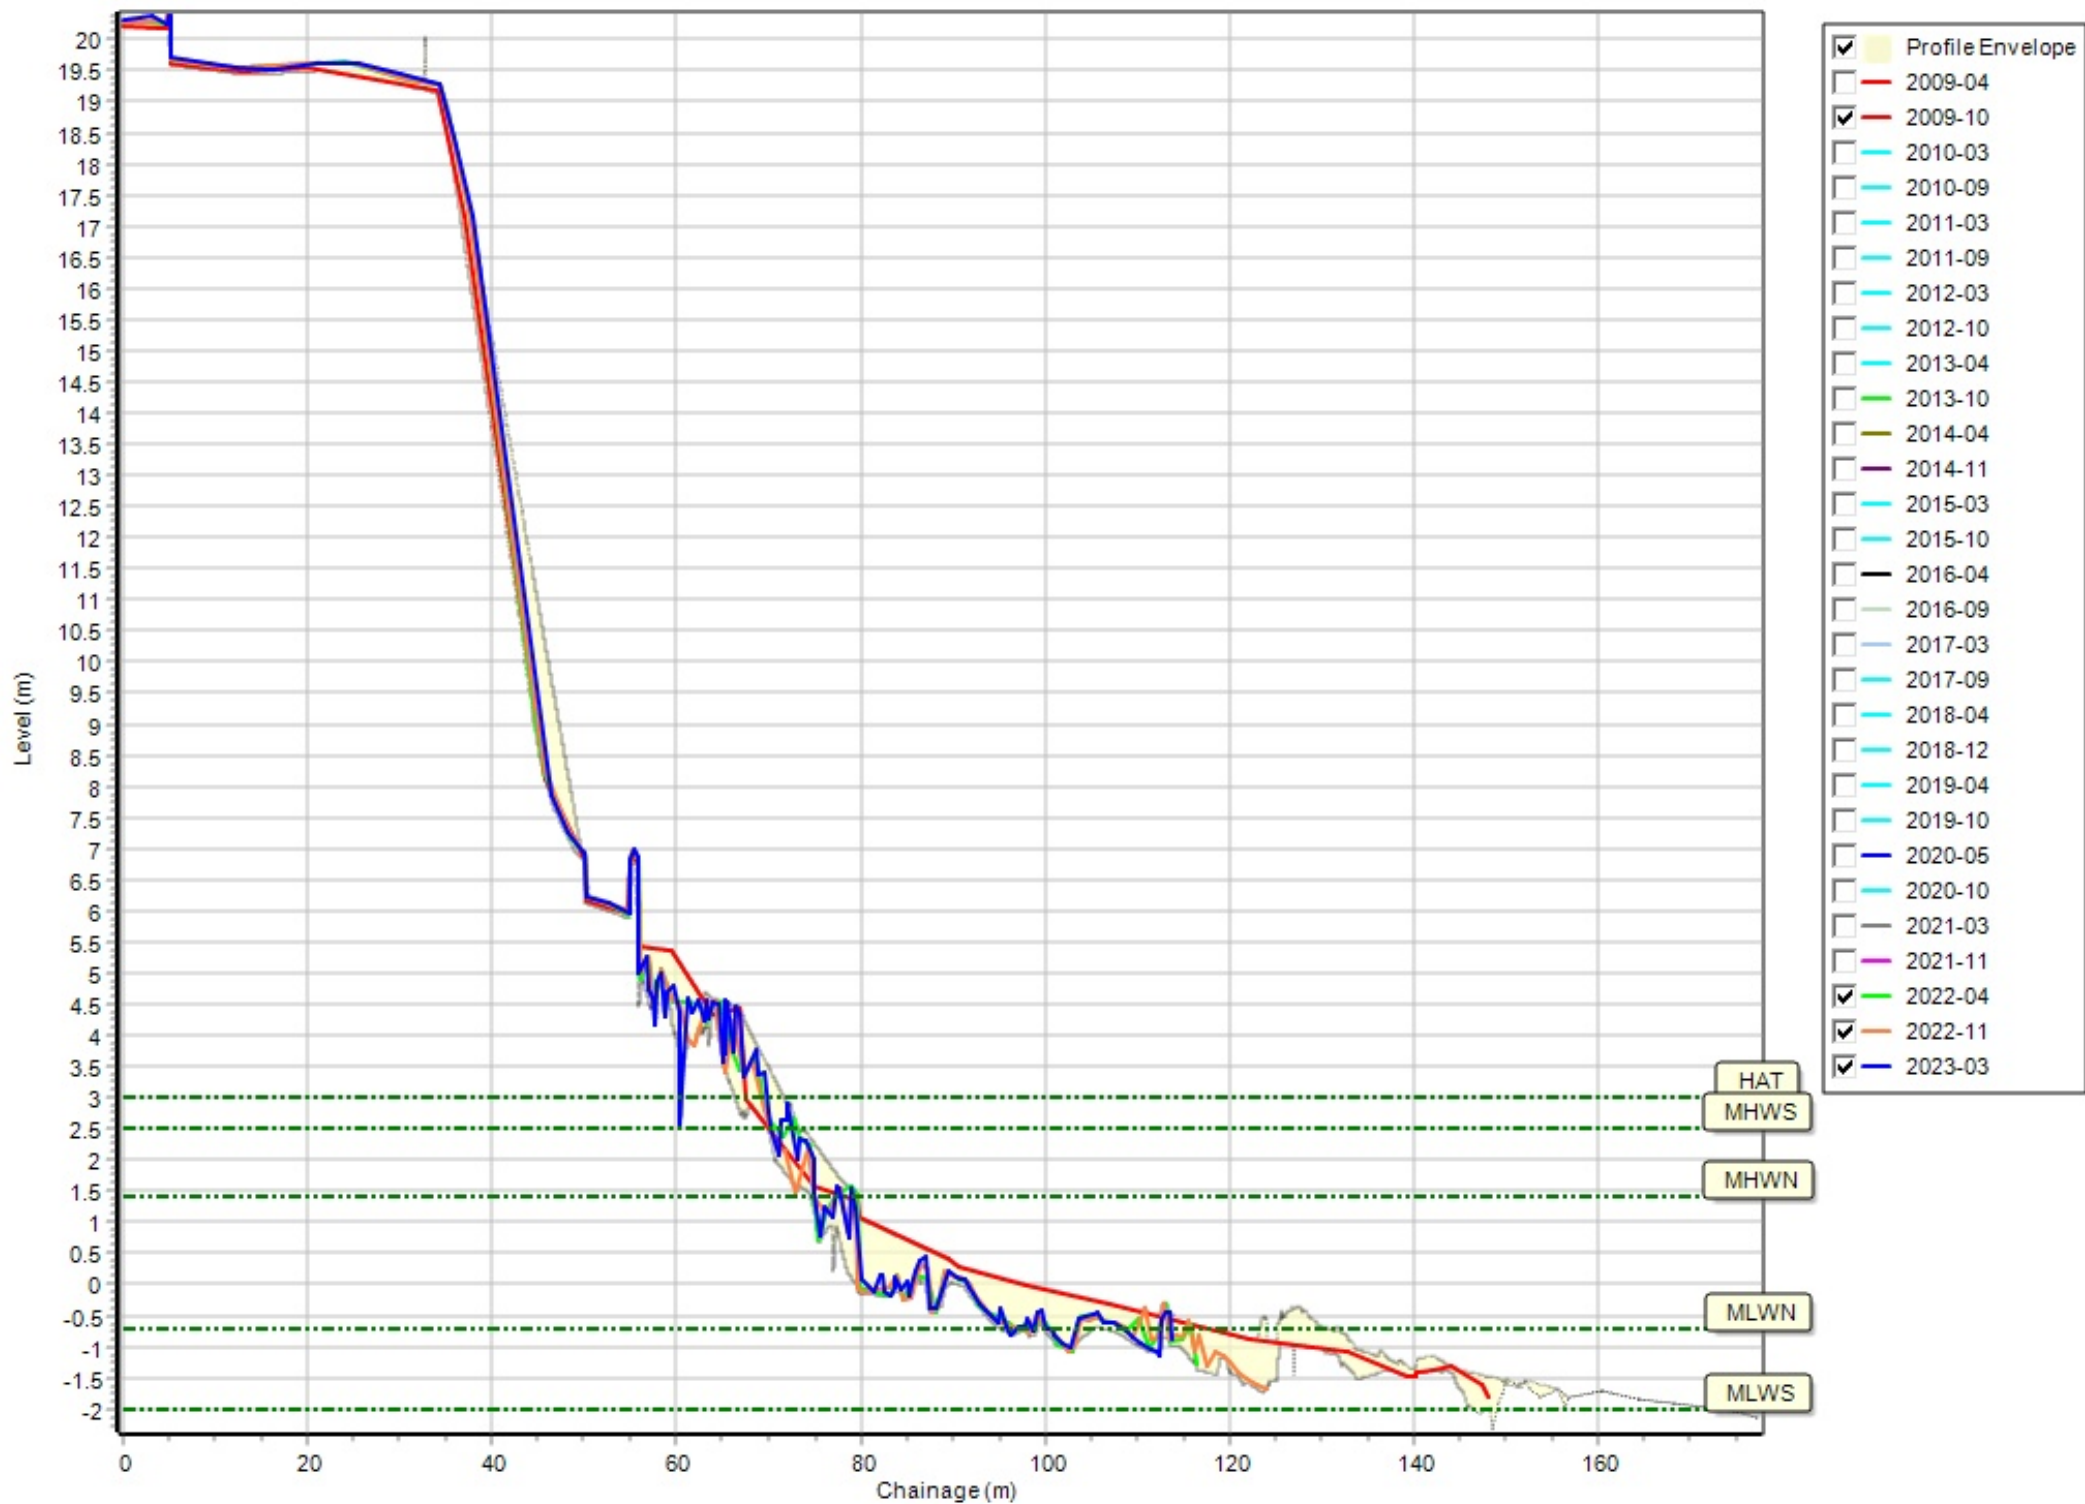
# Profiles: 1bEA1

Survey Date	Description of Changes Since Last Survey	Interpretation
10 <sup>th</sup> March 2023	<p><b>Beach Profiles:</b></p> <p>Featherbed Rocks is monitored by one beach profile line (<b>1bEA1</b>) during the Partial Measures survey (Appendix A). The previous survey was November 2022.</p> <p>Over the winter months, Profile <b>1bEA1</b> has experienced very little change. Chainage 0m to 55m covers the cliff top, cliff face and promenade and remains largely constant due to protection offered by the rock armour. It is assumed small variabilities observed in the cliff face is due to the margin of error of the survey technique rather than true change. The uneven profile at the base of the sea wall between 55m and 80m is due to the rock armour. Beyond 90m there remains no sediment over the shore platform which is reflected in an uneven profile.</p>	<p>Very little to no change has occurred at Profile 1bEA1 since the previous survey. The rocky foreshore remains exposed fronting the defended section.</p> <p><b>Longer term trends:</b></p> <p>The rocky nature of the foreshore means it is unlikely to undergo significant changes in morphology unless sediment is deposited. Previous monitoring indicates that a veneer beach tends to accumulate over the summer and is stripped off by winter storms, giving rise to small and localised changes in profile. Although the veneer beach has not been observed for a number of years. The upper part of the profile, which covers the cliff, promenade and rock armour remains unchanged, as does the lower part of the profile which covers the rocky foreshore.</p>

- At Featherbed Rocks the shore platform remains exposed seaward of the rock armour. As a result of the absence of superficial beach sediment, there has been very little change since the previous survey.

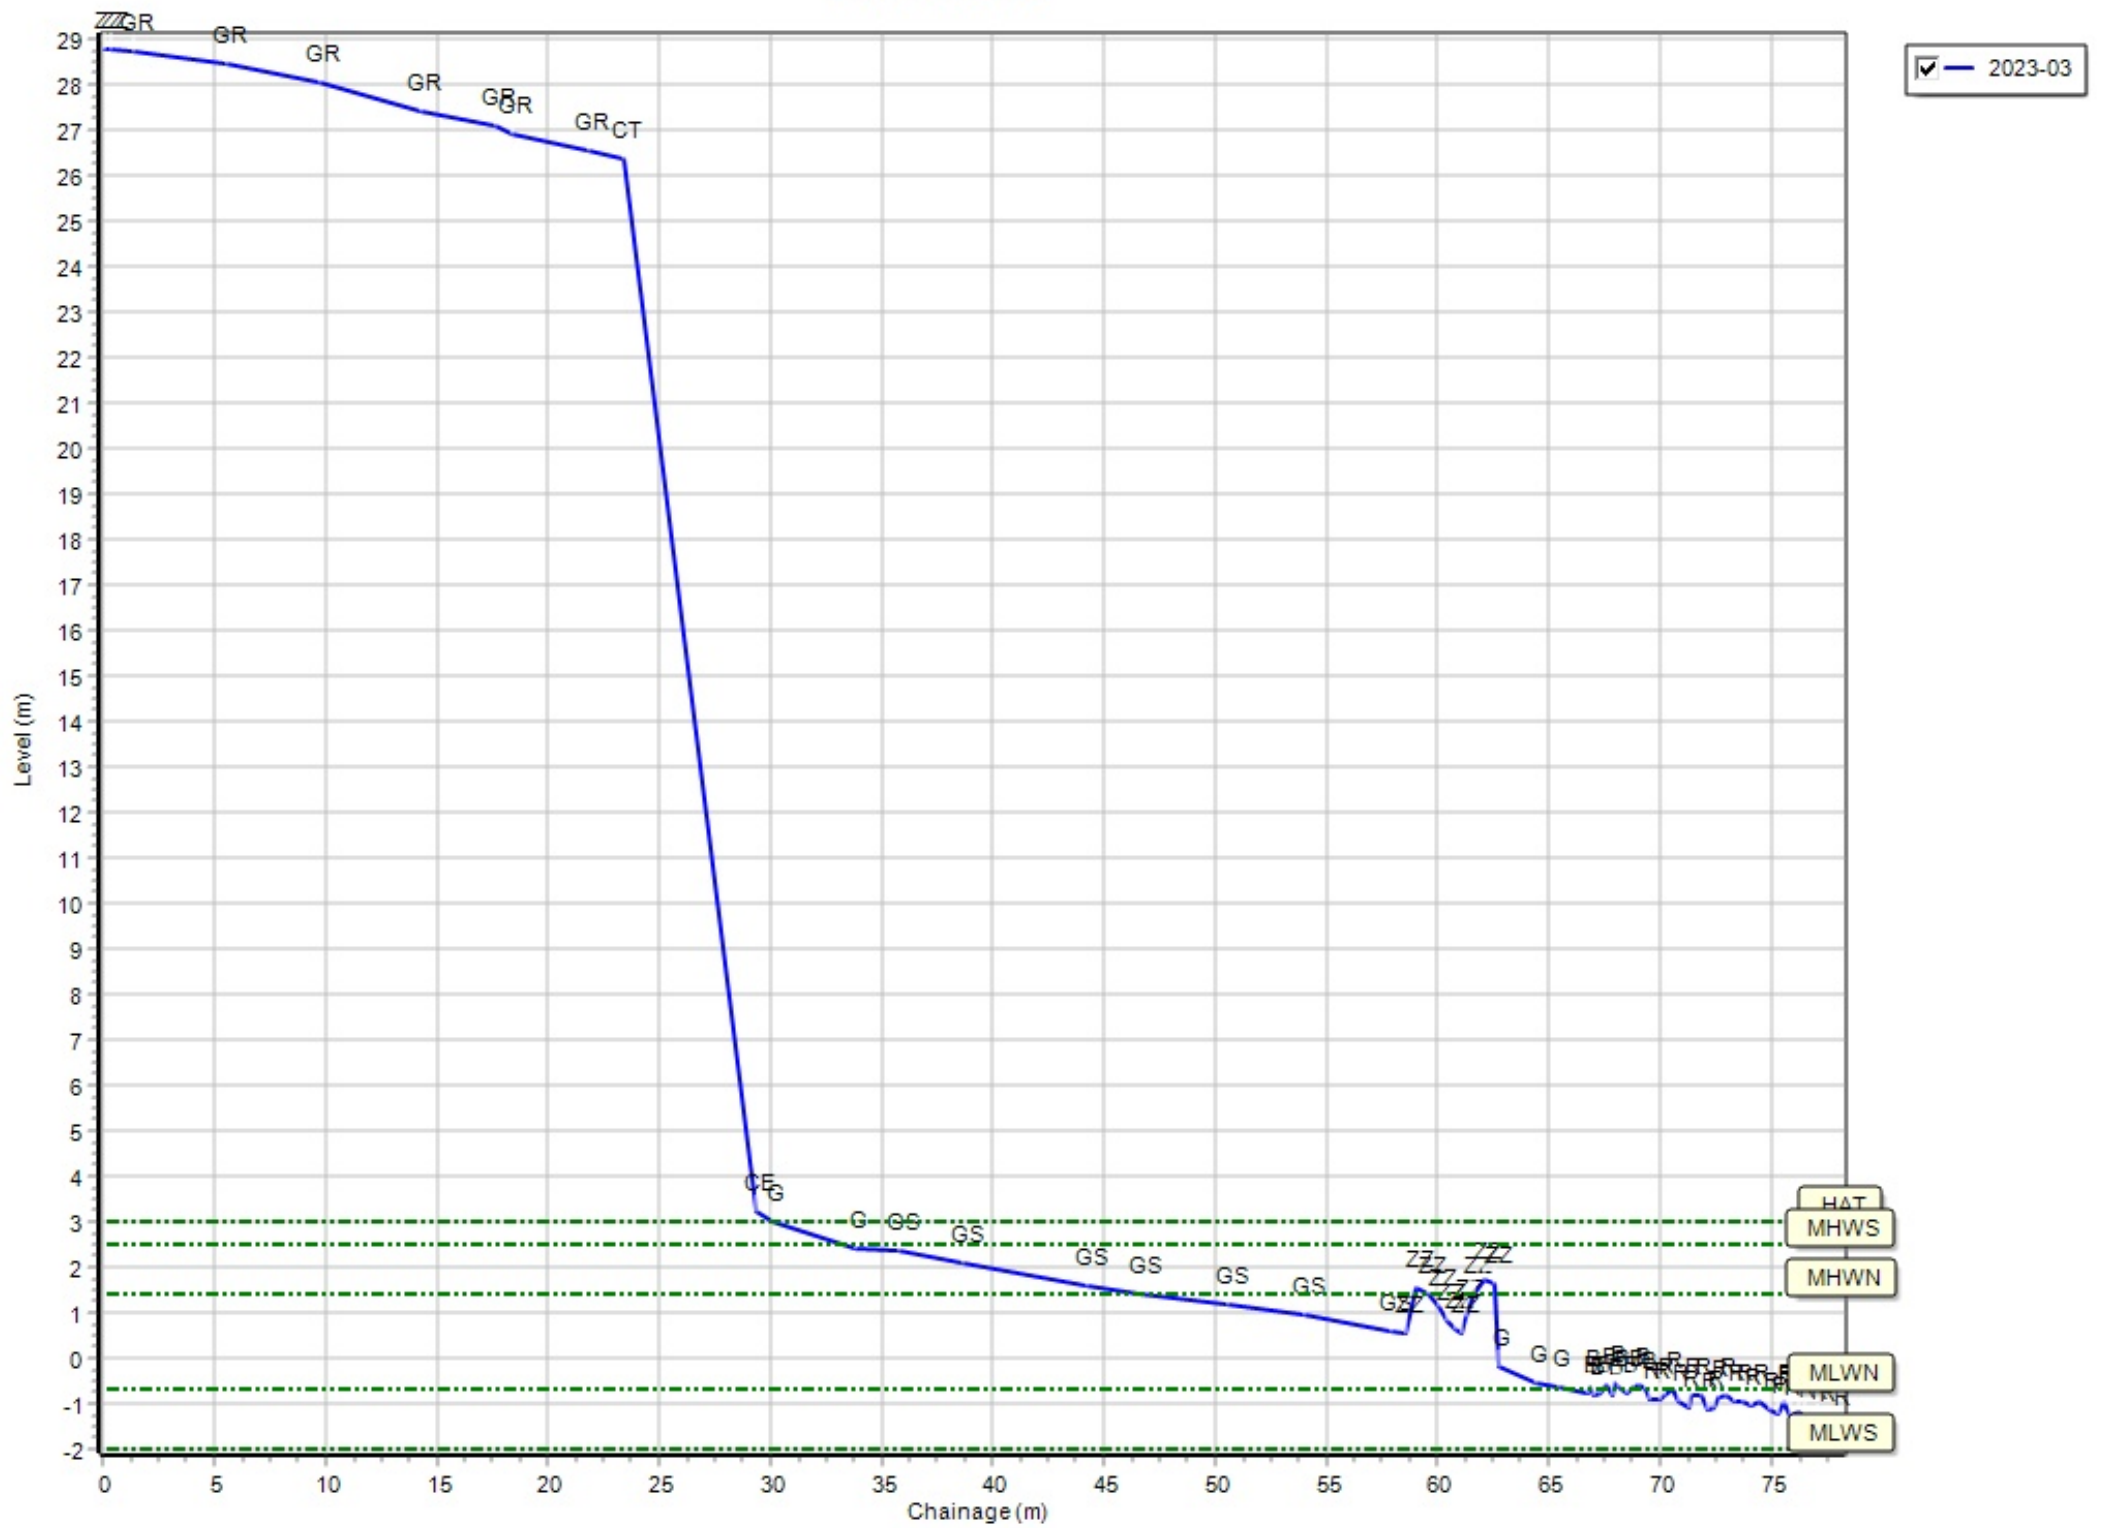
# Profiles: 1bSH1B

Survey Date	Description of Changes Since Last Survey	Interpretation
10 <sup>th</sup> March 2023	<p><b>Beach Profiles:</b></p> <p>Blast Beach is covered by four beach profile lines during the Partial Measures survey (Appendix A).</p> <p>Profile <b>1bSH1B</b>, added in October 2015, is adjacent to the sewage works south of Seaham. The profile consists of cliff to chainage 30m followed by a gravelly beach, the beach is bisected by a concrete obstruction at chainage 59m. The 2023 Partial Measures survey showed that there has been consistent erosion of the of the upper beach until the concrete obstruction of up to 0.5m in level. Seaward of the concrete blocks, the beach has again been eroded by 0.25m in level over a 5m length. From chainage 66m onwards the rocky foreshore has experienced little to no change. Overall, the beach is at a very low level when compared to the range of the previous surveys, particular between chainage 29m and 44m which is at the lowest level on record.</p> <p>Profile <b>1bSH1A</b> was added to the programme during the Full Measures survey in September 2009. It is located to the north of the previously-established <b>1bSH1</b>. The Survey Report notes dense vegetation restricts access to the cliff top and cliff base. The 2023 Partial Measures survey showed that the eroding face of the spoil deposit has not retreated any further since the previous survey in November 2022. However, the berm at the toe of spoil face has been eroded away, resulting in a drop in level of up to 2m in places. Seawards of chainage 170m the rocky foreshore remains exposed and has experienced little change.</p> <p>A similar pattern of change is observed at profile <b>1bSH1</b>. The eroding face of the spoil deposit has not retreated any further since the previous survey in November 2022. However, the has significantly dropped in level by up to 1.5m in places. The drop in level has resulted in the rocky foreshore being exposed from chainage 117m onwards.</p> <p>At profile <b>1bSH2</b> dense vegetation again restricted access to the cliff tops skewing the profile across the cliff face up chainage 97m. The residual colliery spoil berm, between changes 100m and 135m has remained largely stable, with all changed limited to <math>\pm 0.15</math>m. Seaward of this, change is limited to <math>\pm 0.2</math>m with erosion occurring between chainage 135m and 163m before switching to accretion to chainage 187m. Overall, the beach is at a medium level compared to the range recorded from previous surveys.</p>	<p>The latest Partial Measures survey showed that erosion has dominated the profiles through Winter 22/23. This is particular noticeable at the northern end Blast Beach where upper beach has dropped in level across by profiles by up 2m. Despite this dramatic drop in level, the colliery spoil face has not retreated over this time period.</p> <p>The change to the south of Blast Beach appears less significantly with all change limited to <math>\pm 0.2</math>m</p> <p>The rocky foreshore is exposed across all profiles.</p> <p><b>Longer term trends:</b></p> <p>The cliffs behind Blast Beach are currently inactive because they are fronted by colliery spoil. The sea cliffs will eventually reactivate as ongoing erosion of the colliery spoil removes the protection it affords to the cliffs. In the past this has been deemed most likely to occur at the southern end of the bay where the spoil was more rapidly eroding. The (previously) accumulating sediment seaward of the colliery spoil in the northern part of the bay was thought to offer the cliffs more protection. However, since the winter of 2014 there has been a reversal in the trend with erosion in the north of the bay and accretion in the south.</p>

- Along Blast Beach, the latest Partial Measures survey showed that erosion has dominated the profiles through Winter 22/23. This is particularly noticeable at the northern end Blast Beach where the upper beach has dropped in level across by profiles by up to 2m. Despite this dramatic drop in level on the upper beach, the colliery spoil face has not retreated over this time period.

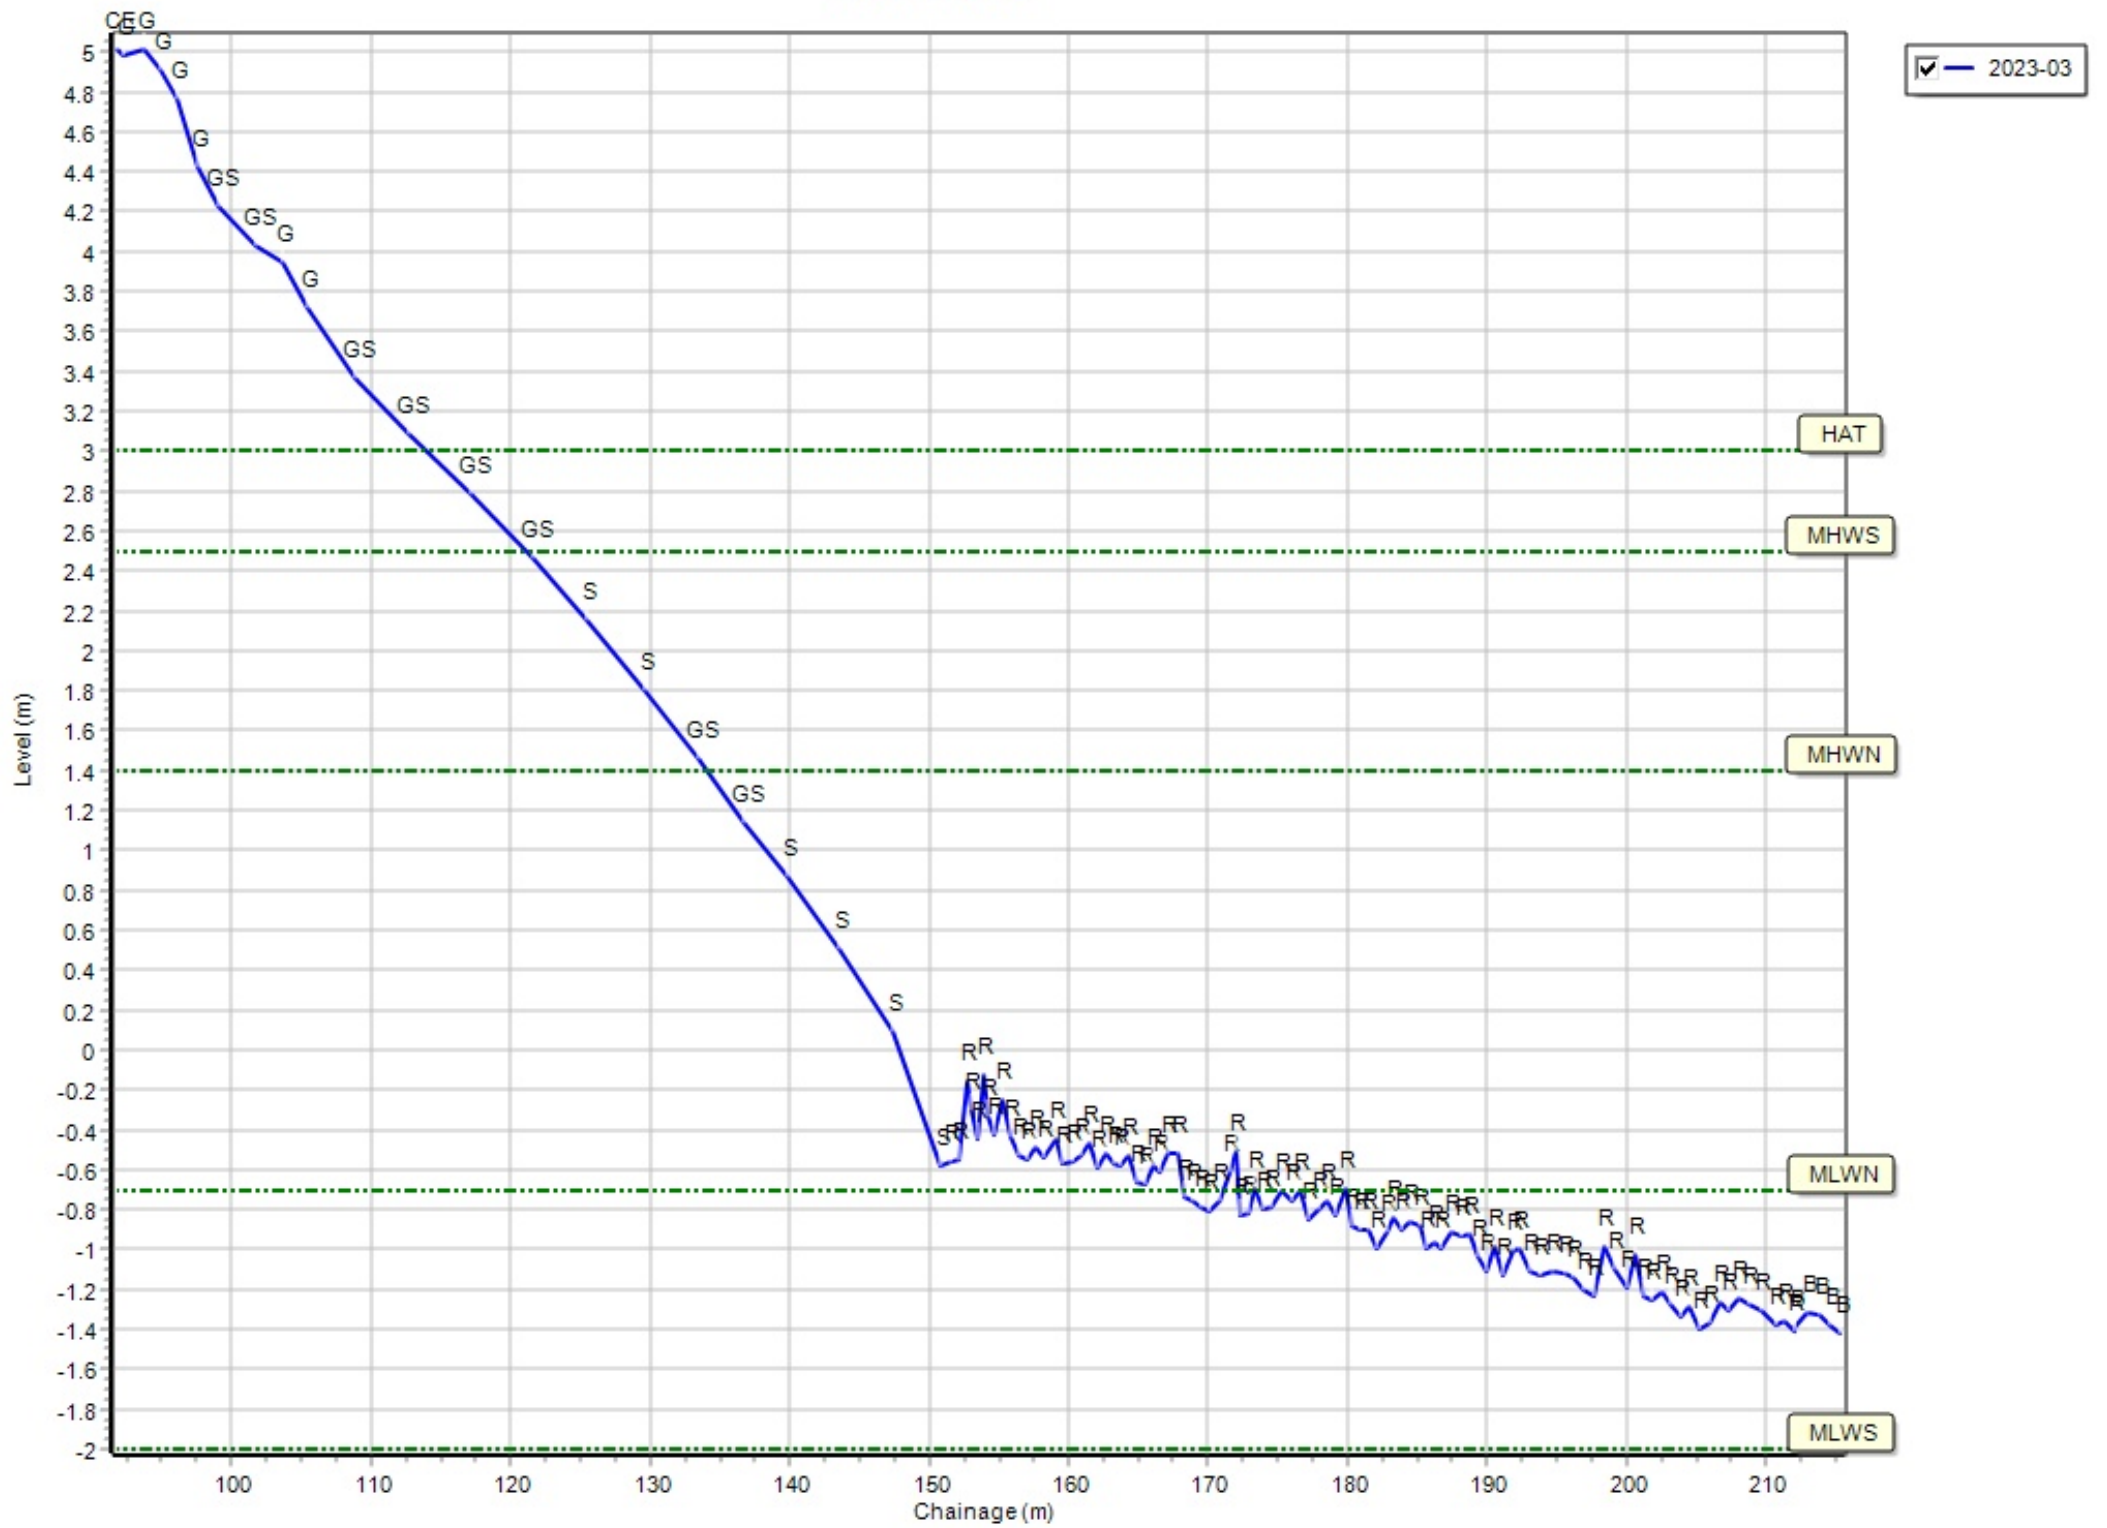
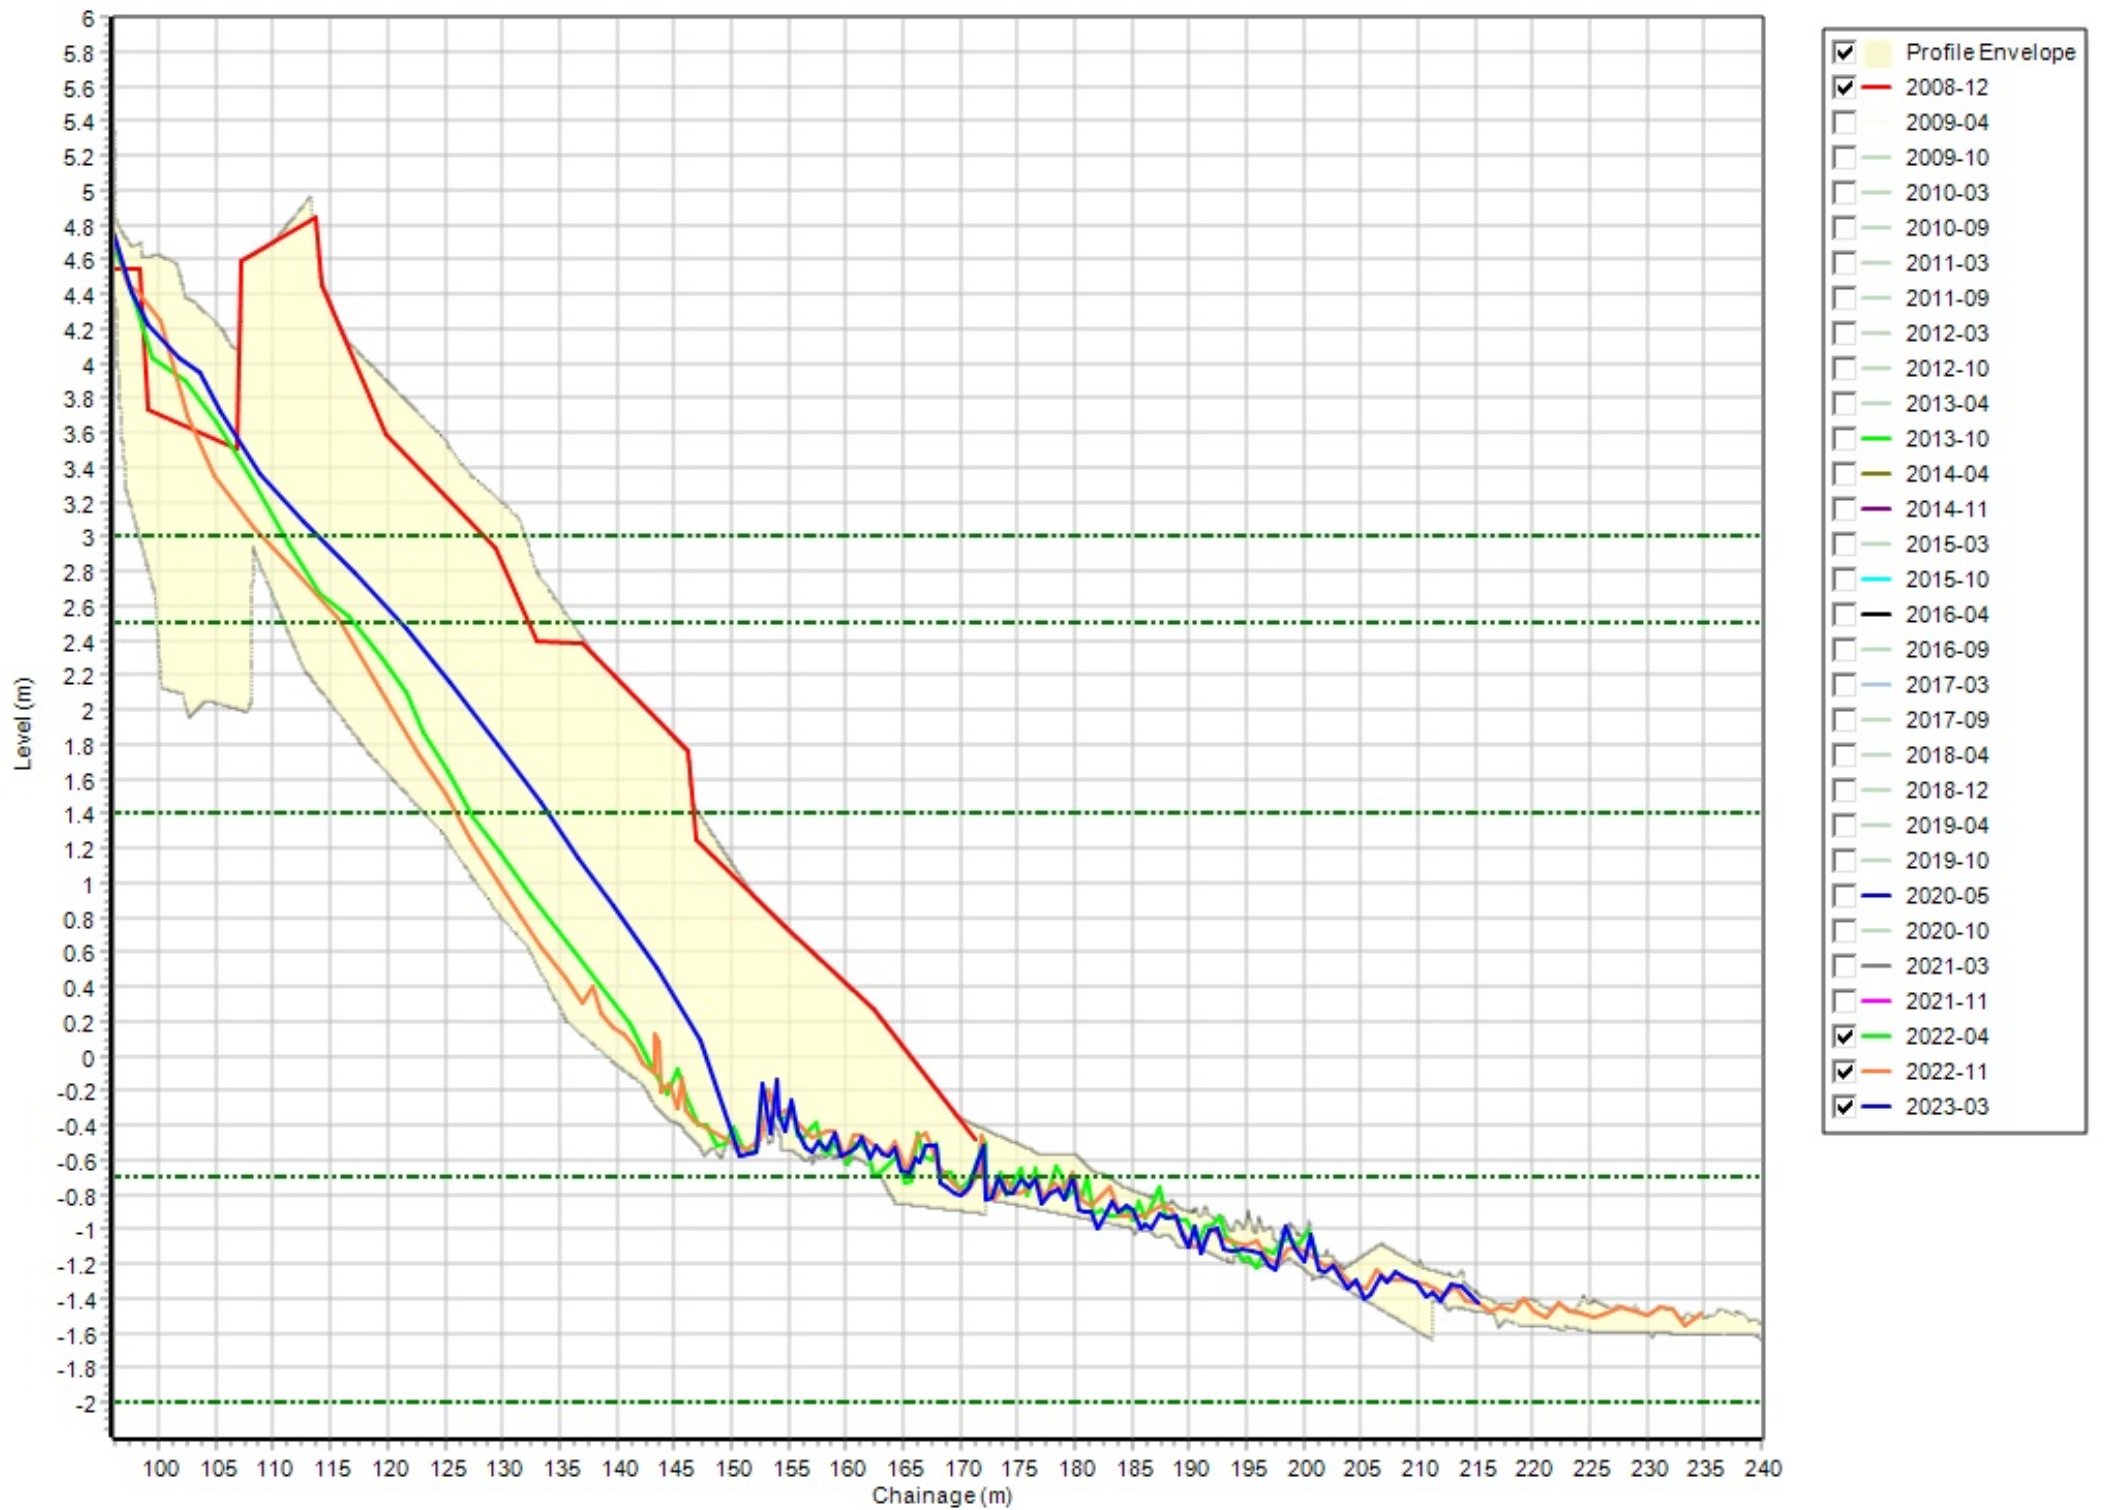
# Profiles: 1cEA2

Survey Date	Description of Changes Since Last Survey	Interpretation
10 <sup>th</sup> March 2023	<p><b>Beach Profiles:</b></p> <p>Hawthorne Hive is covered by one beach profile line <b>1cEA2</b> during the Partial Measures survey (Appendix A). The survey report notes “<i>unable to measure start of Section EA2 as the vegetation has choked out the section line and route over cliff faces</i>” and therefore all surveys following October 2012 start at 95m chainage.</p> <p>Until the Partial Measures survey in April 2013, a channel was present between 95m and 105m chainage, but it has infilled. The survey shows that over the winter months, the upper beach, from chainage 101m to 150m, has accreted by up to 0.6m. Seaward of chainage 150m the rocky foreshore remains exposed. Overall, the beach is at a medium level compared to the range recorded from previous surveys.</p>	<p>Since the previous survey in November 2022, where beach levels were at a very low level, the profile at Hawthorne Hive appears to have undergone a period of recovery with upper beach accreting by up to 0.6m in level.</p> <p><b>Longer term trends:</b></p> <p>Contrary to the results of this survey, the profiles generally show the beach is undergoing progressive erosion.</p> <p>The infilling and incision of the channel seems to be an episodic process and is likely to reflect a combination of annual and seasonal variations in the flow of Hawthorn Burn and storm events which move sediment onshore to block the outflow of the burn.</p>

- Since the previous survey in November 2022, where beach levels were at a very low level, the profile at Hawthorne Hive appears to have undergone a period of recovery with upper beach accreting by up to 0.6m in level.

- The surveyor noted difficulties accessing the cliff tops of sections SH1, SH2 and SH1A and the cliff base of SH1A due to dense vegetation.
- At Hawthorne Hive the surveyor was unable to measure the start of Section EA2 due to vegetation cover.
