**Cell 1 Regional Coastal Monitoring Programme
Analytical Report 2: 'Full Measures' Survey 2009**

**Hartlepool Borough Council
Final Report**

^(*) The present report is **Analytical Report 2** and provides an analysis of the 2009 Full Measures survey for Hartlepool Borough Council's frontage.

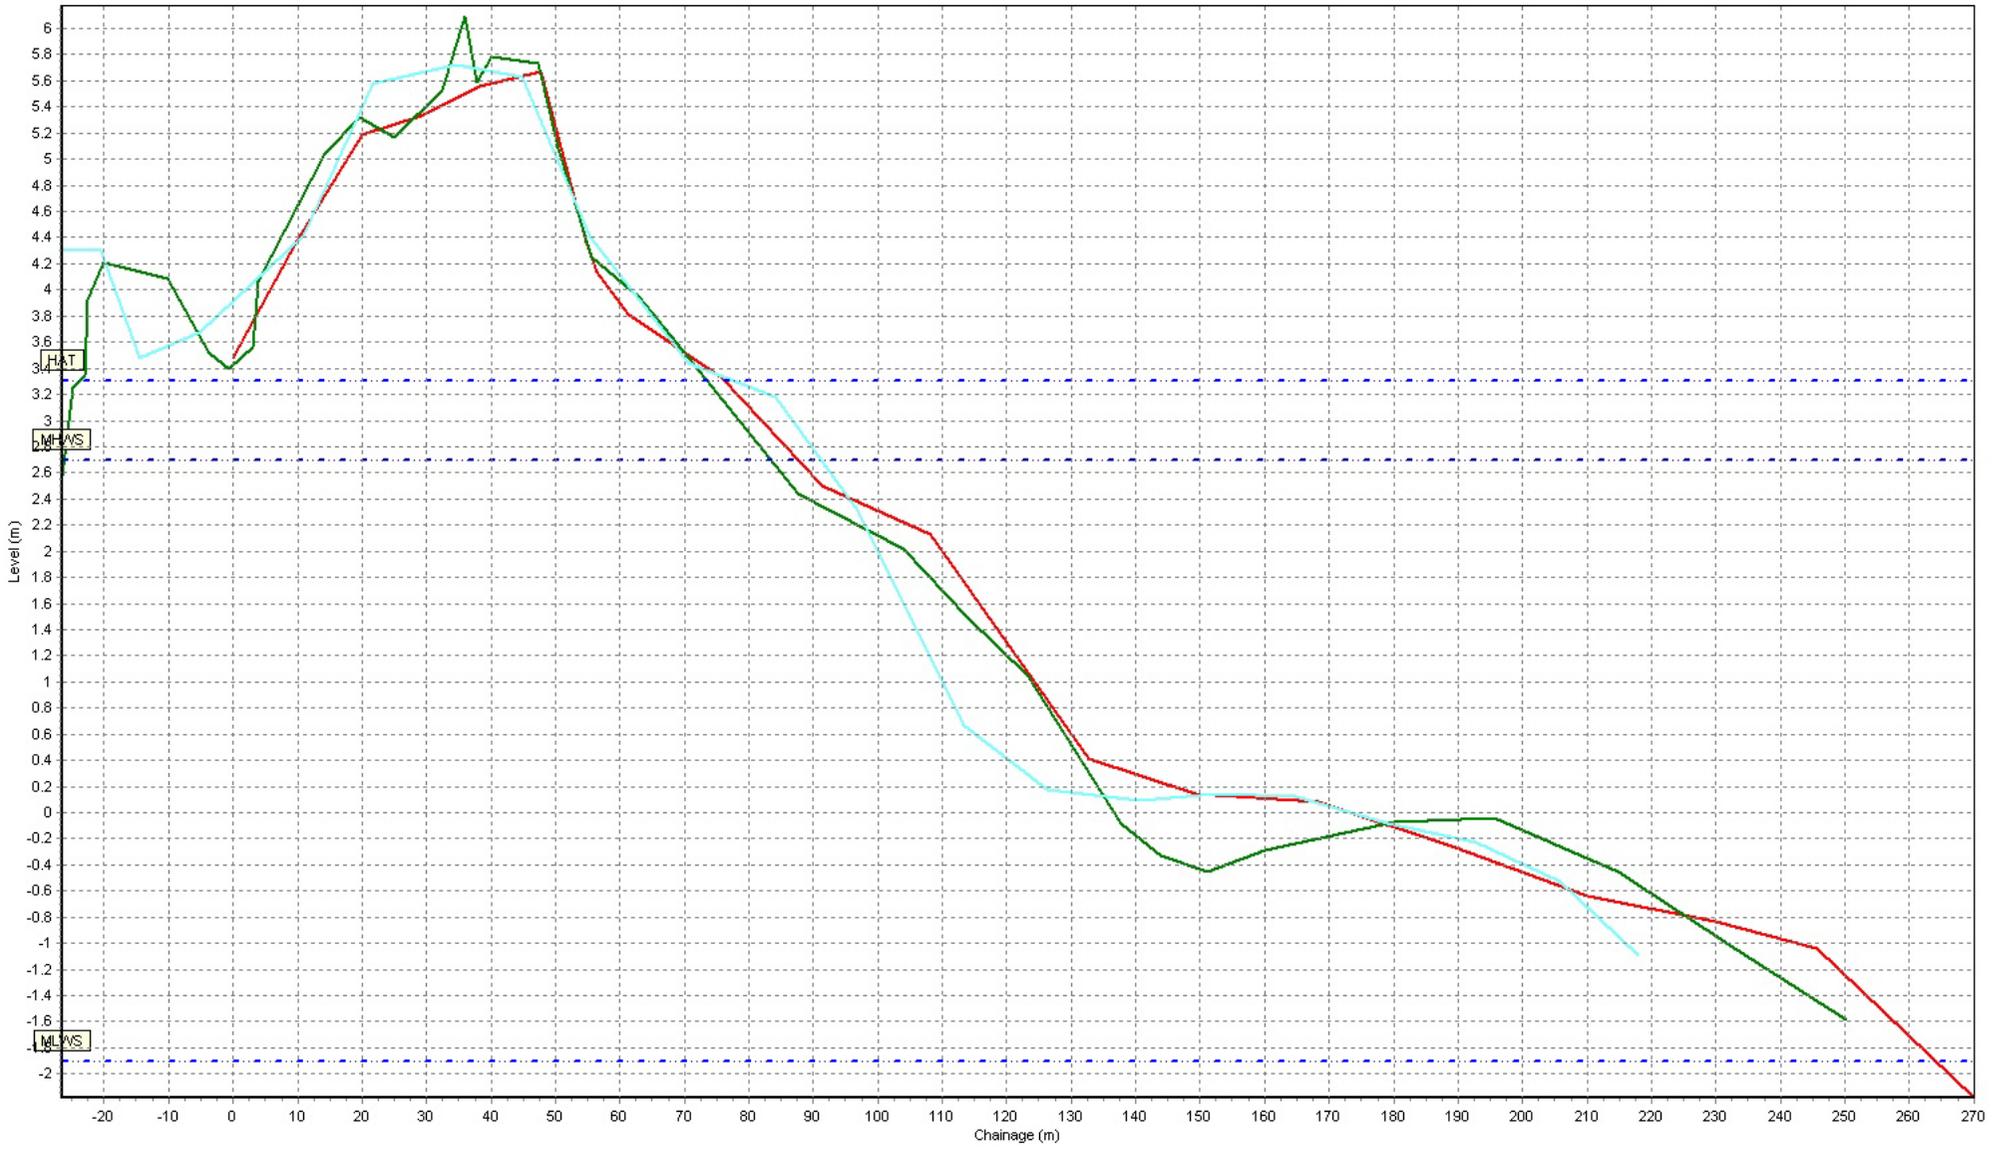
Beach Profiles: 1cHN1

| Survey Date | Description of Changes Since Last Survey | Interpretation |
|---|---|--|
| 09-2009 | <p>Beach Profiles:</p> <p>North Sands is covered by four beach profile lines (Appendix A) during the Full Measures survey.</p> <p>HN1 is located within Durham County Council's jurisdiction, about 400m north of the outfall of Crimdon Beck, but has been reported here so changes can be interpreted in association with those observed elsewhere along North Sands at HN2, HN3 and HN4.</p> <p>HN1 starts at the landward side of the dune crest, which has an elevation of approximately 5.7mOD, and then extends across the foreshore to low water level. The dunes show some minor differences to previous surveys, with flattening of small peaks in the crest to form a generally flatter but wider crest. A berm has developed at the toe of the dunes along the upper beach, but the beach between around MHWN and MWL has steepened notably.</p> <p>HN2 exhibits great stability in the dune crest and face, with changes confined to the foreshore where lowering has occurred between chainages of around 110m and 160m.</p> <p>HN3 extends from slag banks across the foreshore down to low water level. Changes compared to previous surveys were confined to minor fluctuations in foreshore level, and the backing slag banks remain stable at present.</p> <p>HN4 extends across the promenade and sea wall before dropping to beach level. In the current survey, foreshore levels were lower than in either of the previous two surveys, especially seaward of a chainage of 60m where notable lowering occurred.</p> | <p>Beach changes along profiles HN1 and HN2, towards the north of North Sands, appear to be linked with the exchange of sediment between the lower-mid and upper beach sections. This represents a redistribution of sand across the profile width. At present the dunes remain in a stable position.</p> <p>Further south along HN3, by the disused industrial areas, the foreshore changes are less pronounced, meaning that the backing slag banks are presently unaffected by erosion.</p> <p>At the southern end of North Sands, along HN4, lowering of the lower foreshore is very pronounced, resulting in rock outcrops being visible along the length seaward of a chainage of 110m. This suggests that during earlier surveys the rock outcrops were covered by a veneer of sand which, in places, was around 0.75m thick, and that this veneer is highly mobile under storm action.</p> |

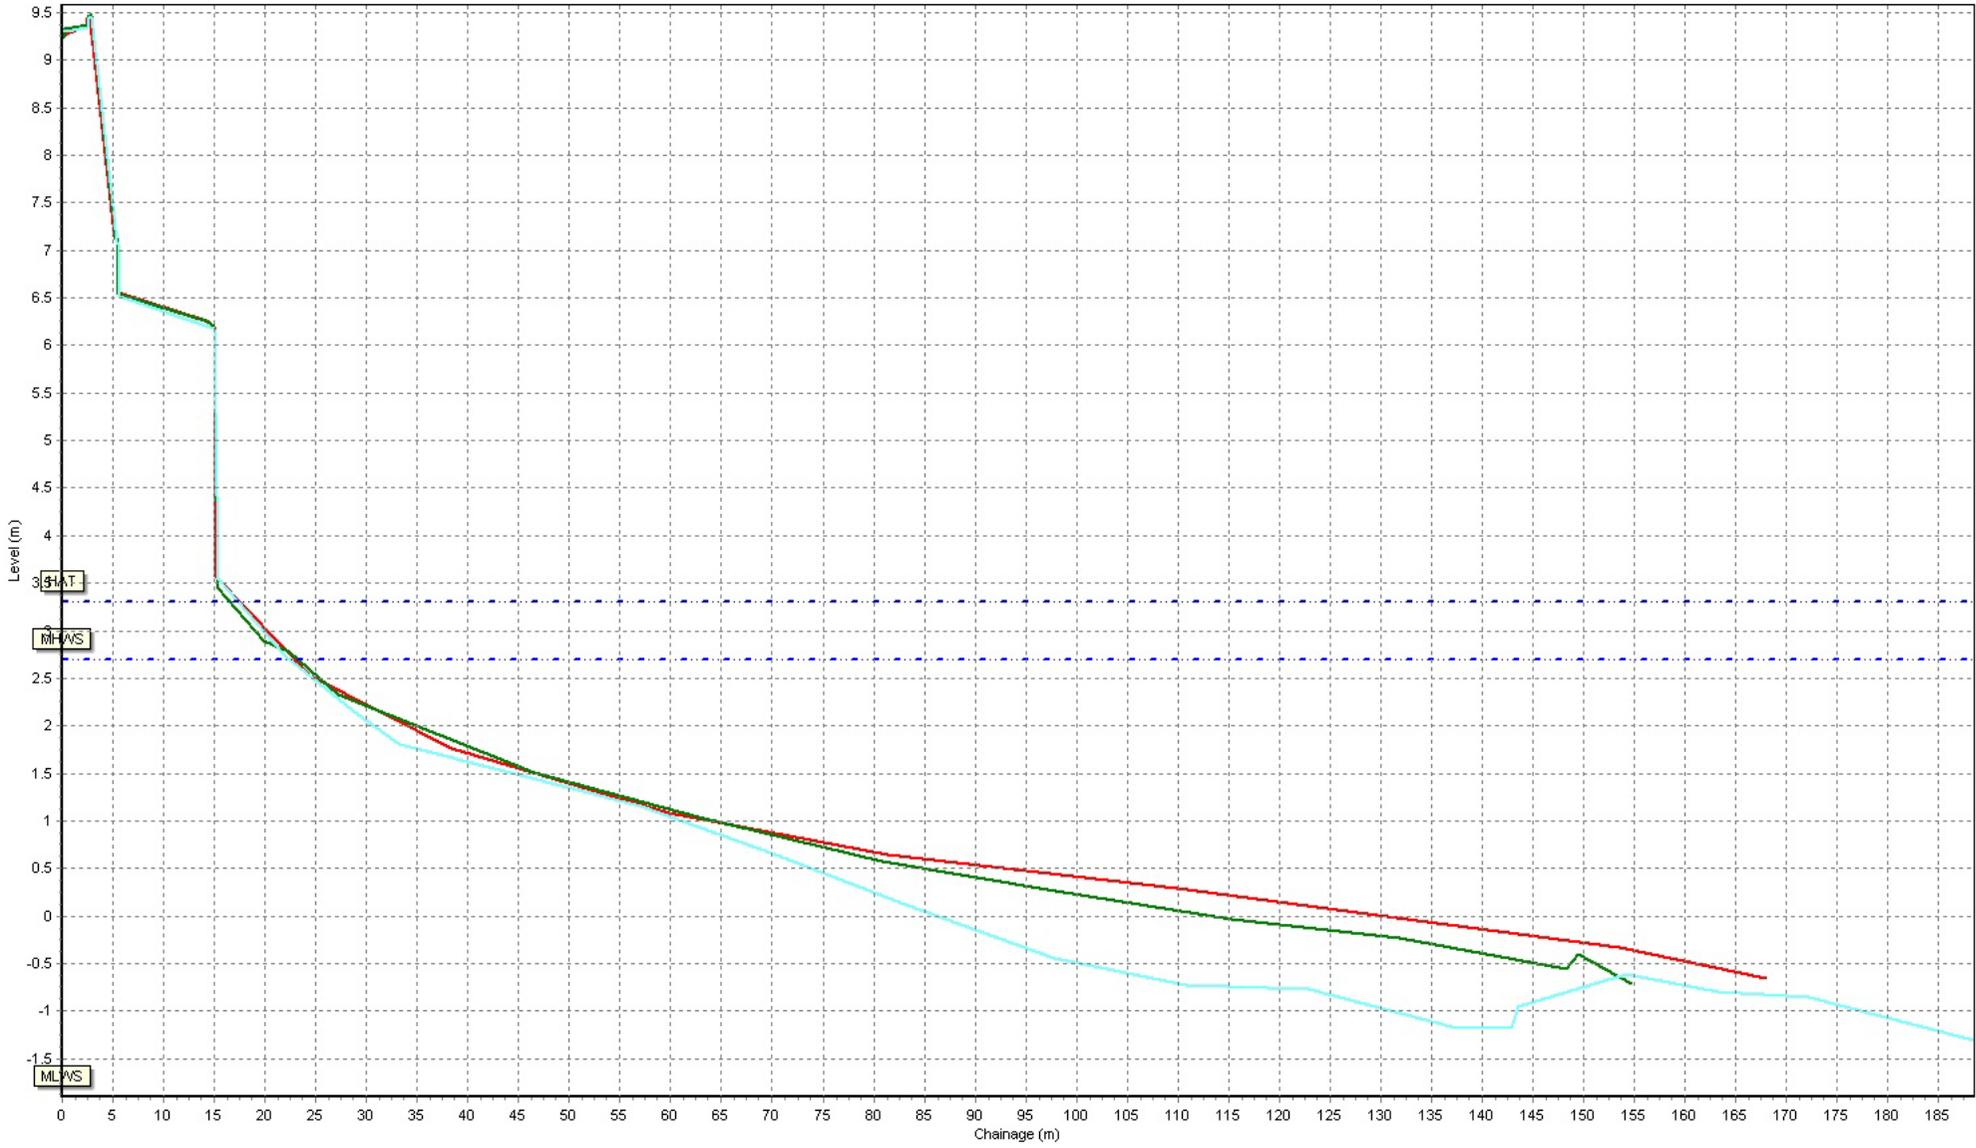
Beach Profiles: 1cHN4

- The most notable areas of change were located at the south-eastern end of North Sands (stripping of the sand veneer from the lower foreshore rock outcrops) and the southern end of Hartlepool Bay adjacent to the North Gare breakwater (mid and upper foreshore lowering). Careful attention will need to be paid to these areas in future surveys.

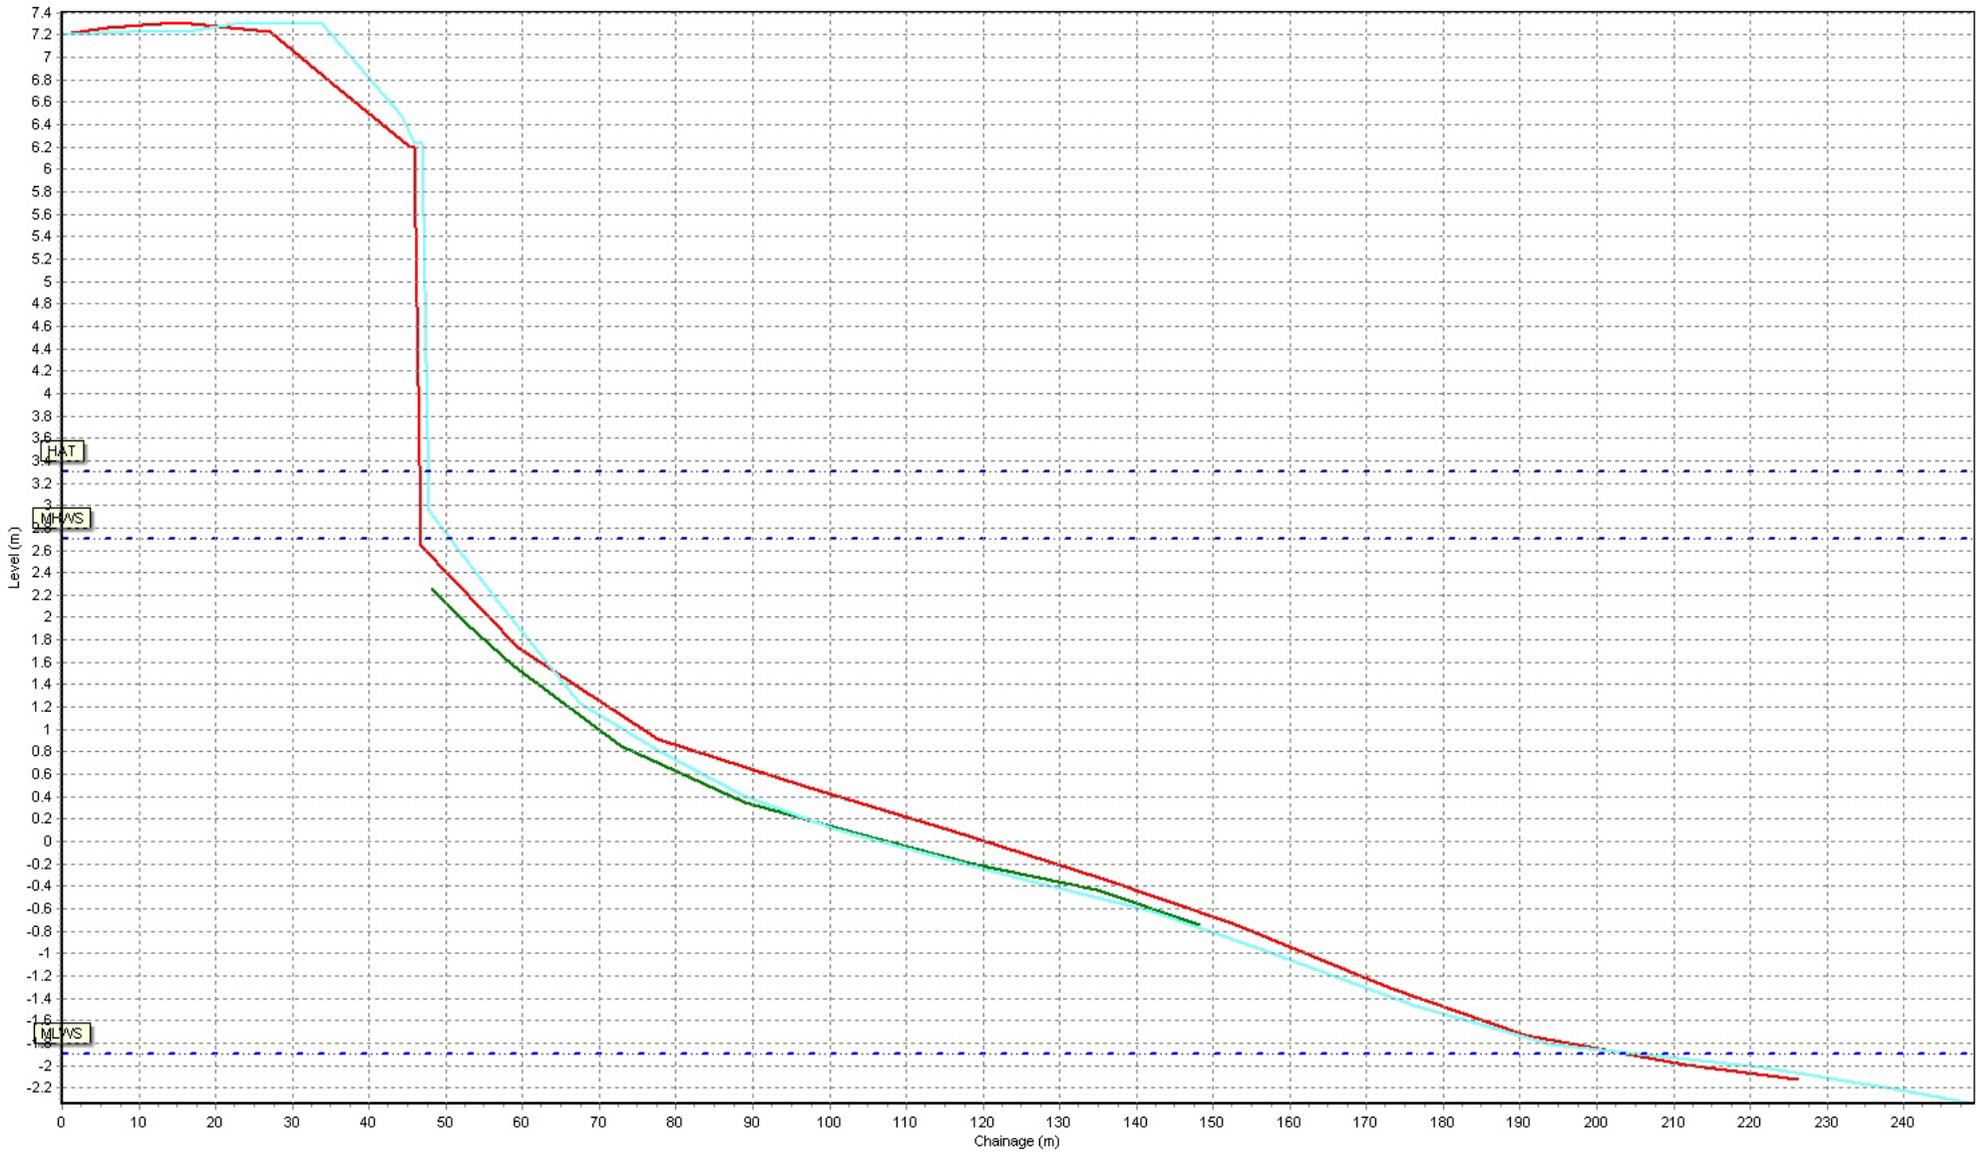
Beach Profiles: 1cHC1

| Survey Date | Description of Changes Since Last Survey | Interpretation |
|---|--|--|
| 09-2009 | <p>Beach Profiles:</p> <p>Middleton is covered by one beach profile line (Appendix A).</p> <p>HC1 showed some upper beach accretion since the previous survey in March 2009 to record the highest beach levels to date at the toe of the vertical wall. Further seaward, the profile form was very similar to the previous survey, but both of these surveys recorded lower levels than were observed in the baseline (November 2008) survey.</p> | <p>Generally, the Middleton beach, pocketed between Middleton Jetty and North Pier, experienced a net lowering over much of the foreshore between the baseline survey (November 2008) and the second survey (March 2009) but has remained relatively constant to date, with some accretion observed at the toe of the vertical wall.</p> |

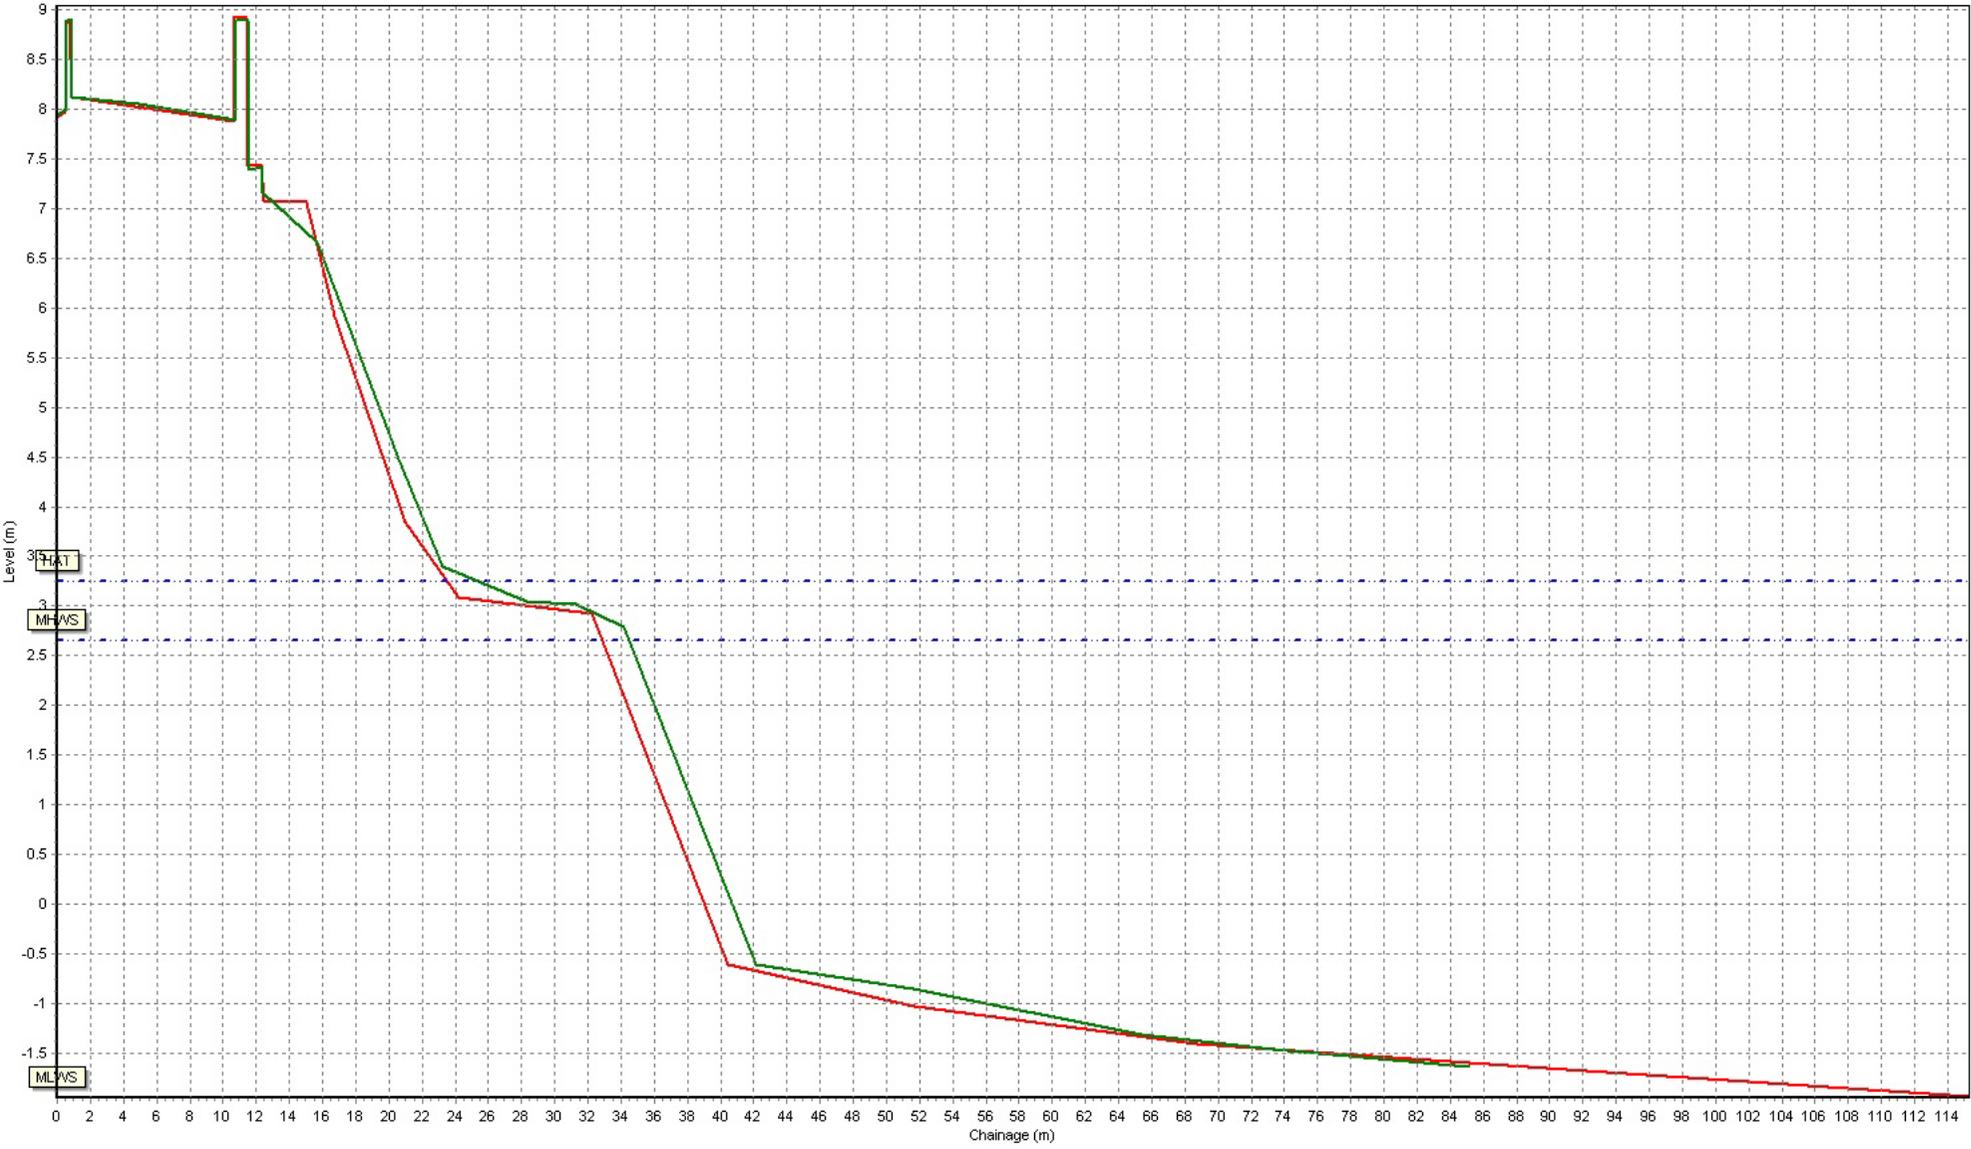
Beach Profiles: 1cHS1

| Survey Date | Description of Changes Since Last Survey | Interpretation |
|---|---|--|
| 09-2009 | <p>Beach Profiles:</p> <p>Hartlepool Bay is covered by four beach profile lines (named HS1 – HS4).</p> <p>HS1 is located approximately 150m south of the root of the South Pier and experience on minor change in foreshore level.</p> <p>HS2 and HS3 both are located more centrally within Hartlepool Bay and are protected by a smaller revetment than is present along HS1. Both profiles exhibited similar changes, with accretion directly at the toe of the rock armour (very notable accretion along HS3), minor erosion over a short length slightly further seaward, minor accretion over a greater length (around MSL) and finally minor erosion at the seaward end of the profile.</p> <p>HS4 is around 1km north of the North Gare breakwater in an area of undefended dunes. There was no significant change compared with the previous survey.</p> | <p>There is only a narrow foreshore width between the toe of the rock armour and the low water line in the north of Hartlepool Bay, but the rock armour structure provides a substantial defence.</p> <p>In central Hartlepool Bay, there appear to be patterns of sediment redistribution, with minor accretion along the very upper beach and along a notable mid beach section, and minor erosion elsewhere.</p> <p>The dunes at Seaton Sands appear presently very stable.</p> |

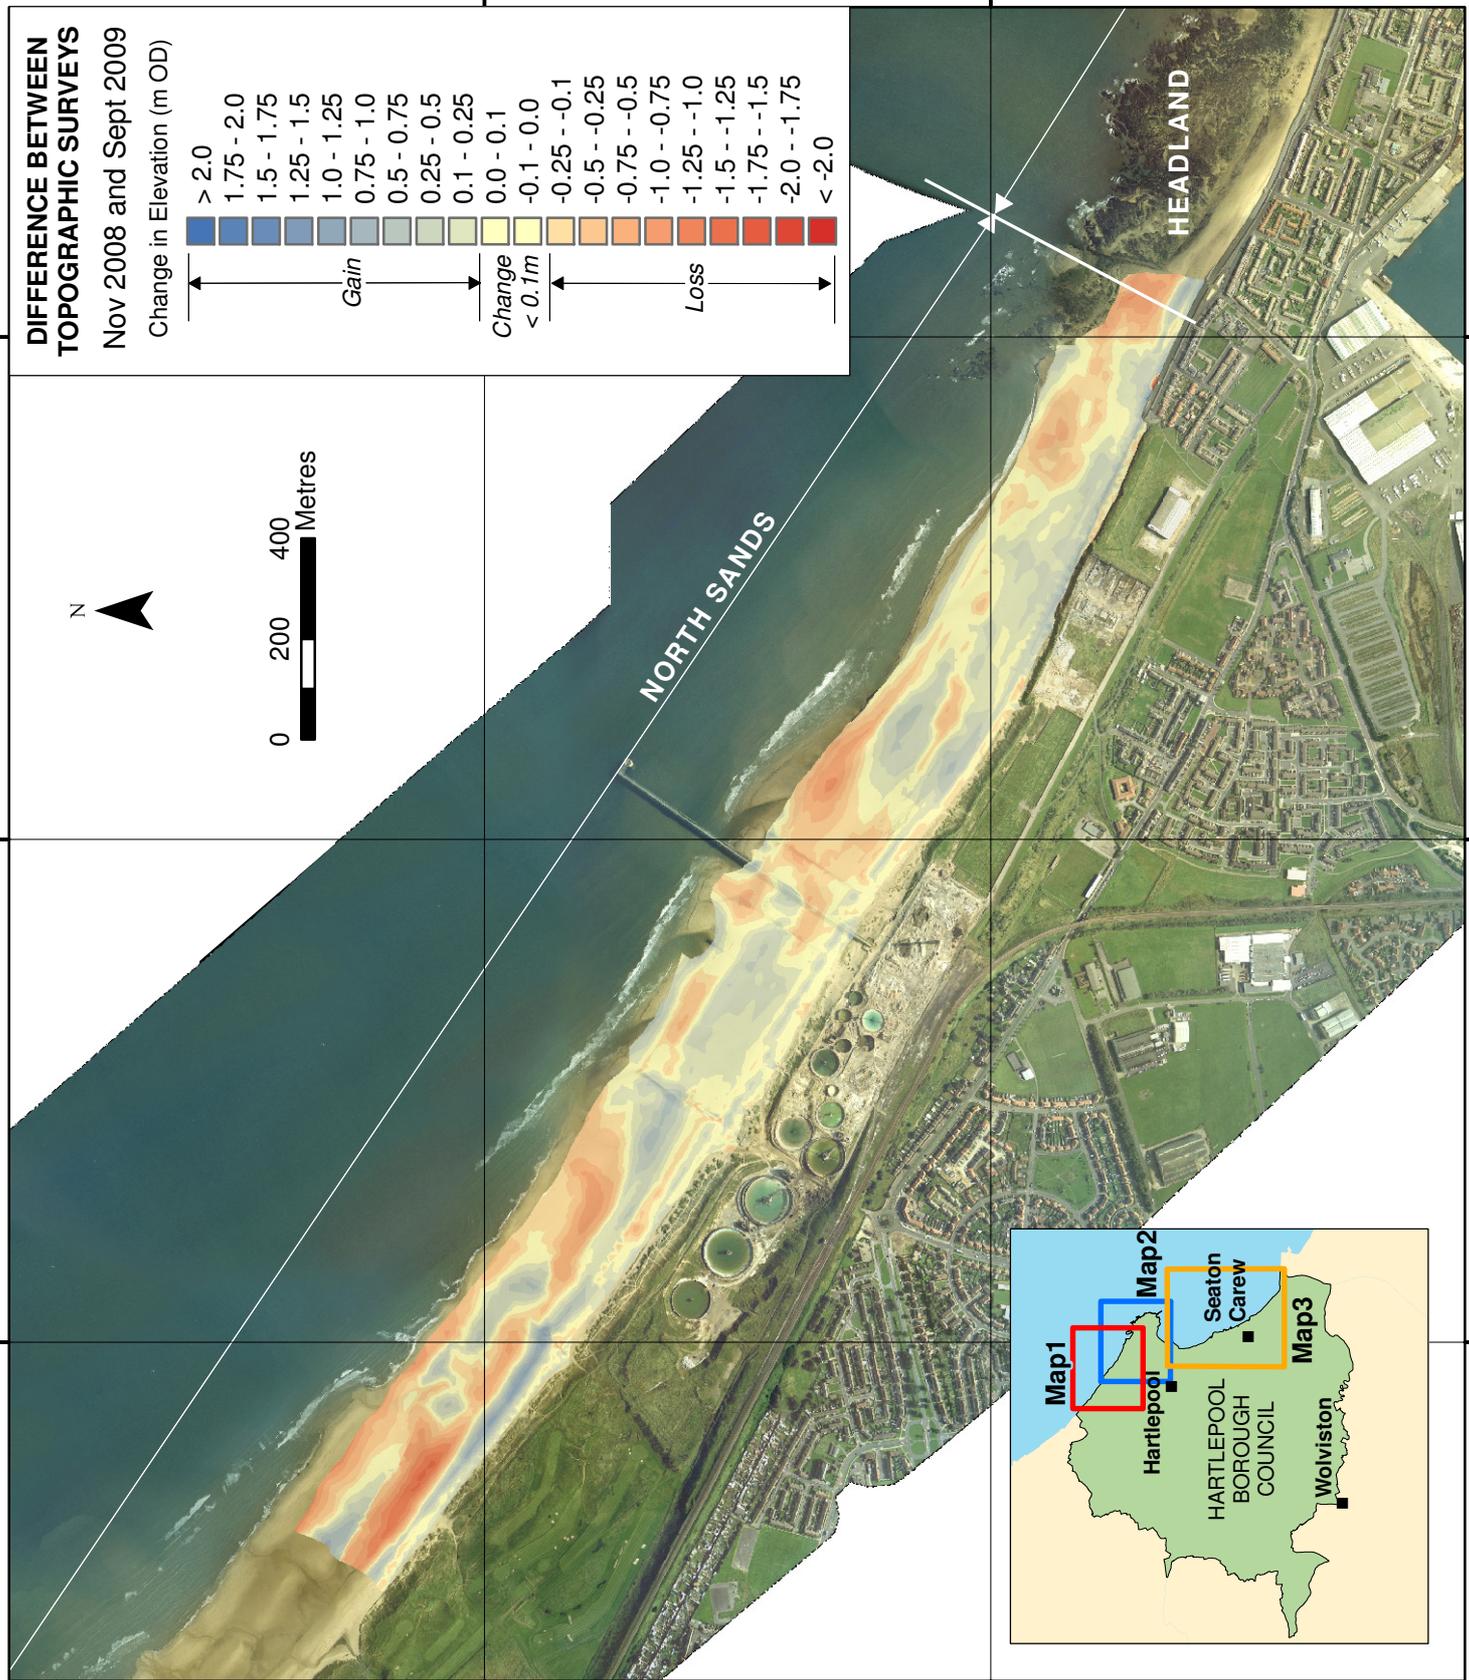
| Survey Date | Description of Changes Since Last Survey | Interpretation |
|---|--|---|
| 09-2009 | <p>Topographic Survey:</p> <p>North Sands is covered by an annual topographic survey. [Note: Every five years, starting from the 2008 baseline survey, coverage is extended further north along North Sands and further south around Hartlepool Headland, but this was not scheduled for the present survey.]</p> <p>Data from the 2009 Full Measures survey have been used to create a DGM (Appendix B – Map 1a) using a Geographic Information System (GIS) computer software package. From this it can be seen that beach levels at the toe of the dunes and slag banks along the northern and central sections of North Sands are relatively high, but there is a narrower width of the higher beach contours fronting the Marine Drive sea wall.</p> <p>The GIS has also been used to calculate the differences between the current topographic survey and the earlier (November 2008) topographic survey, as shown in Appendix B – Map 1b, to identify areas of erosion and accretion.</p> <p>This generally shows a redistribution of sand from the lower to upper beach along most of the frontage between these dates.</p> | <p>The relatively high levels and moderately wide beach at the toe of the dunes and slag banks afford protection to the features against direct wave attack during storms. There generally was some redistribution of sand from the lower and mid beach to the upper.</p> <p>The beach contours along the disused industrial frontage in the centre of North Sands tend to indicate a slight seaward building of mid-beach sections, further protecting the backing slag banks.</p> <p>Further south, the upper beach is narrower, exposing the sea wall to marine conditions more frequently. Lower foreshore levels were also much lower during the most recent survey.</p> |

DIFFERENCE BETWEEN TOPOGRAPHIC SURVEYS
 Nov 2008 and Sept 2009

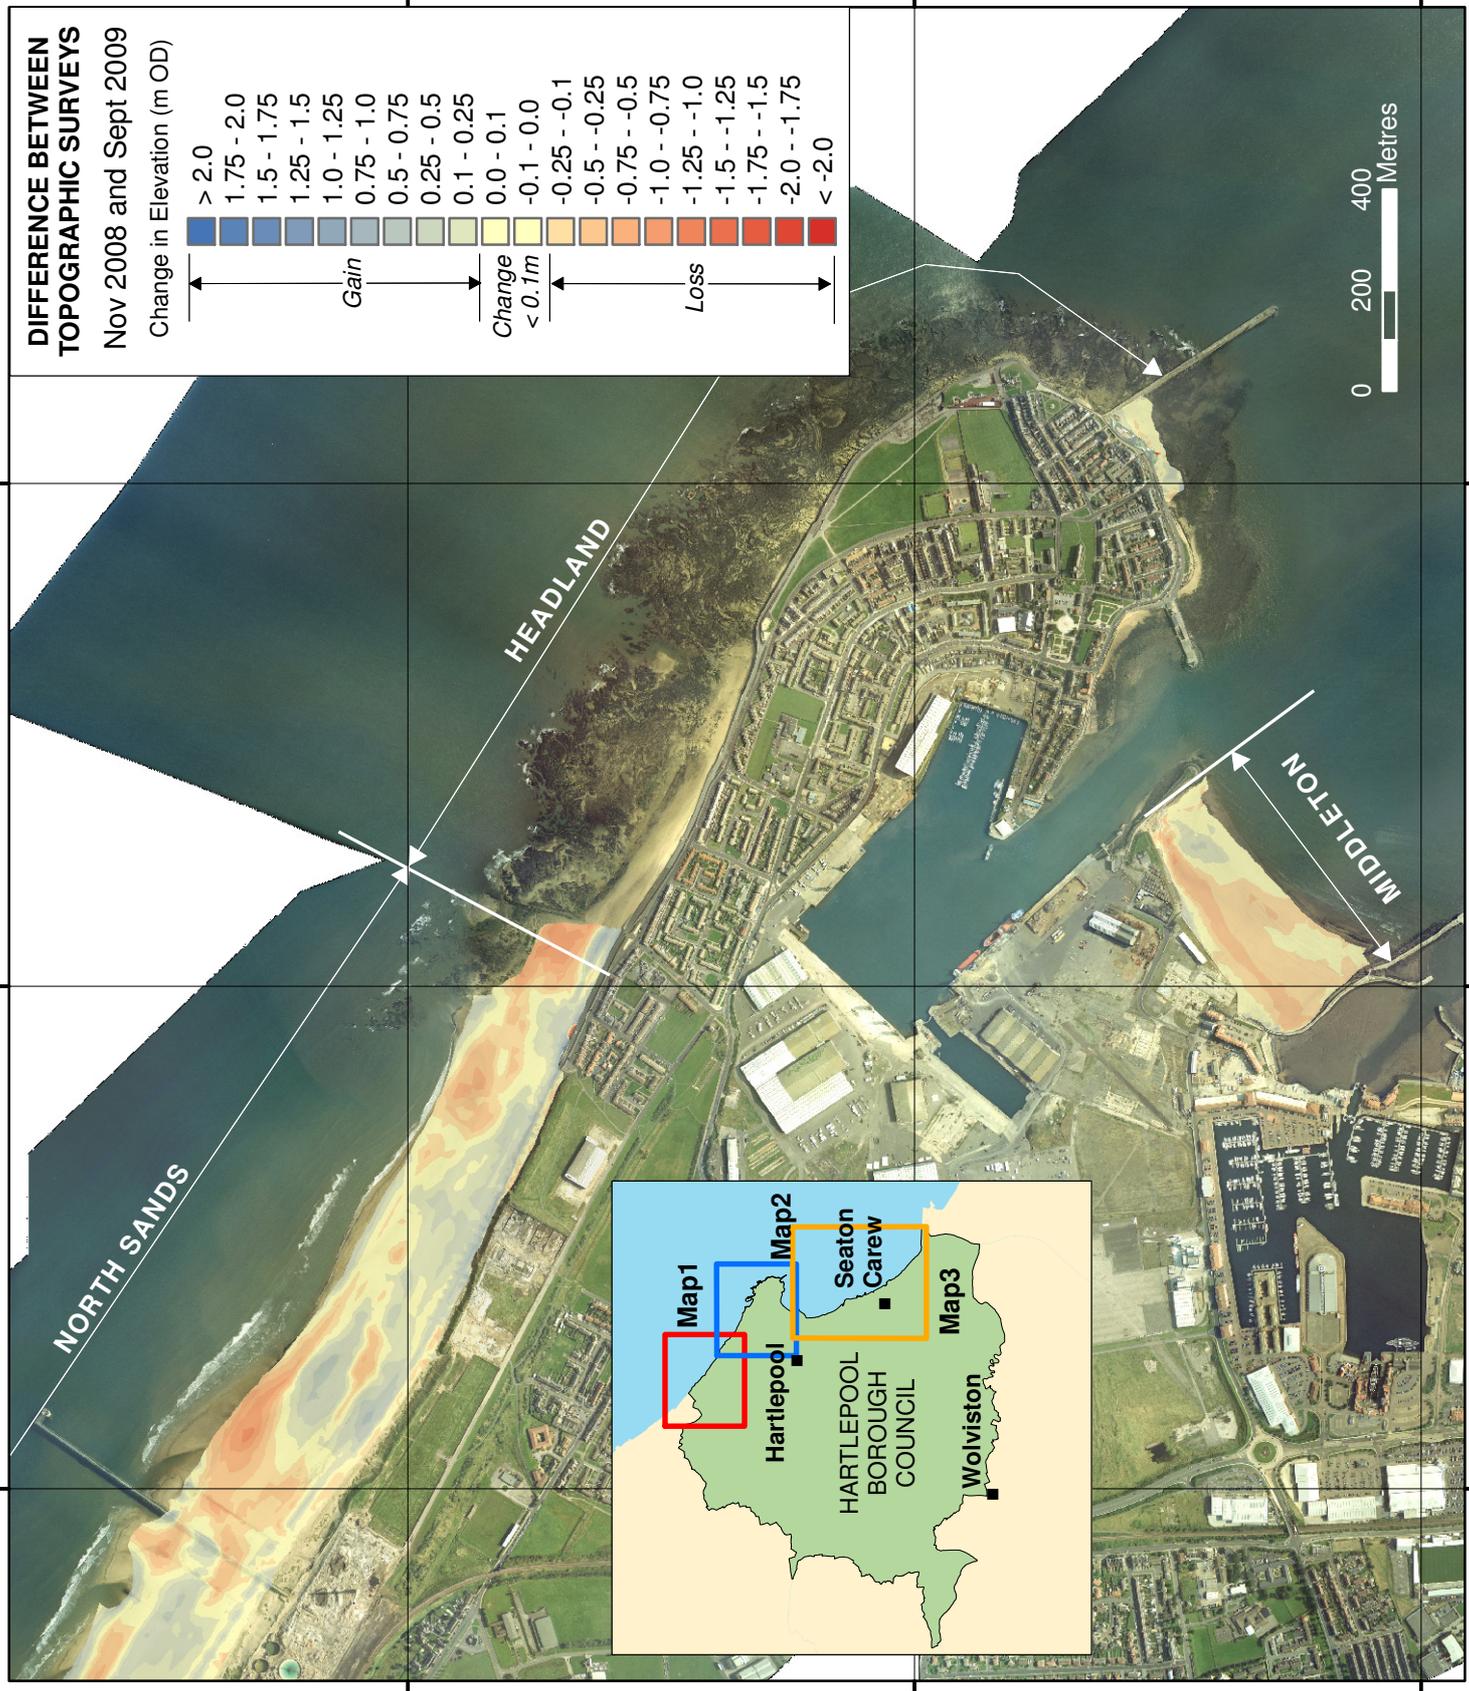
Appendix B - Map 2b
Hartlepool Borough
Council Frontage

| Survey Date | Description of Changes Since Last Survey | Interpretation |
|---|--|--|
| | <p>Topographic Survey:</p> <p>Middleton is covered by an annual topographic survey between Middleton Jetty and North Pier. Data from the 2009 Full Measures survey have been used to create a DGM (Appendix B – Map 2a) using a Geographic Information System (GIS) computer software package.</p> <p>The GIS has also been used to calculate the differences between the current topographic survey and the earlier (November 2008) topographic survey, as shown in Appendix B – Map 2b, to identify areas of erosion and accretion.</p> | |

DIFFERENCE BETWEEN TOPOGRAPHIC SURVEYS
Nov 2008 and Sept 2009

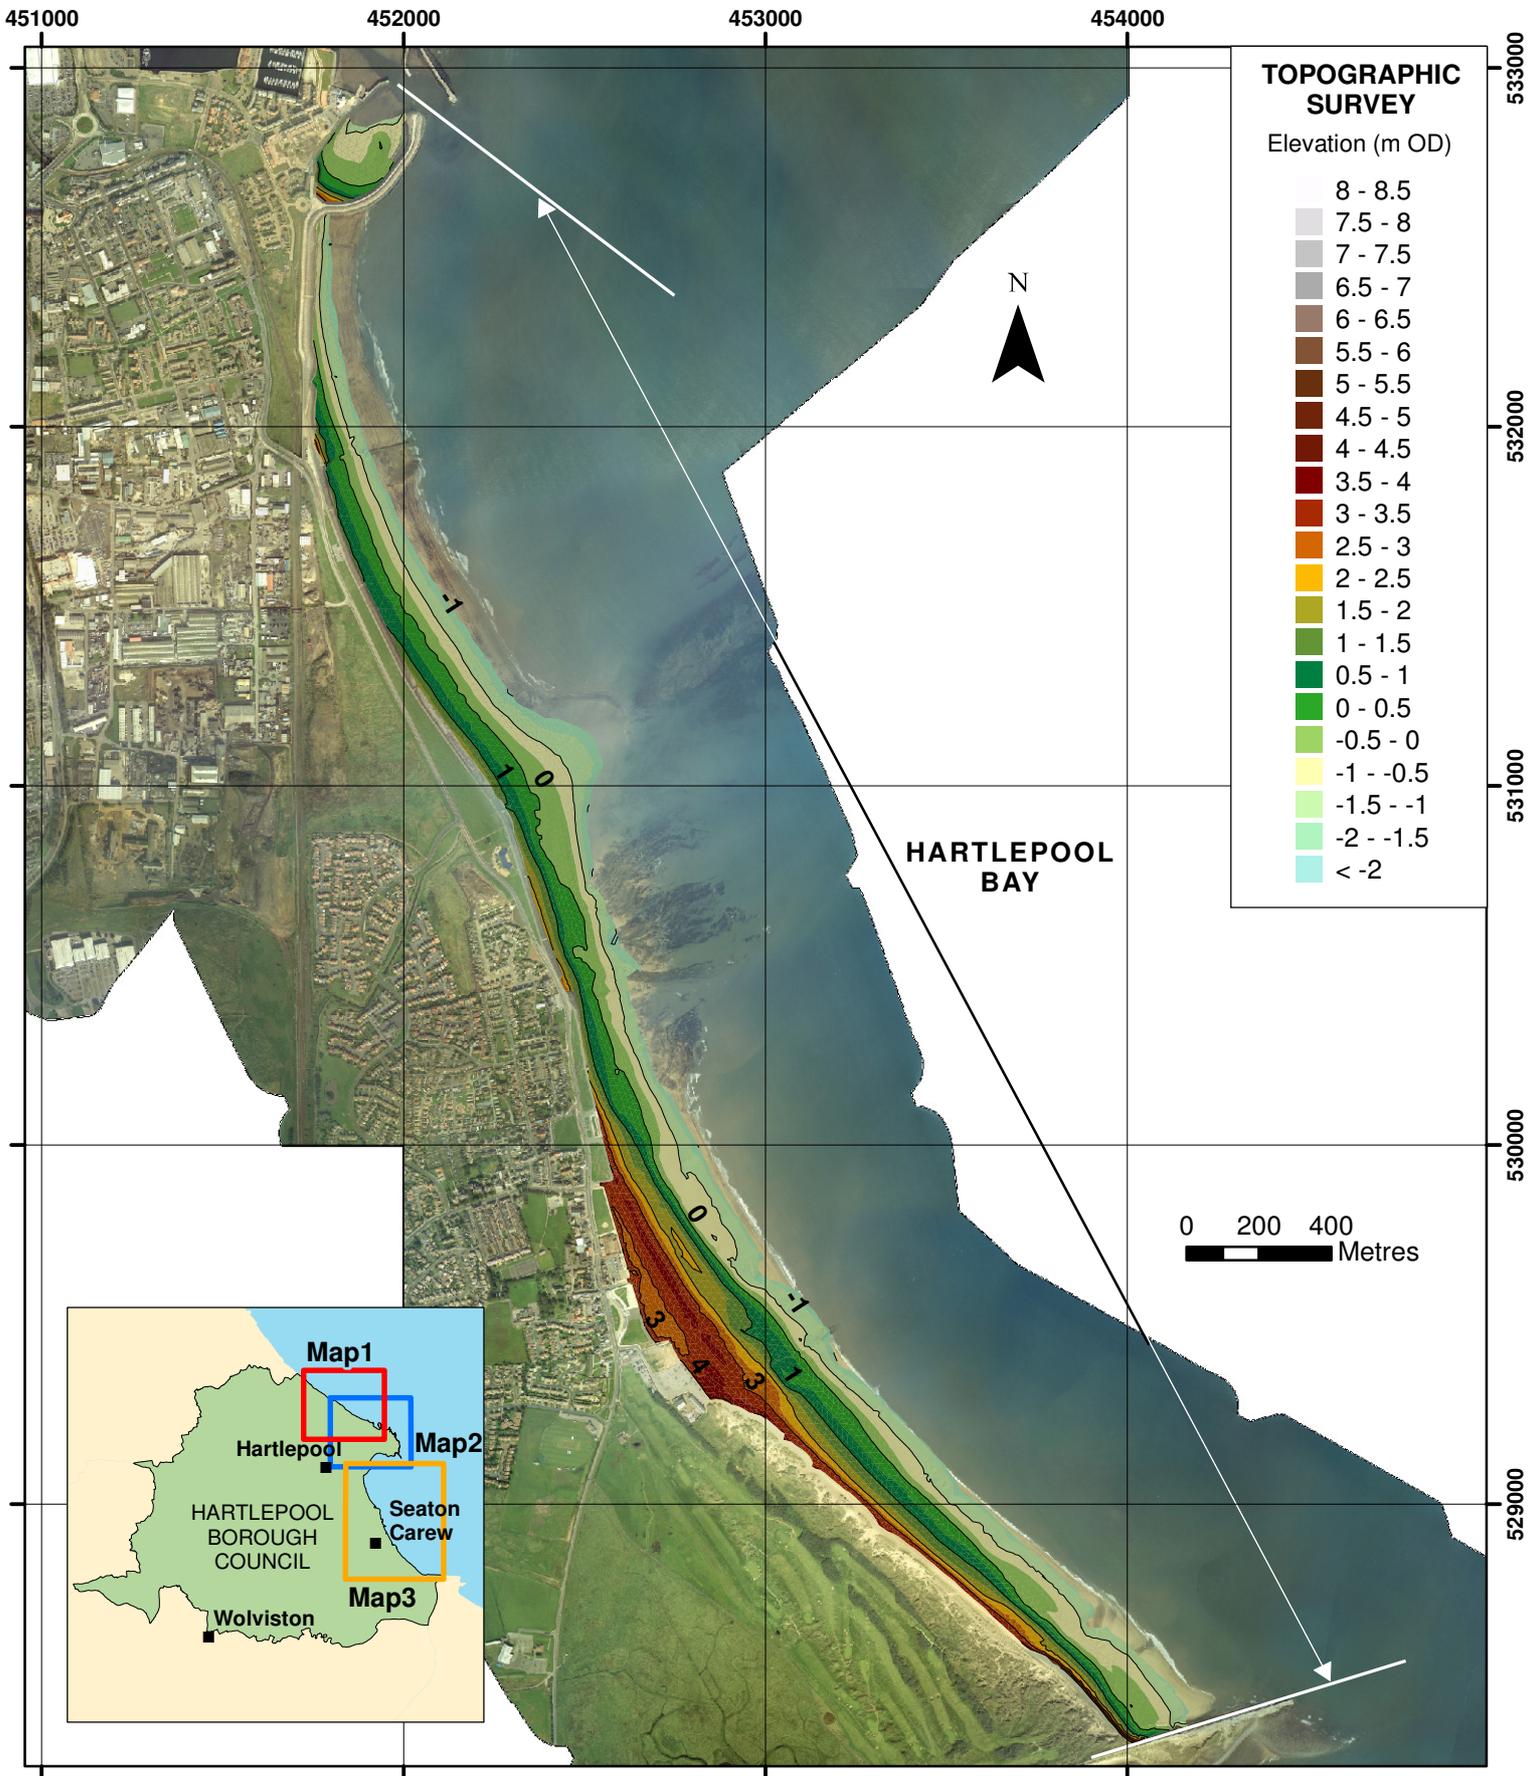
| Survey Date | Description of Changes Since Last Survey | Interpretation |
|---|---|--|
| | <p>Topographic Survey:</p> <p>Hartlepool Bay is covered by an annual topographic survey between the South Pier and the North Gare Breakwater.</p> <p>Data from the 2009 Full Measures survey have been used to create a DGM (Appendix B – Map 3a) using a Geographic Information System (GIS) computer software package. This shows how the beach in the north of the bay, near the marina, is much lower and narrow than elsewhere along the frontage. There is a recessed area towards the south of the bay which has infilled with sand.</p> <p>The GIS has also been used to calculate the differences between the current topographic survey and the earlier (March 2009) topographic survey, as shown in Appendix B – Map 3b, to identify areas of erosion and accretion. The beach, generally, has been remarkably stable since the earlier survey, with minor accretion along most of the frontage and only a small number of isolated patches of erosion.</p> | <p>Some notable beach lowering occurred between March 2009 and September 2009 at the very southern end of the bay, adjacent to the North Gare breakwater. This is an apparent reversal of the notable accretion that was recorded in this location between December 2008 (as part of the <i>Seaton Carew Strategy Study</i>), and March 2009.</p> |

TOPOGRAPHIC SURVEY
