**Cell 1 Regional Coastal Monitoring Programme  
Analytical Report 1: 'Full Measures' Survey 2011**

**Hartlepool Borough Council  
Final Report**

**October 2012**

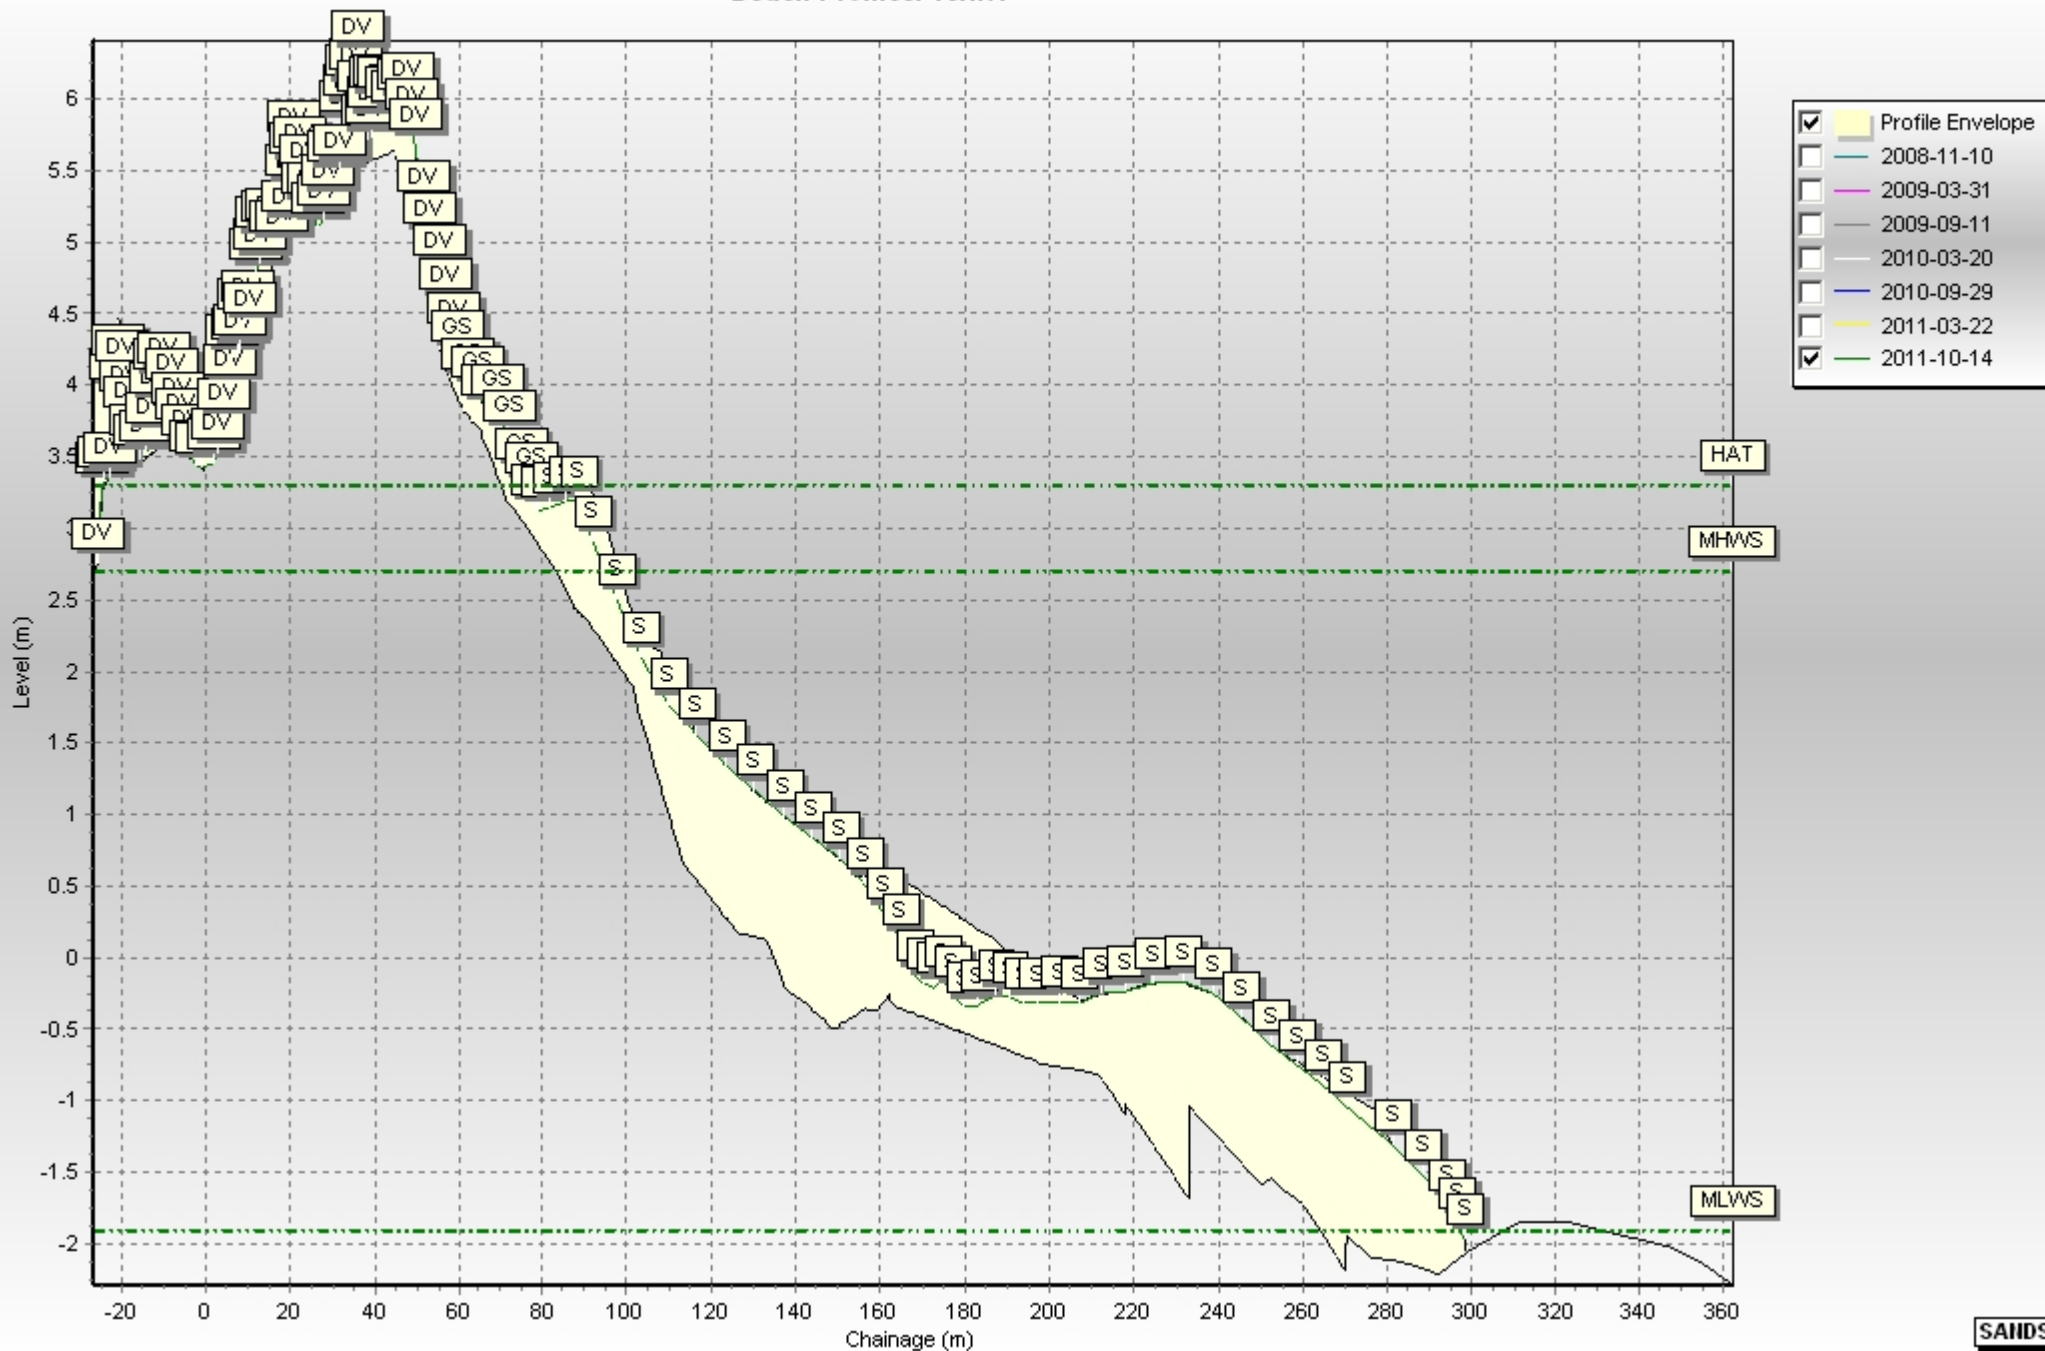
### Beach Profiles: 1cHN1

Survey Date	Description of Changes Since Last Survey	Interpretation
29 <sup>th</sup> Oct 2011	<p><b>Beach Profiles:</b></p> <p>North Sands is covered by four beach profile lines during the Full Measures survey (Appendix A).</p> <p>Profile <b>1cHN1</b> is located within Durham County Council's jurisdiction, about 400m north of the outfall of Crimdon Beck, but has been reported here so changes can be interpreted in association with those observed elsewhere along North Sands at HN2, HN3 and HN4. At <b>1cHN1</b> there is a large sand berm on the lower foreshore which is the most mobile feature on this section. The position of the berm has fluctuated since November 2008. The berm has moved seawards, since March 2011. The crest of the berm was at 180m chainage in March 2011 had moved 50m further down the foreshore October 2011. The crest of the berm is typically 0.3m above the surrounding beach level. The beach between the berm and MHWS has accreted.</p> <p>The lowering which previously occurred at the toe of the dunes along <b>1cHN2</b> during past surveys has been reversed in the October 2011 survey. The toe of the dunes has accreted by 1m since the erosion was at its worst on March 2010 and is comparable with the other post-summer surveys. The beach above MHWS has accreted by around 0.5m although there has been slight erosion (0.25m) below MHWS.</p> <p>Profile <b>1cHN3</b> has been stable above the level of HAT since 2008. Below HAT there is a 1.5m high lump in the profile. The lump is assumed to be the sand ridge at north end of beach, which was noted in the survey. It is unknown what process formed this accumulation of material. There appears to have been erosion of the foreshore beneath the berm (110m to 190m chainage) where the beach level has dropped by 0.5m over a width of 60m. It appears that the volume of the beach as a whole is similar between the Spring 2011 and Autumn 2011 surveys.</p> <p>At Profile <b>1cHN4</b> in the March 2011 survey there had been some erosion at the base of the defence, where the beach level has dropped by 0.3m. The trend foreshore lowering had reversed over the</p>	<p>The North Sands frontage has been characterised by seasonal changes again in 2011. The variability of beach berms and accretion at the toe of the dunes/defence in HN1, HN2 and HN4 is likely to be due to seasonal variations in forcing factors on this beach.</p> <p>Profile HN3 has been stable but it is difficult to interpret the mound on the foreshore, which could be man made.</p> <p>The topographic difference plot shows accretion overall, which agrees with the berms observed topographic survey. The differences in accretion and erosion recorded on the beach shows that the beach is steepening. This is very different from the behaviour observed in 2010 when there was notable lowering of the upper beach along its entire length, with the central section experiencing erosion across its whole inter-tidal zone.</p>

It should be noted that beach profile HN1 is located within Durham County Council's jurisdiction but has been reported here so changes can be interpreted in association with those observed elsewhere along North Sands, along HN2, HN3 and HN4. Construction works being carried out on the seawall at beach profile 1cHS3 meant the full survey could not be undertaken. The site will hopefully be accessible in future surveys.

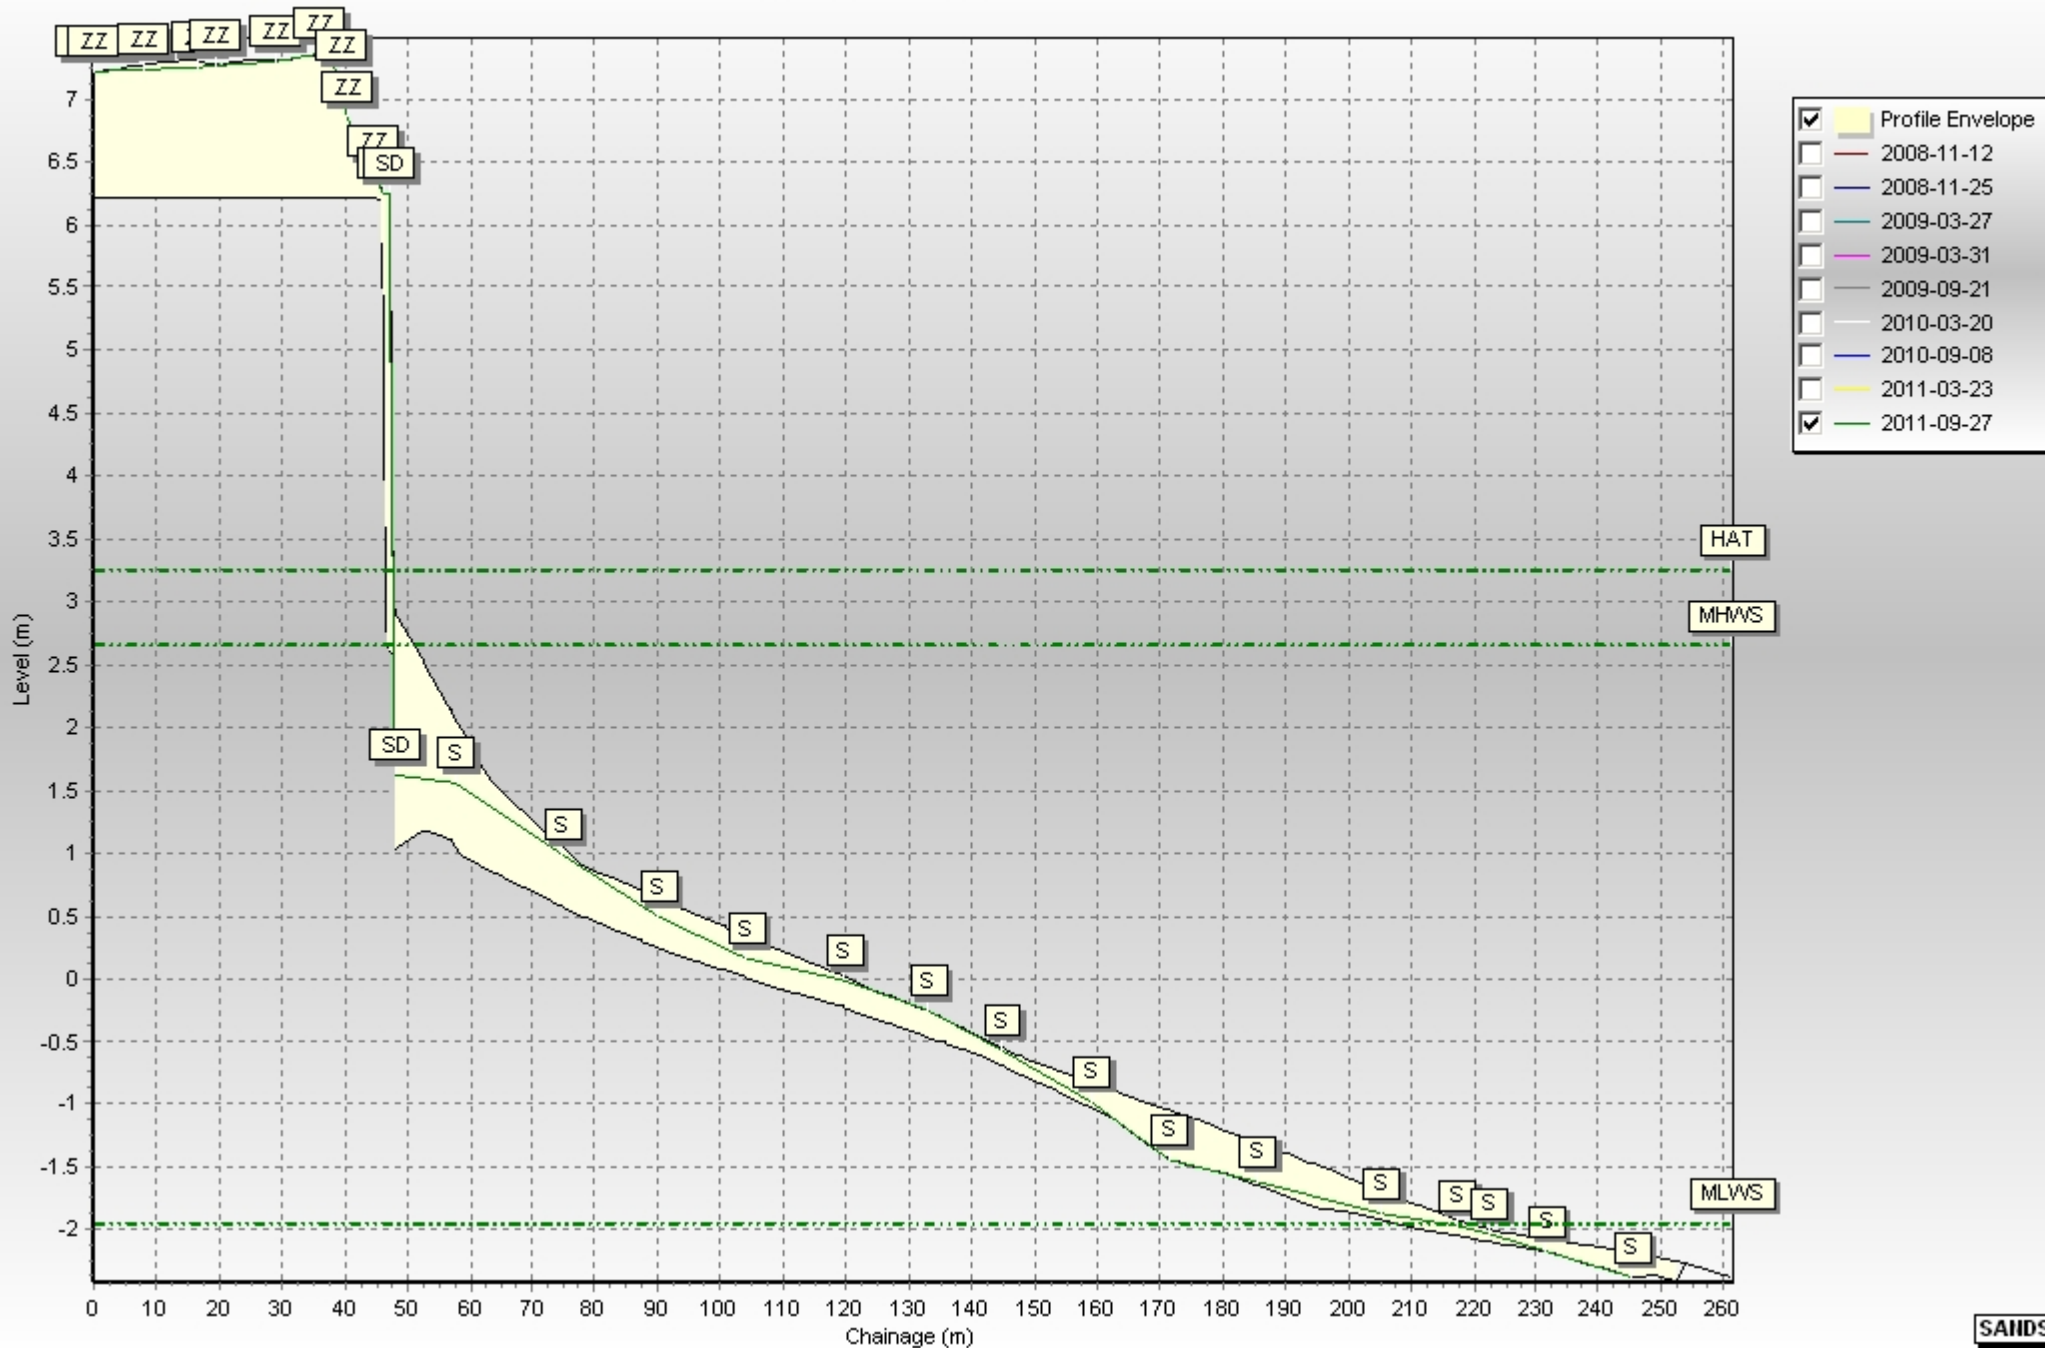
### Beach Profiles: 1cHC1

Survey Date	Description of Changes Since Last Survey	Interpretation
27 <sup>th</sup> Sept 2011	<p><b>Beach Profiles:</b></p> <p>Middleton is covered by one beach profile line during the Full Measures survey (Appendix A).</p> <p>Profile <b>1cHC1</b> experienced significant lowering of around 1.5m at the toe of the vertical sea wall between September 2009 and March 2011. Over the subsequent summer months this scour at the base of the sea wall appears to have abated and the profile has accreted by around 0.4m at the toe of the sea wall since by September 2011. The foreshore has also accreted and is at a high level compared to the previous surveys.</p>	<p>The changes along most of the beach profile are within the bounds of previously recorded change. In the previous 2 surveys, the levels directly at the toe of the wall were particularly low, being 1.9m lower than those recorded in September 2009. In the September 2011 survey this has recovered significantly and the recorded beach level adjacent to the wall is about 0.5m higher although still 1.3m lower than in 2009.</p>

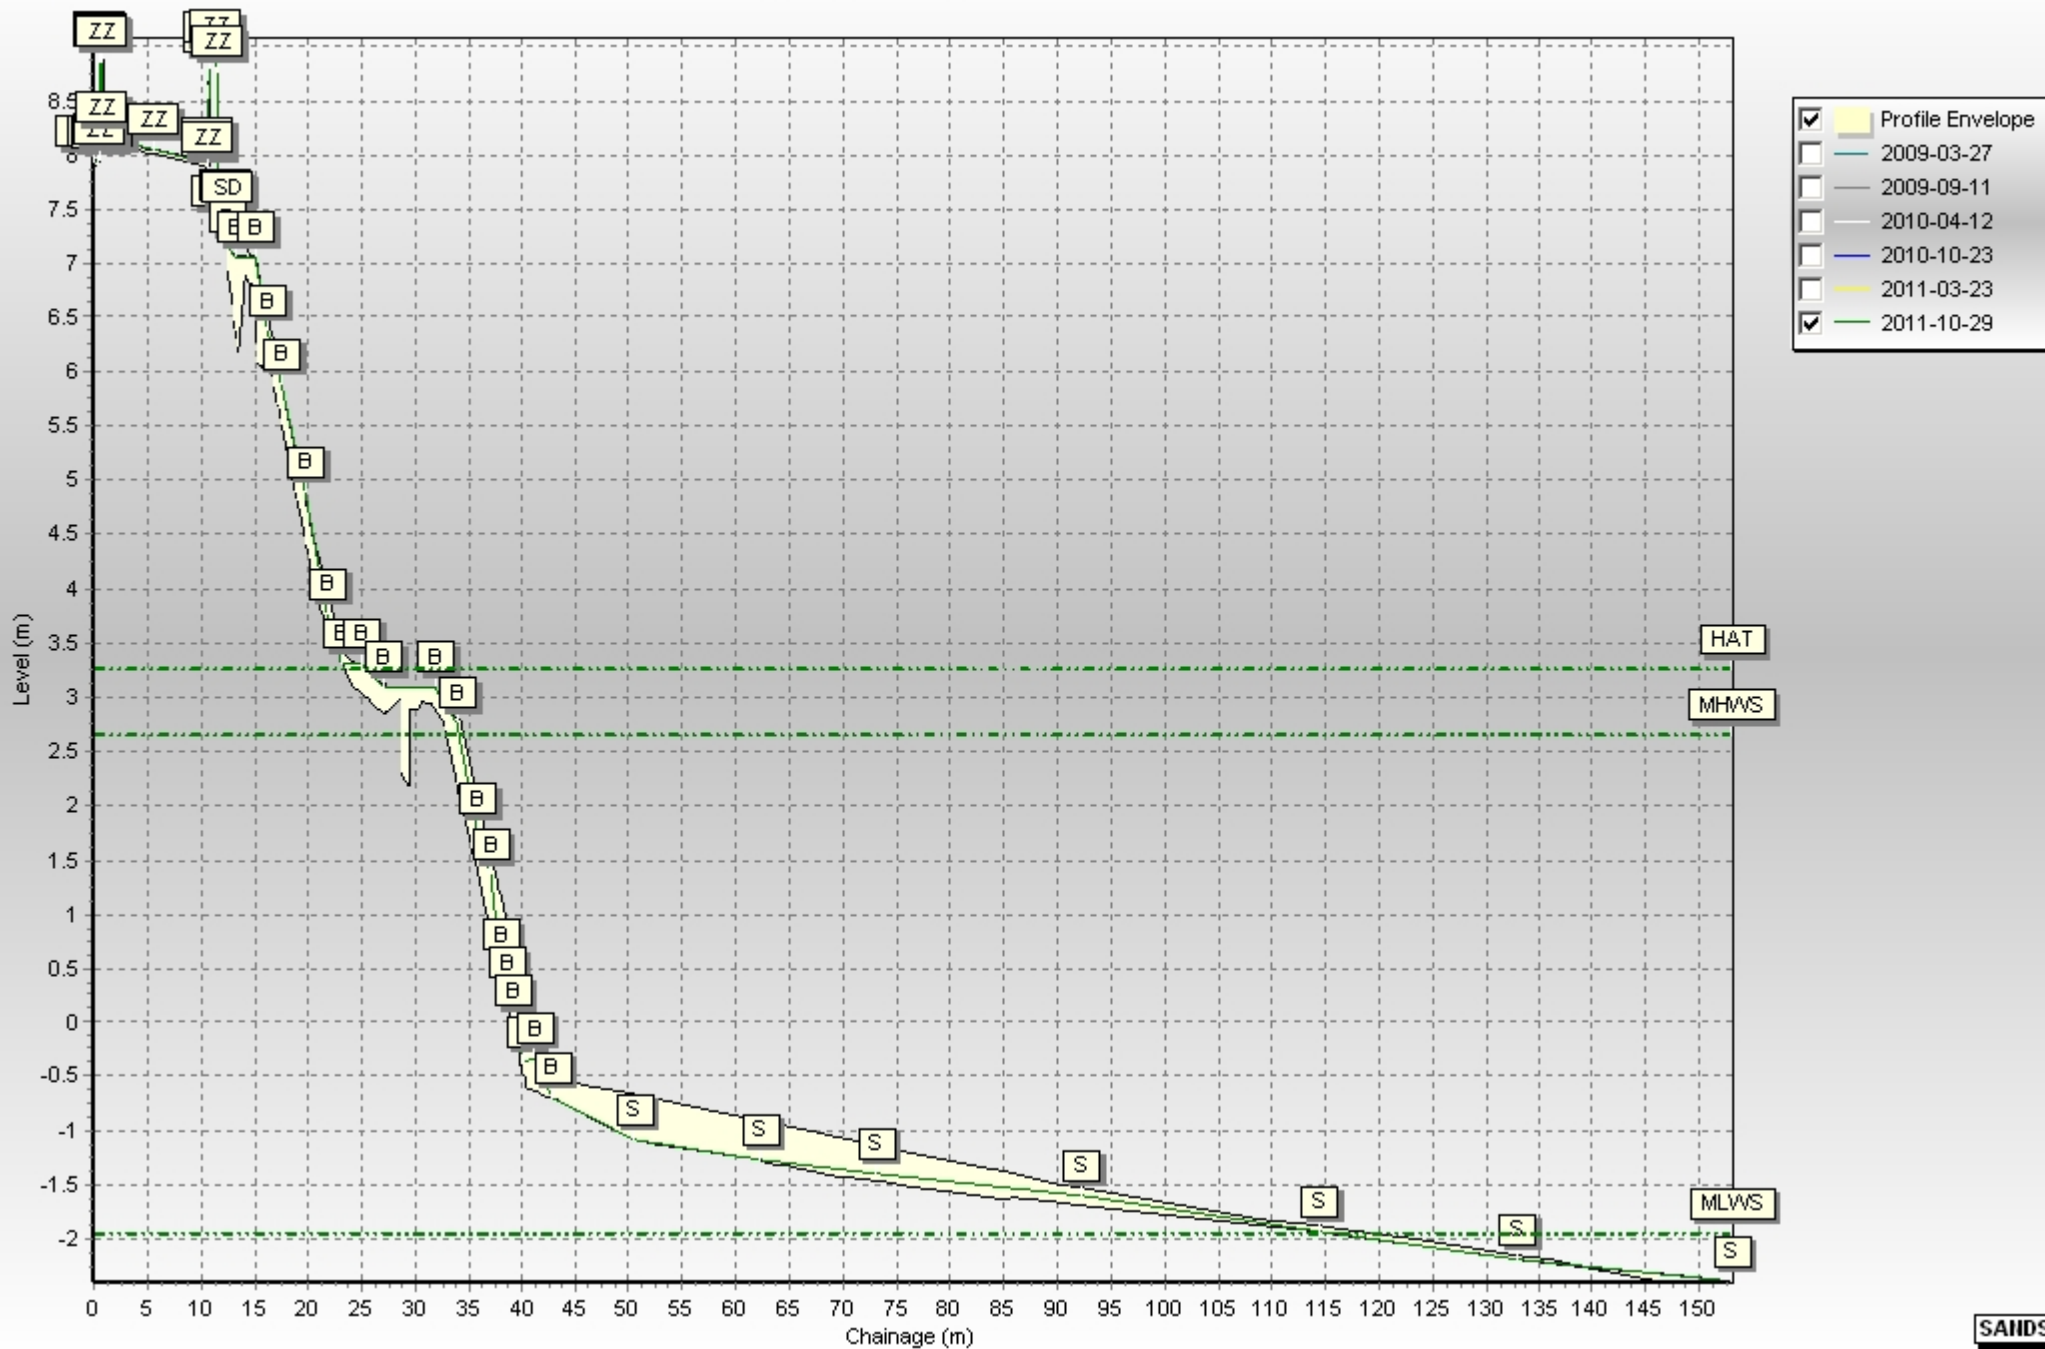
### Beach Profiles: 1cHS1

Survey Date	Description of Changes Since Last Survey	Interpretation
29 <sup>th</sup> Oct 2011	<p><b>Beach Profiles:</b></p> <p>Hartlepool Bay is covered by four beach profile lines during the Full Measures survey (Appendix A).</p> <p>Profile <b>1cHS1</b> is located approximately 150m south of the root of the South Pier. The profile starts at the wall to the rear of the promenade and extends across the promenade, over the fronting concrete splash wall and down the sloping face of the rock armour revetment before reaching the beach. It then gently slopes down to low water. The profile experienced lowering at the toe of the defence and throughout the rest of the beach of up to 0.4m.</p> <p>Profile <b>1cHS2</b> has been largely stable along its length since March 2011. Overall the beach level on this profile was high compared to the profiles carried out since March 2009.</p> <p>At profile <b>1cHS3</b> there were construction works being carried out on the seawall and the survey could not be carried out at this location.</p> <p>The profile <b>1cHS4</b> is located further south, around 1km north of the North Gare breakwater. It is in the area of undefended dunes at Seaton Sands. The profile covers approximately 350m of dunes before reaching the open coast. The Dune section looks reasonably stable. The beach beyond 325m chainage has accreted by 0.25m with modest erosion (a loss of around 0.1m) occurring since March 2011 from 375m chainage onwards. The level of this frontage is high compared to profiles carried out since March 2009.</p> <p><b>Topographic Survey:</b></p> <p>Hartlepool Bay is covered by an annual topographic survey between the South Pier and the North Gare Breakwater. Data from the 2009 Full Measures survey have been used to create a DGM (Appendix B – Map 3a) using a Geographic Information System (GIS) computer software package. The plot shows the two smaller bays within the log-form Hartlepool Bay. There is a slight headland or promontory in the shoreline plan form at Carr House Sands in the lee of Long Scar rocks between Hartlepool and Seaton Carew. For the rest of the bay the contours run shore parallel, meaning that there is a gently shelving</p>	<p>There has been some beach lowering at HS1, the erosion has been concentrated at the toe of the defence.</p> <p>Both HS2 and HS4 have shown relative stability, although both profiles are high compared to previous surveys. HS3 could not be fully surveyed.</p> <p>The topographic change plots show that during 2011 the north and south parts of the bay accreted overall with the dividing promontory showing erosion. The Seaton Carew frontage has been subject to more erosion than in the north, especially on the upper third of the beach. There has also been erosion on the lower part of the beach at Seaton Sands, close to the North Gare Breakwater. Erosion was recorded here during 2010 and it is possible the beach is getting steeper.</p>

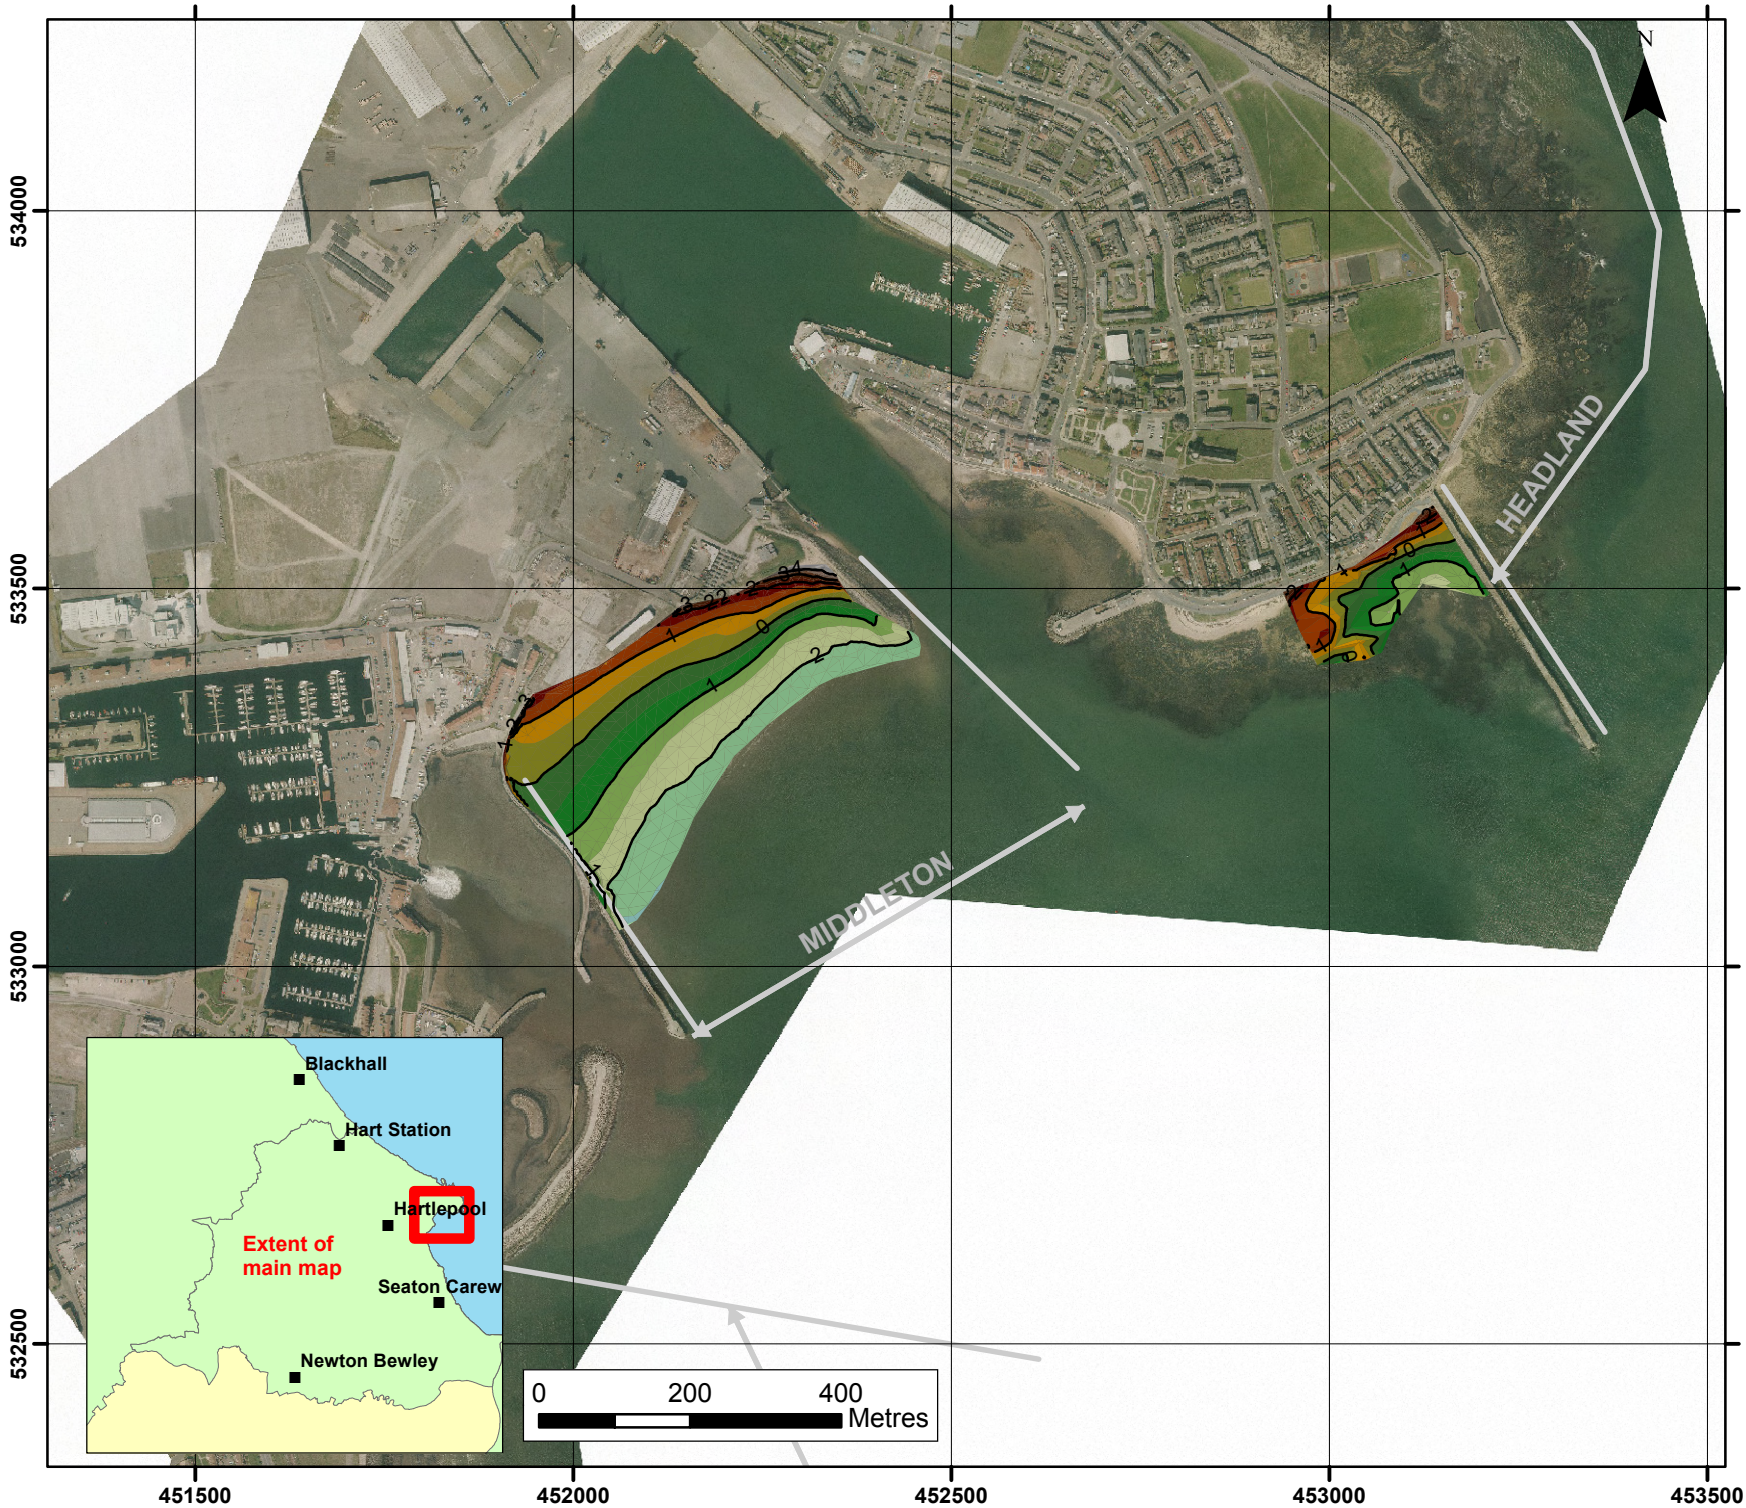
**Appendix B- Map 2a  
Topographic Survey  
Headland and Middleton  
Hartlepool Borough  
Council**

<p><b>Topographic Survey:</b></p> <p>Middleton is covered by an annual topographic survey between Middleton Jetty and North Pier. Data from the 2011 Full Measures survey have been used to create a DGM (Appendix B – Map 2a) using a Geographic Information System (GIS) computer software package. The beach contours recorded in September 2011 show a difference in the steepness of the beach at each end of the frontage. The beach closest to the harbour breakwaters is steep with an almost concave pattern of contours. At the western part of the beach has a much shallower slope. There do not appear to be any berms on the beach. These observations are very similar to those reported in the 2010 Full Measures Report.</p> <p>The GIS has also been used to calculate the differences between the Winter 2010 and Winter 2011 topographic survey, as shown in Appendix B – Map 2b, to identify areas of erosion and accretion. Over 2011, on the eastern side, the beach has eroded by 1m close to the harbour breakwaters. On the western side and at the very top of the beach for the whole frontage there was accretion of around 0.5m over 2011. This means that the difference in beach slopes on each side of the Middleton Section has continued to develop since 2010.</p>	<p>The beach has an observed increase in steepness as you move east. This change was also apparent in the 2010 Full Measures plots. The prevailing processes in 2011 have acted to exacerbate the difference in beach levels with erosion on the steepest part close to the harbour wall. On the western side of the bay on the shallow slope accretion has occurred.</p> <p>It is likely that the eastern side of Middleton will come under greater pressure from coastal processes with more severe waves causing erosion. It will be interesting to see how this develops through the coming years.</p>

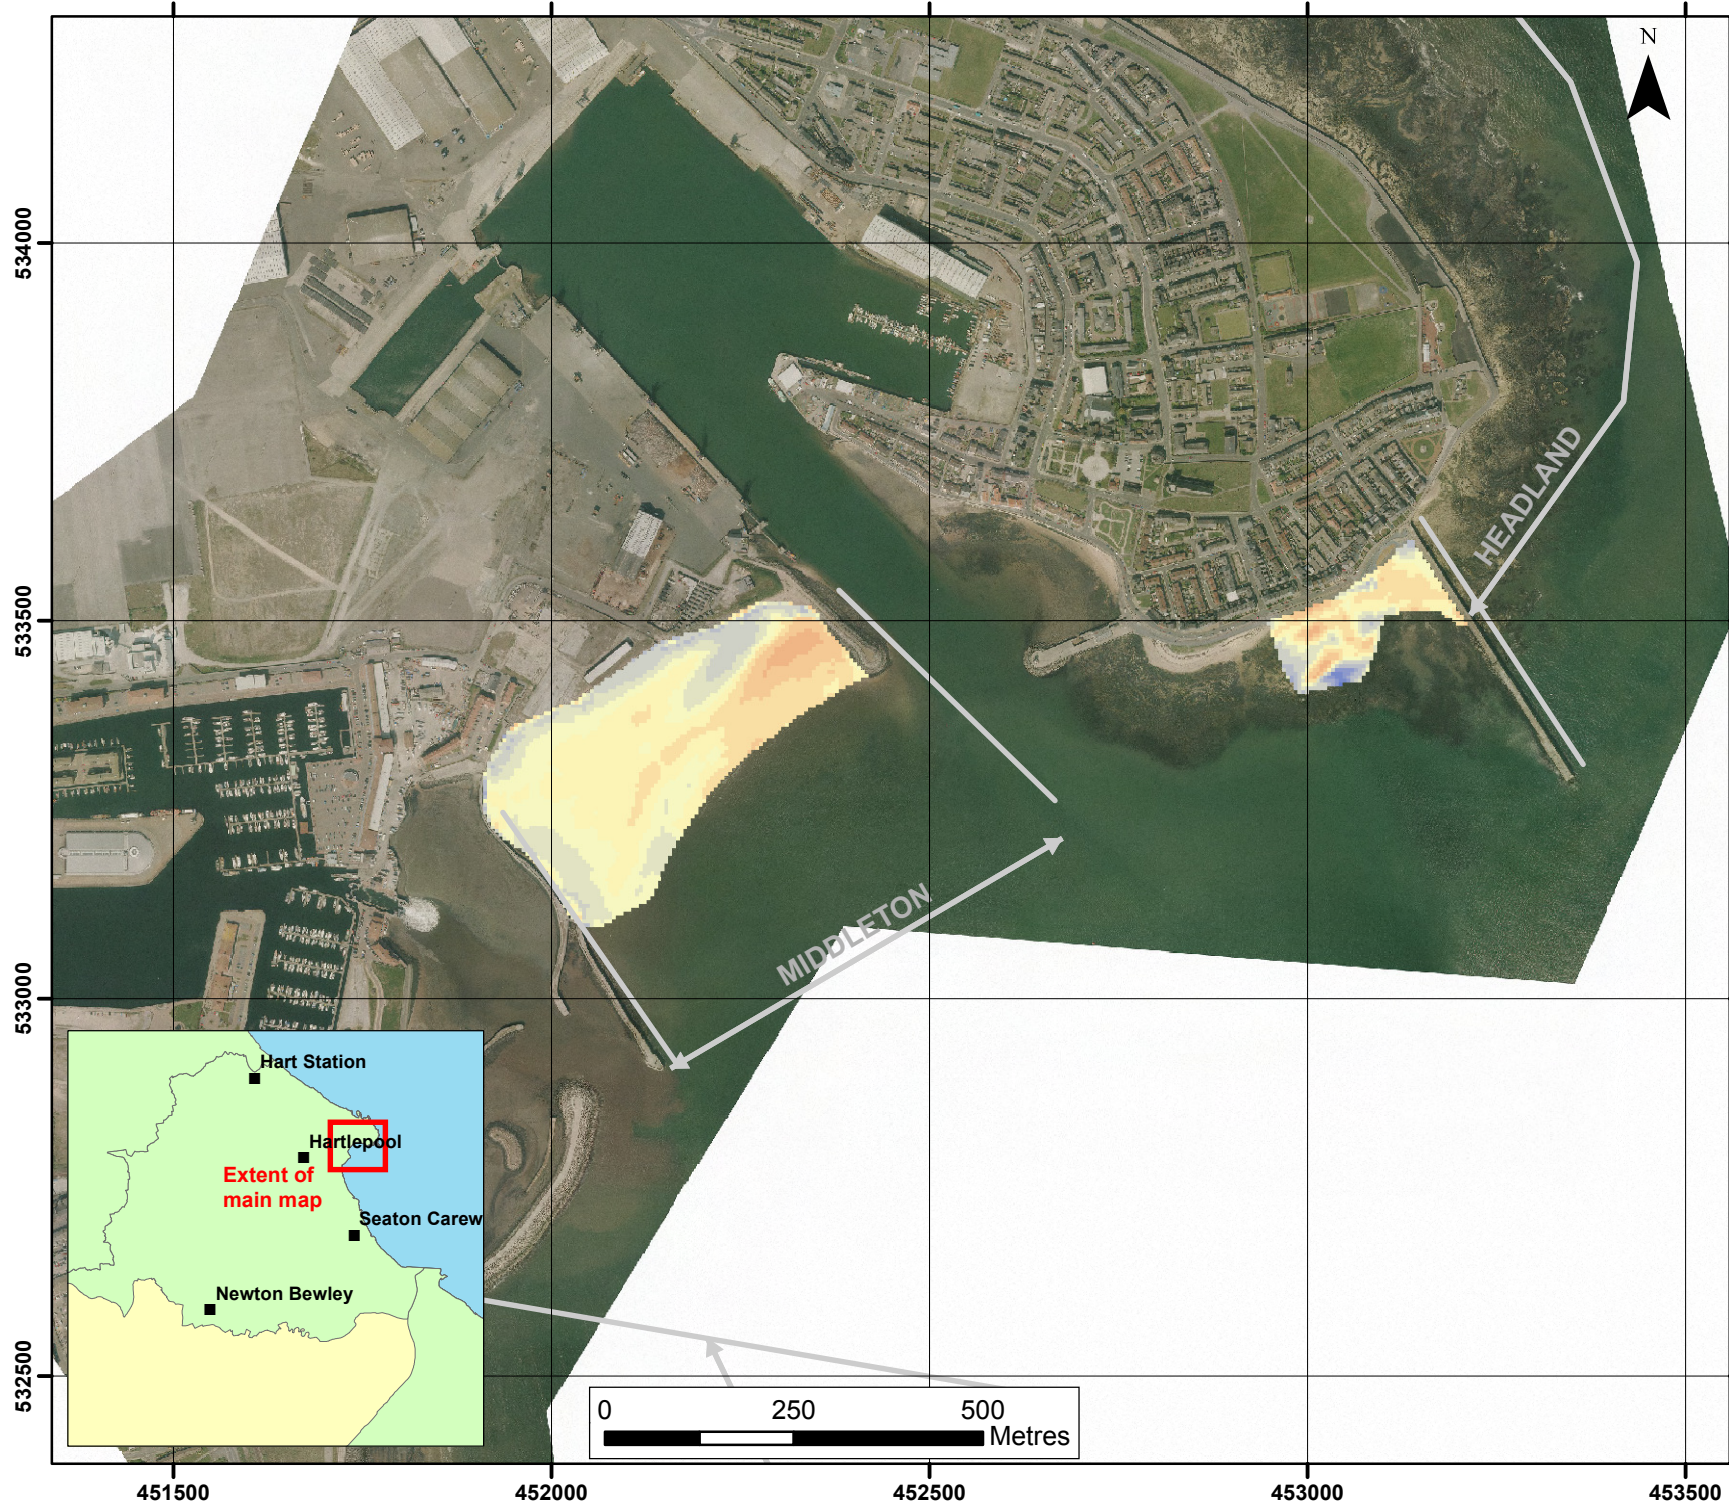
**Appendix B- Map 2b  
 Topographic Difference  
 Headland and Middleton  
 Hartlepool Borough  
 Council**

- At Middleton beach profiles show that there is large variability in the level of the beach on this frontage. In the previous survey, the levels directly at the toe of the wall are particularly low, being 1.9m lower than those recorded in September 2009. This has recovered and now the beach level adjacent to the wall is higher. The topographic change plots show that the beach has an observed increase in steepness as you move east. This change was also apparent in the 2010 Full Measures plots. The prevailing processes in 2011 have acted to exacerbate the difference in beach levels with erosion on the steepest part close to the harbour wall. On the western side of the bay on the shallow slope accretion has occurred.
