**Cell 1 Regional Coastal Monitoring Programme  
Update Report 1: 'Partial Measures' Survey 2009**

**Hartlepool Borough Council  
Final Report**

<sup>(\*)</sup> The present report is **Update Report 1** and provides an analysis of the 2009 Partial Measures survey for Hartlepool Borough Council's frontage. It is intended as a brief update of the key findings from this survey to maintain an understanding of ongoing changes.

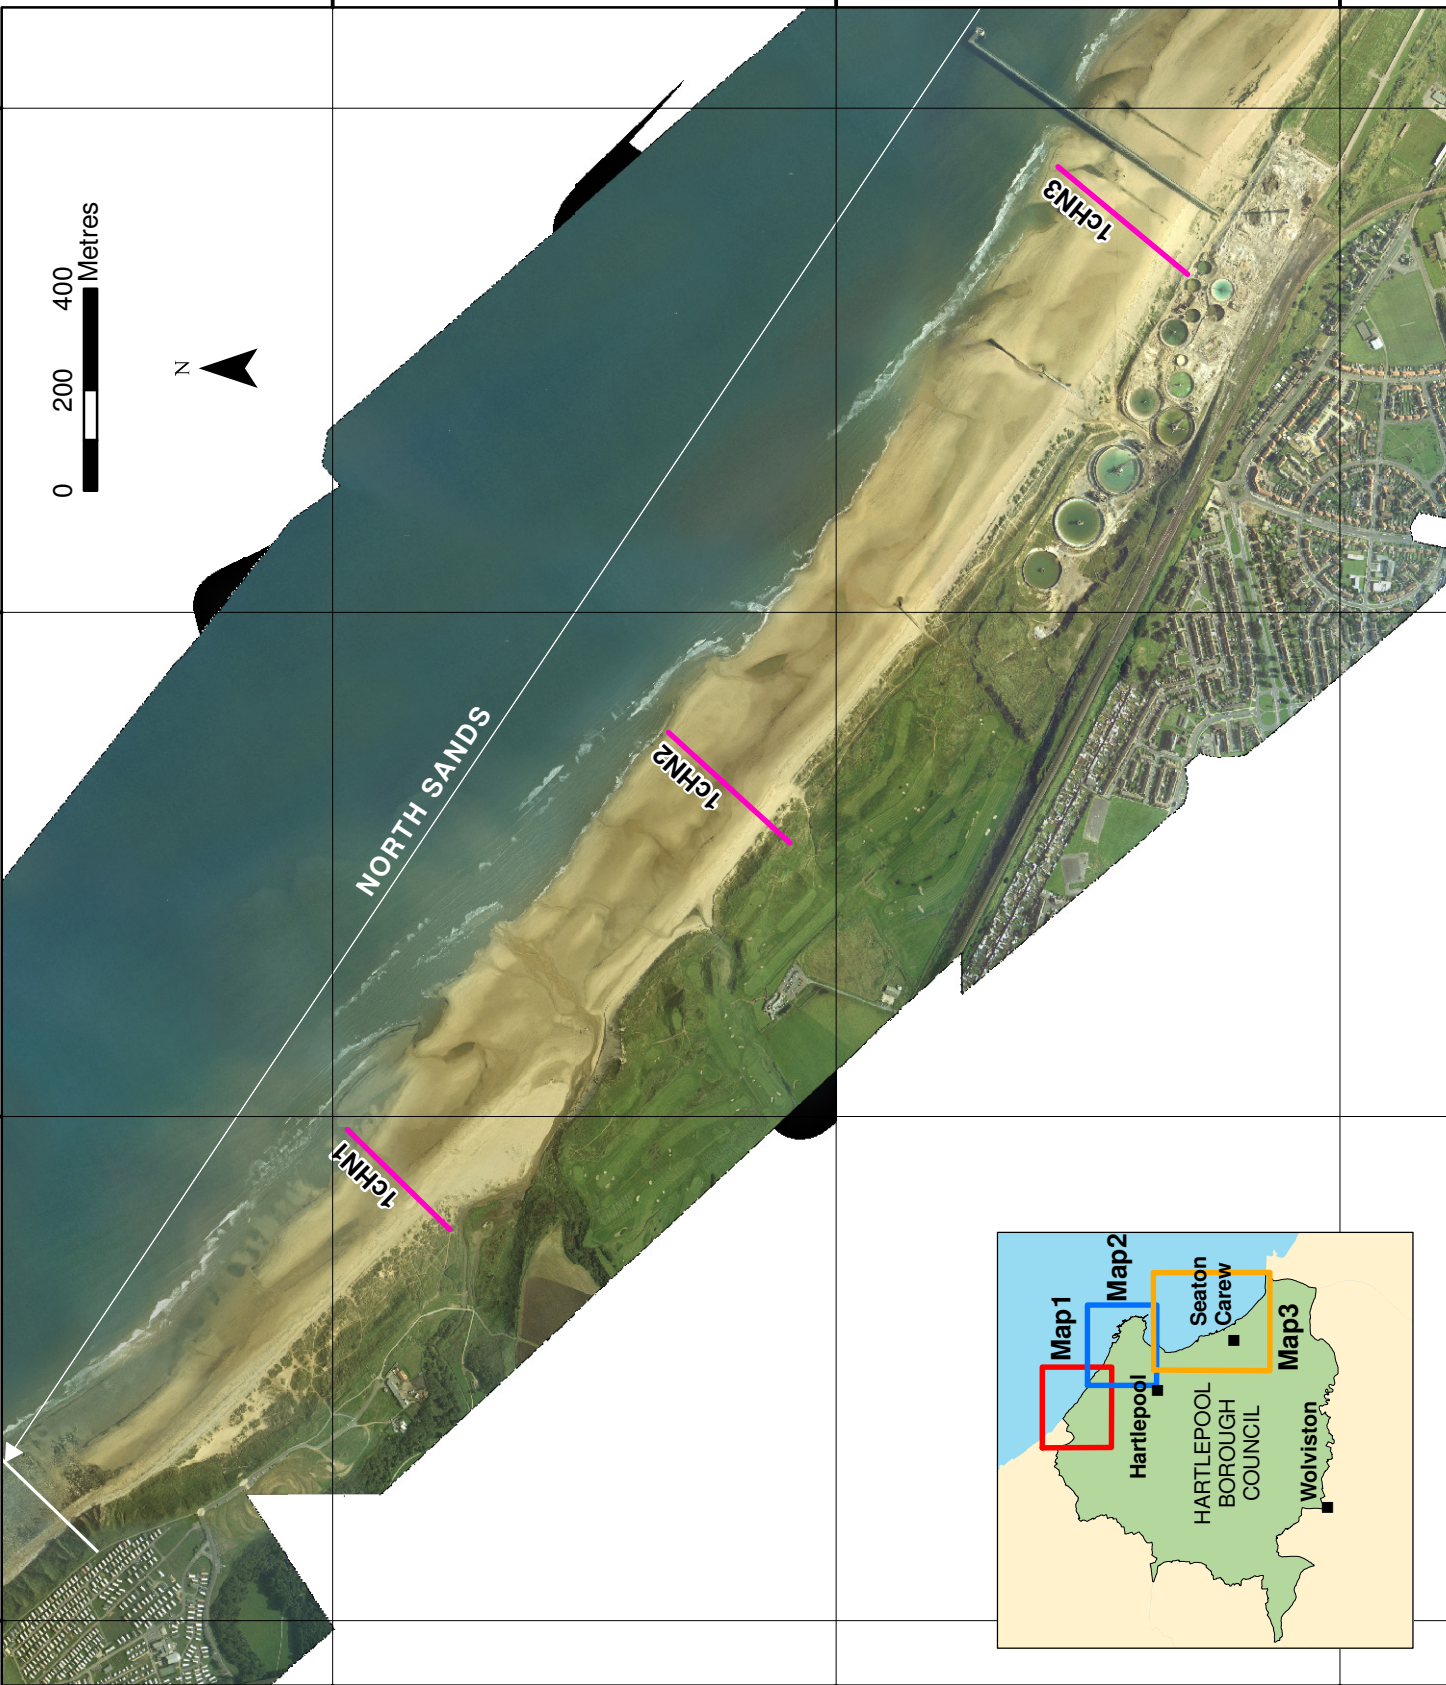
**Figure 1 - Map 1  
 Hartlepool Borough  
 Council Frontage**

**SURVEY LOCATIONS**

**Topographic Profiles**

- Annual
- Bi-Annual

**Topographic Surveys**

- 6 monthly
- yearly
- 5 yearly

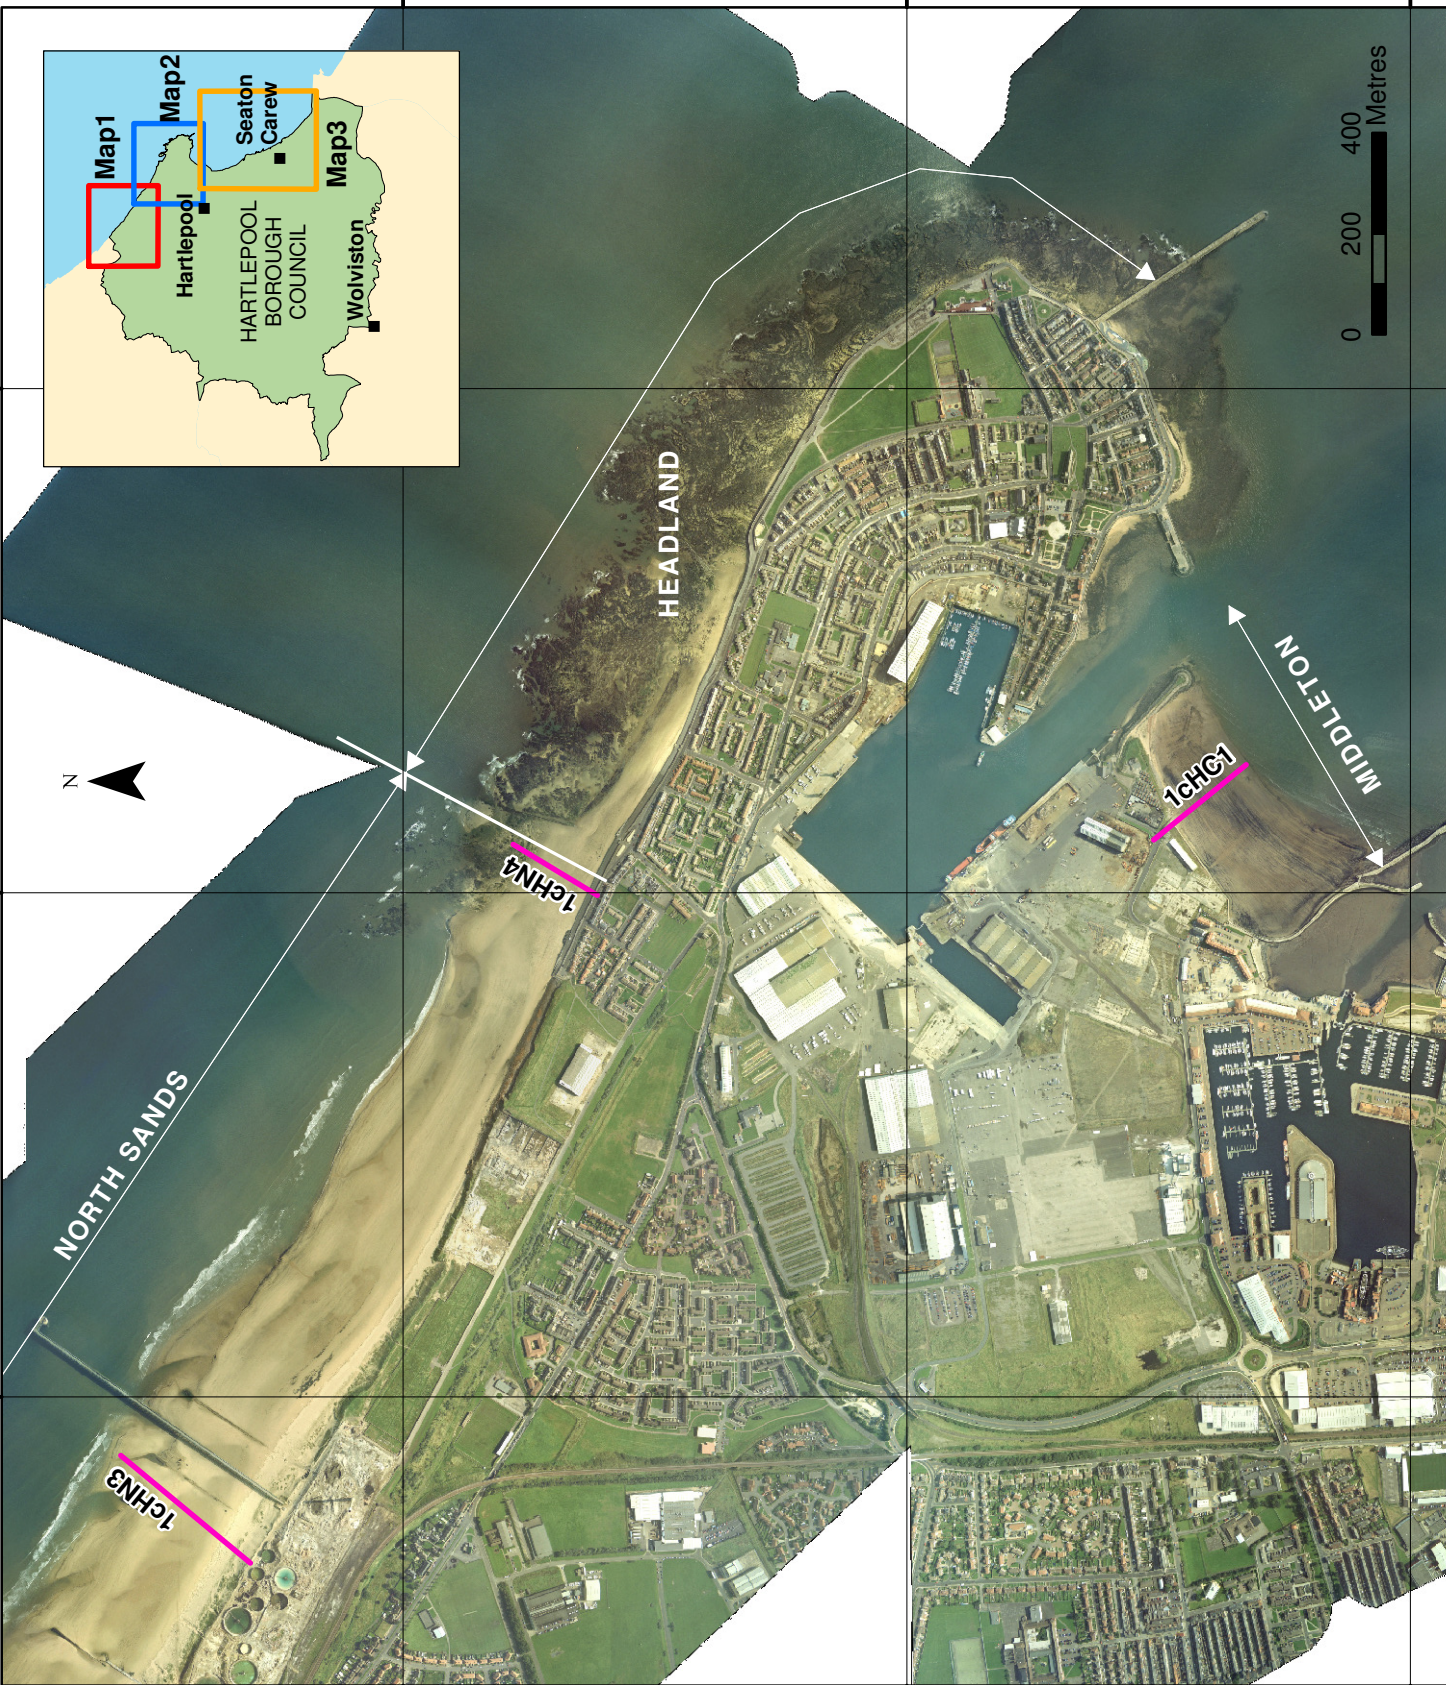
**Figure 1 - Map 2  
Hartlepool Borough  
Council Frontage**

**SURVEY LOCATIONS**

**Topographic Profiles**

- Annual
- Bi-Annual

**Topographic Surveys**

- 6 monthly
- yearly
- 5 yearly

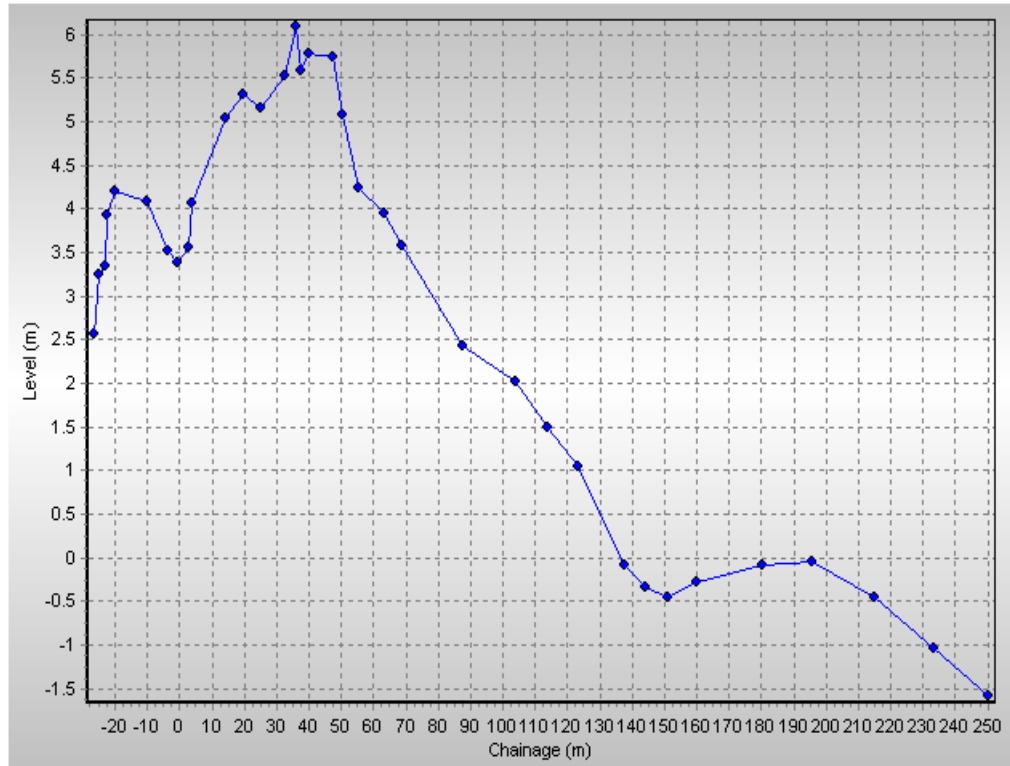
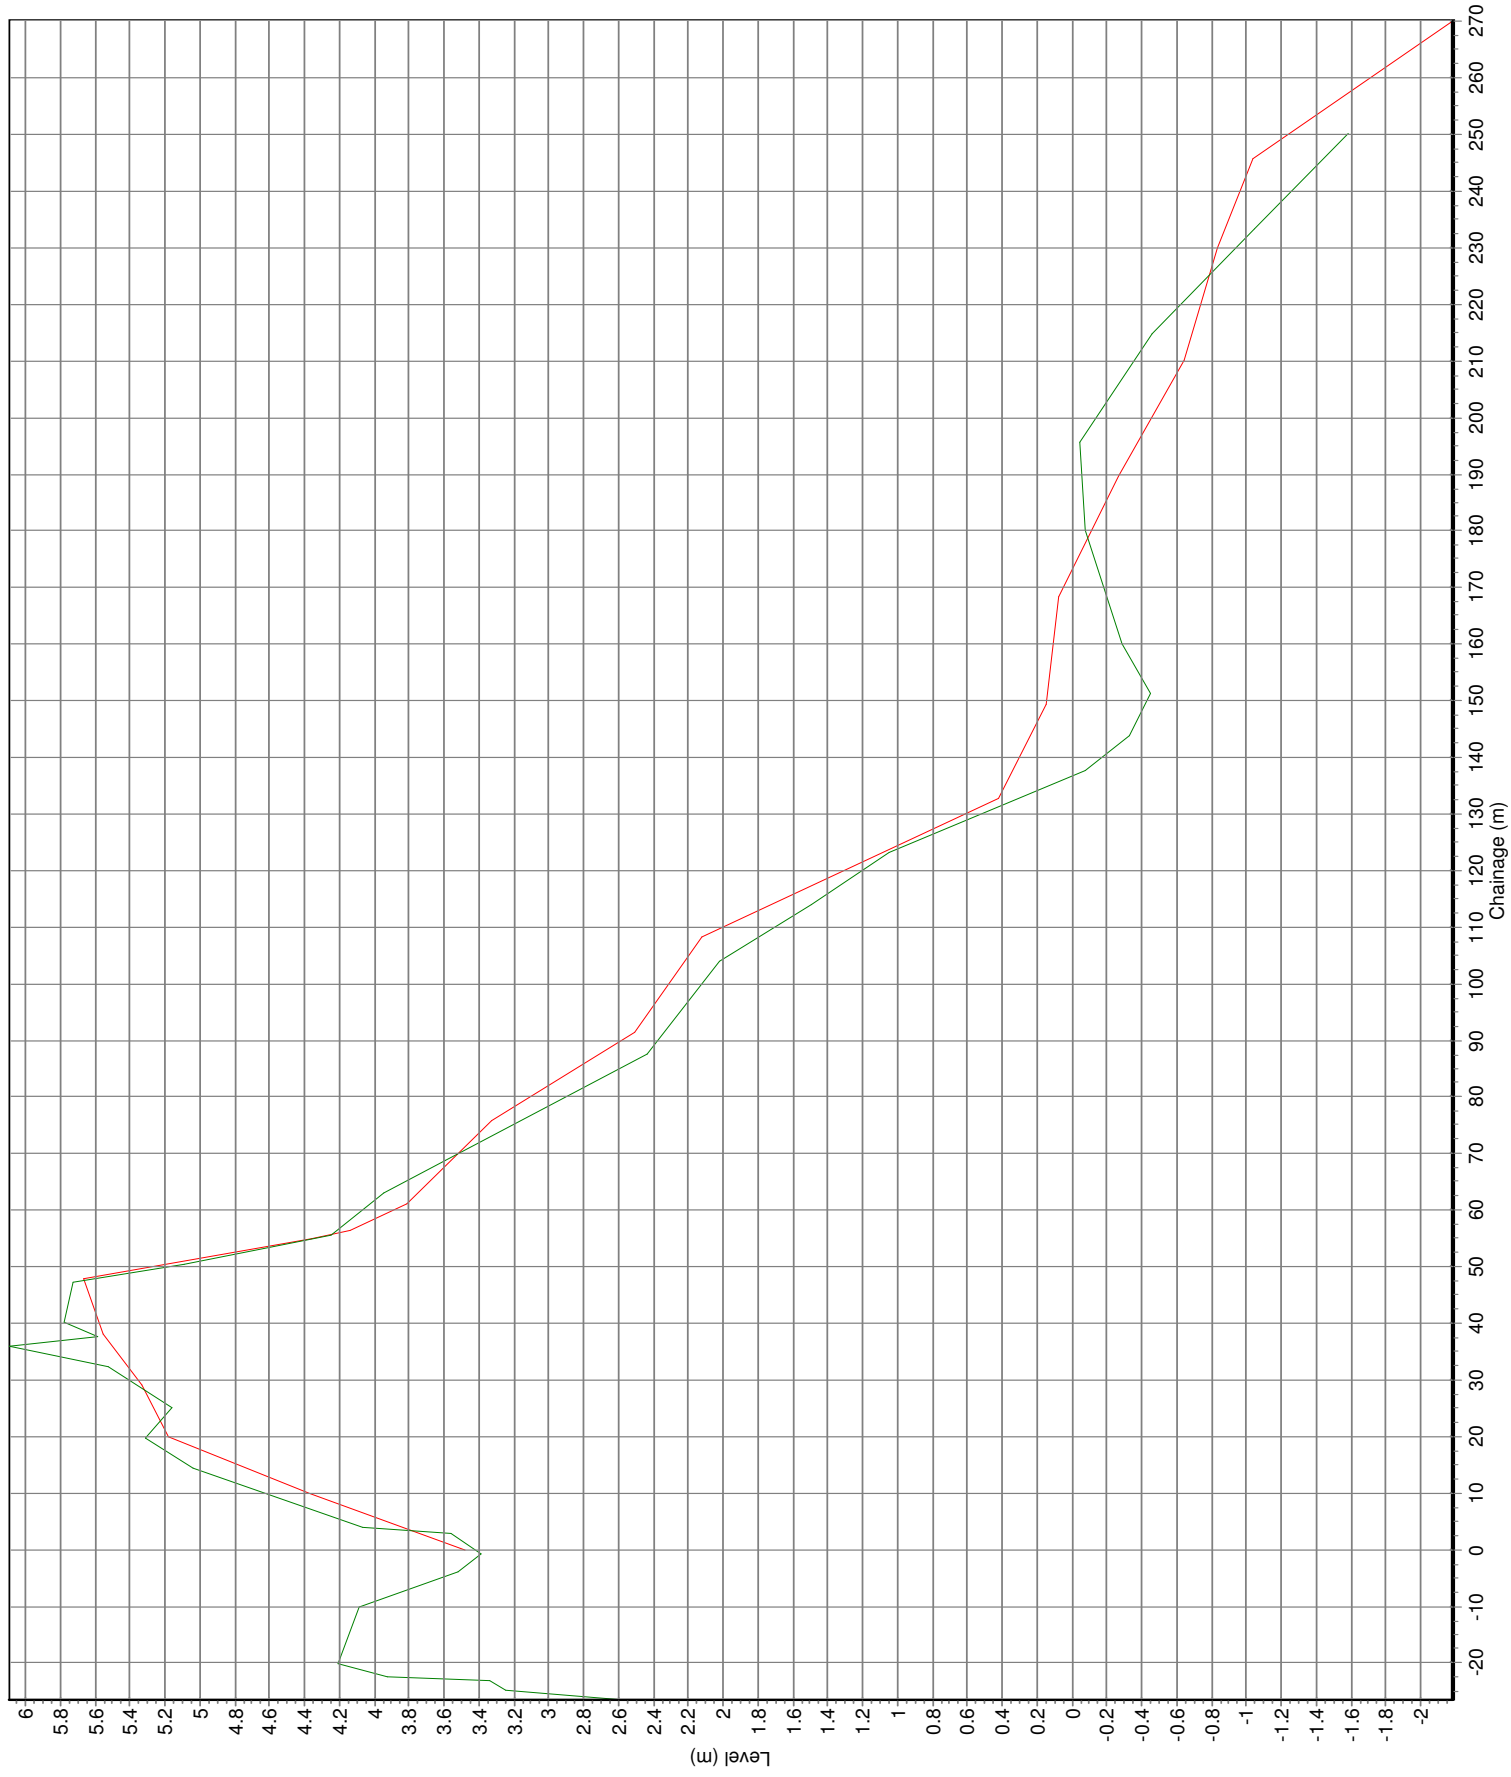
Beach Profiles: 1cHN1

Survey Date	Description of Changes Since Last Survey	Interpretation
03-2009	<p><b>Beach Profiles:</b></p> <p>North Sands is covered by four beach profile lines during the Partial Measures survey (Appendix A).</p> <p>Along HN1 the profile has lowered between a chainage of 70m and 180m, including a quite substantial lowering around 150m chainage of over 0.5m. However, accretion has occurred lower down the profile and at the toe of the dunes. Further accretion of blown sand has occurred on the dune crest and seaward face of the fronting dune ridge.</p> <p>HN2 experienced lowering along the entire profile length below HAT. At a chainage of around 200m this reached a maximum lowering of some 1.3m, but generally it was of the order of 0.5m. Above HAT there was very little change in the dune.</p> <p>The slag banks at the landward end of profile HN3 did not show any change, but the foreshore accreted slightly along its entire length seaward of MHWS. The maximum change was at a chainage of around 0.4m where the levels increased by around 0.4m</p> <p>HN4 showed a small amount of lowering directly at the toe of the sea wall and promenade, over a width of around 7m from the toe. Seaward of here, the profile experienced slight accretion to a chainage of around 65m. Thereafter, the profile lowered, resulting in rocky outcrops being exposed at a chainage of around 150m due to loss of sand coverage.</p>	<p>In general, profiles towards the north of North Sands experienced foreshore lowering along much (HN1) or all (HN2) of their length and areas further south, around HN3, experienced accretion. This may represent a modest longshore redistribution of sediment. In both cases, the backing dunes (in the north) and slag banks (further south) did not experience adverse change and in places there was modest accretion of blown sand.</p> <p>Further south still, along HN4, beach levels lowered to the extent that rock outcrops were exposed on the lower profile. Here, levels also lowered slightly at the toe of the sea wall and promenade.</p>

- There was some foreshore lowering observed along the northern section of North Sands, although the backing dunes were unaffected and in places experienced modest accretion of wind blown sand.

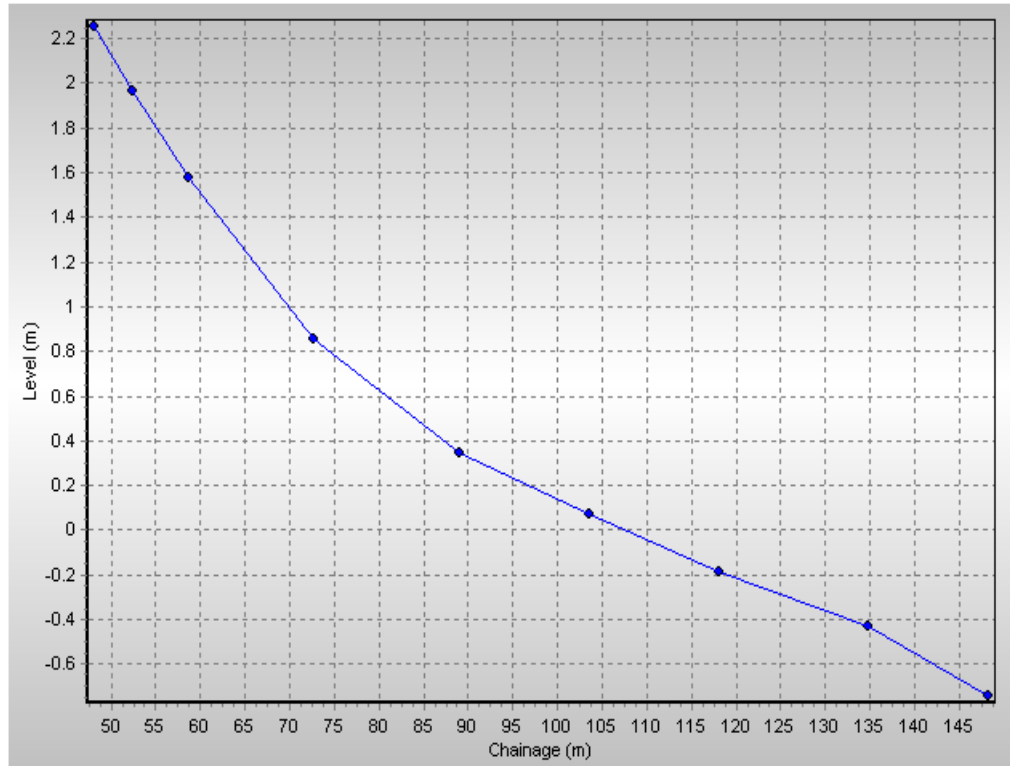
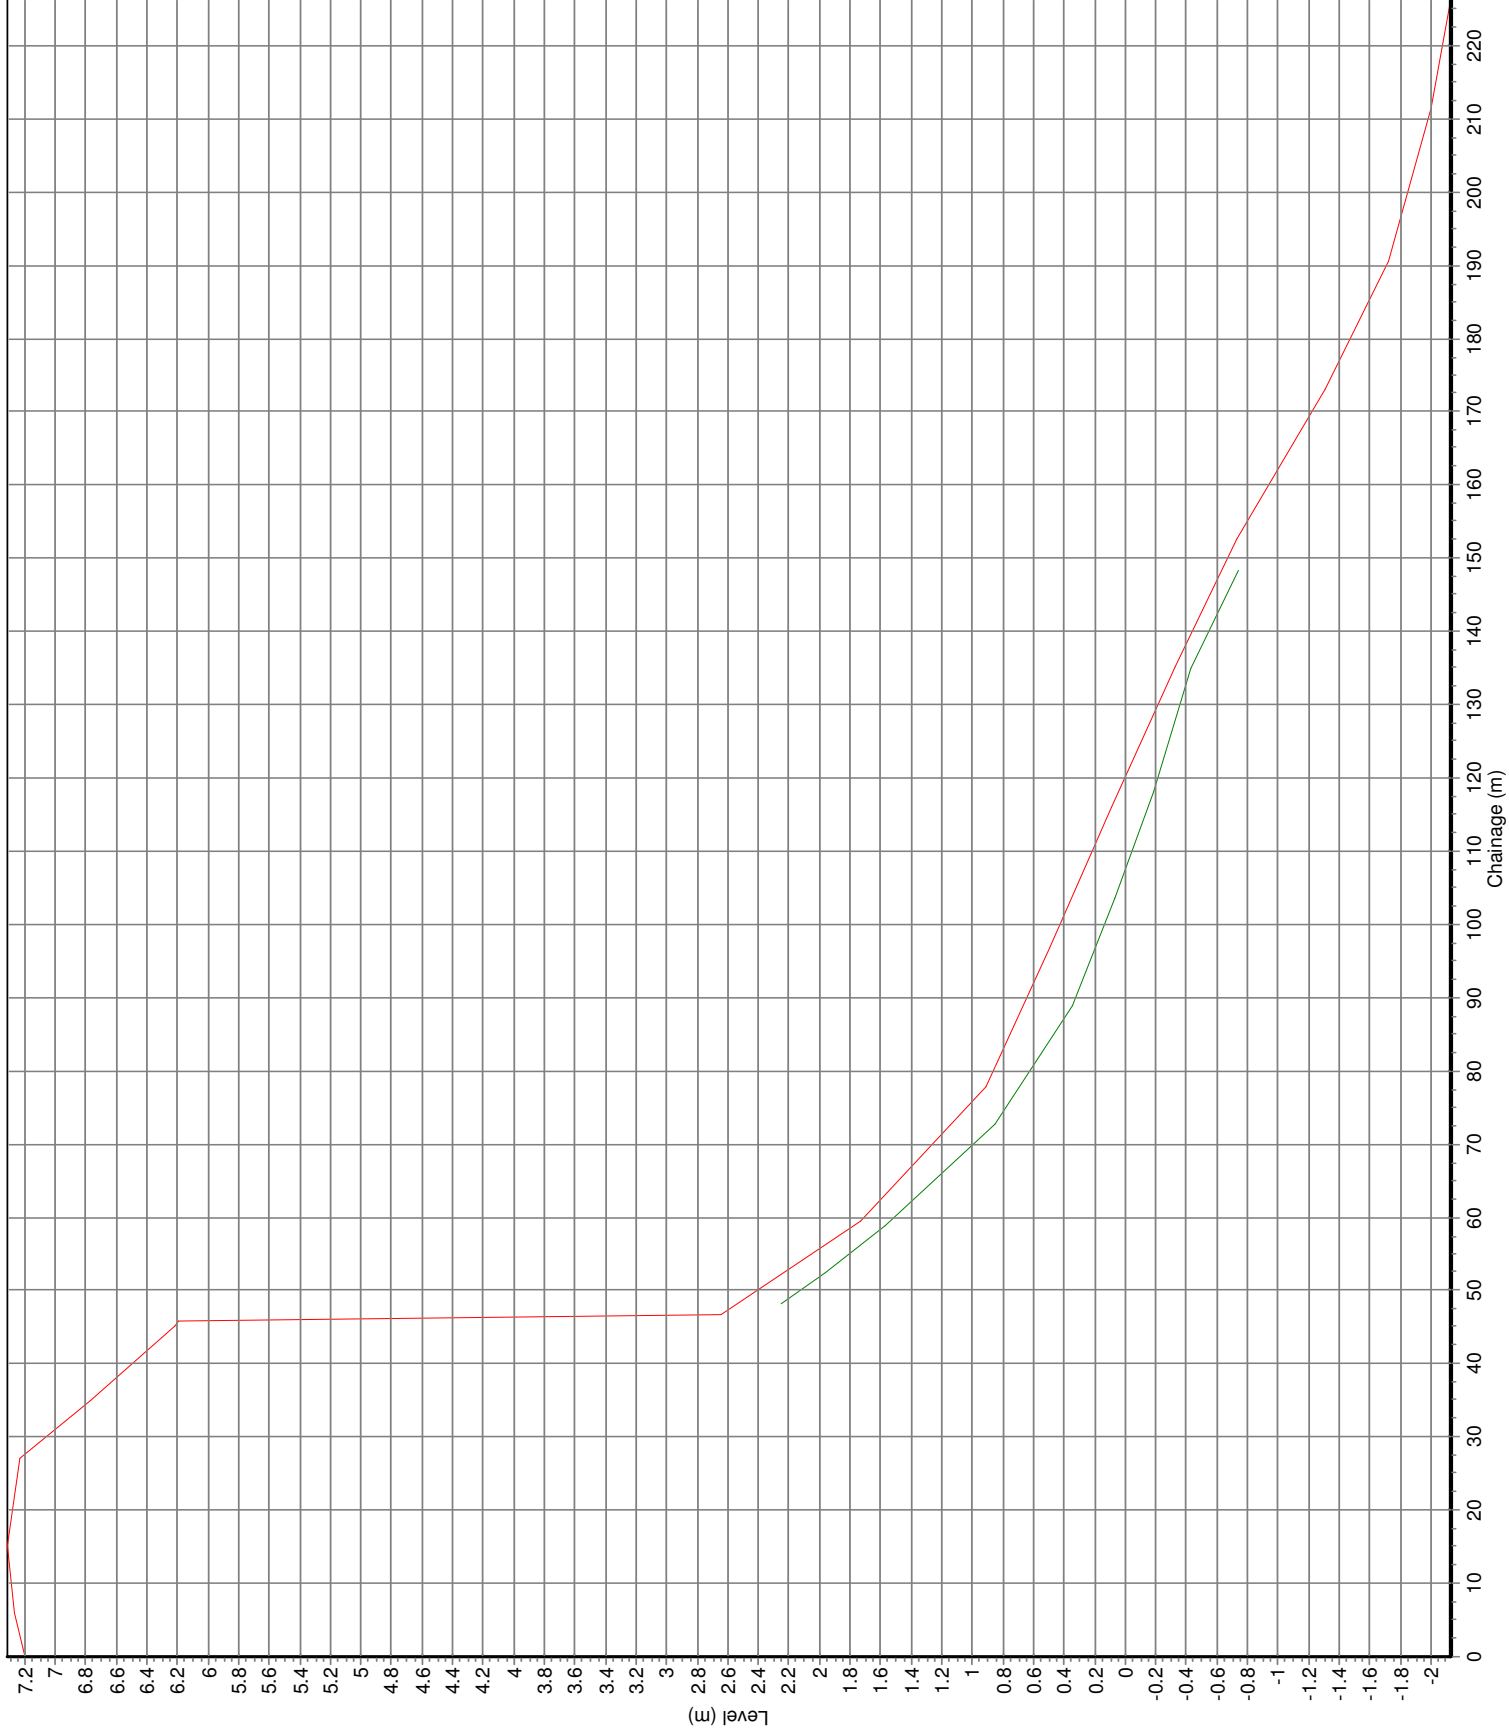
# Beach Profiles: 1cHC1

Survey Date	Description of Changes Since Last Survey	Interpretation
03-2009	<p><b>Beach Profiles:</b></p> <p>Middleton is covered by one beach profile line during the Partial Measures survey (Appendix A).</p> <p>Profile HC1 lowered in level along all of its surveyed length, in places by up to 0.35m. A similar profile form was observed on both surveys.</p>	<p>The lowering of profile HC1 is likely to be due to strong wave conditions stripping the beach of sediment. It will be important to continue monitoring here to see whether this is a seasonal behaviour or a longer term trend.</p>

- Along Middleton, the foreshore has been lowered, probably by wave action removing beach sediment. It will be important to continue monitoring here to see whether this is a seasonal behaviour or a longer term trend.

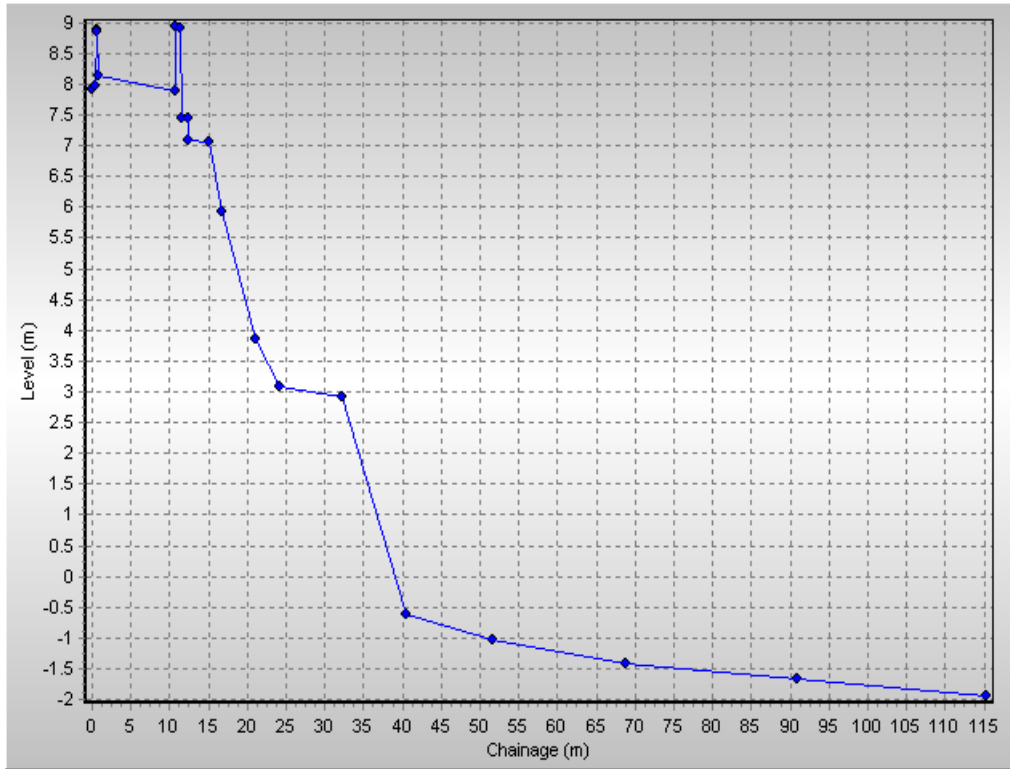
## 1cHS1

Survey Date	Description of Changes Since Last Survey	Interpretation
03-2009	<p><b>Beach Profiles:</b></p> <p>Hartlepool Bay is covered by four beach profile lines during the Partial Measures survey (Appendix A). These were not surveyed during the Full Measures survey in November 2008 for the reasons previously described and so were recorded for the first time during the present survey.</p> <p>HS1 is located approximately 150m south of the root of the South Pier. The profile starts at the wall to the rear of the promenade and extends across the promenade, over the fronting concrete splash wall and down the sloping face of the rock armour revetment before reaching the beach. It then gently slopes down to low water level at the time of the survey.</p> <p>HS2 and HS3 are similar in that they both start across the promenade and then extend down the sea wall to beach level, crossing the rock armour protection at the toe of the wall. The profiles then both slope gently down to low water mark.</p> <p>HS4 is located further south, around 1km north of the North Gare breakwater. It is in the area of undefended dunes at Seaton Sands. The profile covers a width of approximately 350m of dunes before reaching beach level. The beach then slopes gently down to low water level.</p>	<p>These profiles will be monitored for evidence of seasonal behaviour in beach profile responses and longer term trends of net erosion or accretion.</p>

- Along Hartlepool Bay there does not appear to be a uniform response along the frontage as a whole, but instead quite different responses were observed in the north and south. This may be a reflection of the different behaviours in a defended versus an undefended section of beach, or due to a longshore redistribution of sediment.
