**Cell 1 Regional Coastal Monitoring Programme
Update Report 2: 'Partial Measures' Survey 2010**

**Hartlepool Borough Council
Final Report**

Update Report 2
'Partial Measures' Survey 2010

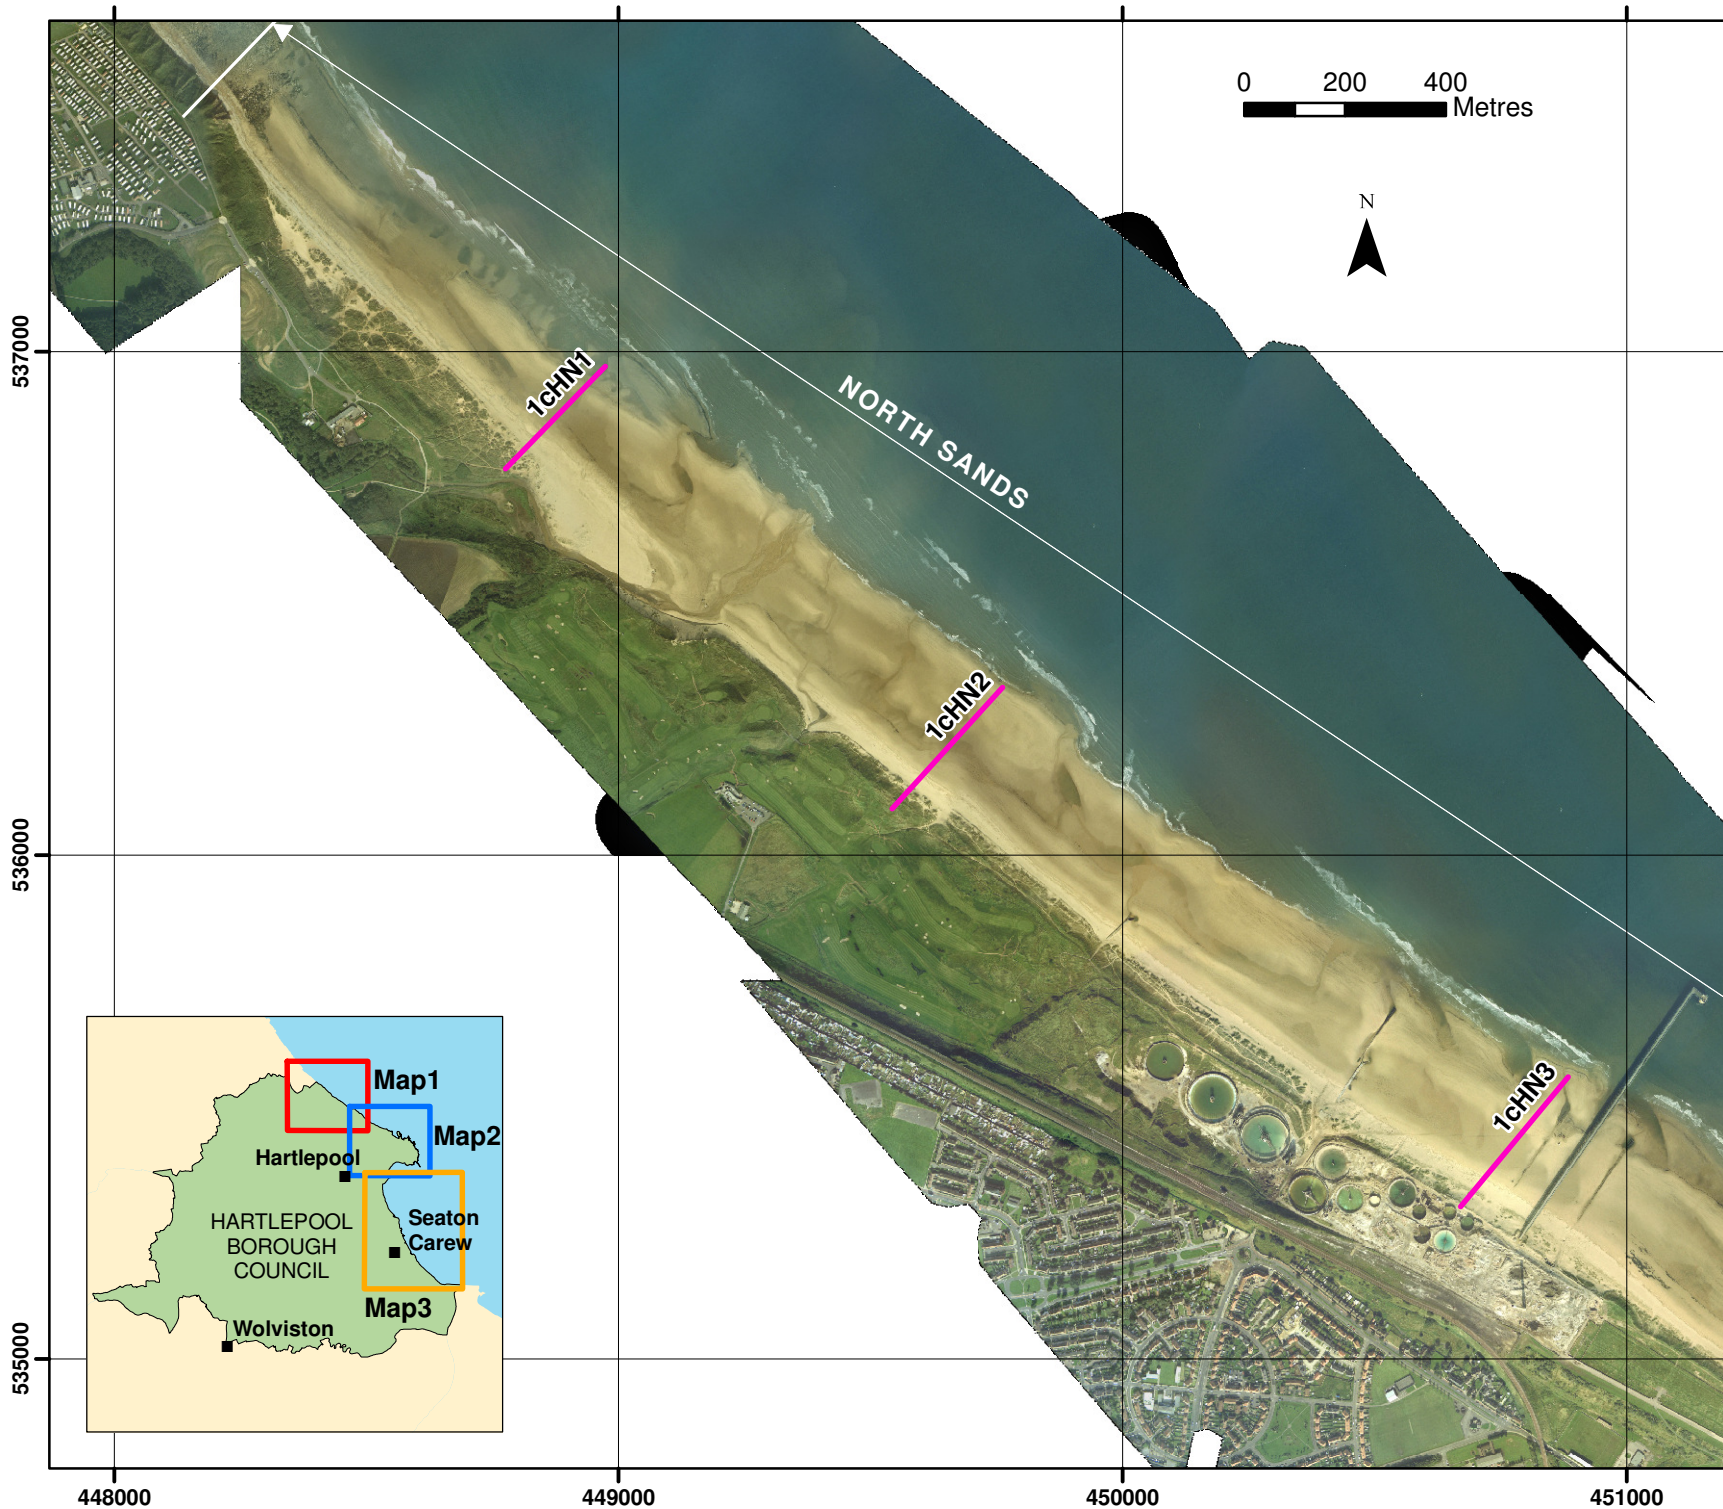
**Figure 1 - Map 1
Hartlepool Borough
Council Frontage**

The location of these surveys is shown in Figure 1. They have also previously been provided on a digital file which can be opened in Google Earth showing the locations of the surveys.

SURVEY LOCATIONS

Topographic Profiles

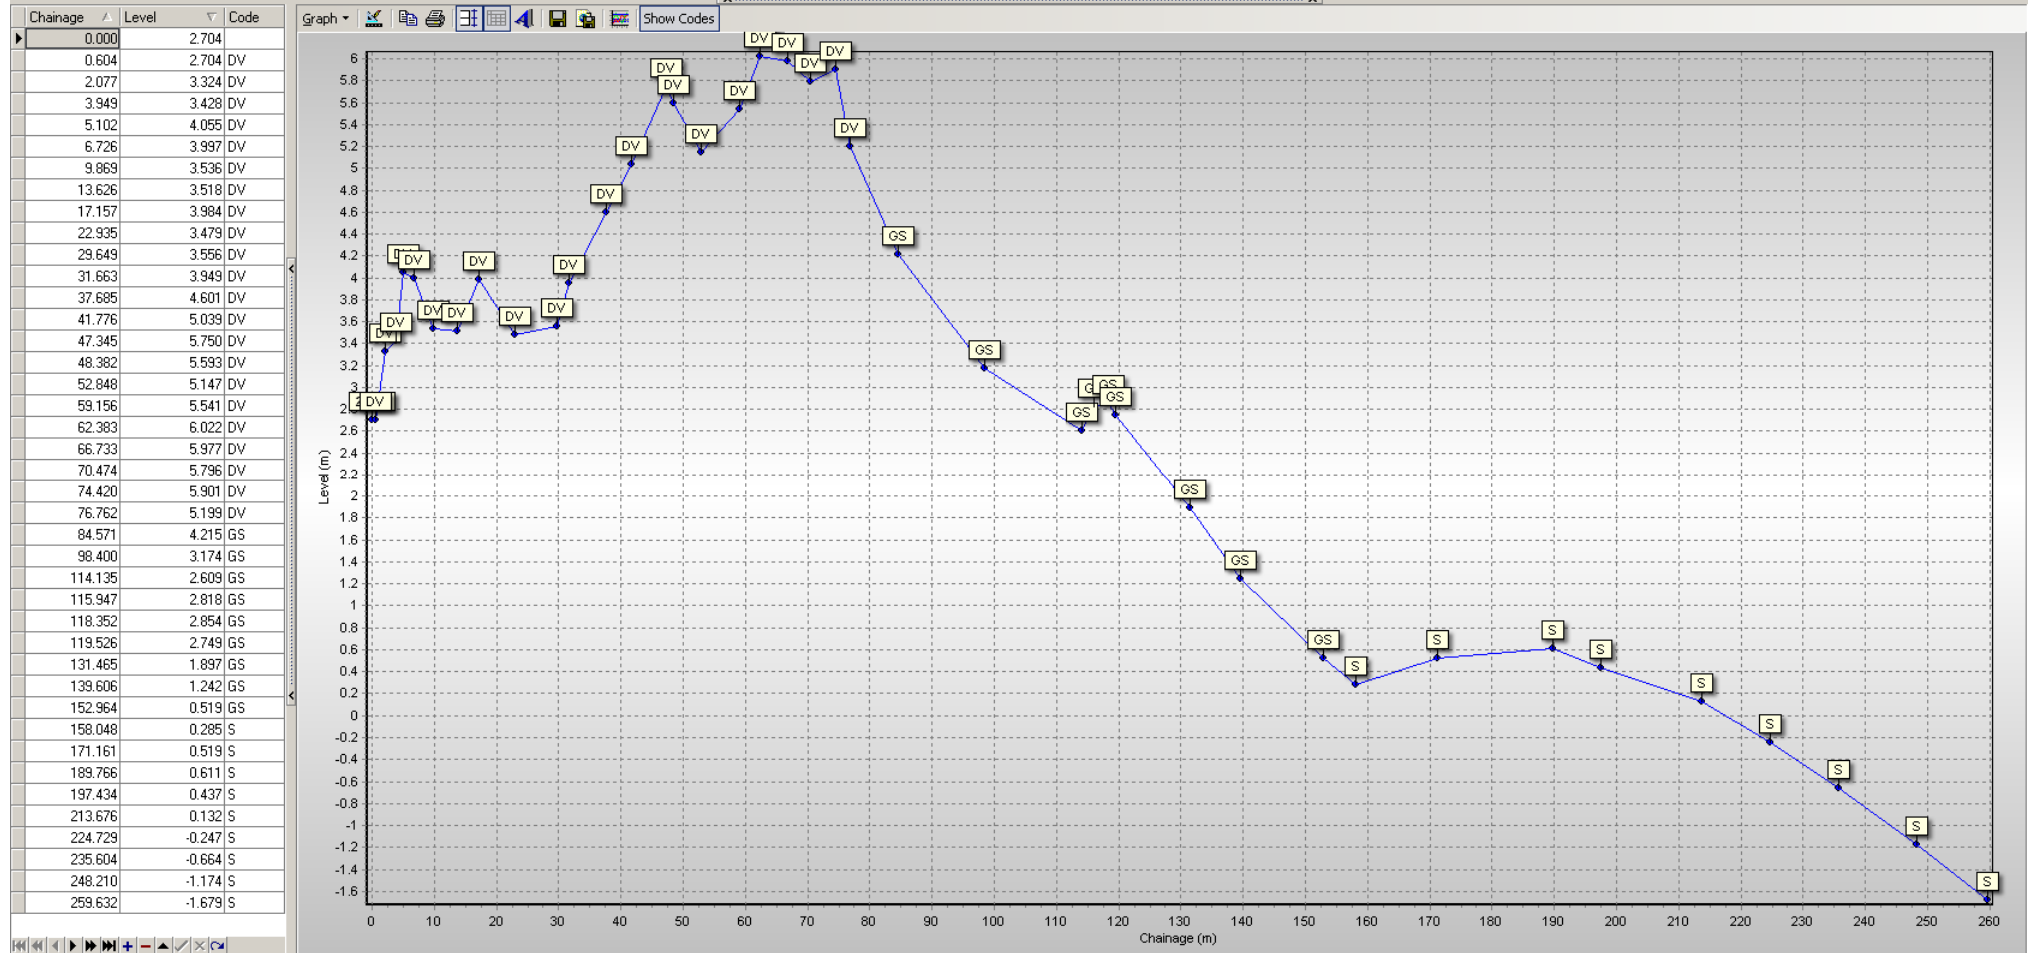
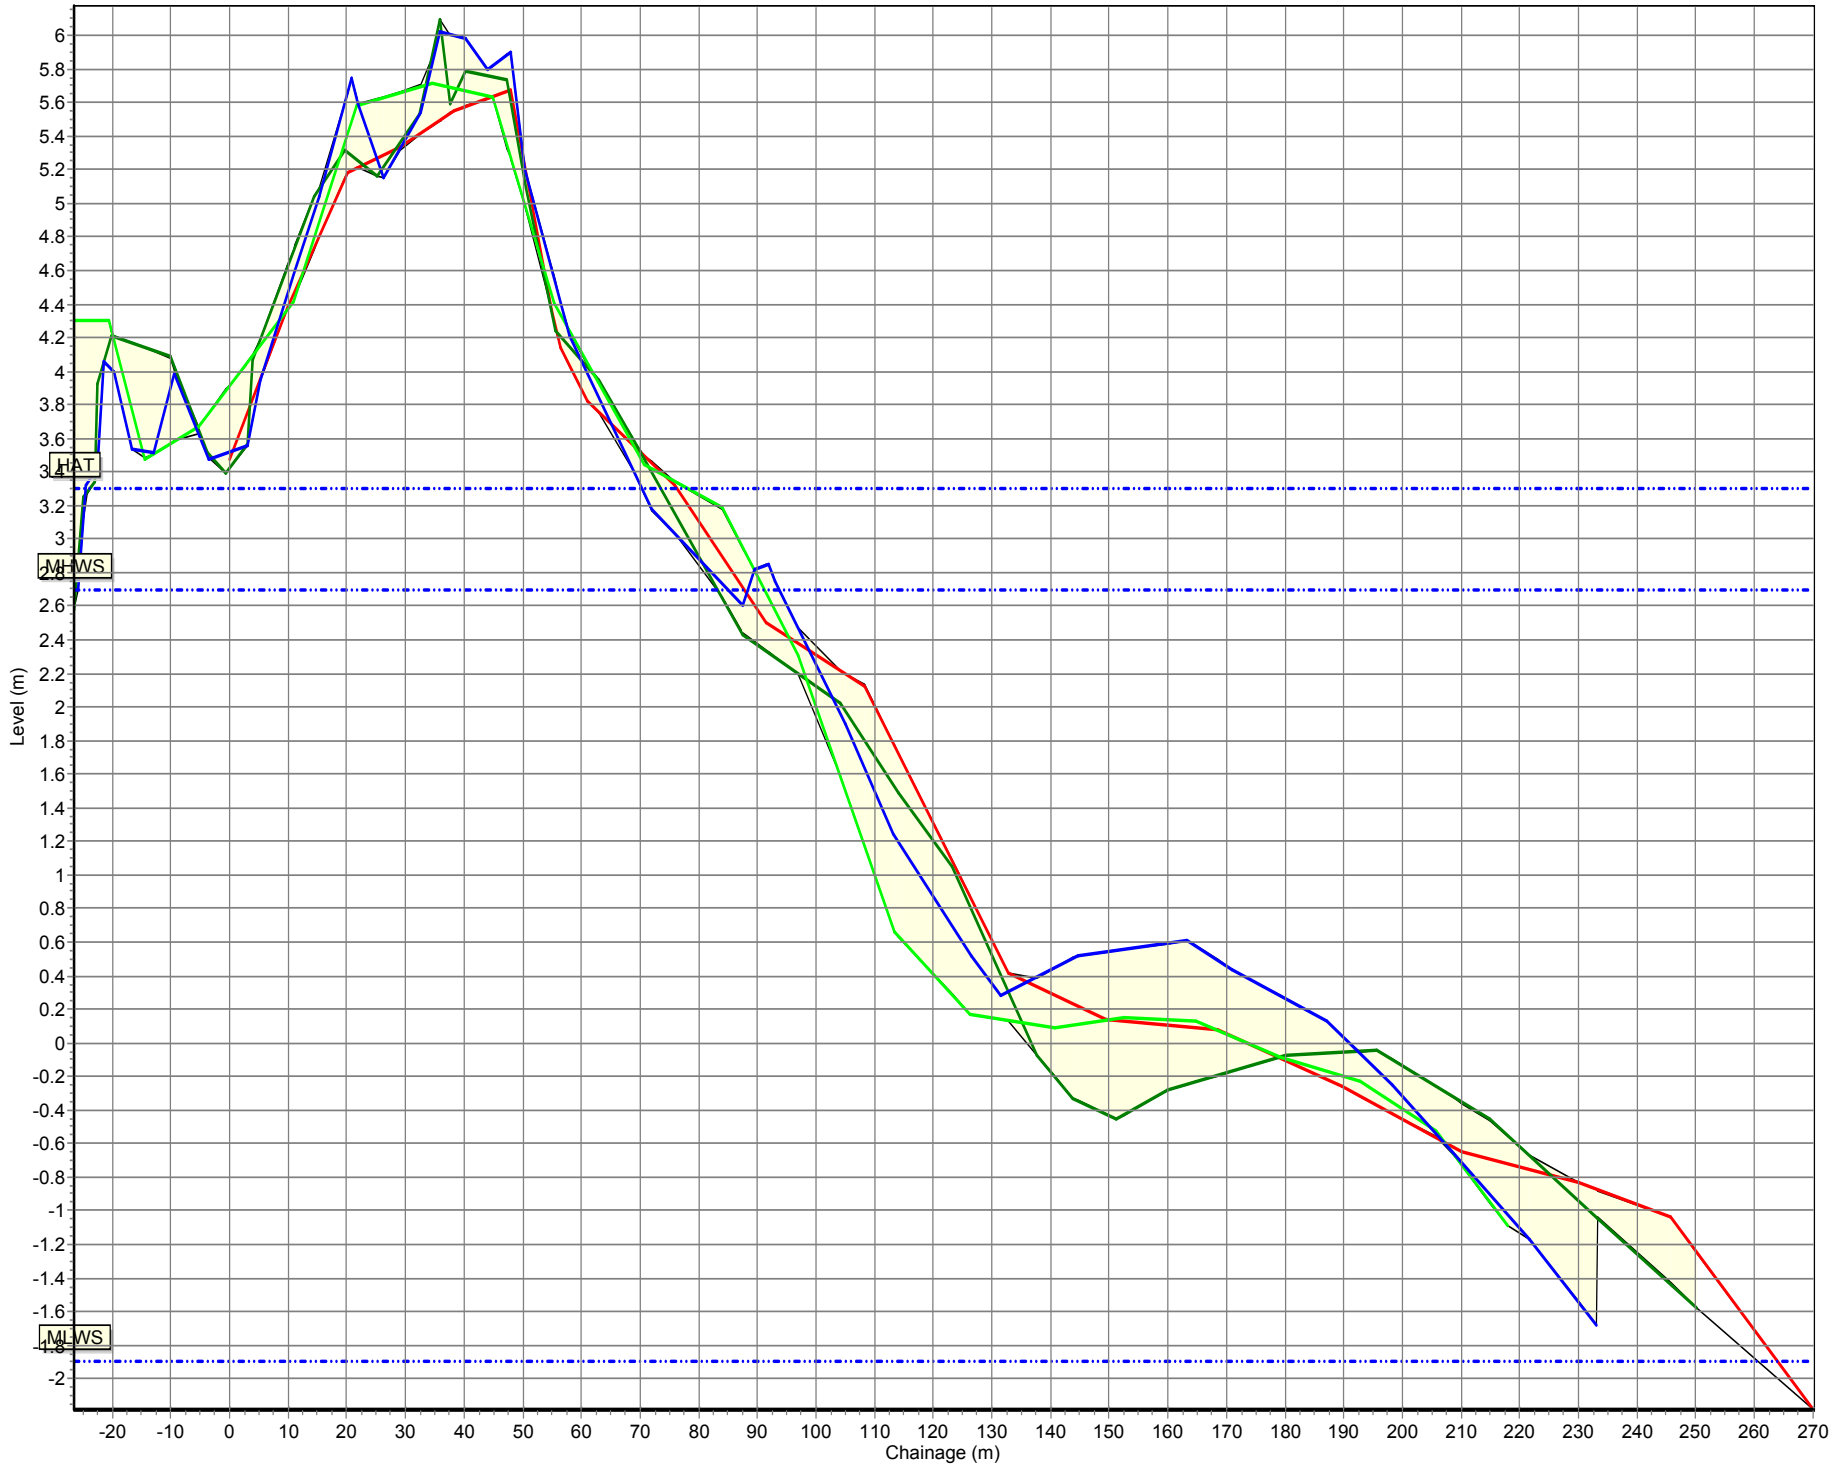
Beach Profiles: 1cHN1

1cHN1 – 20/03/2010

- Profiles Envelope
- 10/11/2008
- 31/03/2009
- 11/09/2009
- 20/03/2010

| Survey Date | Description of Changes Since Last Survey | Interpretation |
|---|---|---|
| 03-2010 | <p>Beach Profiles:</p> <p>North Sands is covered by four beach profile lines during the Partial Measures survey (Appendix A).</p> <p>HN1 is located within Durham County Council's jurisdiction, about 400m north of the outfall of Crimdon Beck, but has been reported here so changes can be interpreted in association with those observed elsewhere along North Sands at HN2, HN3 and HN4. Despite flattening of the berm previously recorded at around HAT and some landward recession of the steeper lower part of the foreshore, the majority of the seaward face of the profile has experienced accretion, with a large berm being formed, centred at around MSL and a smaller berm present at around MHWS. The dunes face and crest remains healthy and the crest morphology has changed from the wider flatter berm previously recorded in September 2009 back to a 'peakier' crest as observed in March 2009, with the highest crest of the dune being at a level of 6mODN.</p> <p>HN2 experienced lowering along much of the profile length below HAT, including a notable lowering at the toe of the dunes which now adopt a more vertical profile just above HAT. Despite this, the dune face and crest remained stable. Generally the lowering was caused by the flattening of two berms identified in the previous survey, resulting in in-filling of the trough in between the berms.</p> <p>The slag banks at the landward end of profile HN3 did not show any change, but the foreshore further accreted slightly along its entire length seaward of MHWS, including some growth in the crest height and width of the narrow dunes fronting the slag banks.</p> <p>HN4 showed notable lowering along the upper beach, seaward of the toe of the sea wall to a chainage of around 65m, and notable accretion further seaward to a chainage of around 145m. At the seaward edge of the profile, however, the sand veneer was removed, exposing the rock outcrops.</p> | <p>Profiles HN1 and HN2 both experienced the formation of a flatter form than that recorded in the preceding survey in September 2009. This is classic indication of profile response to high wave energy, typically associated with winter beach behaviour. HN2 experienced erosion at the toe of the dunes, leaving a vertical edge just above HAT.</p> <p>HN3 generally showed accretion across its length, while HN4 showed a re-distribution of sediment from the upper to lower parts of the foreshore, except for the very seaward edge where bare rock was exposed.</p> |

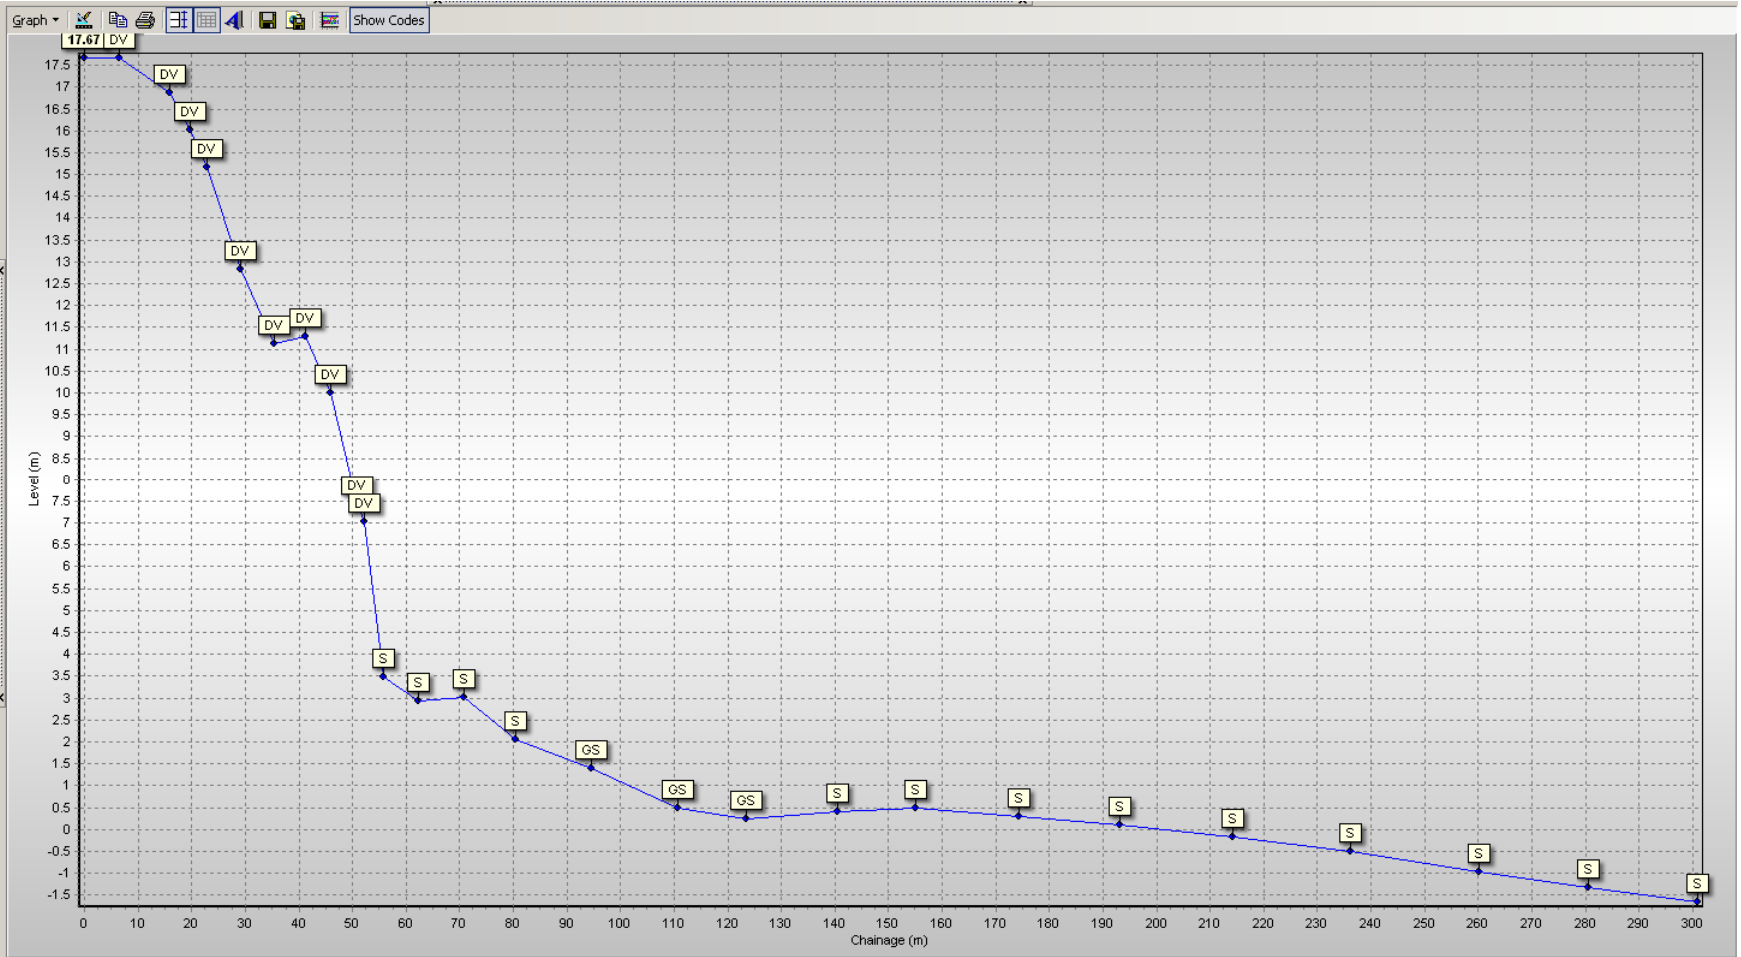
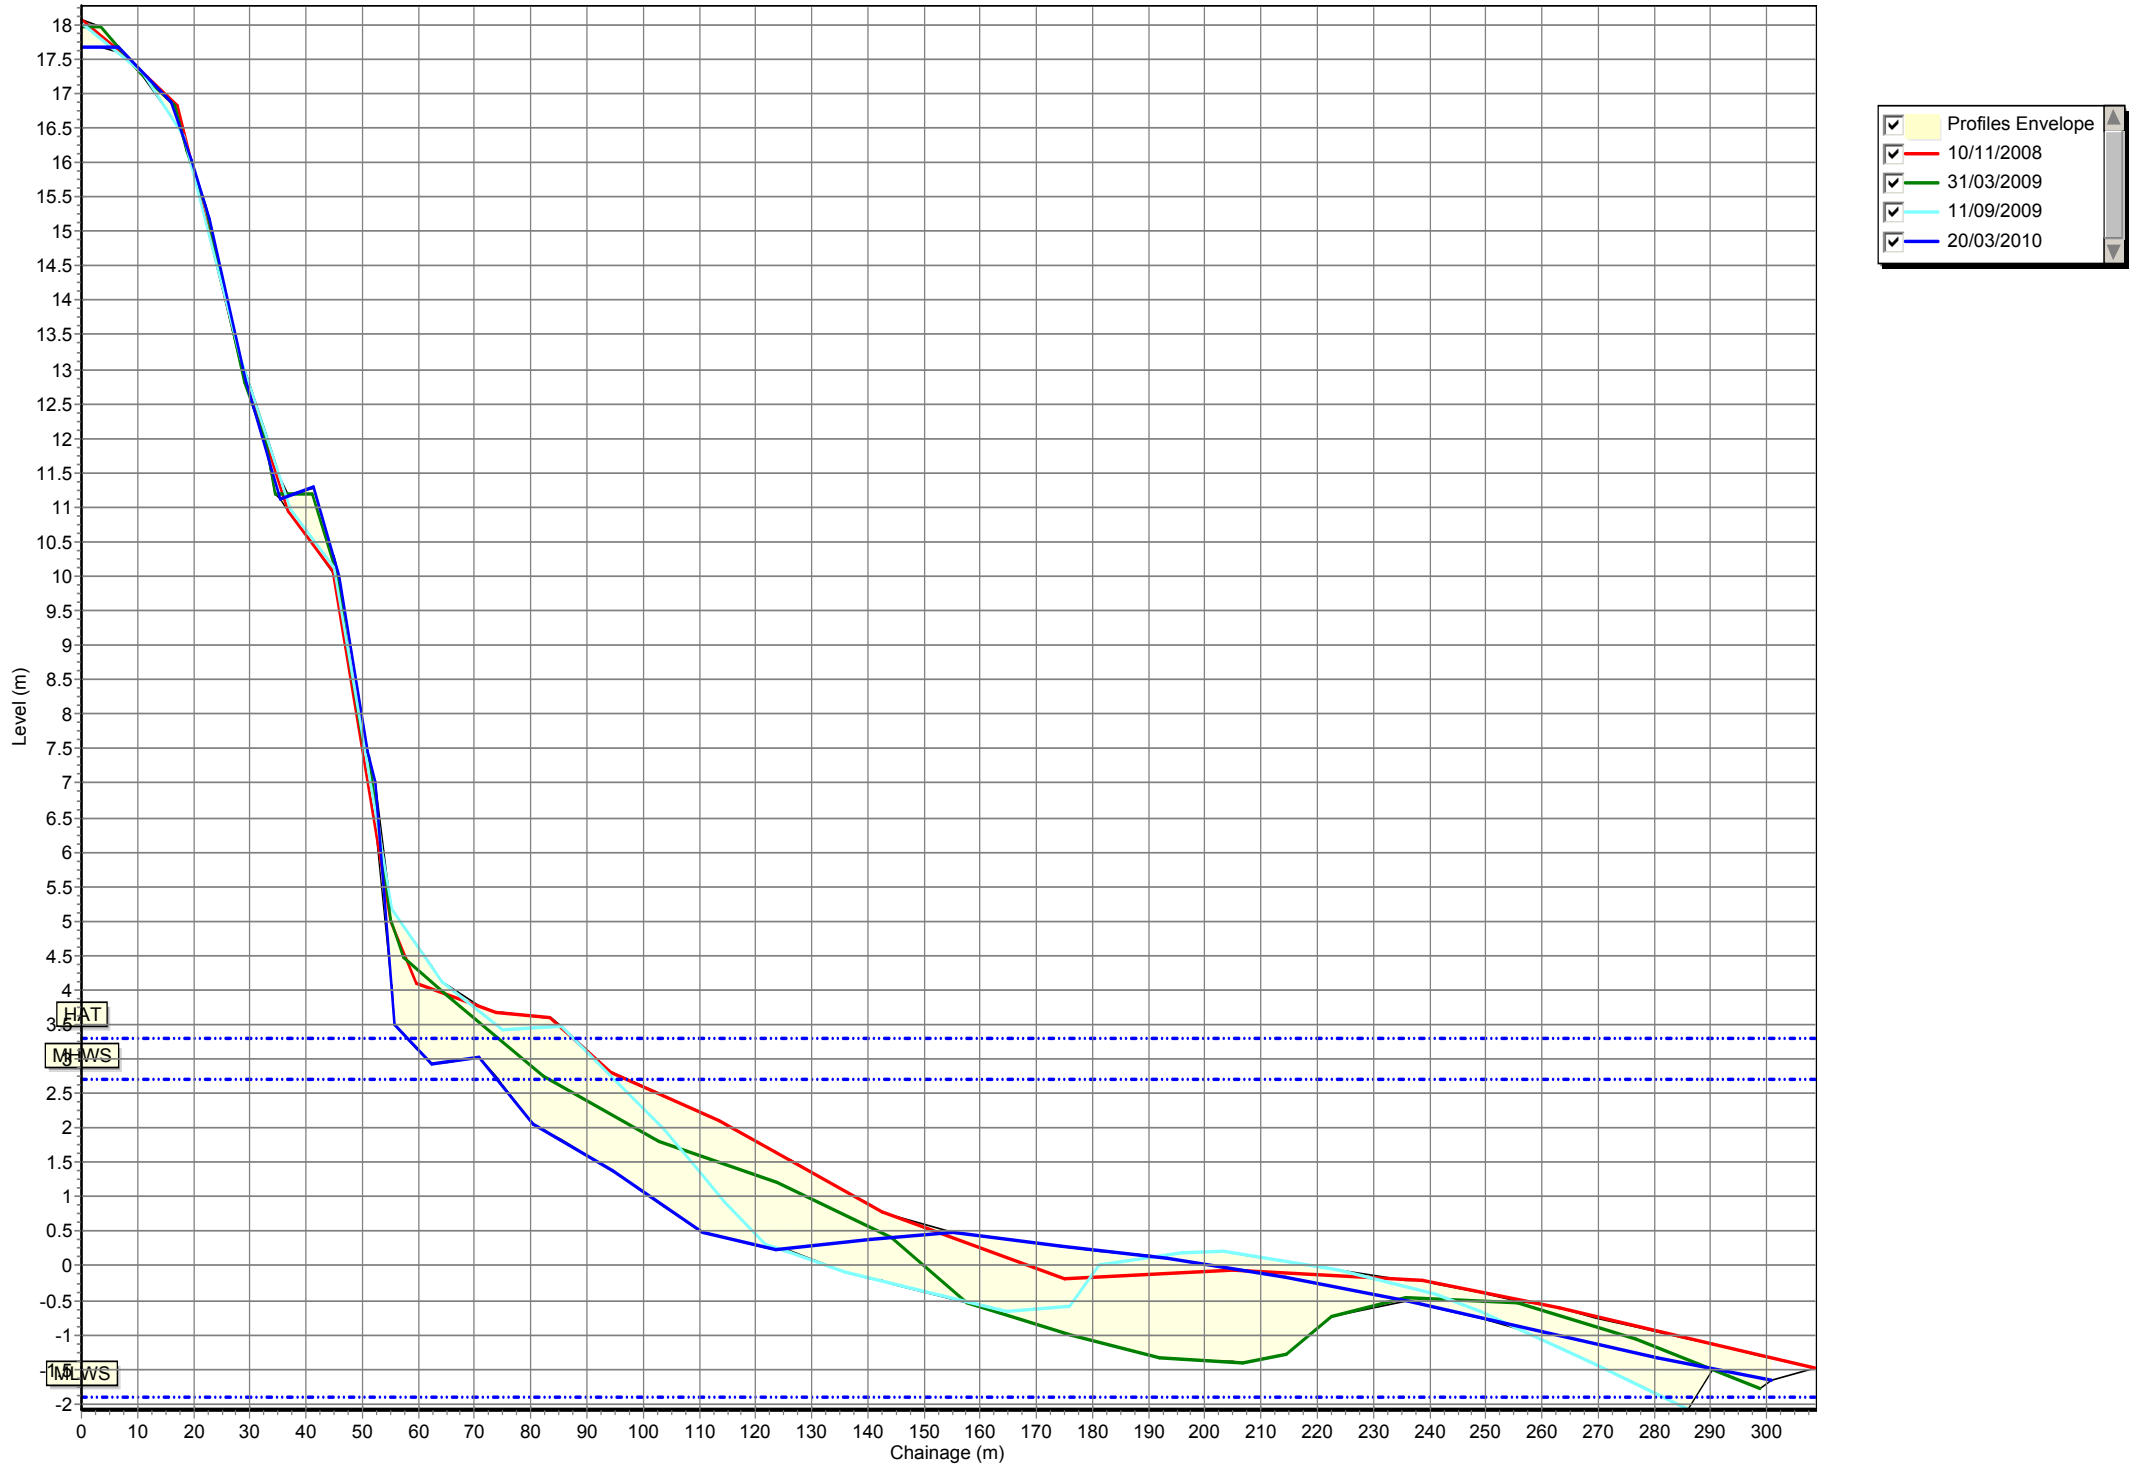
Beach Profiles: 1cHN2

1cHN2 – 20/03/2010

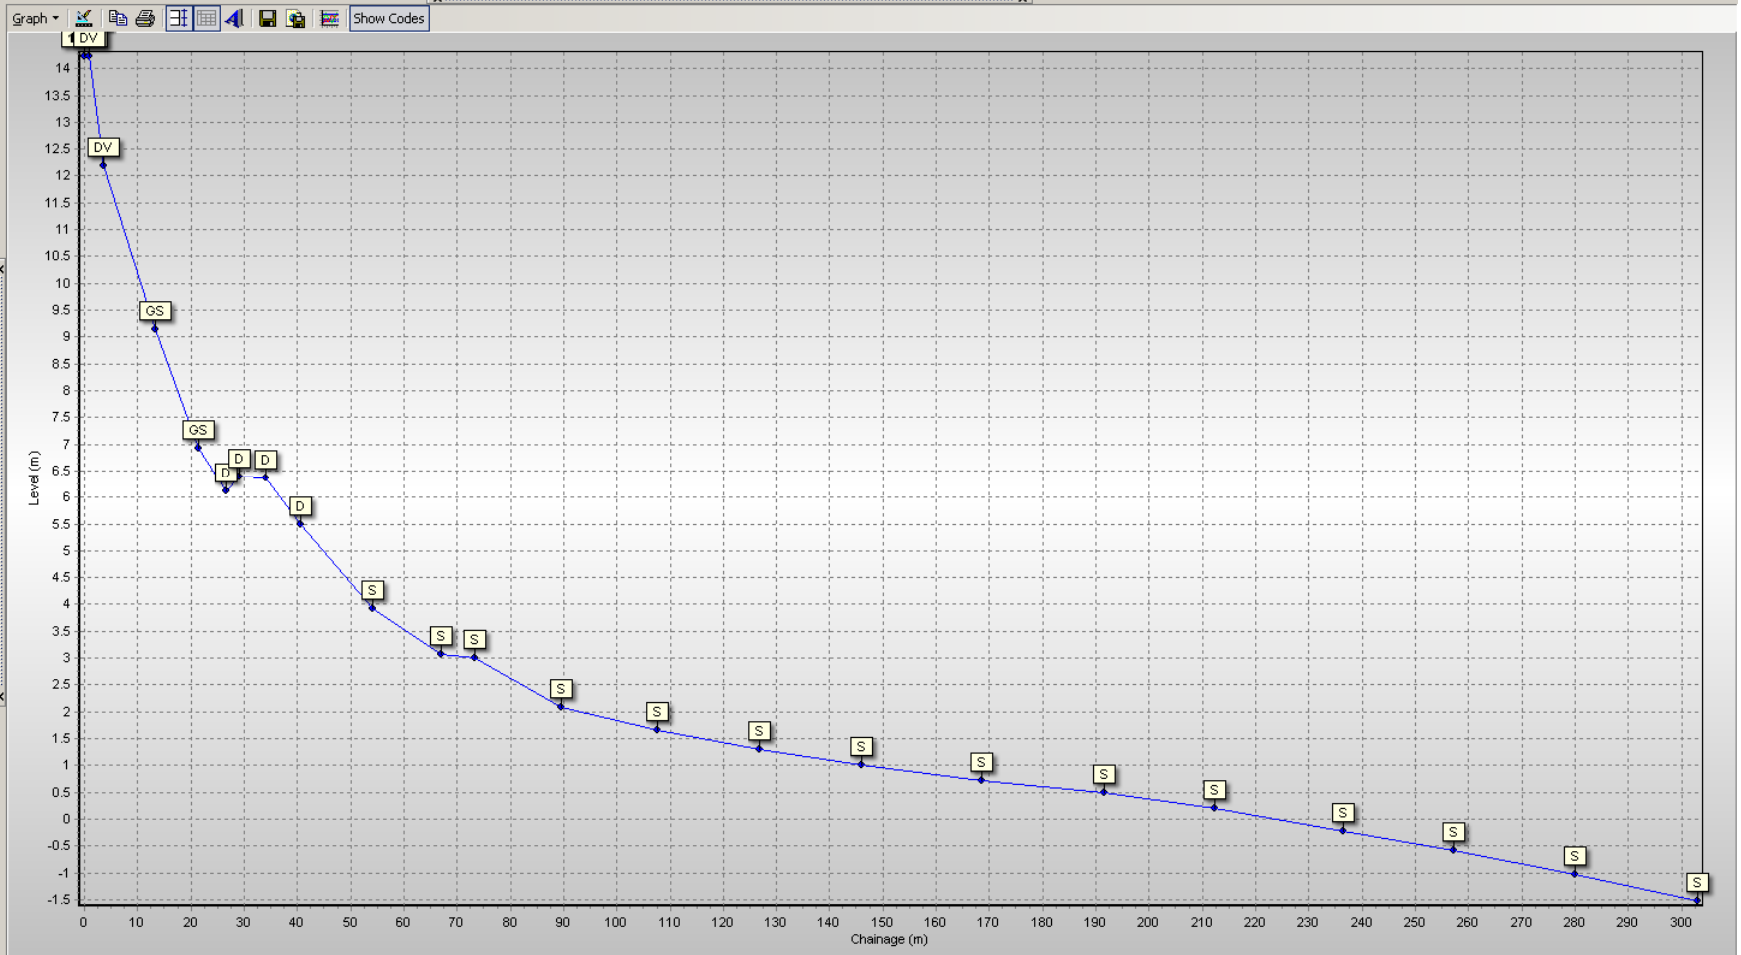
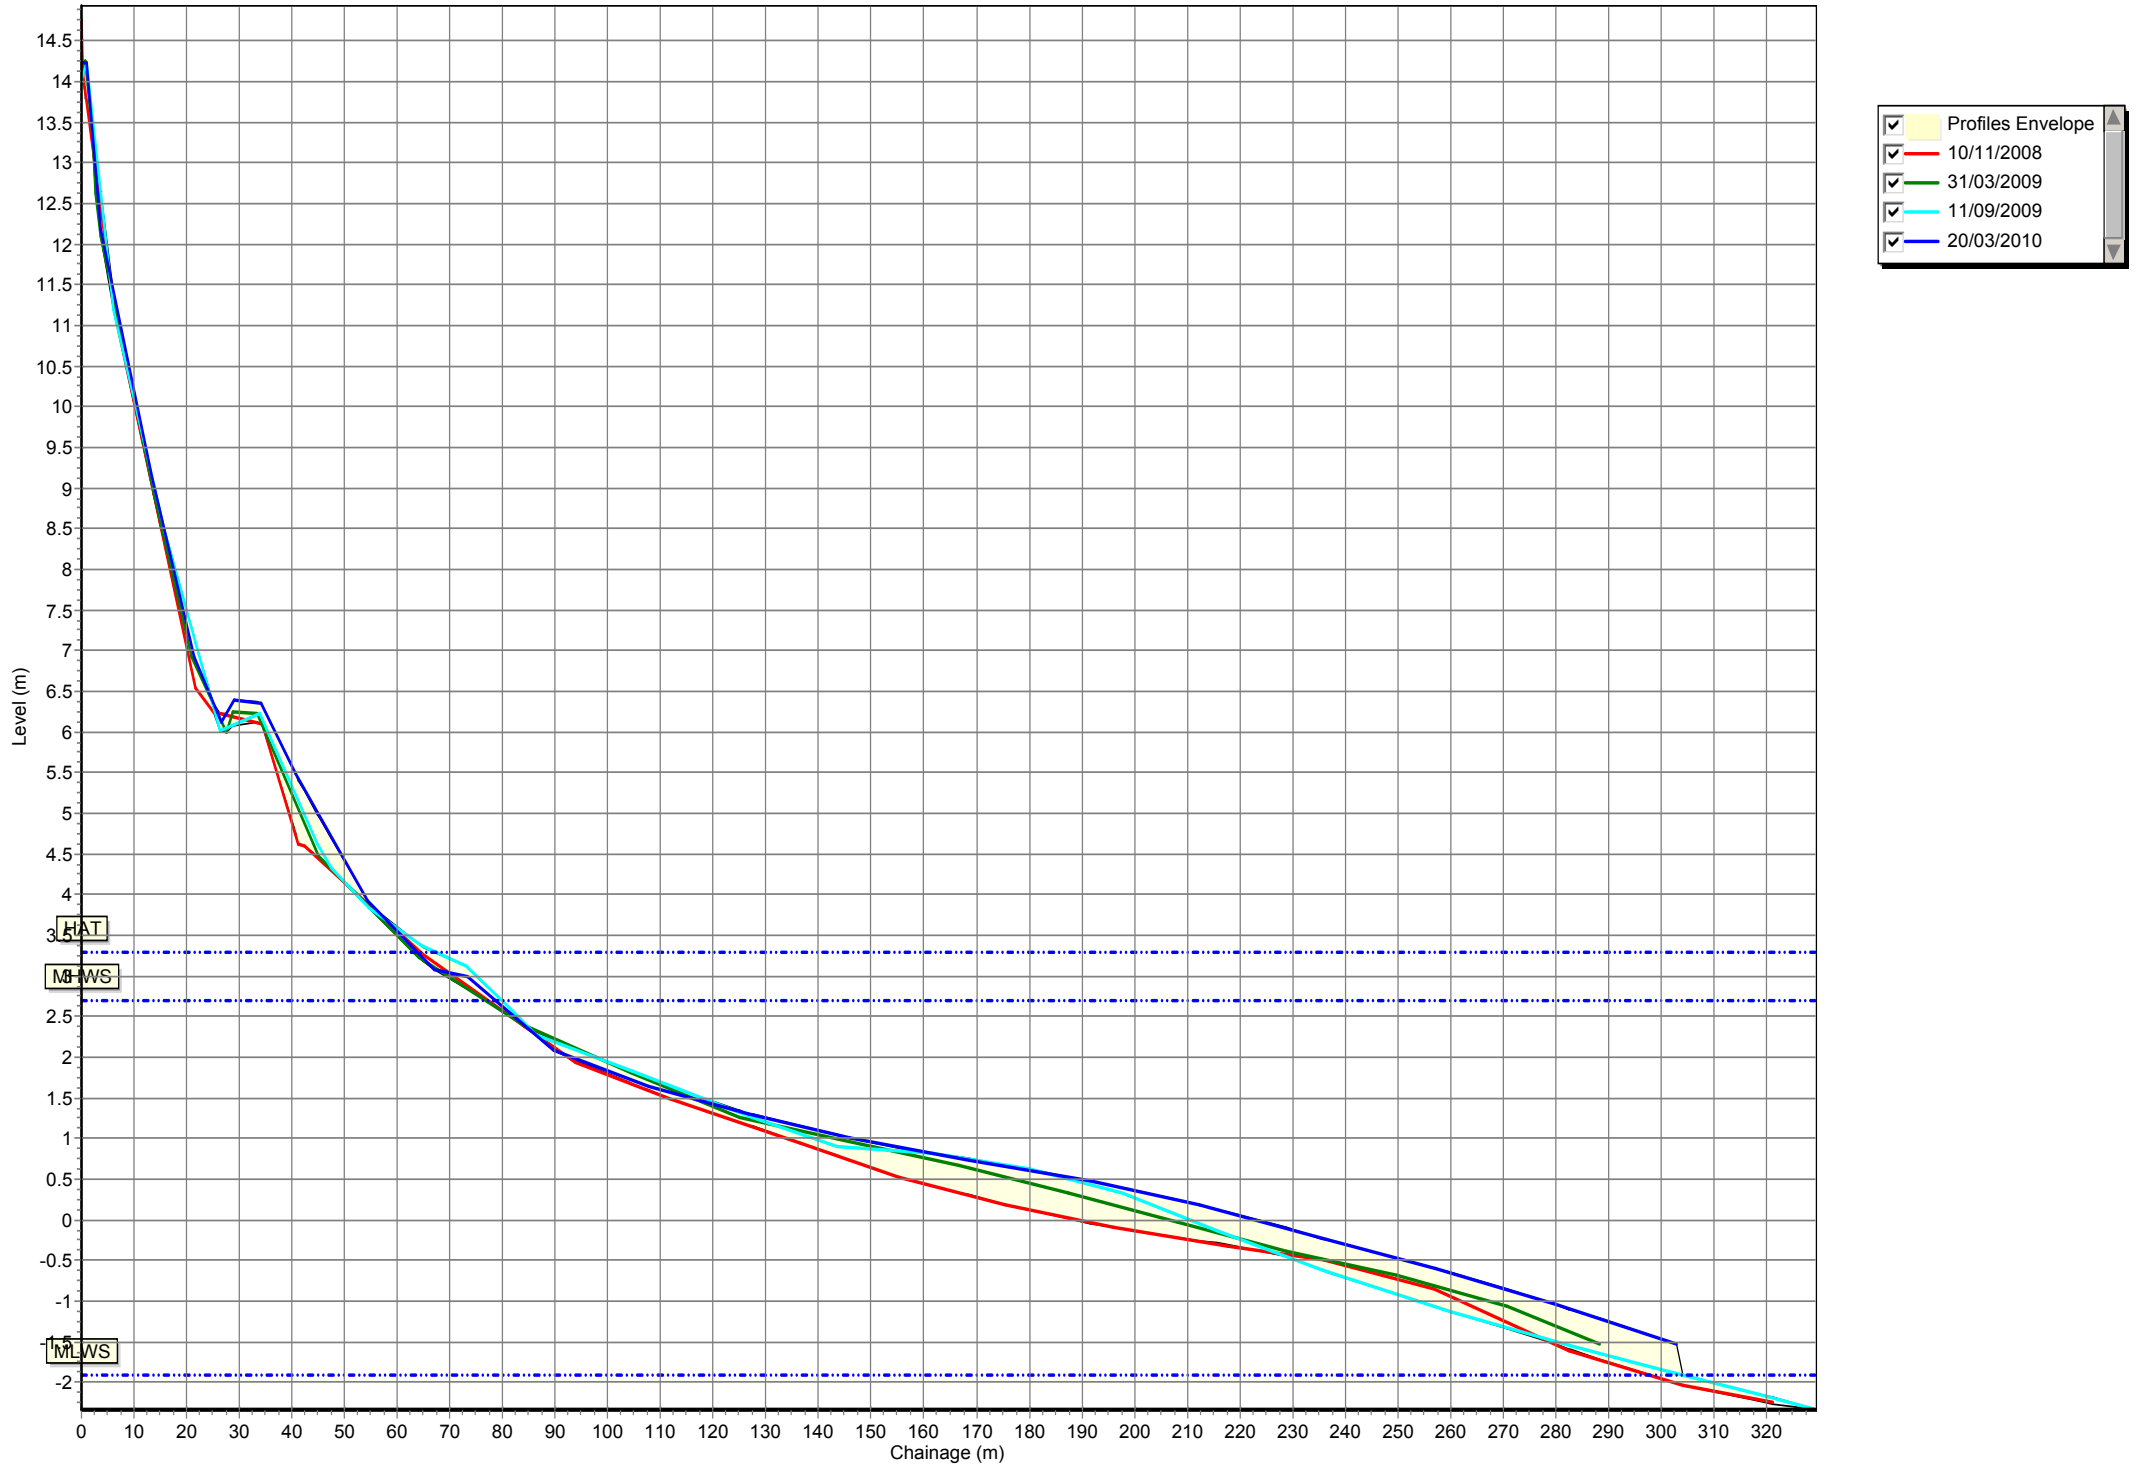
Beach Profiles: 1cHN3

1cHN3 – 20/03/2010
