**Cell 1 Regional Coastal Monitoring Programme
Update Report 2: 'Partial Measures' Survey 2010**

**Hartlepool Borough Council
Final Report**

Update Report 2
'Partial Measures' Survey 2010

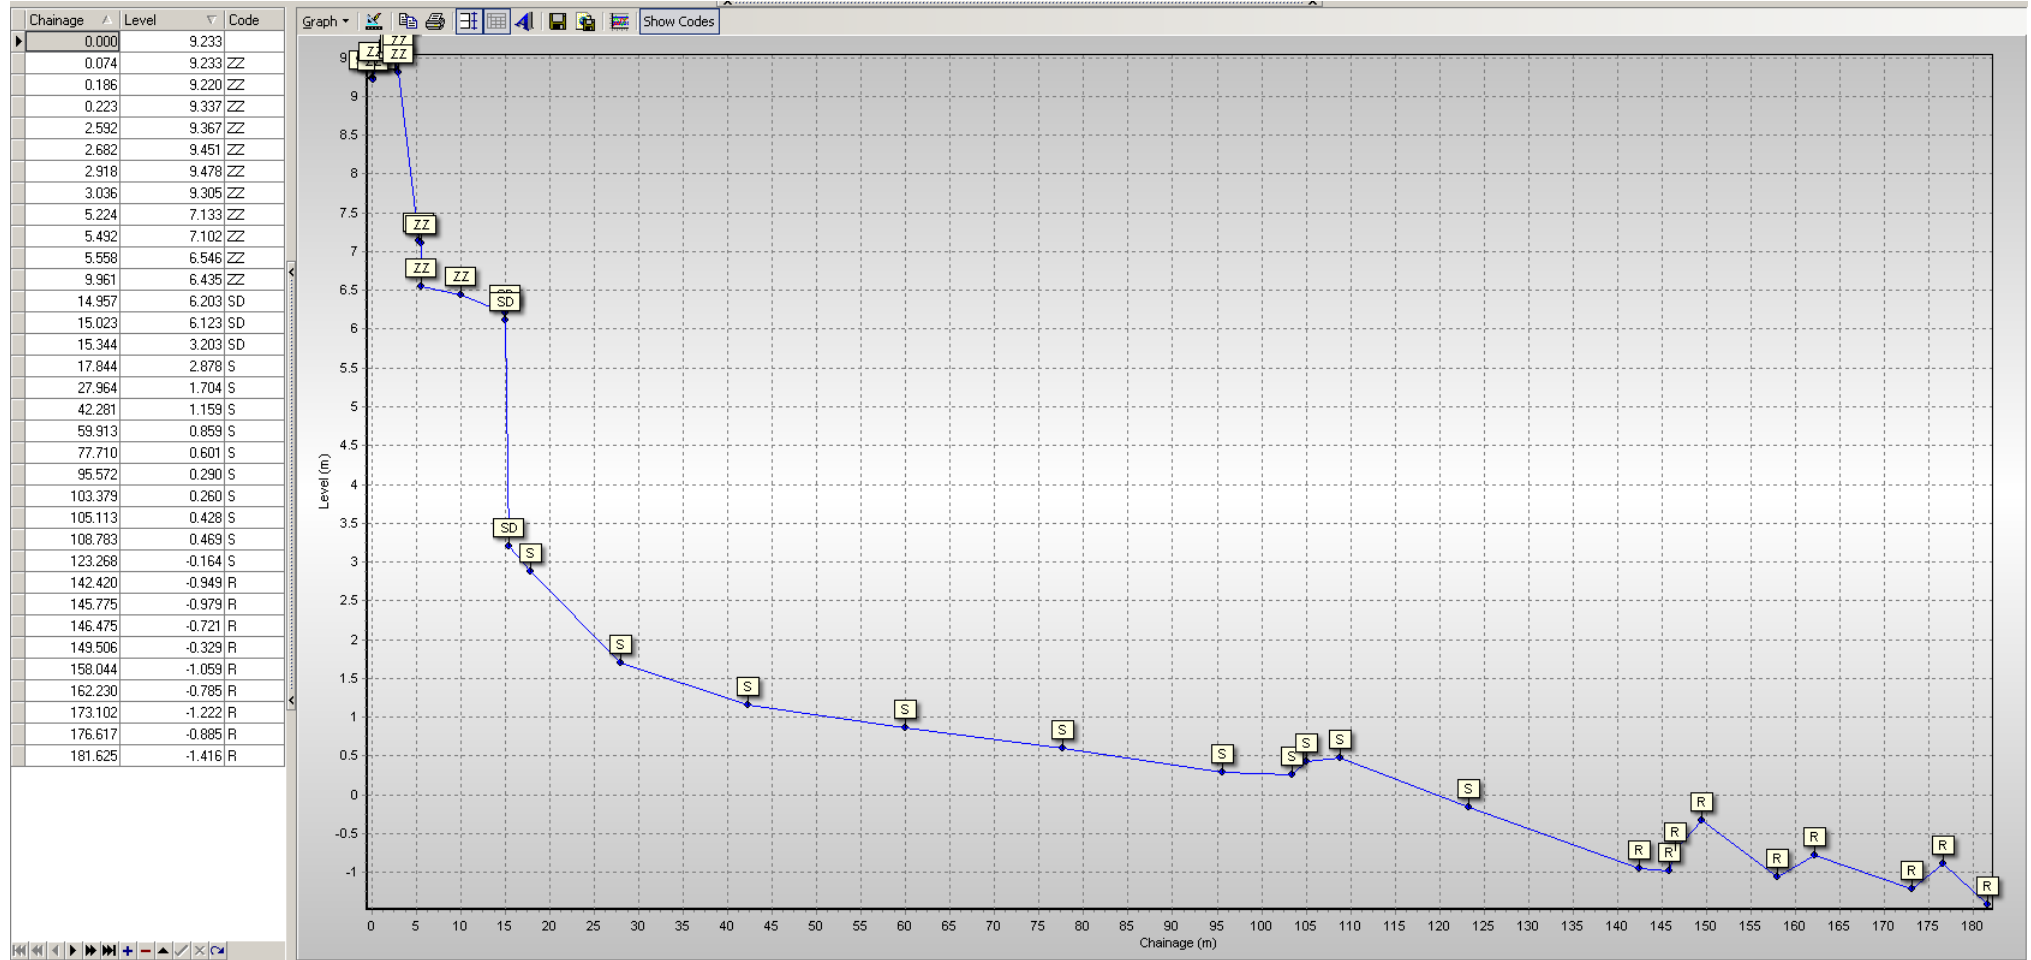
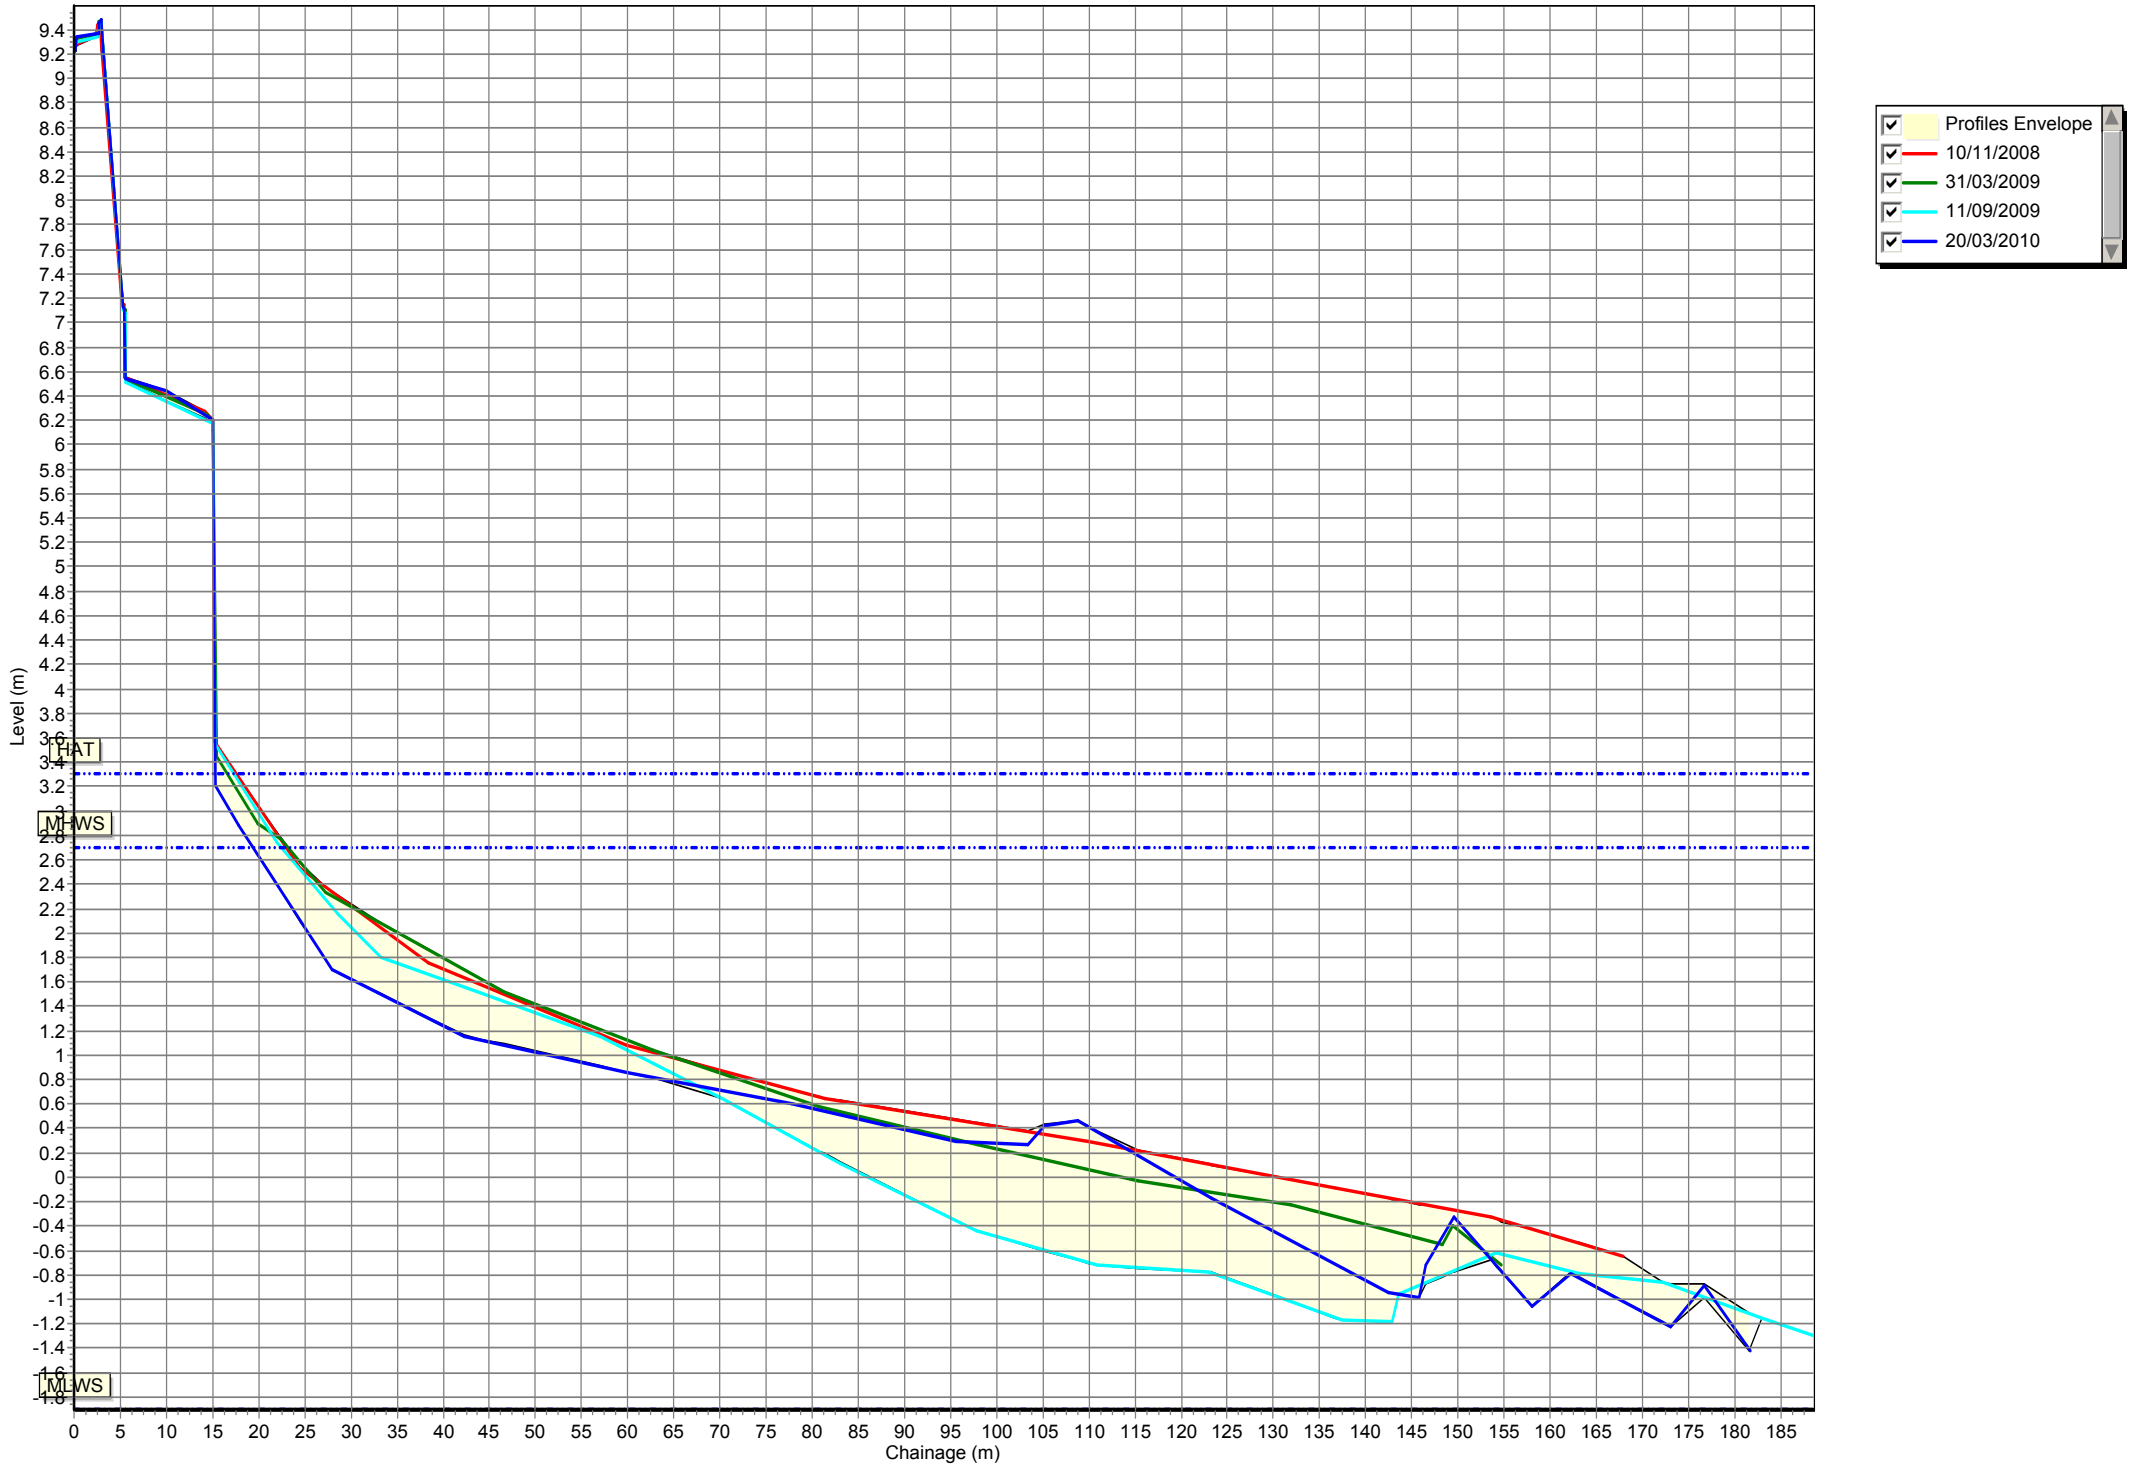
Beach Profiles: 1cHN4

1cHN4 – 20/03/2010

| Survey Date | Description of Changes Since Last Survey | Interpretation |
|---|---|---|
| 03-2010 | <p>Beach Profiles:</p> <p>North Sands is covered by four beach profile lines during the Partial Measures survey (Appendix A).</p> <p>HN1 is located within Durham County Council's jurisdiction, about 400m north of the outfall of Crimdon Beck, but has been reported here so changes can be interpreted in association with those observed elsewhere along North Sands at HN2, HN3 and HN4. Despite flattening of the berm previously recorded at around HAT and some landward recession of the steeper lower part of the foreshore, the majority of the seaward face of the profile has experienced accretion, with a large berm being formed, centred at around MSL and a smaller berm present at around MHWS. The dunes face and crest remains healthy and the crest morphology has changed from the wider flatter berm previously recorded in September 2009 back to a 'peakier' crest as observed in March 2009, with the highest crest of the dune being at a level of 6mODN.</p> <p>HN2 experienced lowering along much of the profile length below HAT, including a notable lowering at the toe of the dunes which now adopt a more vertical profile just above HAT. Despite this, the dune face and crest remained stable. Generally the lowering was caused by the flattening of two berms identified in the previous survey, resulting in in-filling of the trough in between the berms.</p> <p>The slag banks at the landward end of profile HN3 did not show any change, but the foreshore further accreted slightly along its entire length seaward of MHWS, including some growth in the crest height and width of the narrow dunes fronting the slag banks.</p> <p>HN4 showed notable lowering along the upper beach, seaward of the toe of the sea wall to a chainage of around 65m, and notable accretion further seaward to a chainage of around 145m. At the seaward edge of the profile, however, the sand veneer was removed, exposing the rock outcrops.</p> | <p>Profiles HN1 and HN2 both experienced the formation of a flatter form than that recorded in the preceding survey in September 2009. This is classic indication of profile response to high wave energy, typically associated with winter beach behaviour. HN2 experienced erosion at the toe of the dunes, leaving a vertical edge just above HAT.</p> <p>HN3 generally showed accretion across its length, while HN4 showed a re-distribution of sediment from the upper to lower parts of the foreshore, except for the very seaward edge where bare rock was exposed.</p> |

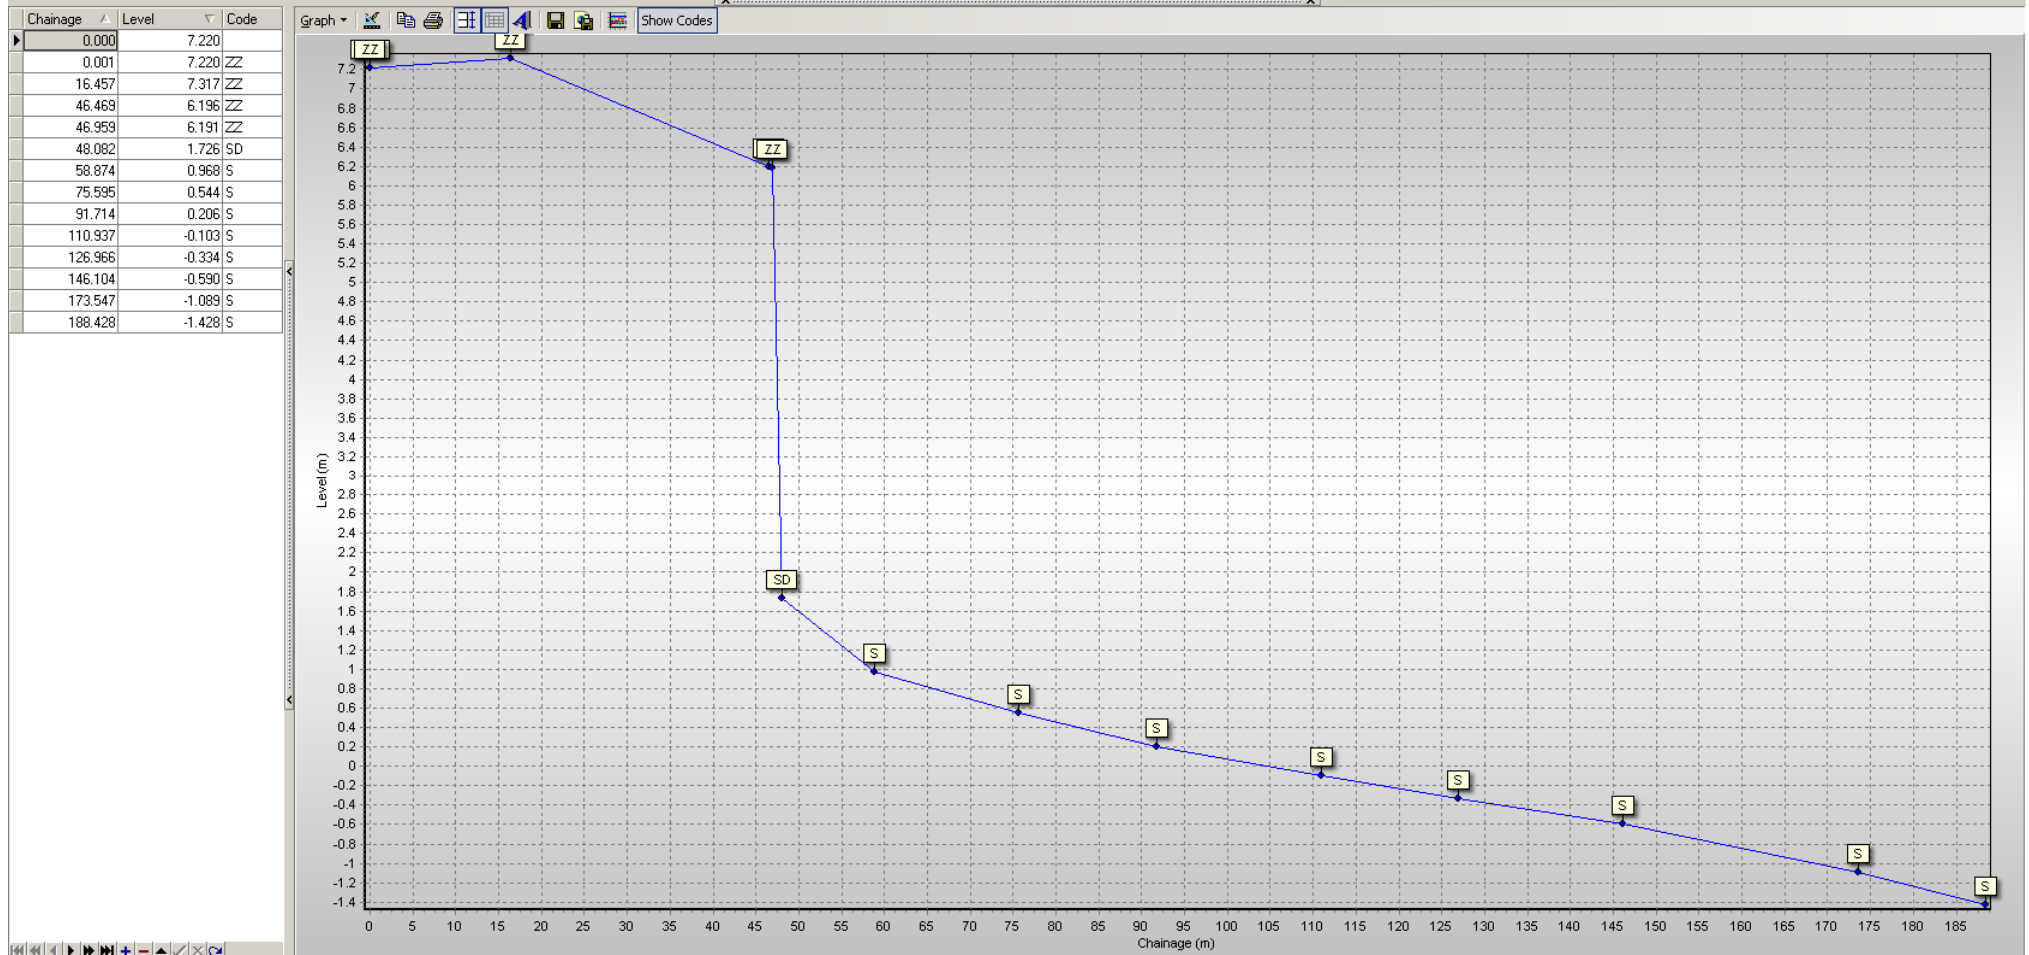
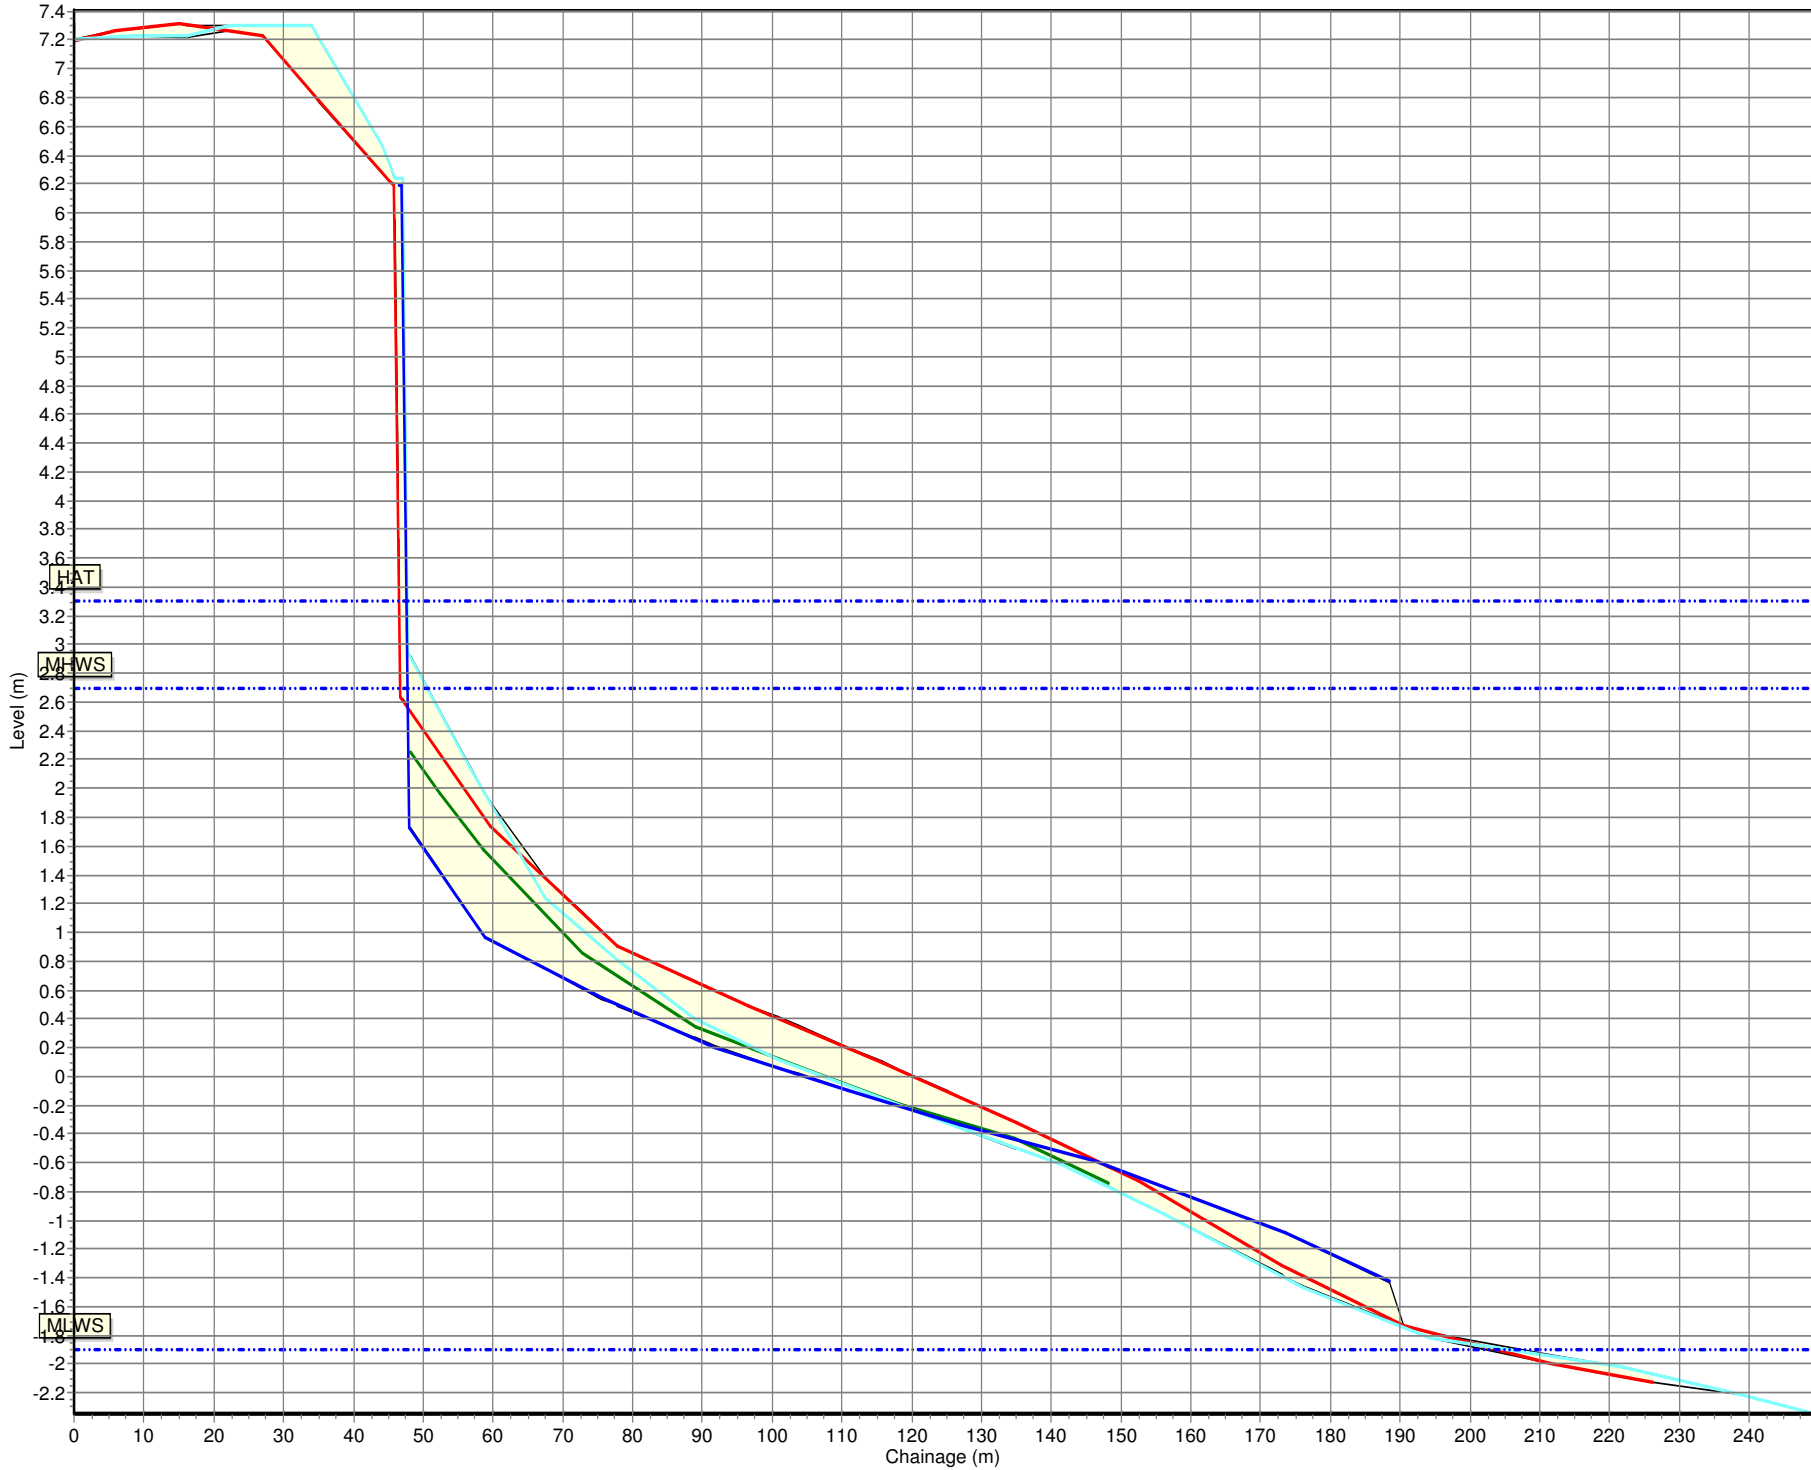
Beach Profiles: 1cHC1

1cHC1 – 20/03/2010

- Profiles Envelope
- 25/11/2008
- 31/03/2009
- 21/09/2009
- 20/03/2010

| Survey Date | Description of Changes Since Last Survey | Interpretation |
|---|--|---|
| 03-2010 | <p>Beach Profiles:</p> <p>Middleton is covered by one beach profile line during the Partial Measures survey (Appendix A).</p> <p>Profile HC1 experienced significant lowering at the toe of the vertical wall that fronts the industrial land, with levels some 1.2m lower than those recorded in September 2009. Beach levels remained very low across the profile to a chainage of 105m. Seaward of here the profile gradually improved to reach high levels at its seaward edge. Note: The surveyors report access difficulties across the land behind the vertical wall and therefore this section should be ignored from the analysis.</p> | <p>The changes along HC1 led to the formation of a flatter, wider profile than that recorded in September 2009. This is a typical beach response to high wave energy over the winter.</p> |

Access constraints mean that parts of the landward sections of transects HC1 and HS4 can no longer be surveyed. This is not considered significantly adverse because the ability to survey the seaward sections of these profiles (seaward of the wall or dune defences) remains unaffected.

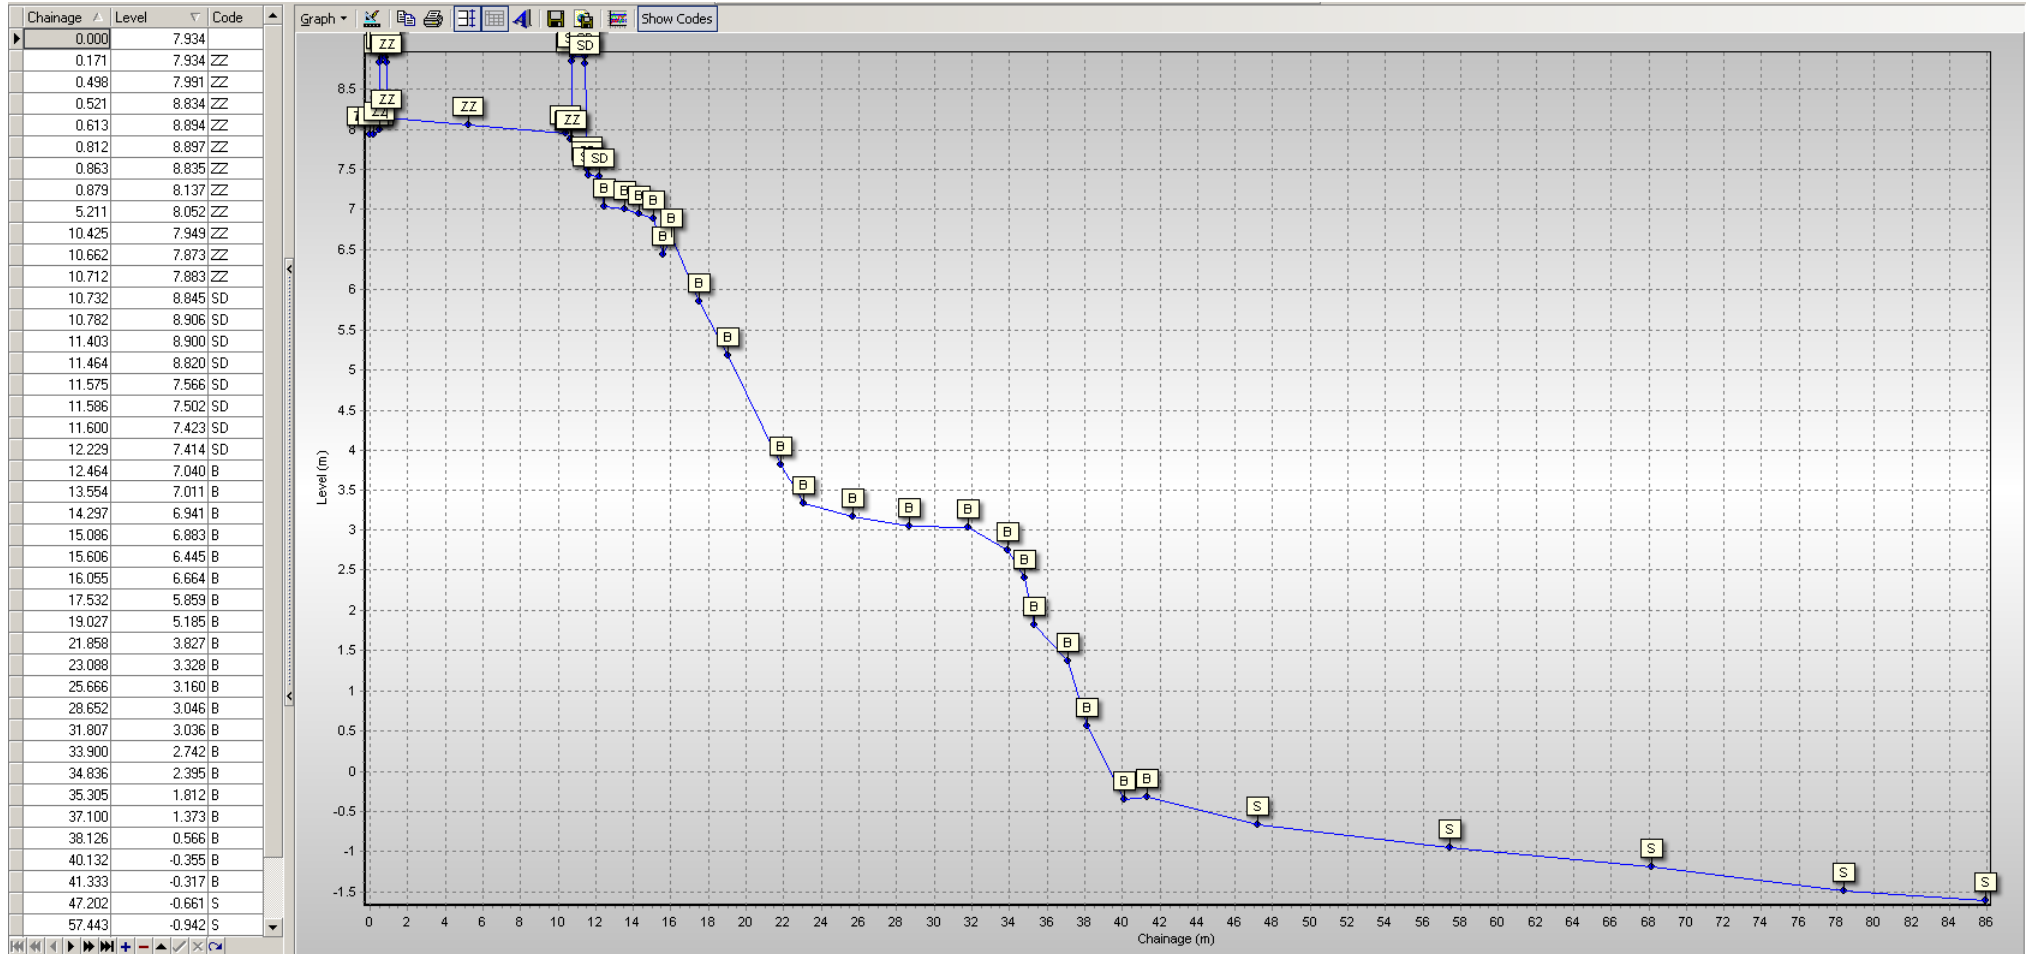
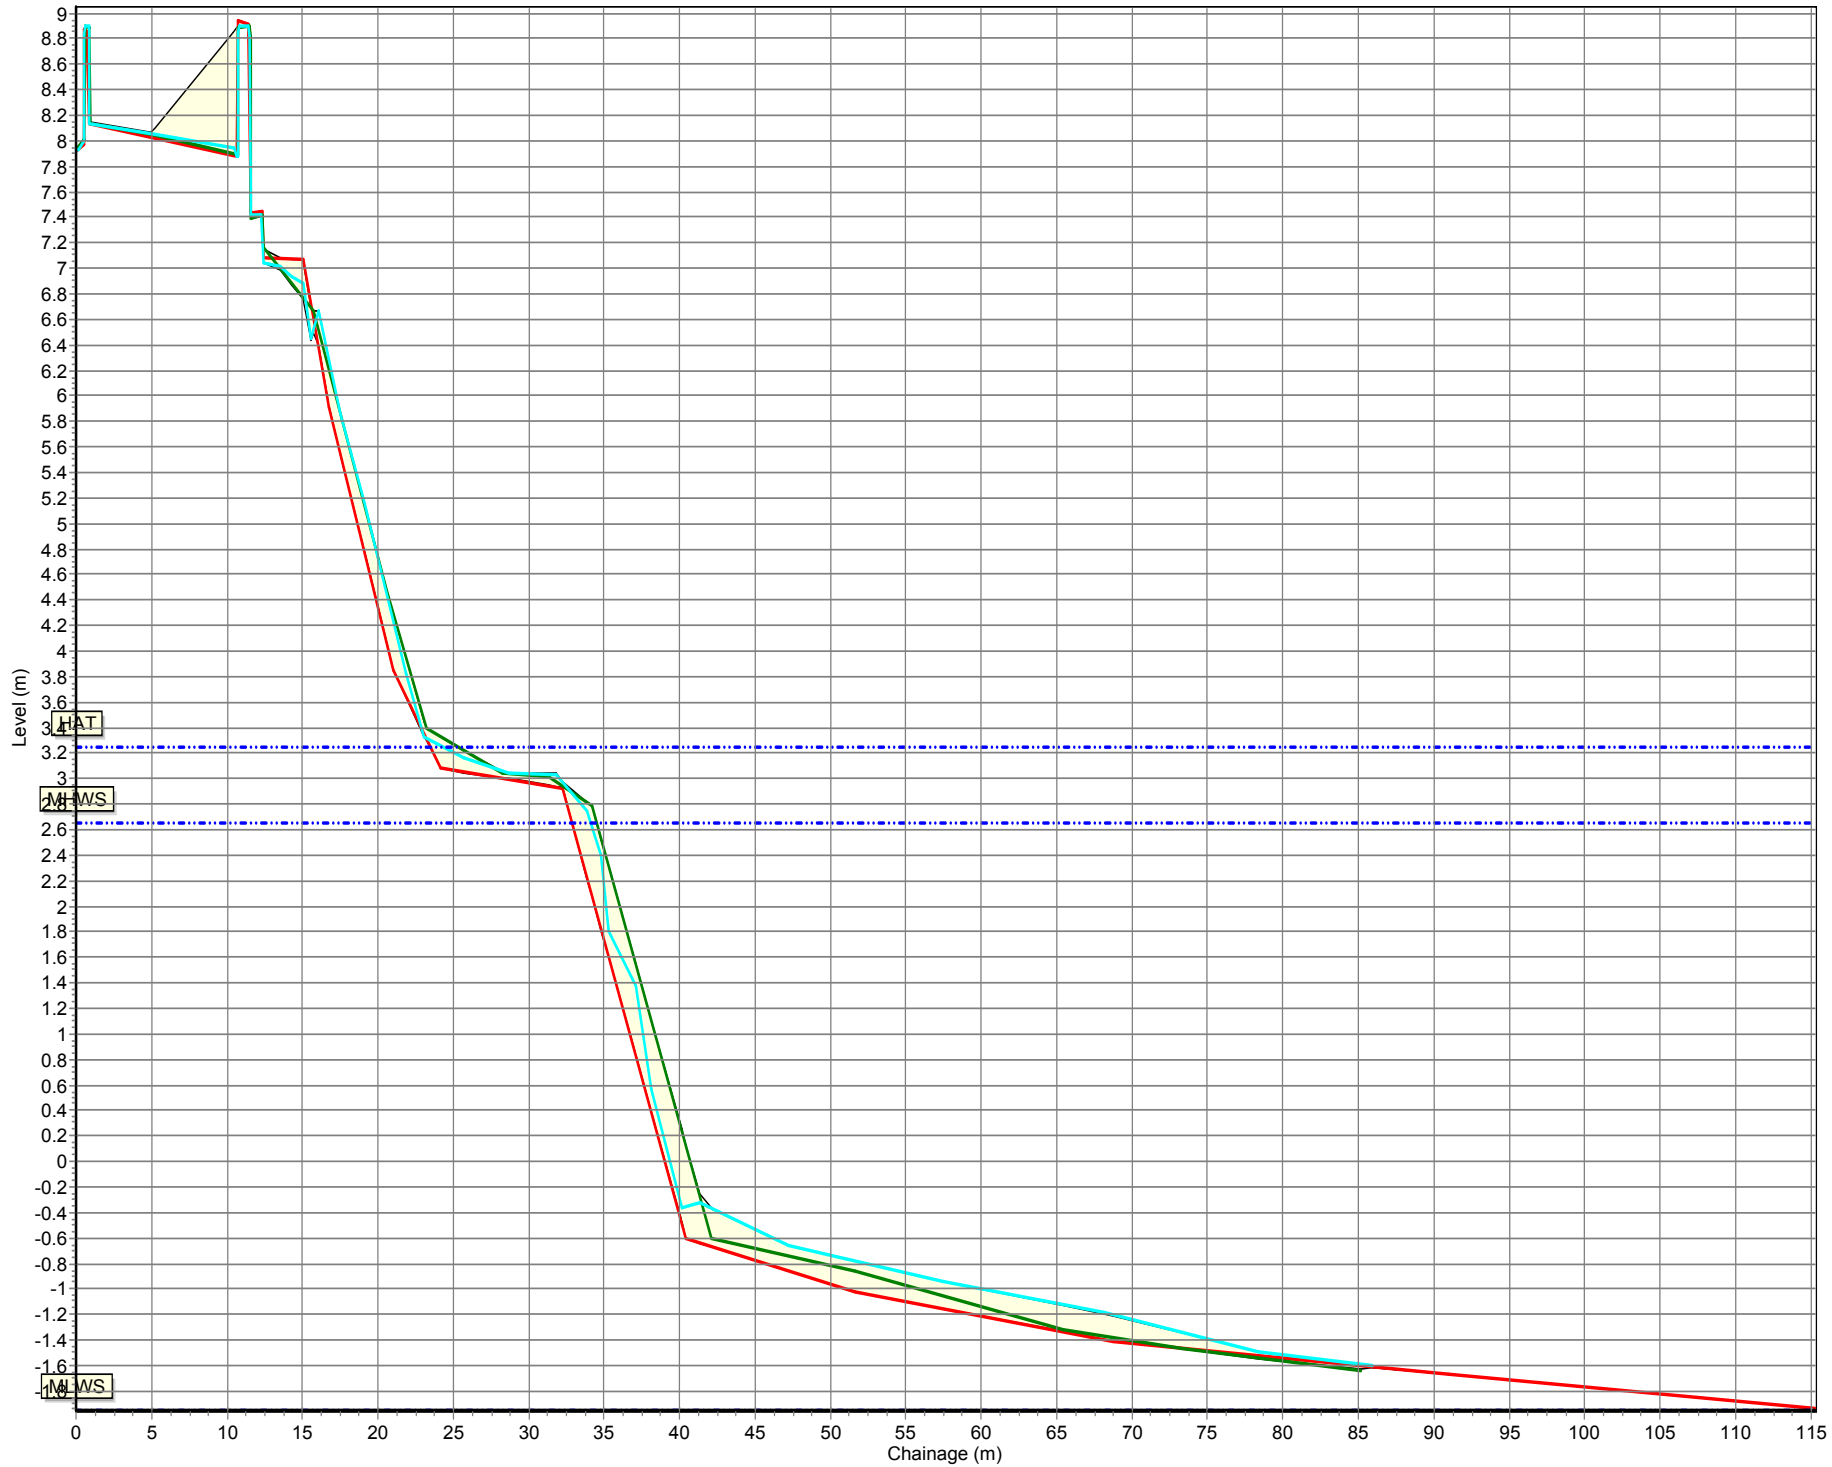
Beach Profiles: 1cHS1

1cHS1 – 12/04/2010

- Profiles Envelope
- 27/03/2009
- 11/09/2009
- 12/04/2010

| Survey Date | Description of Changes Since Last Survey | Interpretation |
|---|---|--|
| 03-2010 | <p>Beach Profiles:</p> <p>Hartlepool Bay is covered by four beach profile lines during the Partial Measures survey (Appendix A). These were not surveyed during the Full Measures survey in November 2008 for the reasons previously described and so were recorded for the first time during the present survey.</p> <p>HS1 is located approximately 150m south of the root of the South Pier. The profile starts at the wall to the rear of the promenade and extends across the promenade, over the fronting concrete splash wall and down the sloping face of the rock armour revetment before reaching the beach. It then gently slopes down to low water level at the time of the survey. The foreshore has experienced modest accretion since the September 2009 survey. It appears that there are also some changes on the seaward face of the lower part of the revetment, but this is likely to be due to the March 2010 survey picking out individual rock features more precisely than the September 2009 survey which took a point at the top and toe of the slope.</p> <p>HS2 and HS3 are similar in that they both start across the promenade and then extend down the sea wall to beach level, crossing the rock armour protection at the toe of the wall. The revetment along HS2 is also fronted by boulders. The profiles then both slope gently down to low water mark.</p> <p>HS2 experienced modest accretion along its length, although there was notable cut-back of the boulders at the toe of the revetment.</p> <p>HS3 experienced the redistribution of sediment from the upper beach, where levels dropped at the toe of the revetment by up to 1.3m, to the lower foreshore, where levels increased by up to 0.4m.</p> <p>HS4 is located further south, around 1km north of the North Gare breakwater. It is in the area of undefended dunes at Seaton Sands. The profile covers a width of approximately 350m of dunes before reaching beach level. The beach then slopes gently down to low water level. The surveyors reported problems with access in March 2010 due to dense bushes and the erection of a new security fence along the golf course. This means that parts of the landward section of this transect can no longer be surveyed. There was some minor redistribution of sediment from the upper beach, where a small berm recorded in September 2009 became flattened, to the lower foreshore where modest accretion occurred.</p> | <p>The changes experienced throughout the winter of 2009/2010 along Hartlepool Bay were very modest compared with changes experienced elsewhere across the north east of England.</p> <p>Generally, there was a modest flattening of the profile form, resulting in lowering of the upper beach levels and increase in lower beach levels.</p> |

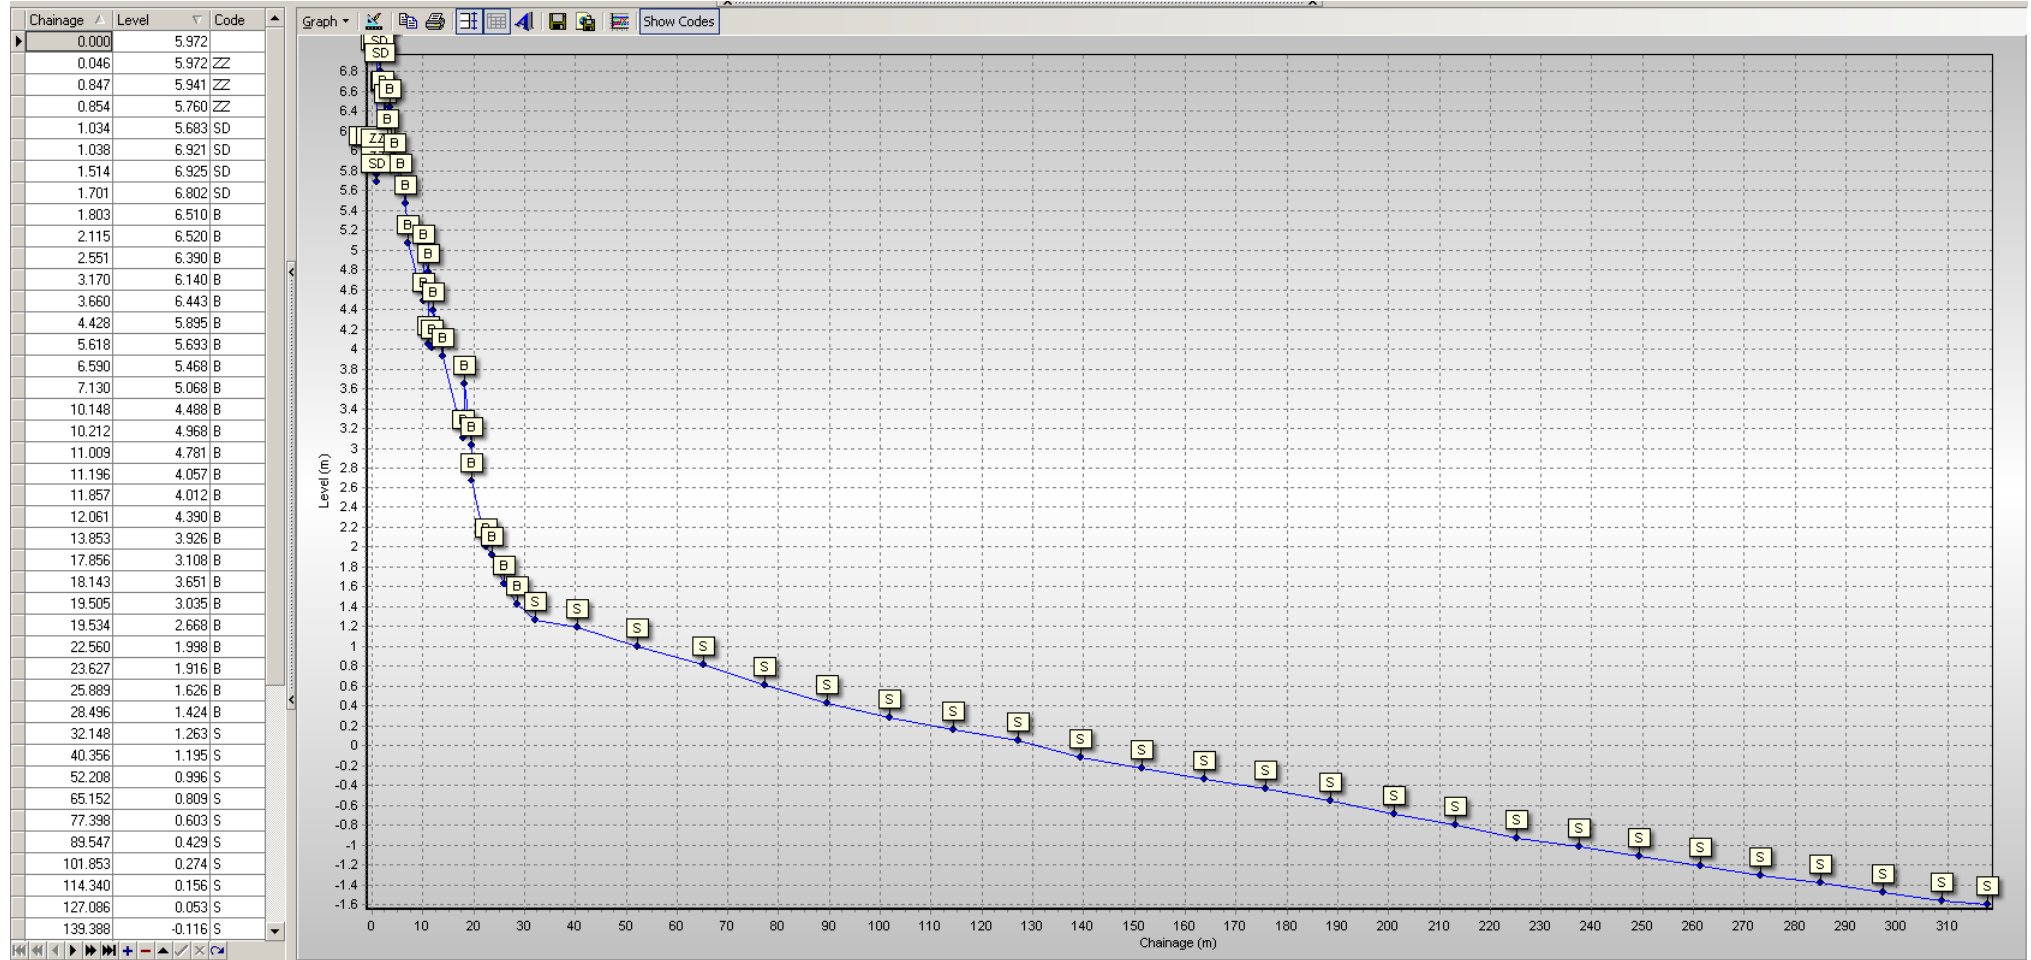
Beach Profiles: 1cHS2

1cHS2 – 12/04/2010

- Profiles Envelope
- 27/03/2009
- 11/09/2009
- 12/04/2010
