**Cell 1 Regional Coastal Monitoring Programme
Update Report 2: 'Partial Measures' Survey 2010**

**Hartlepool Borough Council
Final Report**

Update Report 2
'Partial Measures' Survey 2010

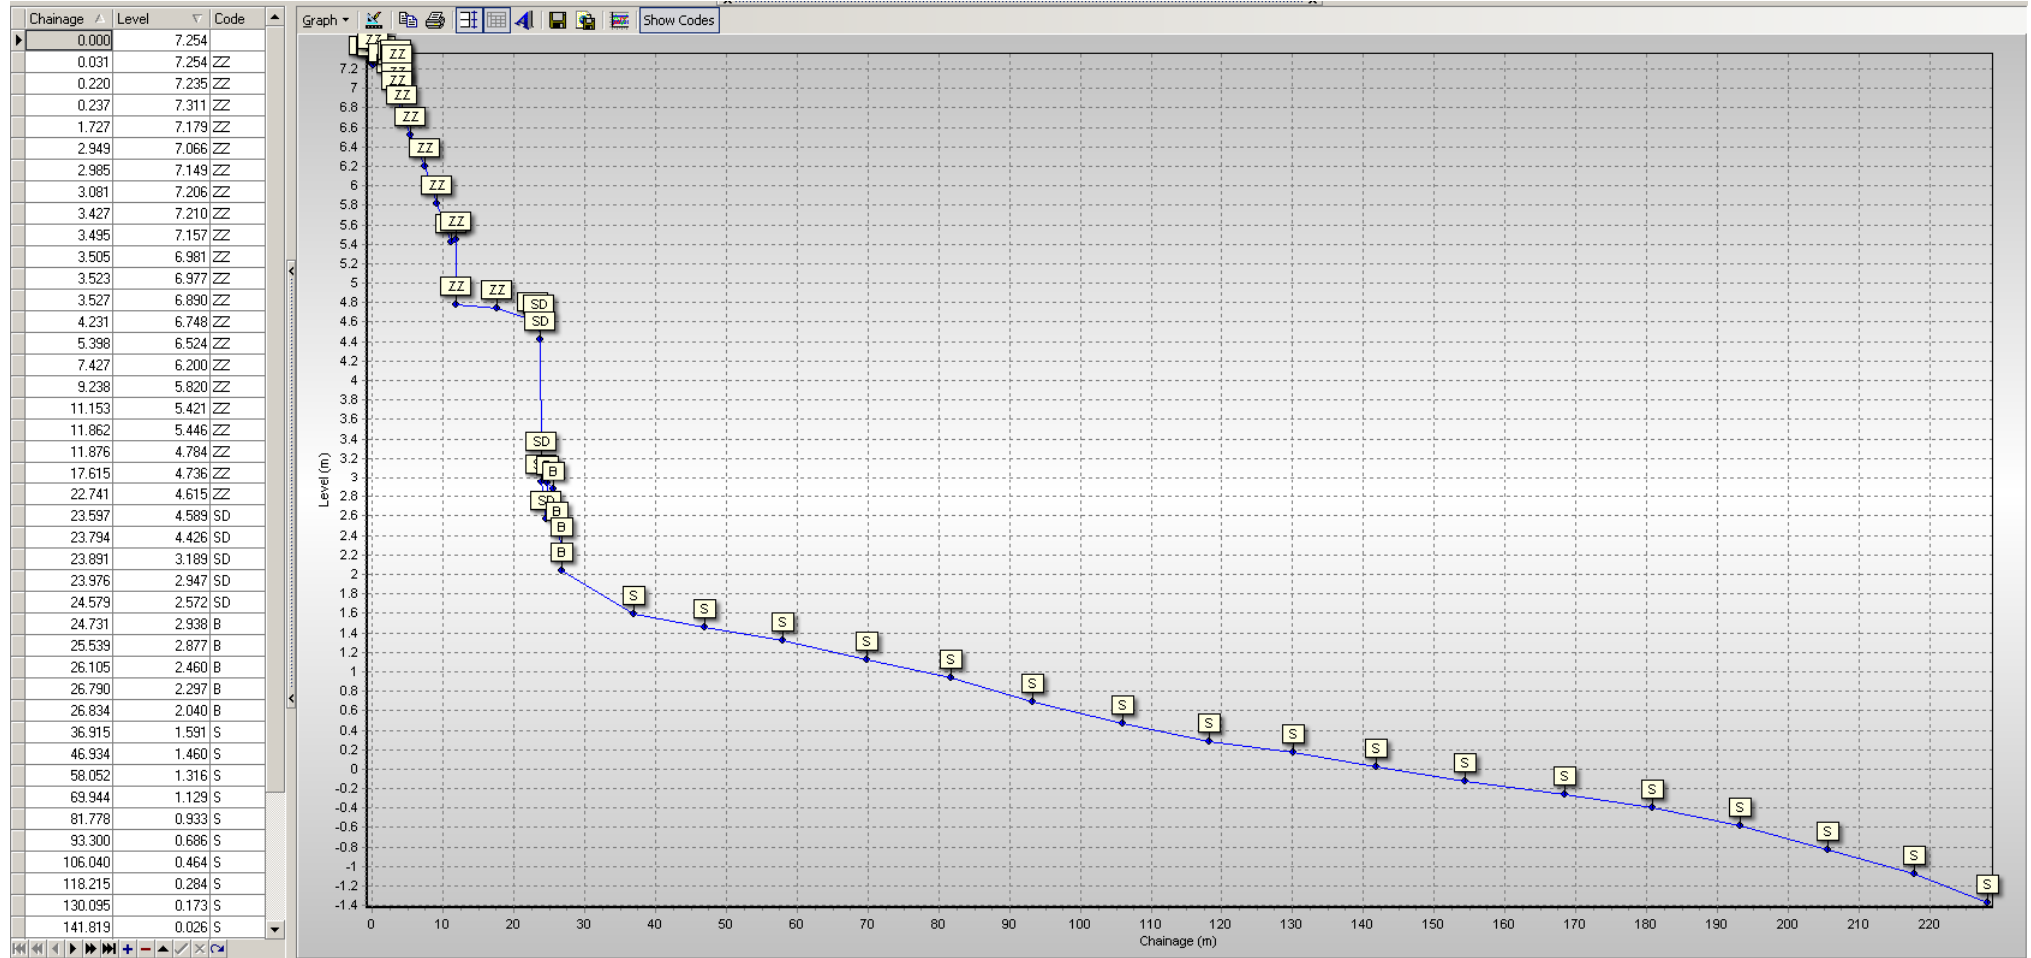
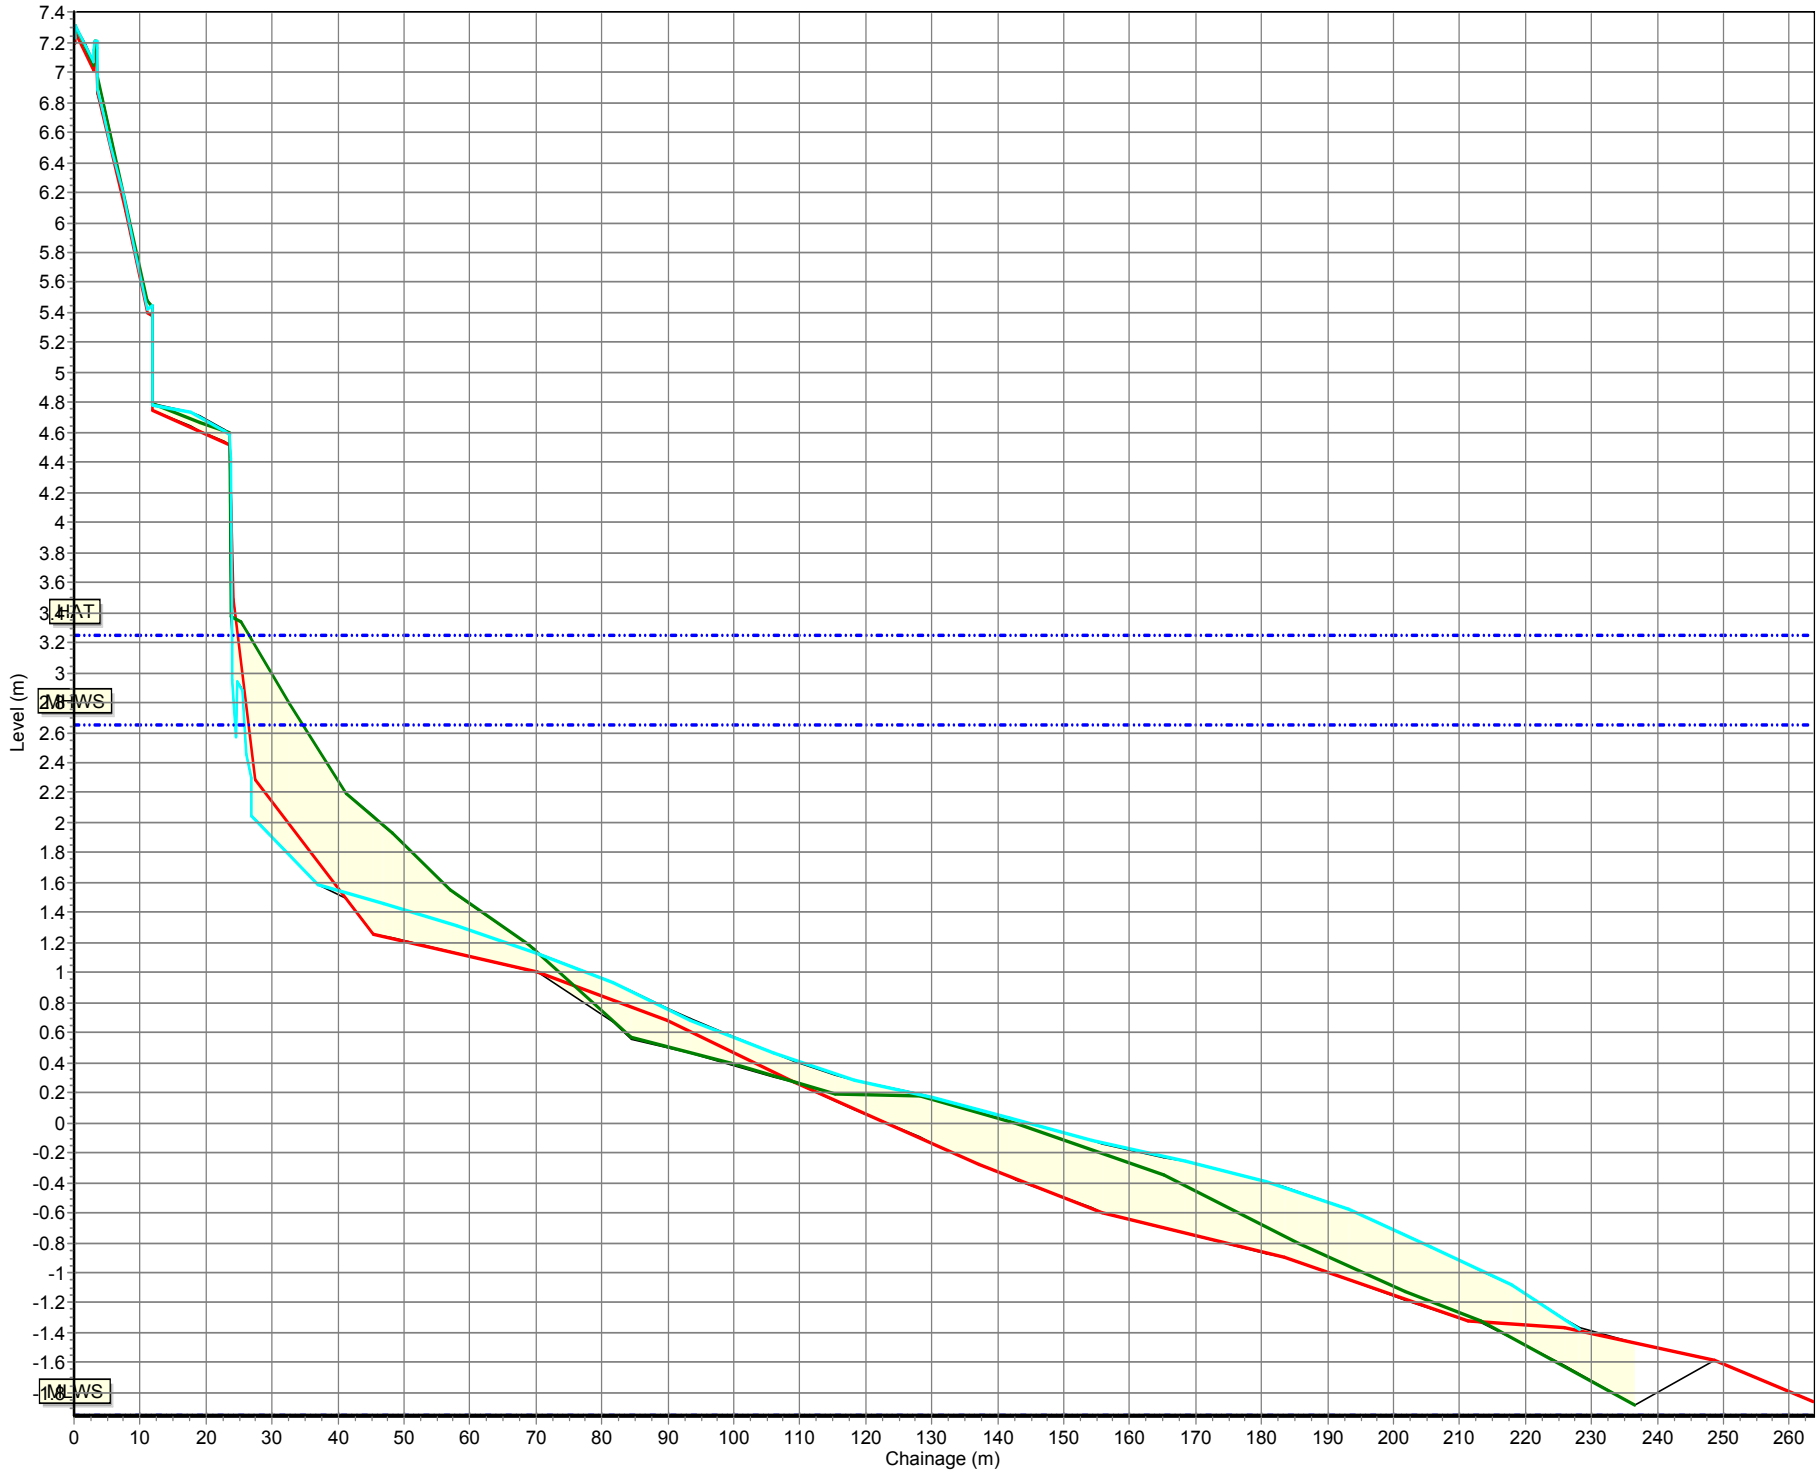
Beach Profiles: 1cHS3

1cHS3 – 12/04/2010

- Profiles Envelope
- 27/03/2009
- 11/09/2009
- 12/04/2010

| Survey Date | Description of Changes Since Last Survey | Interpretation |
|---|---|--|
| 03-2010 | <p>Beach Profiles:</p> <p>Hartlepool Bay is covered by four beach profile lines during the Partial Measures survey (Appendix A). These were not surveyed during the Full Measures survey in November 2008 for the reasons previously described and so were recorded for the first time during the present survey.</p> <p>HS1 is located approximately 150m south of the root of the South Pier. The profile starts at the wall to the rear of the promenade and extends across the promenade, over the fronting concrete splash wall and down the sloping face of the rock armour revetment before reaching the beach. It then gently slopes down to low water level at the time of the survey. The foreshore has experienced modest accretion since the September 2009 survey. It appears that there are also some changes on the seaward face of the lower part of the revetment, but this is likely to be due to the March 2010 survey picking out individual rock features more precisely than the September 2009 survey which took a point at the top and toe of the slope.</p> <p>HS2 and HS3 are similar in that they both start across the promenade and then extend down the sea wall to beach level, crossing the rock armour protection at the toe of the wall. The revetment along HS2 is also fronted by boulders. The profiles then both slope gently down to low water mark.</p> <p>HS2 experienced modest accretion along its length, although there was notable cut-back of the boulders at the toe of the revetment.</p> <p>HS3 experienced the redistribution of sediment from the upper beach, where levels dropped at the toe of the revetment by up to 1.3m, to the lower foreshore, where levels increased by up to 0.4m.</p> <p>HS4 is located further south, around 1km north of the North Gare breakwater. It is in the area of undefended dunes at Seaton Sands. The profile covers a width of approximately 350m of dunes before reaching beach level. The beach then slopes gently down to low water level. The surveyors reported problems with access in March 2010 due to dense bushes and the erection of a new security fence along the golf course. This means that parts of the landward section of this transect can no longer be surveyed. There was some minor redistribution of sediment from the upper beach, where a small berm recorded in September 2009 became flattened, to the lower foreshore where modest accretion occurred.</p> | <p>The changes experienced throughout the winter of 2009/2010 along Hartlepool Bay were very modest compared with changes experienced elsewhere across the north east of England.</p> <p>Generally, there was a modest flattening of the profile form, resulting in lowering of the upper beach levels and increase in lower beach levels.</p> |

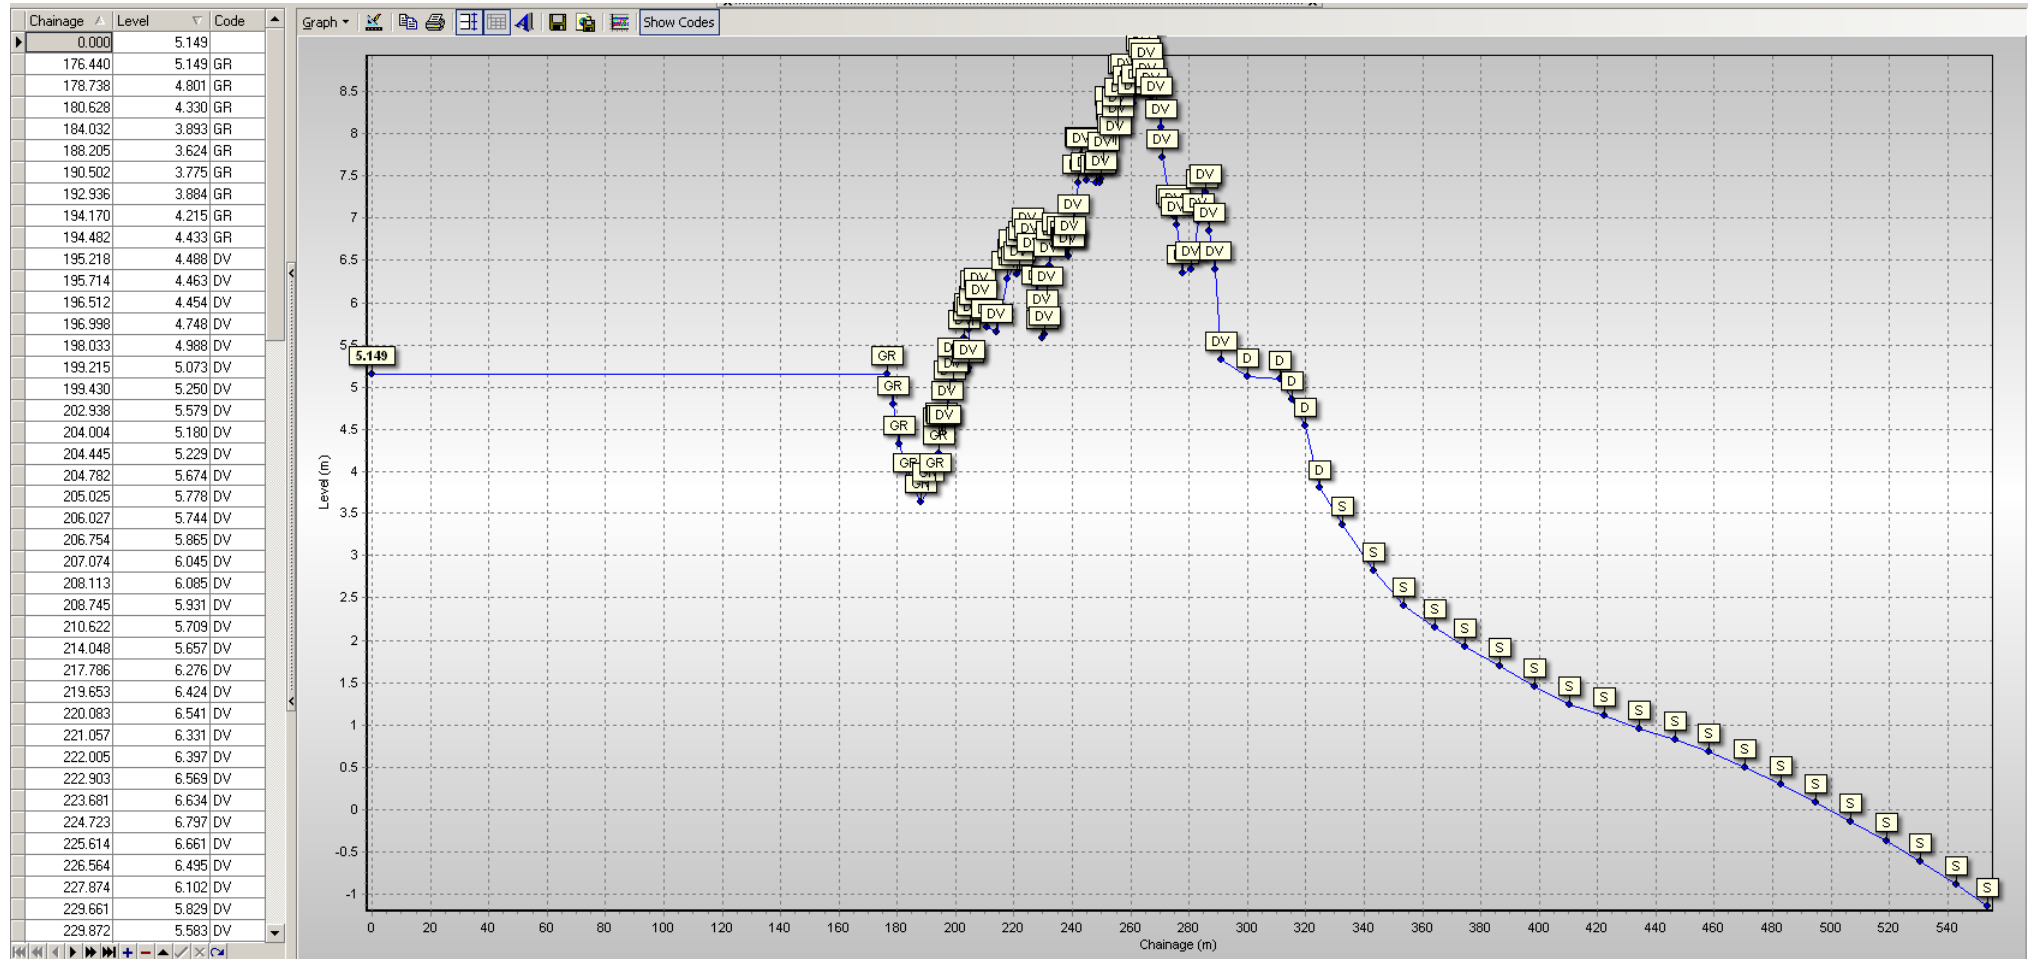
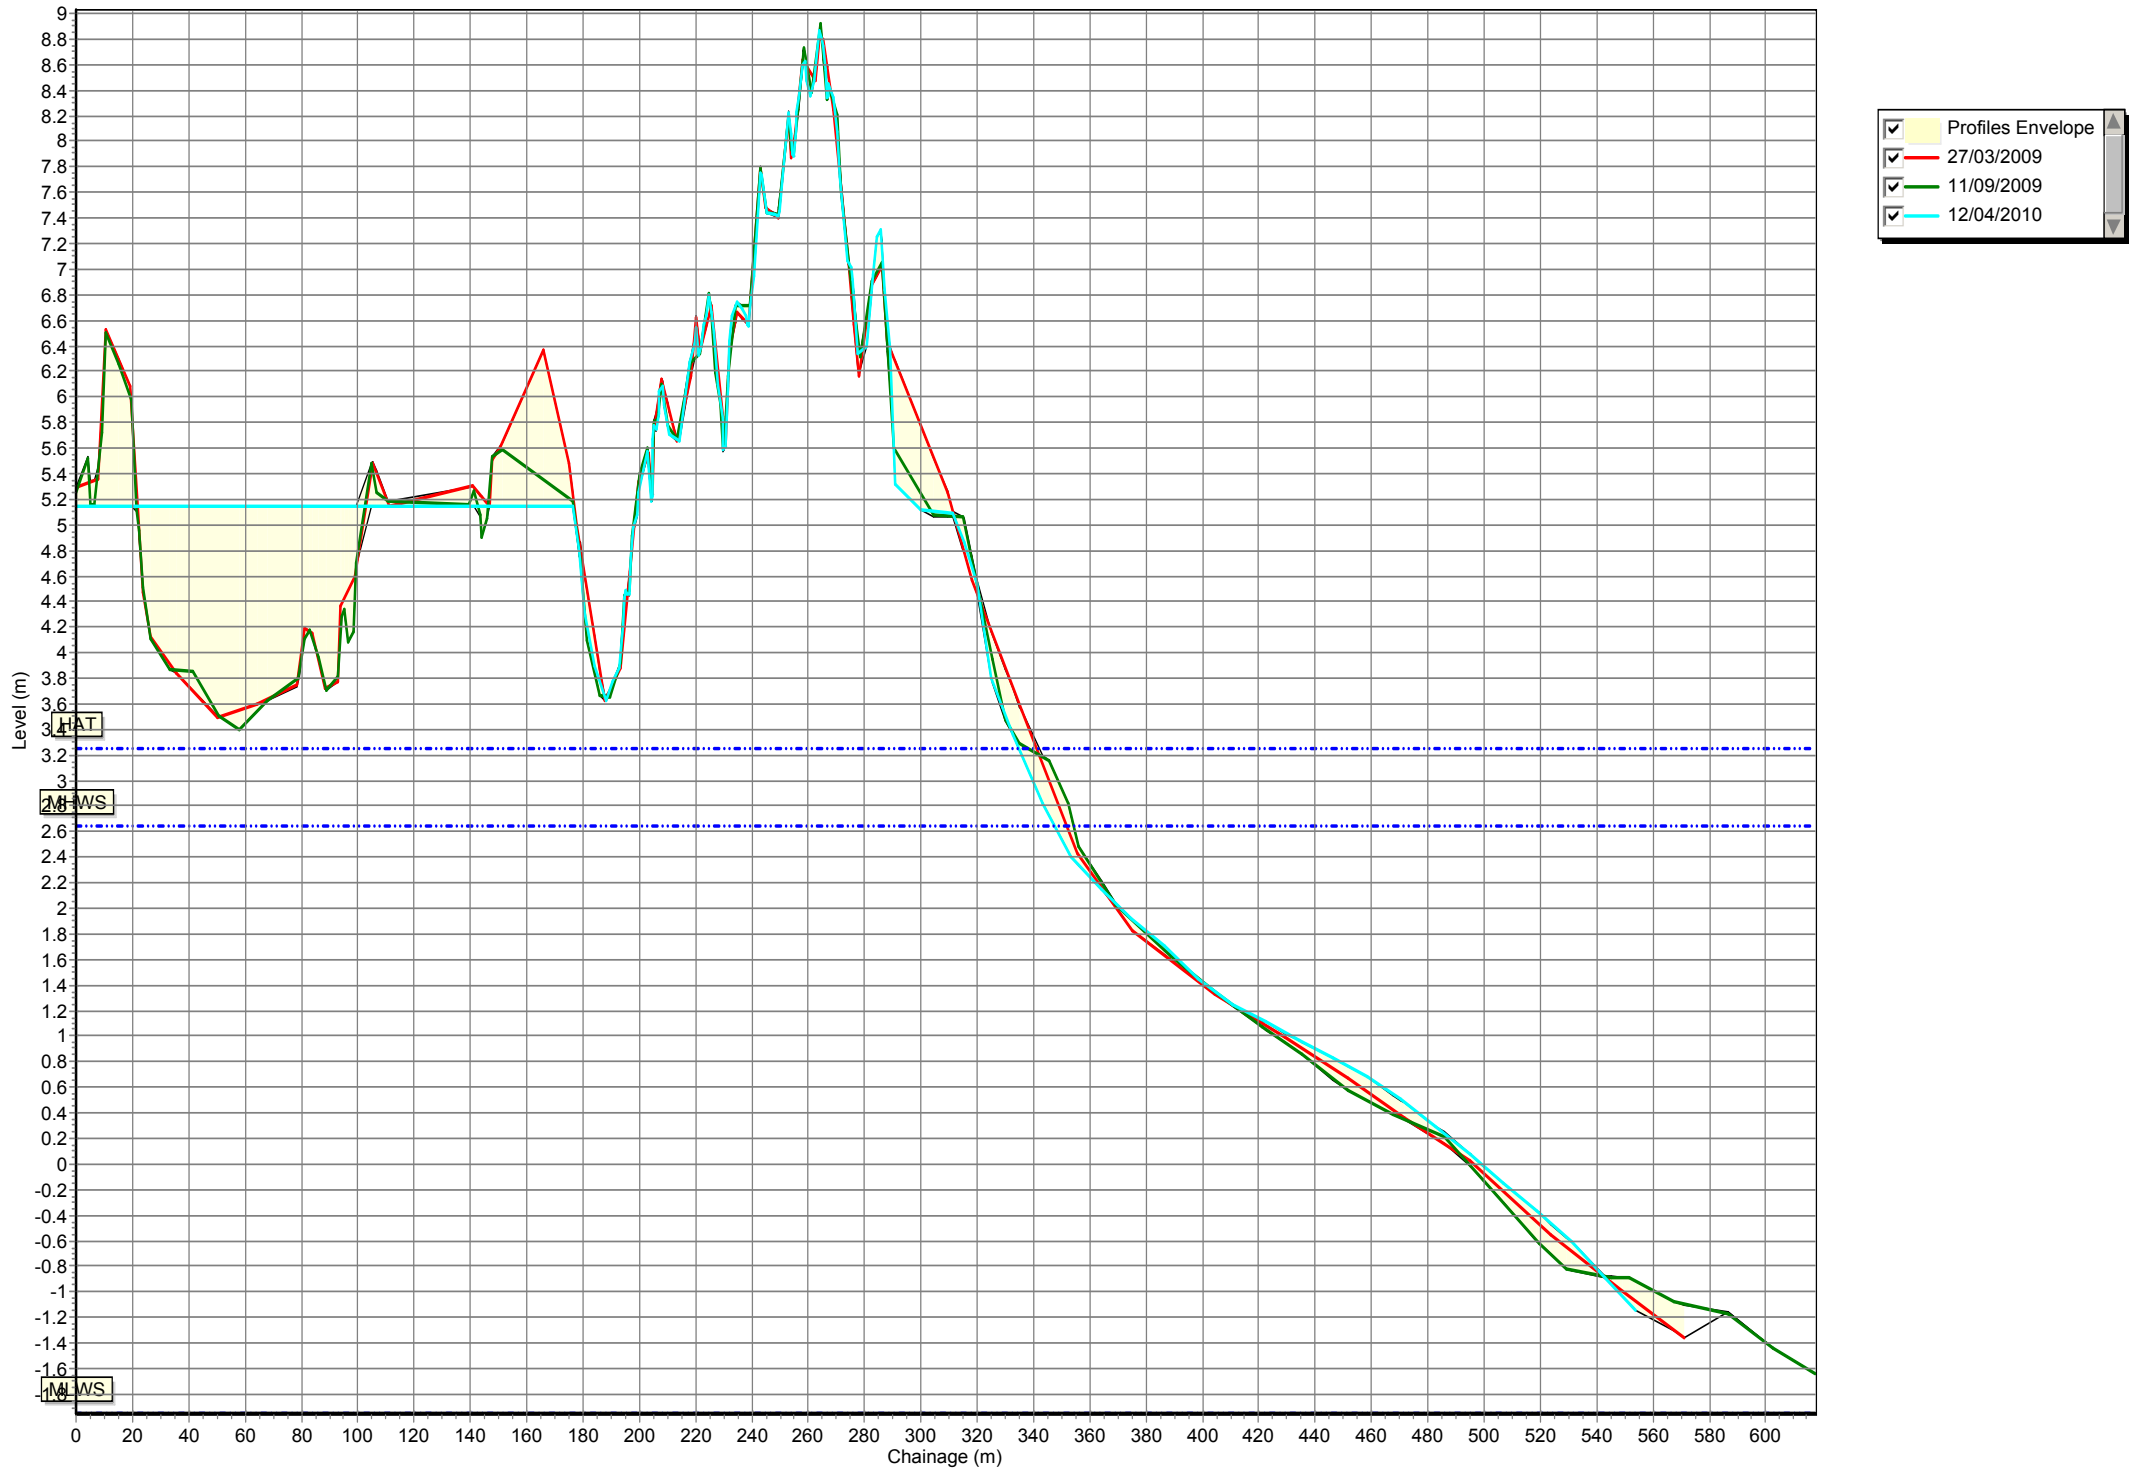
Beach Profiles: 1cHS4

1cHS4 - 12/04/2010

Access constraints mean that parts of the landward sections of transects HC1 and HS4 can no longer be surveyed. This is not considered significantly adverse because the ability to survey the seaward sections of these profiles (seaward of the wall or dune defences) remains unaffected.
