**Cell 1 Regional Coastal Monitoring Programme
Update Report 4: 'Partial Measures' Survey 2012**

(*) The present report is **Update Report 4** and provides an analysis of the 2012 Partial Measures survey for Hartlepool Council's frontage.

Update Report 4
 Partial Measures Survey
 Spring 2012

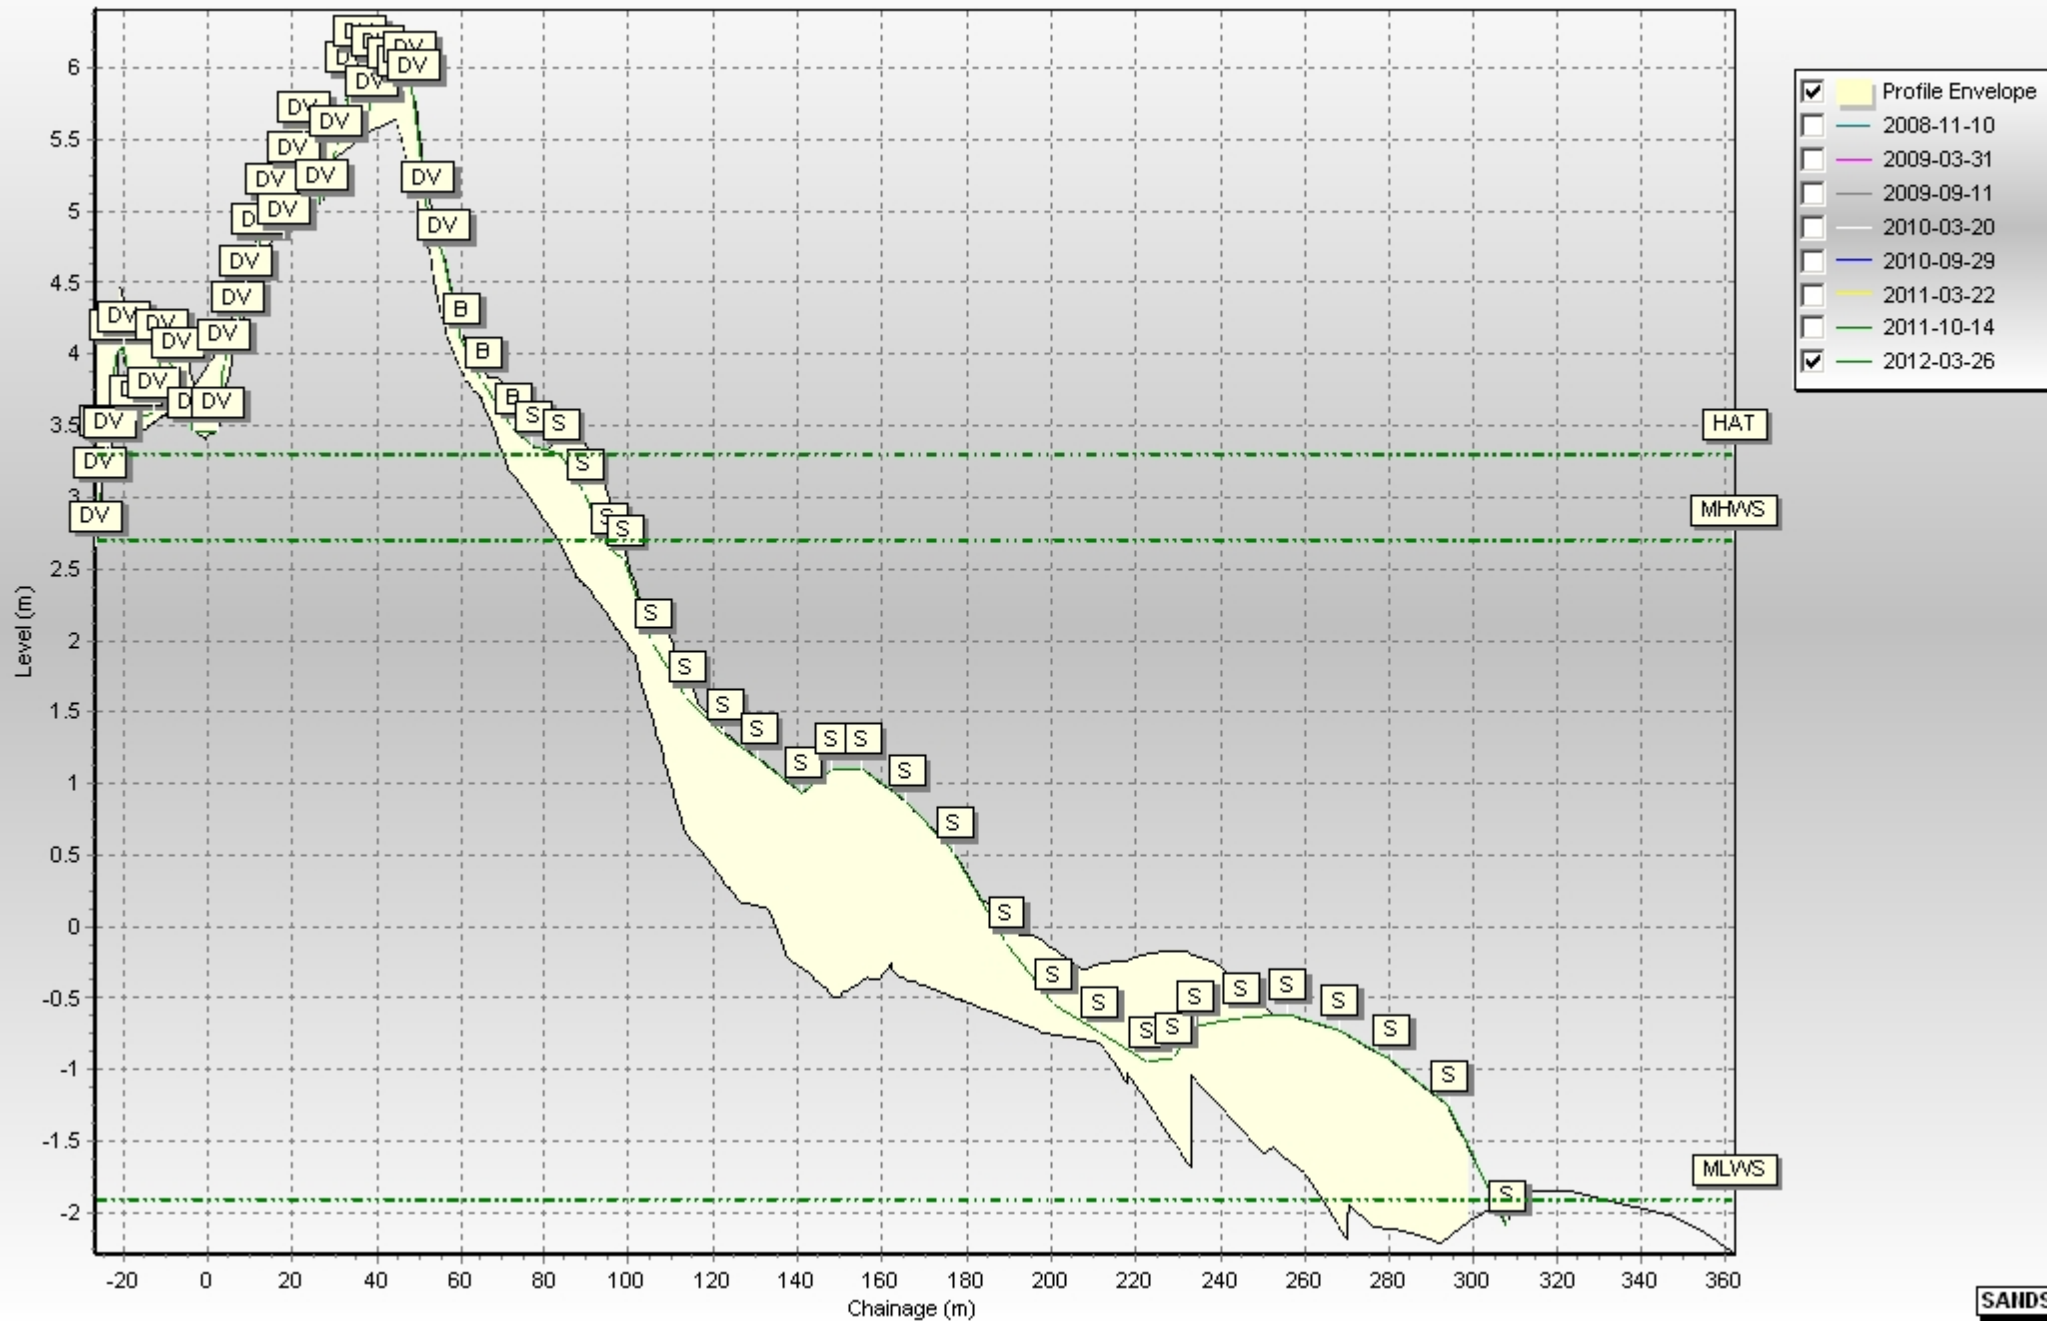
Beach Profiles: 1cHN1

Survey Date	Description of Changes Since Last Survey	Interpretation
26/03/12	<p>Beach Profiles:</p> <p>North Sands is covered by four beach profile lines during the Partial Measures survey (Appendix A) that were last surveyed in October 2011.</p> <p>Profile HN1 is located within Durham County Council's jurisdiction, about 400m north of the outfall of Crimdon Beck, but has been reported here so changes can be interpreted in association with those observed elsewhere along North Sands at HN2, HN3 and HN4. The form of both the beach and the dune sections of the profile in March 2012 were very similar to that recorded in October 2011. The upper beach is similar to the previous survey. Between MLWS and MHWS a second berm has appeared on the beach. It is considered likely that the single berm recorded in October 2011 was re-worked to form two features. The growth of the berms represents a gain of up to 0.6m in some places and erosion of around 0.5 in other places. Overall the volume of the beach appears to have remained stable.</p> <p>Profile HN2 shows stability from 0m chainage to 50m chainage. At 50m chainage a berm has appeared since October 2011 what indicates localised accretion of c. 0.5m over the summer months. The rest of the beach has accreted by 0.4m since October 2011 and the small berm that was present in October had been removed by March 2012.</p> <p>Profile HN3 exhibited very little change above HAT. The 0.7m high beach berm that was present between 80m and 100m chainage in October 2011 has been flattened. Below the level of the berm a depression that had form during the October 2011 survey had been filled in. The beach overall has flatten and reached a gradient comparable with the other surveys which have been carried out at this location.</p> <p>Profile HN4 showed that the beach had eroded by 0.4m overall, which is to be expected during the winter. A berm had developed in the middle of the beach over the winter months that indicated accretion of around 0.25m since the last survey.</p>	<p>Profiles HN1 and HN2 are showing widespread accretion over the winter, which is likely to be due to the erosion of material from above the beach or from alongshore areas. Since the last survey, profiles HN3 and 4 have lost material, which is a typical beach response to winter storm events.</p> <p>Longer term trends: All the profiles appear to be stable above the HAT line with variation of the beach below. At HN1 and 2 the beach levels were among the highest recorded since October 2008.</p> <p>At HN3 beach gradient recorded was similar to the previous spring profiles recorded at this location although the level was lower.</p> <p>At HN4 the beach shows a reasonably high level of variability. The March 2012 beach level was comparatively low, with the rocks at the lowest extent of the survey being exposed.</p>

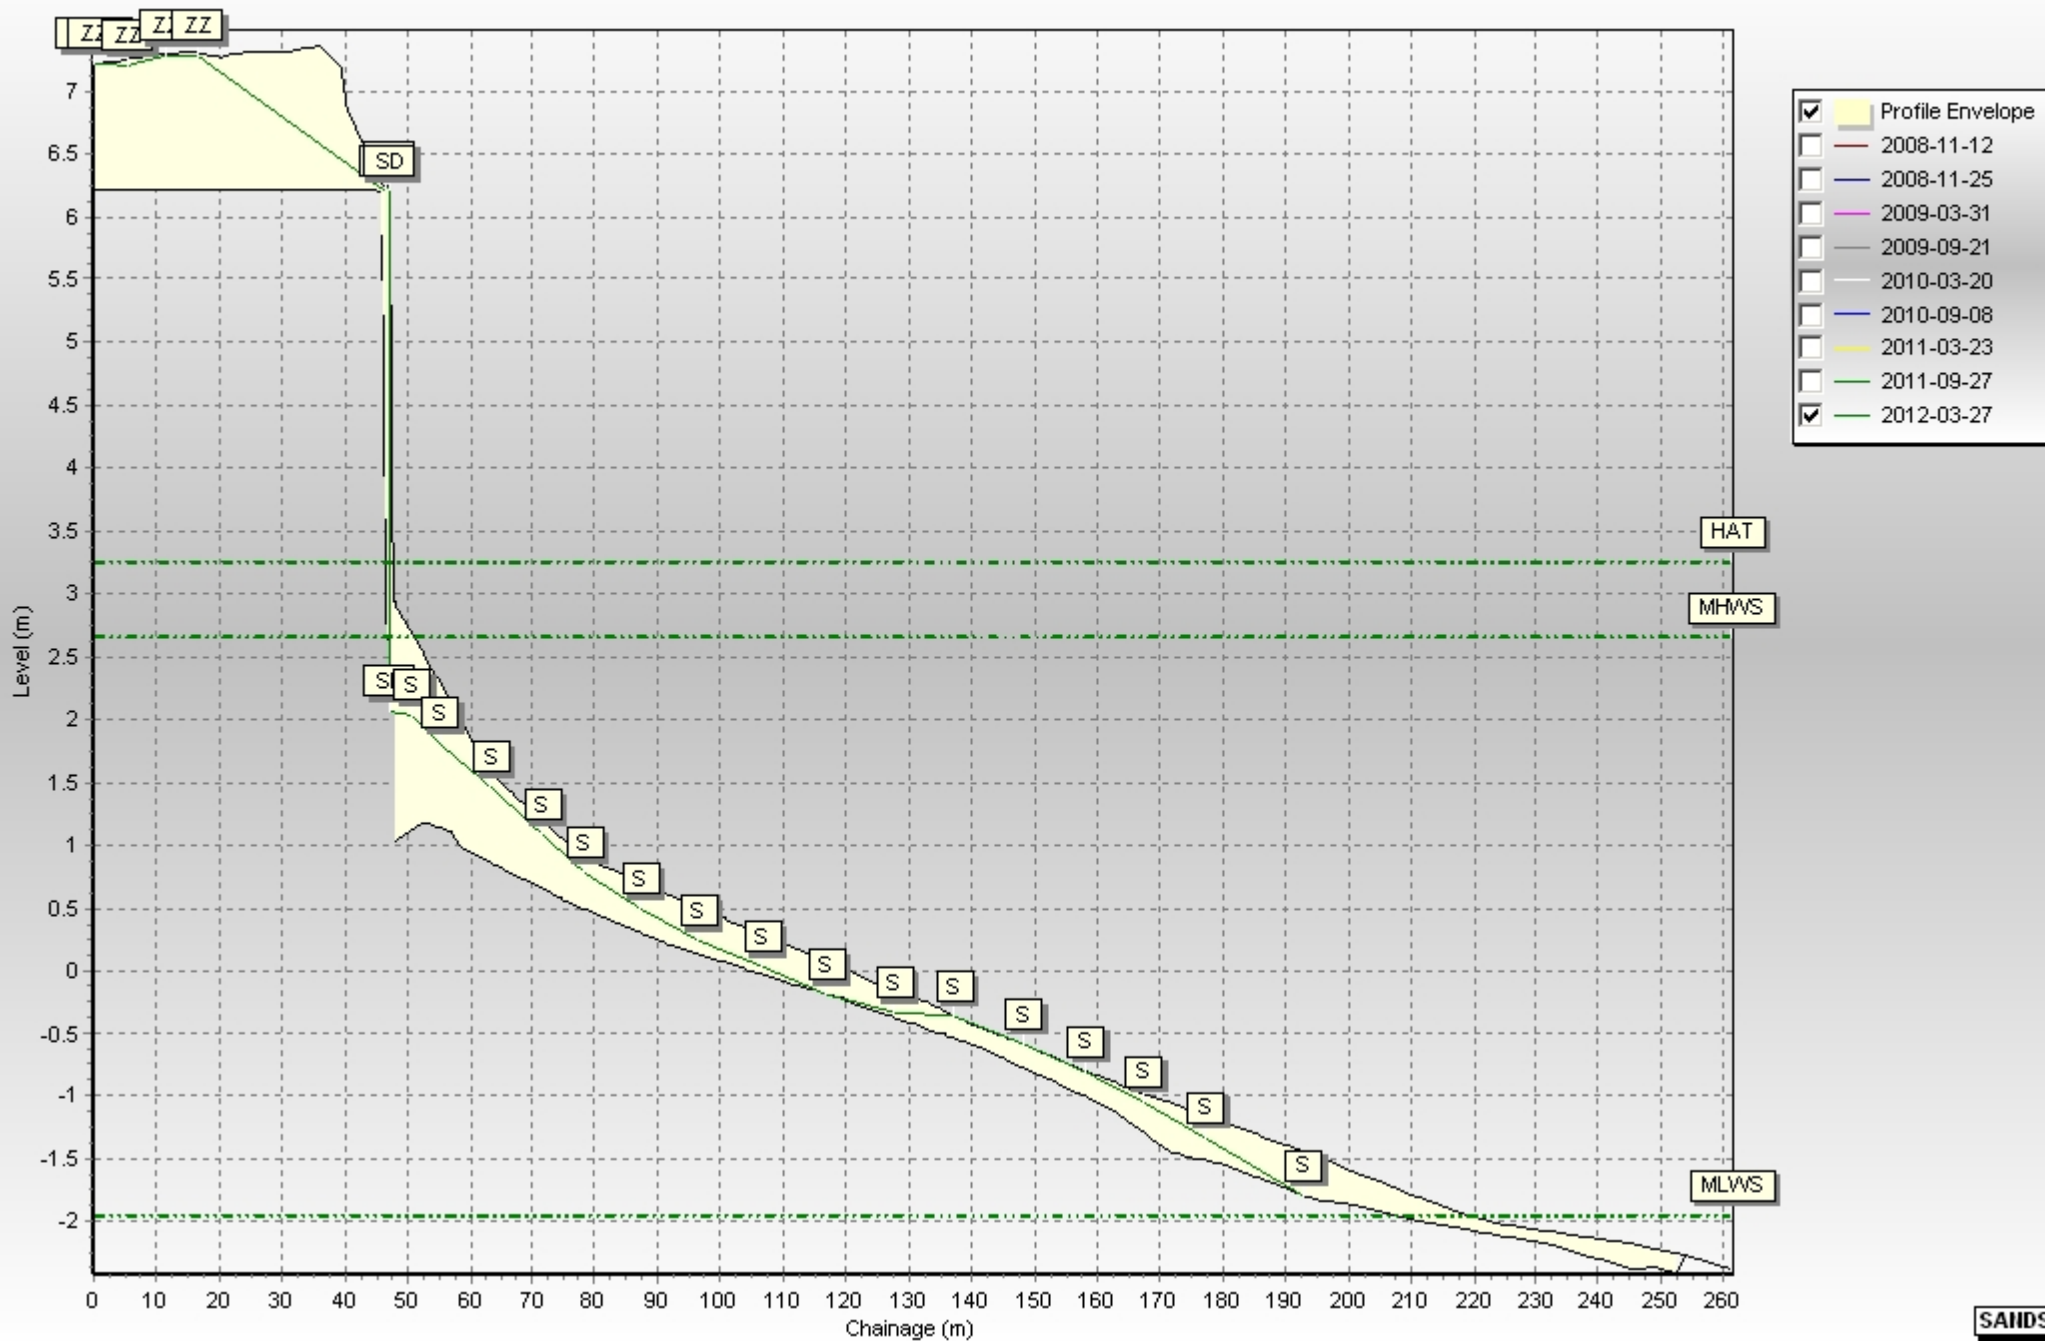
Beach Profiles: 1cHC1

Survey Date	Description of Changes Since Last Survey	Interpretation
27/03/12	<p>Beach Profiles:</p> <p>Middleton is covered by one beach profile line during the Partial Measures survey (Appendix A). The profile was last surveyed in September 2011.</p> <p>Profile HC1 has reasonably high compared to the last survey. At the toe of the defence and between 140 to 185m chainage the beach has accreted over the 2011/12 Winter. Between 70m and 140m the beach has eroded by a maximum of only 0.2m,.</p>	<p>The beach was at a high level compared to the previous surveys.</p> <p>Longer term trends: The beach level at this location tends to fluctuate through time, with the most variable area being adjacent to the sea wall. There is no clear pattern in the beach variability, with no obvious signal of long term change. The March 2012 surveys are the most similar to the March and September 2009 surveys.</p>

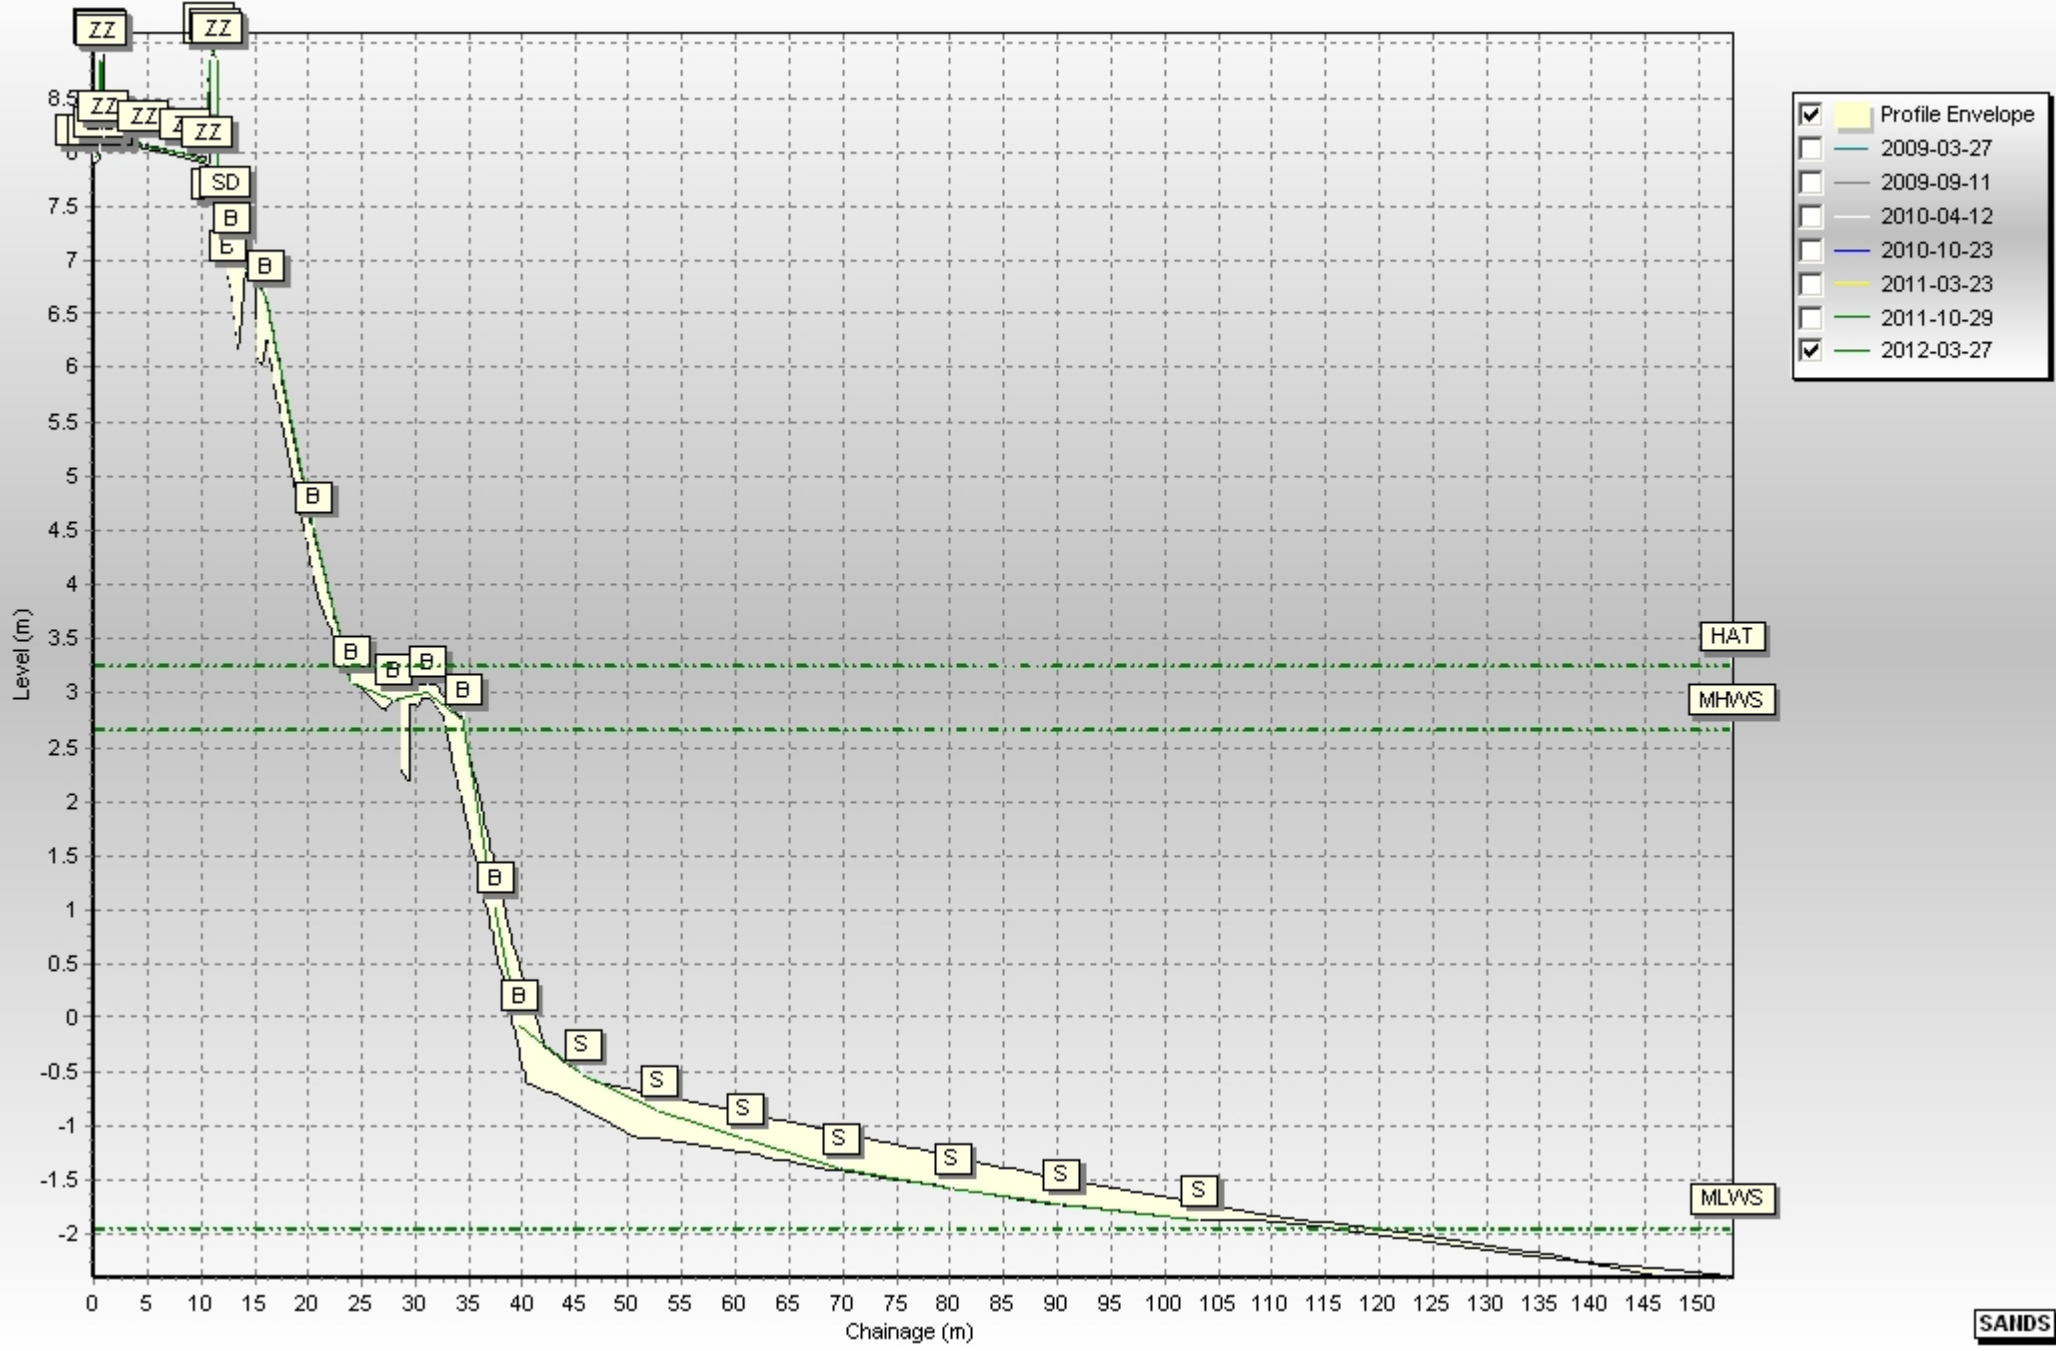
Beach Profiles: 1cHS1

Survey Date	Description of Changes Since Last Survey	Interpretation
26/03/12	<p>Beach Profiles:</p> <p>Hartlepool Bay is covered by four beach profile lines during the Partial Measures survey (Appendix A). The profiles were last surveyed in October 2011.</p> <p>Profile HS1 is located approximately 150m south of the root of the South Pier. The profile starts at the wall to the rear of the promenade and extends across the promenade, over the fronting concrete splash wall and down the sloping face of the rock armour revetment before reaching the beach. The majority of changes in the profile occur beyond 40m chainage. The beach level is comparable overall to the last survey. Close to the sea wall the beach has accreted by 0.4m since the last survey. Beyond 70m chainage the beach appears to have eroded by around 0.25m, which shows that overall the beach is steepening, with a net transfer of sediment towards the back of the beach. HS2 has a similar pattern of change and is also steepening, with the upper beach accreting by around 0.1m in most places and the lower beach eroding by up to 0.2m</p> <p>At profile HS3 during the March 2012 survey there were sea defence construction works taking place on the beach. As a result there is a new sea wall apparent. The October 2011 full measures survey for HS3 was not carried at this location out due to the construction works and therefore the last survey at this location is March 2011. When the current survey is compared to the March 2011 survey the beach profiles are very similar, although accretion of around 0.3m is visible along the whole profile. The March 2012 profile should be taken as the new baseline for future changes because the effect of the new defence on the beach.</p> <p>Profile HS4 is located around 1km north of the North Gare Breakwater, within the area of undefended dunes at Seaton Carew. The main dune ridge has remained very stable over time, but a foredune developing on the seaward face in October 2010 was reduced in crest height by March 2012. A lobe of material was seen between HAT and MHWS in the current survey, which is a similar size to the foredune seen in the last survey. This could be evidence of collapse of the foredune and reworking of sediment into the beach system. The level of the beach was reasonably high and changed in elevation by $\pm 0.25\text{m}$ along the foreshore since October 2011. The overall morphology and elevation of the profile has not changed since October 2011.</p>	<p>The beach profiles at HS1 and HS2 have become steeper over the winter of 2011/12, as sediment has been transferred towards the back of the beach. This transfer of sediment is typical of winter conditions. Profile HS3 has been the location of a new sea defence and consequently the current survey cannot be directly compared to past surveys. However, since construction of the defence, the beach level does appear to have risen compared to surveys since March 2009.</p> <p>At HS4 the level of the upper beach is high compared to previous surveys, which could be due to the collapse of the fore dune on to the beach and reworking of sediment. The lower half of the beach, beyond 400m chainage, is lower than the previous surveys. The profile is steeper than the previous profiles, showing the same pattern of transfer of sediment to the back of the beach during winter.</p> <p>Longer term trends: The beach levels are high and healthy. It is noteworthy that the profiles have all steepened over the last six months or more. However, there are no obvious trends of behaviour over the long term apart from the natural fluctuation of the beach level.</p>
