Cell 1 Regional Coastal Monitoring Programme Update Report 9: 'Partial Measures' Survey 2017

Hartlepool Council

July 2017

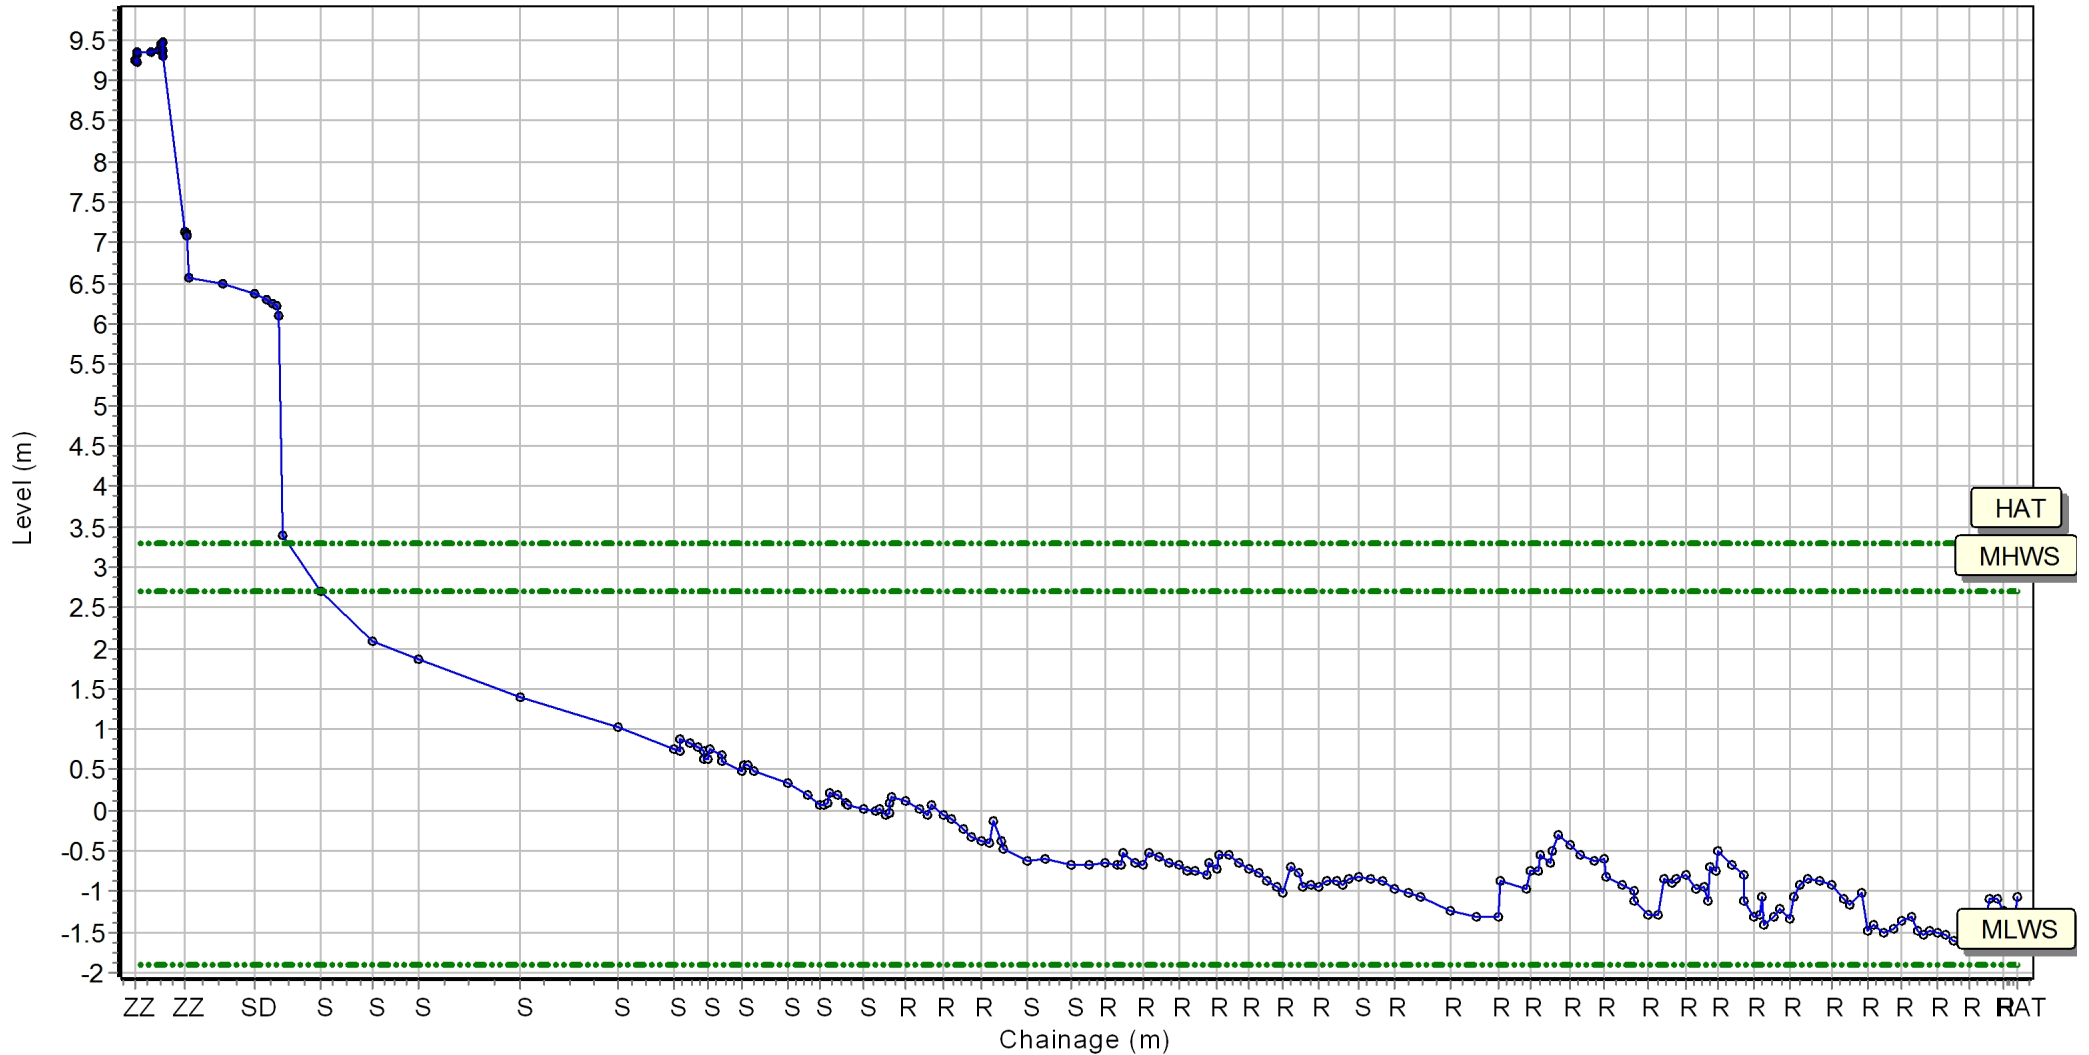
Location: 1cHN4A

Summary: 2017 Partial Measures Topo Survey

Easting: 451997.114 Northing: 534616.627 Profile Bearing: 25 ° from North

Beach Profile

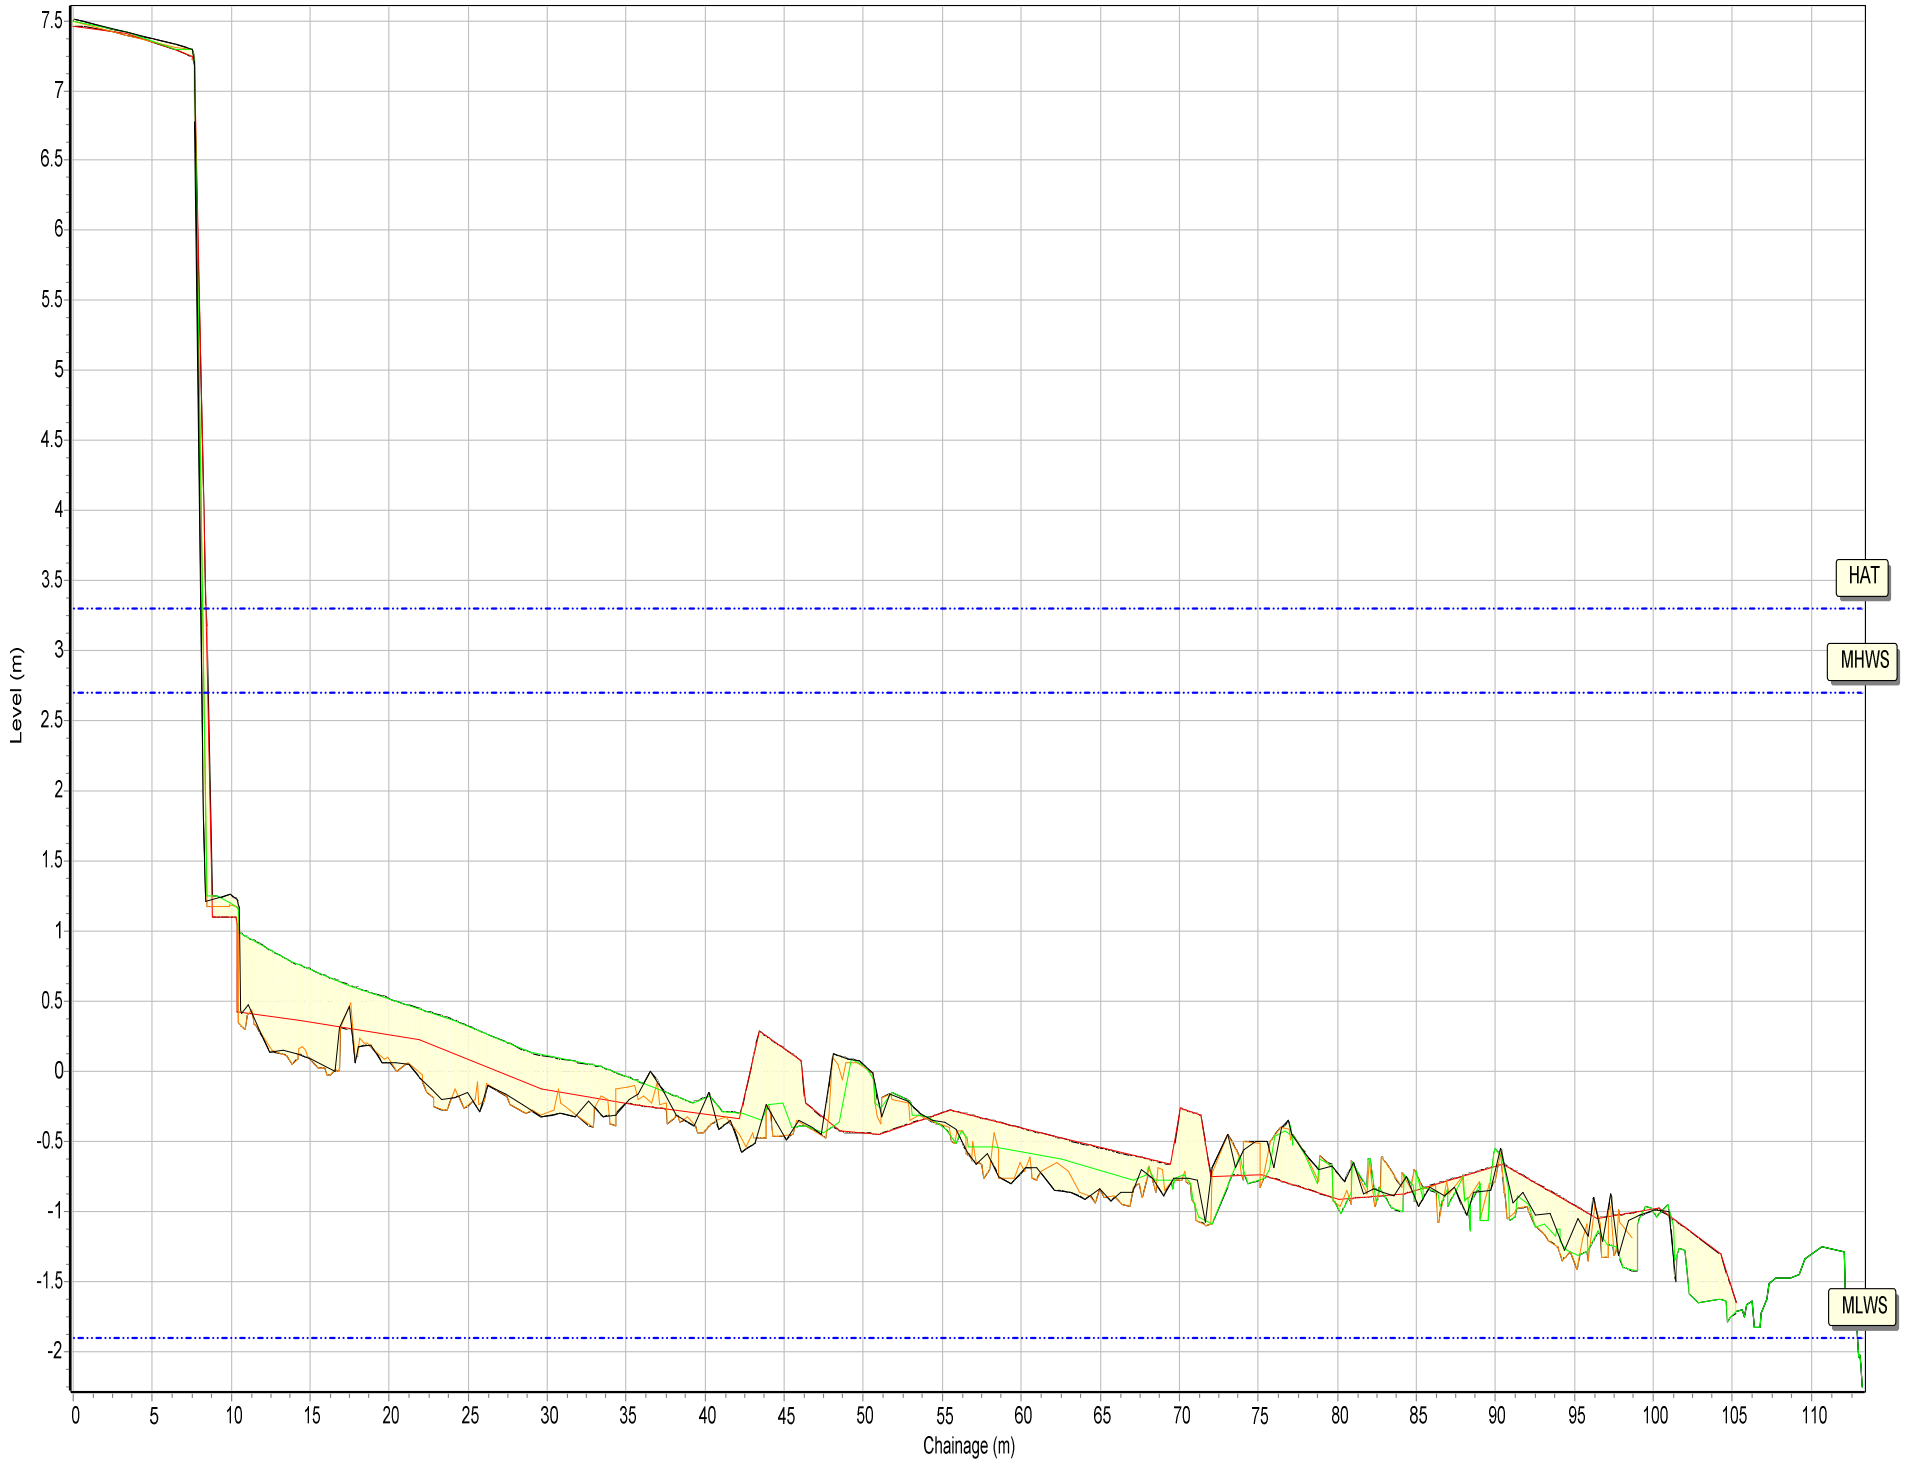
Beach Profiles: 1cHN4A

Survey Date	Description of Changes Since Last Survey	Interpretation
	<p>between chainage 115m to 160m of <0.2m, and up to 0.7m between chainage 160m and 245m. The only area of accretion is at the toe of the beach, seawards of chainage 245m, with accretion of up to 0.7m, extending the toe of the beach seawards by c.50m. Overall the beach is at a medium-low level compared to the range recorded from previous surveys, with the exception of the toe of the beach which is relatively high.</p> <p>At Profile 1cHN3 there has been little change to the dunes, however the fore dune at 35m-40m chainage has accreted by 0.1m since August 2016. The upper beach between chainage 40m and 80m has dropped by up to 0.8m, removing the berm previously recorded at chainage 70m. Between chainage 80m and 160m the beach has accreted slightly by up to 0.2m. From chainage 160m to 250m the beach has eroded by up to 0.4m. The toe of the beach seawards of 250m shows accretion of 0.5m, extending the toe seawards by c.40m. Overall the profile is at a low level compared to the range recorded from previous surveys, particularly between chainages 40m-75m, 160-180m, and 215m-230m which have the lowest recorded levels.</p> <p>At Profile 1cHN3a the dune front at 20m chainage has remained stable since March 2014. Beyond 20m chainage the rest of the beach level has dropped by up to 0.6m since August 2016, creating a smoother profile. Overall the profile is at its lowest recorded level between chainage 20m and 140m, seawards of chainage 140m the profile is at a more medium level.</p> <p>Profile 1cHN4 shows little change in the defended part of the profile. Between chainage 15m and 60m the sandy upper beach has increased in level by up to 0.4m. From 60m to the end of the survey at 200m chainage the rocks at the bottom of the beach are exposed (with some small patches of accumulated sand), which is common for this profile. From chainage 62m to 105m the exposed platform was previously covered by sand in the August 2016 survey. The upper beach is at a relatively medium level compared to the range recorded from the previous surveys, with the remainder of the profile at a relatively low level with the rock platform exposed.</p> <p>Profile 1cHN4a was established in October 2011. The defended part of the profile to 10m chainage has not changed since October 2011. The rocky shore platform is exposed over the remainder of the profile, which is due to a drop in beach level of up to 0.6m since the previous survey in August 2016 between chainage 10m and 40m. From chainage 40m seawards the rock platform remains exposed as it was in the previous survey. The profile is therefore at a relatively low level compared to the range recorded in previous surveys as no beach is present at all, with the rock platform exposed over the full profile.</p>

- At Middleton there was no access to upper section on profile 1cHC1.
- Construction work was being carried out on new coastal defences to the east of profile 1cHN4A.
- The rest of the survey was completed without incident.

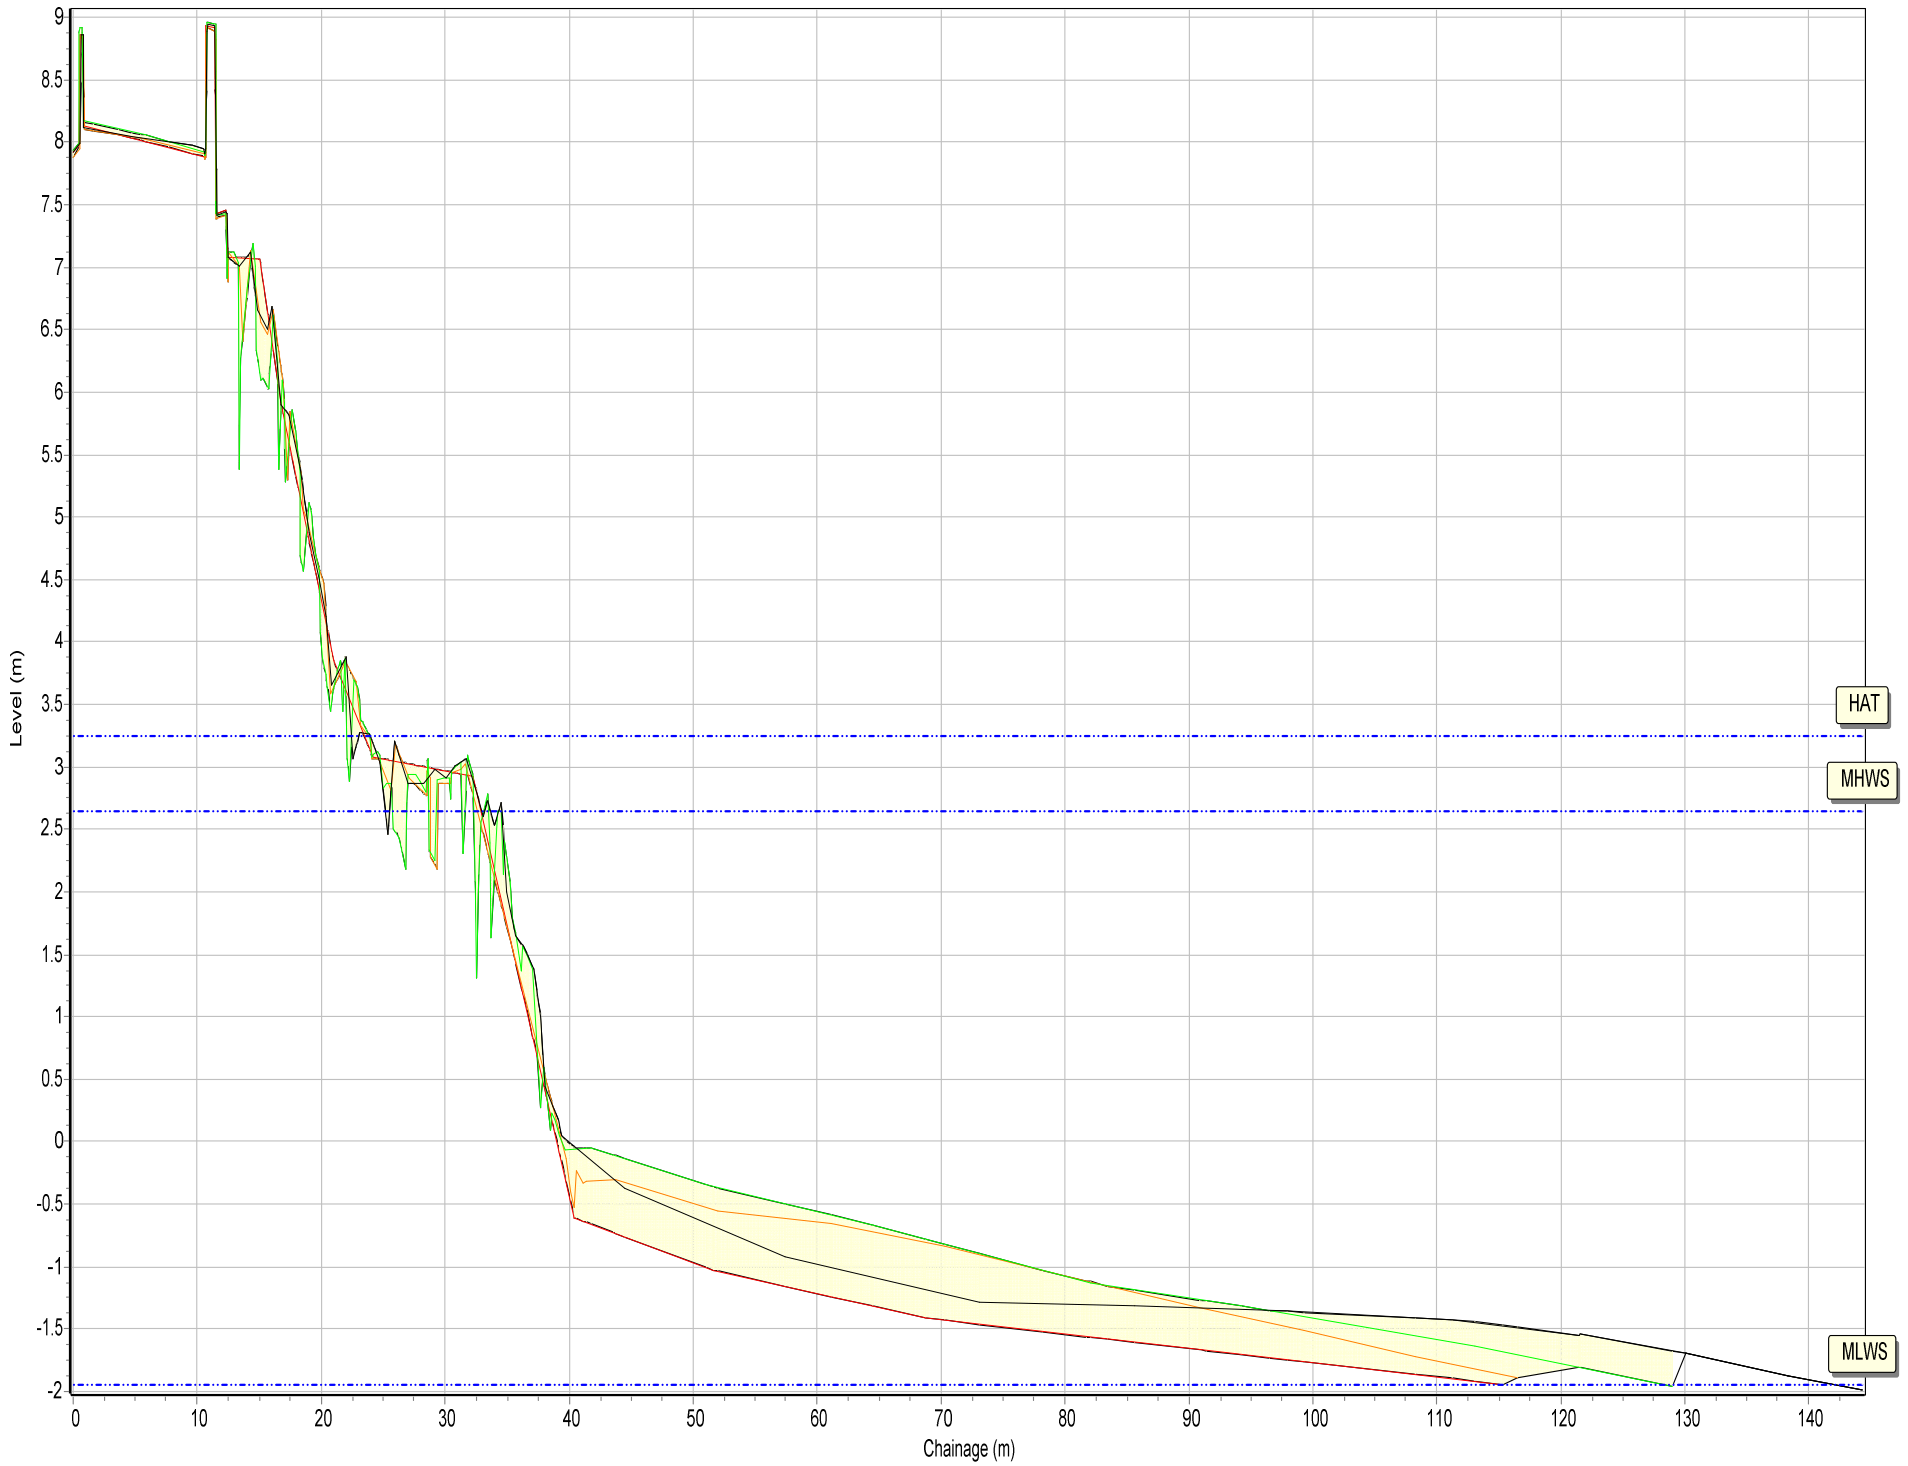
Beach Profiles: 1cHS1

Survey Date	Description of Changes Since Last Survey	Interpretation
2 nd April 2017	<p>Beach Profiles:</p> <p>Hartlepool Bay is covered by four beach profile lines during the Partial Measures survey (Appendix A).</p> <p>Profile 1cHS1 is located c. 150m south of the root of the South Pier. The profile starts at the wall to the rear of the promenade and extends over the fronting concrete splash wall and down the sloping face of the rock armour revetment before reaching the beach. Very little change has occurred until 40m chainage, which is the toe of the sea wall, since September 2014. The upper beach between 40m and 95m chainage has dropped by 0.4m since August 2016. From chainage 95m seawards the beach has accreted by up to 0.3m, extending the toe of the beach seawards by c.15m. The upper beach is at a medium level compared to the range recorded from previous surveys, whilst the lower beach between chainage 95m and 145m is the highest recorded.</p> <p>Profile 1cHS2 has shown the formation of two berms since the flat, mid-level beaches which were recorded in April and November 2015. The profile shows stability of the base of the seawall at 20m chainage, where there is some rock armour on the upper beach. Between chainage 25m and 260m there has been erosion of up to 0.3m. Seawards of chainage 260m there has been accretion of up to 0.5m, extending the toe of the beach seawards by c.40m, with the formation of a berm at chainage 290m. Overall the profile is at a relatively medium level compared to the range recorded from previous surveys.</p> <p>Profile 1cHS3 shows no changes over the defended part of the profile up to 30m chainage. Between chainage 30m and 195m there has been erosion of up to 0.5m. Seawards of chainage 195m there has been accretion of up to 0.8m, extending the toe of the beach seawards by c.55m and making it flatter. Overall the profile is generally at a relatively medium level compared to the range recorded from previous surveys, with the lower beach being relatively high.</p> <p>Profile 1cHS4 is located 1km north of the North Gare Breakwater, within the area of undefended dunes at Seaton Carew. The part of the profile dominated by dunes, to 290m chainage, has remained stable. The depression between the main body of dunes and the foredune at 300m chainage is deepening and has been since 2013. The photographs suggesting lowering may result from footpath erosion. The crest of the foredune at 320m chainage has remained stable since September 2016. Between chainage 340m</p>	<p>Overall the profiles show that the beach is at a relatively medium level in most places, with the profiles flattening compared to September 2016. At HS 1 there has been progressive accretion with the most recent profile being among the highest recorded for the lower beach.</p> <p>The dunes are in good condition. The foredune continues to accrete but erosion associated with a walkway is causing localised lowering in HS4 that may affect stability of the wider dune system in the long term.</p> <p>Longer term trends: Beach levels within Hartlepool Bay in April 2017 were at a medium level in comparison to previous surveys. The beach levels have been progressively increasing across the bay.</p>
