Cell 1 Regional Coastal Monitoring Programme Update Report 9: 'Partial Measures' Survey 2017

Redcar and Cleveland Council

July 2017

(*) The present report is **Update Report 9** and provides an analysis of the 2017 Partial Measures survey for Redcar and Cleveland Council's frontage.

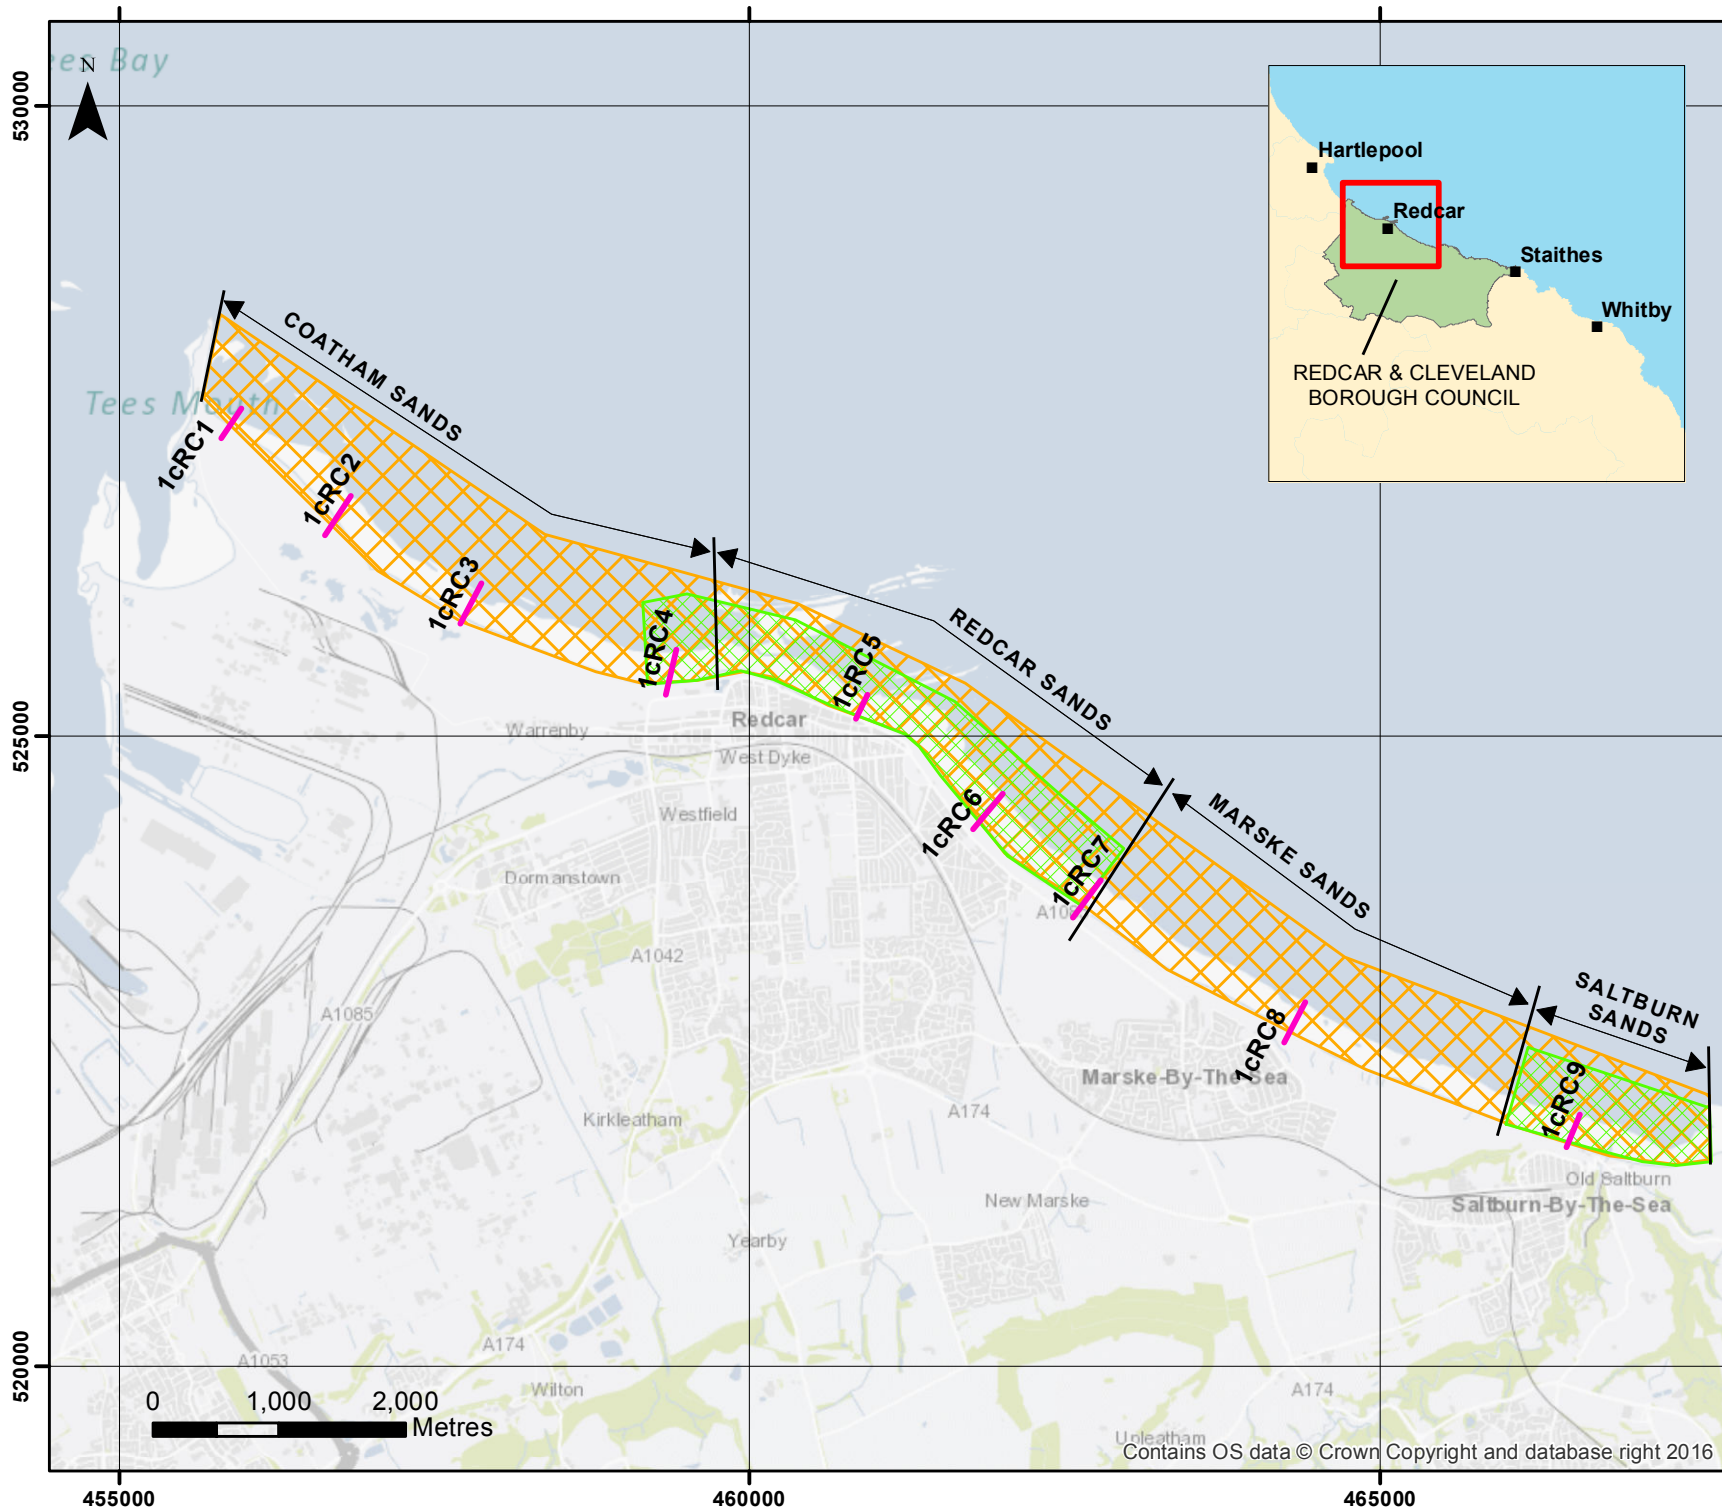
Figure 2 - Map 1

The location of these surveys is shown in Figure 2. The Partial Measures survey was undertaken along this frontage between 30th March at Skinningrove, 27th and 29th March at Redcar (Coatham Sands, Redcar Sands, Markse Sands and Saltburn Sands) and 6th March 2016 at Staithes. During the surveys the weather was mostly overcast with varying sea states. Specific weather conditions are detailed in the survey reports.

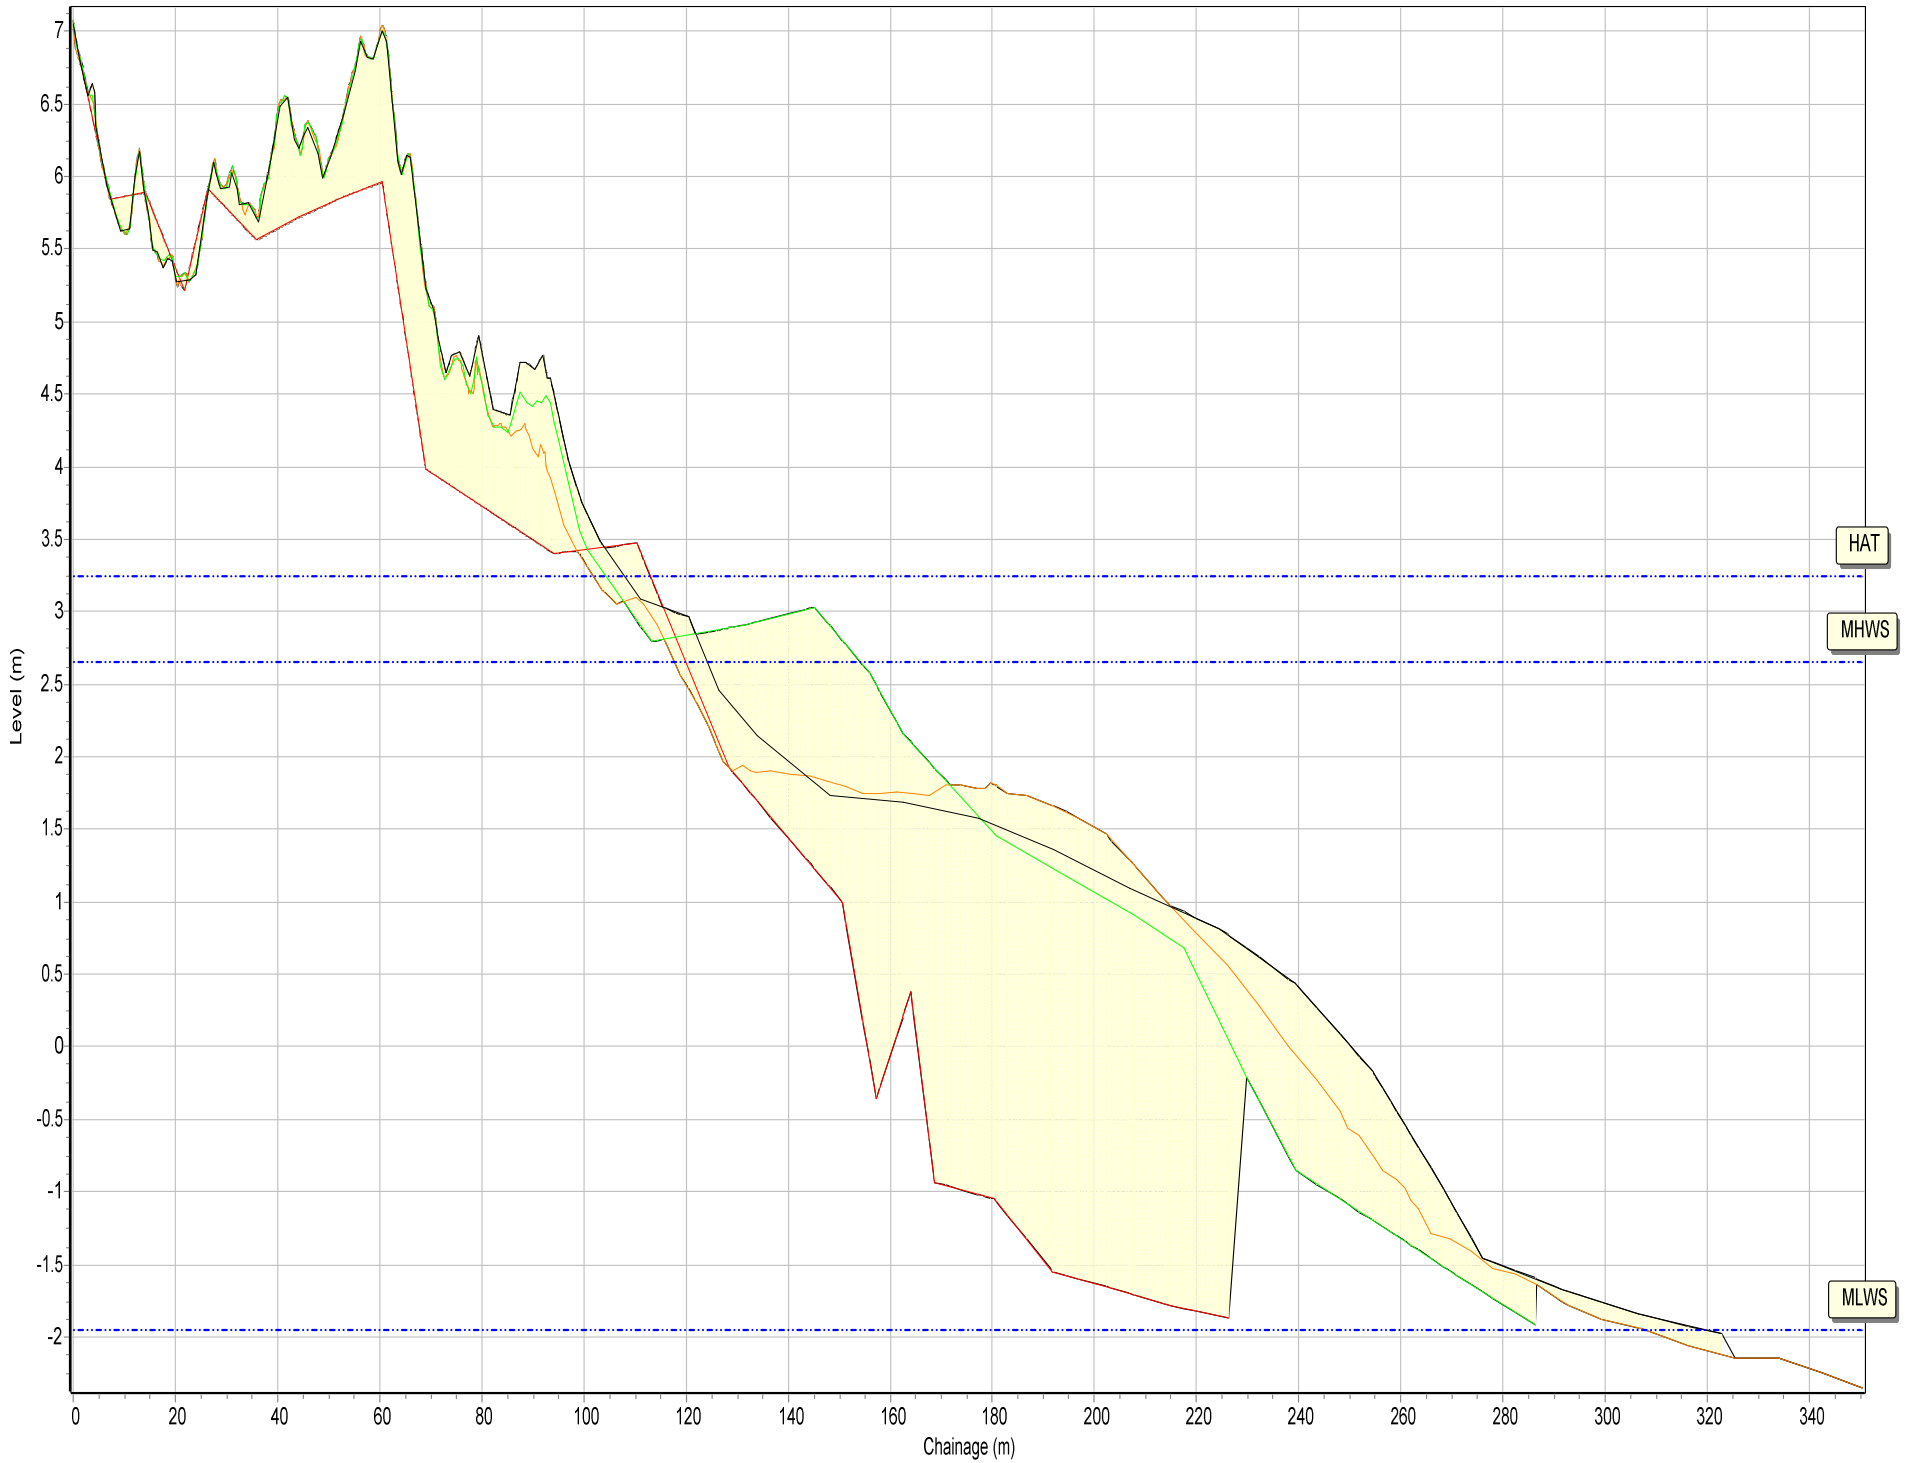
Beach Profiles: 1cRC1

Survey Date	Description of Changes Since Last Survey	Interpretation
29 th March 2017	<p>Beach Profiles:</p> <p>Coatham Sands is covered by four beach profiles during the Partial Measures survey (1cRC1 to 1cRC4; Appendix A) that were last surveyed in October 2016.</p> <p>Profile 1cRC1 is located 300m southeast of the South Gare Breakwater, in the lee of the German Charlies slag banks. The upper profile to 80m chainage is dominated by dunes that have remained stable since 2009. The highest dune, closest to the beach, is unchanged since October 2013. The foredune between 80m and 120m chainage has increased in height by 0.3m, and is at its highest recorded level. Between 120m and 180m chainage the upper beach has eroded by up to 1.2m since October 2016, removing the berm previously surveyed. From 180m to the end of the profile at 320m chainage the lower beach level is high, having accreted by up to 1.2m, but more typically <0.4m, forming a more convex shape to the profile. Overall the upper and lower beach is at the highest recorded level.</p> <p>At profile 1cRC2 the dunes have remained stable with a small amount of accretion of <0.2m on the foredunes. Between chainage 100m and 190m there has been very little change, ± 0.1m. From chainage 190m to 360m there has been erosion of up to 0.3m. Seawards of chainage 360m a berm has formed at the toe of the beach, up to 0.6m above the previously surveyed beach level. Overall the beach is at a medium-high level compared to the range recorded from previous surveys, with the dunes and lower beach showing highest recorded levels.</p> <p>Profile 1cRC3 showed little change to 60m chainage, with the main dune and foredune crests both remaining stable since April 2014. The beach between 60m and 215m has dropped since October 2016 by up to 0.7m but more typically 0.3m, removing the berm previously recorded at chainage 165m. Between chainage 165m and 260m the beach has accreted by 0.3m infilling a low spot. Between 260m and the end of the survey at 350m chainage erosion of up to 0.5m has occurred removing the lower beach berm. The overall effect is a smoother and less steep profile. The dunes are at a high level compared to the range recorded from previous surveys, however the upper beach is at a relatively low</p>	<p>Overall the beaches are healthy. The dune areas remained stable over the winter of 2016/17, which conforms to a wider trend towards stability.</p> <p>At RC1 there was a very high upper and lower beach with a depression in the centre of the beach. The berm on the lower beach has been progressively accreting since monitoring started in 2008. March 2017 was among the highest recorded profiles for the upper and lower beach. A similar pattern was observed at RC2 where there was also a high upper and lower beach.</p> <p>At RC3 the beach has remained stable overall although the berms on the bottom of the beach have lowered over the winter.</p> <p>At RC4 the beach was stable apart the lower beach accreting. This shows that accretion of the lower beach occurred in all of the profiles.</p> <p>Longer term trends:</p> <p>All of the Redcar profiles show progressive accretion of the beach. The dunes are stable or accreting on their seaward extent.</p> <p>The pattern of accretion in the east of the bay with erosion or limited accretion in the central bay is consistent with previous observations of an eastwards net transfer of material at Coatham sands.</p>

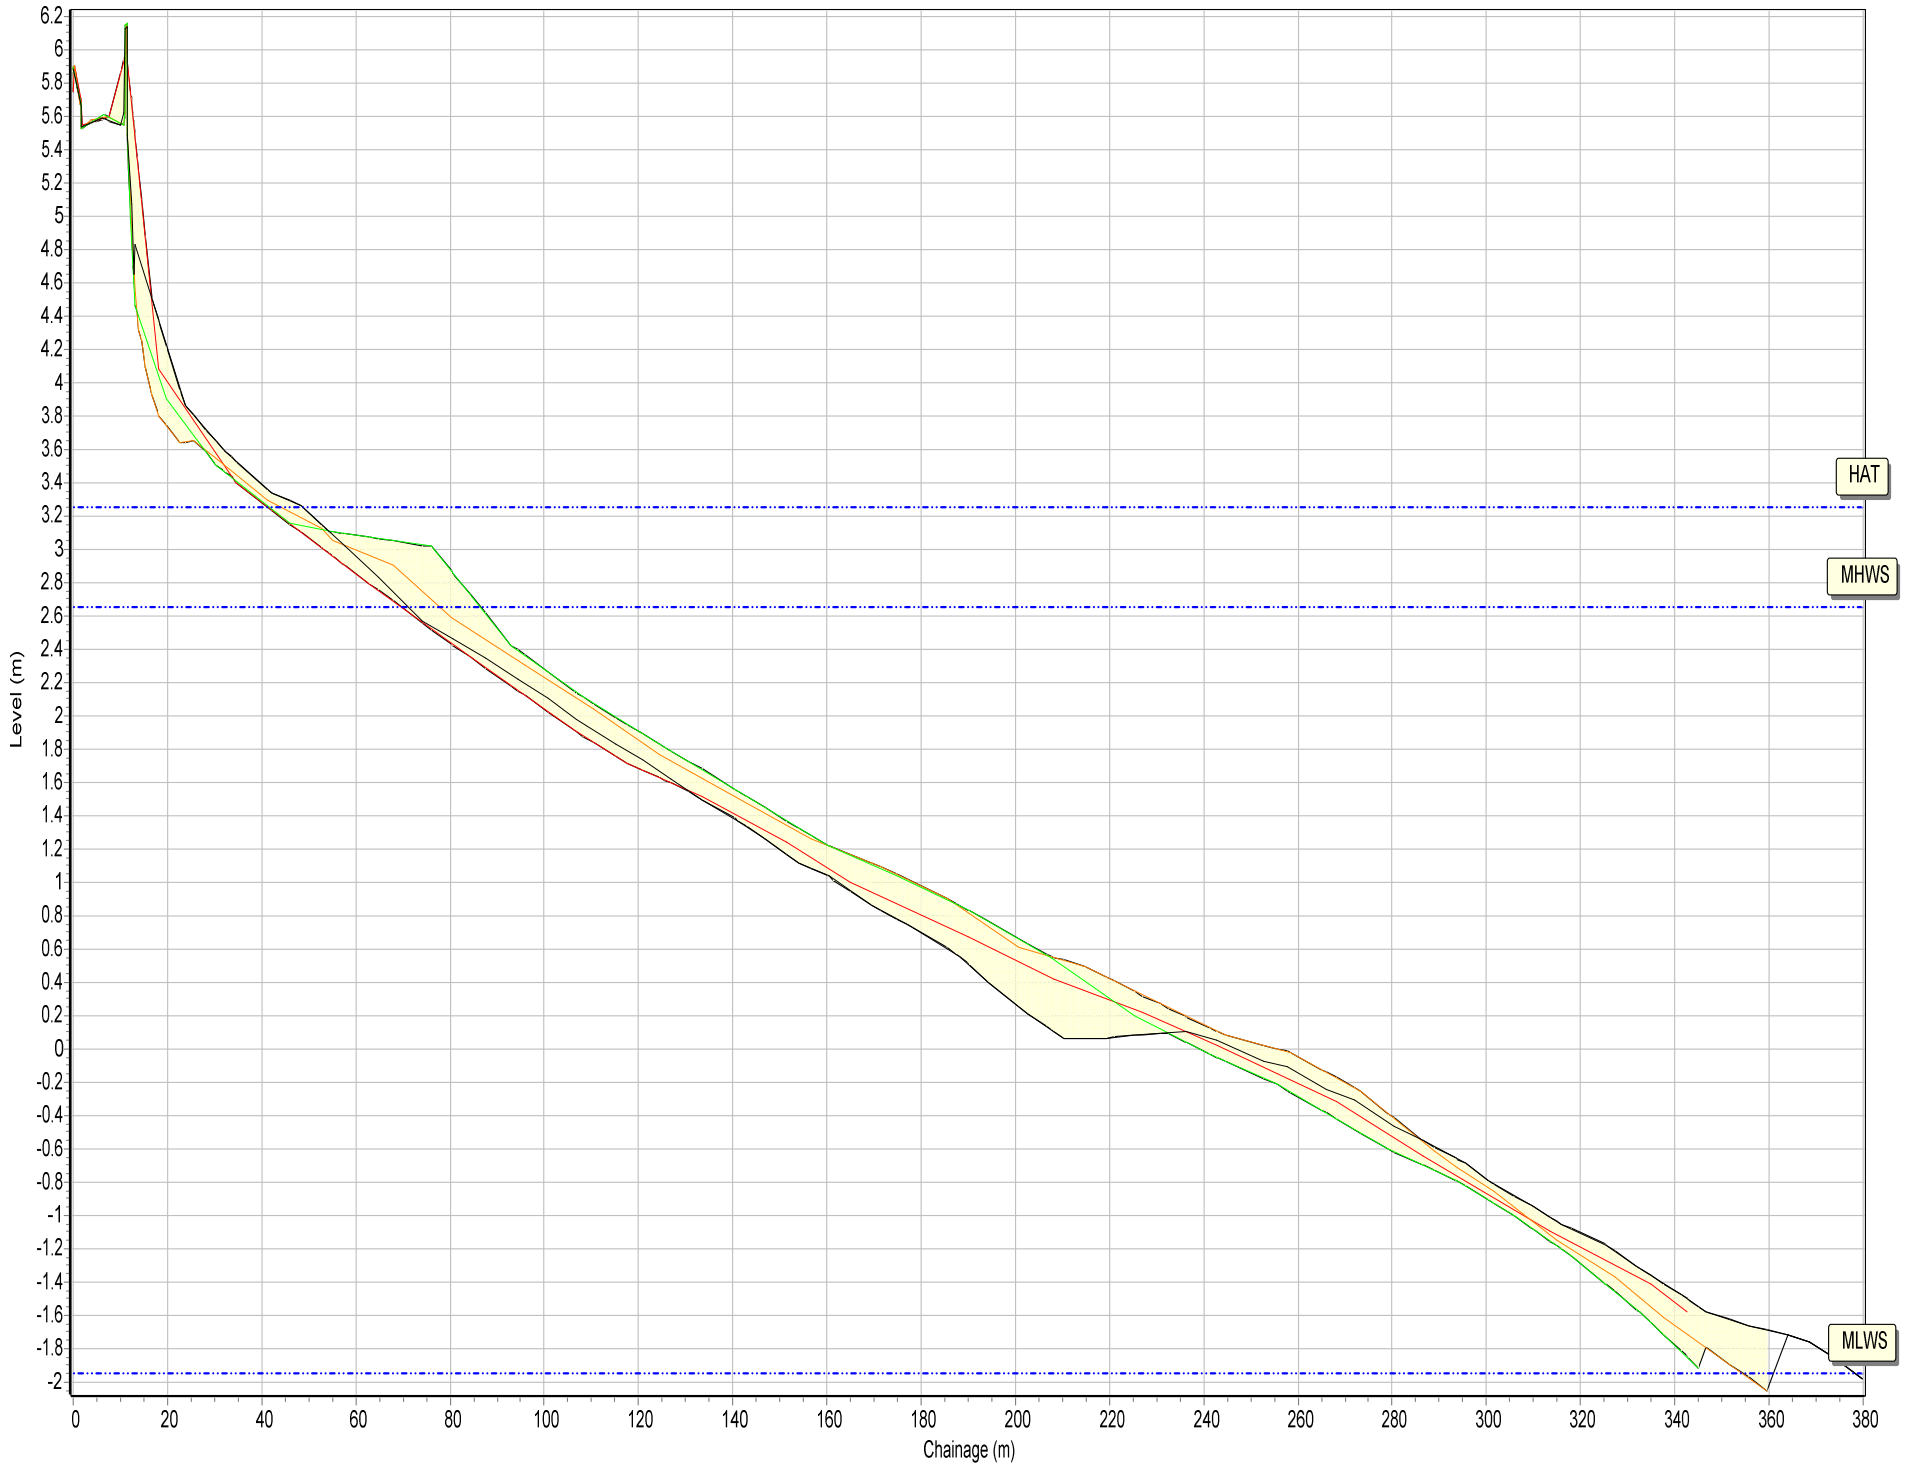
Beach Profiles: 1cRC4

Survey Date	Description of Changes Since Last Survey	Interpretation
	<p>level, and the lower beach at a more medium level.</p> <p>Profile 1cRC4 is located at the beginning of the defended section at Coatham and Redcar. No change has occurred landward of the base of the seawall. The beach levels at the toe fo the seawall have increased by up to 0.4m. Between chainage 55m and 235m here has been erosion of up to 0.4m, removing the upper berm previously recorded at chainage 75m. Seawards of chainage 235m there has been accretion of up to 0.2m. Overall the profile is at a medium-low level compared to the range recorded from previous surveys, with the middle section particularly low (chainage130m to 230m).</p>

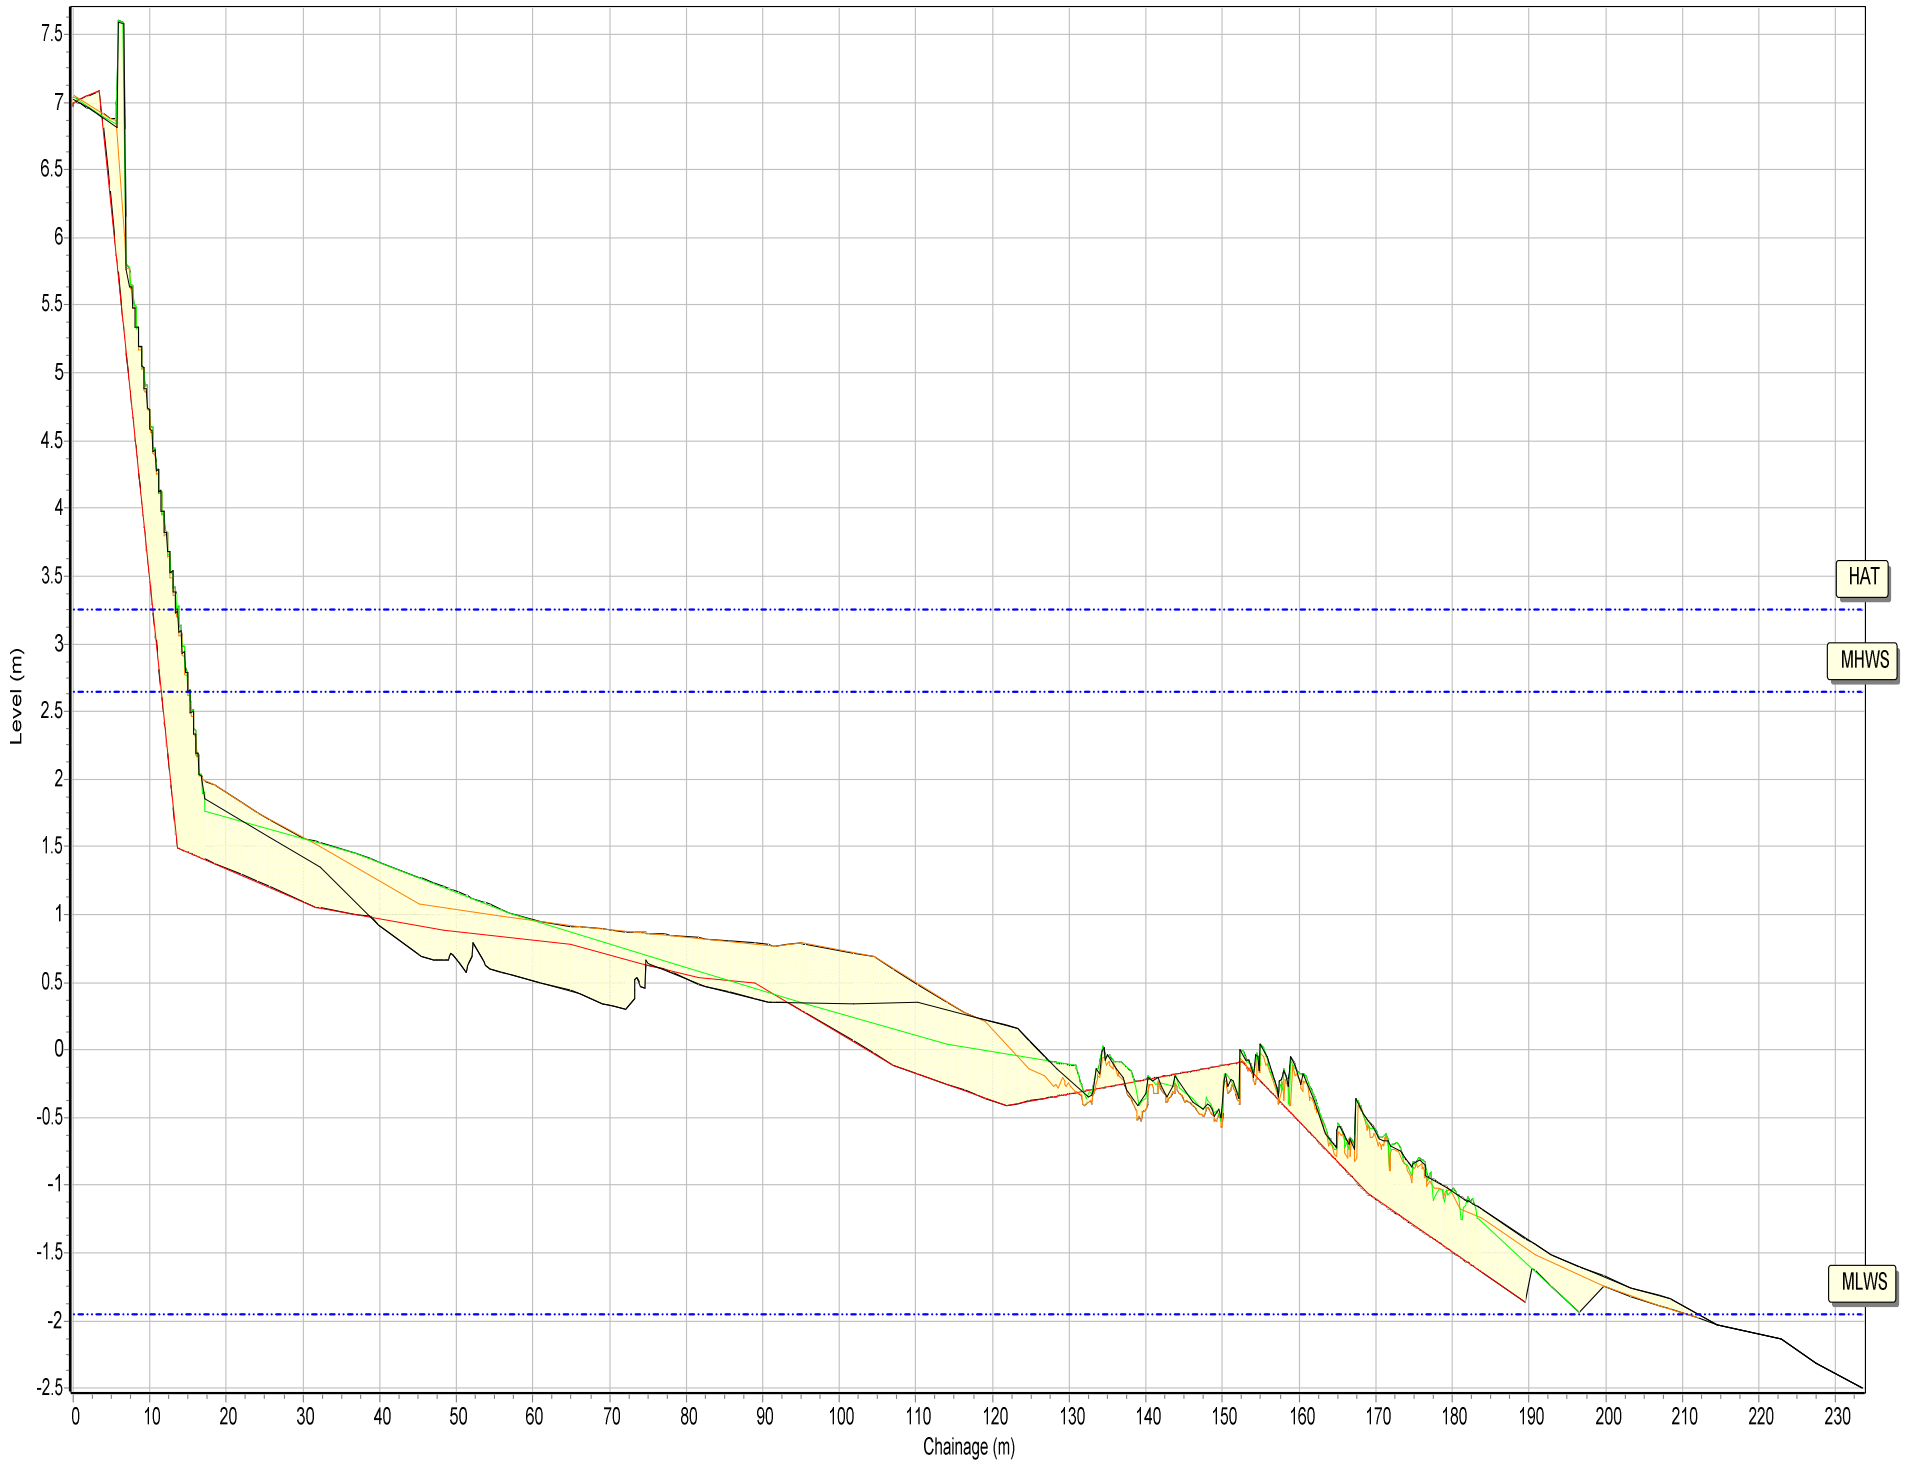
Beach Profiles: 1cRC5

Survey Date	Description of Changes Since Last Survey	Interpretation
29 th March 2017	<p>Beach Profiles:</p> <p>Redcar Sands is covered by three beach profiles (RC5 to RC7; Appendix A), with RC7 being approximately on the boundary with the Marske Sands area. They were last surveyed in October 2016.</p> <p>At profile 1cRC5 the sea defences constructed in 2012 remain unchanged as far as 20m chainage. From the sea defences to chainage 95m there has been erosion of up to 0.5m creating a depression and exposing sections of rock at chainages 50m and 75m. Between chainage 95m and 130m there has been accretion of up to 0.3m forming a berm. Between 130m and 185m chainage the rocks in the lower beach remain exposed. From 185m chainage to the end of the survey at 230m chainage the beach has accreted by 0.3m. Overall the beach is at a relatively medium level compared to the range recorded from previous surveys, except between chainage 40m and 75m where it is relatively low, and chainage 120 where it is relatively high.</p> <p>The profile at 1cRC6 has not changed landward of 55m chainage since the last survey due to the presence of the sea defence. The profile has changed very little seawards of chainage 55m, with small amounts of alternating erosion and accretion of ± 0.2m. A small berm has formed at the toe of the beach at chainage 300m. Overall the profile is at a medium-high level compared to the range recorded from previous surveys.</p> <p>Profile 1cRC7 is undefended. The profile has changes little to 80m chainage. The dune face at 60m chainage remained stable since October 2014. From 80m chainage the beach level has dropped since October 2016, by up to 1.1m but more typically < 0.3m. The upper and lower beach are at a relatively low level compared to the range recorded from previous surveys, but at a medium-high level in the mid-beach.</p>	<p>All of the profiles show erosion but remain within the bounds of the previous profiles.</p> <p>Longer term trends:</p> <p>Profiles RC5 and RC7 show movement of beach berms, across the profile with some evidence for gradual accretion.</p>

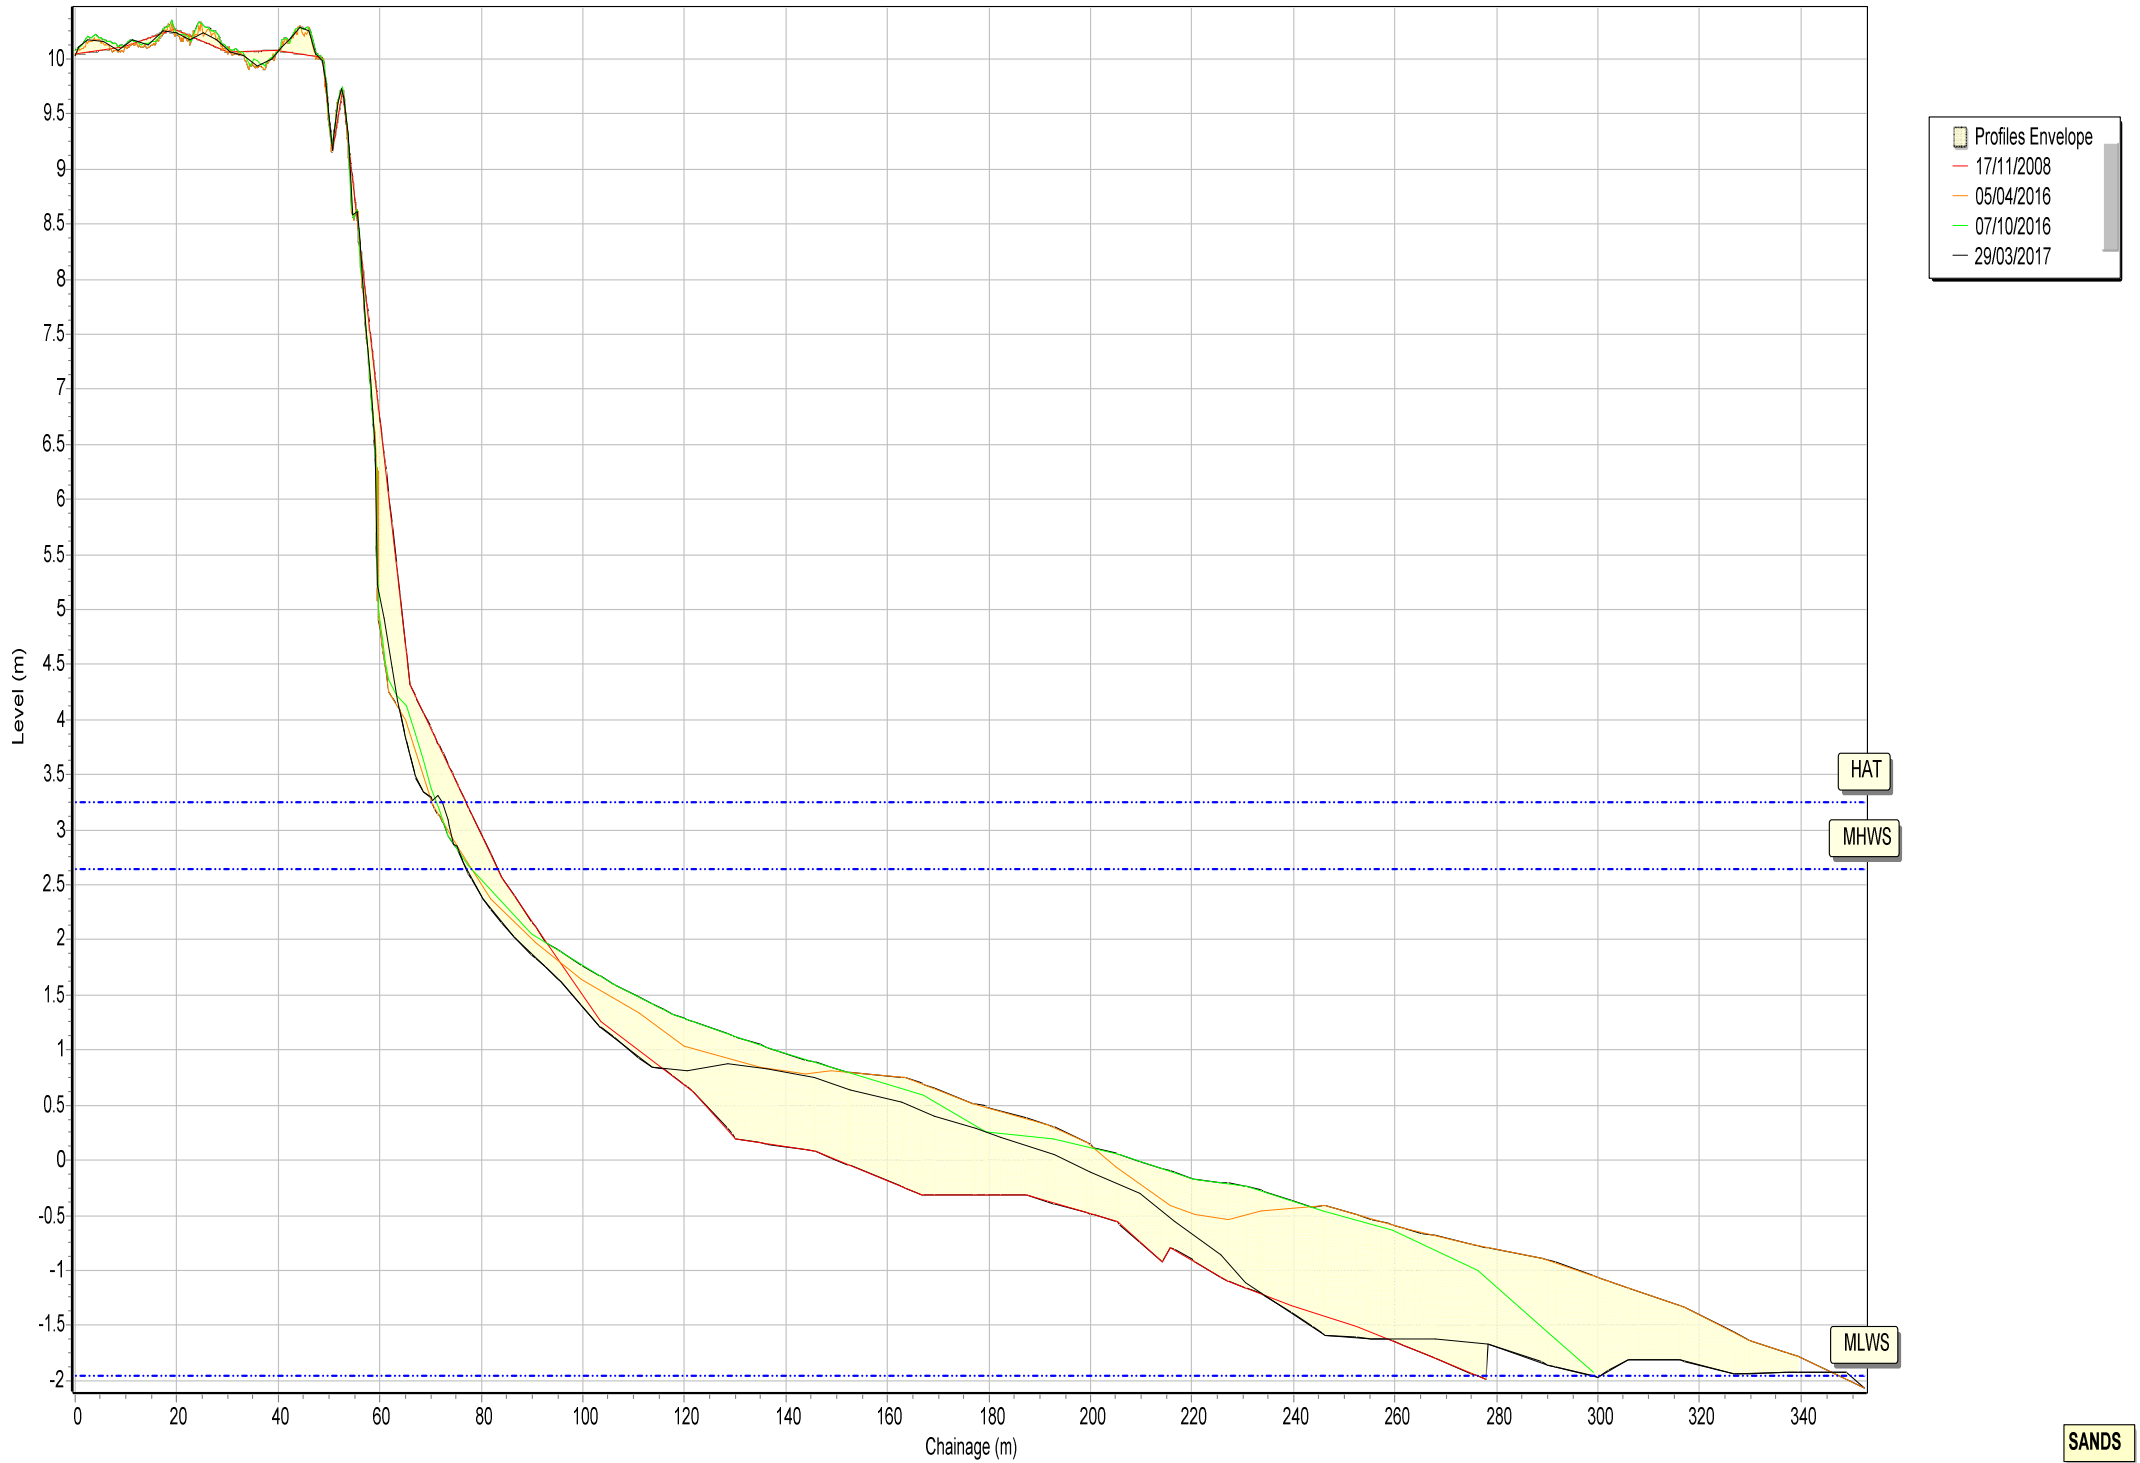
Beach Profiles: 1cRC7

Survey Date	Description of Changes Since Last Survey	Interpretation
<p>29th March 2017</p>	<p>Beach Profiles:</p> <p>Marske Sands is covered by two beach profiles during the Partial Measures survey (RC7 to RC8; Appendix A). RC7 is on the boundary with the Redcar Sands area.</p> <p>Profile 1cRC7 is located along The Stray and has been discussed in Section 2.2.</p> <p>Profile 1cRC8 is unchanged as far as 55m chainage. Since April 2014 the dune face has remained stable, which contrasts with the winter of 2013/14 when 10m of recession was recorded. From 55m to 300m chainage the beach level has dropped by up to 0.5m since October 2016. From chainage 300m to the end of the profile at 330m the beach level has increased by 0.2m, forming a berm. The profile is relatively low in the upper beach compared to the range recorded from previous surveys (chainage 55m to 100m), but at a more medium-high level along the rest of the profile.</p>	<p>The cliffed face of the dune remained stable at both RC7 and RC8 following the recession over the winter of 2013/14.</p> <p>RC8 shows erosion, however a berm has formed on the lower beach.</p> <p>Longer term trends:</p> <p>The April 2014 profiles were amongst the lowest seen at 1cRC8, due to the December 2013 storm surge. The beach has recovered and levels are now comparatively medium-high.</p>

- At Marske Sands, the cliffed face of the dune remained stable at both RC7 and 8 following the recession caused by the winter storms of 2013/14. RC8 shows erosion but with a berm forming on the lower beach.

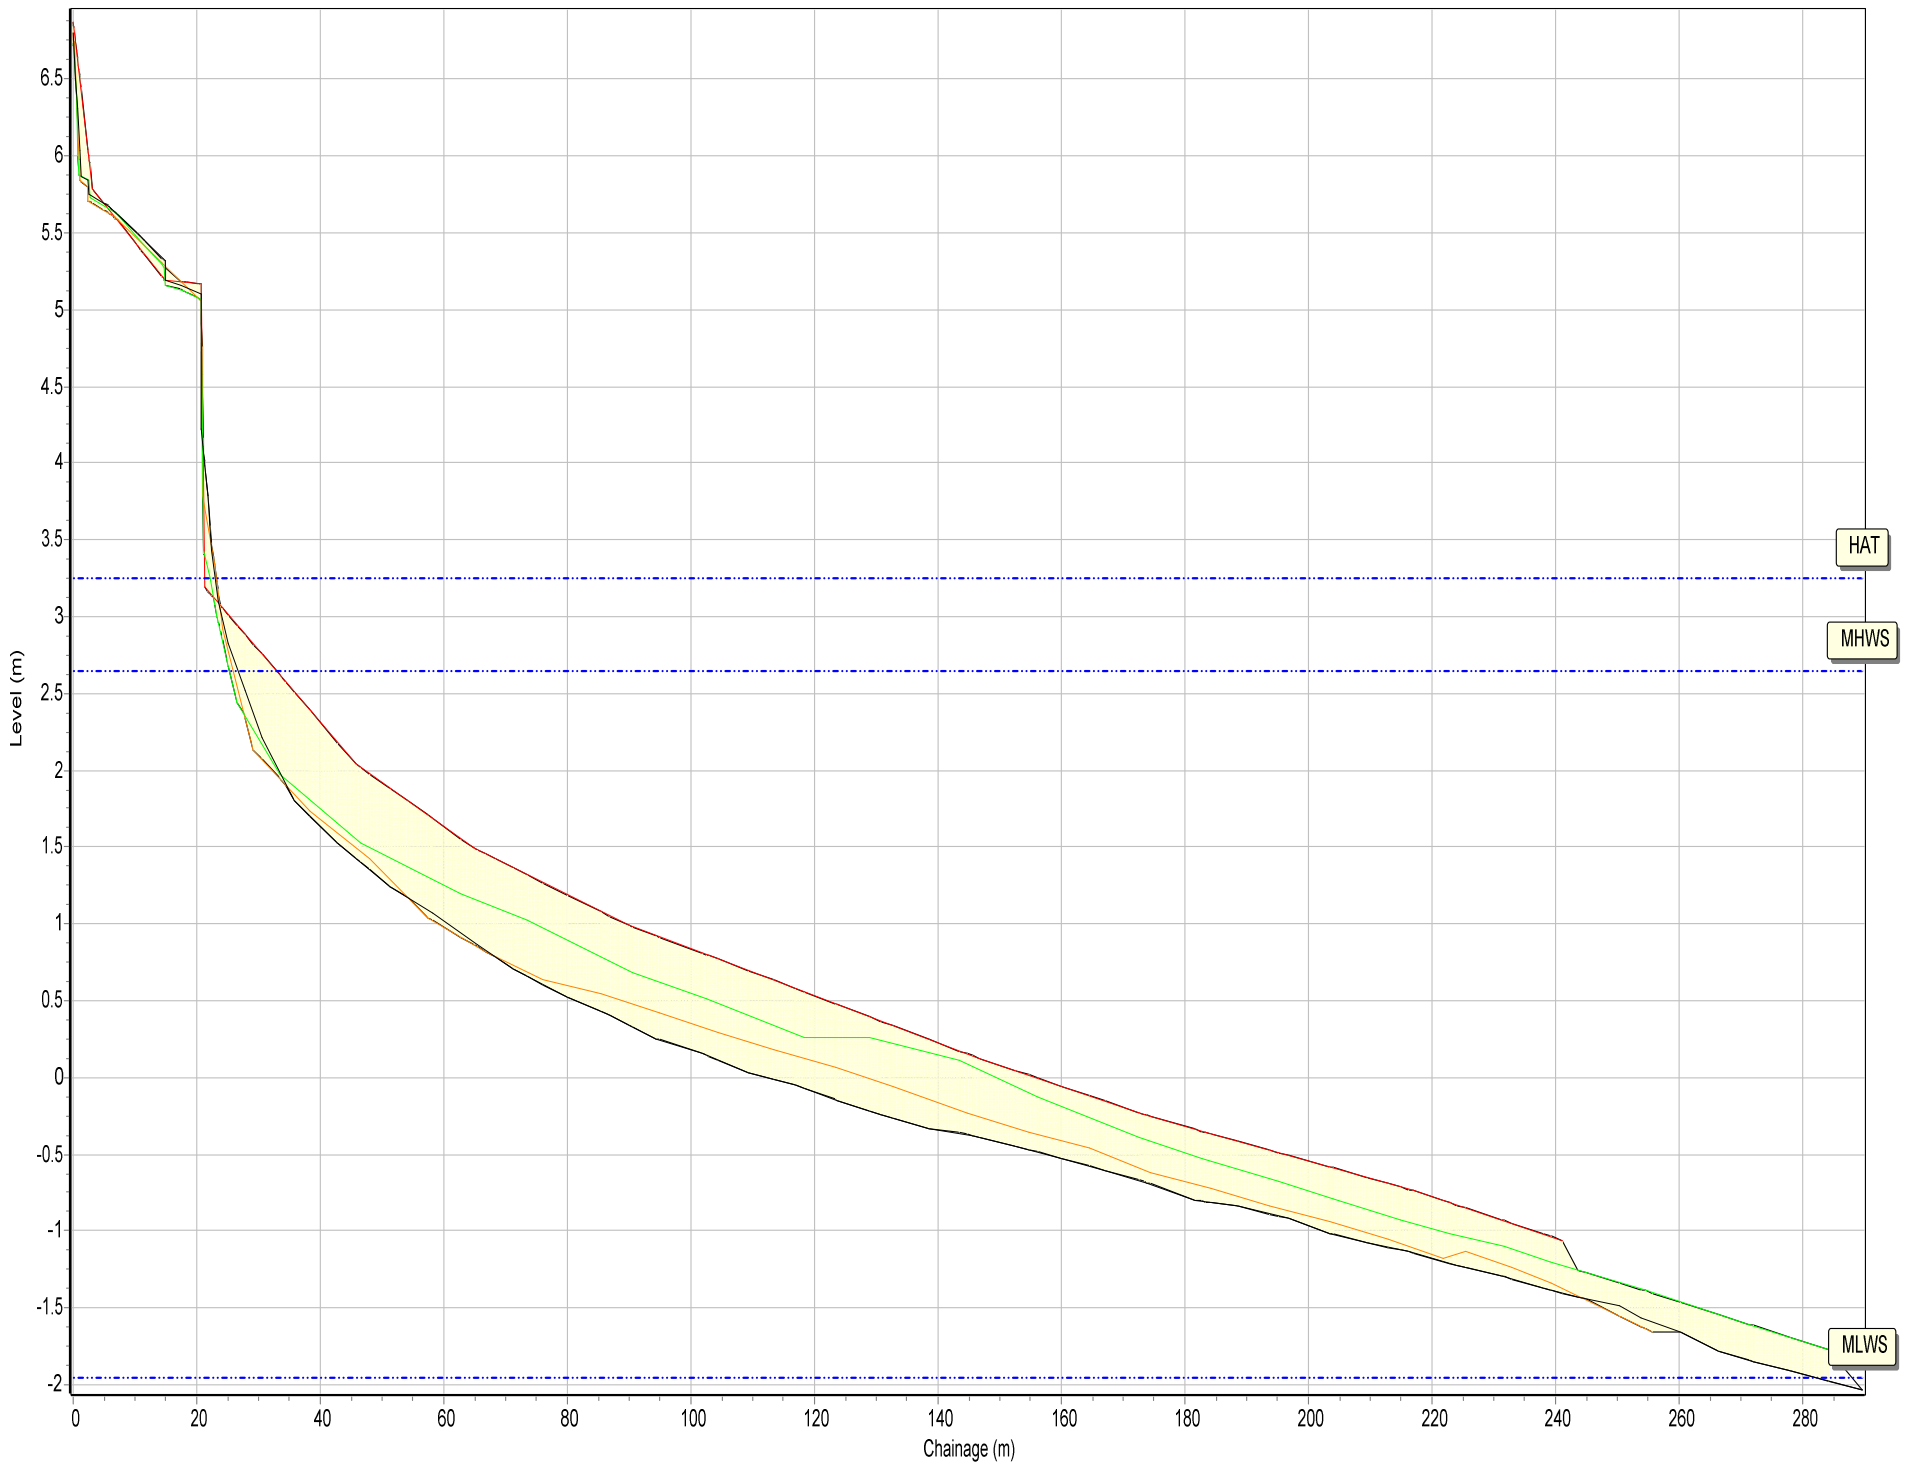
Beach Profiles: 1cRC9

Survey Date	Description of Changes Since Last Survey	Interpretation
29 th March 2017	<p>Beach Profiles:</p> <p>Saltburn Sands is covered by one beach profile (RC9; Appendix A).</p> <p>Overall Profile 1cRC 9 has experienced no change over the section covered by the sea defence as far as 30m chainage. Seawards of chainage 30m there has been erosion of up to 0.5m. The section of beach between chainage 50m and 170m is the lowest recorded compared to the previous surveys, seawards of 170m the beach is at a relatively medium level.</p>	<p>The drop in beach level at RC9 over the winter of 2016/17 was relatively high. Overall, the beach level is low and has been eroding at a low rate since 2008.</p> <p>Longer term trends: The profile plots show net erosion, although there are periods of recovery. The profile for March 2017 is the lowest recorded in the upper beach but in the middle of the range of lower beach profiles.</p>

- At Saltburn Sands, the profile plots show net erosion, although there are years of recovery. The profile for March 2016 is one of the lowest recorded in the upper beach but in the middle of the range of lower beach profiles.
