Cell 1 Regional Coastal Monitoring Programme Update Report 11: 'Partial Measures' Survey 2019

Redcar and Cleveland Council

May 2019

(*) The present report is **Update Report 11** and provides an analysis of the 2019 Partial Measures survey for Redcar and Cleveland Council's frontage.

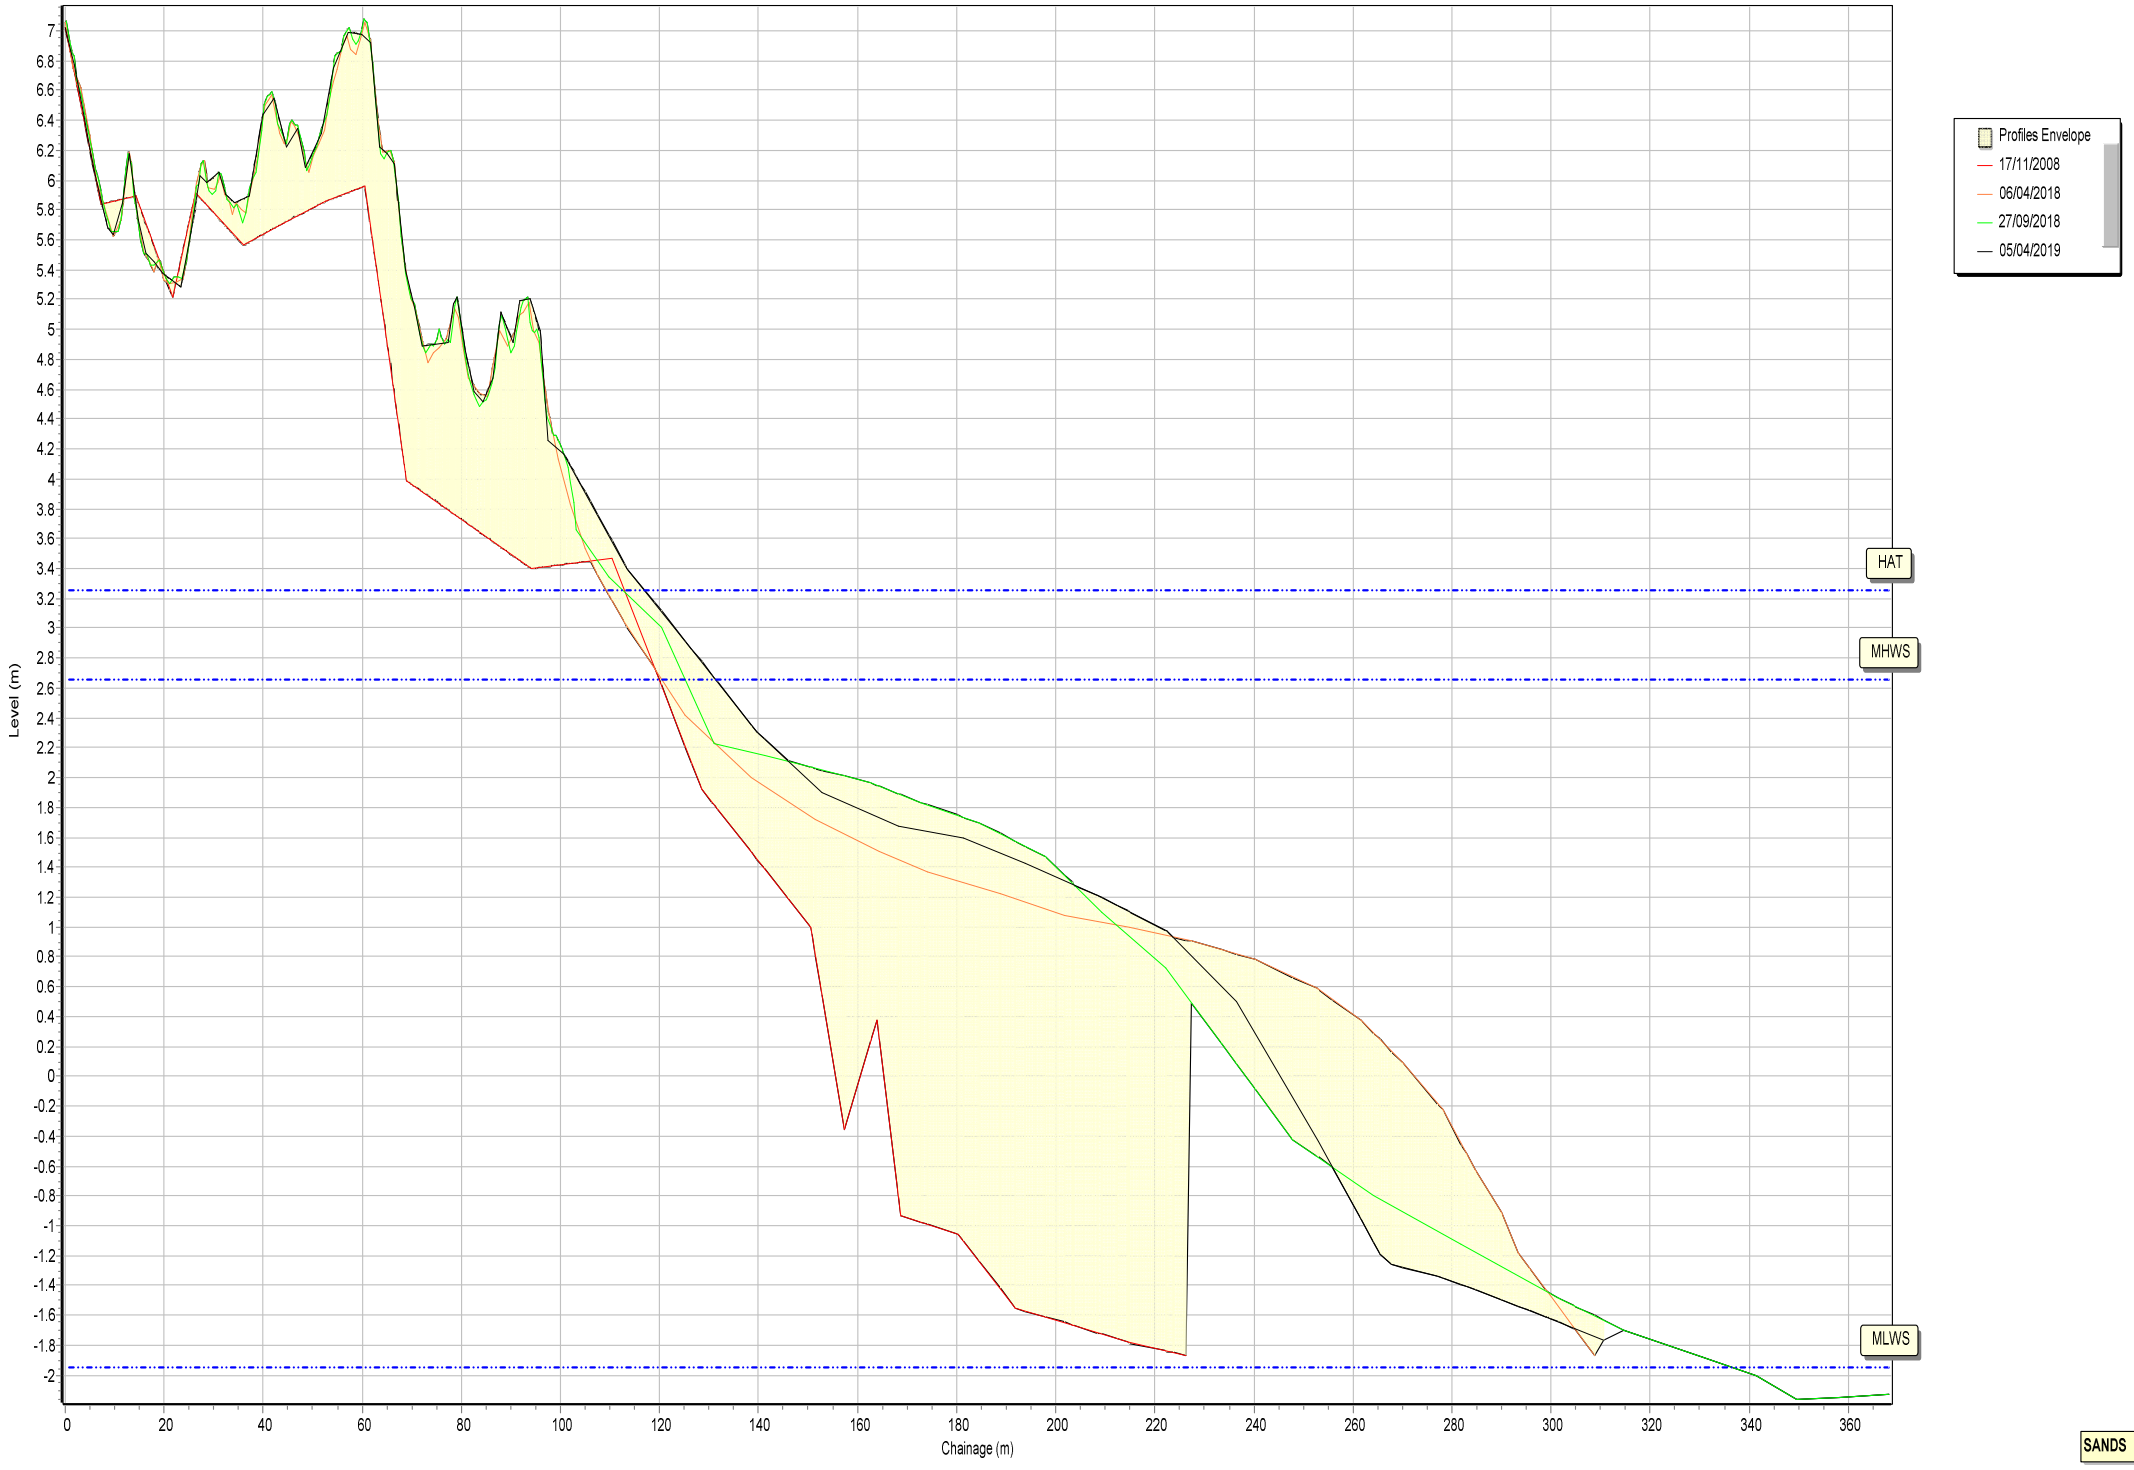
Beach Profiles: 1cRC1

Survey Date	Description of Changes Since Last Survey	Interpretation
5 th April 2019	<p>Beach Profiles:</p> <p>Coatham Sands is covered by four beach profiles during the Partial Measures survey (1cRC1 to 1cRC4; Appendix A) that were last surveyed in September 2018.</p> <p>Profile 1cRC1 is located 300m southeast of the South Gare Breakwater, in the lee of the German Charlies slag banks. The upper profile to 105m chainage is dominated by dunes that have remained stable since 2009. The highest dune (chainage 60m), closest to the beach, is unchanged since October 2013. The foredune between 70m and 105m chainage has remained stable since the previous survey and is at its highest recorded level. Between 105m and 150m chainage the upper beach has accreted by up to 0.5m since September 2018, over the same time period the beach between chainage 145m and 210m has eroded by approximately 0.3m. The profile is at its highest recorded level between chainage 210m and 220m, whilst the lower beach has experienced some erosion from chainage 250m to the end of the survey at chainage 310m. The profile is at a high – mid level compared to the range of previously recorded results.</p> <p>At profile 1cRC2 the dunes have remained largely stable with accretion of up to 0.3m on the foredunes between chainage 30m and 100m since the previous survey. The beach profile is dominated by accretion of up to 0.4m, creating a smoother profile. The upper beach, directly fronting the foredune between chainage 70m and 140m is at its highest recorded level. Overall the beach is at a medium-high level compared to the range recorded from previous surveys, whilst the dunes remain at their highest recorded levels.</p> <p>Profile 1cRC3 showed the main dune has remained stable since April 2014, with the foredune between chainage 16m and 51m showing erosion of up to 0.2m since the previous survey. The seaward face and toe of the foredune has advanced from chainage 52m to 54m. The beach between 55m and 210m has dropped since September 2018 by up to 0.3m. Seaward of 210 the level of erosion increases significantly, and the toe of the beach has lost up to 0.6m making the lower beach at its lowest recorded level. The lower beach berm recorded in the April 2018 survey between chainage 240m and the end of survey at chainage 330m has now been entirely eroded. The dunes remain stable at a high level</p>	<p>Overall the beaches are healthy. The dune areas all show accretion on the foredunes over the winter of 2018/19, which conforms to a wider trend towards stability. The dunes are at their highest recorded levels for all profiles.</p> <p>Generally, the profiles show that accretion to be the dominant process on the upper beach since the previous survey, whilst the lower beach experiences more erosion. Notably the lower beach on profiles RC3 and RC4 is at its lowest recorded levels, the beach levels of the western profiles, RC1 and RC2, are healthier and are high to medium within their previously recorded range, however the eastern profiles, RC3 and RC4, show their lowest recorded levels in the lower beach, meaning they sit lower in the range of previously recorded results.</p> <p>Longer term trends:</p> <p>All of the Redcar profiles show the dunes are stable or accreting on their seaward extent. The beaches to the west show a typical longer-term trend of progressive accretion. The beaches in the centre and to the east have a more fluctuating long-term pattern.</p> <p>The erosion in the east of the bay with low beach levels is not consistent with previous observations of</p>

Survey Date	Description of Changes Since Last Survey	Interpretation
	<p>compared to the range recorded from previous surveys, however the lower beach is at its lowest recorded level, whilst the rest of the profile sits at medium level compared with the range of previously recorded results.</p> <p>Profile 1cRC4 is located at the beginning of the defended section at Coatham and Redcar. There has been a loss of up to 0.6m of material at the base of the seawall throughout the winter of 2018. Between chainage 20m and 55m here has been accretion of up to 0.3m. A shallow berm appears to be forming between chainage 55m and 70m. Between chainage 70m and 165m there has been accretion of up to 0.2m. Seawards of this point, from chainage 165m to the end of the survey at 330m there has been up to 0.55m of erosion meaning that a substantial length of the lower beach is now at its lowest recorded level. Overall the profile is at a low level compared to the range recorded from previous surveys, with the lower section at its lowest recorded levels.</p>	<p>an eastwards net transfer of material at Coatham sands.</p>

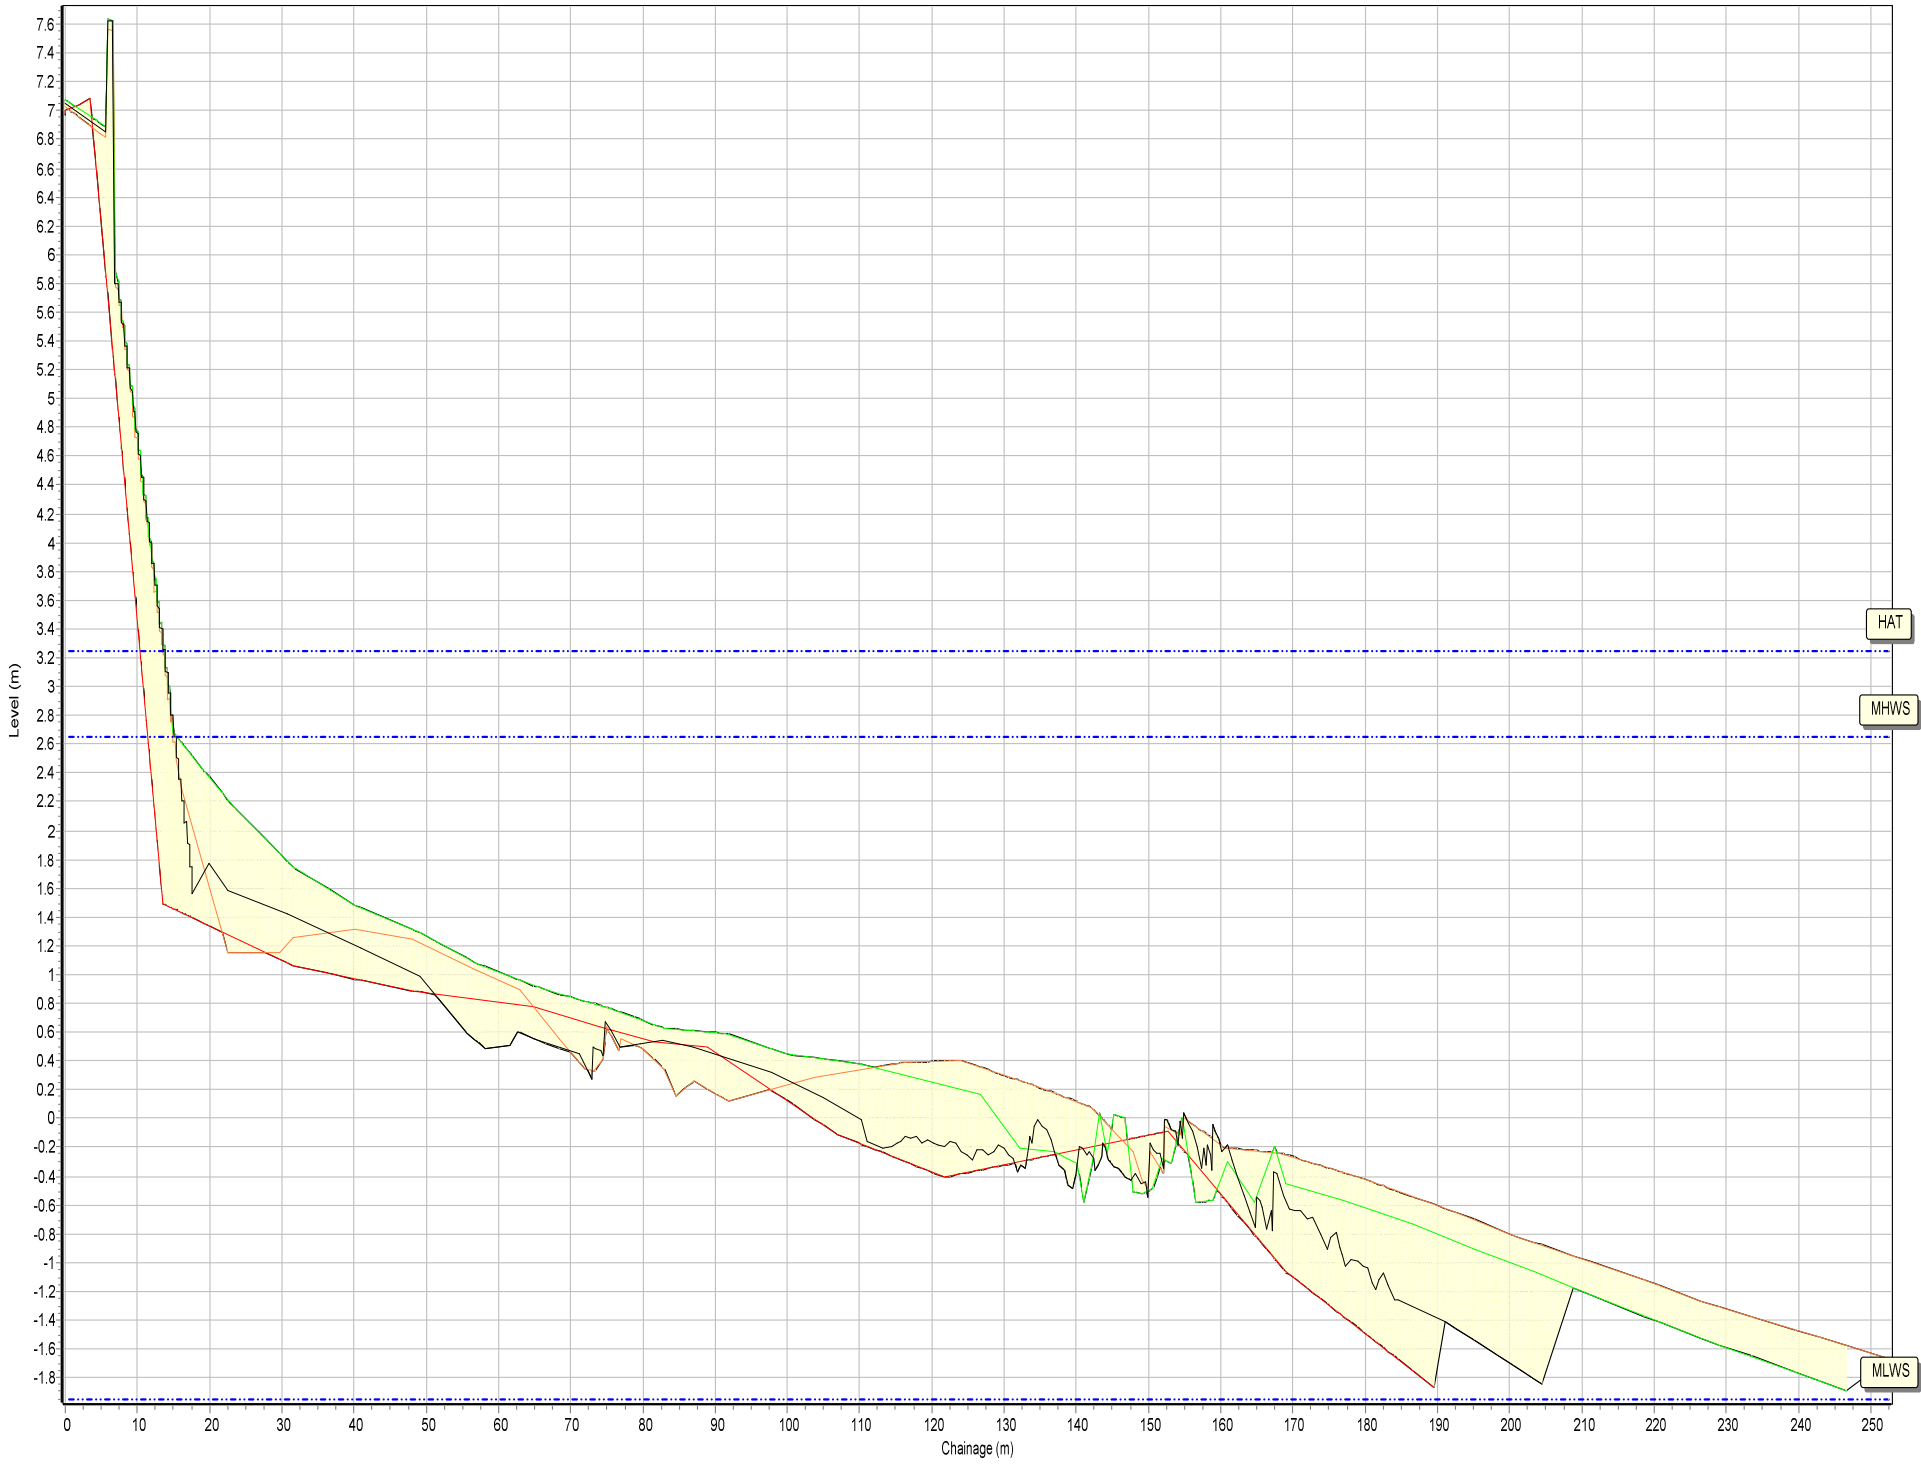
Beach Profiles: 1cRC5

Survey Date	Description of Changes Since Last Survey	Interpretation
5 th April 2019	<p>Beach Profiles:</p> <p>Redcar Sands is covered by three beach profiles (RC5 to RC7; Appendix A), with RC7 being approximately on the boundary with the Marske Sands area. They were last surveyed in September 2018.</p> <p>At profile 1cRC5 the sea defences constructed in 2012 remain unchanged as far as 20m chainage. There has been erosion at the toe of the sea defence of 1.1m. Two berms (chainage 20m – 50m, and chainage 70m to 110m) have both moved landward, between them the beach is at its lowest recorded level at chainage 60m. Both berms are now significantly depleted when compared to previous surveys. Seawards of the rock exposure at chainage 155m there has been significant erosion of up to 0.7m. Overall the upper beach is at a low level compared to the range recorded from previous surveys.</p> <p>The profile at 1cRC6 has not changed landward of 55m chainage since the last survey due to the presence of the sea defence. There has been some erosion between chainage 57m and 70m of up to 0.3m. The rest of the beach profile from chainage 75m is dominated by accretion, with beach levels having increased by up to 0.4m since September 2019. Between chainage 230m and 260m the profile is at its highest recorded level. Seawards of this point the profile drops off steeply, with the seaward end of the profile having experienced up to 0.3m of toe erosion. there is approximately 0.2m of toe erosion seaward of 280m. The profile is at a high level compared with the range of previously recorded results. The profile is generally very evenly graded, with only the toe of the beach having experienced any significant erosion.</p> <p>Profile 1cRC7 is undefended. The dune face at 60m chainage remained stable since October 2014. Between chainage 70m and 90m there has been some minor erosion of up to 0.2m. Two distinct berms have moved landward since the previous survey. The upper berm (chainage 100m to 175m) has flattened significantly over the course of the winter, whilst the lower berm (chainage 230m to 300m) has remained more prominent, with a steep landward face. From chainage 170m to 230m the profile is at its lowest recorded level. Overall the beach profile is at a relatively low-medium level compared to the range recorded from previous surveys.</p>	<p>All of the profiles, except RC6 show erosion as the dominant process but remain largely within the bounds of the previous profiles. Profiles RC5 and RC7 show the movement of berms and accretion on the lower beach. Profile RC6 has experienced a significant volume of accretion across its entire reach.</p> <p>Longer term trends:</p> <p>Profiles RC5 and RC7 show movement of beach berms, across the profile with some evidence for gradual accretion.</p>

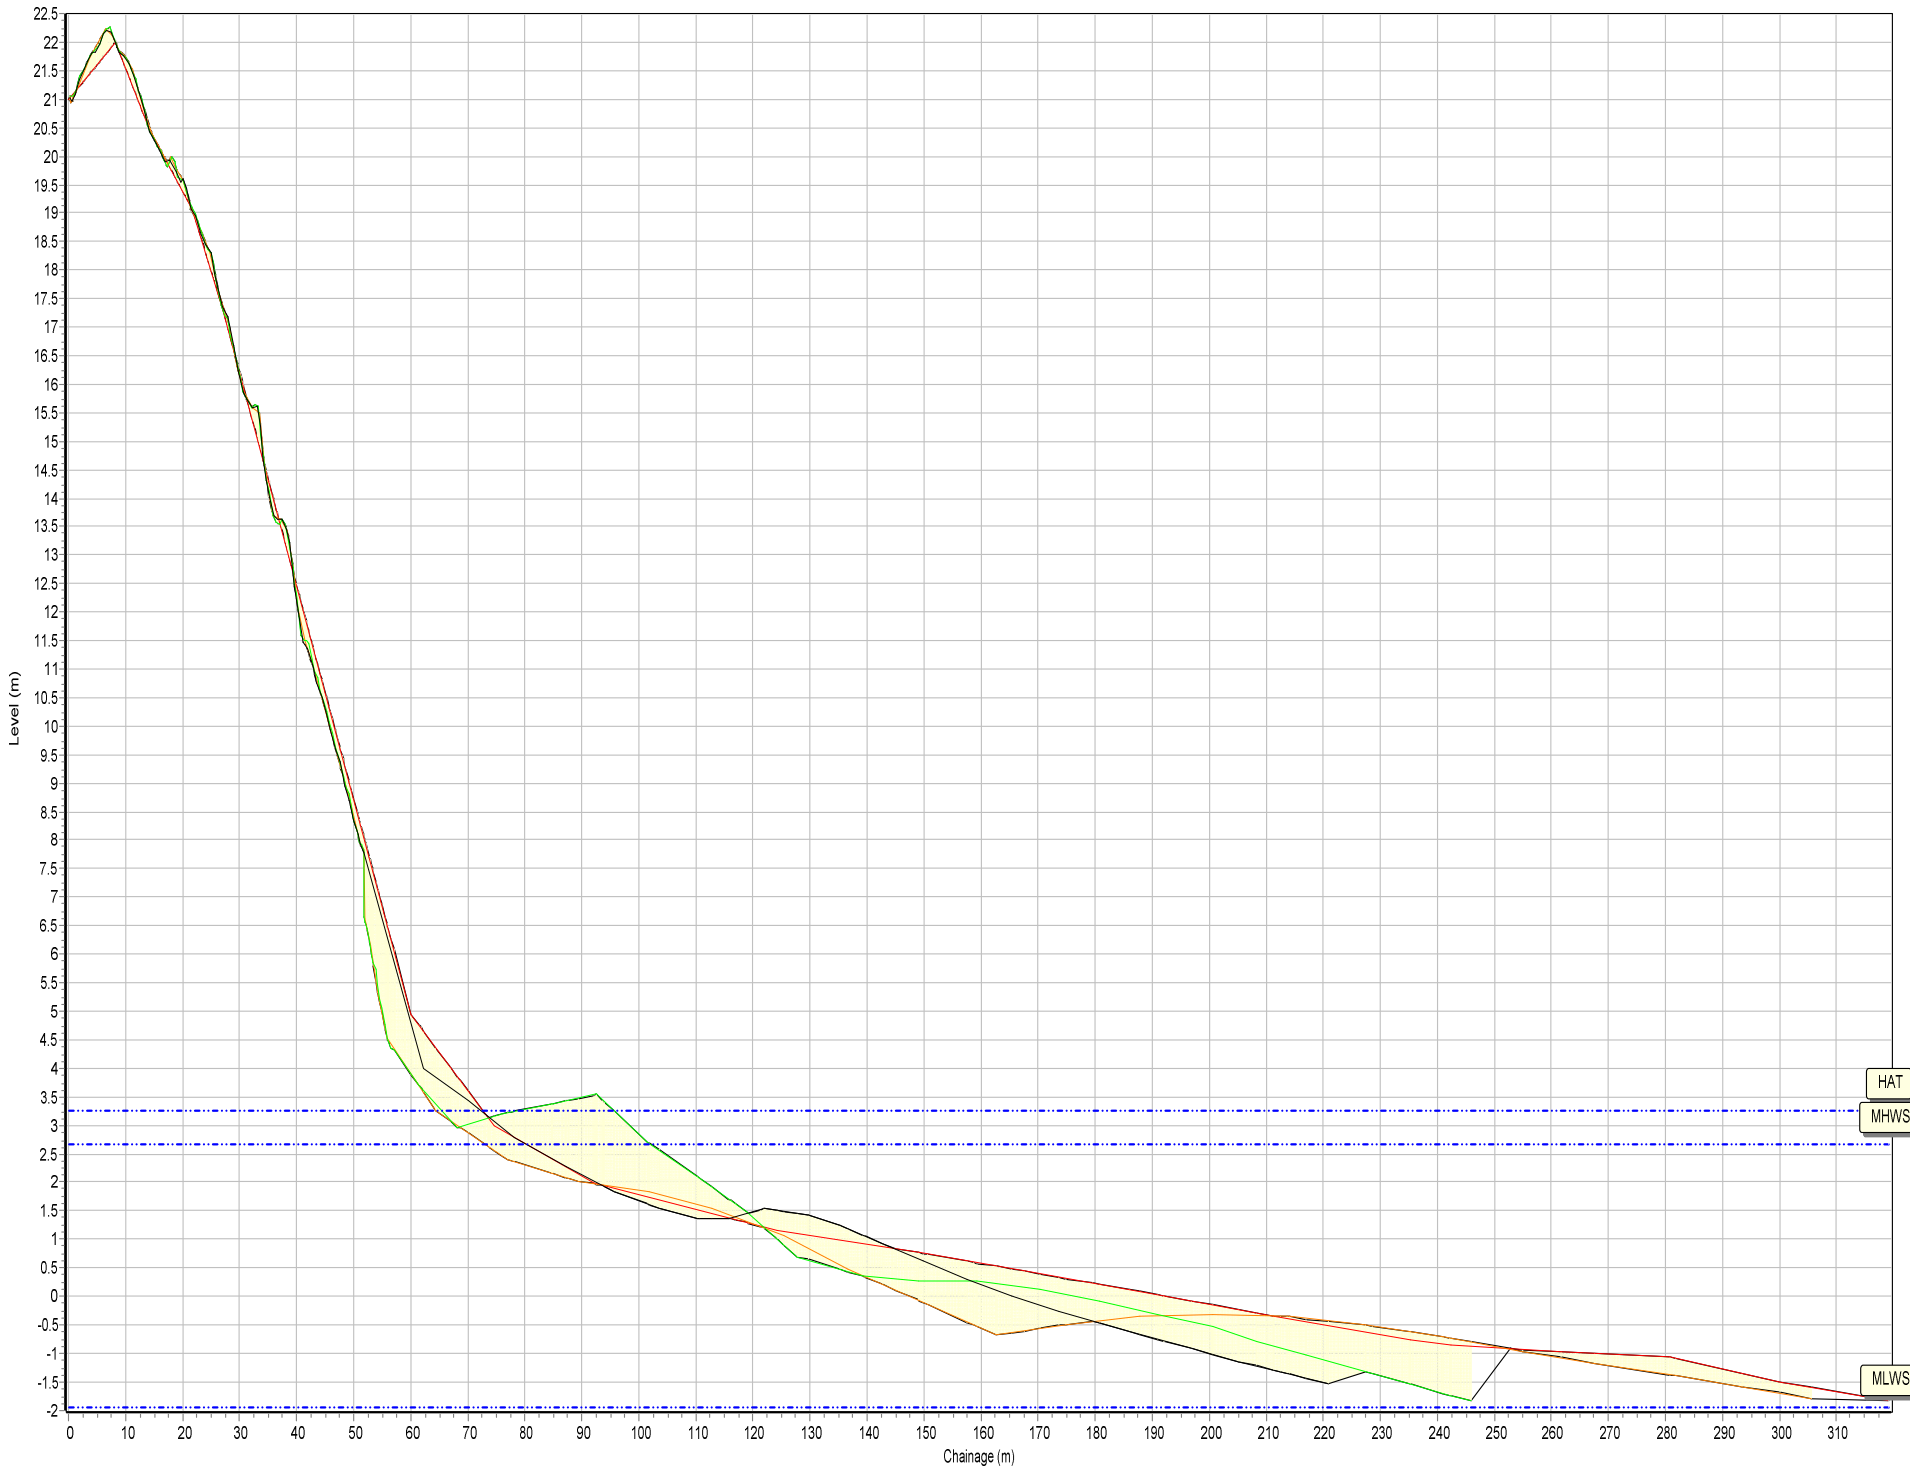
Beach Profiles: 1cRC8

Survey Date	Description of Changes Since Last Survey	Interpretation
5 th April 2019	<p>Beach Profiles:</p> <p>Marske Sands is covered by two beach profiles during the Partial Measures survey (RC7 to RC8; Appendix A). RC7 is on the boundary with the Redcar Sands area.</p> <p>Profile 1cRC7 is located along The Stray and has been discussed in Section 2.2.</p> <p>Profile 1cRC8 is largely unchanged as far as 50m chainage. Since April 2014 the dune face (chainage 50m) has remained stable, which contrasts with the winter of 2013/14 when 10m of recession was recorded. Seawards of chainage 50m, at the base of the cliff there has been some accretion of material meaning the toe of the slope has advanced by approximately 5m, this is likely caused by slight slumping of material from the face of the dune. A berm which had formed around chainage 90m has been eroded and the beach level in this location is now particularly low. From chainage 110m to 160m a shallow berm has formed. It is likely that this is the landward movement of a berm which was recorded in the lower beach in September 2018. The profile is relatively low in the upper beach compared to the range recorded from previous surveys (chainage 60m to 115m). On the lower beach the profile is at its lowest recorded level between chainage 180m and 200m. Generally, the profile is at a medium-low level when compared with the range of previously recorded results.</p>	<p>The cliffed face of the dune remained stable at both RC7 and RC8 following the recession over the winter of 2013/14.</p> <p>RC8 shows erosion, with a depression forming in the mid beach.</p> <p>Longer term trends:</p> <p>The April 2014 profiles were amongst the lowest seen at 1cRC8, due to the December 2013 storm surge. The beach has recovered however beach levels in 2019 remain low.</p>

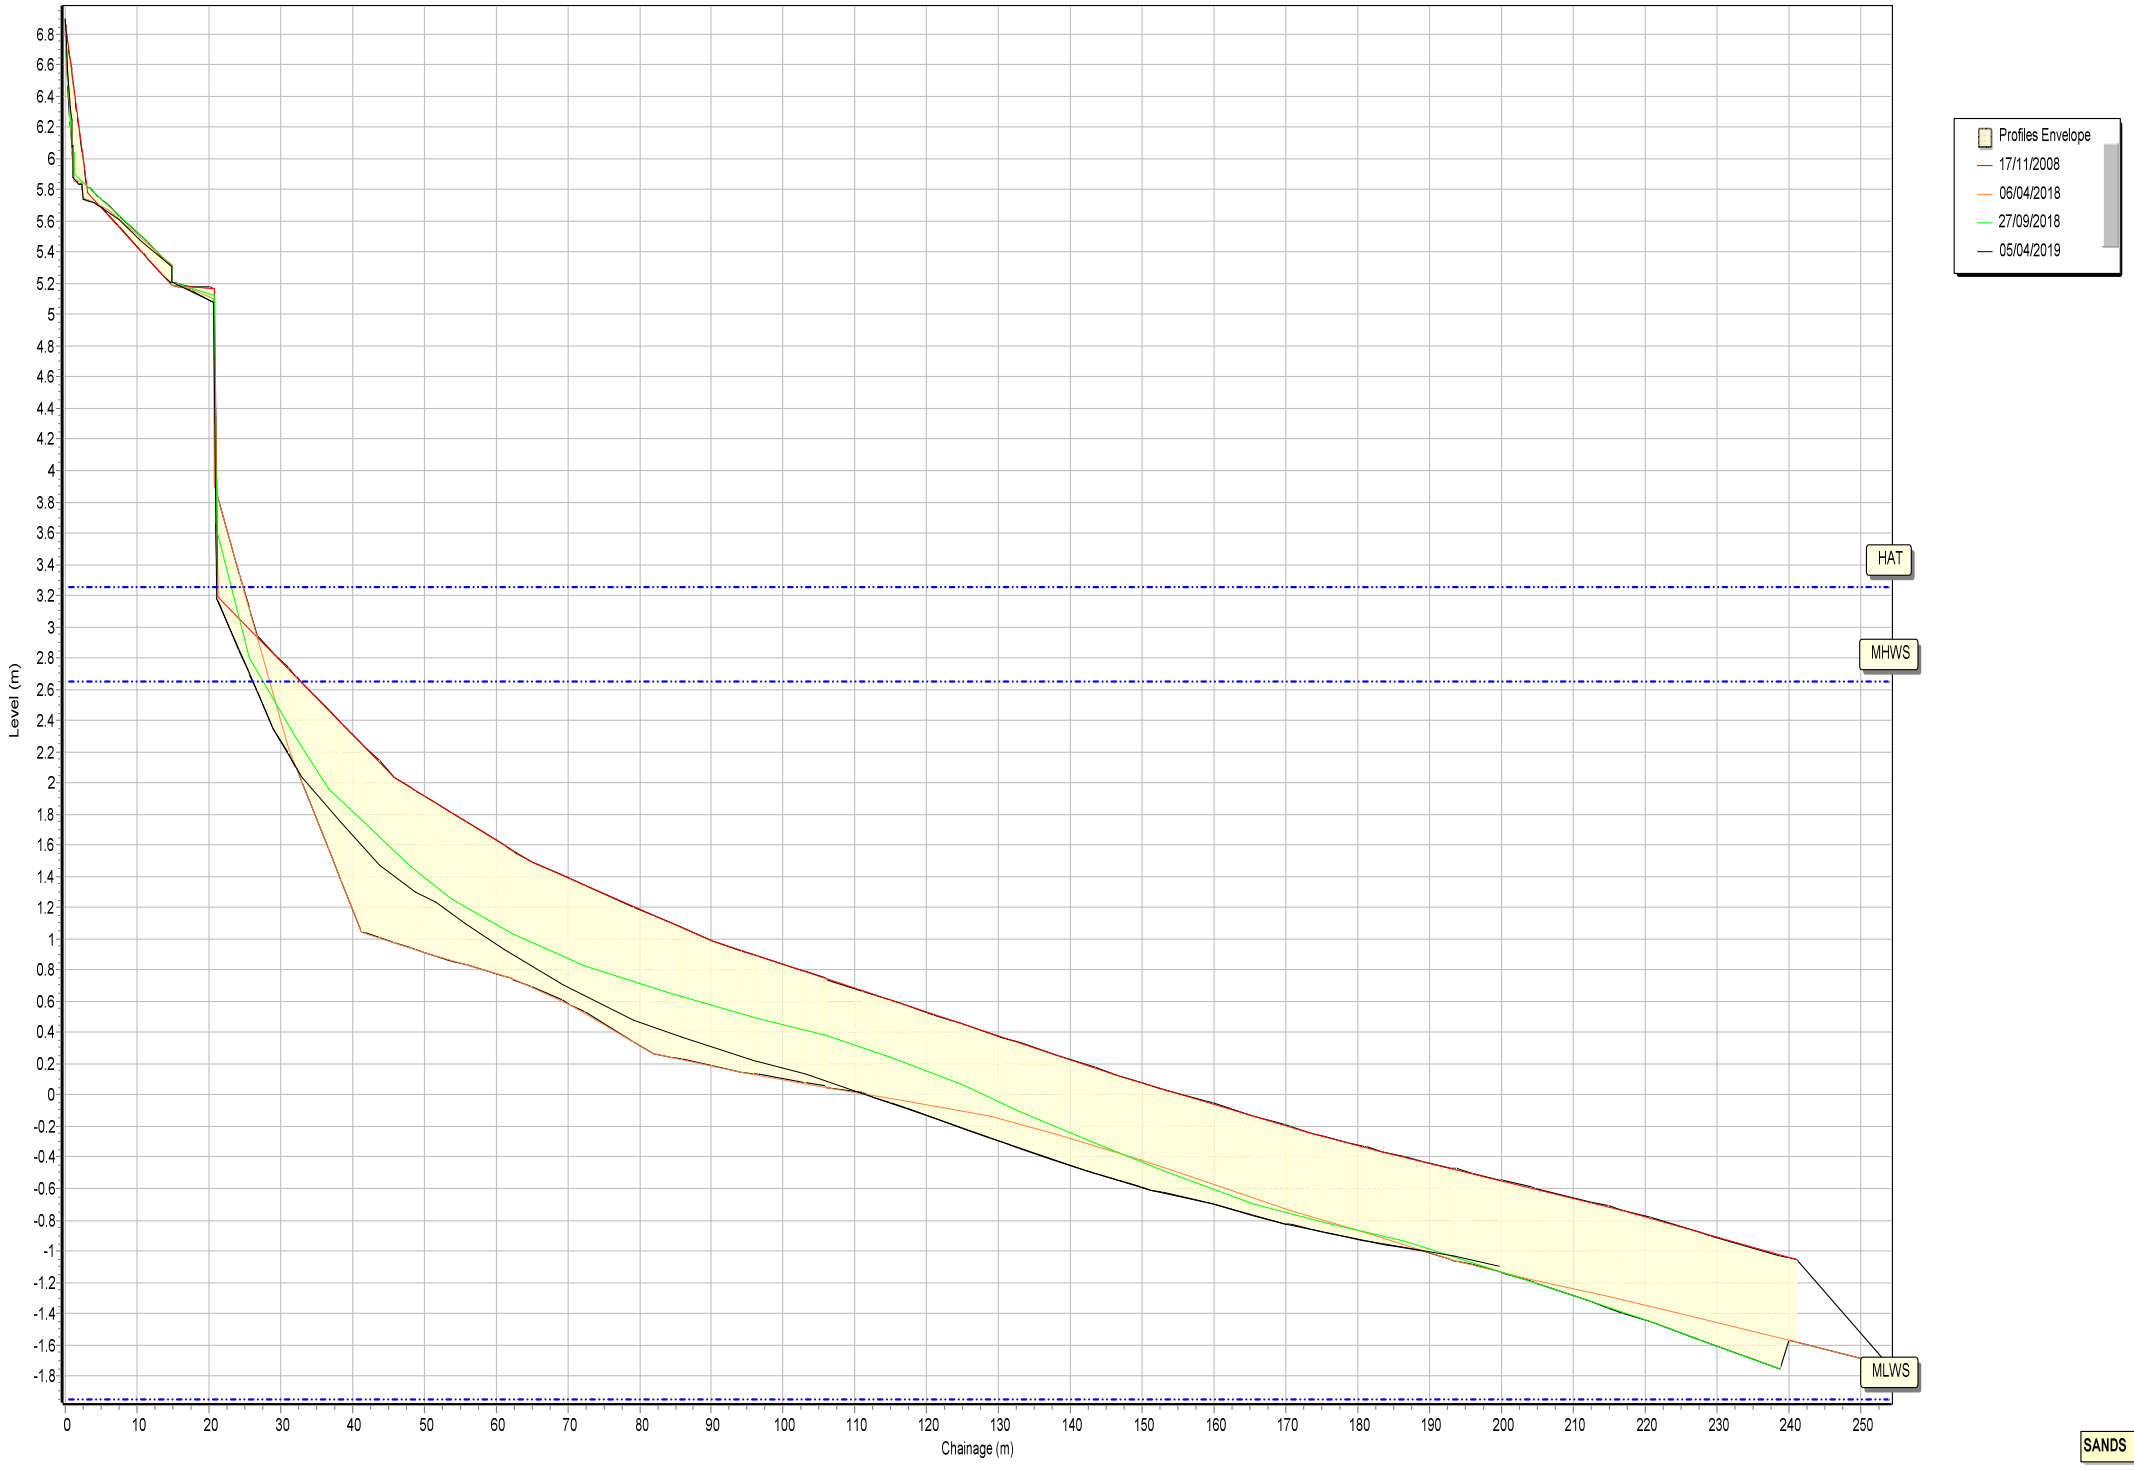
Beach Profiles: 1cRC9

Survey Date	Description of Changes Since Last Survey	Interpretation
5 th April 2019	<p>Beach Profiles:</p> <p>Saltburn Sands is covered by one beach profile (RC9; Appendix A).</p> <p>Overall Profile 1cRC 9 has experienced no change over the section covered by the sea defence as far as 20m chainage. There has been slight erosion at the toe of the seawall. Seawards of chainage 30m there has been erosion of up to 0.3m across the rest of the profile. The section of beach between chainage 110m and 180m is the lowest recorded compared to the previous surveys, the rest of the profile is at a relatively low level.</p>	<p>Although the drop-in beach level at RC9 over the winter of 2018/19 was not as significant as following the previous winter (17/18), the beach level is still particularly low. Overall, the beach level is low and has been eroding at a low rate since 2008.</p> <p>Longer term trends: The profile plots show net erosion, although there are periods of recovery. The profile for April 2019 is the lowest recorded in the mid and lower beach.</p>

- Following some recovery over the summer of 2018 at Saltburn Sands the expected winter (2018/19) drawdown has depleted beach levels significantly with the April 2019 profile being the lowest on record in the mid and lower beach.
