Cell 1 Regional Coastal Monitoring Programme Update Report 12: 'Partial Measures' Survey 2020

Redcar and Cleveland Council

August 2020

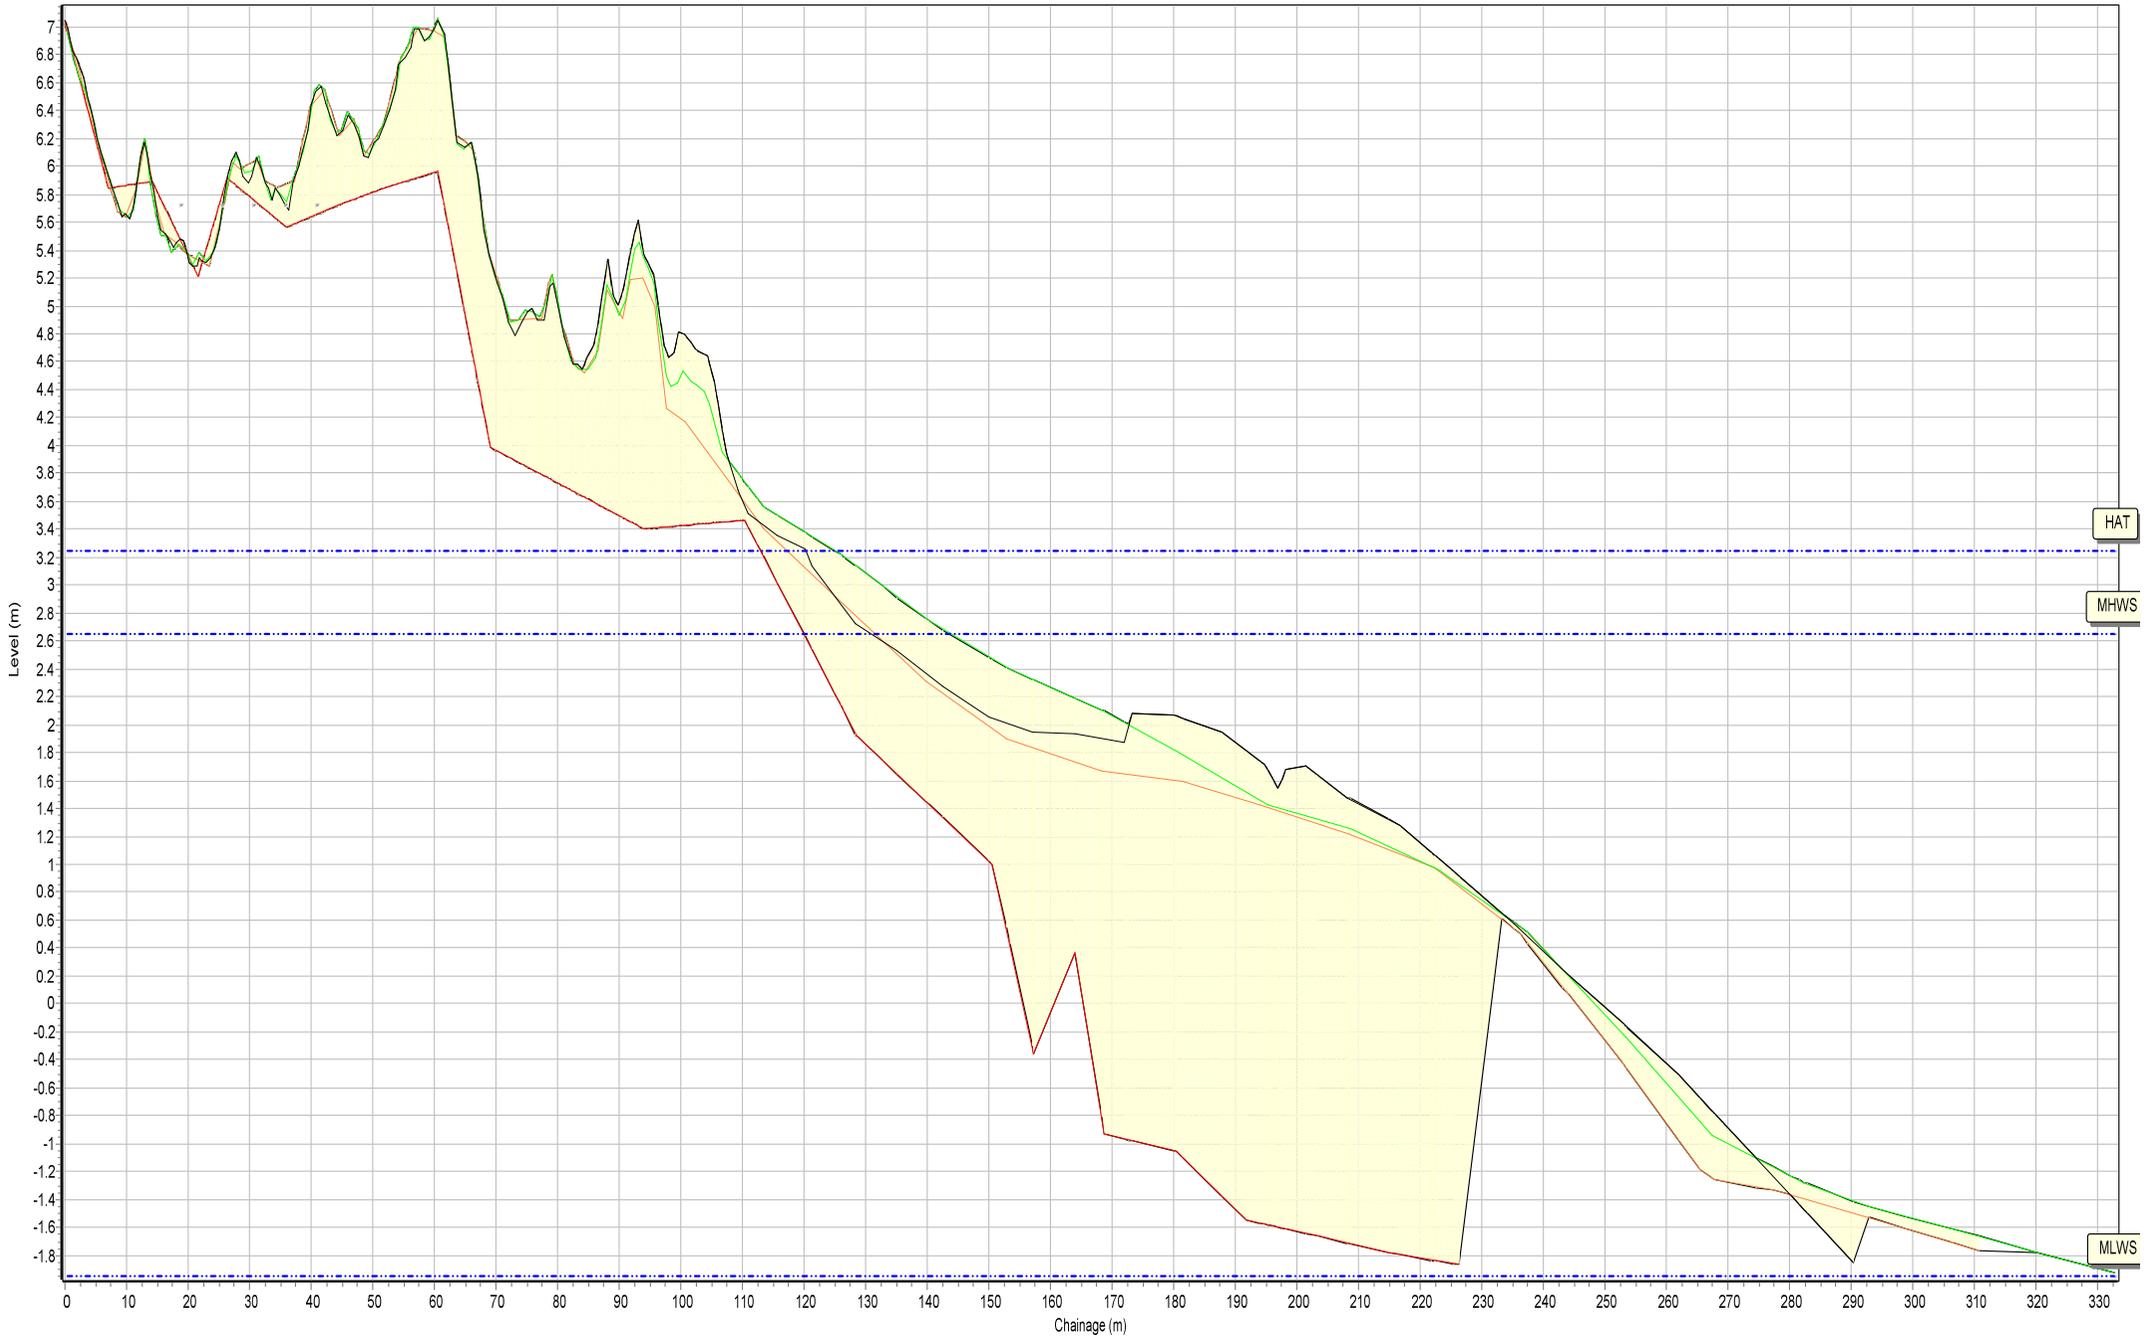
Beach Profiles: 1cRC1

Survey Date	Description of Changes Since Last Survey	Interpretation
29 th May 2020	<p>Beach Profiles:</p> <p>Coatham Sands is covered by four beach profiles during the Partial Measures survey (1cRC1 to 1cRC4; Appendix A) that were last surveyed in October 2019.</p> <p>Profile 1cRC1 is located 300m southeast of the South Gare Breakwater, in the lee of the German Charlies slag banks. The upper profile to 105m chainage is dominated by dunes that have remained stable since 2009. The highest dune (chainage 60m), is unchanged since October 2013. Since the previous survey, the foredune between 70m and 105m chainage has remained stable with some accretion of up to 0.4m on its seaward face, and is at its highest recorded level. Between 107m and 170m chainage the upper beach has eroded by up to 0.5m since October 2019. Over the same time period the beach between chainage 170m and 210m has accreted by approximately 0.5m, forming two shallow mid-beach berms. The profile remains largely unchanged between chainage 230m and 260m, with a small amount of accretion of up to 0.1m between chainage 260m and 275m. At the toe of the beach, from 275m to the end of the profile at 285m, there has been erosion of up to 0.5m. The profile is at its highest recorded level between chainage 97m to 107m and 173m and 225m. Overall, the profile is at a high level compared to the range of previously recorded results.</p> <p>At profile 1cRC2 the dunes have remained largely stable with accretion of up to 0.4m on the foredunes between chainage 79m and 100m since the previous survey. The upper beach between chainage 100m and 130m has experienced erosion of up to 0.2m, with this material moving down the beach to create a small berm between 135m and 145m. The upper mid beach between chainage 145m and 180m has experienced no change. The remainder of the mid-beach has experienced a low level of accretion of up to 0.2m between chainage 180m and 330m. The lower beach from chainage 325m to the end of the survey at chainage 390m has experienced a low level of erosion of up to 0.2m. Between chainages 79m to 98m, 132m to 152m and 297m to 303m, the profile is at its highest recorded level. Overall the beach is at a high level compared to the range recorded from previous surveys, whilst the dunes remain at their highest recorded levels, particularly the foredune.</p>	<p>Overall the beaches are healthy. The dune areas all show stability or some minor accretion on the foredunes over the winter of 2019/20, which conforms to a wider trend of stability. The dunes are at their highest recorded levels for all profiles.</p> <p>Generally, the profiles show a varied trend of accretion and erosion with most changes limited to the range recorded from previous surveys. There does tend to be more accretion on the lower beach in the eastern profiles RC2, 3 and 4. Although the most western profile is a slight anomaly due to erosion at the beach toe, much of the lower beach has experienced accretion. All of the profiles remain at healthy levels and demonstrate a long term trend of stability.</p> <p>Longer term trends:</p> <p>All of the Redcar profiles show the dunes are stable or accreting on their seaward extent. The beaches to the west show a typical longer-term trend of progressive accretion. The beaches in the centre and to the east have a more fluctuating long-term pattern.</p>

- At Coatham Sands the profiles have remained relatively stable with some erosion noted on the lower beach in the west.
- Across Redcar Sands, erosion has tended to be the dominant process in the west, however the levels here remain within the bounds of previously recorded results. The remainder of the profiles have been dominated with accretion, most notably in the east of the survey extent. At Marske Sands the cliffed face of the dune generally remained stable, despite some slight slumping of material at the toe of the dune. There has been very limited accretion and erosion across the profile with the beach at a medium level

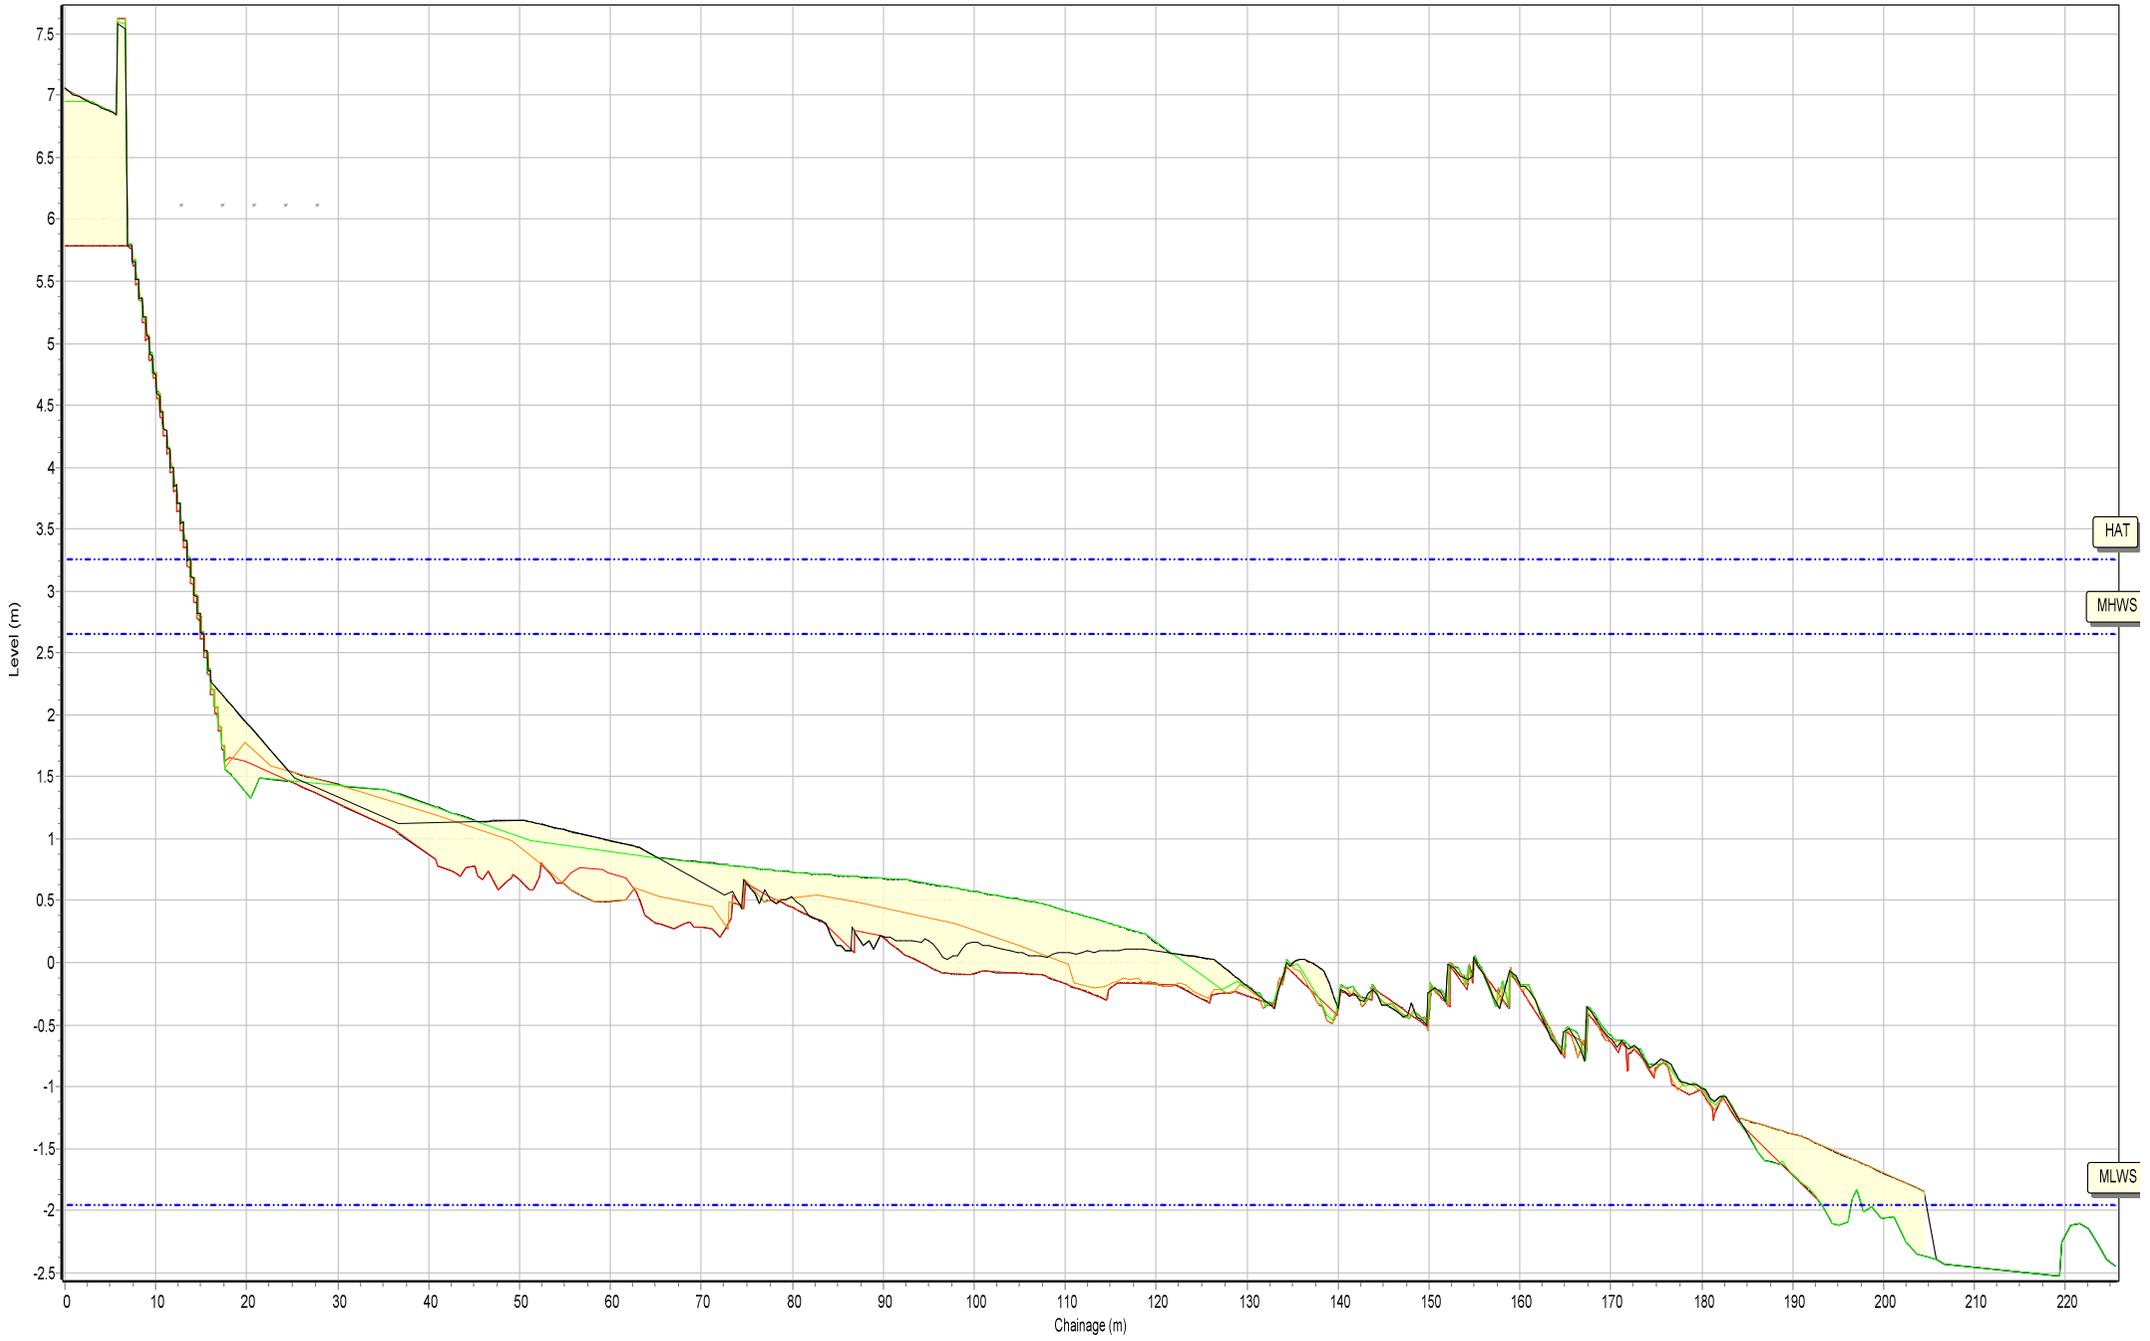
Beach Profiles: 1cRC5

Survey Date	Description of Changes Since Last Survey	Interpretation
29 th May 2020	<p>Beach Profiles:</p> <p>Redcar Sands is covered by three beach profiles (RC5 to RC7; Appendix A), with RC7 being approximately on the boundary with the Marske Sands area. They were last surveyed in October 2019.</p> <p>At profile 1cRC5 the sea defences constructed in 2012 remain unchanged as far as 20m chainage. There has been accretion at the toe of the sea defence of 0.9m. From chainage 25m to 45m there has been erosion the upper beach berm by 0.4m, whilst from chainage 45m to 65m there has been accretion of up to 0.3m, with this forming the crest of the present upper beach berm. The mid beach has experienced further erosion of up to 0.5m, which means the upper beach berm is now more prominent due to the more significant erosion on the upper and mid beach. The rock exposure at chainage 155m remains exposed and the low levels reported seawards of this point in October 2019 remain. Overall the upper beach is at a medium level whilst the remainder of the beach is at a low level compared to the range recorded from previous surveys. In particular the section of profile from chainage 81m-90m is the lowest on record.</p> <p>The profile at 1cRC6 has not changed landward of 55m chainage since the last survey due to the presence of the sea defence. There has been some minor erosion of up to 0.2m between chainage 57m and 63m whilst from chainage 63m to 90m a similar level of accretion has been experienced. The mid beach has experienced a low level of erosion of between 0.1m and 0.2m from chainage 90m to 200m. The lower beach from chainage 200m to the end of the survey at chainage 319m has experience minor change within the survey tolerance of ± 0.1m. The profile remains at a high level compared with the range of previously recorded results. The profile is generally very evenly graded, with the sections from chainage 230m – 240m and chainage 280m – 290m being the highest on record.</p> <p>Profile 1cRC7 is undefended. The dune face at 60m chainage remained stable since October 2014. Between chainage 70m and 95m the toe of the dune has slipped, with 0.4m of erosion around chainage 75m and 0.2m of accretion around chainage 85m. The remainder of the profile, from chainage 95m to the end of the survey at chainage 340m there has been accretion of up to 1.0m, with some shallower sections of accretion fully covering the lower beach berm previously recorded here. Overall the beach profile is at a high level across most of its length, with the exception of the toe of the dunes where it is at its lowest recorded level at chainage 70m, when compared to the range recorded from previous</p>	<p>Profiles 1cRC5 shows erosion to be the dominant process but remains largely within the bounds of the previous results. Profiles RC6 and RC7 show accretion to be dominant process with beach levels remaining medium, with RC7 experiencing a significant level of accretion over much of its extent. Each of the profiles shows some evidence of movement of berms, Longer term trends:</p> <p>Profiles RC5 and RC7 show movement of beach berms, across the profile with some evidence for gradual accretion.</p>

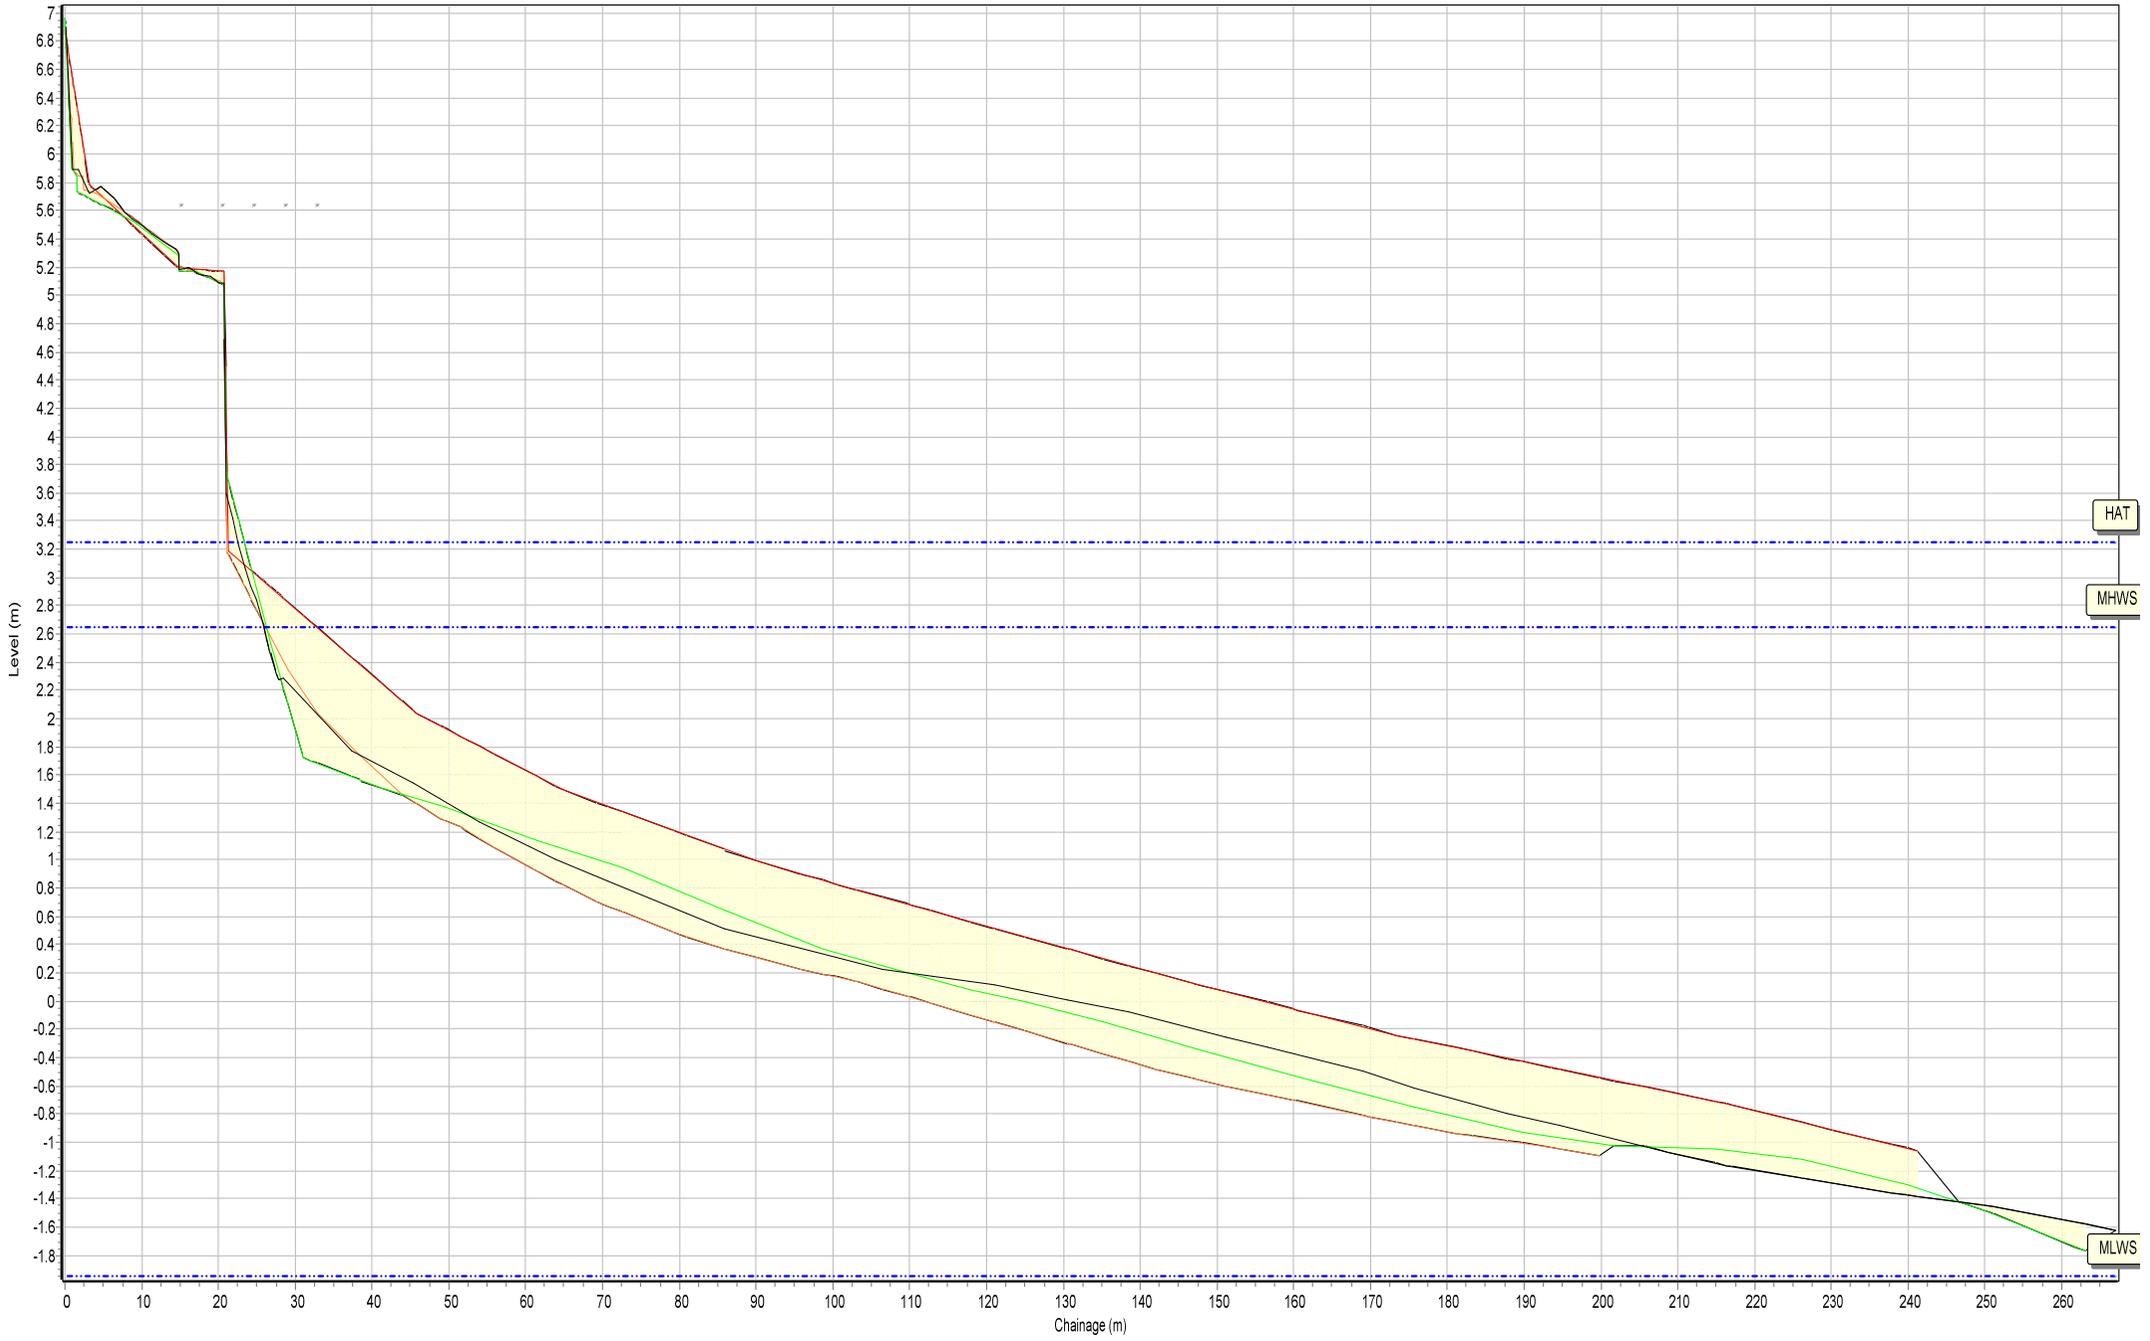
Beach Profiles: 1cRC9

Survey Date	Description of Changes Since Last Survey	Interpretation
29 th May 2020	<p>Beach Profiles:</p> <p>Saltburn Sands is covered by one beach profile (RC9; Appendix A).</p> <p>Overall Profile 1cRC9 has experienced no change over the section covered by the sea defence as far as 20m chainage. There has been accretion of up to 0.8m at the toe of the seawall to chainage 52m. Seawards of chainage 52m there has been erosion of up to 0.2m across the upper beach. The mid-beach from chainage 110m to 210m has experienced a similarly low level of accretion. Whilst a shallow beach berm previously recorded at the profile toe has been eroded from chainage 210m to the end of the survey at 265m. The beach lies at a medium level when compared to the previous surveys.</p>	<p>The profile has remained stable over the winter of 2019/ 20 with a relatively even balance of erosion and accretion. The effects of the seasonal drawdown noted in this location previously may be masked in this spring's survey results due to the delay caused by the Covid19 lockdown restrictions meaning the surveys were undertaken in late May. Overall, the beach is at a medium level and despite some erosion, appears relatively stable when compared with the previous survey</p> <p>Longer term trends: The profile plots show net erosion, although there are periods of recovery. The May 2020 results may be slightly misleading due to them being undertaken in late spring / early summer.</p>

- At Saltburn Sands the profile has remained relatively stable with a balance of erosion and accretion. Previously reported winter drawdown in this area may be somewhat masked by the effects of a later survey window.
