**Cell 1 Regional Coastal Monitoring Programme
Update Report 13: 'Partial Measures' Survey 2021**

Redcar and Cleveland Council

May 2021

(*) The present report is **Update Report 13** and provides an analysis of the 2021 Partial Measures survey for Redcar and Cleveland Council's frontage.

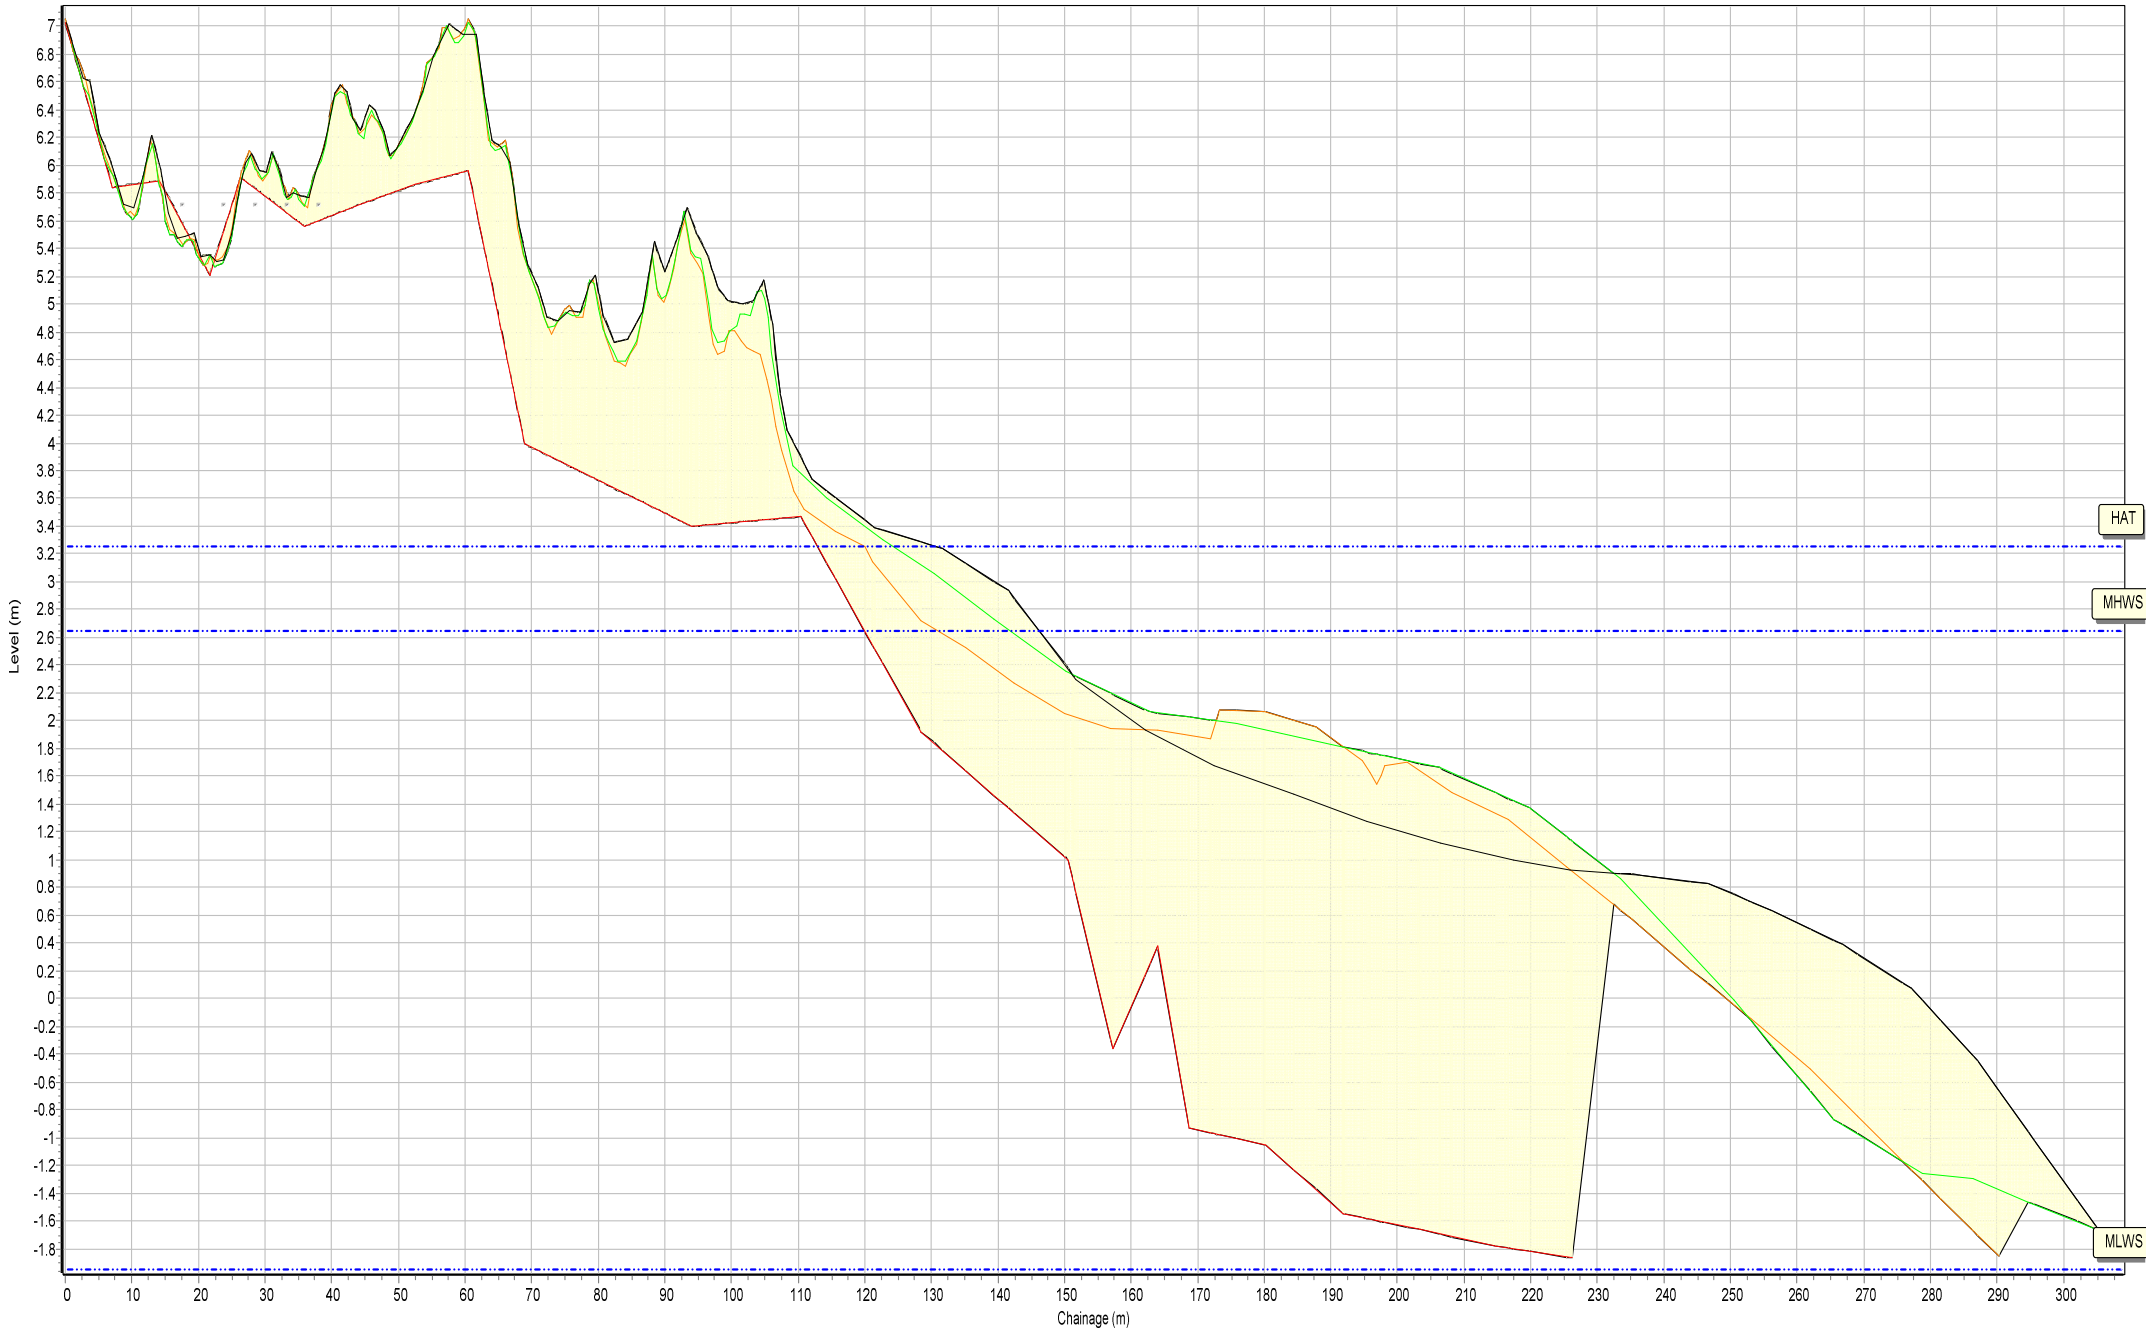
Beach Profiles: 1cRC1

Survey Date	Description of Changes Since Last Survey	Interpretation
15 th – 17 th March 2021	<p>Beach Profiles:</p> <p>Coatham Sands is covered by four beach profiles during the Partial Measures survey (1cRC1 to 1cRC4; Appendix A) that were last surveyed in autumn 2020.</p> <p>Profile 1cRC1 is located 300m southeast of the South Gare Breakwater, in the lee of the German Charlies slag banks. The upper profile to 105m chainage is dominated by dunes that have remained stable since 2009. The highest dune (chainage 60m) is unchanged since October 2013. Since the previous survey, the foredune between 70m and 105m chainage has remained stable, with an accretion of up to 0.4m across the dunes and 0.1m accretion on its seaward face which is now at its highest level recorded. The upper beach between chainage 105m and 151m has accreted by up to 0.3m and the lower beach seaward of chainage 232m has accreted by up to 1.2m. The middle beach between chainages 151-232m has lowered by up to 0.5m. Overall, the profile is at a high level compared to the range of previously recorded results, particularly between chainages 90-140m and 232-305m which are at their highest level recorded.</p> <p>At profile 1cRC2 the dunes have remained largely stable with accretion of up to 0.5m on the foredunes between chainage 67m and 95m since the previous survey. The upper beach between chainage 95m and 137m has accreted by up to 0.4m, forming a small berm at chainage 125m which is now at its highest level recorded. The middle and lower beach seaward of chainage 125m has lowered by up to 0.5m. Overall the beach is at a medium-high level compared to the range recorded from previous surveys, whilst the dunes remain at their highest recorded levels, particularly the foredune.</p> <p>Profile 1cRC3 showed the main dune has remained stable since April 2014. The crest and seaward face of the foredune has experienced some minor accretion of up to 0.1m to chainage 100m since the previous survey. The majority of the profile seaward of chainage 100m has lowered by up to 0.2m on the middle beach and 0.6m on the lower beach. A hollow at chainage 245m has infilled by up to 0.4m. Overall the profile is at a medium-high level compared with the range recorded from previous surveys. The dunes, which have remained stable over the winter of 2020/21, are at a high level compared to the range recorded from previous surveys. The lower beach berm from chainage 235m to the end of the</p>	<p>Generally, the profiles show a variable trend of accretion and erosion, with most changes limited to the range recorded from previous surveys. Generally, the beach profiles show accretion within the dunes and at the dune toe, and erosion across the middle beach. The central profiles (1cRC2 and 1cRC3) have lowered on the lower beach, whilst 1cRC1 and 1cRC4 have accreted. The dune areas all show stability or some accretion on the foredunes over the winter of 2020/21 and are at their highest recorded level at all profiles.</p> <p>Longer term trends:</p> <p>All beach profiles at Coatham show the dunes are stable or accreting on their seaward extent. The beaches to the west show a typical longer-term trend of progressive accretion. The beaches in the centre and to the east have a more fluctuating long-term pattern.</p>

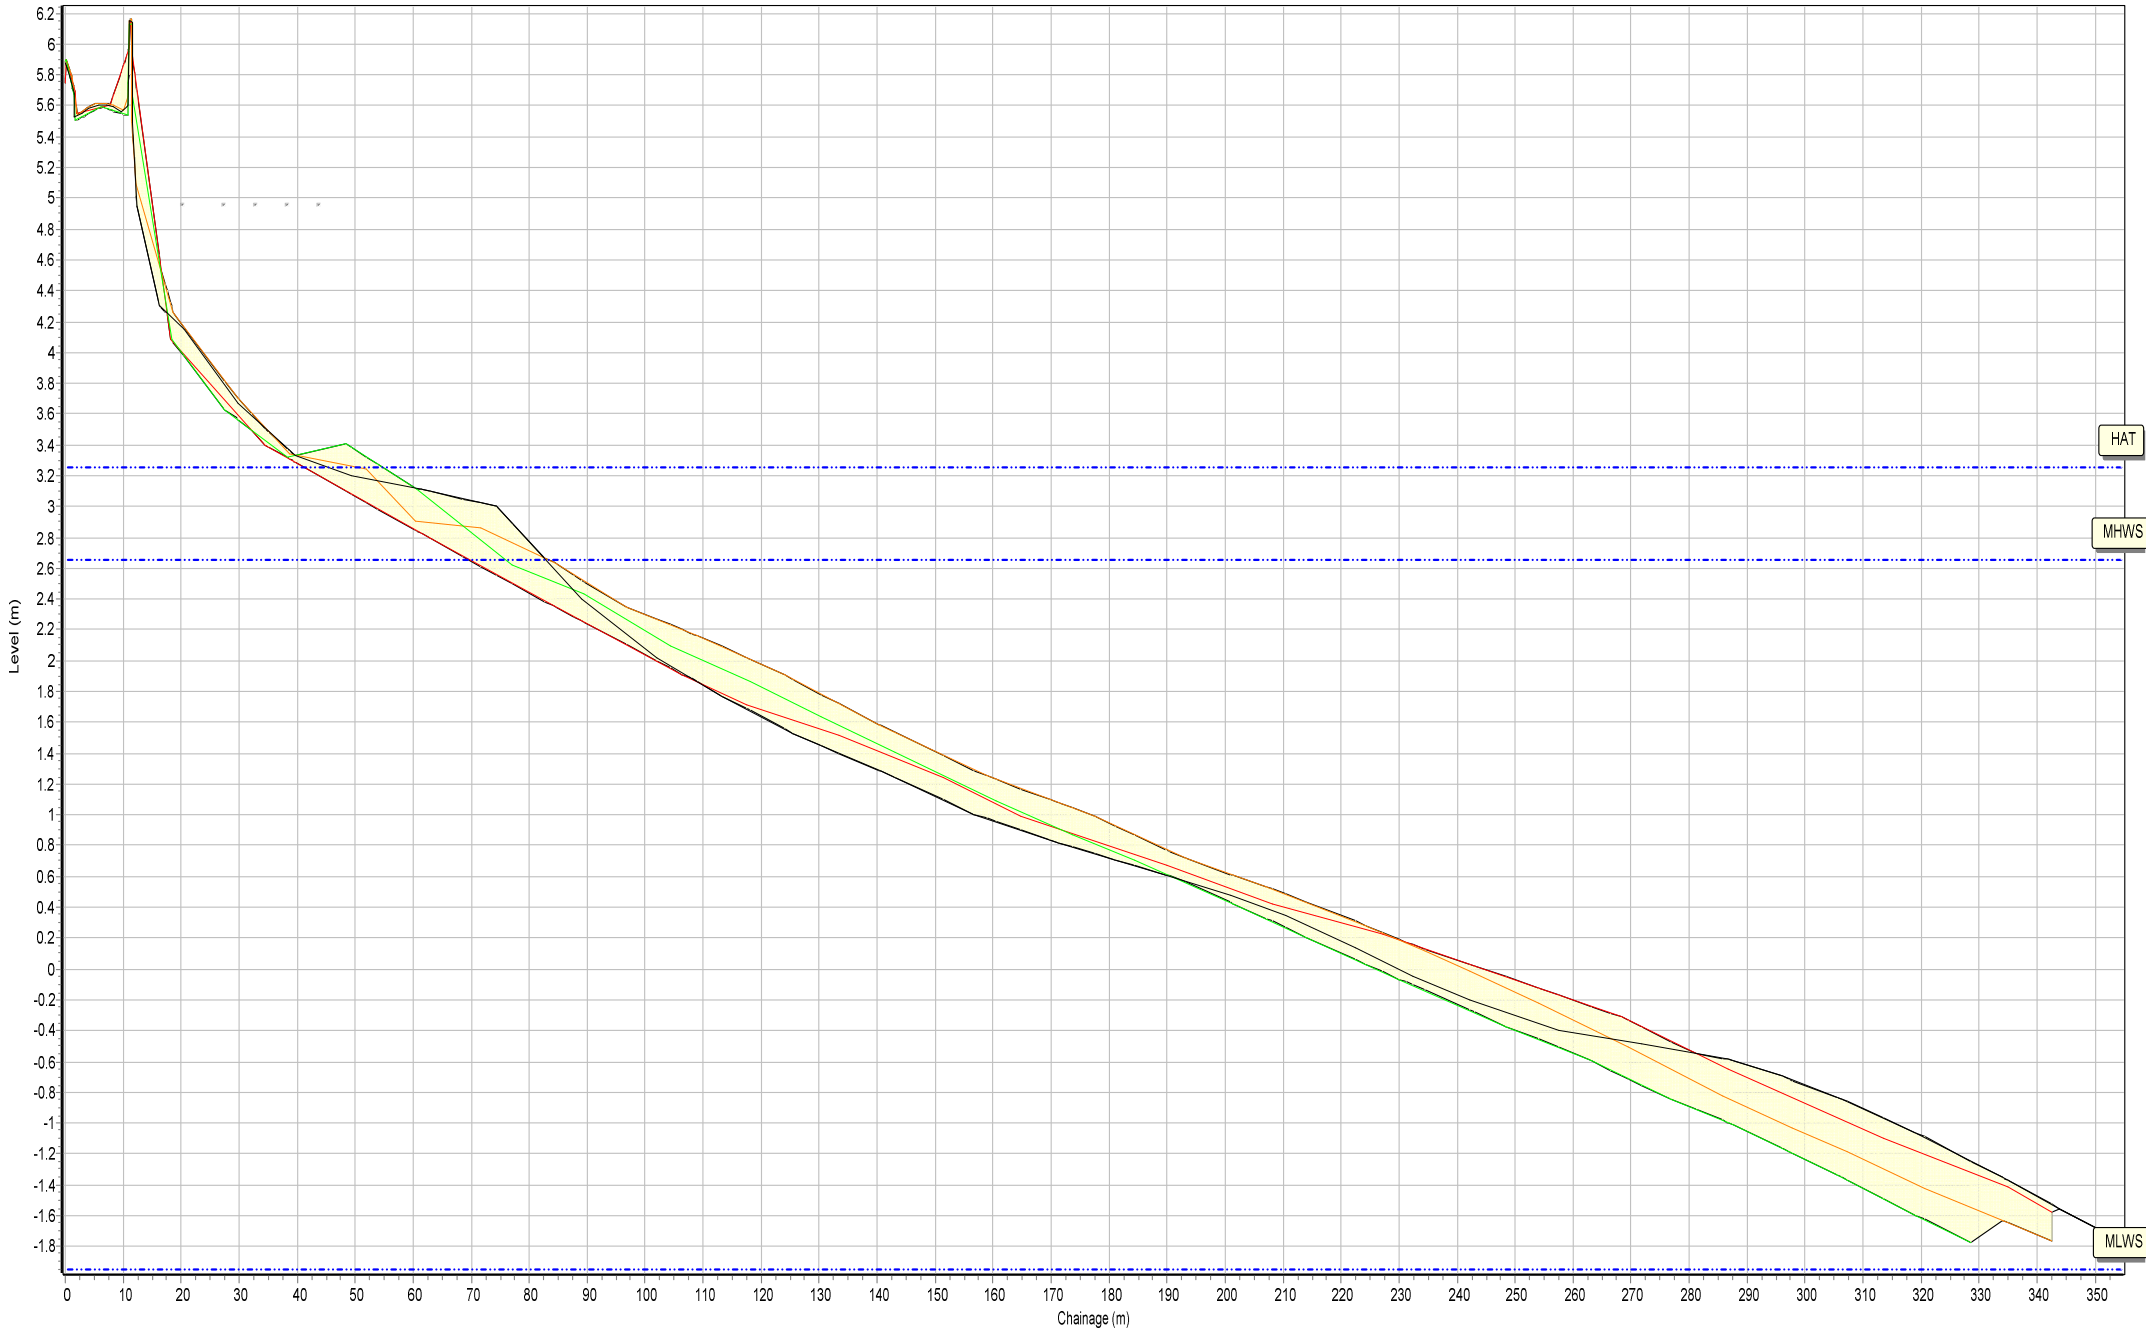
Beach Profiles: 1cRC4

Survey Date	Description of Changes Since Last Survey	Interpretation
	<p>survey at 260m is the highest recorded level in this location.</p> <p>Profile 1cRC4 is located at the beginning of the defended section at Coatham and Redcar. There has been accretion of up to 0.2m at the base of the seawall throughout the winter of 2020/21. An upper beach berm has migrated seaward by approximately 30m. The middle beach has lowered by up to 0.2m to chainage 190m, before switching to accretion on the lower beach by up to 0.5m. Overall the profile is at a high level across the upper beach, a low level on the middle beach and a medium level on the lower beach when compared to the range recorded from previous surveys.</p>

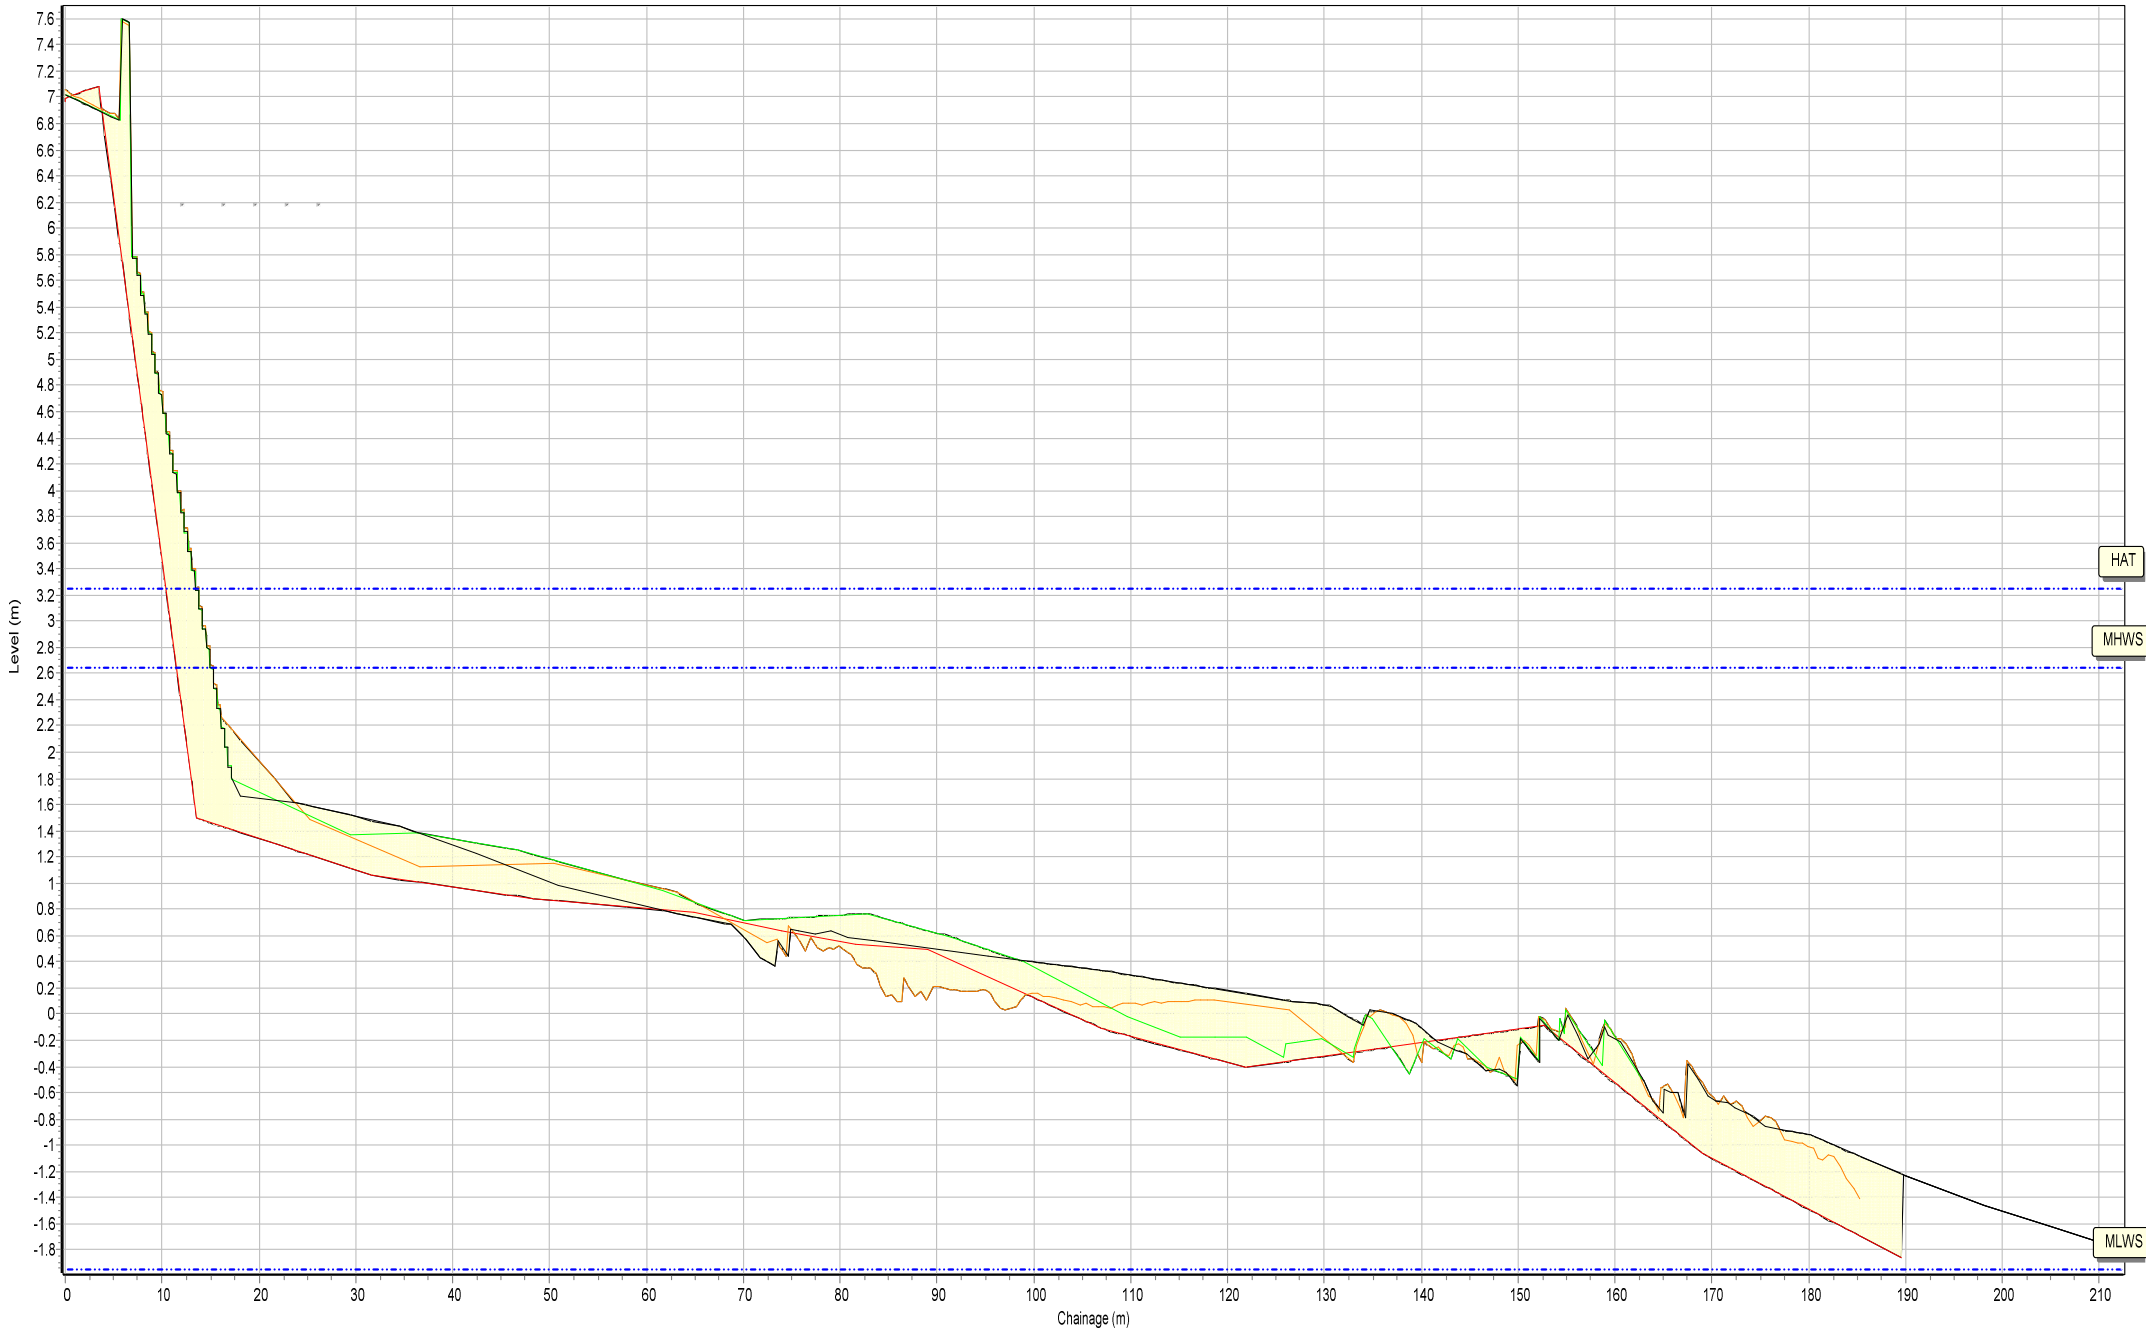
Beach Profiles: 1cRC5

Survey Date	Description of Changes Since Last Survey	Interpretation
<p>15th – 17th March 2021</p>	<p>Beach Profiles:</p> <p>Redcar Sands is covered by three beach profiles (1cRC5 to 1cRC7; Appendix A), with 1cRC7 being approximately on the boundary with the Marske Sands area. They were last surveyed in autumn 2020.</p> <p>At profile 1cRC5 the sea defences constructed in 2012 remain unchanged as far as 20m chainage. There has been accretion at the toe of the sea defence of 0.1m to chainage 36m. From chainage 36m to 97m there has been a lowering of the middle beach by up to 0.3m, exposing a patch of rocks at chainage 75m. The lower beach has accreted by up to 0.4m to chainage 145m. The rock exposure seawards of chainage 145m remains exposed and the low levels reported seawards of this point in October 2019 remain. Overall, the profile is at a medium level compared to the range recorded from previous surveys.</p> <p>Profile 1cRC6 has not changed landward of 55m chainage since the last survey due to the presence of the sea defence, with very little to no change at the toe of the sea defence to chainage 90m. Seaward of this point, the upper middle and lower beach have lowered evenly by up to 0.3m. Overall, the profile is at a medium level compared with the range of previously recorded results.</p> <p>Profile 1cRC7 is undefended. The profile has not changed landward of 67m chainage since the last survey. There has been a lowering of the upper beach by up to 1.0m and the lower beach by up to 1.0m. The middle beach between chainages 190-230m has accreted by up to 0.3m. The profile is at a medium level compared with the range of previously recorded results.</p>	<p>Profiles at Redcar shows erosion to be the dominant process, however beach profiles remain within the bounds of the previous results.</p> <p>Longer term trends:</p> <p>Profiles 1cRC5 and 1cRC7 show movement of beach berms across the profile.</p>

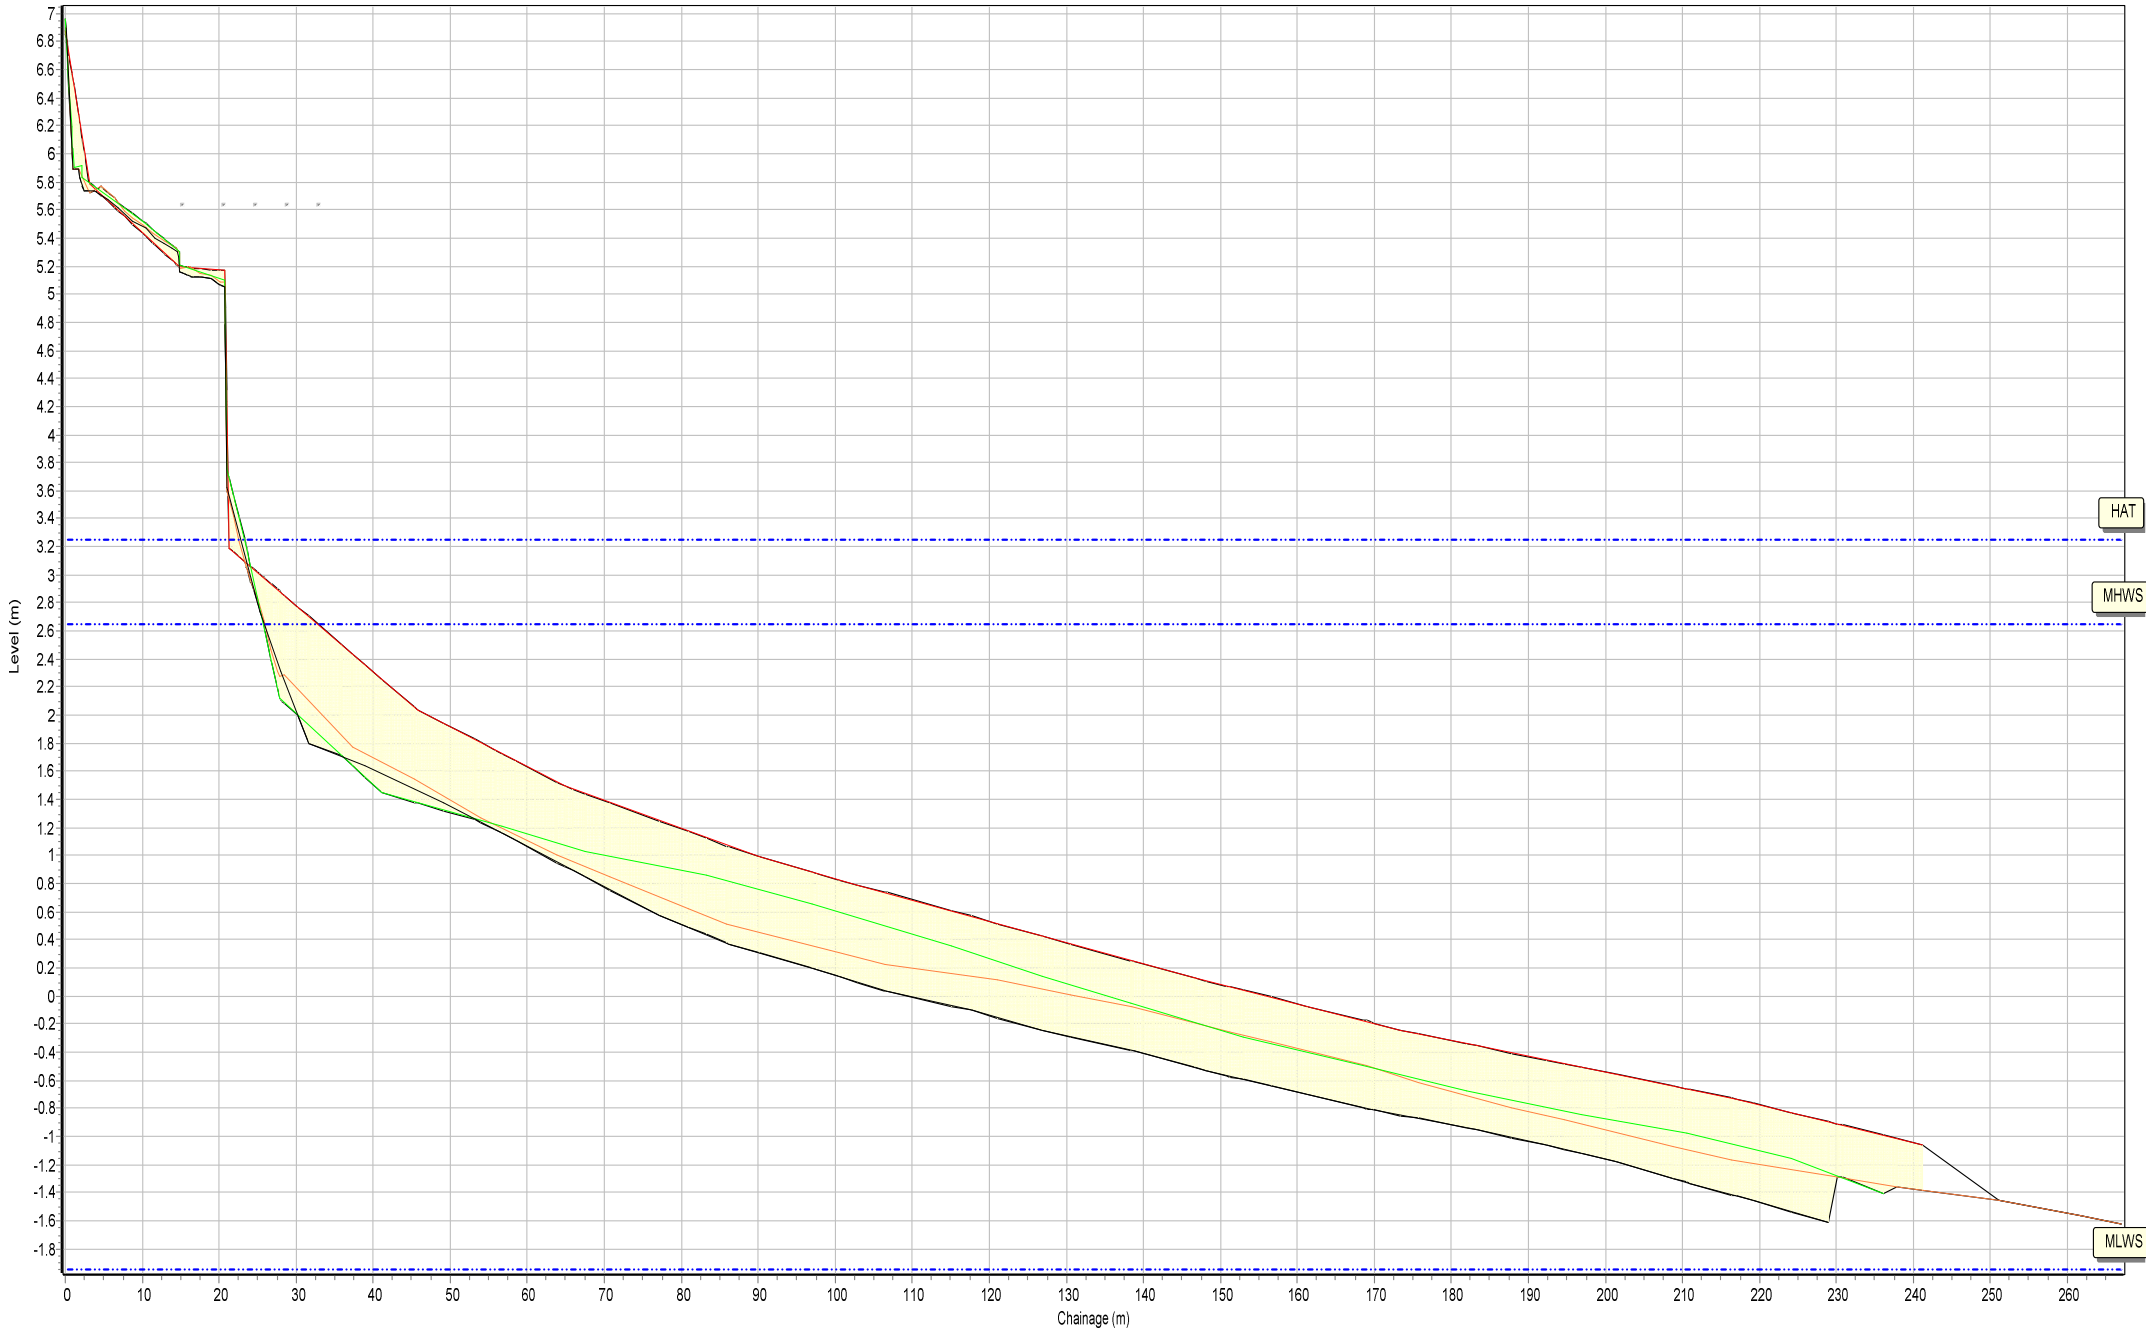
Beach Profiles: 1cRC9

Survey Date	Description of Changes Since Last Survey	Interpretation
<p>15th – 17th March 2021</p>	<p>Beach Profiles:</p> <p>Saltburn Sands is covered by one beach profile (1cRC9; Appendix A).</p> <p>Overall profile 1cRC9 has experienced no change over the section covered by the sea defence as far as 20m chainage. There has been accretion of up to 0.2m at the toe of the seawall to chainage 30m. Seawards of chainage 30m there has been erosion of up to 0.4m across the beach profile. The beach lies at a low level when compared to the previous surveys.</p>	<p>The profile has remained stable over the winter of 2020/21, with an even erosion of up to 0.4m across the majority of the beach profile. Overall, the beach is at a low level but appears relatively stable when compared with the previous surveys.</p> <p>Longer term trends: The profile plots show net erosion, although there are periods of recovery.</p>
