Cell 1 Regional Coastal Monitoring Programme Update Report 14: 'Partial Measures' Survey 2022

Redcar and Cleveland Council

July 2022

^(*) The present report is **Update Report 14** and provides an analysis of the 2022 Partial Measures survey for Redcar and Cleveland Council's frontage.

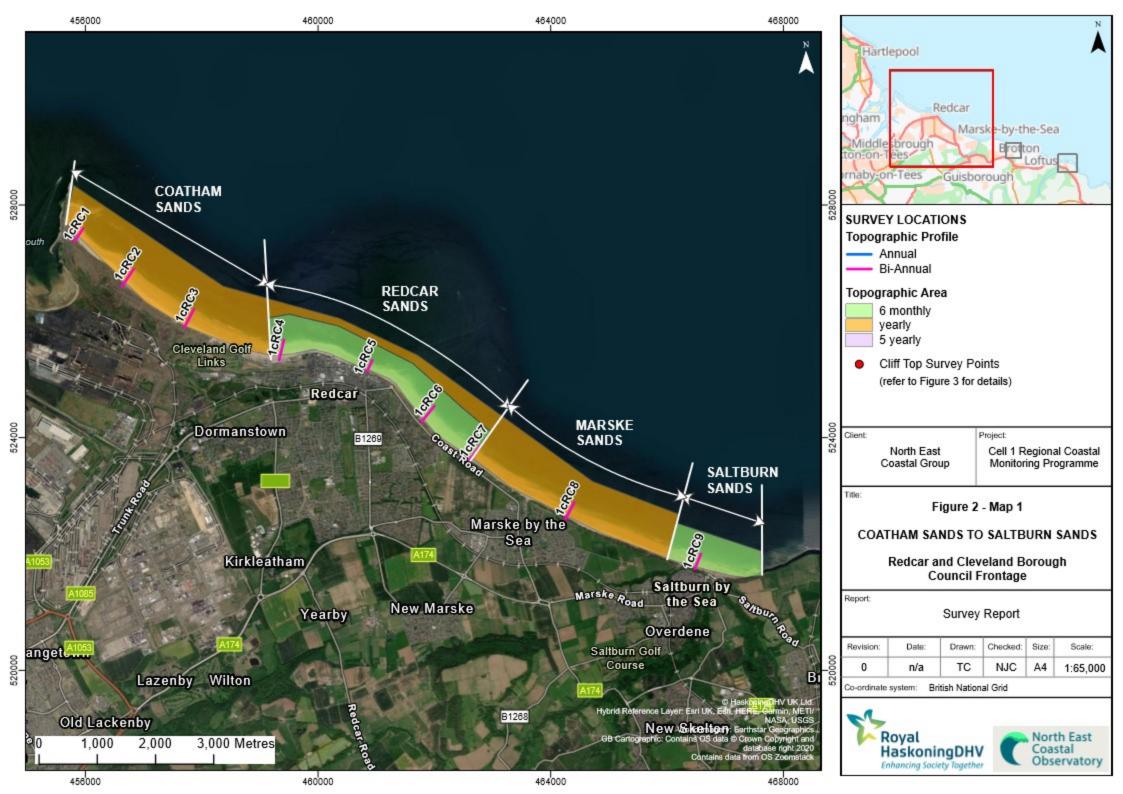
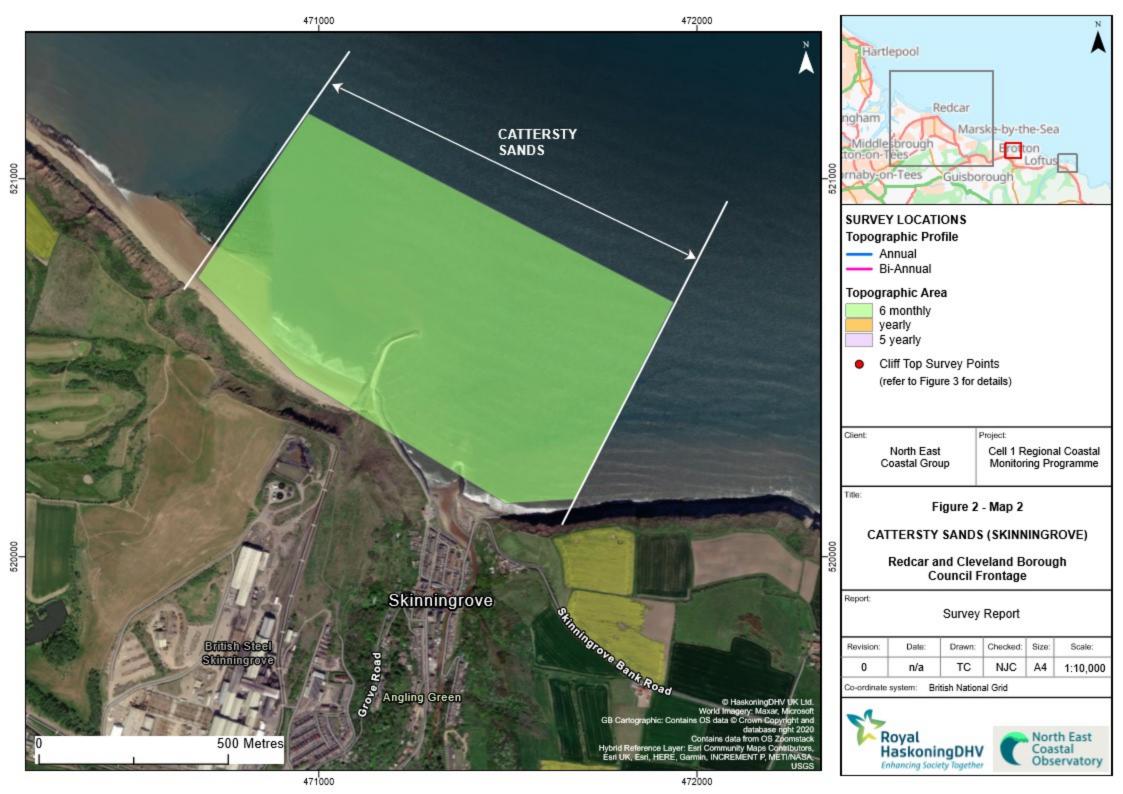
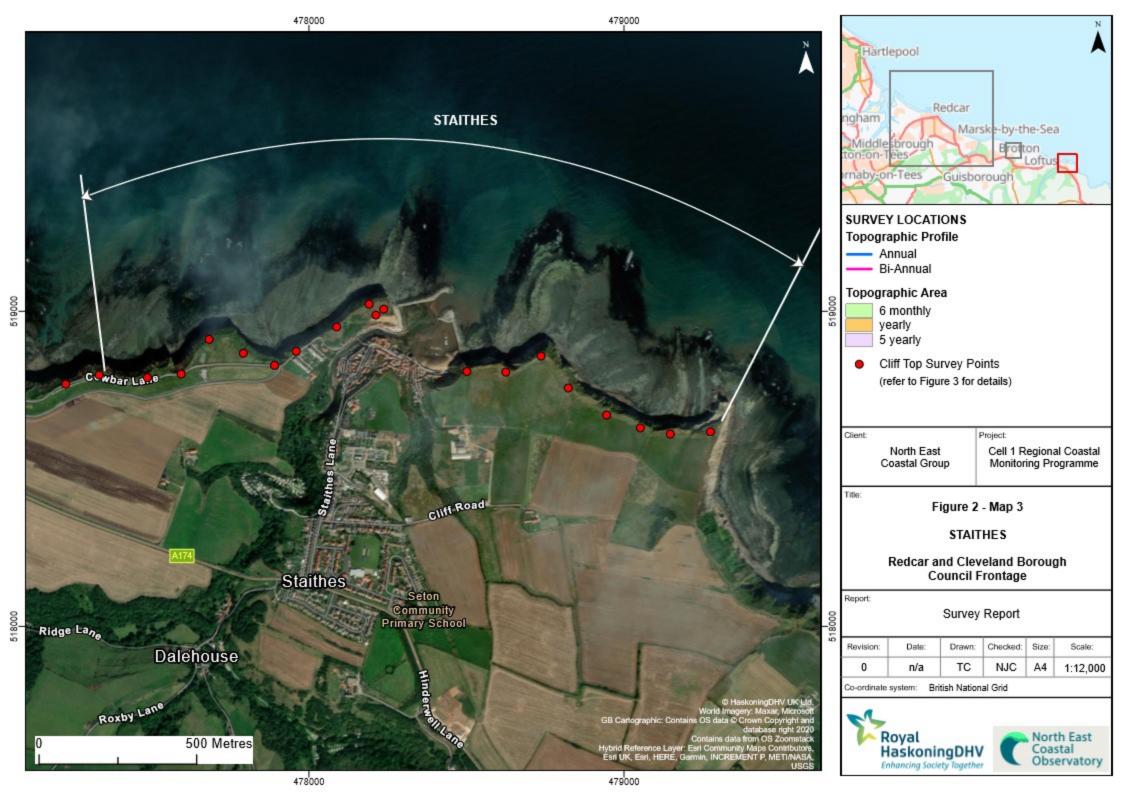
The location of these surveys is shown in Figure 2 and 3. The Partial Measures survey was undertaken along this frontage between 19th and 21st April at Redcar (Coatham Sands, Redcar Sands, Markse Sands and Saltburn Sands), 22th March at Skinningrove and 25th April at Staithes. During the surveys the weather was varied with varying sea states. Specific weather conditions are detailed in the survey reports.

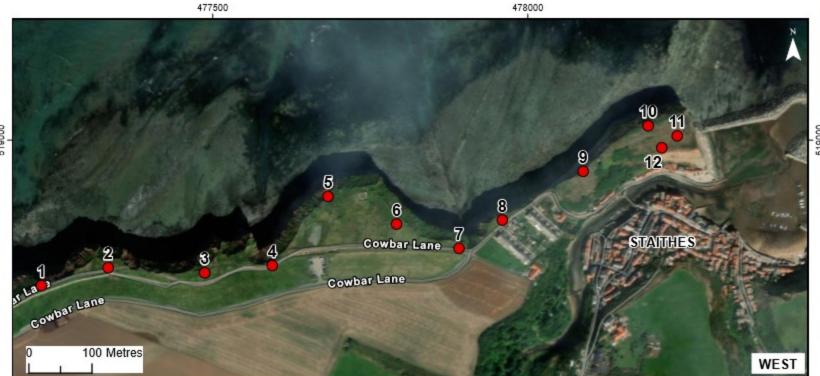
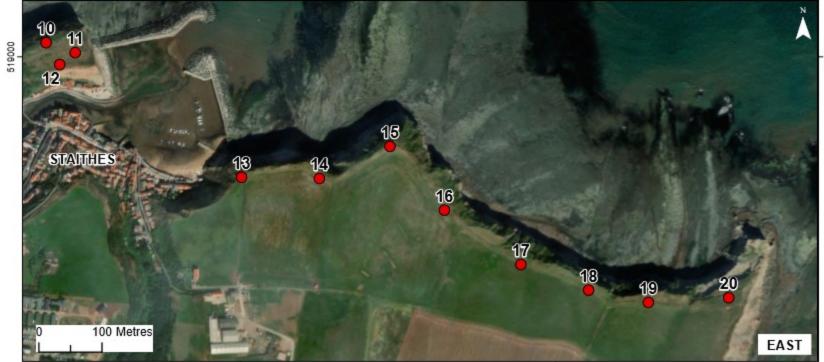
Figure 3 - Map 1

Cliff Top Survey Points

Twenty ground control points have been established at Staithes (Figure 3 – Map 1). The maximum separation between any two points varies along the coast, reflecting the degree of risk from the erosion. The cliff top surveys at Staithes are undertaken bi-annually. Measurements are taken from a fixed ground control point along a fixed bearing to the edge of the cliff top.

Survey Date	Description of Changes Since Last Survey	Interpretation
25 th April 2022	Cliff-top Survey: Twenty ground control points have been established at Staithes for the purposes of cliff top monitoring. The separation between any two points is a nominal 100m. The cliff top surveys at Staithes are undertaken bi-annually. Data collection involves a distance offset measurement from the ground control point to the cliff edge along a fixed bearing. Appendix C provides results from the April 2022 survey, showing the distance from the ground control point to the edge of the cliff top along the defined bearing and changes in position since the November 2008 baseline survey and the previous October 2021 survey. The results provided in Appendix C show that the majority of the profiles show little or no erosion since the previous survey, with only 2 points experiencing erosion greater than the survey error (0.20m). These are Point 4 (0.27m) and Point 5 (0.30m), both located to the west of the survey extent. 12 of the 20 survey points noted apparent 'accretion' of the cliff top, this is likely to be due to difficulties in accurately identifying the cliff edge through vegetation. The long term recession rates show that three points at Staithes are now greater than 0.2m/year (Point 1 along the road to the west of Staithes (0.6m), Point 4 (0.20m) and Point 13 adjacent to the eastern breakwater at Staithes (0.23m)).	The recorded changes to the cliff top between October 2021 and April 2022 are generally small. There has been two points which show retreat of the cliff top greater than the survey error (Point 4 and Point 5). Longer term trends: Table C1 in Appendix C presents the erosion rates calculated from the data collected since 2008. Points 1, 4, and 13 are the only locations with a significant recession rate, which ranges from 0.20 to 0.60m/yr.

- At Staithes, the recorded changes to the cliff top between October 2021 and April 2022 are generally small. There has been two points which show retreat of the cliff top greater than the survey error (Point 4 and Point 5).

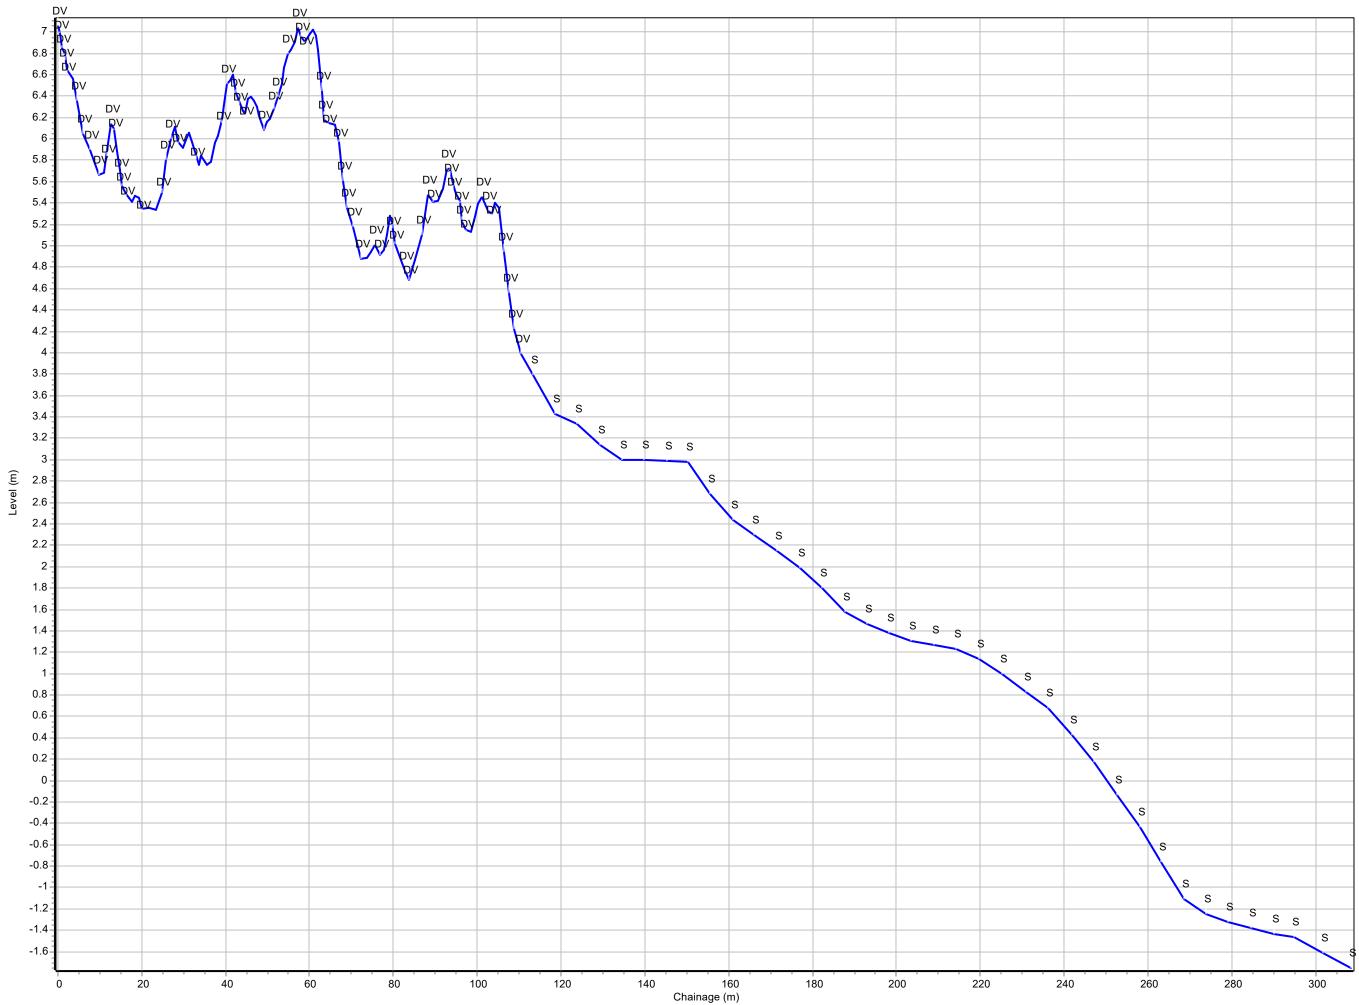
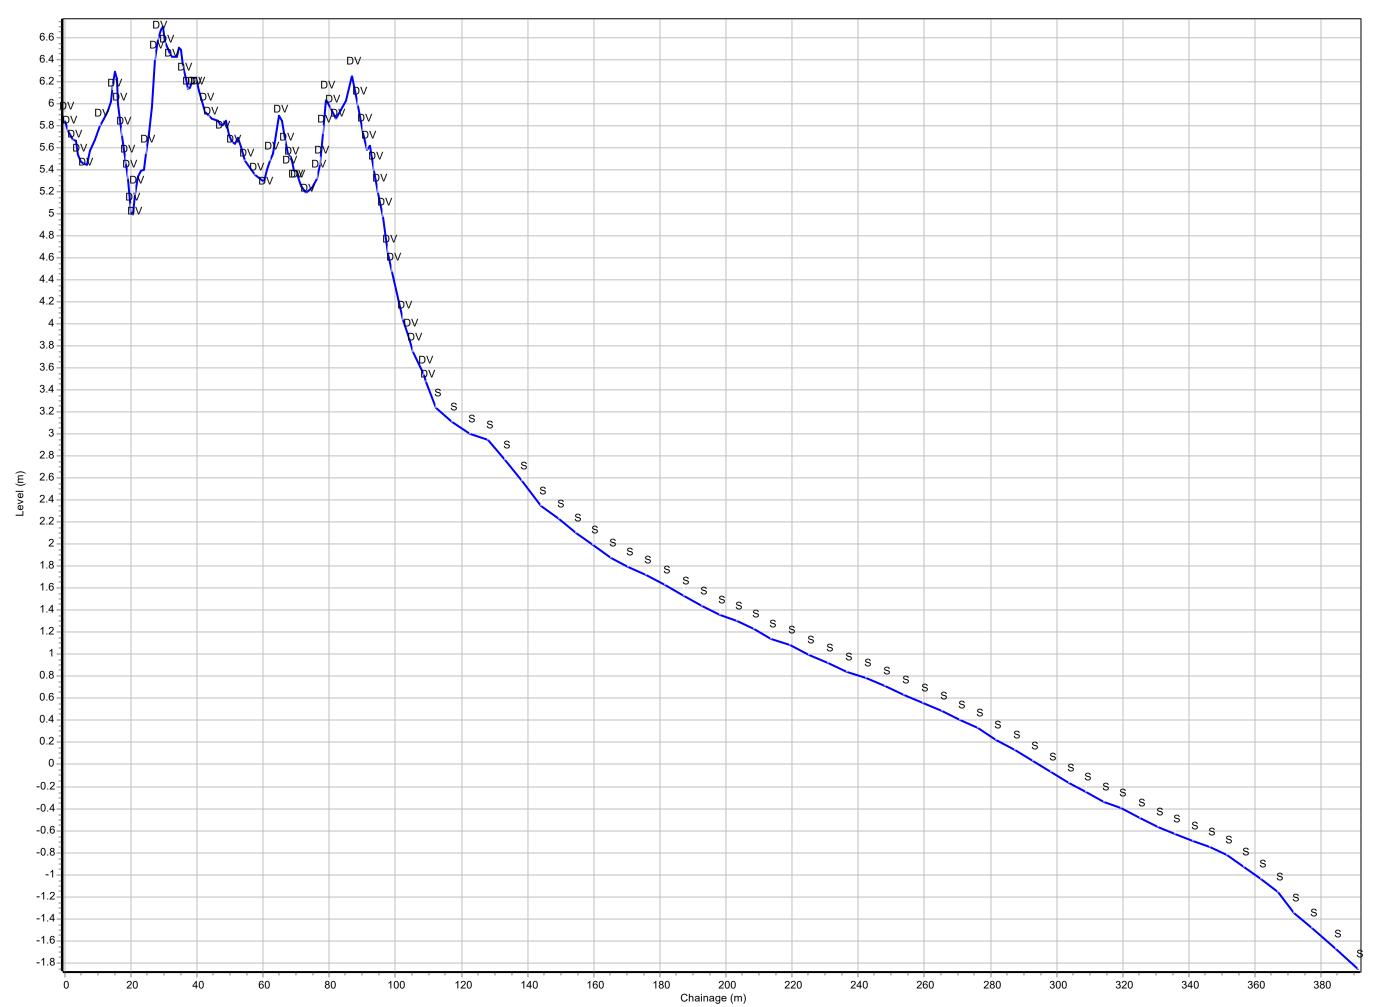
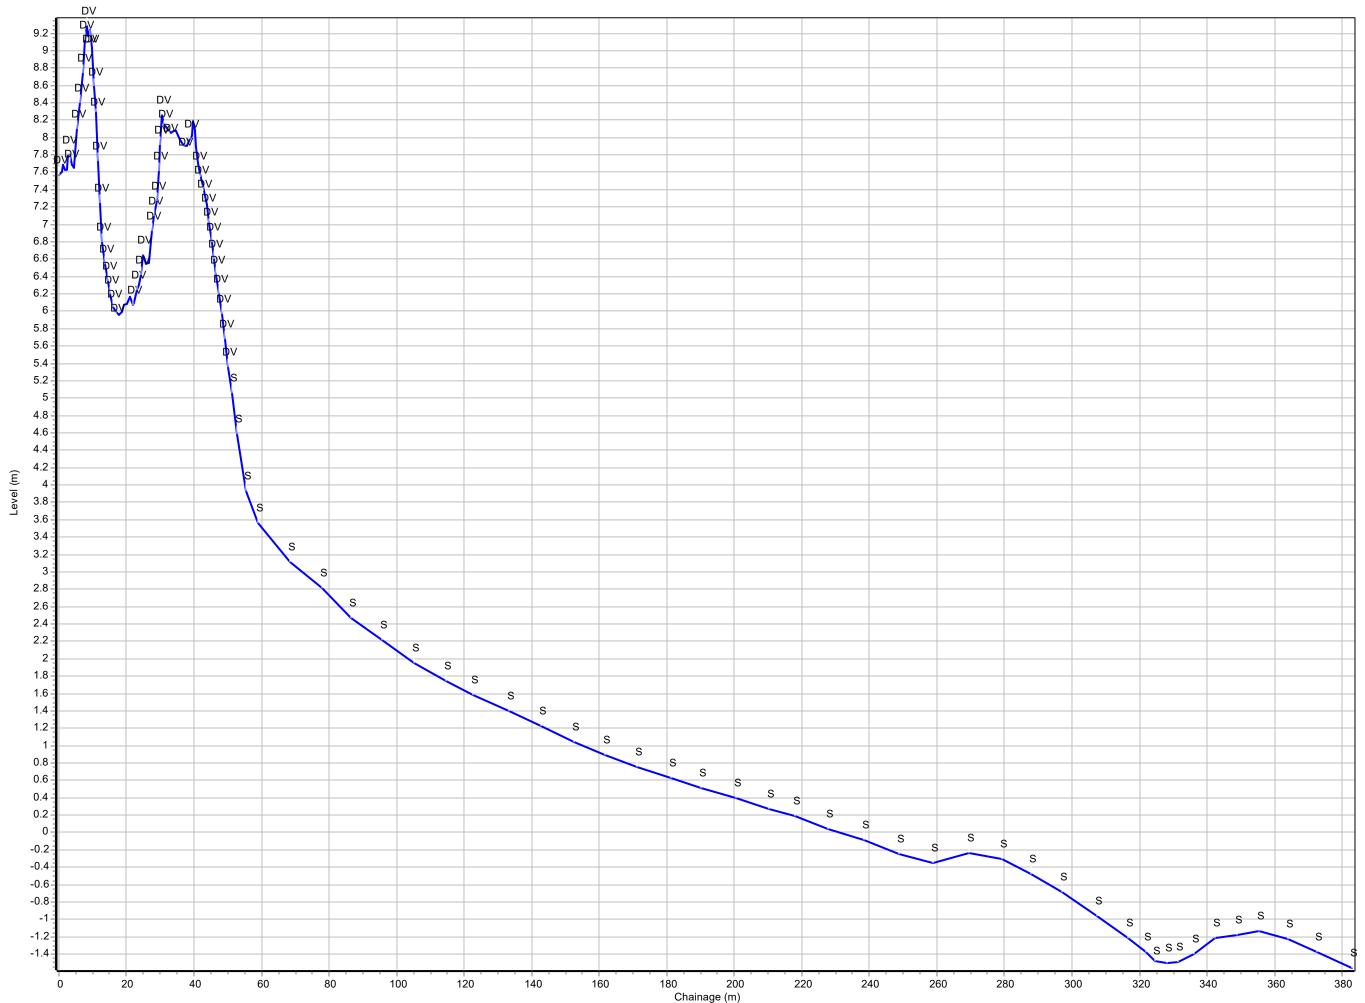
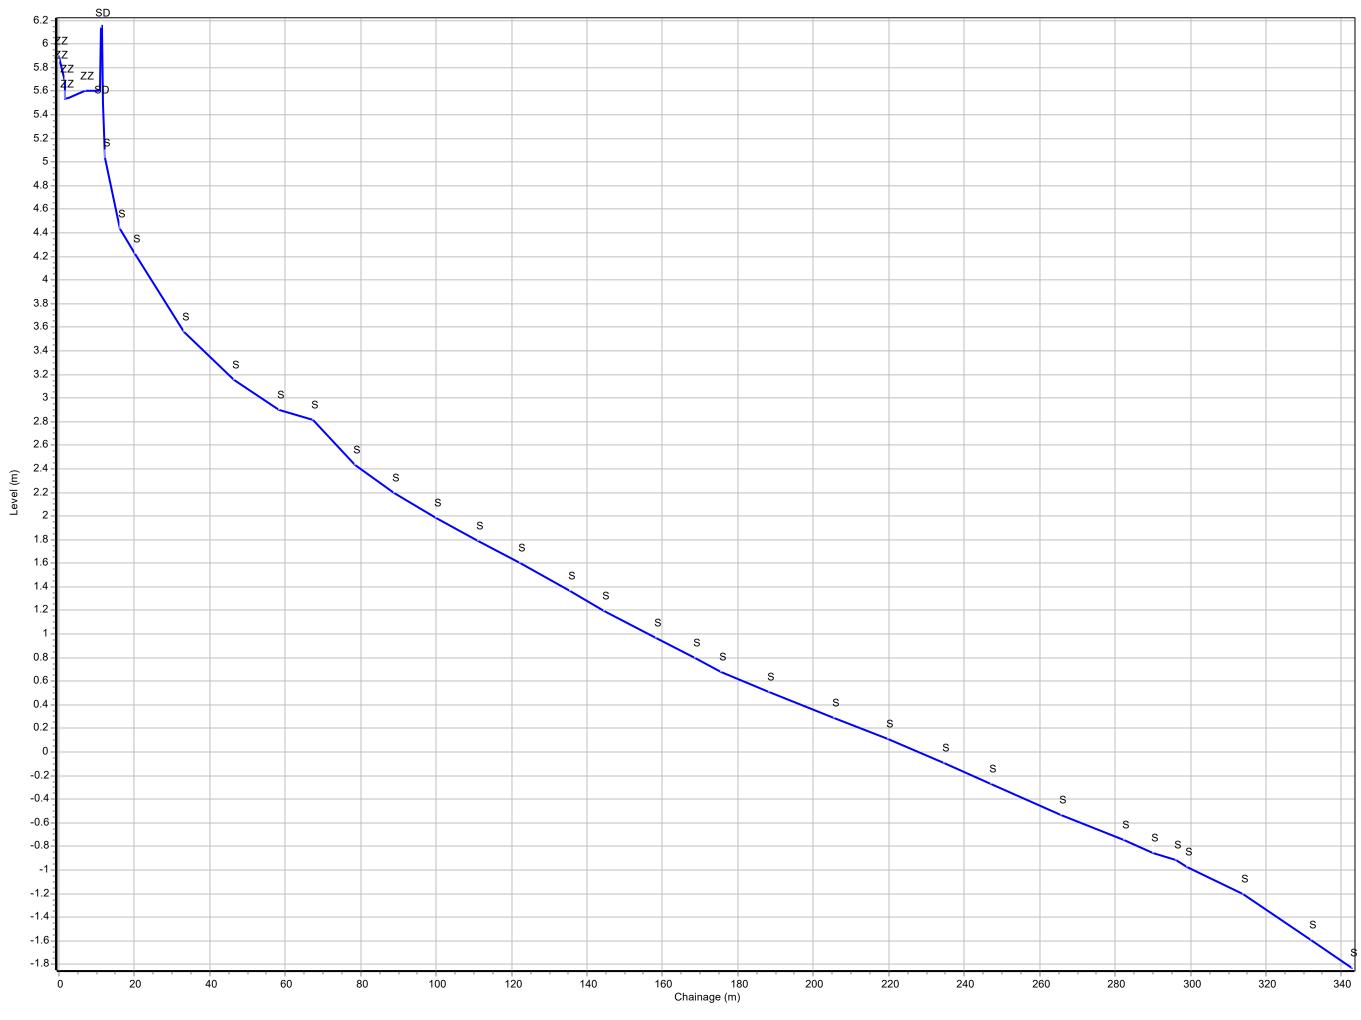
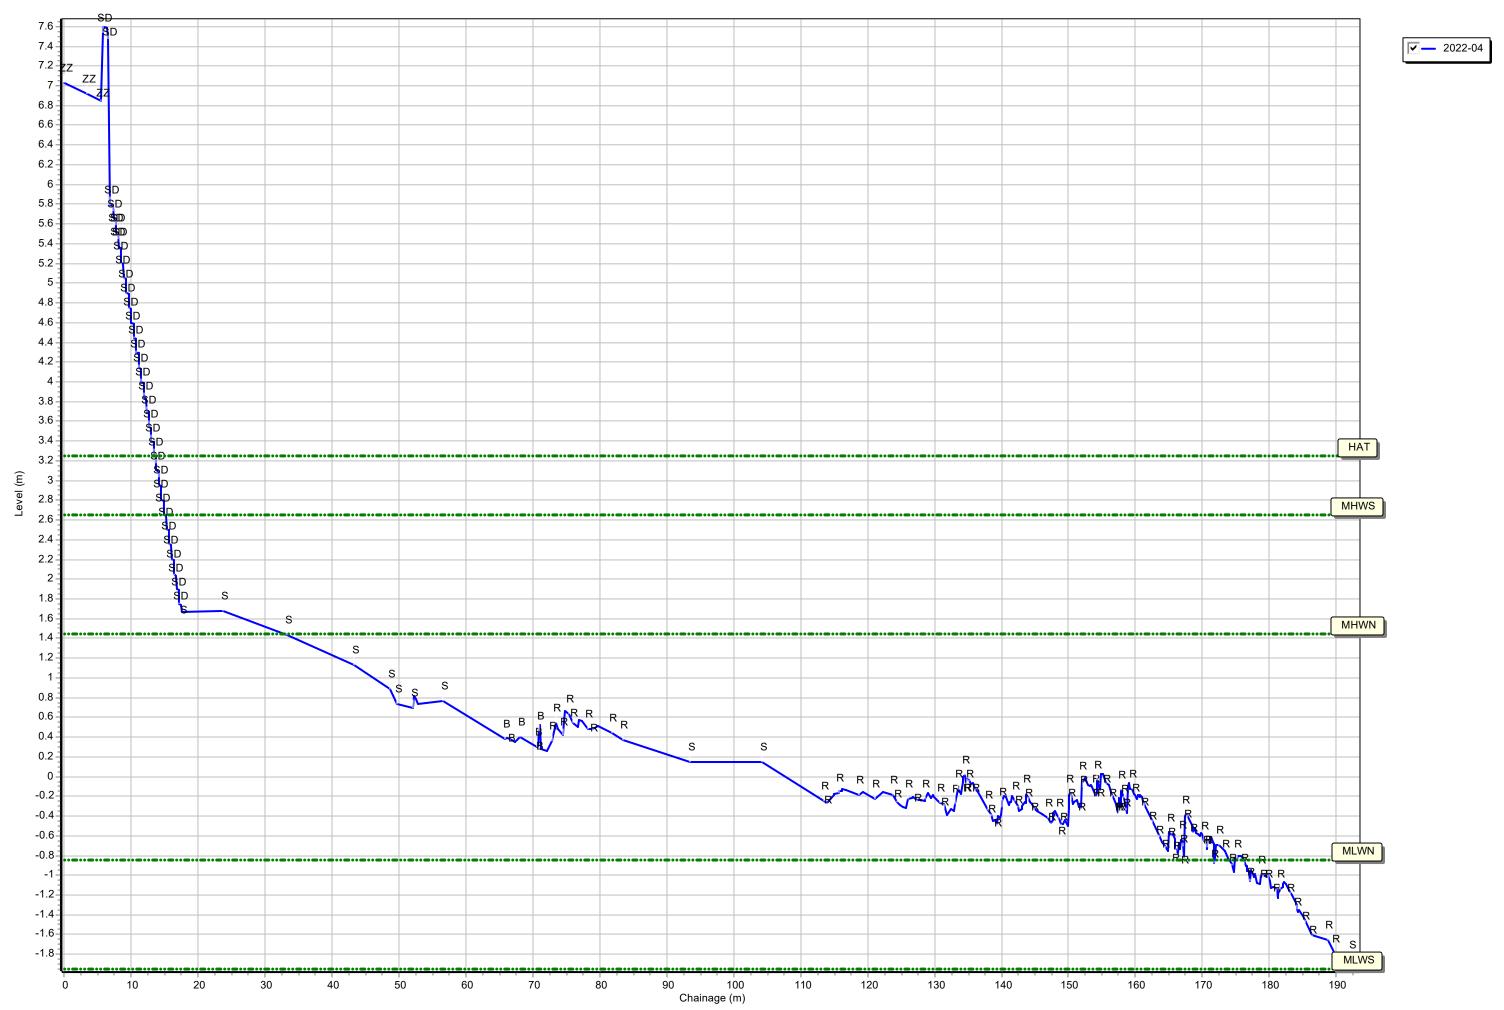
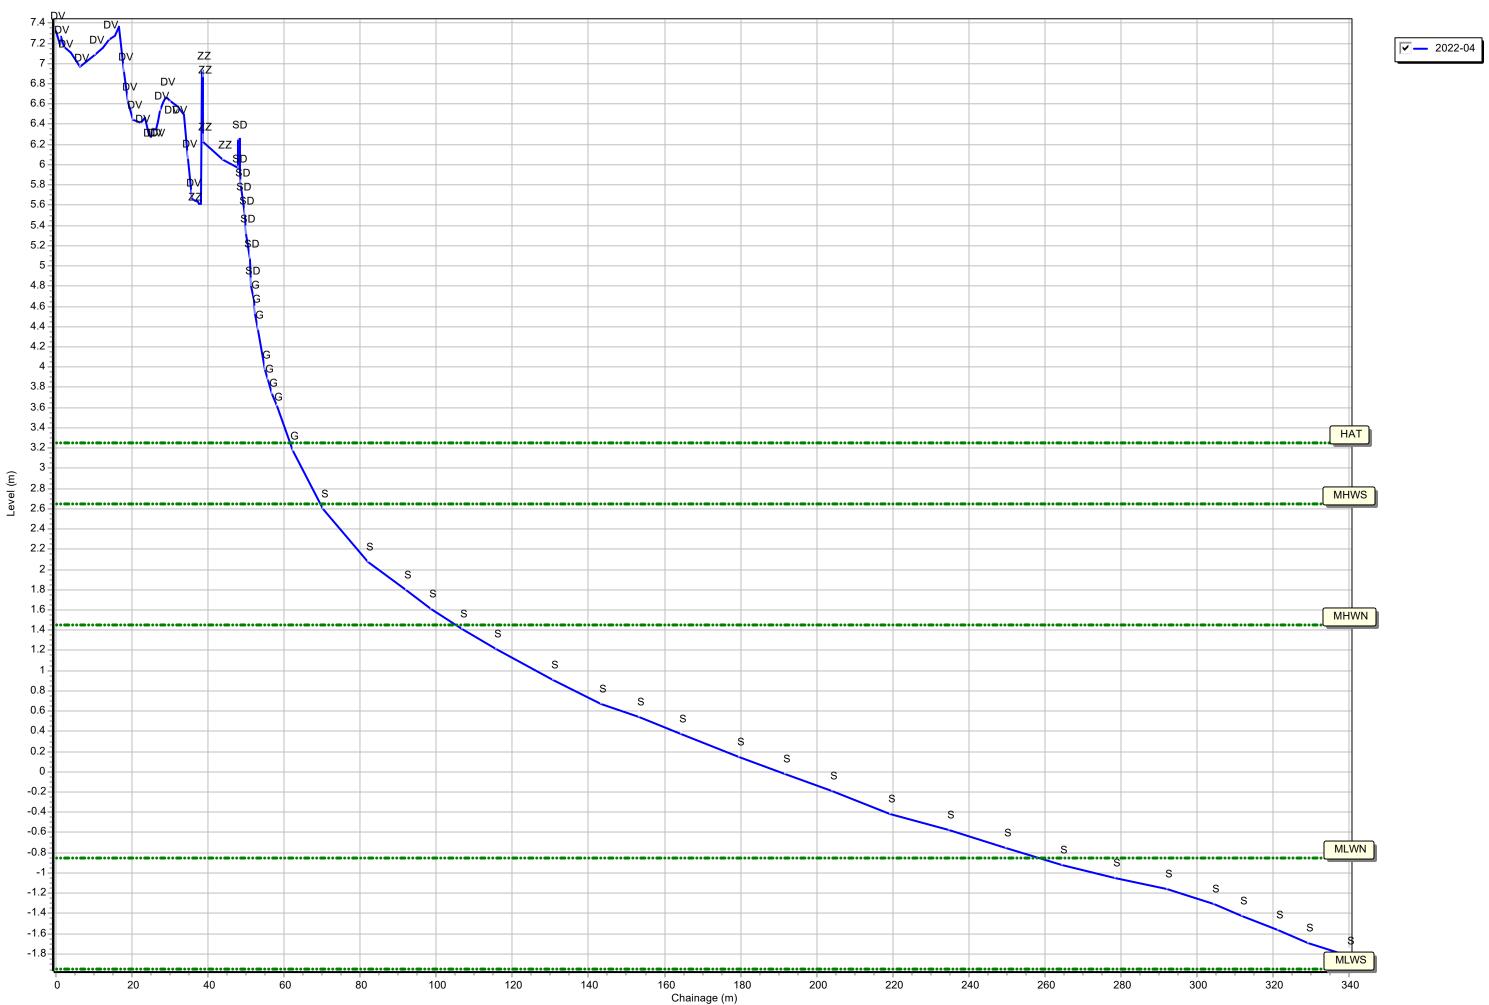
Appendix A Beach Profiles

Survey Date	Description of Changes Since Last Survey	Interpretation
19 th – 21 st April 2022	Beach Profiles: Coatham Sands is covered by four beach profiles during the Partial Measures survey (1cRC1 to 1cRC4; Appendix A) that were last surveyed in autumn 2021. Profile 1cRC1 is located 300m southeast of the South Gare Breakwater, in the lee of the German Charlies slag banks. The upper profile to 105m chainage is dominated by dunes that have remained stable since 2009. The highest dune (chainage 60m) is unchanged since October 2013. The beach appears to have experienced a general draw down of material from the upper beach to the mid and lower beach. From the toe of the foredune to chainage 215m, the beach has dropped in level since October 2021 by a magnitude up to 0.45m. Between chainage 215m and 260m the beach has accreted by 0.55m in level. Overall, the profile remains at a high level compared to the range of previously recorded results. At profile 1cRC2 the face of the foredune has advanced seaward approximately 1m. The crest has also accreted by 0.1m in level. The rear dunes have remained largely stable. The majority of the upper beach, between chainage 102m to 210m, is unchanged, except a small length of erosion at 115m. The lower beach profile has smoothened out causing alternating lengths of accretion and erosion where several beach berms were observed previously. The magnitude of change is limited to ±0.55m. Overall the beach is at a very high level compared to the range recorded from previous surveys. Profile 1cRC3 showed the main dune has remained stable since April 2014, with little change again observed to chainage 52m since October 2021. At the toe of the dunes, the upper beach from chainage 52m to chainage 80m has decreased in level by 0.3m. Between chainages 80m and 150m the beach has experienced negligible change. Seaward of chainage 150m it appears there has been some drawdown of material with a drop in level occurring to chainage 240m and an increase in level between 260m and 302m of similar magnitude (0.25m). Overall, the profile remains at a high level compared to the range of pr	Since the previous survey in October 2021, there has been a relatively small change across the profiles, particular the two central profiles. There is a general trend of drawdown of material from the upper and middle sections of the beach to the lower sections. With all four profiles experiencing accretion along the lower profile, albeit at varying magnitudes All four profiles show the dunes have remained stable over winter 2021/22 with either no change or minor accretion observed. Longer term trends: All beach profiles at Coatham show the dunes are stable or accreting on their seaward extent. The beaches to the west show a typical longer-term trend of progressive accretion. The beaches in the centre and to the east have a more fluctuating long-term pattern.

Survey Date	Description of Changes Since Last Survey	Interpretation
	Profile 1cRC4 is located at the beginning of the defended section at Coatham and Redcar. There has been no change in the profile up to the seawall at chainage 12m. The steep upper beach, between chainage 12m and 30m, has been eroded dropping in level by up to 0.3m. Seawards of chainage 30m, the beach profile has generally slackened. This is as a result of a minor drop in level between chainage 30m to 215m and a similar magnitude accretion seaward of chainage 215m. The profile remains at a low level when compared to the range recorded from previous surveys.

Survey Date	Description of Changes Since Last Survey	Interpretation
	Beach Profiles: Redcar Sands is covered by three beach profiles (1cRC5 to 1cRC7; Appendix A), with 1cRC7 being approximately on the boundary with the Marske Sands area. They were last surveyed in October 2021. At profile 1cRC5 the sea defences constructed in 2012 remain unchanged as far as 18m chainage. The beach levels at the toe of the structure have dropped by 0.55m in level since the previous inspection exposing more of the stepped revetment. Beach levels have also dropped between 44m and 96m exposing the rock foreshore platform. Seaward of chainage 110m the rock foreshore remains exposed. Overall, the beach levels at a low level when compared to the range of previous surveys.	Beach levels remain low between Coatham Rocks and Redcar Rocks, with further erosion exposing additional rocky foreshore. The eastern profiles appear to demonstrate drawdown of material from the upper beach to the lower beach typical of winter conditions. Longer term trends: Profiles 1cRC5 and 1cRC7 show movement of beach berms across the profile.

Loth Lot	Profile 1cRC6 has experienced negligible change landward of chainage 150m since the last survey due, in part, to the presence of the sea defence up to 55m. Seaward of chainage 150m, the lower beach has accreted by 0.6m in level causing the profile to slacken. Overall, the beach is at medium level when compared the range previous surveys, except the very lower beach which at the highest level on record.	
19 th – 21 st April 2022	Profile 1cRC7 is undefended. The profile has not changed landward of chainage 65m since the last survey. Between chainages 70m and 223m, the beach levels have dropped, by 0.1m on the upper beach and 0.4m on the mid beach. There has been a rise in level between chainages 223m and 288m, suggesting a winter draw down of sediment. The lower foreshore has been exposed seaward of chainage 288m. Overall, the beach is at medium level when compared the range previous surveys, except the very lower beach which at the lowest level on record.

Survey Date	Description of Changes Since Last Survey	Interpretation
19 th – 21 st April 2022	Beach Profiles: Marske Sands is covered by two beach profiles during the Partial Measures survey (1cRC7 to 1cRC8; Appendix A). 1cRC7 is on the boundary with the Redcar Sands area. Profile 1cRC7 is located along The Stray and has been discussed in Section 2.2. Profile 1cRC8 is located to the south of Church Howle at Marske By the Sea. The first 55m of the profile are covered by dunes which have remained in unchanged since the previous survey in autumn 2021. The beach, seaward of chainage 50m, has generally remained stable also. There is alternating lengths of accretion and erosion caused by the smoothening of the profile, but the majority of these areas of change are limited to ±0.1m in level, with the maximum change occurring at chainage 220m with a drop of 0.4m. Overall, the profile is generally at a medium level when compared to the range recorded from previous surveys	The beach and dunes appear to have remained stable over winter 2021/22. Some evidence of beach drawndown is observed in profile 1cRC7. Longer term trends: The beach and dunes have been recovering since the exceptionally stormy winter of 2013/14 causing record lows The beach levels in April 2022 were at medium level.

Survey Date	Description of Changes Since Last Survey	Interpretation
	Beach Profiles: Saltburn Sands is covered by one beach profile (1cRC9; Appendix A). Profile 1cRC9 is covered by a sea defence as far as chainage 20m and has experienced no change over this defended length. At the toe of the sea defence up to chainage 42m the beach level has dropped by 0.2m in level. For the majority of the beach, between chainages 42m and 183m, the profile has remained largely stable with minor change limited to ±0.15m. Seawards of chainage 183m, the lower beach has accreted by up to 0.5m in level. The beach is at a medium level when compared to the range of previous surveys.	The profile has remained largely stable over winter 21/22. Accretion of the lower beach suggest a slight draw down of material. Longer term trends: The profile plots show net erosion, although there are periods of recovery.
19 th – 21 st April 2022	Topographic Survey: Saltburn Sands is covered by a 6-monthly topographic survey. Data have been used to create a DGM (Appendix B – Map 2). The beach topography consists of shore parallel contours, with a small change at the mouth of the channel. This DGM has been compared against the previous (autumn 2021) survey in Appendix B – Map 5. The difference plot comparing the DGMs shows that over winter 21/22, erosion has dominated the upper and mid beach, alternating to accretion across the lower beach. The anomaly to this pattern is the section of beach fronting the beach huts where accretion has dominated both the lower beach and the upper beach, with minor accretion again occurring in the mid beach. The magnitude of change varies across the frontage with the most intense change (±1.25m) occurring at the western extent, eastern extent and at the mouth of Skelton Beck.

- At Coatham Sands, there has been a relatively small change across the profiles, particular the two central profiles. There is a general trend of drawdown of material from the upper and middle sections of the beach to the lower sections. With all four profiles experiencing accretion along the lower profile, albeit at varying magnitudes

- Along Redcar Sands, beach levels remain low between Coatham Rocks and Redcar Rocks, with further erosion exposing additional rocky foreshore. The eastern profiles appear to demonstrate drawdown of material from the upper beach to the lower beach typical of winter conditions.

- At Marske Sands, the beach and dunes appear to have remained stable over winter 2021/22
- At Saltburn Sands, the profile has remained largely stable over winter 2021/22. Accretion
 of the lower beach suggest a slight draw down of material.
