Cell 1 Regional Coastal Monitoring Programme Update Report 14: 'Partial Measures' Survey 2022

Redcar and Cleveland Council

July 2022

^(*) The present report is **Update Report 14** and provides an analysis of the 2022 Partial Measures survey for Redcar and Cleveland Council's frontage.

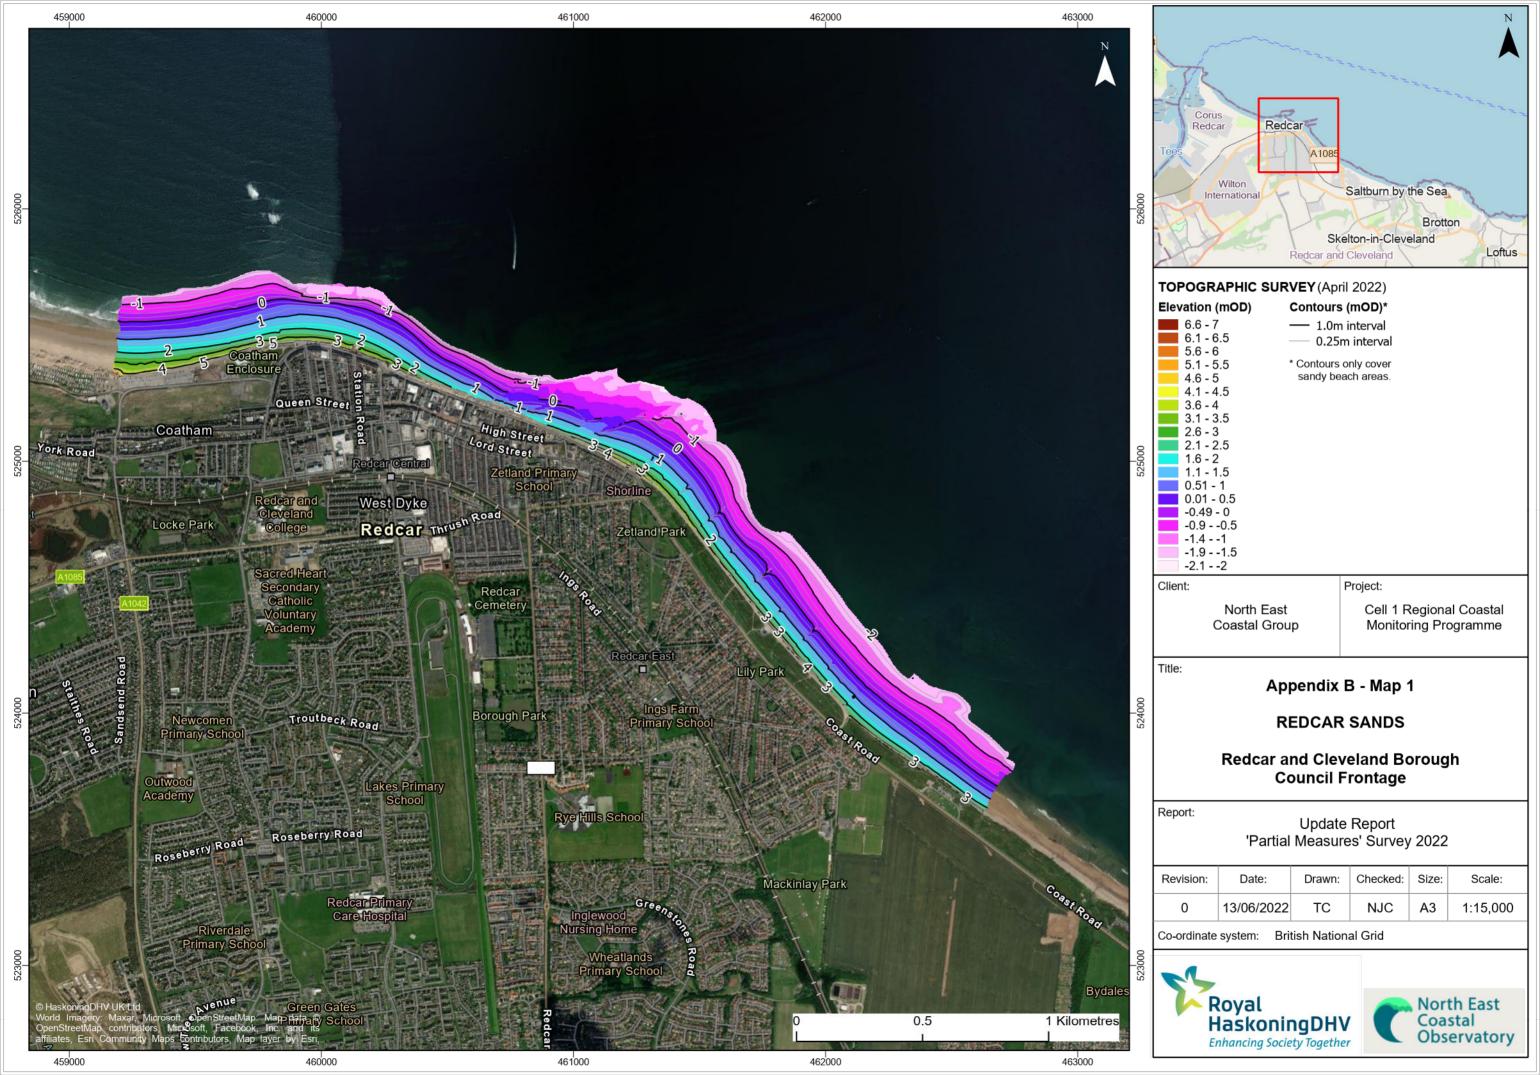
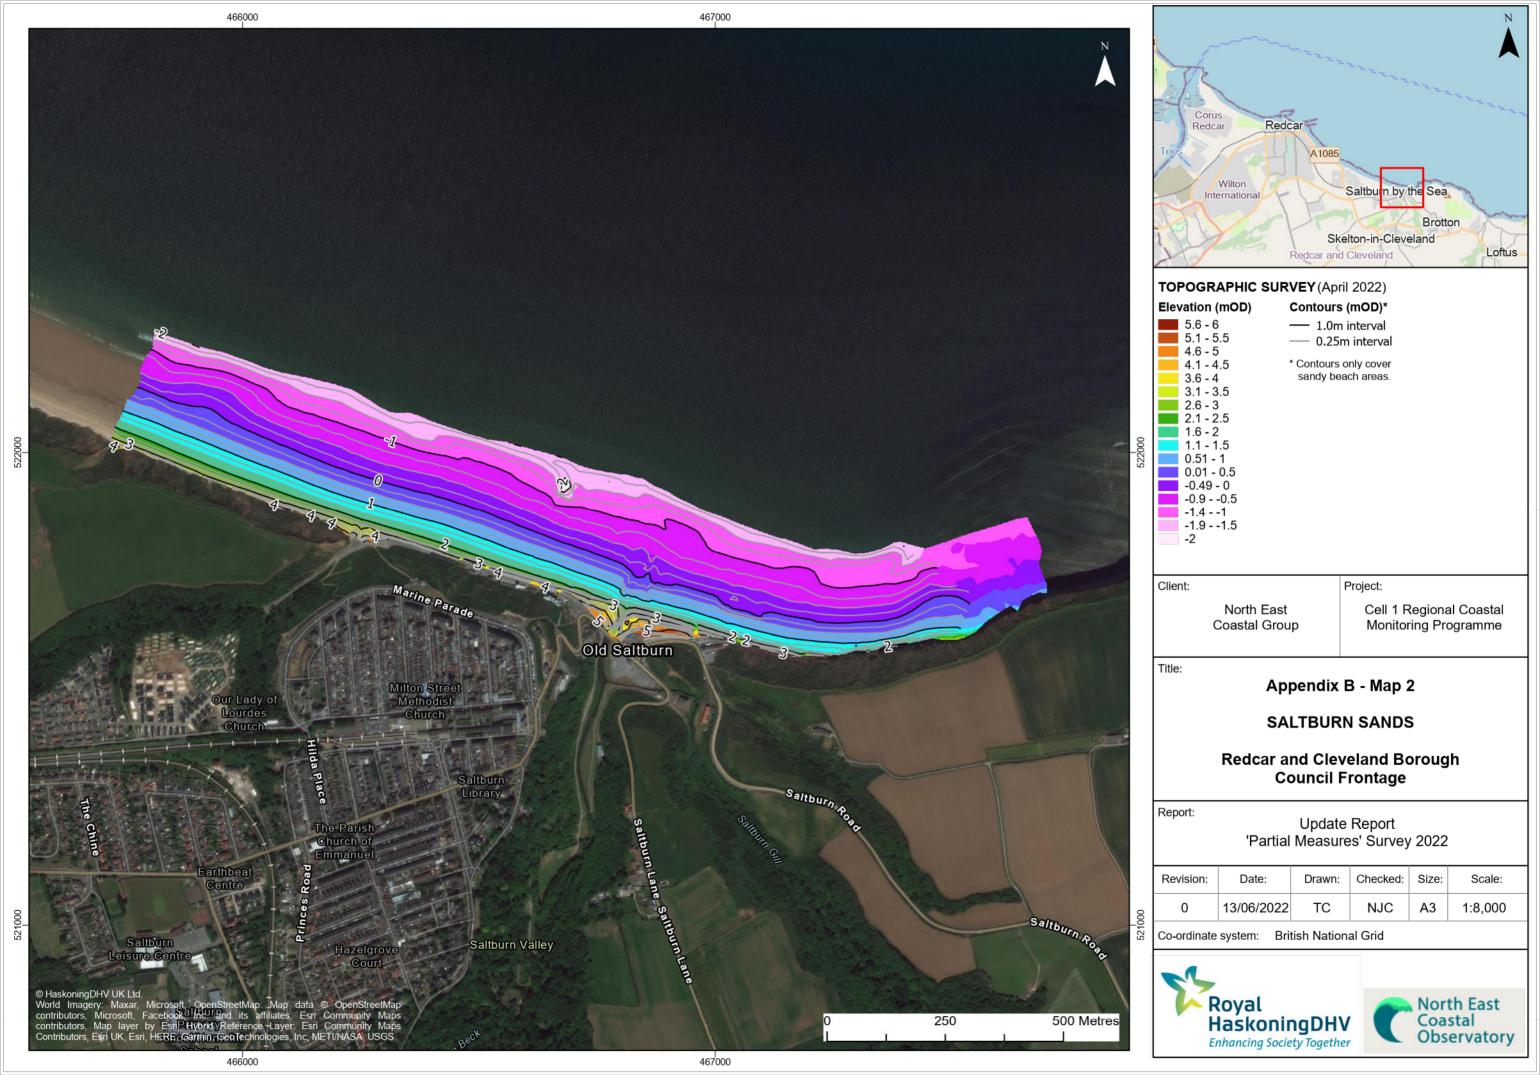
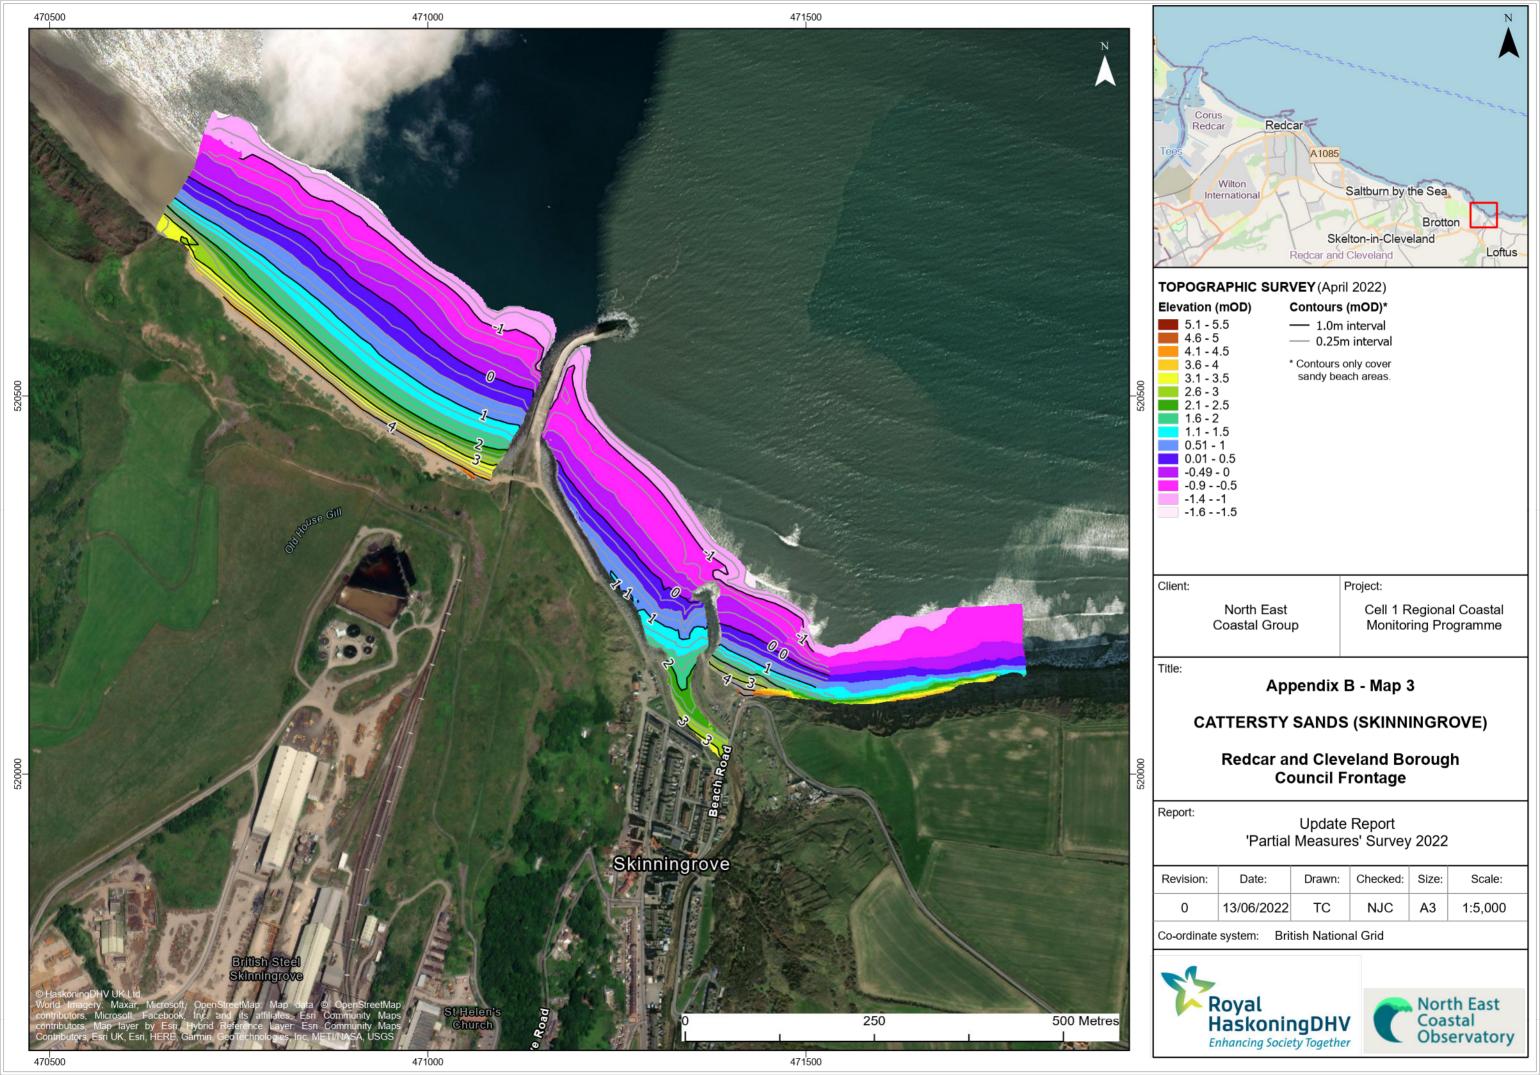
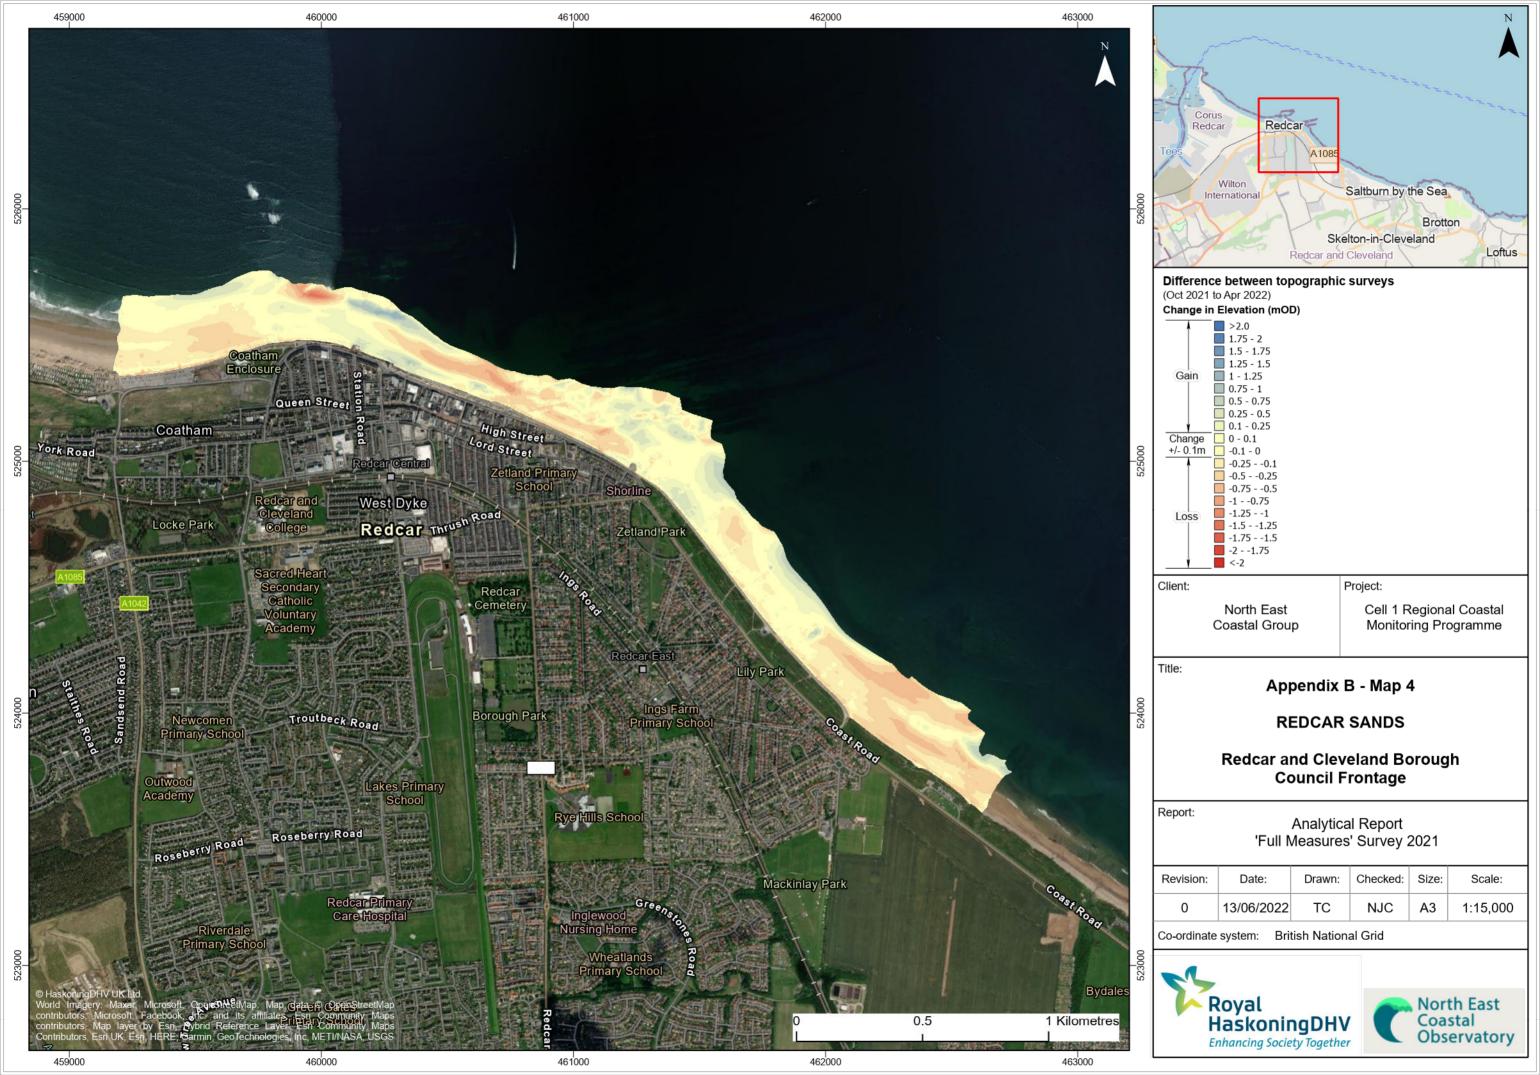
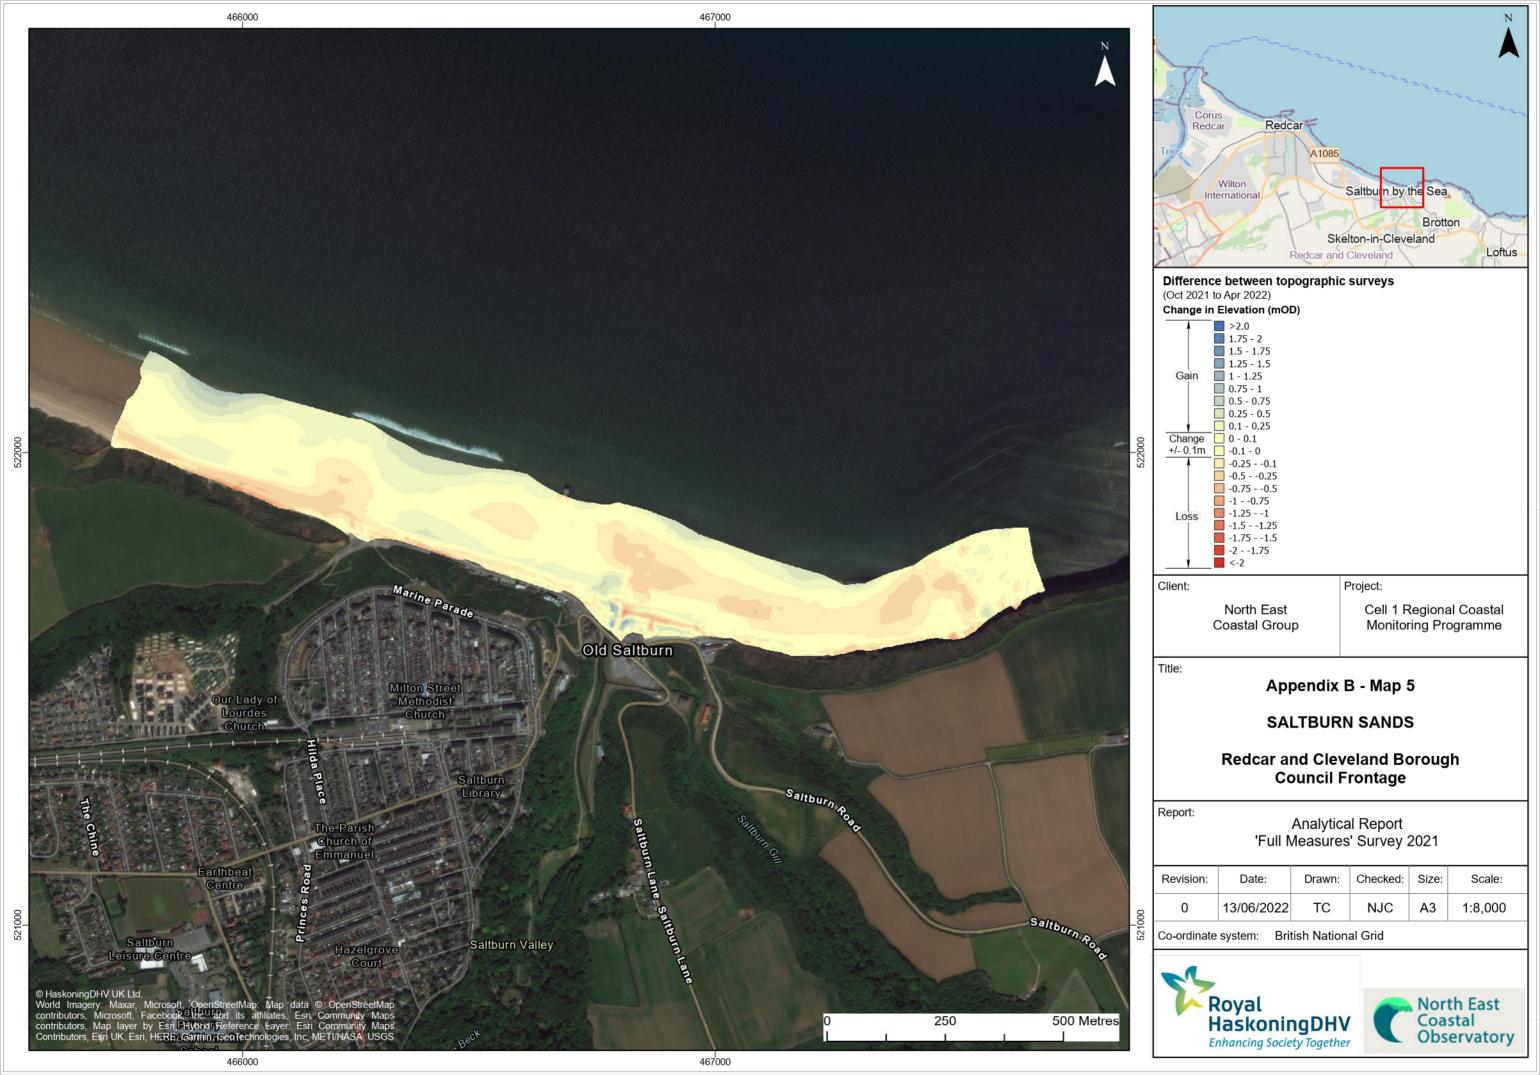
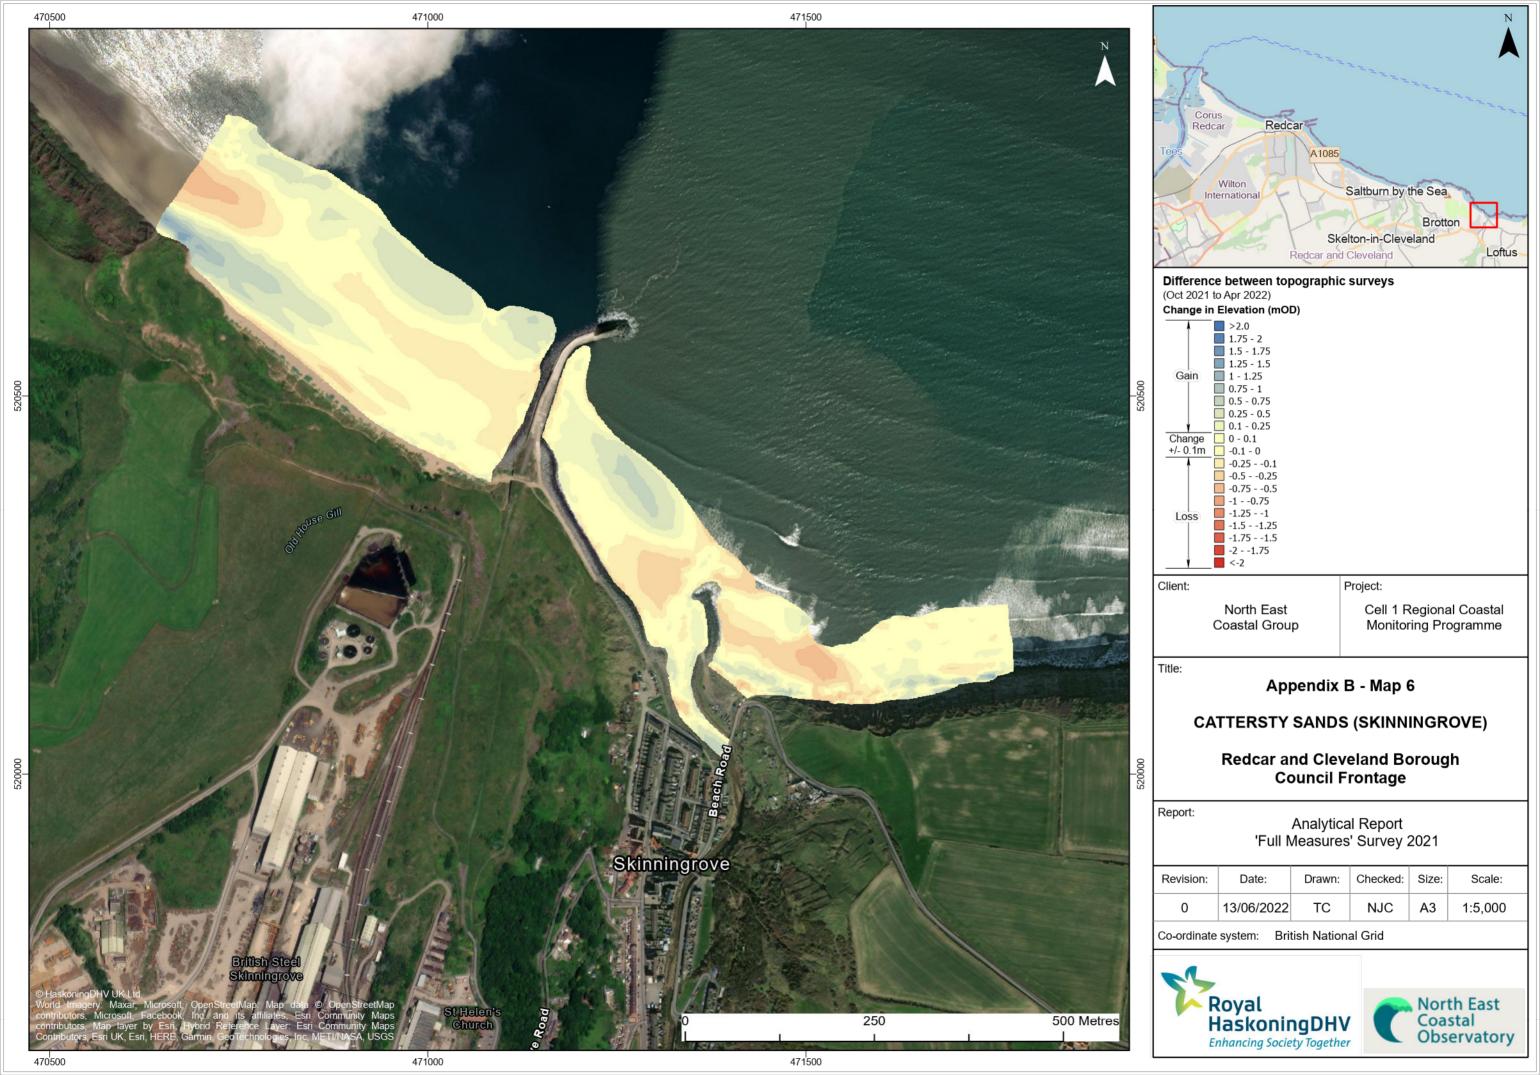
Appendix B Topographic Survey

Topographic Survey: Redcar Sands is covered by a 6-monthly topographic survey. Data have been used to create a DGM (Appendix B – Map 1) using a GIS. The DGM shows that the beach topography is broadly parallel to the shore, although there is a slight embayment with a slightly steeper beach between the two headlands at Coatham Rocks and Redcar Rocks. The contours around Redcar Rocks are distorted due to the exposed rocky foreshore.	The topographic difference plots shows that despite apparent wide scale change across Redcar Sands, there appears to be a balance between accretion and erosion suggesting the volume of sediment has remained stable.
	The GIS has also been used to calculate the differences between the current topographic survey (autumn 2020) and the most recent (April 2021) topographic survey, as shown in Appendix B – Map 4,

Survey Date	Description of Changes Since Last Survey	Interpretation
	to identify areas of erosion and accretion.	
	The difference plot shows that over winter 21/22, change has been inconsistent across Redcar Sands. At the eastern extent, at the transition to Marske Sands, the beach profile has been dominated by erosion by up to -1.5m on the lower beach. At Redcar Rocks there is patchy low level accretion (+1.0m), characteristic of the rocky foreshore. Between Redcar Rocks and Coatham Rocks the beach has experience intense erosion in the mid beach (-1.75m) with some accretion occurring in the upper and lower extents. At the western extents, at the transition to Coatham Sands, the beach has again been dominated by erosion.,

Survey Date	Description of Changes Since Last Survey	Interpretation
22 nd April 2022	Topographic Survey: Cattersty Sands is covered by a 6-monthly topographic survey. Data have been used to create a DGM (Appendix B – Map 3). The beach is steeper to the west of the breakwater than the east, but in both areas the gradient is relatively smooth. East of the breakwater, the beach is punctuated by Kilton Beck and the harbour. Immediately east of the former fishtail groyne (which has since been modified to a rock breakwater arm), the stream has cut a channel, which is most deeply incised at its landward extent. The survey report notes that "strong onshore winds restricted the depth which was achievable on the day". The April 2022 DGM has been compared against the previous (autumn 2021) survey in Appendix B – Map 8. To the west of the breakwater, there is three distinct bands of shoreline parallel change, with accretion evident on the upper and lower beach and erosion evident in the mid beach. The magnitude of change is most intense at the very western extents at ±1.5m. Between the breakwater and the reconfigured river mouth rock armour accretion has dominated the lower beach. At the mouth itself, erosion is dominant with change limited to -1.25m. In the bay to the east of the rock armour, small scale accretion (+1.0m) is evident on the upper beach and at the toe of the adjacent cliffs with erosion again controlling the lower beach.	The data plot shows that there has been a mixture of accretion and erosion throughout the frontage, with neither process dominating. Accretion is observed to the west of the breakwater on the upper and lower beach and also at the toe of the cliffs to the east. Erosion has dominated on either side of the reconfigured river mouth rock armour. Longer term trends: Although not observed during this survey, the long-term trend shows that on the north-west side of the breakwater there is erosion on the upper beach and accretion on the lower beach. On the south-east side of the breakwater there is a long-term pattern of accretion on the mid beach with erosion in the channel mouth. The winter erosion dominates the overall behaviour of the beach but the calmer weather in the summer months should lead to some accretion. If the erosion of the upper beach continues it is likely to drive cliff failures which would add material to the upper beach for redistribution.

- Across Cattersty Sands, the data plot shows that there has been a mixture of accretion
 and erosion throughout the frontage, with neither process dominating. Accretion is
 observed to the west of the breakwater on the upper and lower beach and also at the toe
 of the cliffs to the east. Erosion has dominated on either side of the reconfigured river
 mouth rock armour.
