NORTH
YORKSHIRE
COUNCIL

Cell 1 Regional Coastal Monitoring Programme Analytical Report 16: Full Measures Survey 2023

**North Yorkshire Council
February 2024**

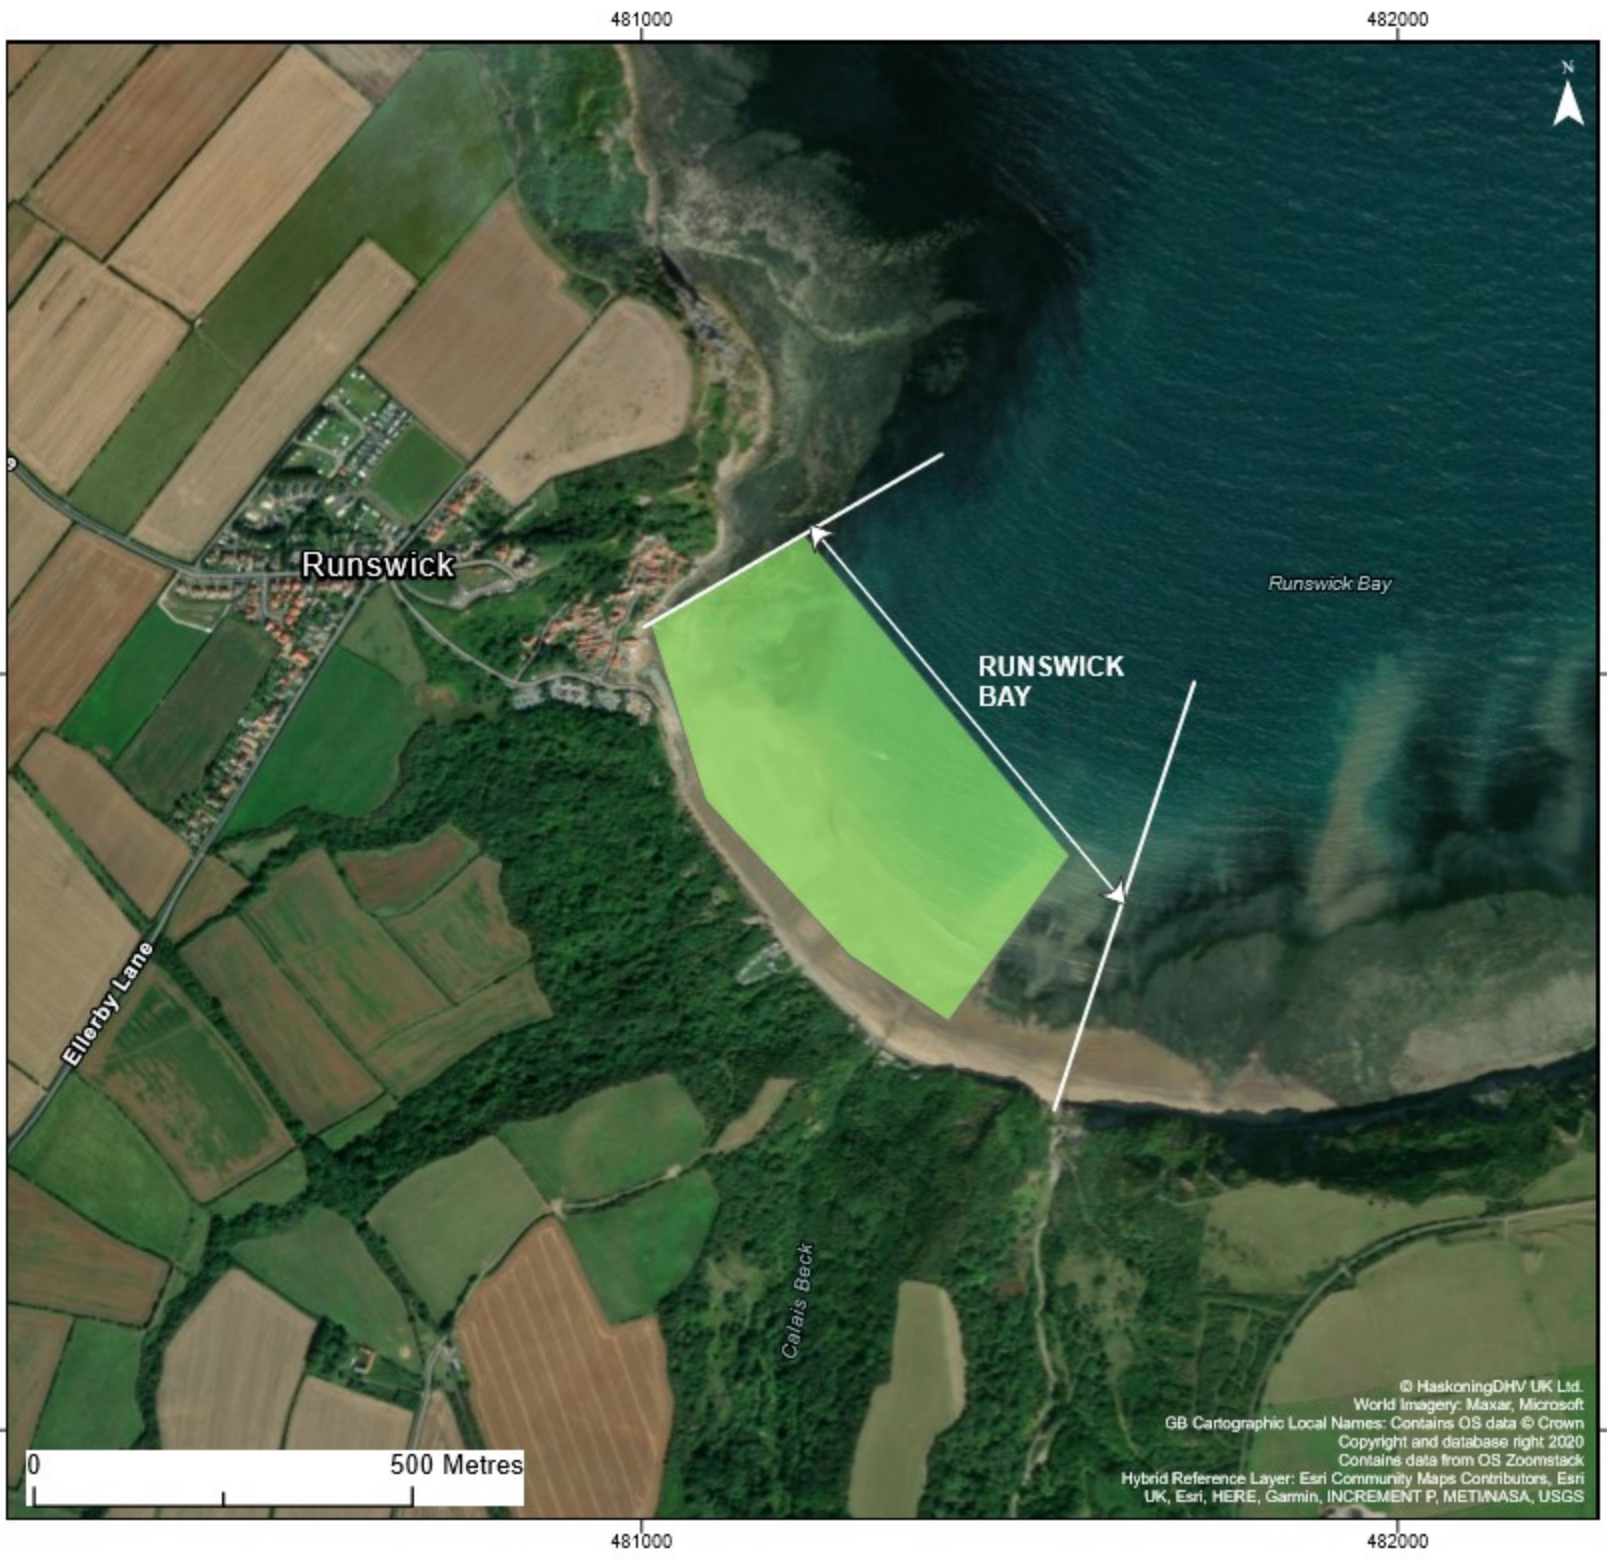
SURVEY LOCATIONS

The location of these surveys is shown in Figure 2. Full Measures surveys were undertaken along this frontage between August and September 2023. The weather and sea state varied in that time, for details of the survey conditions refer to the Academy Geomatics survey reports for each location.

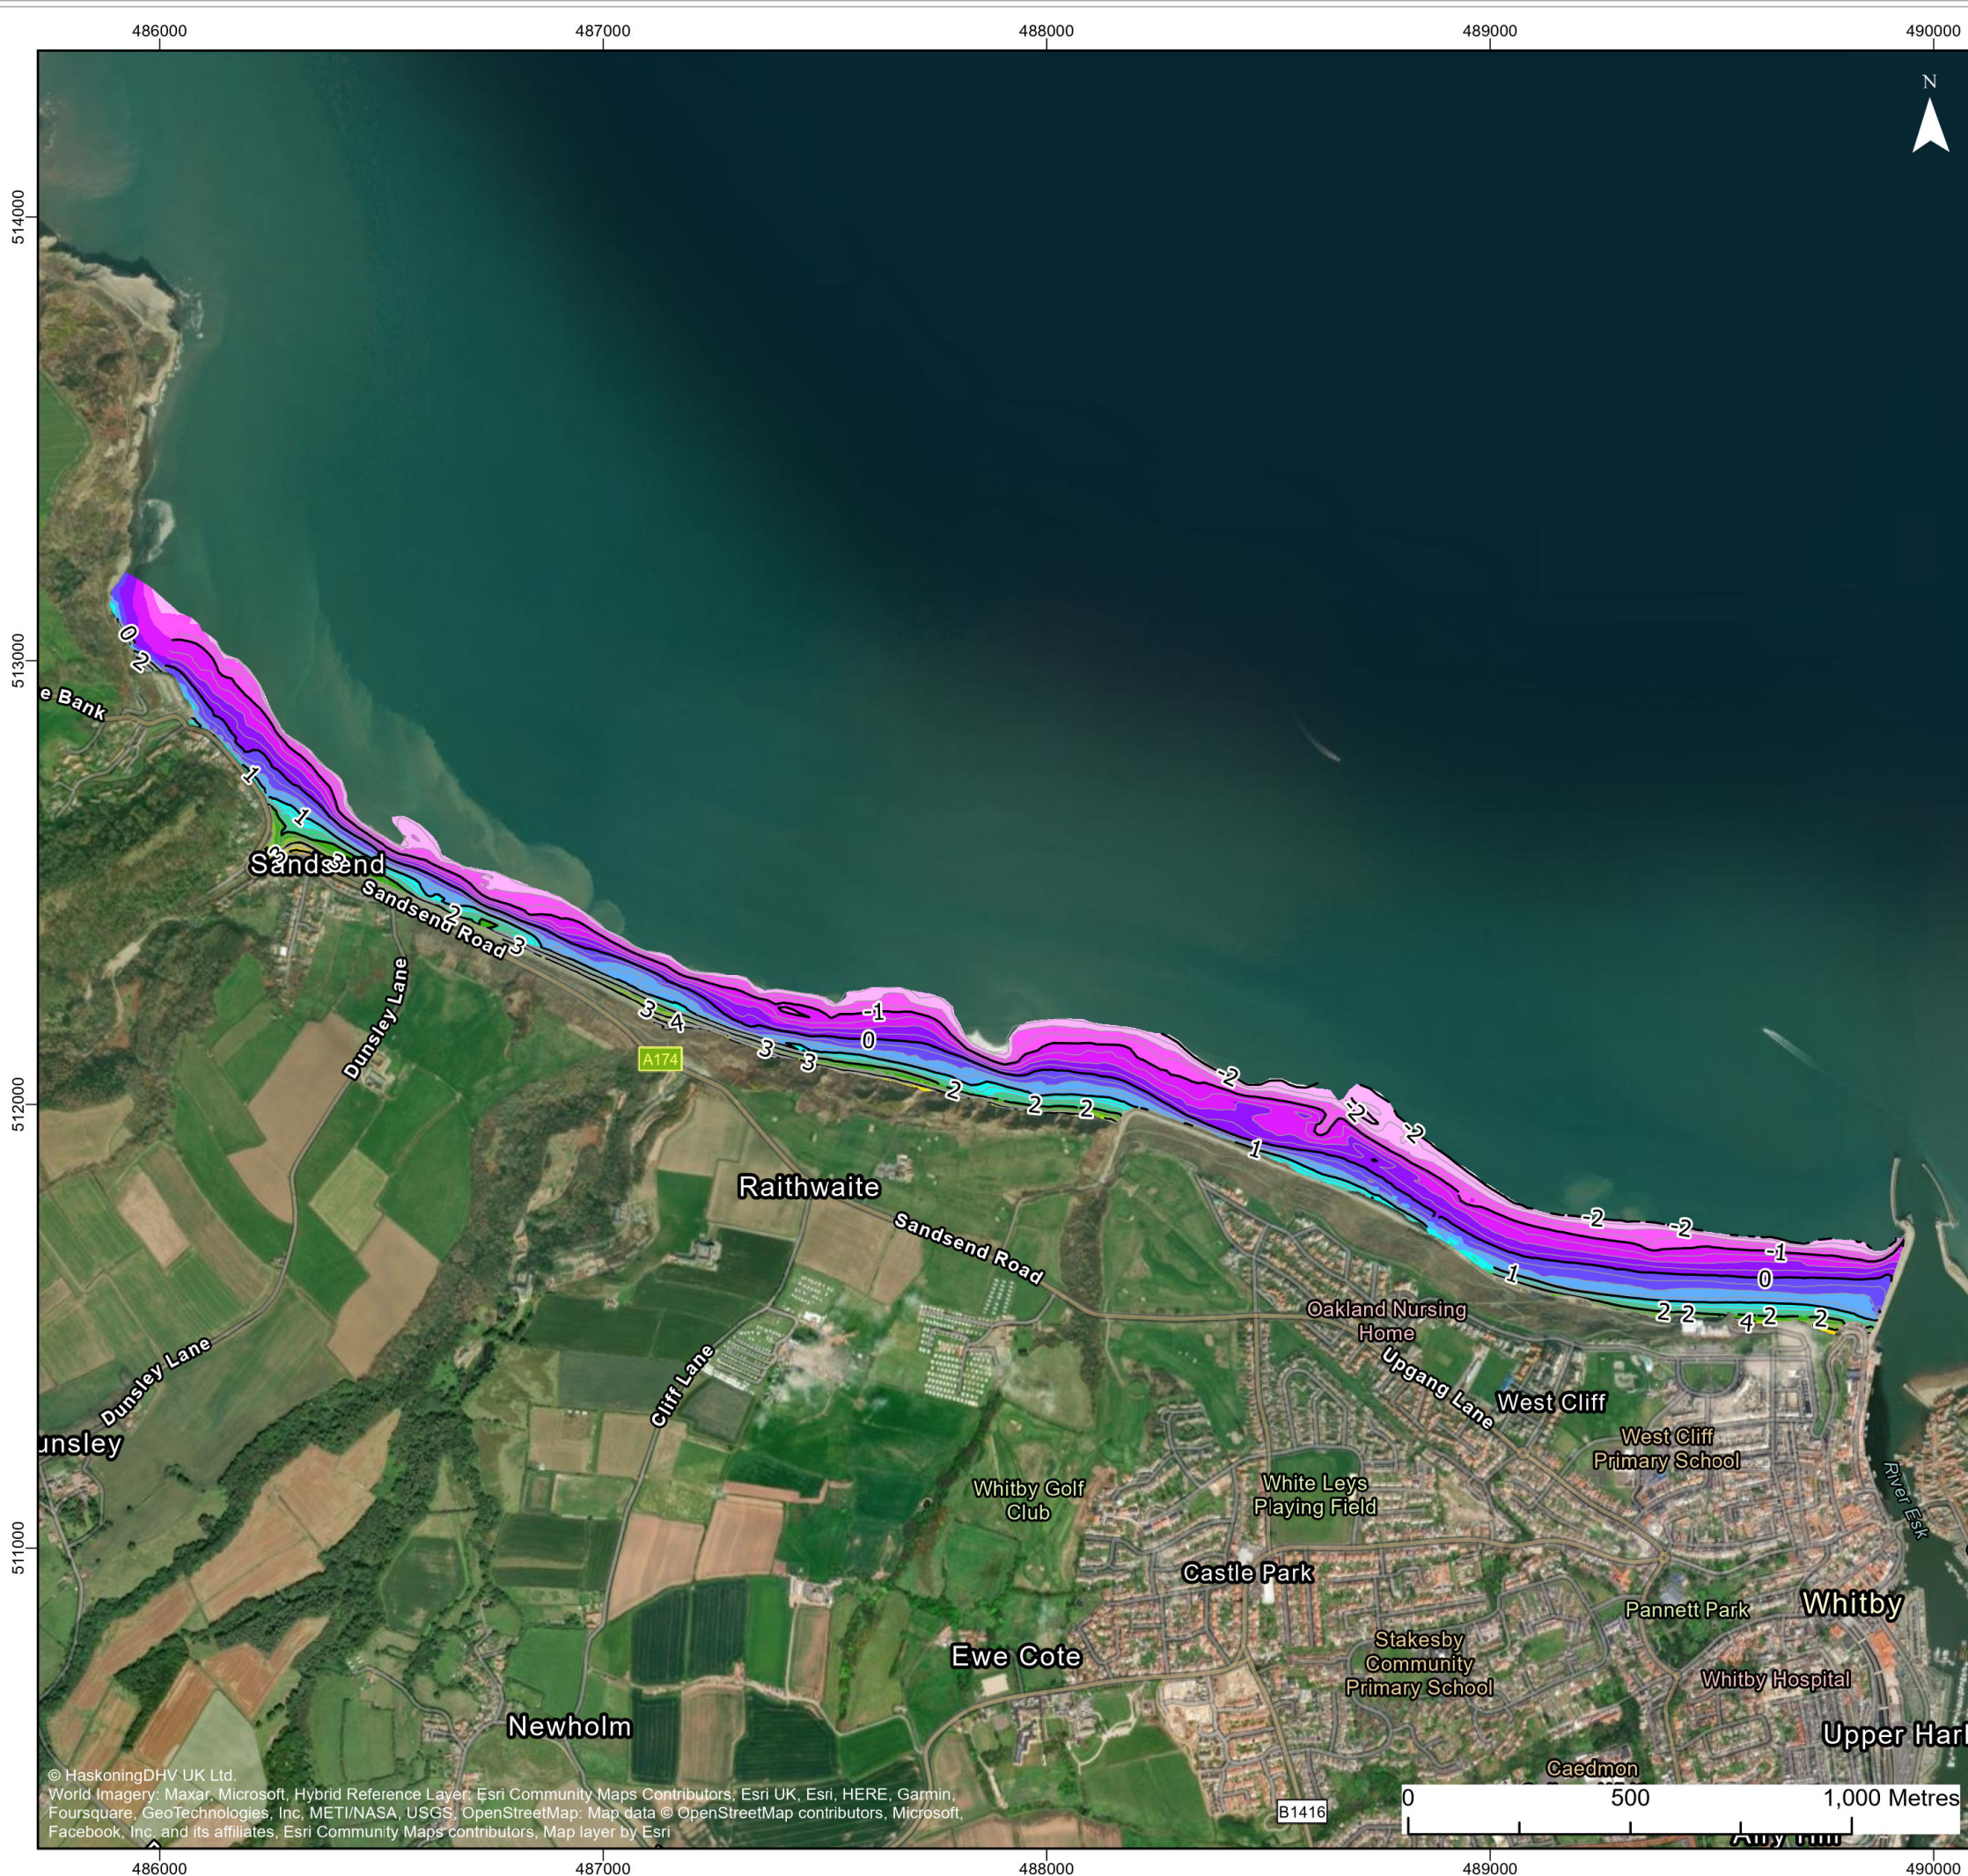
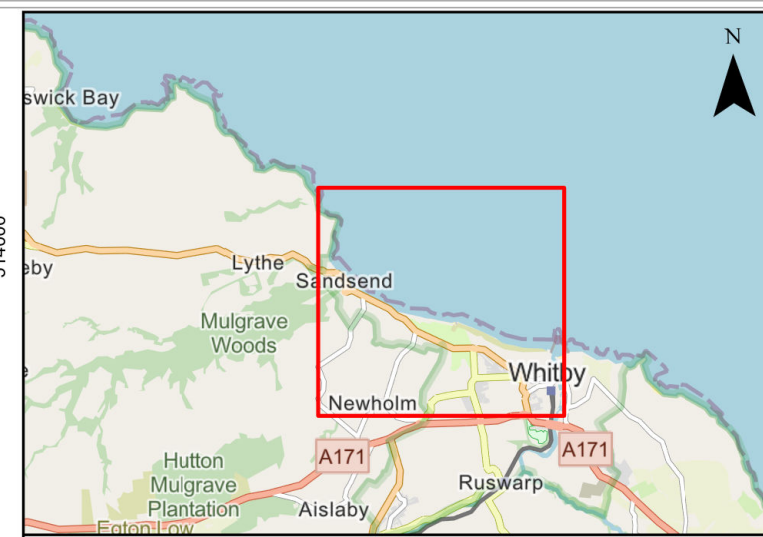
TOPOGRAPHIC SURVEY (August 2023)

Elevation (mOD)	Contours (mOD)*
-2.1 - -2	— 1.0m interval
-1.9 - -1.5	— 0.25m interval
-1.4 - -1	
-0.9 - -0.5	* Contours only cover sandy beach areas.
-0.4 - 0	
0.1 - 0.5	
0.6 - 1	
1.1 - 1.5	
1.6 - 2	
2.1 - 2.5	
2.6 - 3	
3.1 - 3.5	
3.6 - 4	
4.1 - 4.5	
4.6 - 5	
5.1 - 5.5	
5.6 - 6

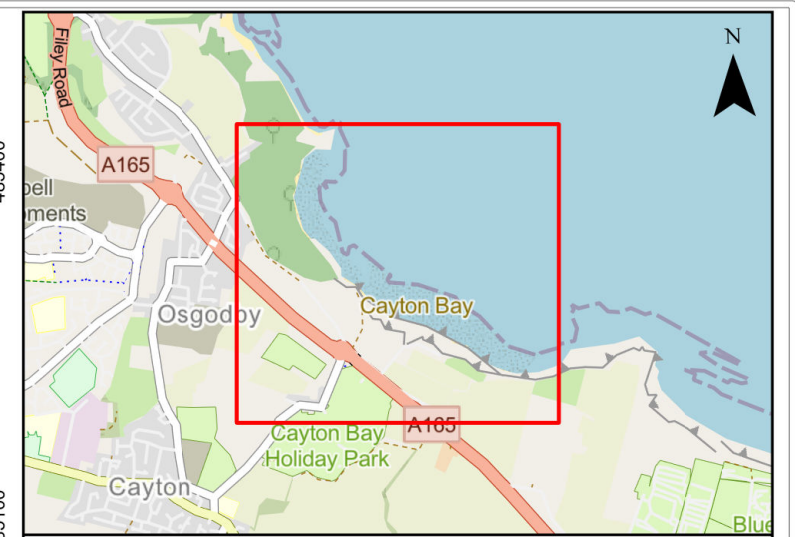
Difference between topographic surveys
(Sept 2022 to Sept 2023)
