Cell 1 Regional Coastal Monitoring Programme Analytical Report 1: 'Full Measures' Survey 2008

Scarborough Borough Council Final Report

May 2009

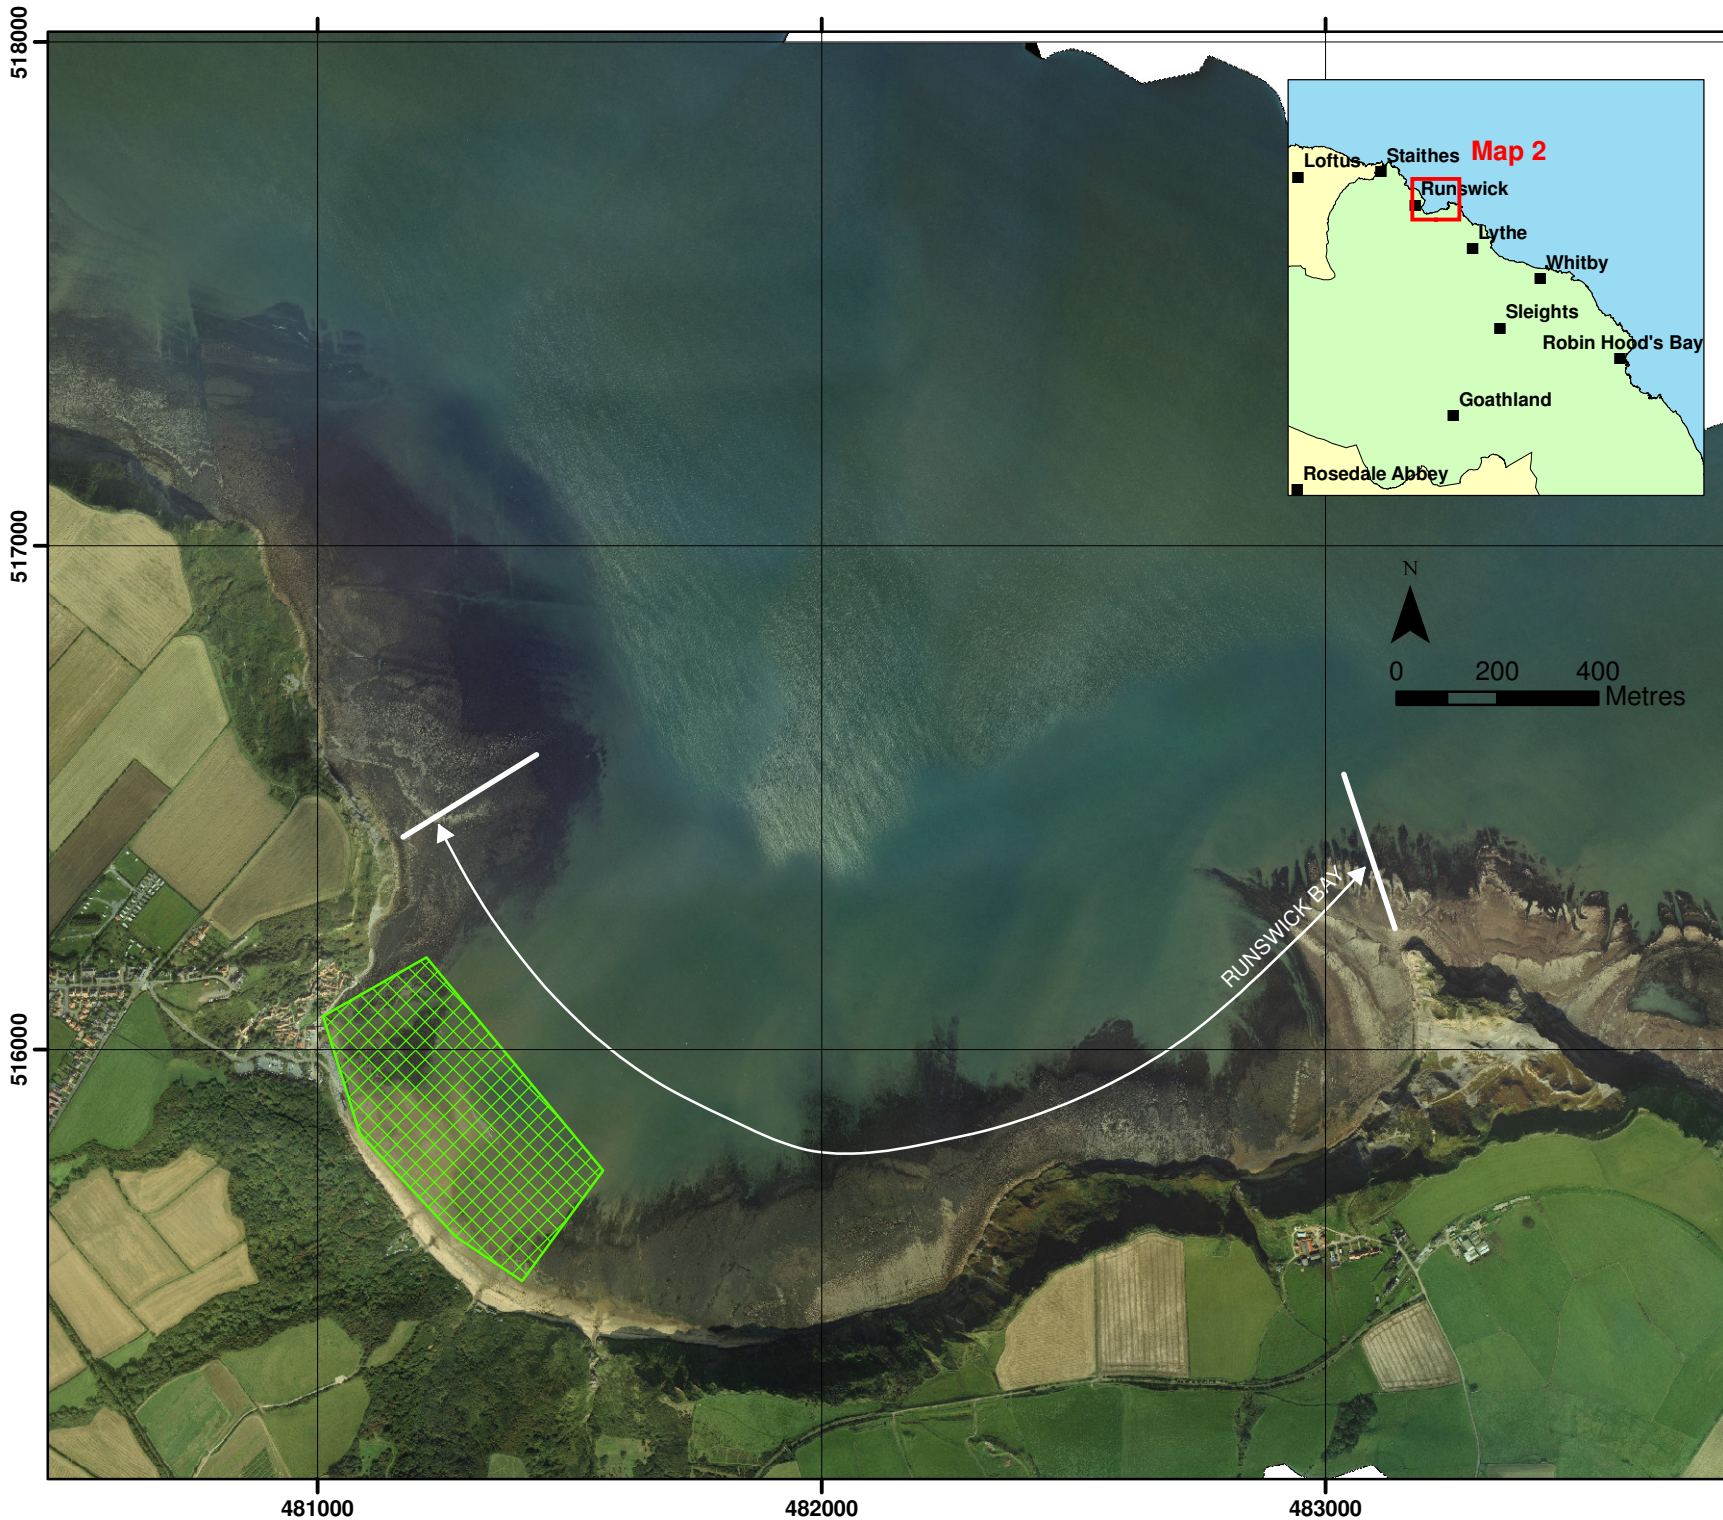
**Figure 2 - Map 2
Scarborough
Borough Council Frontage**

SURVEY LOCATIONS

Topographic Profiles

- Annual
- Bi-Annual

Topographic Surveys

- 6 monthly
- yearly
- 5 yearly

Cliff Top Monitoring Pegs

- @ 50 centres
- @ 100 centres
- @ 300 centres

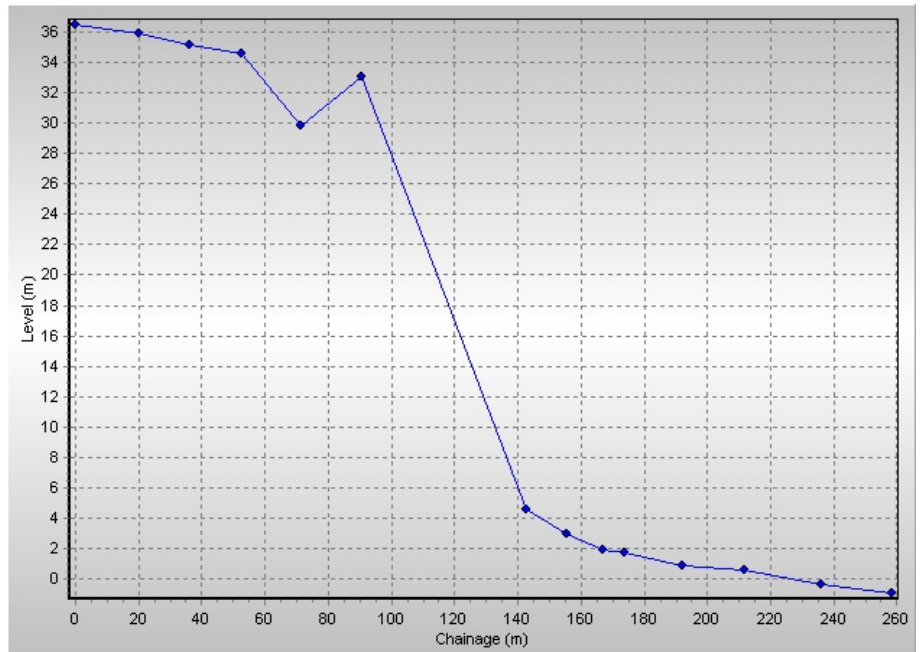
1dWB3

Chainage	Level
0	36.522
20.257	35.967
36.31	35.162
52.398	34.661
71.499	29.87
90.599	33.078
142.914	4.5
155.675	2.901
167.053	1.85
173.948	1.632
191.948	0.82
211.838	0.567
236.239	-0.389
258.428	-0.998

Beach Profile

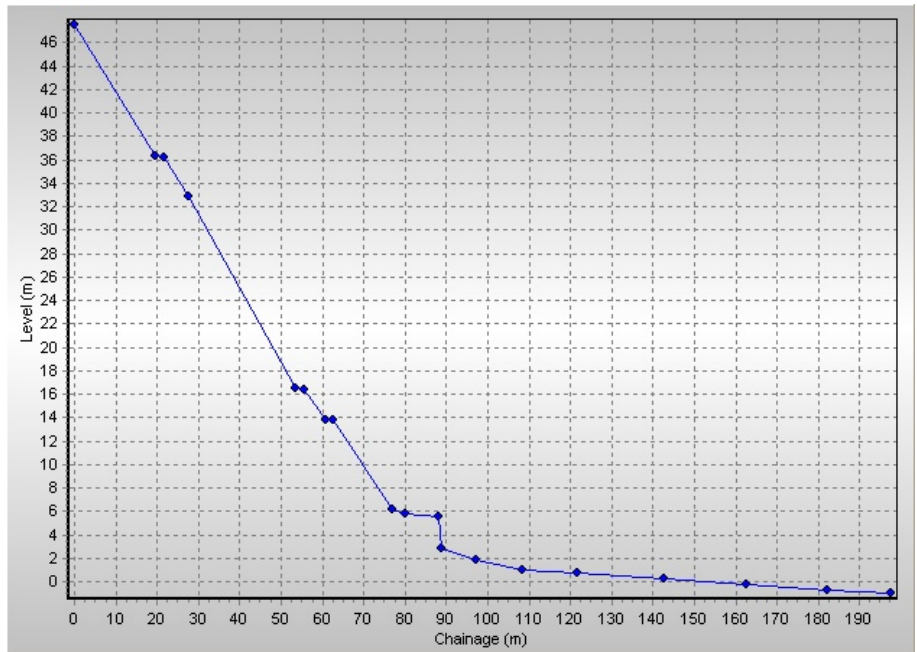
1dSB1

Chainage	Level
0	47.507
19.476	36.338
21.847	36.136
27.483	32.847
53.642	16.542
55.755	16.386
60.857	13.83
62.667	13.813
76.915	6.202
80.159	5.762
88.294	5.557
88.799	2.912
97.12	1.842
108.506	1.07
121.863	0.728
142.661	0.316
162.463	-0.189
182.363	-0.662
197.587	-0.954

Beach Profile
