**Cell 1 Regional Coastal Monitoring Programme  
Analytical Report 6 Full Measures Survey 2013**

**Scarborough Council  
Final Report**

**February 2014**

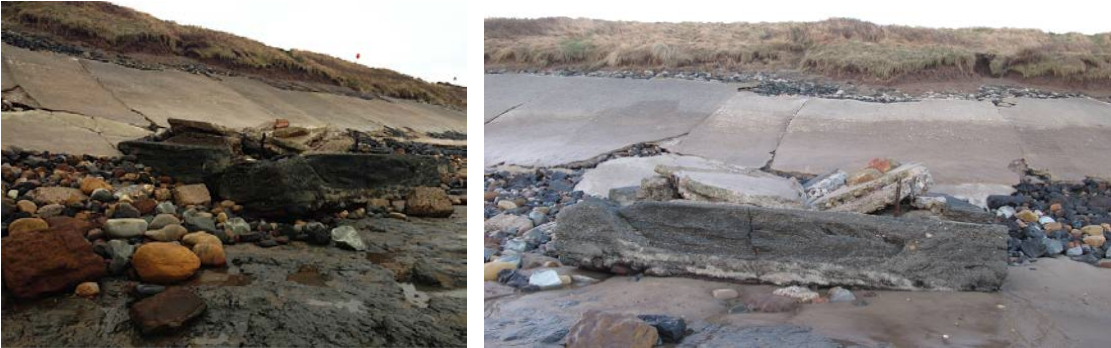
<p>Photographs showing the extensive damage to revetment and the scoured beach with no sand in front of the revetment (left), 8th December and the slightly recovered beach on the 17th December (right).</p> <p>The topographic difference plot for the area covered shows that the beach at the toe of the cliff has eroded by around 1m between September and December 2013. The difference plot shows that the toe of the cliff was also eroded, which is likely to cause increased cliff recession through the winter of 2013/14.</p>	<p>upper beaches with a small amount of accretion over the majority of the beach. This pattern may reflect material from below MLWS being driven onshore by the storm, or erosion of the cliffs to release beach-building material.</p> <p>The topographic plot covers a small area of beach backed by soft cliffs. It highlights erosion of the back of the beach by around 1m, suggesting cliff recession occurred.</p>
