Cell 1 Regional Coastal Monitoring Programme Analytical Report 7 Full Measures Survey 2014

**Scarborough Council
Final Report**

February 2015

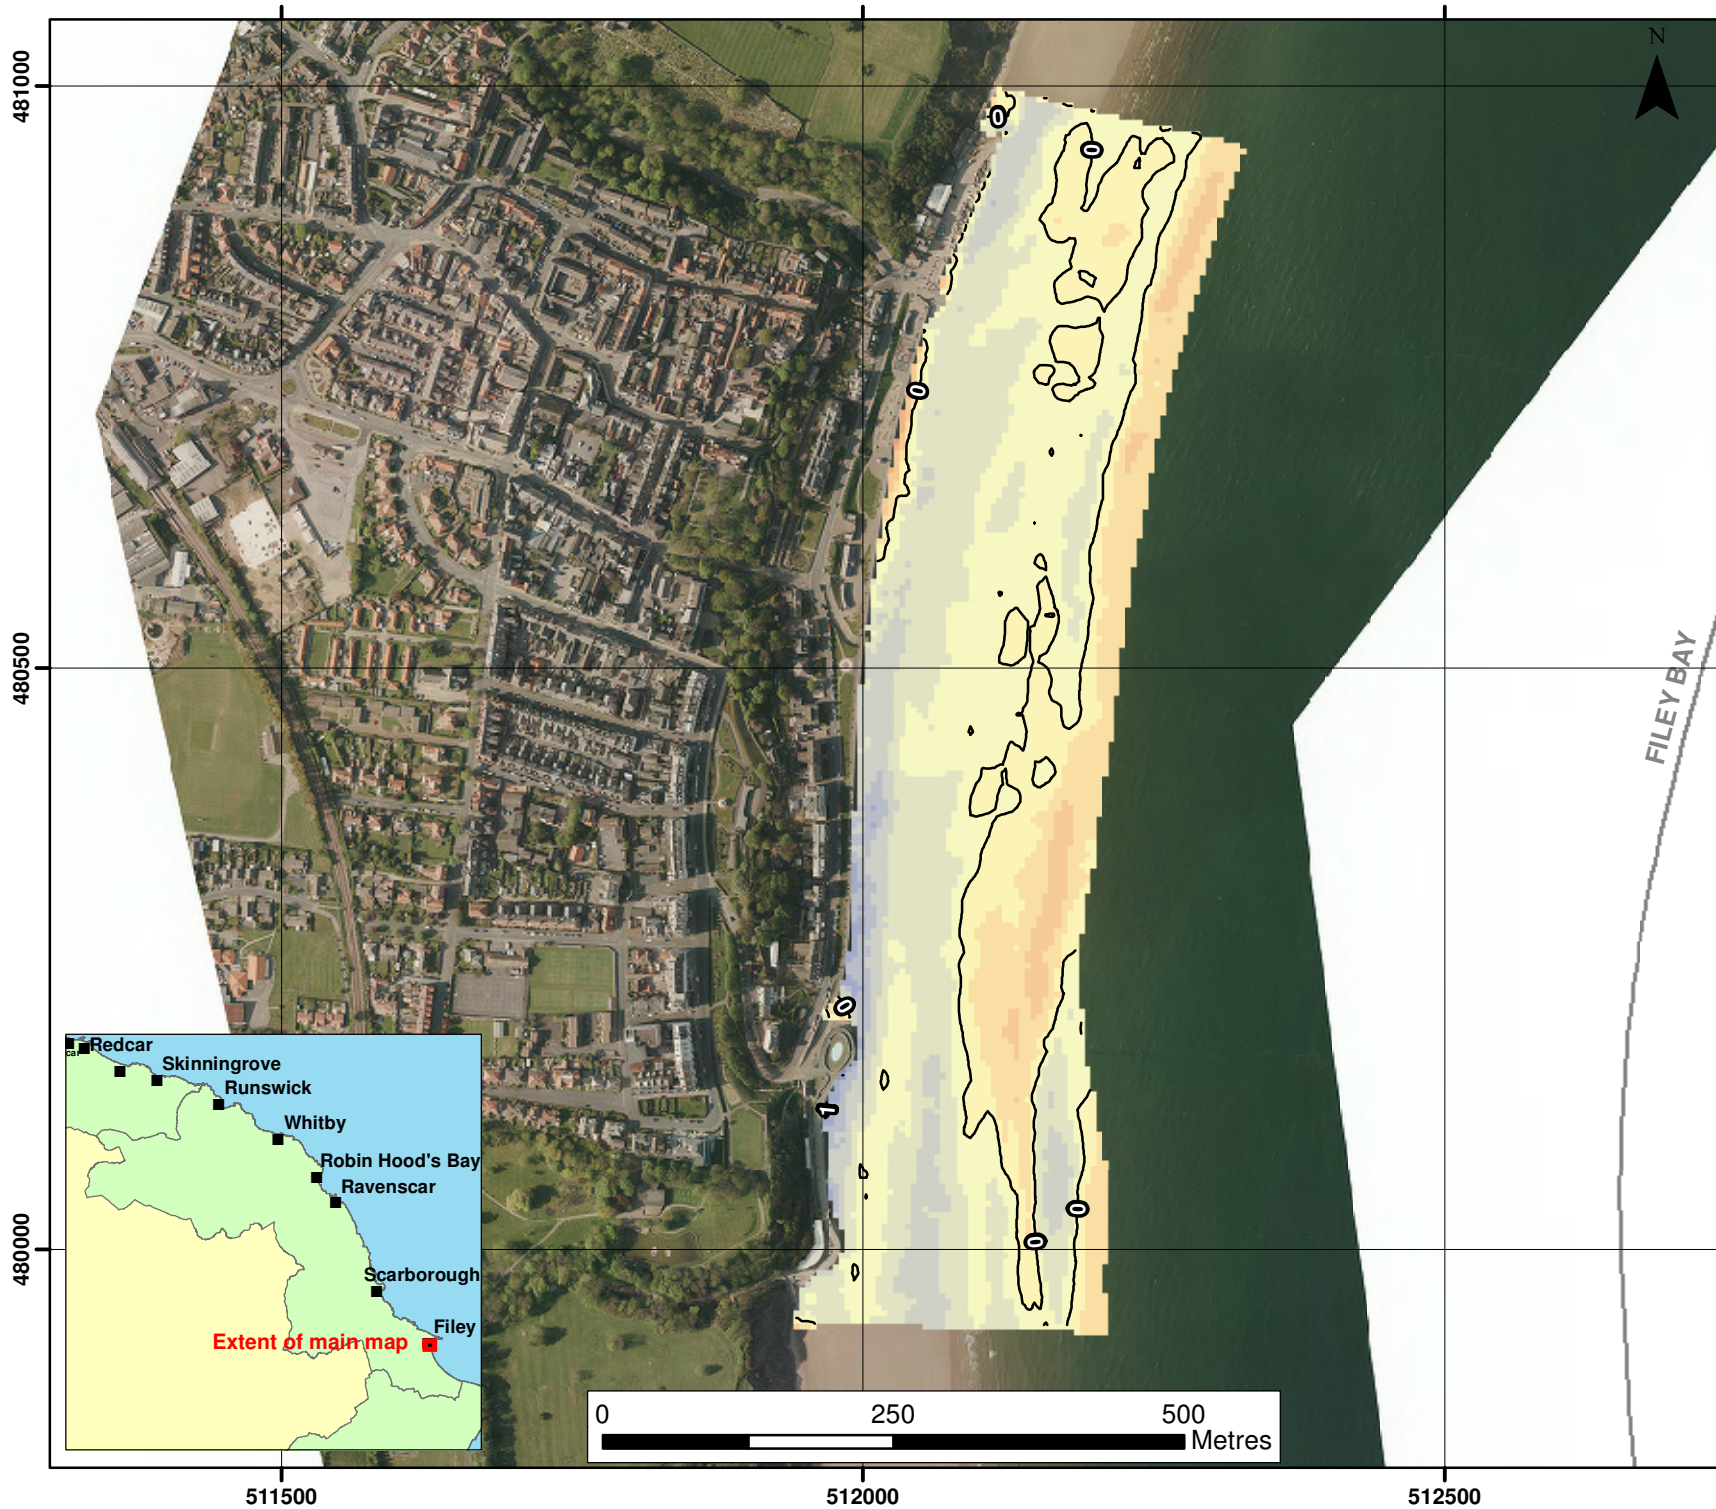
KEY Spring 2014 and Autumn 2014
Change in elevation (m)

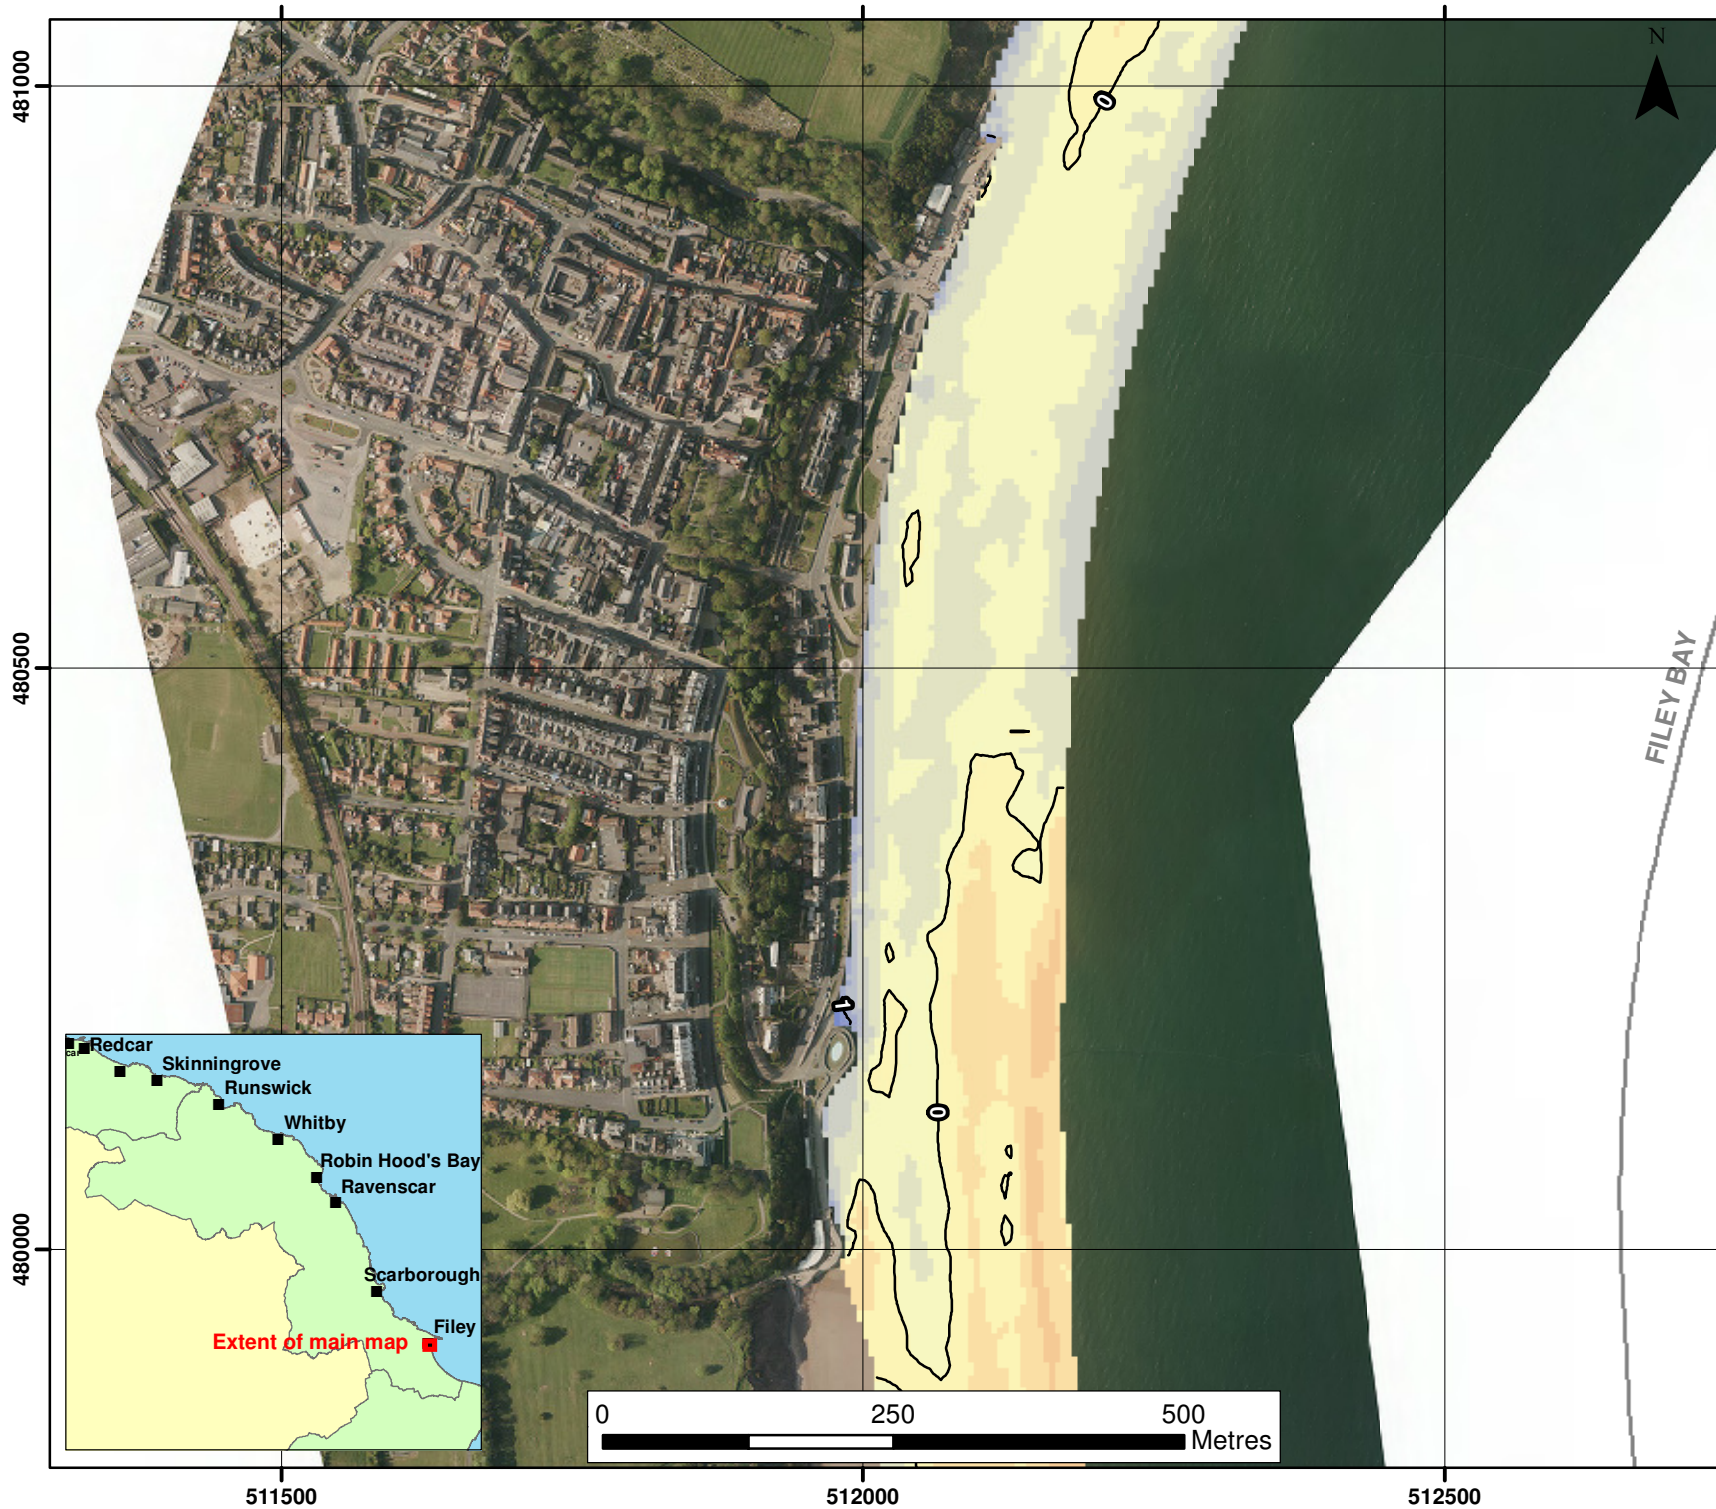
Appendix B- Map 10c
Long-term
Elevation Change
Filey
Scarborough
Borough Council

Survey Date	Description of Changes Since Last Survey	Interpretation
	<p>Appendix B - Map 10a shows that there have been areas of roughly shore-parallel accretion and erosion. The highest magnitude change has been observed in a very small area against the seawall immediately south of the paddling pool where up to 1m of material has accreted. The remaining bands of accretion and erosion show a maximum magnitude of change of $\pm 0.5\text{m}$, with erosion in front of the seawall in the northern part of the frontage and at the seaward edge of the survey, and accretion in between and in the upper beach in the south of the survey area.</p> <p>Long Term Topographic Trends Autumn 2008 to Autumn 2014:</p> <p>The long term trends of change in Filey Bay are shown in Appendix B – Maps 8c and 9c. These show that Speeton Sands in the south of the bay has predominantly experienced erosion and Reighton, Hunmanby and Muston Sands in the middle of the bay have experienced accretion since 2008. The picture is more mixed at Filey Sands and northwards as far as the Brigg, where there is a mixture of erosion and deposition, and the magnitude of these changes is less (no change is $> \pm 1\text{m}$) than further south in the bay.</p> <p>Filey Town Long Term Trends:</p> <p>The long term difference plot for the Filey town frontage is in Appendix B Map 10b. The plot shows that there has been erosion of the foreshore towards the south of the frontage and accretion in the north of the frontage since 2008. The magnitude of change is limited and rarely exceeds $\pm 0.25\text{m}$. The highest magnitude change is area of very limited extent on the slipway immediately north of the paddling pool where there has been accretion of $> 1\text{m}$ since 2008.</p> <hr/> <p>Cliff-top Survey:</p> <p>Twenty-eight ground control points have been established within Filey Bay for the purposes of cliff top monitoring. This includes the installation of three additional locations in September 2010: points 12A (as a replacement for point 13 which can no longer be accessed due to vegetation growth), 24 & 25 (to the north of Filey Bay at Filey Brigg). A further replacement for monitoring point 13, 13A, has been added in 2014.</p> <p>The maximum separation between any two points is nominally 300 m. The cliff top surveys at Filey Bay are undertaken every 6 months. Data collection involves a distance offset measurement from the ground control point to the cliff edge along a fixed bearing.</p>
