**Cell 1 Regional Coastal Monitoring Programme
Analytical Report 8 Full Measures Survey 2015**

**Scarborough Council
Final Report**

February 2016

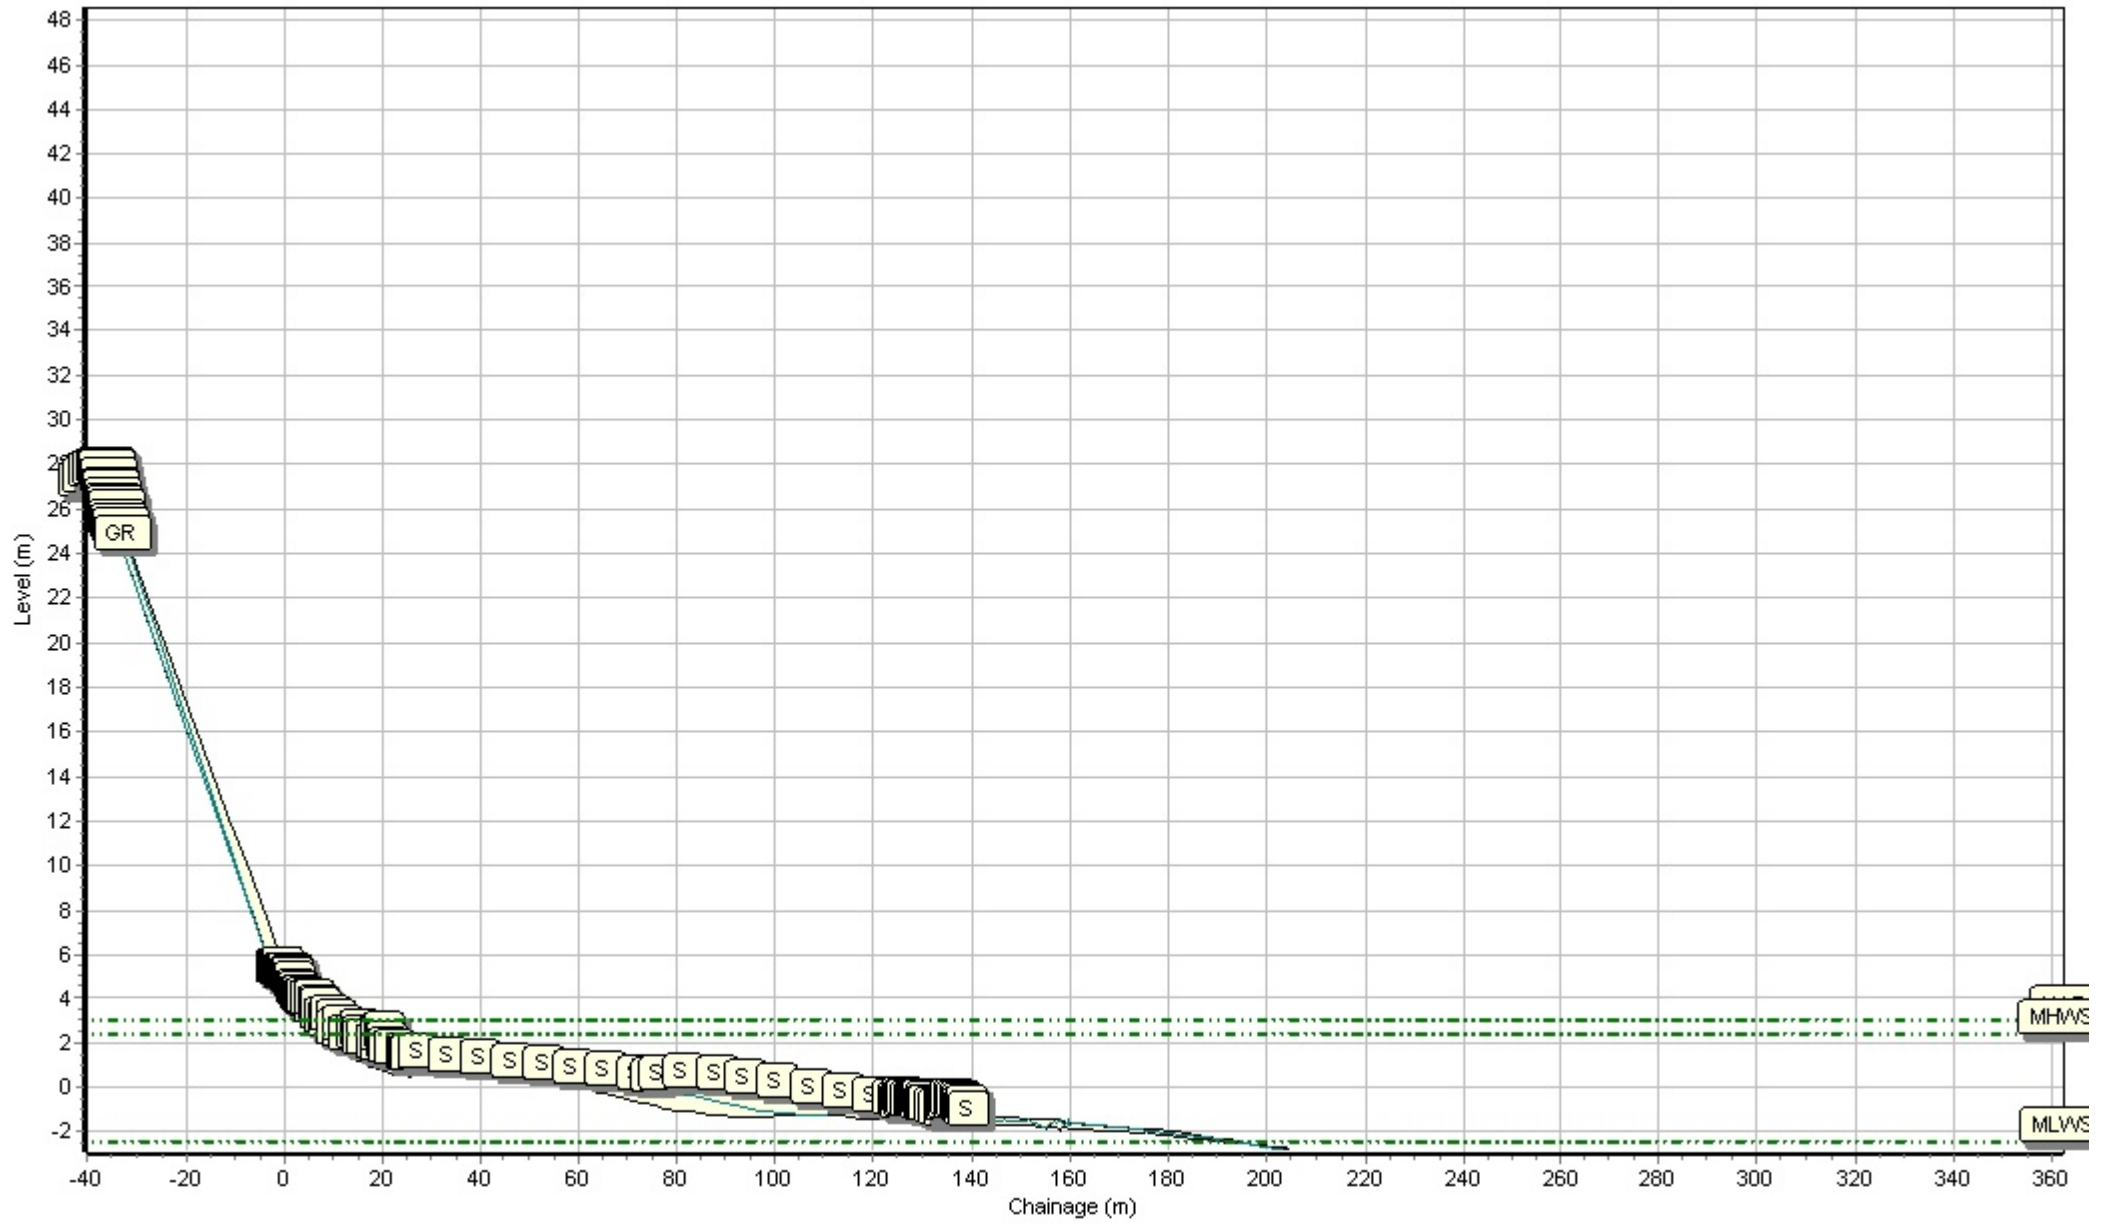
Profiles: 1dCY1

Survey Date	Description of Changes Since Last Survey	Interpretation
<p>12th Nov 2015</p>	<p>Beach Profiles:</p> <p>Cayton Bay is covered by three beach profile lines, distributed between Tenants' Cliff and the south of Cayton Sands (Appendix A). The surveyor noted that due to poor weather and equipment failure, the sections and VMPs were not measured on the same day (12/11/15) the topographical survey (28/10/15) was measured.</p> <p>The cliff face at profile 1dCY1 is vegetated and was difficult for the surveyors to access resulting in poor data in the top of the profile. In the rest of the profile, there was little change as far as 20m chainage between March and November 2015. From 20m to 80m chainage the beach level has dropped by up to 0.4m. Between 80m and 100m chainage a small berm has accreted with 0.1m rise in beach levels since March 2015. From 100m to the end of the survey at 140m the lower beach and rocky exposure have remained stable. Overall the profile November 2015 is among the highest recorded levels.</p> <p>The centre of cliff profile 1dCY2 could not be accessed, so there is low confidence in this part of the data. The survey indicates that there has been little change to 120m chainage. Three berms have accreted in the beach, from 120m to 190m chainage, between 190m and 270m change and from 270m to 340m chainage. The largest berm is on the upper beach 0.3m accretion, the mid berm saw 0.2m accretion while the lower beach berm had only accumulated 0.1m of material since March 2015. Overall the profile November 2015 is among the highest recorded levels.</p> <p>The centre of cliff profile 1dCY3 profile could also not be accessed, so there is low confidence in that part of the data. From 125m to 140m chainage the rocks which were exposed in the top of the beach have been covered by 0.4m of beach material. Between 140 and 190m chainage the beach has remained similar. From 190m to 290m the beach berm present in March 2015 has moved seawards, with the biggest change being a drop of 0.5m.</p> <p>Topographic Survey:</p> <p>Cayton Bay is covered by an annual topographic survey. Data have been used to create a DGM (Appendix B - Map 7a) using GIS. The GIS has also been used to calculate the differences between the</p>	<p>The beach profiles have been stable overall with evidence of the formation of beach berms. CY1 and CY2 are among the highest on record.</p> <p>The plot of difference between Autumn 2014 to Autumn 2015 surveys shows variability in the erosion and accretion in the bay. The main change was erosion on the upper beach.</p> <p>The cliff top survey data shows no change during the summer of 2015.</p> <p>Longer term trends: The pattern of migrating sand bars has remained consistent since 2010 indicating seasonal variation in beach level with no net change.</p> <p>Autumn 2008 to Autumn 2015 trends: The distribution of change on the long term difference plot reflects sediment redistribution northwards and rather than net erosion or accretion in the bay.</p>
