**Cell 1 Regional Coastal Monitoring Programme
Update Report 3: 'Partial Measures' Survey 2011**

**Scarborough Borough Council
Draft Report**

August 2011

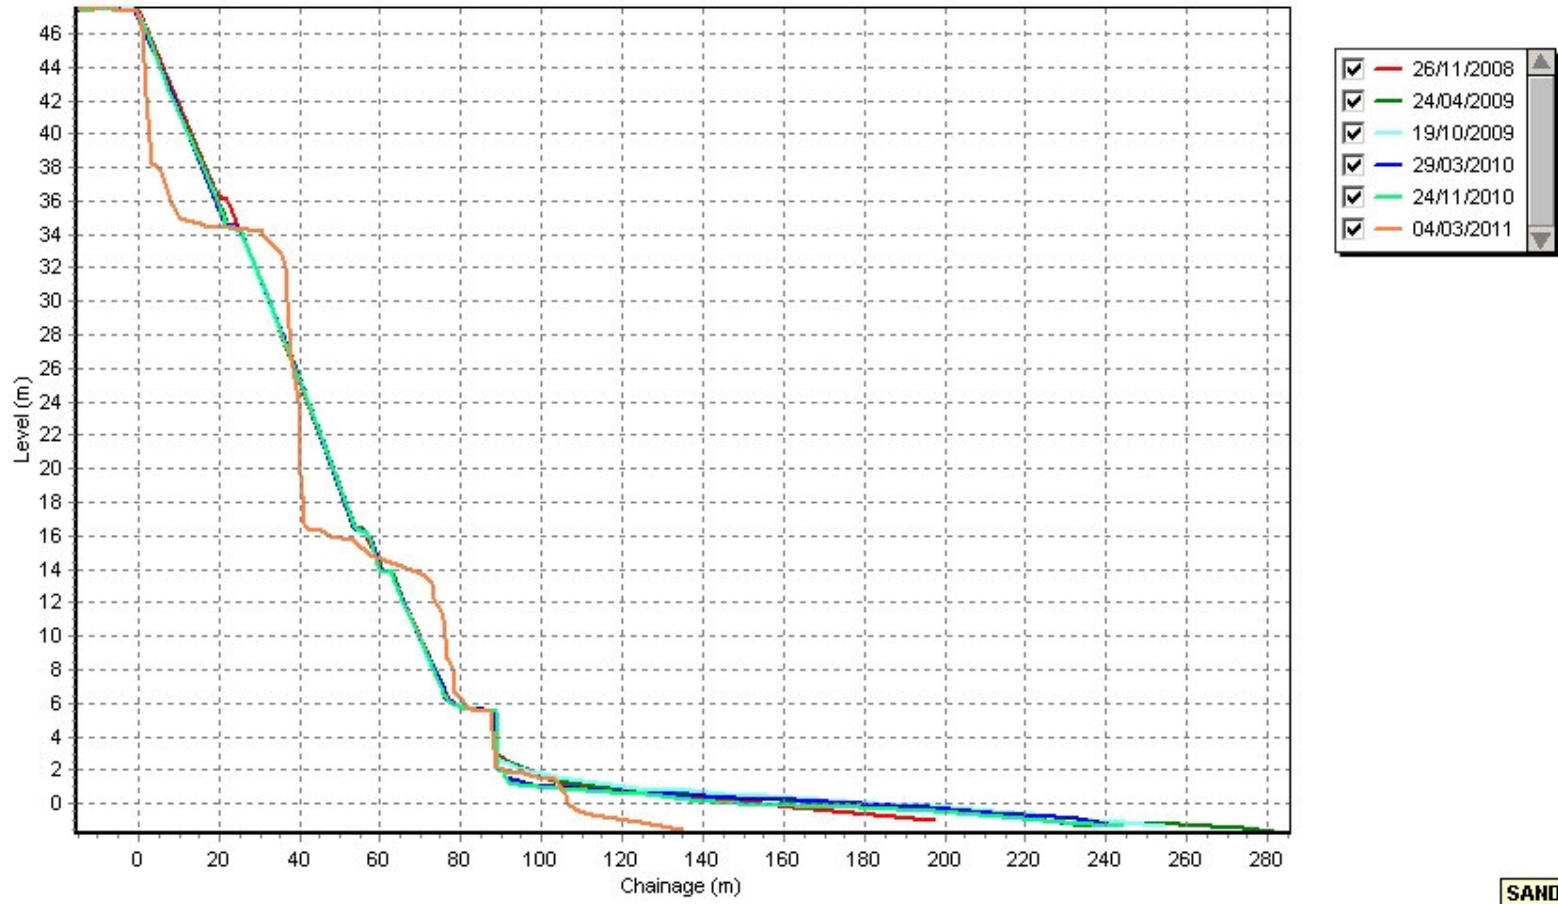
Beach Profiles: 1dWB3

<p>WB 3 - The March 2011 survey for this profile shows a distinctive ‘stepped’ cliff profile which is markedly different from any previous surveys. This has resulted in significant changes in elevation down the cliff face since the last survey – in places up to 8m erosion is observed and elsewhere up to 5m of accretion. It is not clear whether this represents a real change to the cliff face (possibly resulting from cut/fill activities) or whether some error has occurred. Given that the top and base of the cliff have remained in the same place it is suggested that this data does not represent natural cliff change. The profile of the beach section (from c.90m chainage onwards) is initially slightly higher than the previous survey but reduces in elevation with distance seaward so that by a chainage of c.105m it is lower than previous surveys by up to 2m. This does not match the difference DGM shown on Appendix B – Map 4b which shows deposition on the beach along most of the profile length. This suggests an error in the cliff profile</p>
