**Cell 1 Regional Coastal Monitoring Programme
Update Report 7: 'Partial Measures' Survey 2015**

**Scarborough Council
Final Report**

July 2015

(*) The present report is **Update Report 7** and provides an analysis of the 2015 Partial Measures survey for Scarborough Council's frontage.

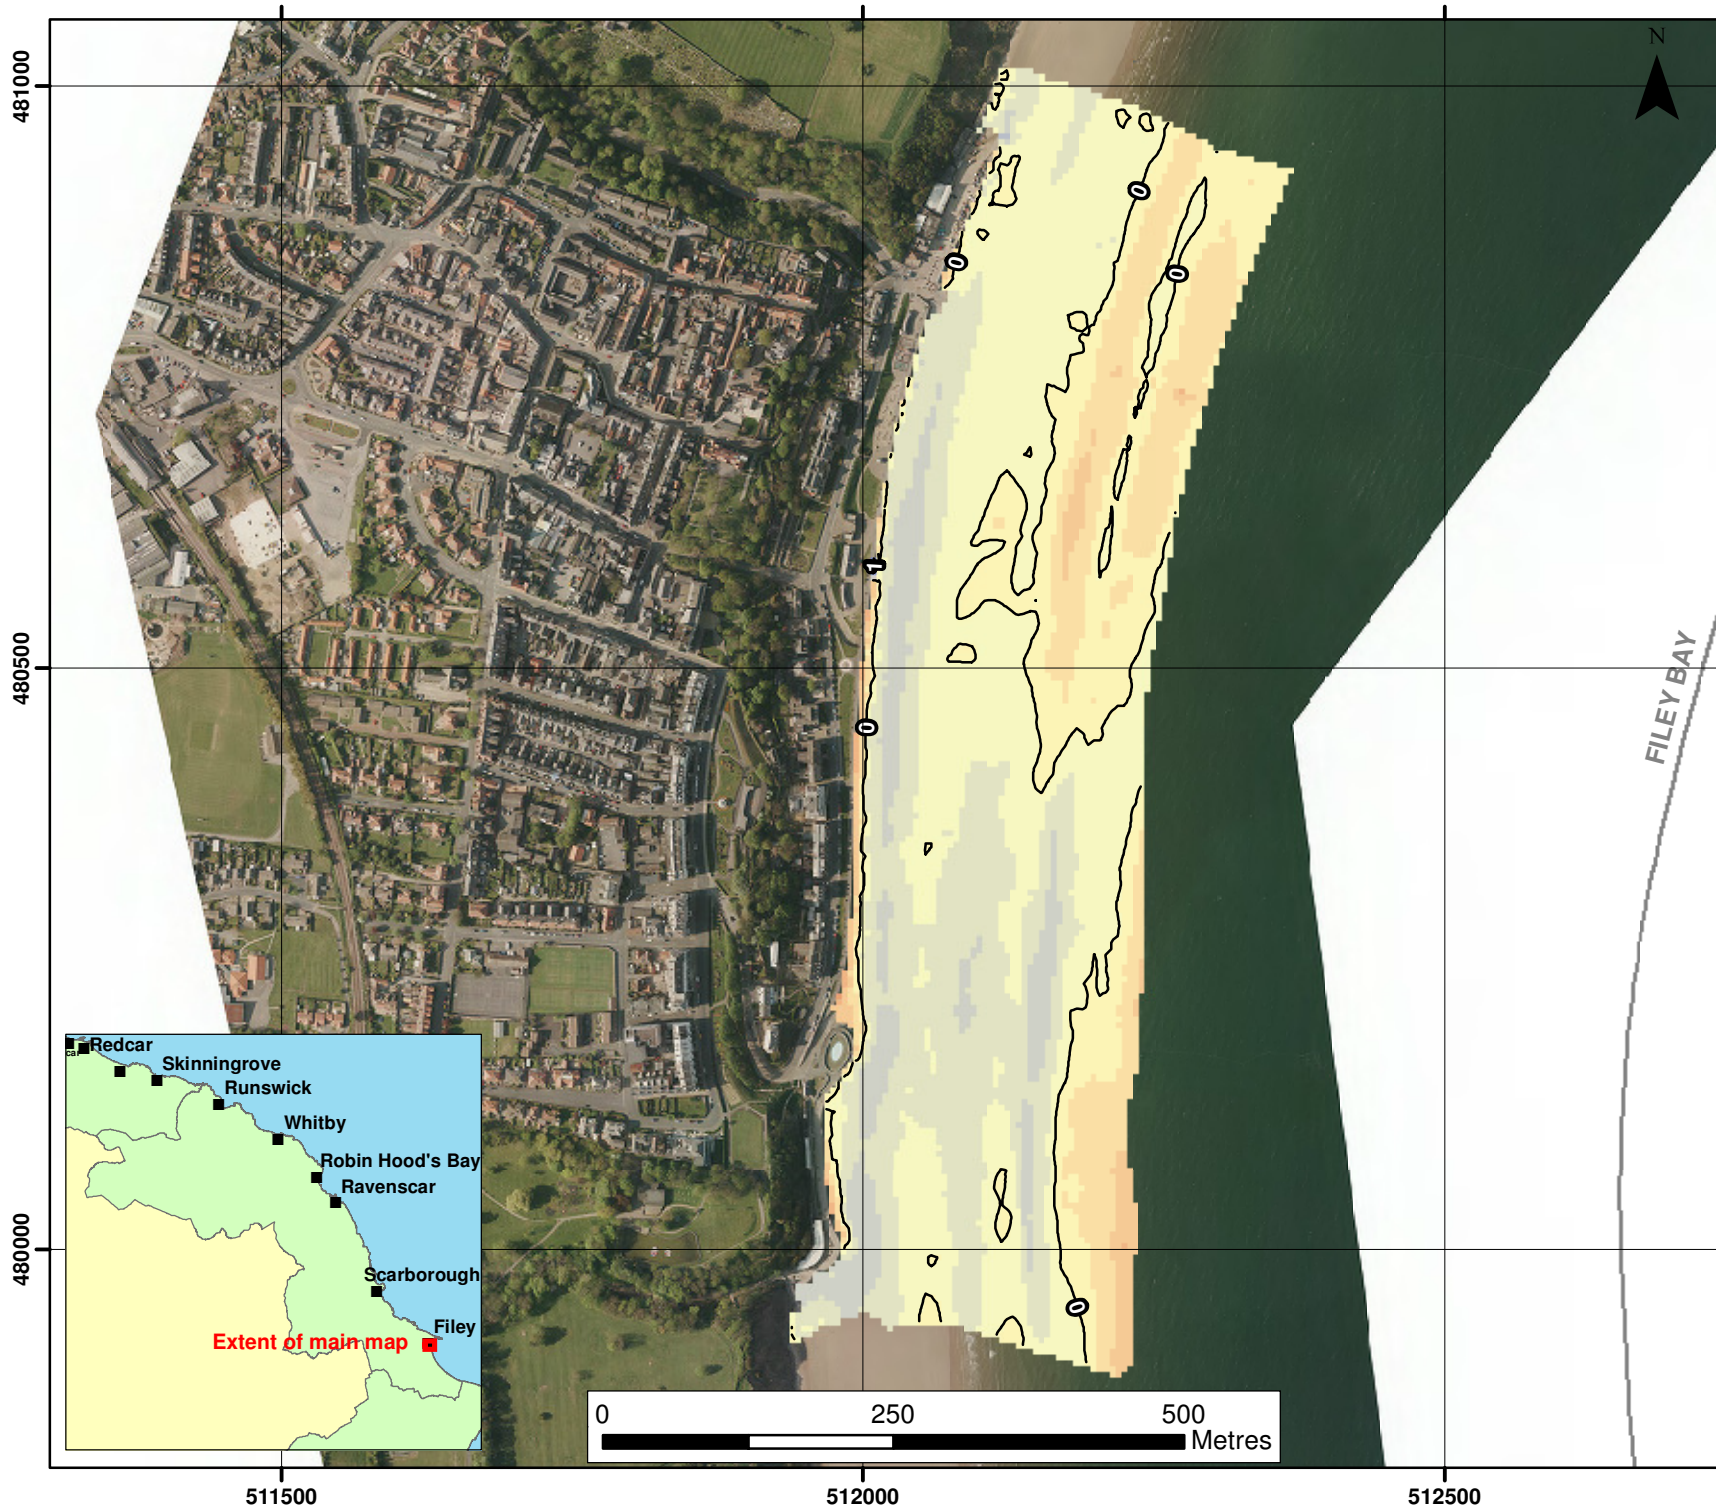
KEY Autumn 2014 and Spring 2015
Change in elevation (m)
