Cell 1 Regional Coastal Monitoring Programme Update Report 13: 'Partial Measures' Survey 2021

**Scarborough Borough Council
June 2021**

(*) The present report is **Update Report 13** and provides an analysis of the 2021 Partial Measures survey for Scarborough Council's frontage.

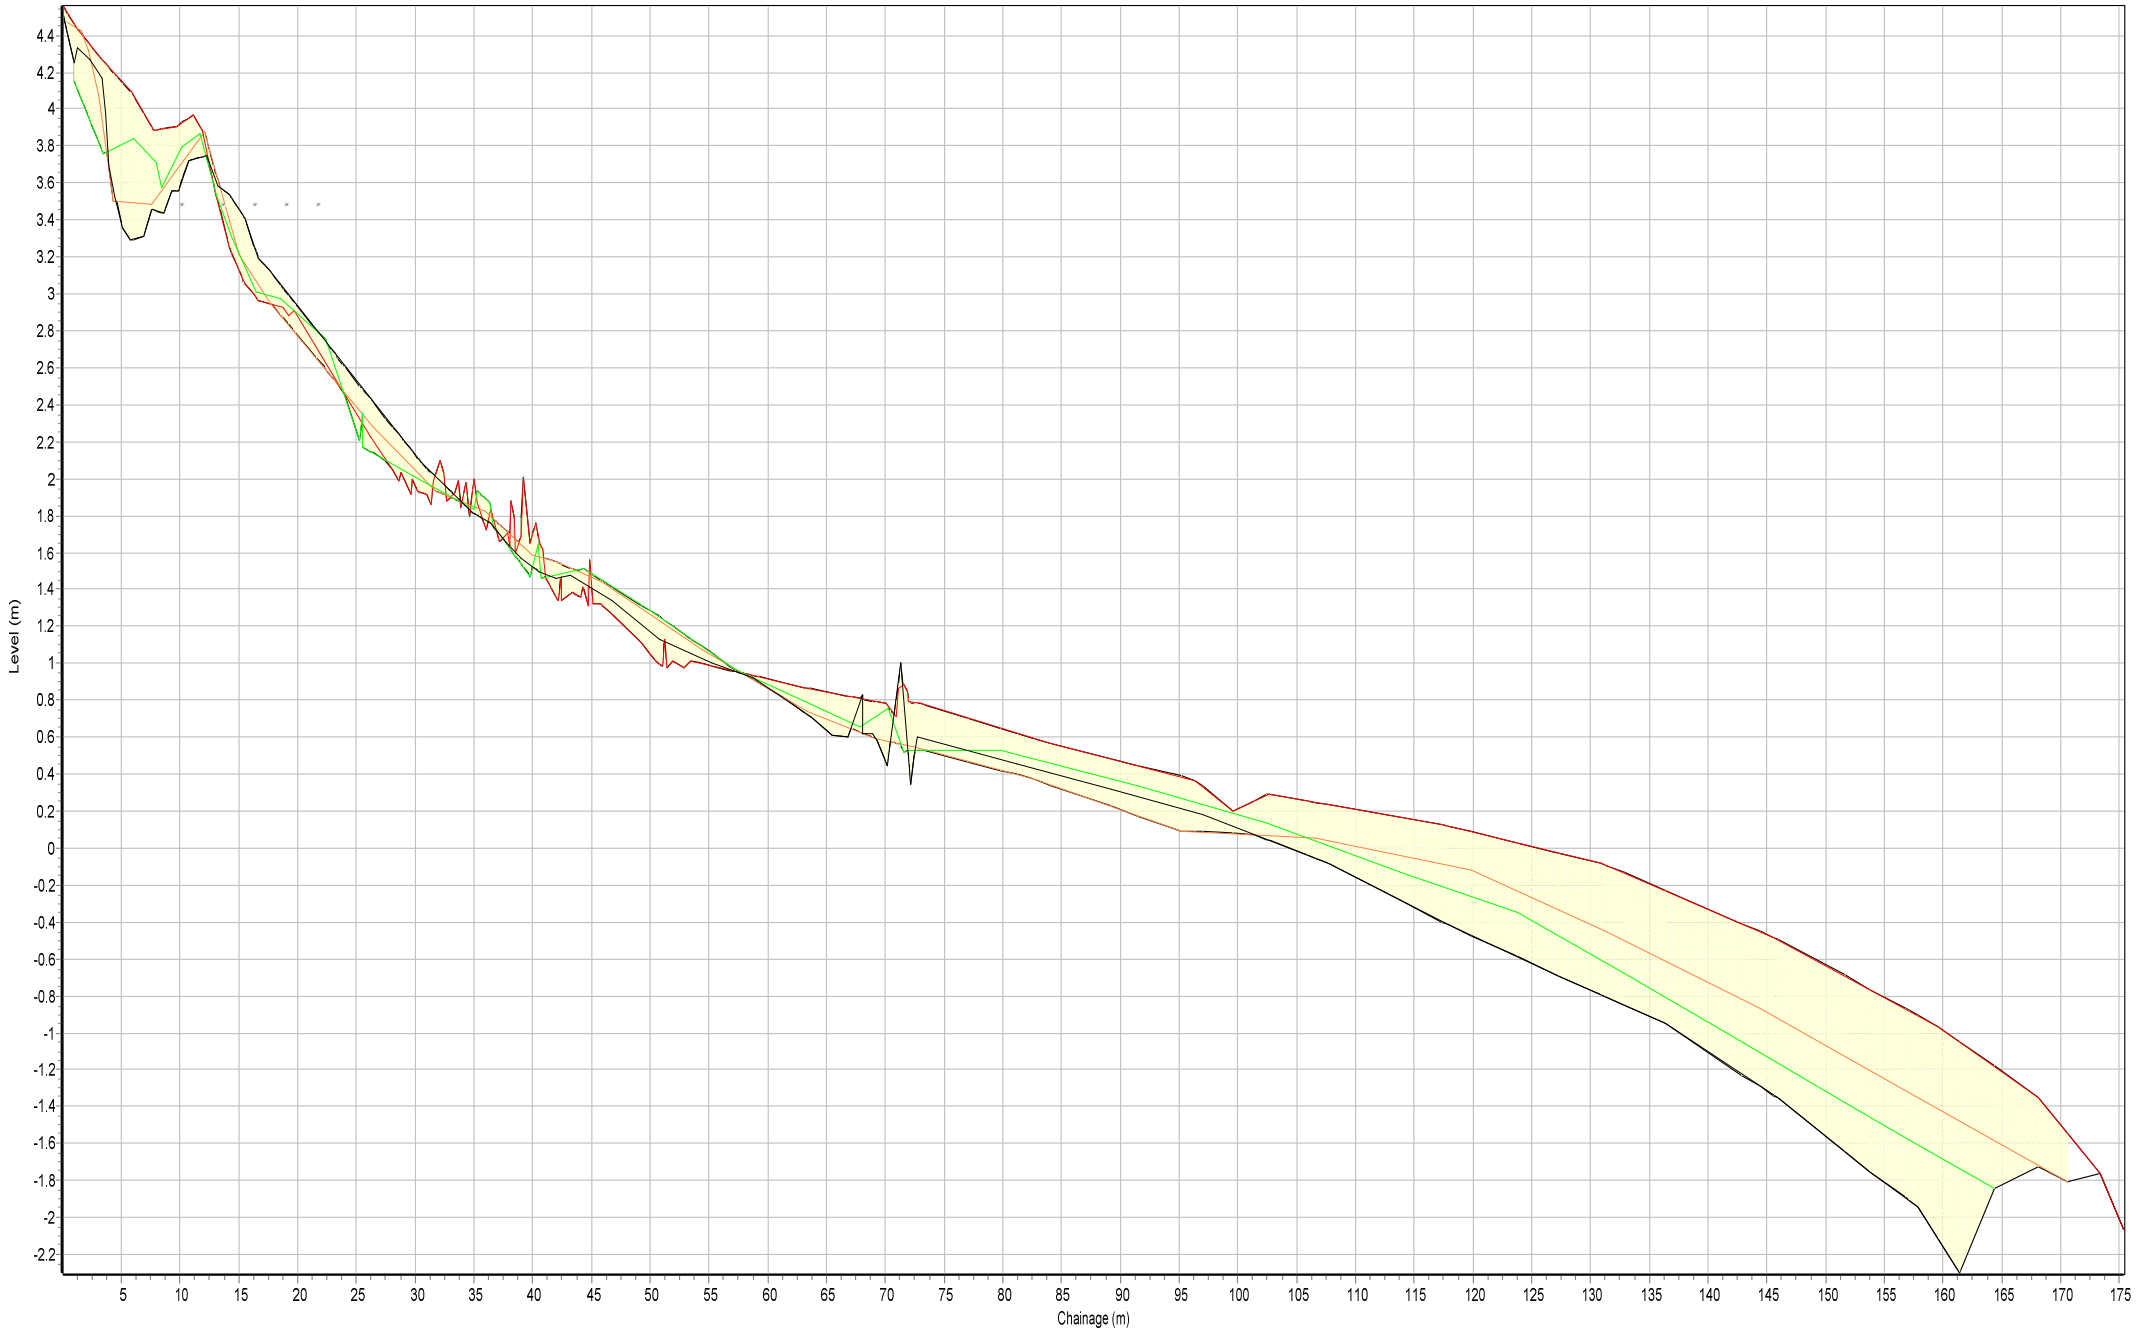
Beach Profiles: 1dCY1A

- The beach profiles in Cayton Bay are dominated by erosion. At some profiles there is an accumulation of material at the cliff toe caused by losses from the cliff face. The narrow channel / depression at profile 1dCY1A has continued to deepen since the previous survey and is now at its lowest point recorded. The cliff monitoring shows that no points underwent recession outside the survey tolerance of 0.2m over the winter of 2020/21.
