**Cell 1 Regional Coastal Monitoring Programme
Scarborough 'Post Storm' Beach Monitoring
Survey Report 2024**

This report presents the Post Storm Walkover Inspection for Scarborough North Bay and South Bay.

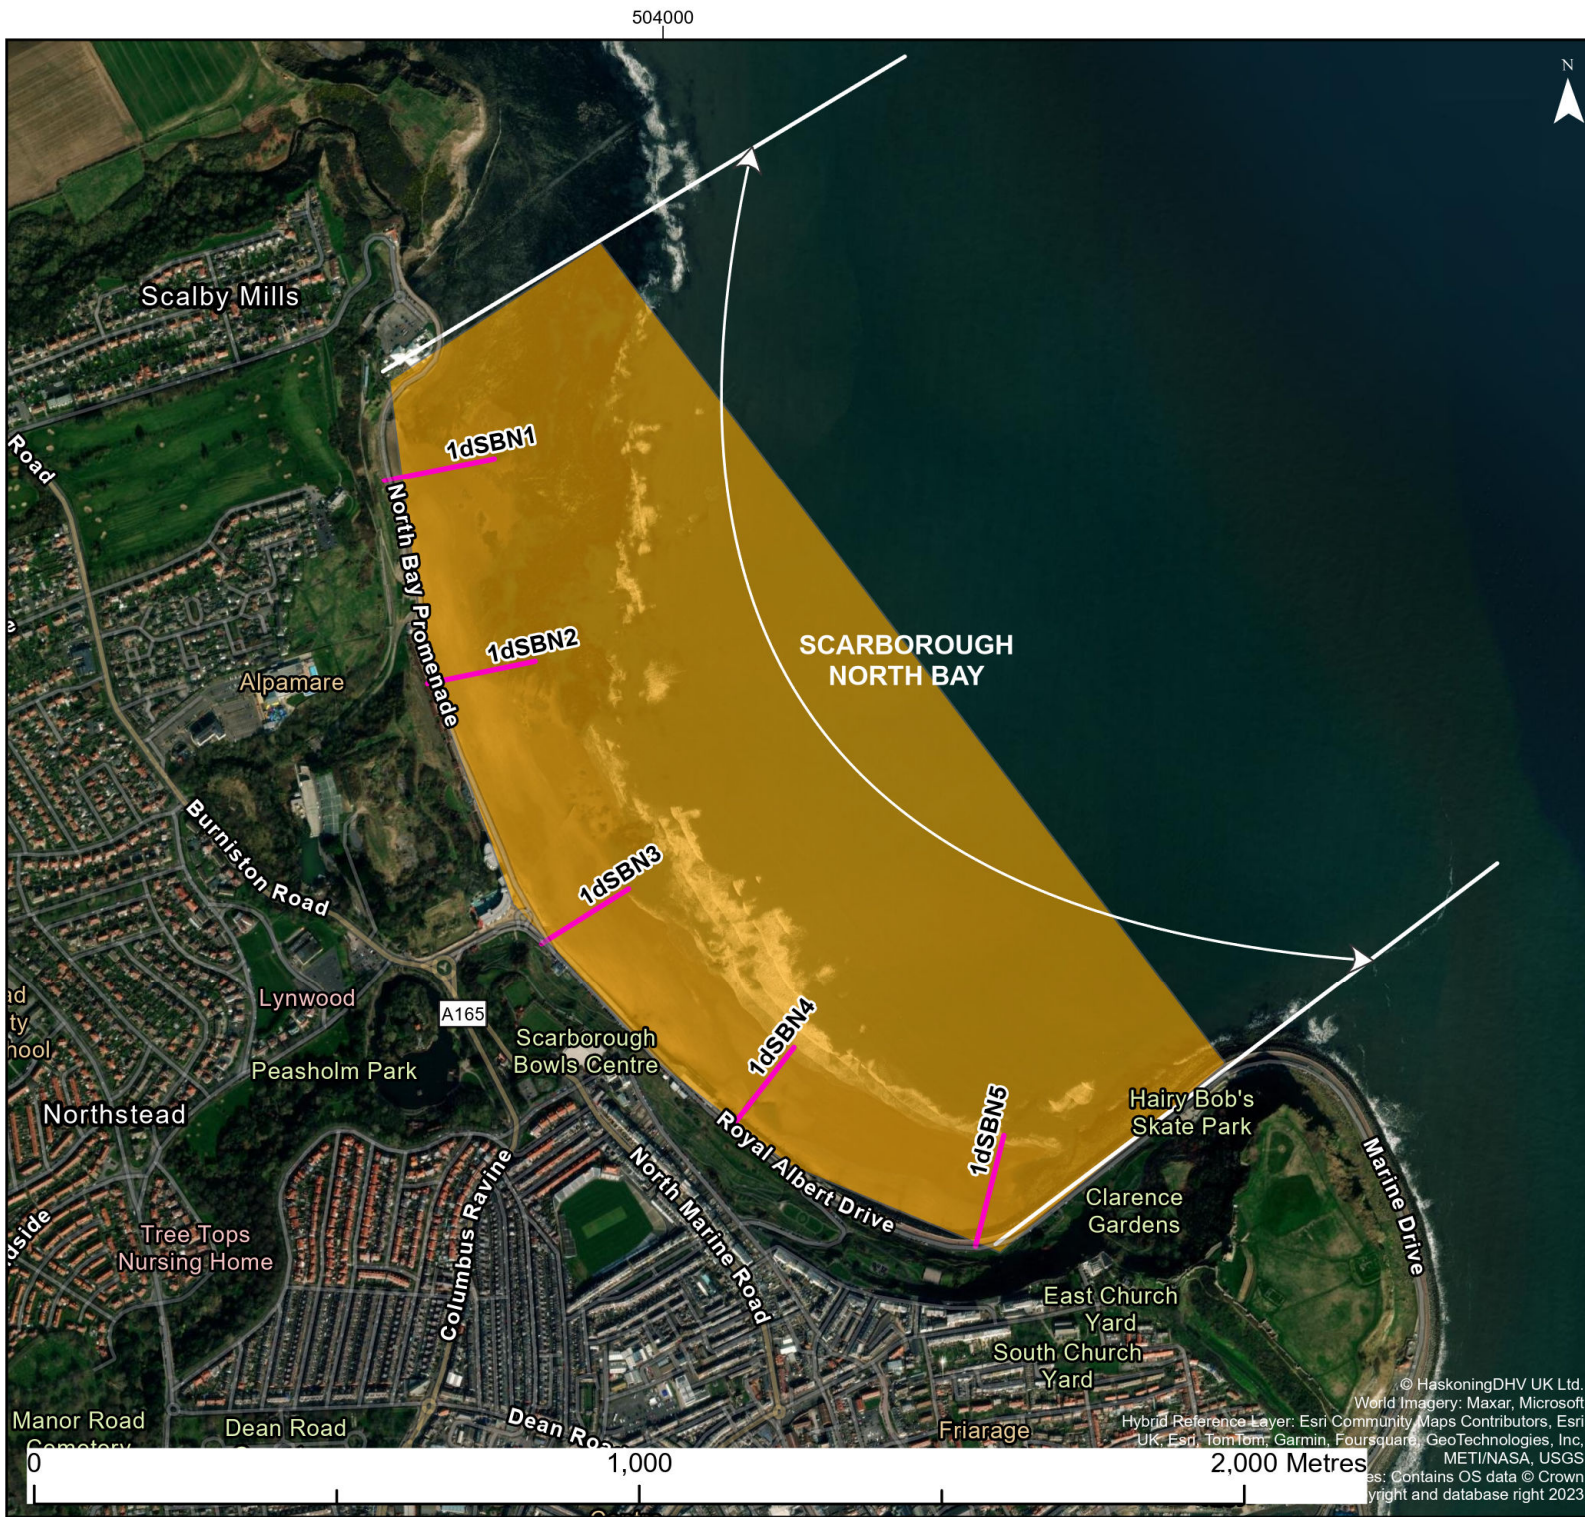
Figure 2 - Map 1

The location of these surveys is shown in **Figure 2**. The Post-Storm survey was undertaken along this frontage on 12th January 2024 and 15th January 2024. During the surveys the weather was dry, the wind varied between force 5 and 8 . The sea state varied between moderate (12th January) and rough (15th January).

SCARBOROUGH NORTH BAY

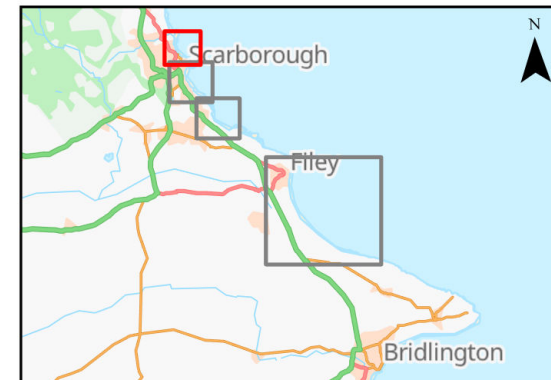
SURVEY LOCATIONS

Topographic Profile

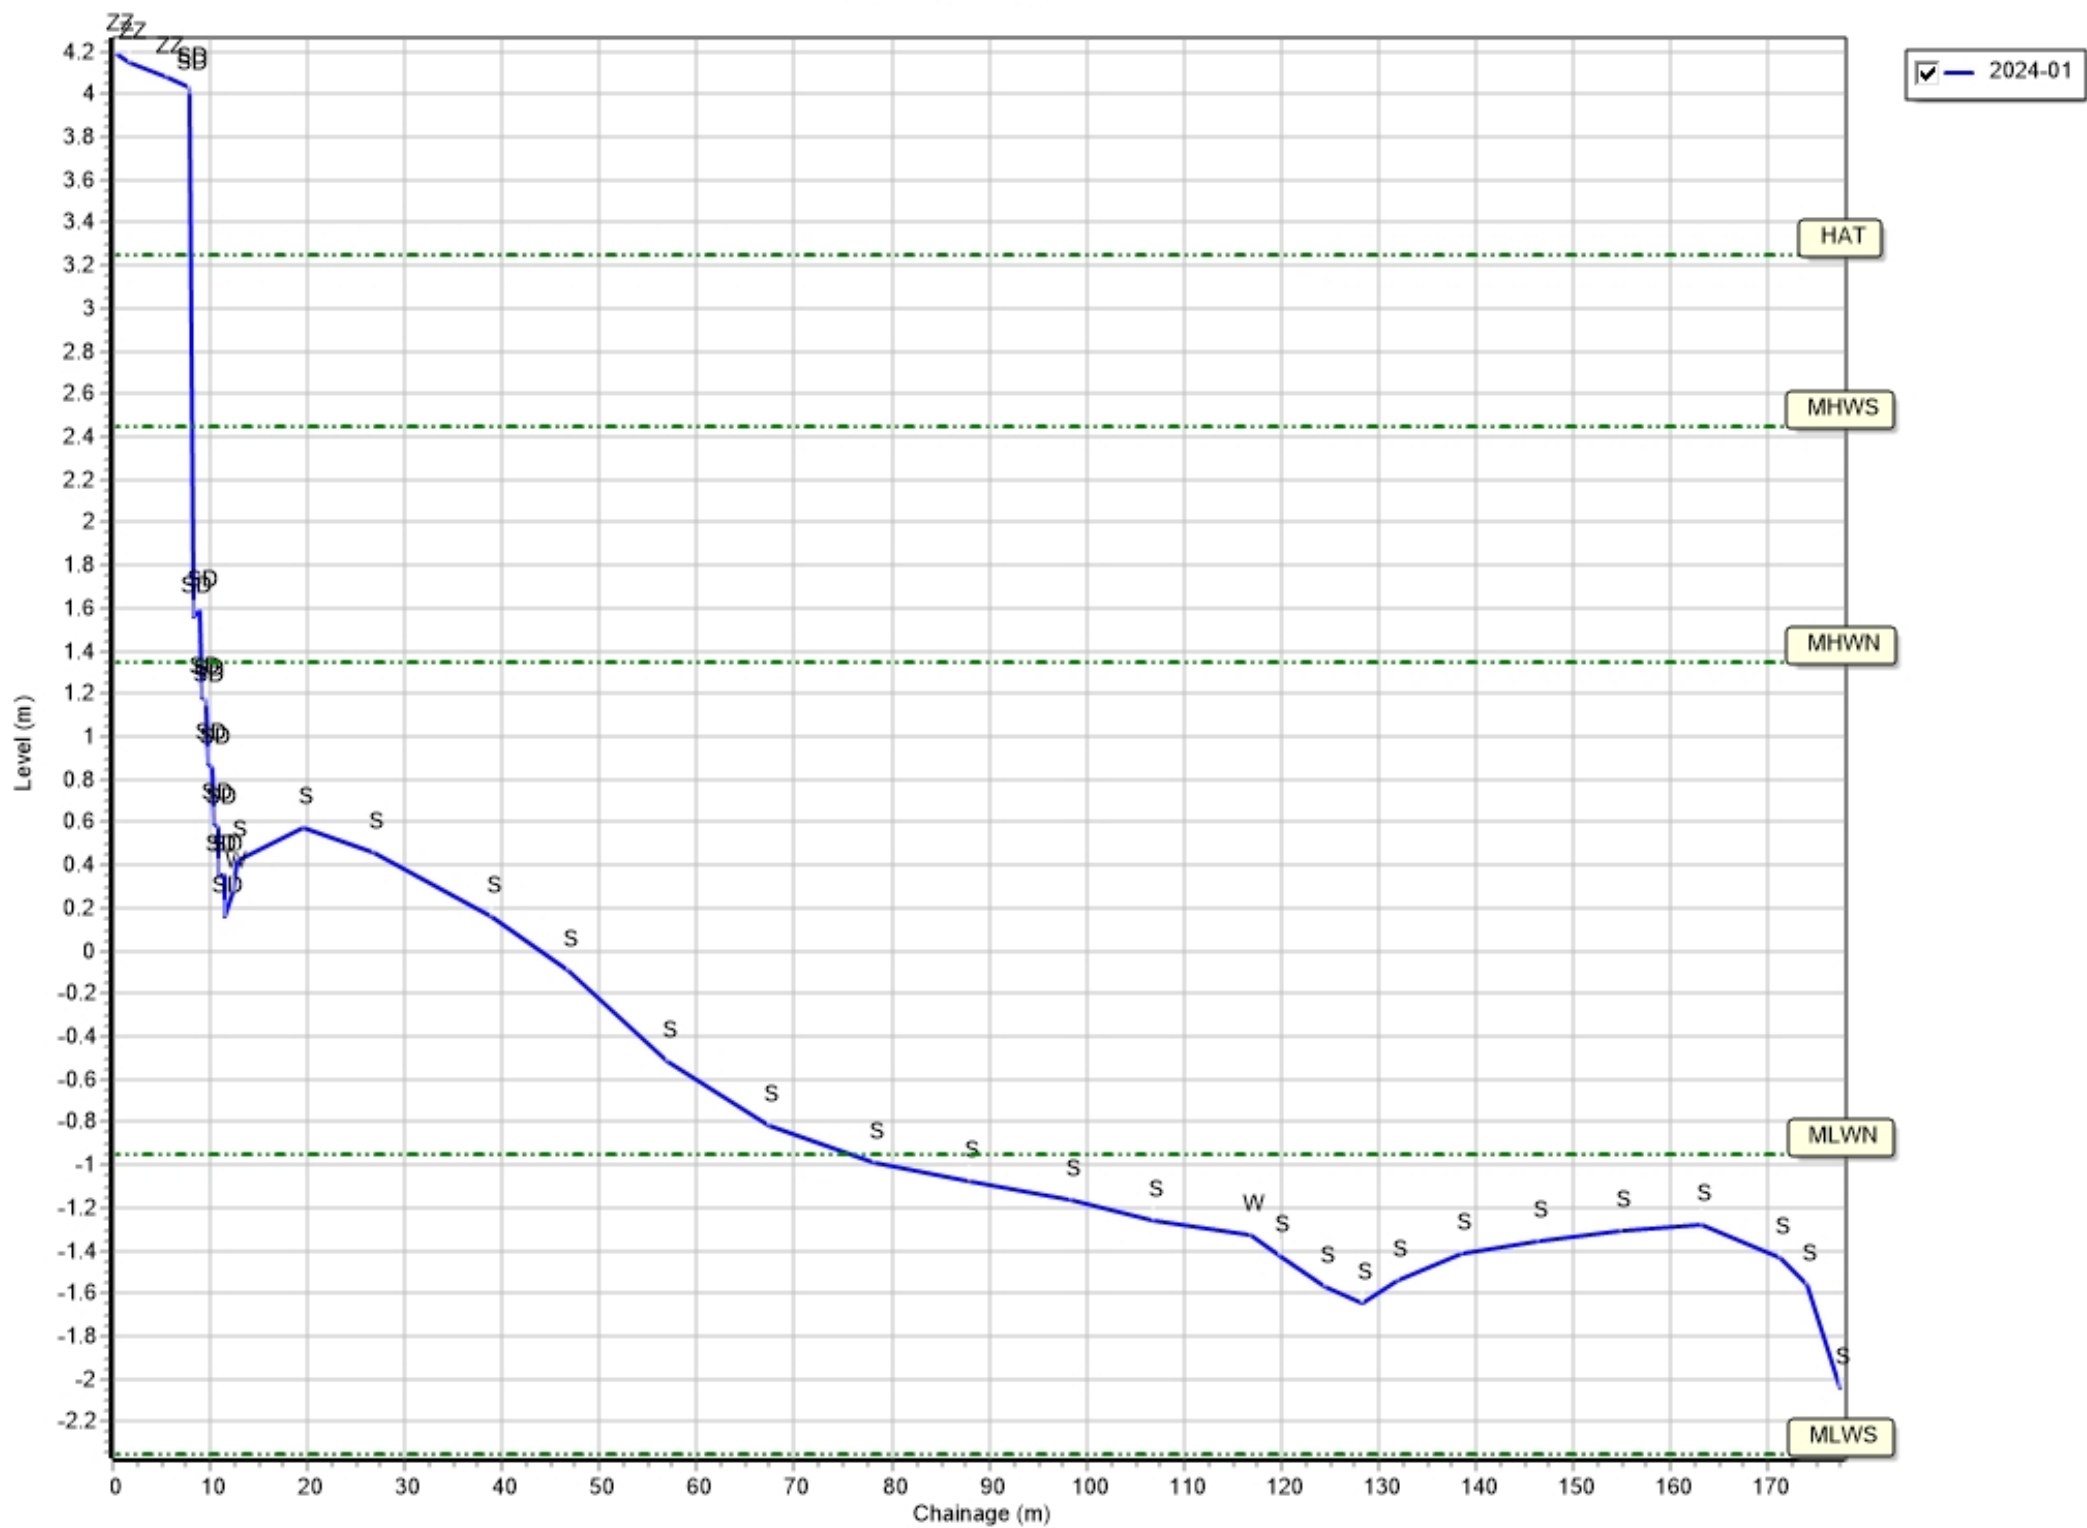
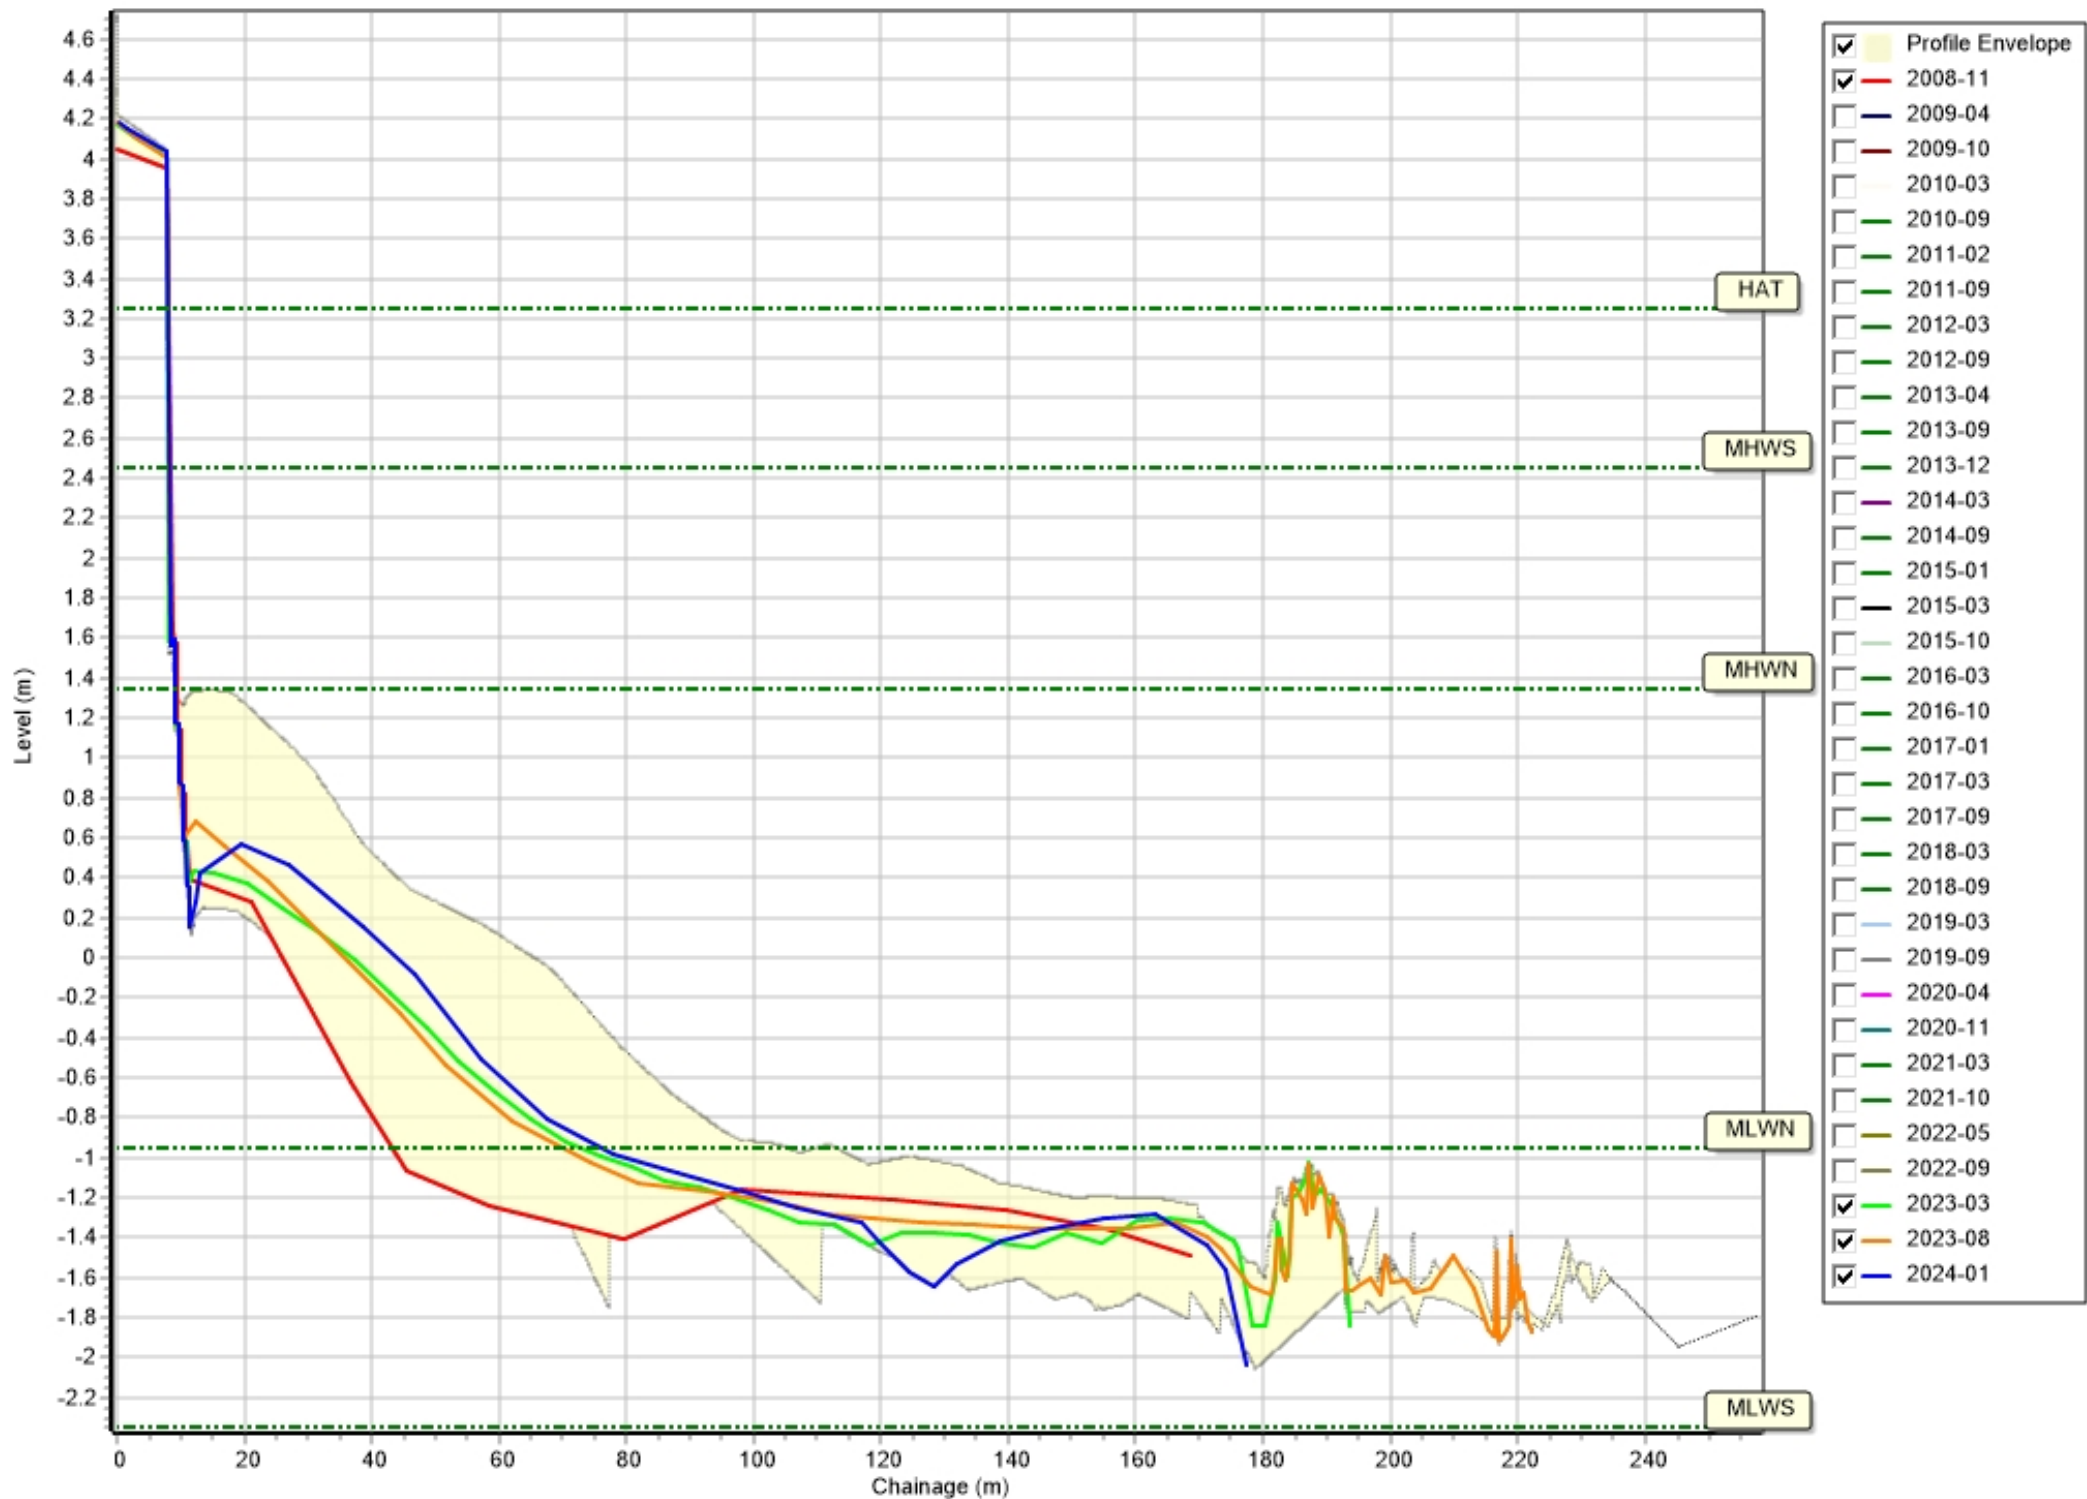
Profiles: 1dSBN1

Survey Date	Description of Changes Since Last Survey	Interpretation
12 th January 2024	<p>Beach Profiles:</p> <p><i>Scarborough North Bay is covered by five beach profile lines, distributed between the Sealife Centre at Scalby Mills and Clarence Gardens (Appendix A).</i></p> <p>Profile 1dSBN1 is located around 200m south of the Sea Life Centre. The profile is covered by promenade and seawall up to chainage 9m. The toe of the seawall is protected by a stepped apron, beach levels at this apron have dropped locally by 0.4m exposing an additional step. This erosion tapers out to no change by chainage 18m. Between chainages 18m and 105m, the beach has accreted by up to 0.3m in level. A shallow channel has been incised between 118m and 146m, before low magnitude accretion up to chainage 166m. Compared to the range of the previous surveys, the beach overall is at medium level with locally very low spots.</p> <p>Profile 1dSBN2 is located close to the former cliff lift. Beach levels at the toe of the seawall (chainage 8m) have dropped in level by 0.8m. This erosion gradually tapers out to no change at chainage 67m. At which point the profile begins to accrete, increasing in magnitude up to chainage 118m with a magnitude of 0.8m. Seawards of chainage 118m, the rocky foreshore remains exposed. The profile remains within the range envelope of the previous surveys.</p> <p>Profile 1dSBN3 is located near Royal Albert Drive. At the toe of the seawall (chainage 13m), the beach has dropped in level by up 0.6m. This magnitude of erosion continues across the profile up to chainage 134m. At which point, the erosion drops in magnitude to -0.1m up until the end of the profile at chainage 172m. The beach has dropped to a medium level when compared to the range of the previous survey.</p> <p>At profile 1dSBN4, the beach levels between the toe of the defences (chainage 25m) and the beginning of the exposed rocky outcrop (chainage 34m) have eroded by up to 0.2m in level. Accretion of up to 0.8m between chainages 40m and 48m has submerged a portion of previous exposed rocky foreshore. Seawards of the remaining length of rocky foreshore the beach has eroded by up to 0.6m in level tapering to no change by chainage 137m. The final 50m of profile has experienced low level accretion (+0.1m). The apparent drawdown of material has resulted in the section of the middle beach</p>	<p>The January 2024 survey indicates that Scarborough North Bay has generally experienced a net erosion as a result of the recent storms.</p> <p>The data suggests that material has been both drawn down the profile from upper to lower beach and also transported from the south to the north.</p> <p>Notably however, the profiles indicate that the majority of the beach has remained with the range envelope of the previous surveys, suggesting the beach has been lower and has recovered in the past.</p>

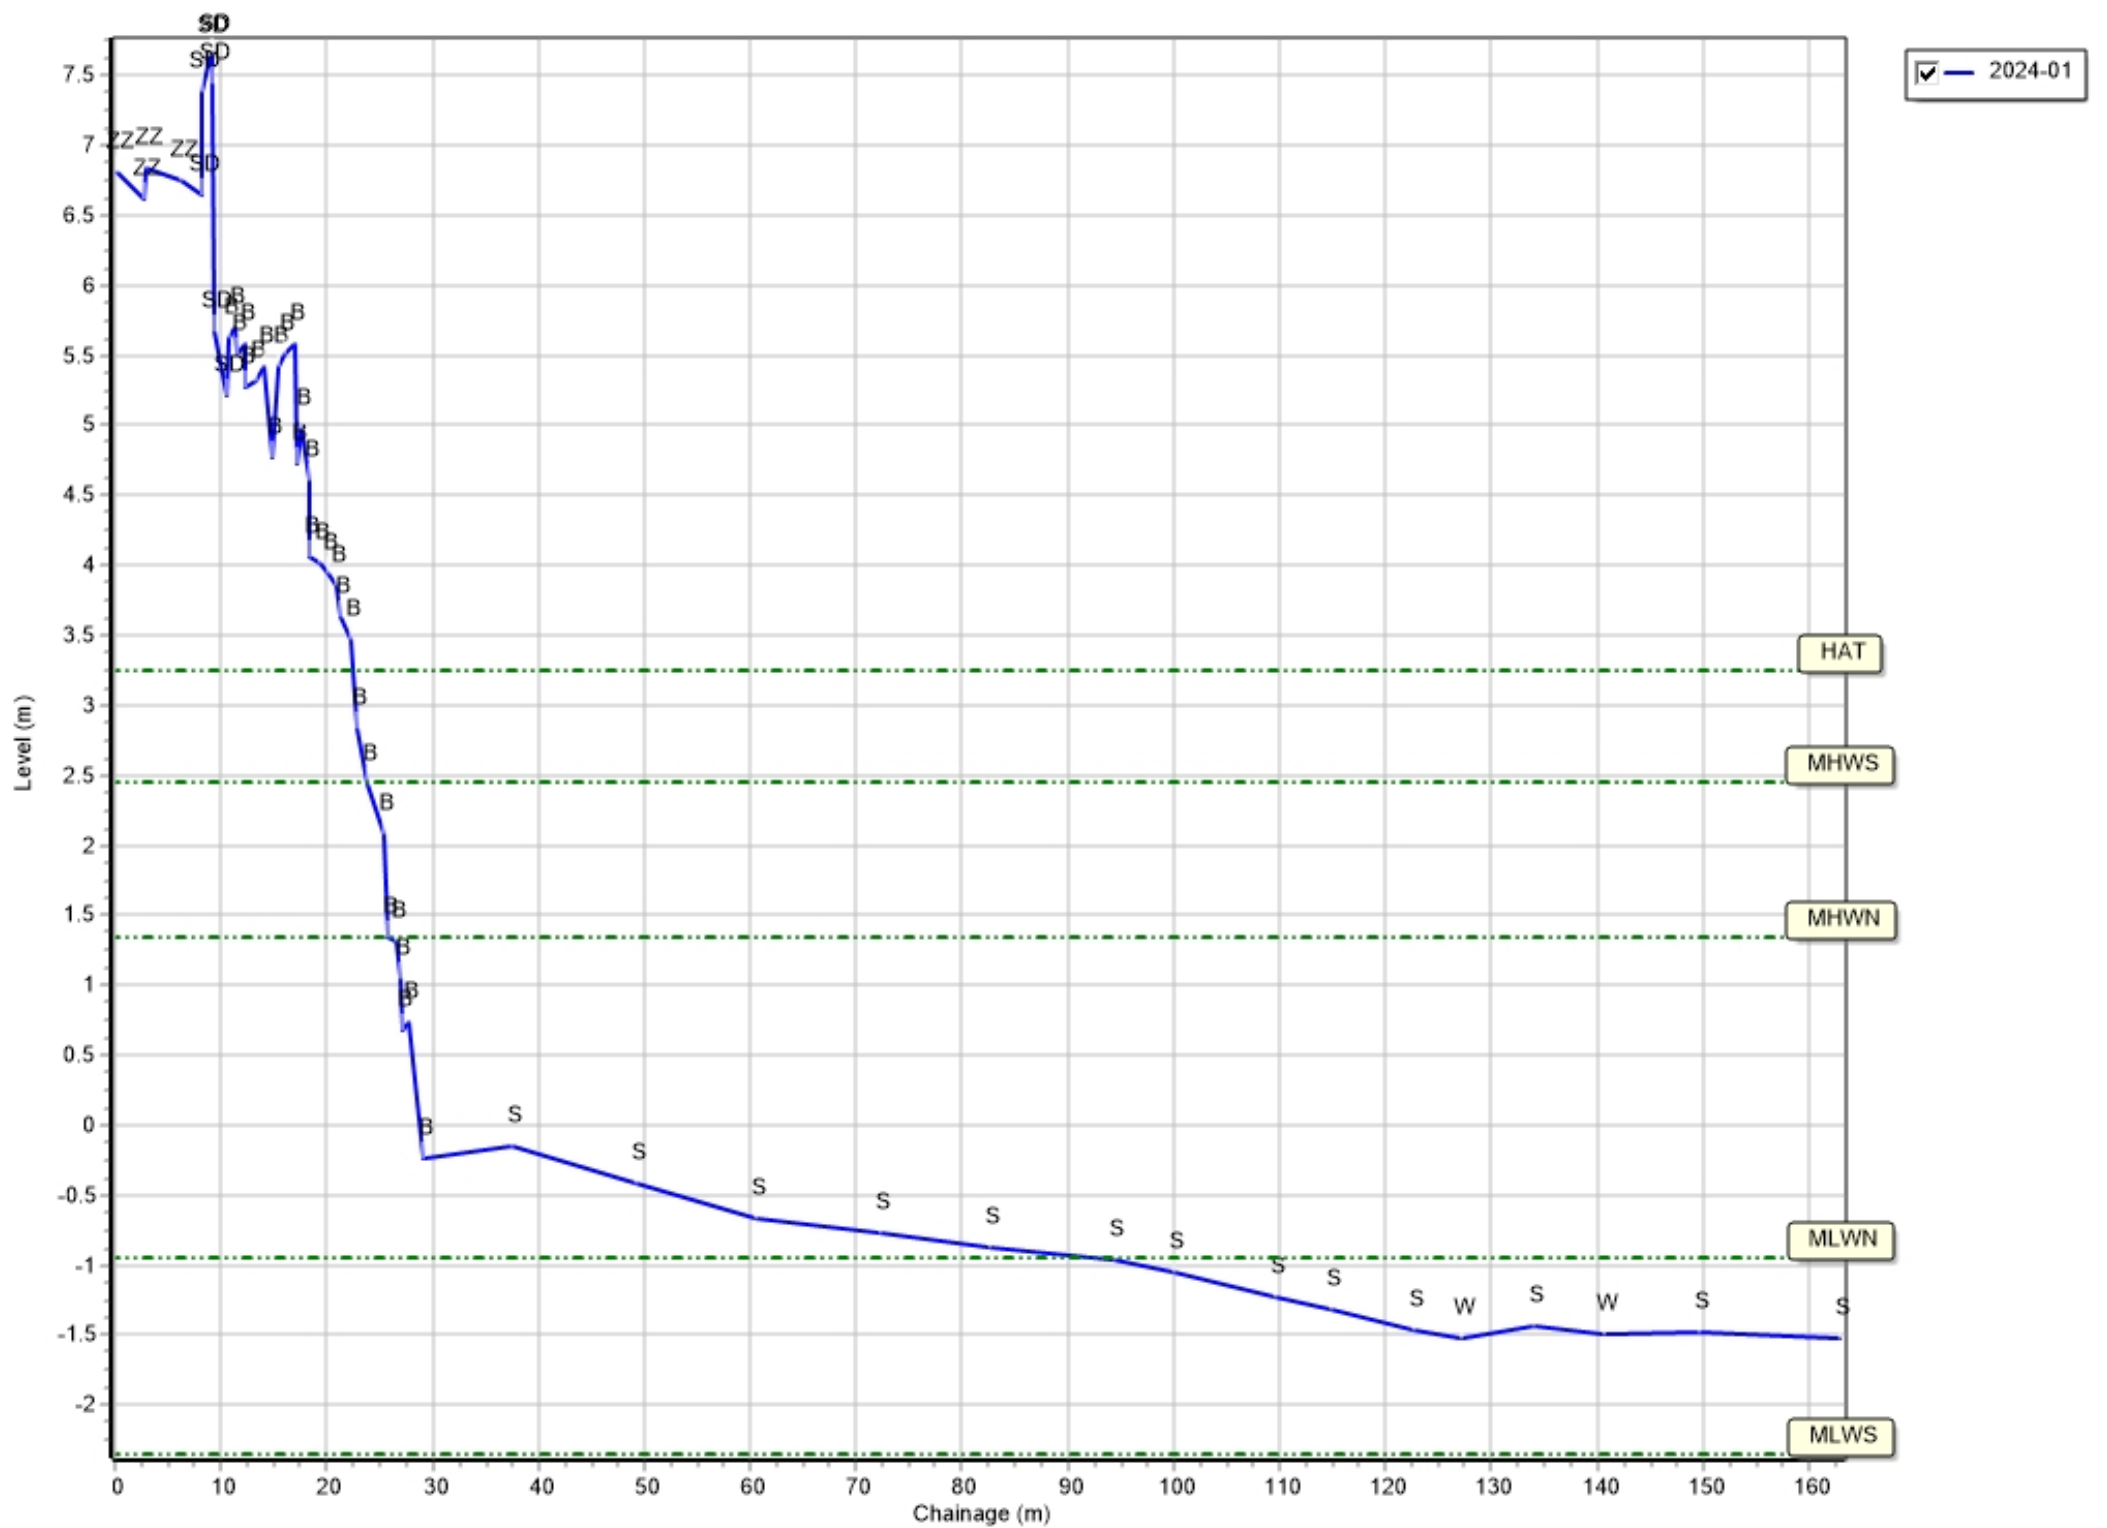
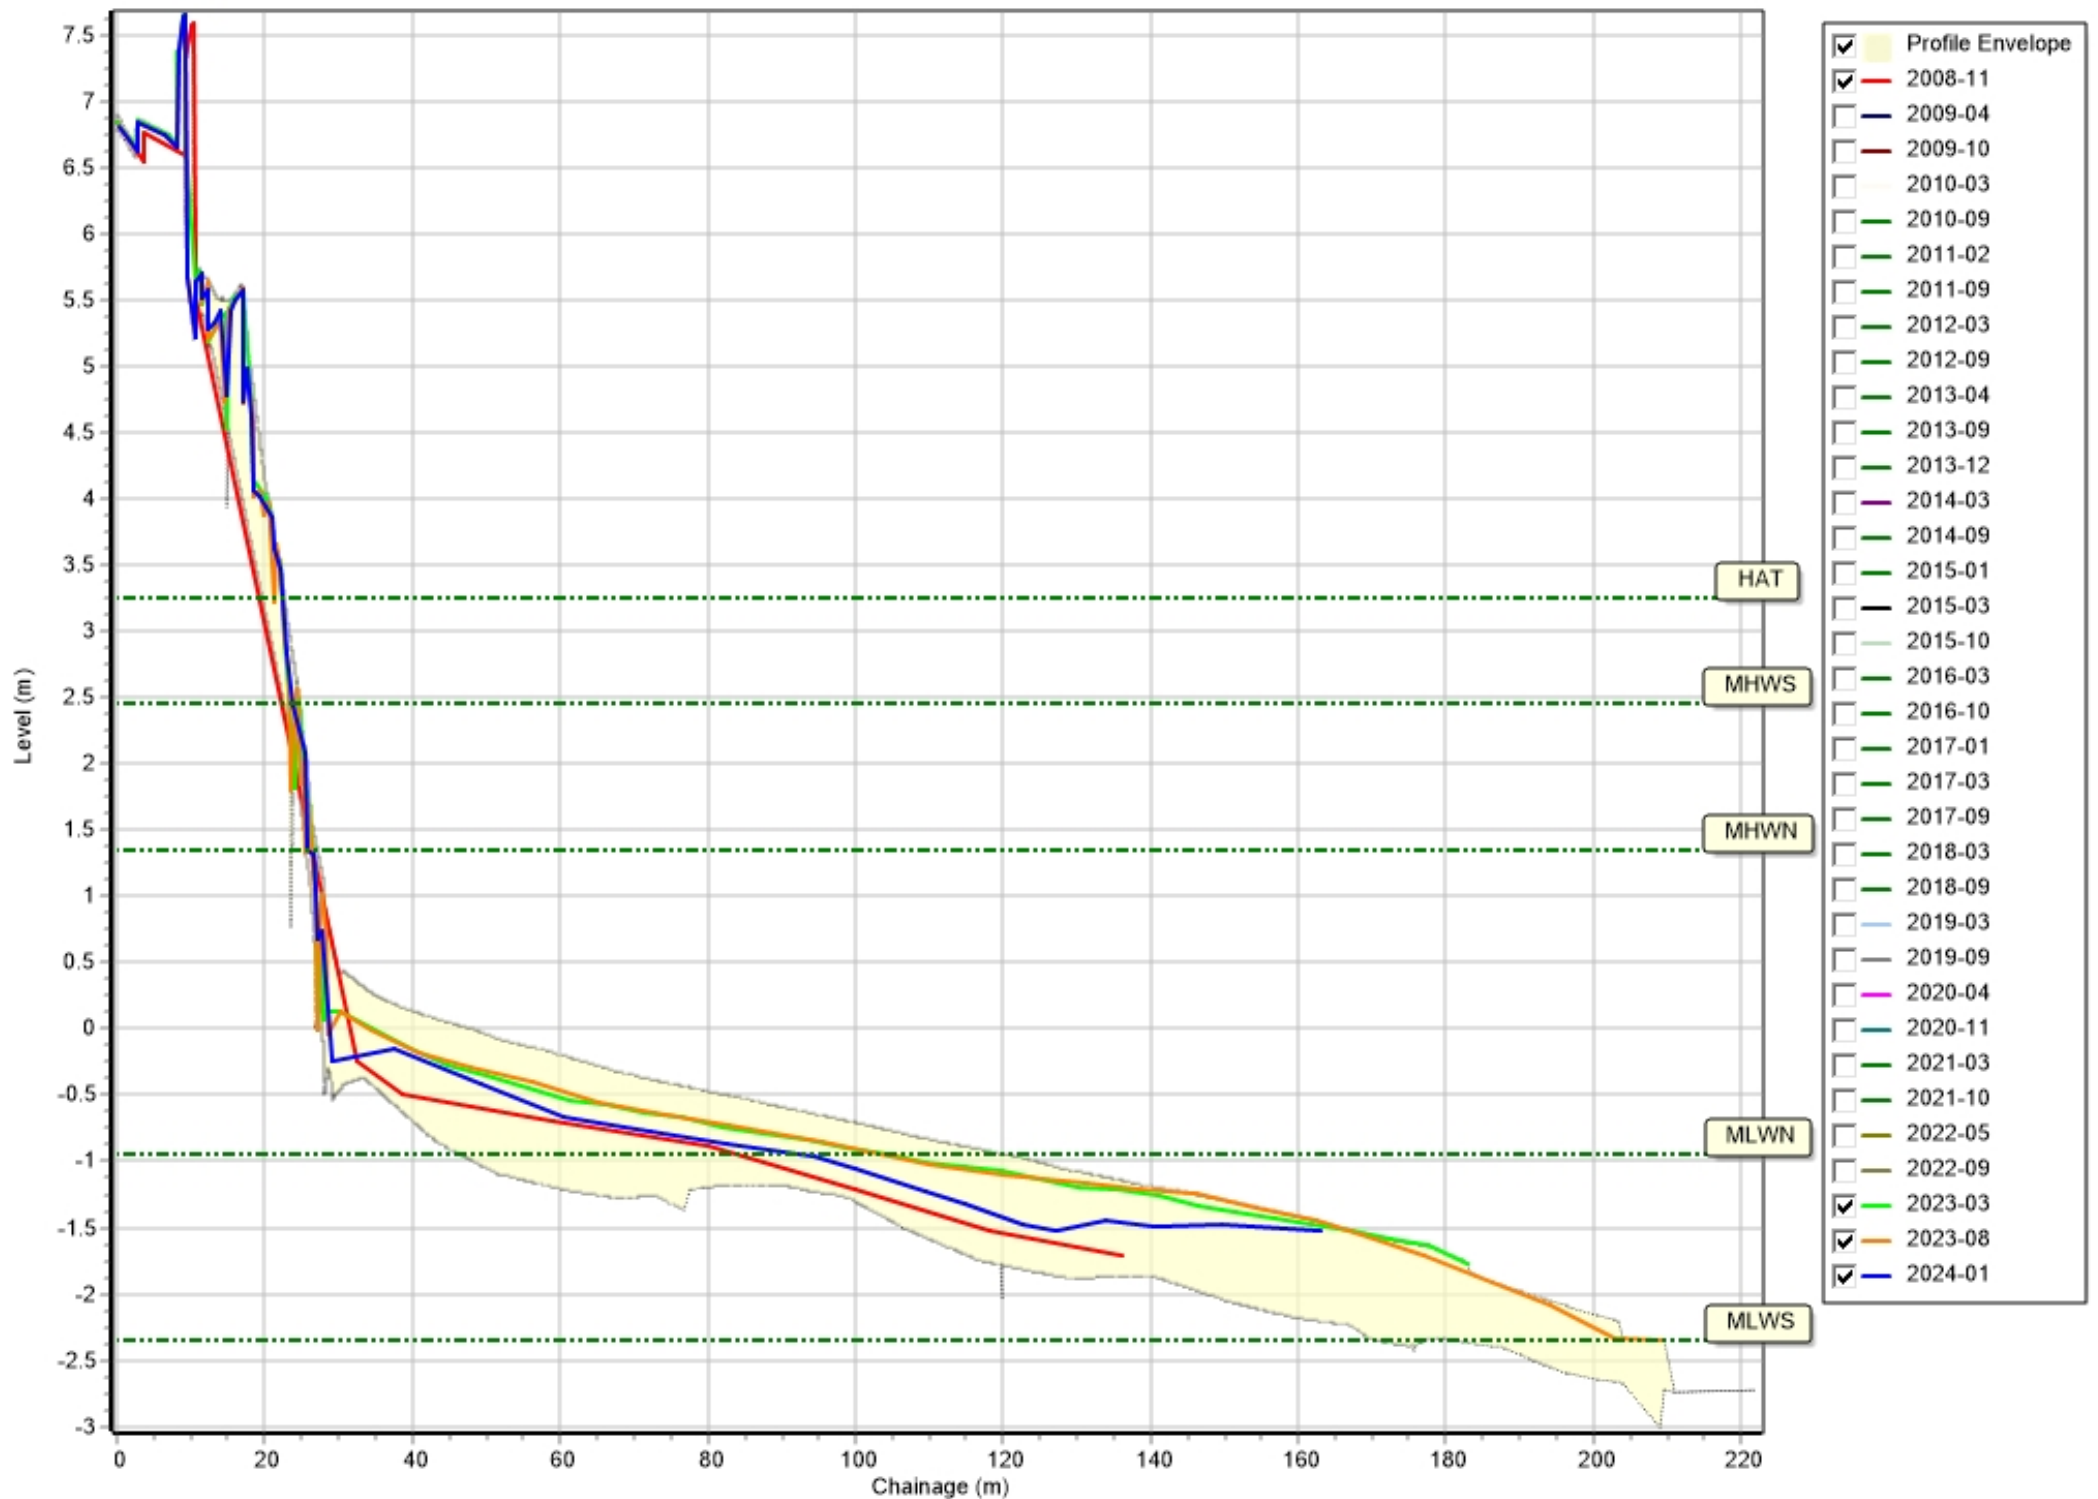
Profiles: 1dSBN5

Survey Date	Description of Changes Since Last Survey	Interpretation
	<p>(chainage 78m to 104m) being the lowest level on record, with sections of the lower beach (chainage 147m to 184m) the highest level on record.</p> <p>Profile 1dSBN5 is located to the south of Clarence Gardens. The profile is covered by the promenade, upstand wall and rock revetment up to chainage 29m and has remained unchanged since the previous survey. Seawards of the revetment, the beach has been eroded, dropping in level initially by up to 0.4m at the toe. This erosion continues up to the end of the profile at chainage 163m. The profile has dropped to a medium level compared to the range of the previous surveys.</p> <p>Topographic Survey:</p> <p>Scarborough North Bay is covered by an annual topographic survey, typically undertaken as part of the Full Measures surveys in the autumn. This additional topographic survey was undertaken in January 2024 to assess the impact of a particular stormy period between October 2023 and Jan 2024 where seven named storms occurred.</p> <p>Utilizing a GIS software, the data has been used to create a DGM, the plot of which is shown in Appendix B - Map 1. The plot shows a distinct pattern of change between the north and south of the bay. In the north, fronting North Bay Promenade, the beach is typically steeper and narrow, transitioning to exposed rocky foreshore on the lower beach. Whereas in the south, the bay appears to be shallower in gradient and lower in elevation. Rocky outcrops are exposed more sporadically and are not limited to the lower beach.</p> <p>The DGM has also been used to calculate the differences between the post storm survey (January 2024) and the previous Full Measures topographic survey (August 2023) (as shown in Appendix B – Map 3), to identify areas of erosion and accretion.</p> <p>The plot shows that the change the south of the bay has been dominated by erosion (lowering) up to -1.25m in magnitude. Very minor accretion (deposition) on the lower beach indicates a drawdown of material down the profile typically of stormy conditions. In the North of the bay the change is more balanced. The upper beach, up to the subtle promontory, has experienced erosion. However, the lower beach extending north has experienced accretion up to +1.0m in level. This indicated both a drawdown of material down the profile, but also potentially net drift across the bay from south to north.</p>
