**Cell 1 Regional Coastal Monitoring Programme
Scarborough 'Post Storm' Beach Monitoring
Survey Report 2024**

This report presents the Post Storm Walkover Inspection for Scarborough North Bay and South Bay.

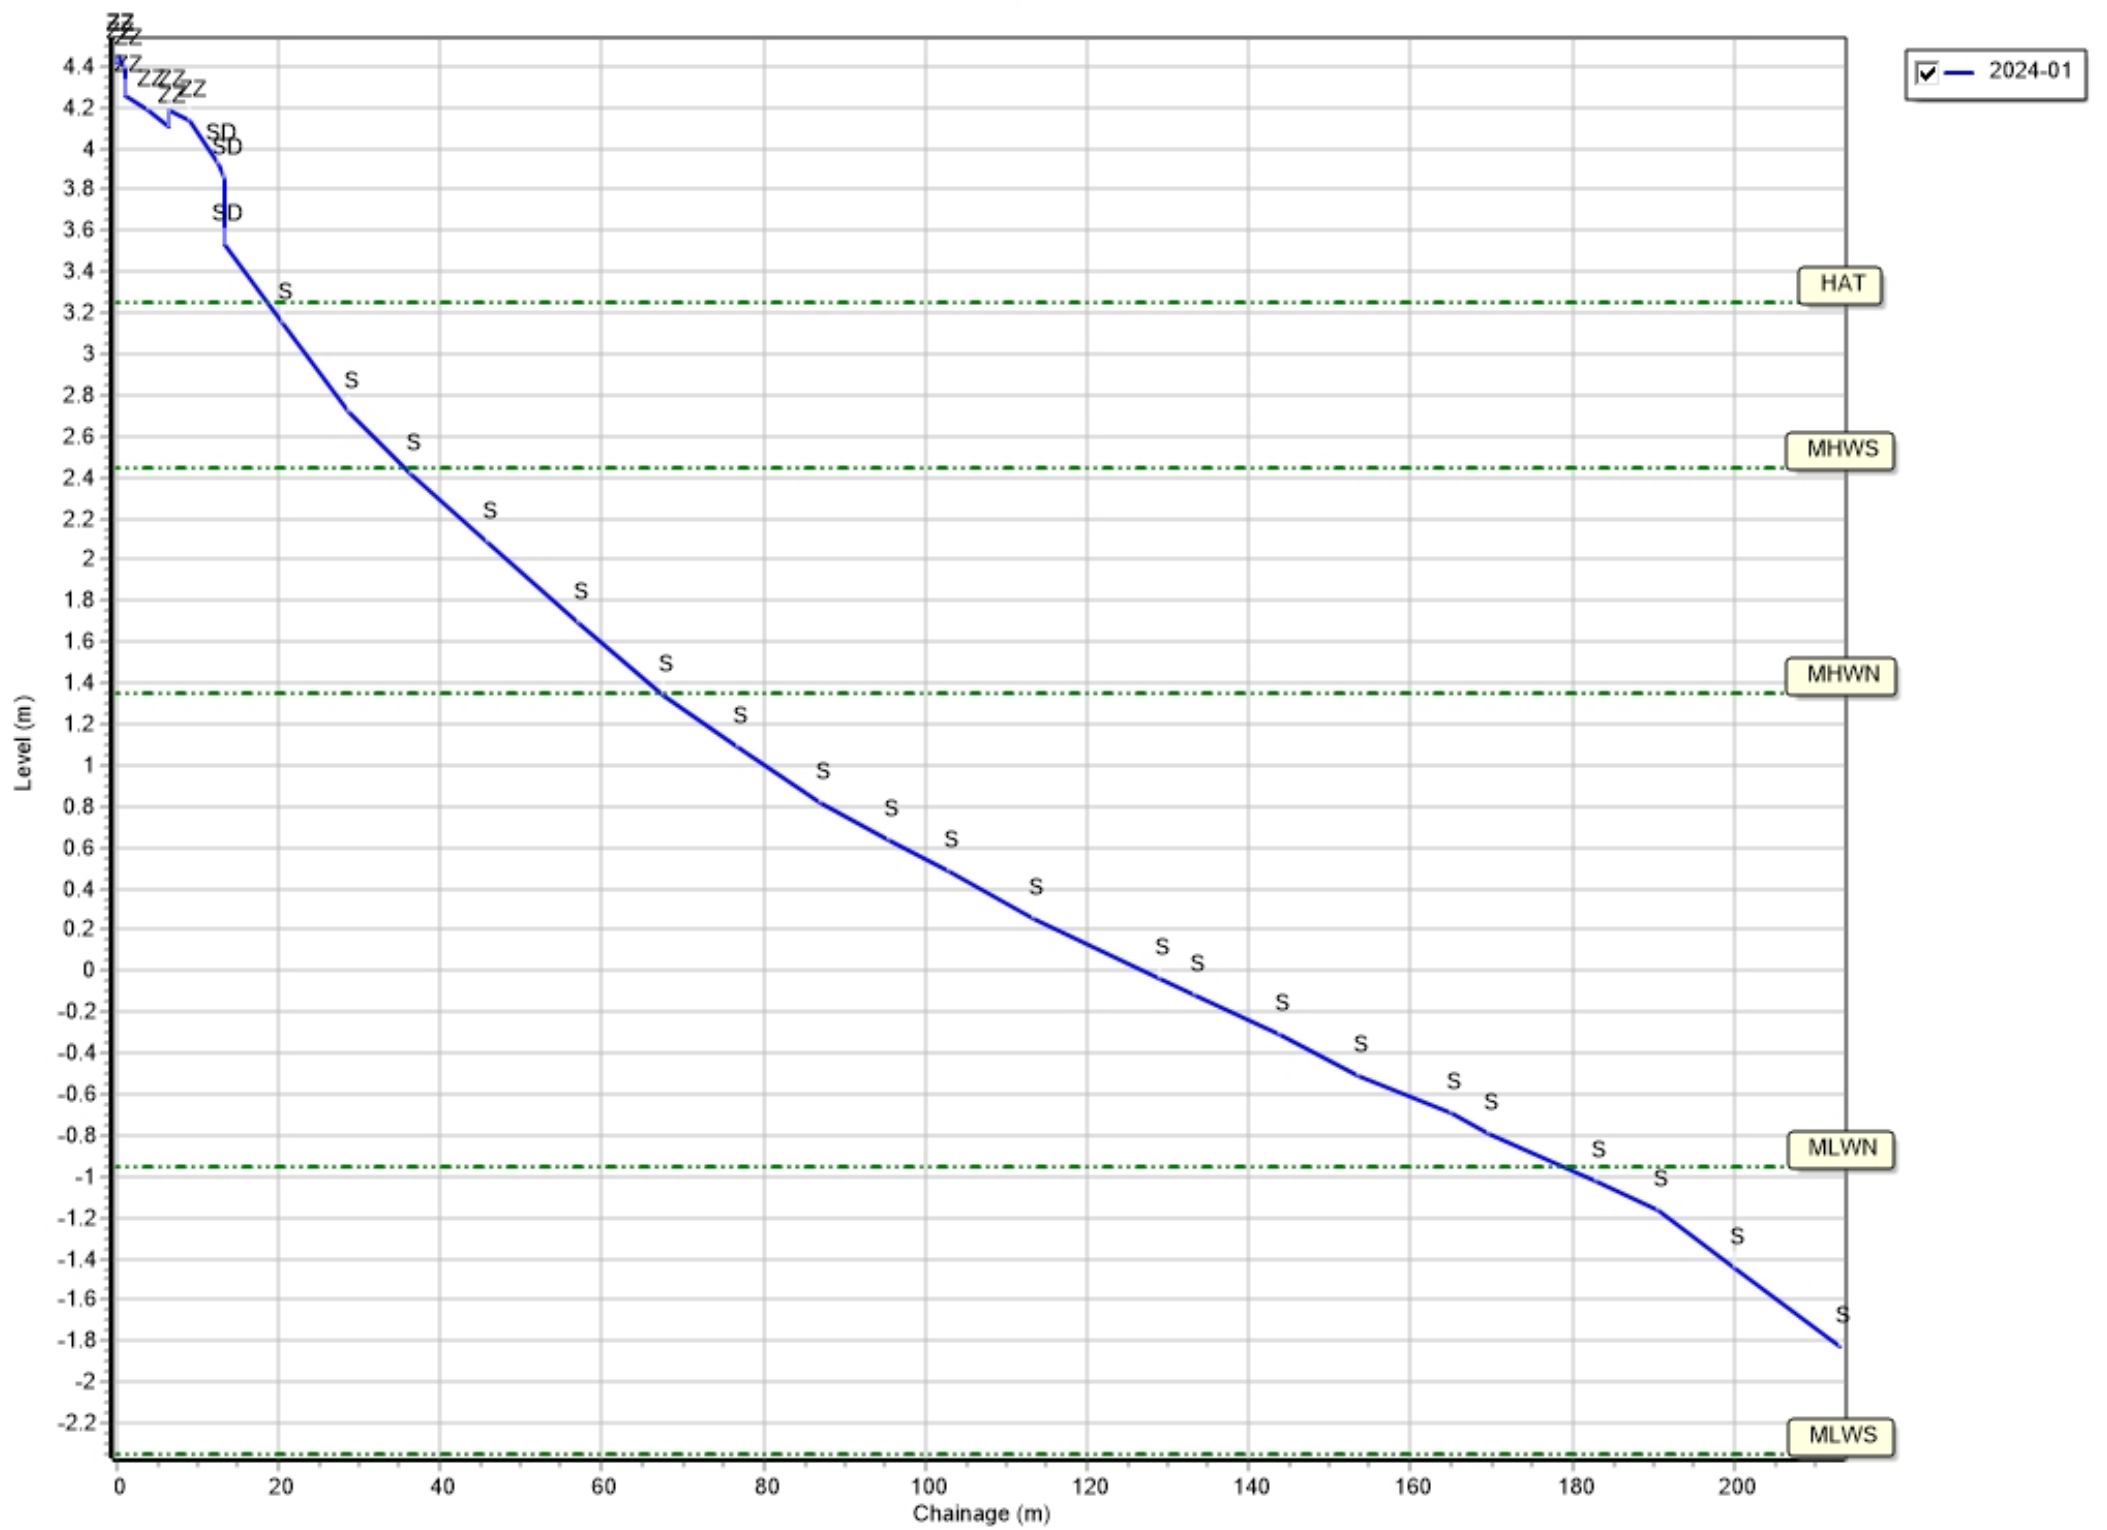
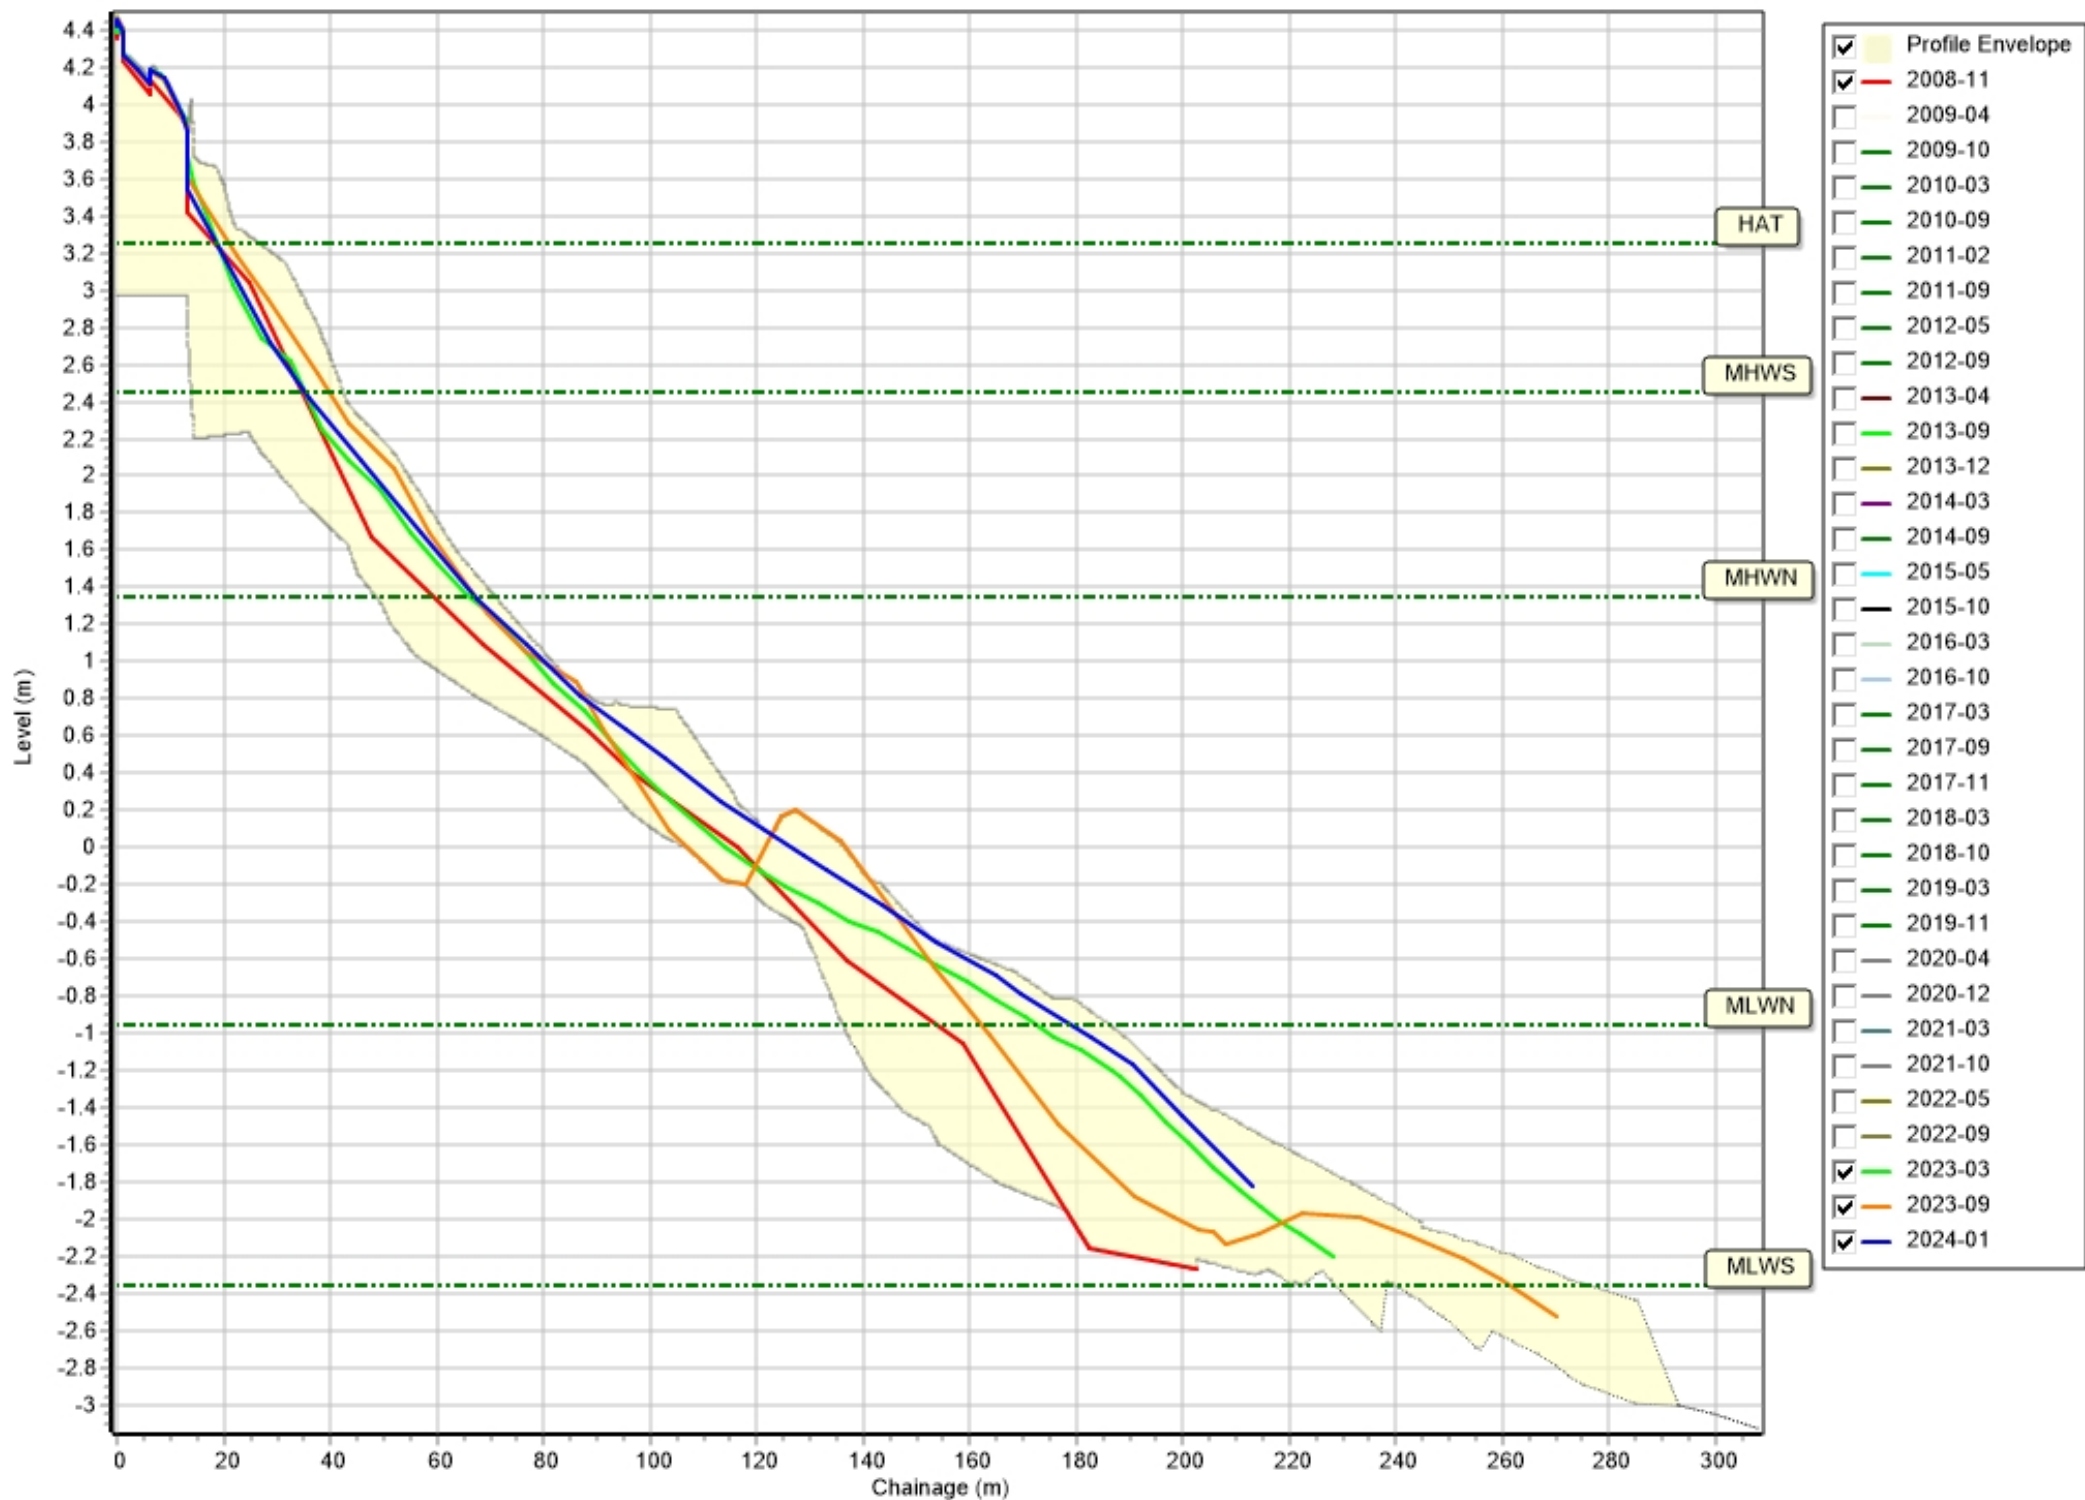
Profiles: 1dSBS1

Survey Date	Description of Changes Since Last Survey	Interpretation
15 th Jan 2024	<p>Beach Profiles:</p> <p><i>Scarborough South Bay is monitored by four beach profiles, between the harbour in the north and the Spa Complex in the south (Appendix A).</i></p> <p>At profile 1dSBS1, the beach has initially accreted at the toe of the seawall by 0.2m in level. This low level accretion continues across the upper beach up until chainage 52m. The mid beach, between chainages 52m and 130m, has eroded by up to 0.3m in level. Seawards of 130m the beach has again accreted by up to 0.25m. This apparent drawn down of material has resulted in the lower beach being at a high level (compared to the range of the previous surveys) with the mid beach at a low level.</p> <p>Profile 1dSBS2 is located on the shore fronting St Nicholas Cliff. At the toe of the wall, beach levels have dropped by 0.6m in level. The is erosion continues seawards, tapering out to no change at chainage 100m. At which point the beach starts to accrete up the end of the profile at chainage 200m (+0.5), indicating the draw down of material. Incidentally, compared to the range of the previous surveys, the upper beach is at a high level and the lower beach a low level.</p> <p>Profile 1dSBS3 is located 250m north of the Scarborough Spa complex and is defended up until chainage 9m by the seawall. At the toe of the seawall, beach levels have dropped locally by up to 0.7m in level, exposing the vertical section of concrete toe beam. This erosion continues seawards, tapering out by chainage 129m. At which point the beach starts to accrete up to the end of the profile at chainage 210m, indicating the draw down of material. As per profile 1dSBS2, compared to the range of the previous surveys, the upper beach is at a high level and the lower beach a low level.</p> <p>Profile 1dSBS4 is located on the beach in front of the Scarborough Spa Complex. The beach at the toe of the seawall has eroded 1m in level since the previous inspection, this has not only exposed the concrete toe beam but also the bedrock it is founded on. The beach profile itself displays a similar pattern of widescale erosion (although slightly lower magnitude – 0.4m). Levels at the seawall are at a very low (second only flowing the beast from the east in 2018 and the winter storms in 2013). Levels across the beach are at medium to low level.</p>	<p>Similar to North Bay, the January 2024 survey indicates that Scarborough South Bay has generally experienced a net erosion as a result of the recent storms.</p> <p>The data suggests that material has been both drawn down the profile from upper to lower beach and also transported from the south to the north, accumulating in the lee of the harbour.</p> <p>Unlike Scarborough North Bay, the beach level at South Bay, particular to the south, are very low. In fact beach levels at the toe of the seawall have not been as low since the ‘Beast from the East’ storm in 2018 and, before that, the winter storms of 2013. Following the aforementioned recent historic events beach levels did recover over time. It is predicted that a similar pattern of slow recovery will be observed following the Winter 2023/24 storms.</p>

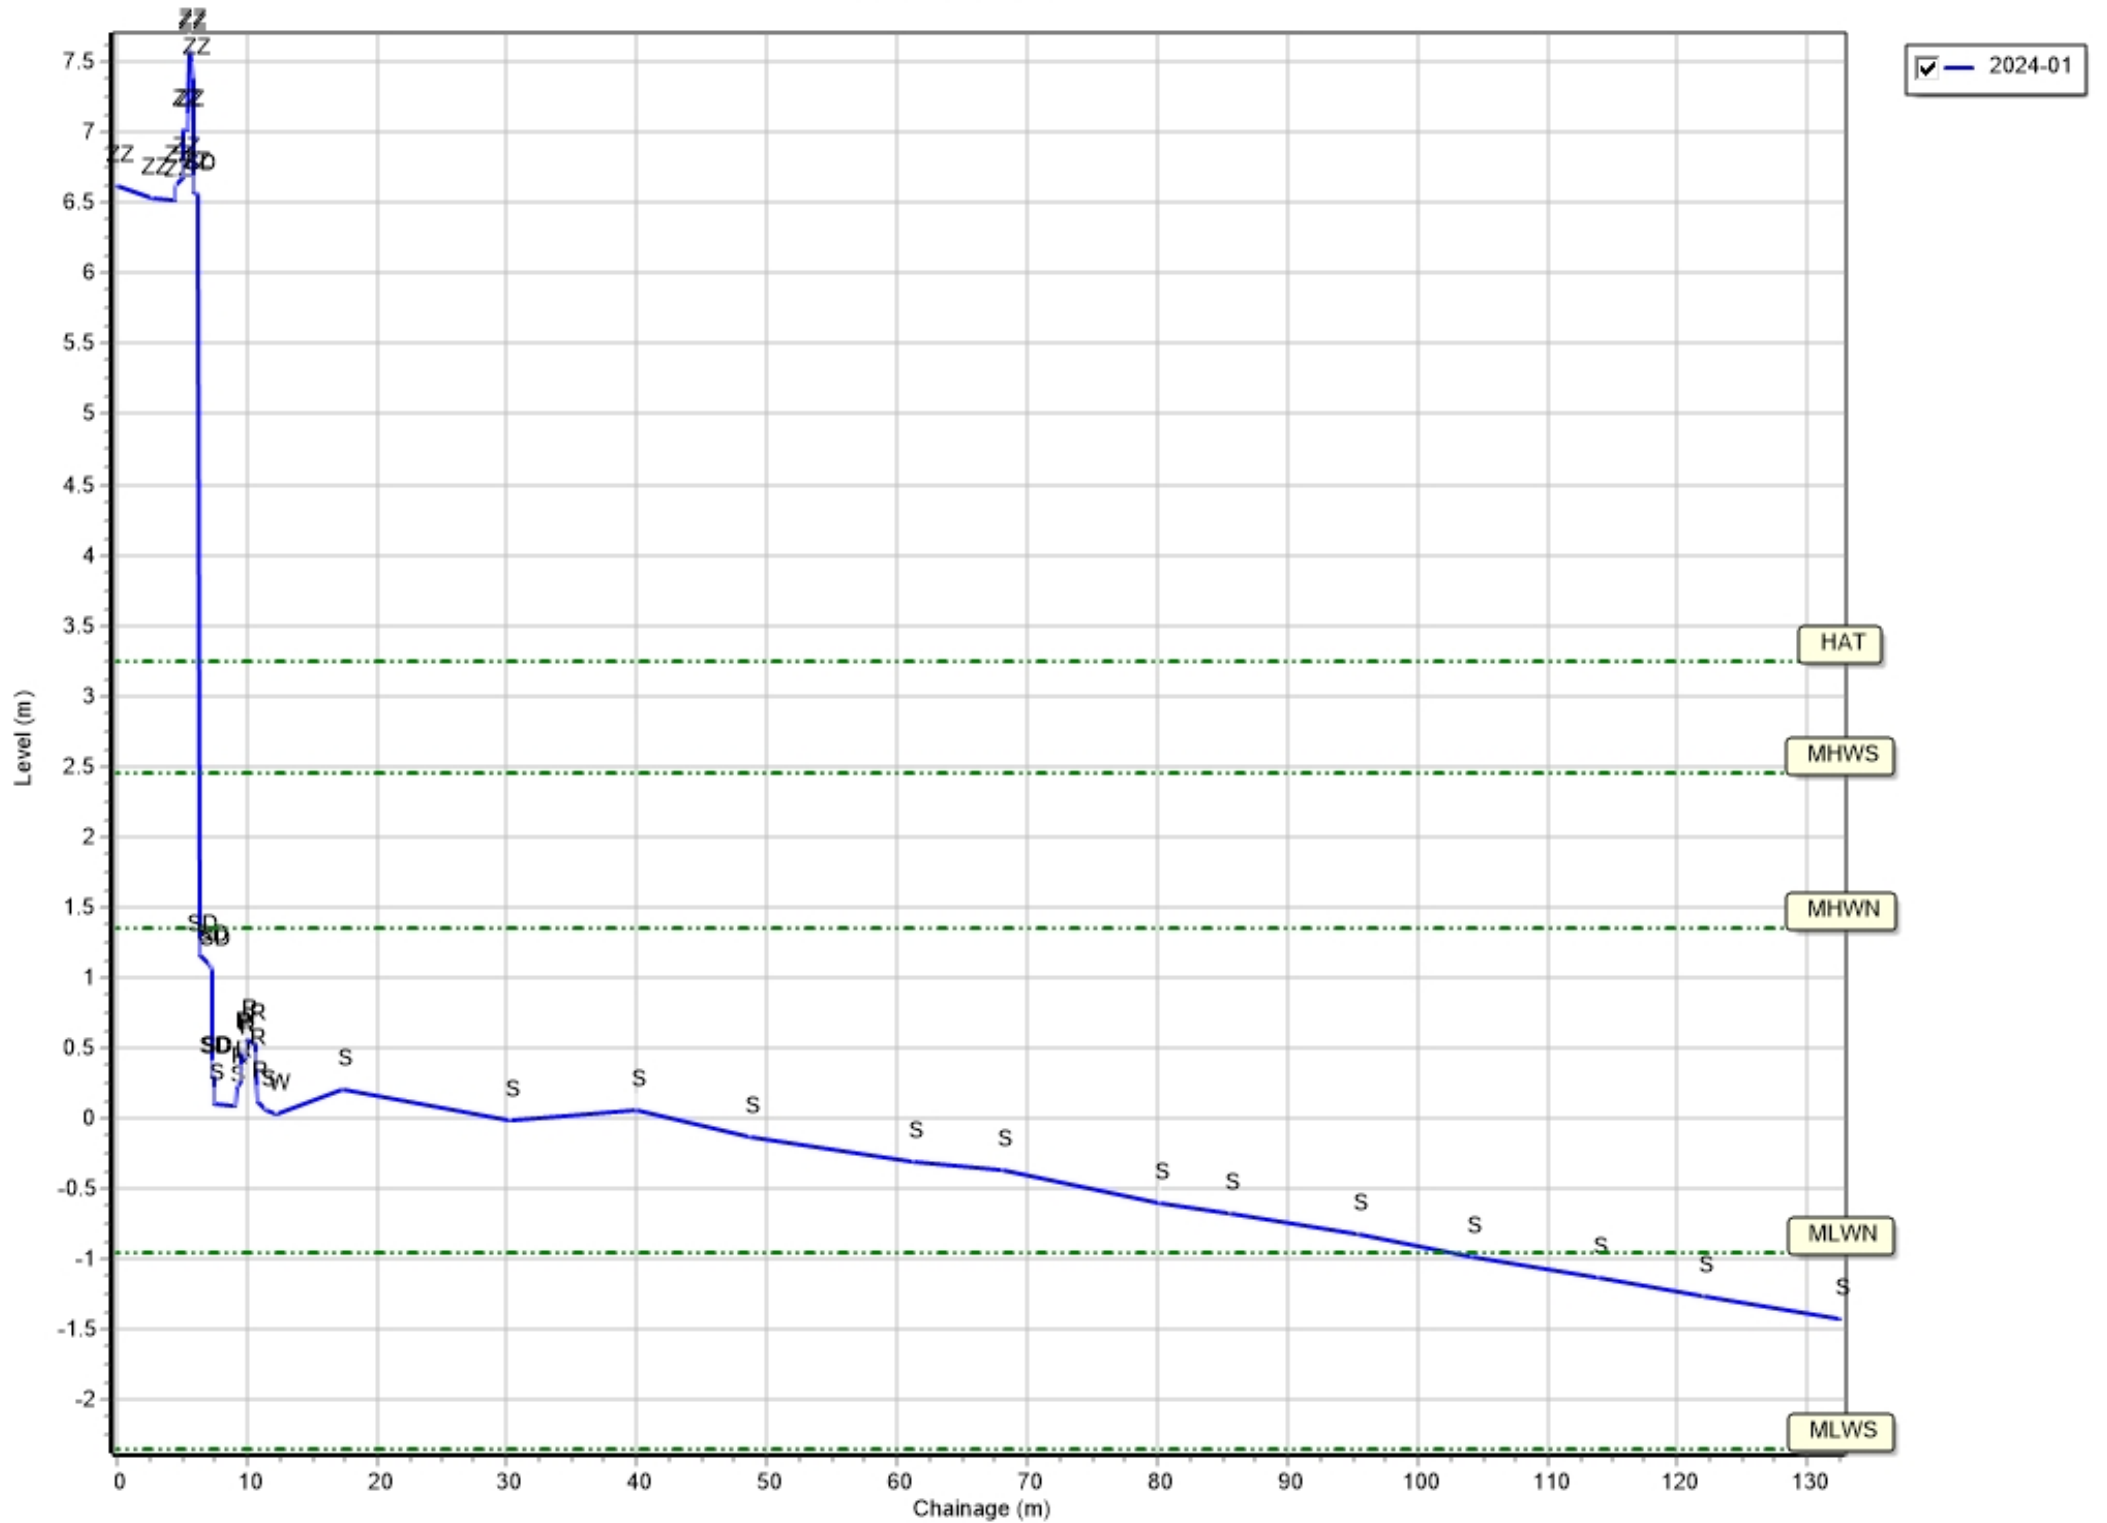
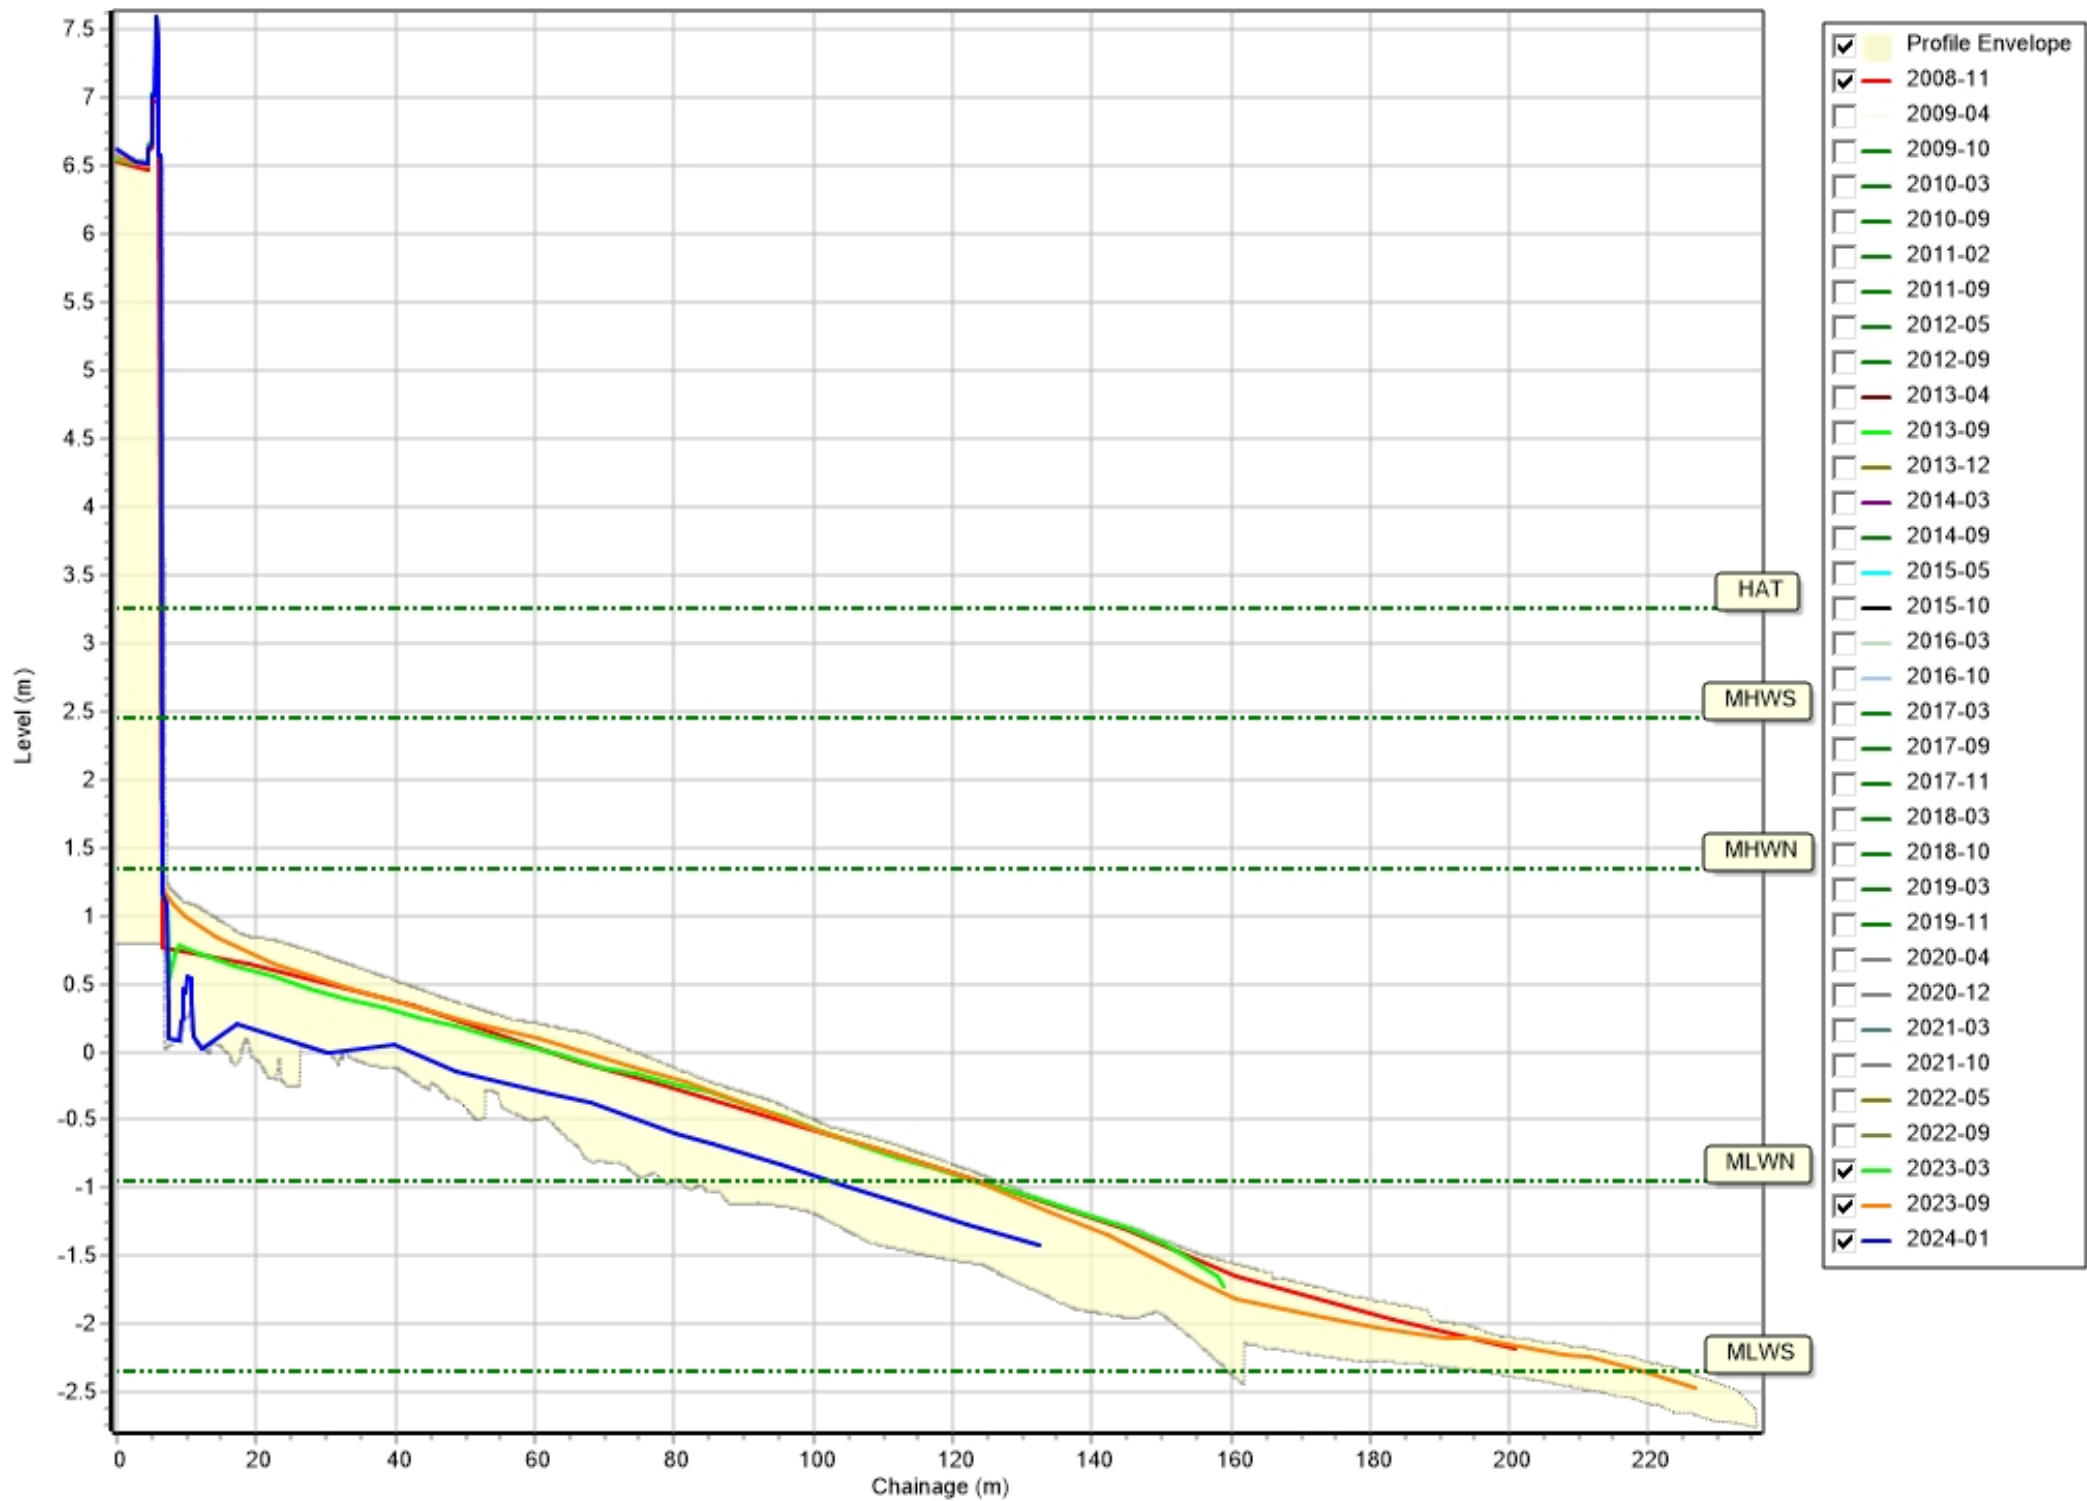
Profiles: 1dSBS4

Unlike Scarborough North Bay, the beach levels at South Bay, particularly in the south, are very low. In fact, beach levels at the toe of the seawall have not been as low since the 'Beast from the East' storm in 2018 and, before that, the winter storms of 2013. Following those recent historic events beach levels did progressively recover over time. It is predicted a similar pattern of slow recovery will be observed following the Winter 2023/24 storms.

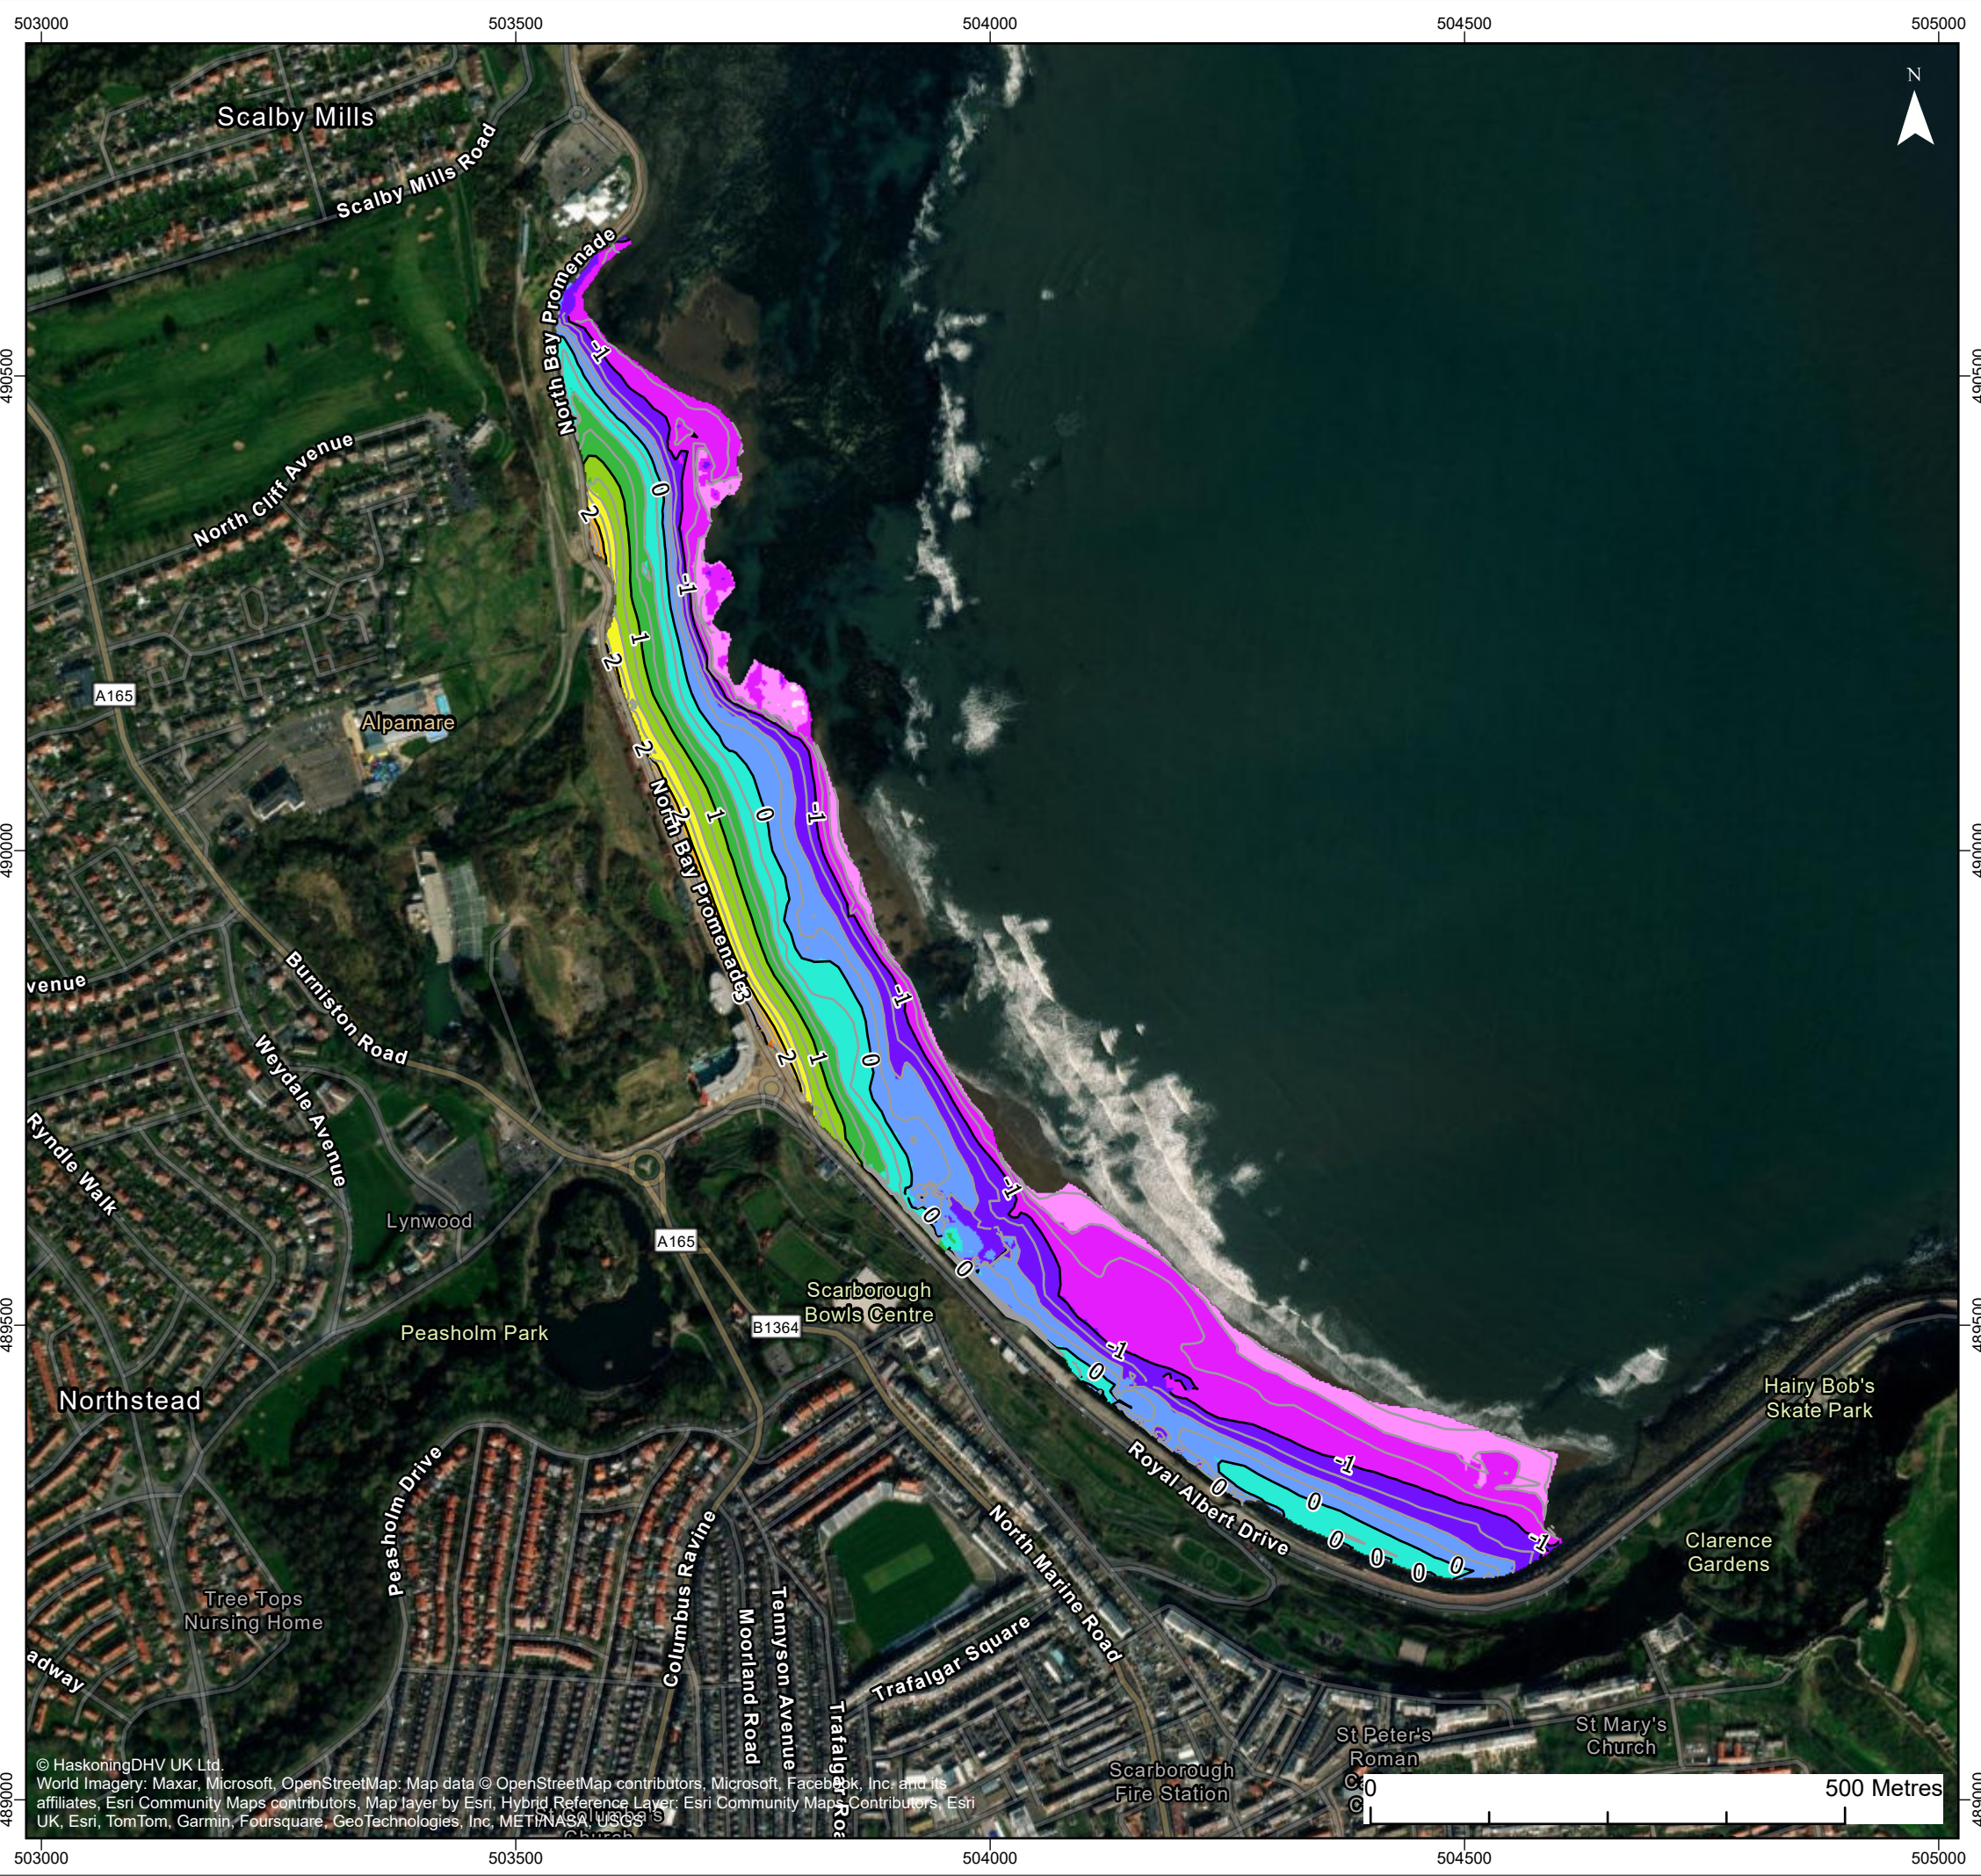
Appendix B - Map 1

Survey Date	Description of Changes Since Last Survey	Interpretation
	<p>(chainage 78m to 104m) being the lowest level on record, with sections of the lower beach (chainage 147m to 184m) the highest level on record.</p> <p>Profile 1dSBN5 is located to the south of Clarence Gardens. The profile is covered by the promenade, upstand wall and rock revetment up to chainage 29m and has remained unchanged since the previous survey. Seawards of the revetment, the beach has been eroded, dropping in level initially by up to 0.4m at the toe. This erosion continues up to the end of the profile at chainage 163m. The profile has dropped to a medium level compared to the range of the previous surveys.</p> <p>Topographic Survey:</p> <p>Scarborough North Bay is covered by an annual topographic survey, typically undertaken as part of the Full Measures surveys in the autumn. This additional topographic survey was undertaken in January 2024 to assess the impact of a particular stormy period between October 2023 and Jan 2024 where seven named storms occurred.</p> <p>Utilizing a GIS software, the data has been used to create a DGM, the plot of which is shown in Appendix B - Map 1. The plot shows a distinct pattern of change between the north and south of the bay. In the north, fronting North Bay Promenade, the beach is typically steeper and narrow, transitioning to exposed rocky foreshore on the lower beach. Whereas in the south, the bay appears to be shallower in gradient and lower in elevation. Rocky outcrops are exposed more sporadically and are not limited to the lower beach.</p> <p>The DGM has also been used to calculate the differences between the post storm survey (January 2024) and the previous Full Measures topographic survey (August 2023) (as shown in Appendix B – Map 3), to identify areas of erosion and accretion.</p> <p>The plot shows that the change the south of the bay has been dominated by erosion (lowering) up to -1.25m in magnitude. Very minor accretion (deposition) on the lower beach indicates a drawdown of material down the profile typically of stormy conditions. In the North of the bay the change is more balanced. The upper beach, up to the subtle promontory, has experienced erosion. However, the lower beach extending north has experienced accretion up to +1.0m in level. This indicated both a drawdown of material down the profile, but also potentially net drift across the bay from south to north.</p>

TOPOGRAPHIC SURVEY (January 2024)

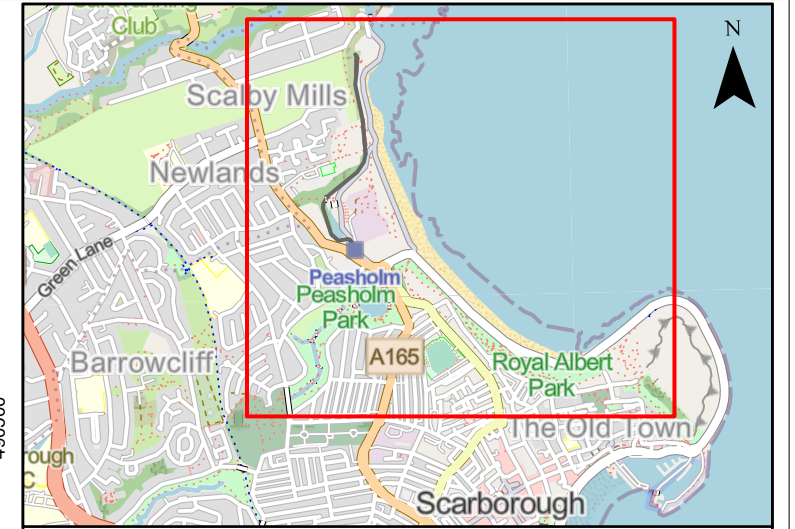
Elevation (mOD)	Contours (mOD)*
-2.3 - -2	— 1.0m interval
-1.9 - -1.5	— 0.25m interval
-1.4 - -1	
-0.9 - -0.5	* Contours only cover sandy beach areas.
-0.4 - 0	
0.1 - 0.5	
0.6 - 1	
1.1 - 1.5	
1.6 - 2	
2.1 - 2.5	
2.6 - 3	
3.1 - 3.5

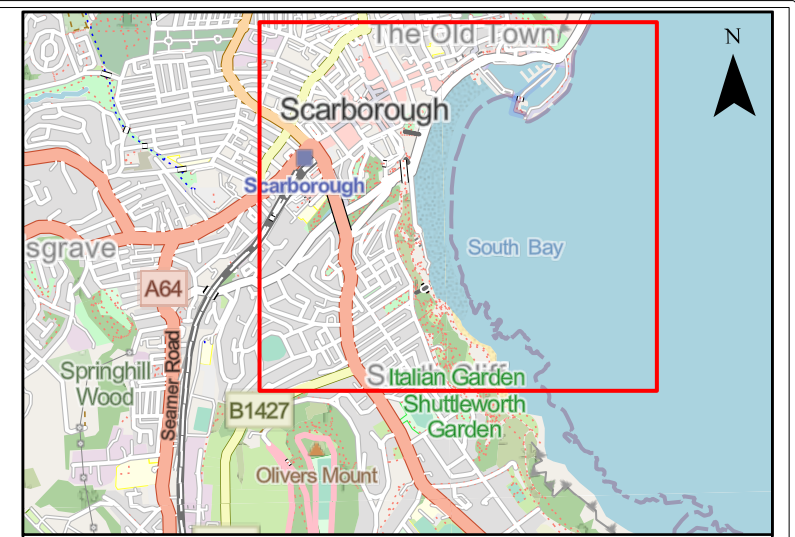
TOPOGRAPHIC SURVEY (January 2024)

Elevation (mOD)	Contours (mOD)*
-1.5 - -1.5	— 1.0m interval
-1.4 - -1	— 0.25m interval
-0.9 - -0.5	
-0.4 - 0	
0.1 - 0.5	
0.6 - 1	
1.1 - 1.5	
1.6 - 2	
2.1 - 2.5	
2.6 - 3	
3.1 - 3.5	
3.6 - 4

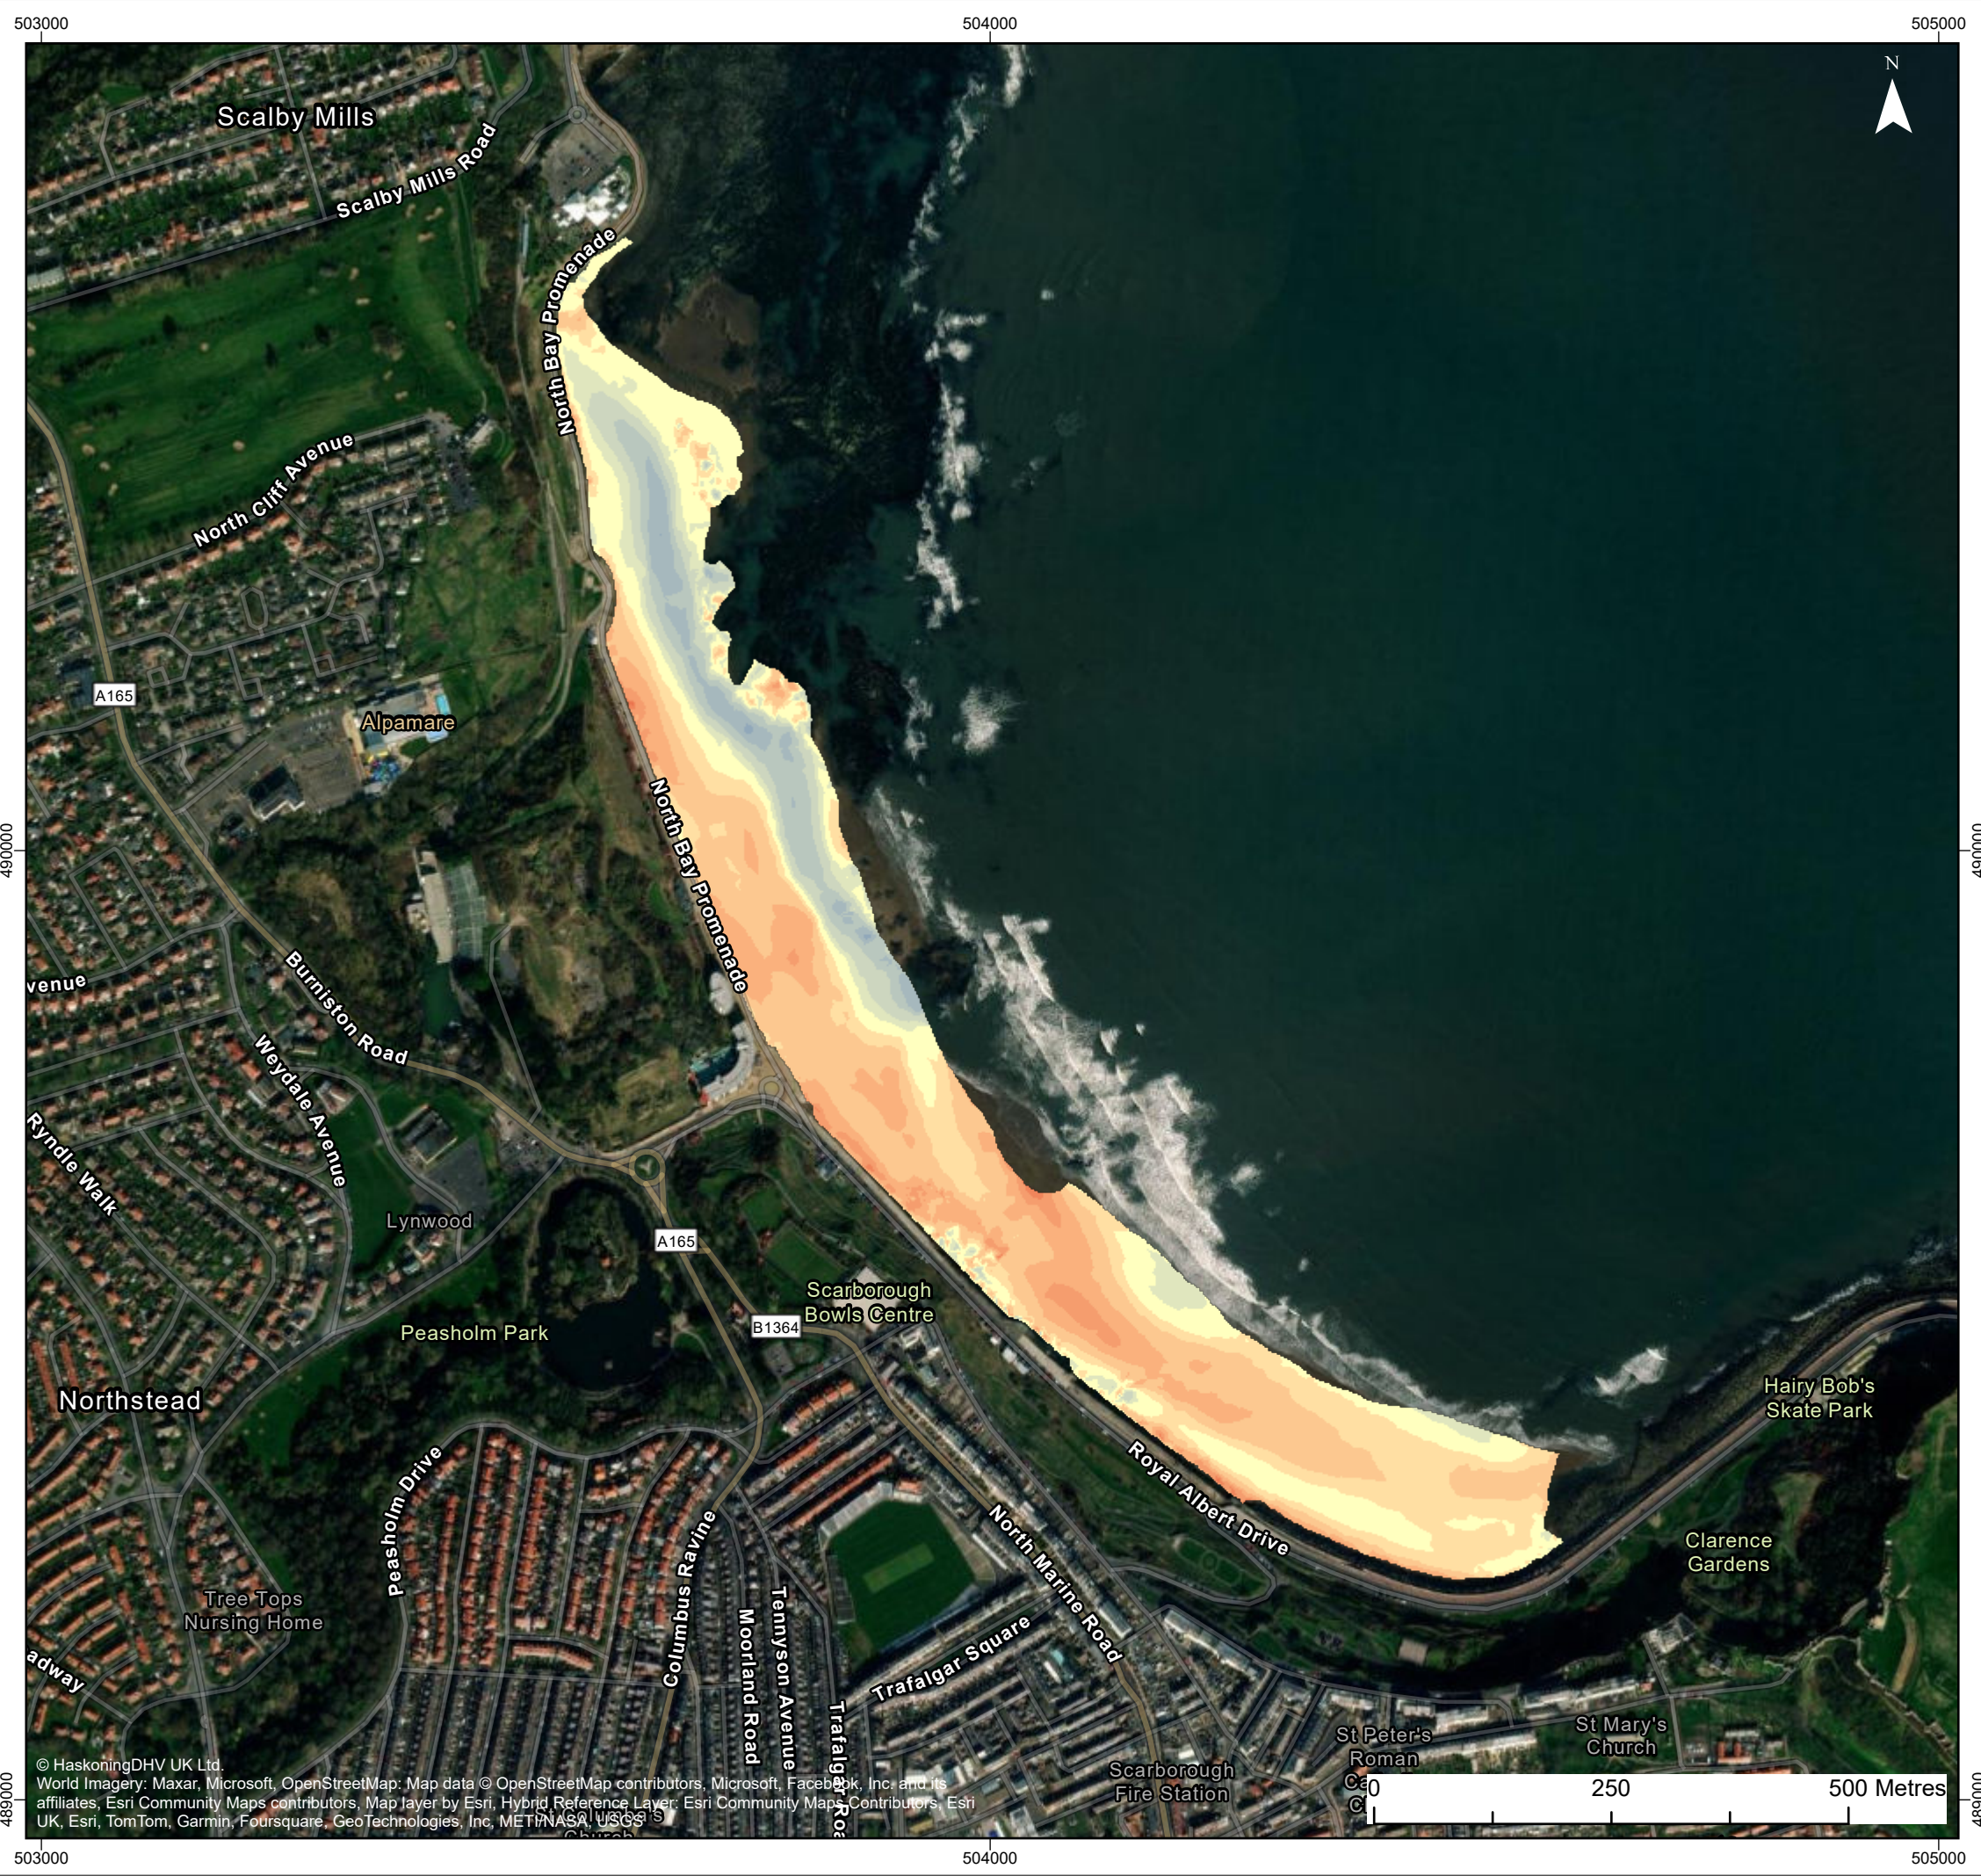
Appendix B - Map 3

The January 2024 survey indicates that Scarborough North Bay generally experienced a net erosion as a result of the Winter 2023/24 storms. The data suggest that material has been both drawn down the profile from upper to lower beach and also potentially transported from the south to the north of the bay. Notably however, the profiles indicate that the majority of the beach has remained within the range envelope of the previous surveys, suggesting the beach has been lower and has recovered in the past.
