**Cell 1 Regional Coastal Monitoring Programme
Scarborough 'Post Storm' Beach Monitoring
Survey Report 2024**

This report presents the Post Storm Walkover Inspection for Scarborough North Bay and South Bay.

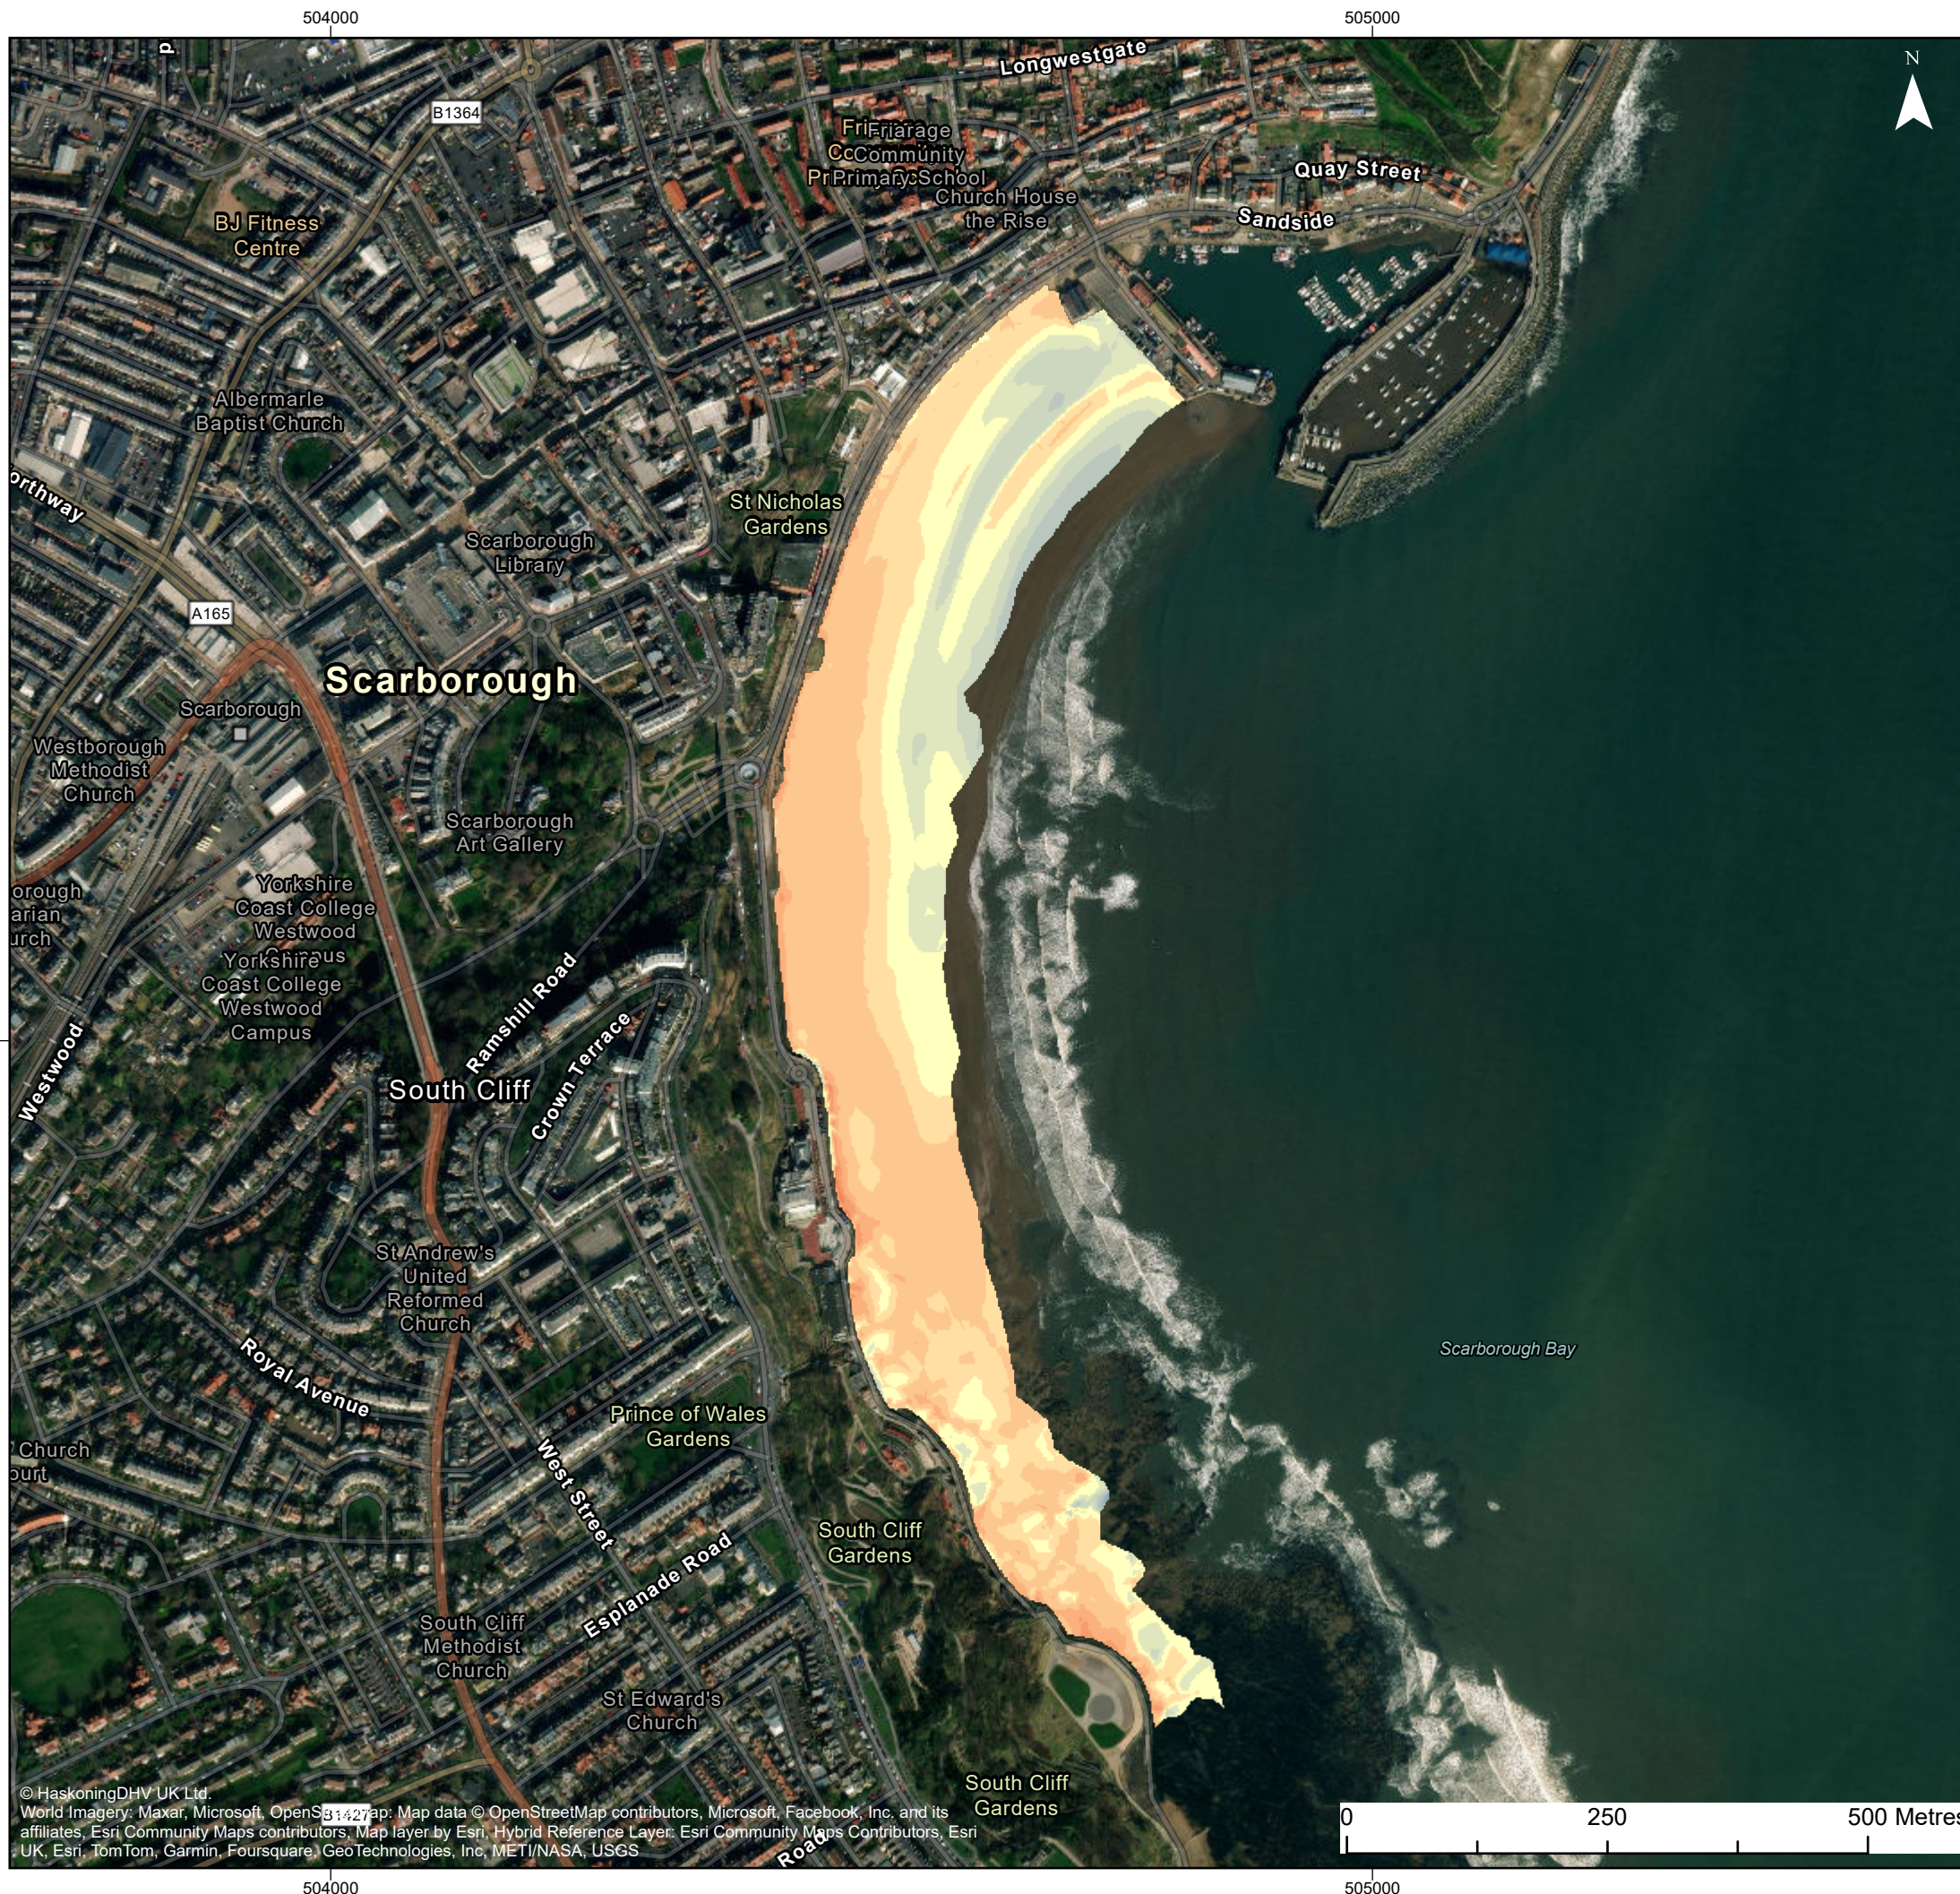
Appendix B - Map 4

Survey Date	Description of Changes Since Last Survey	Interpretation
	<p>Topographic Survey:</p> <p>Scarborough South Bay is covered by an annual topographic survey typically undertaken in Autumn. This additional survey has been undertaken in January 2024 to assess the impact of a particular stormy period between October 2023 and Jan 2024 where seven named storms occurred.</p> <p>The data from this survey has been used to create a DGM (Appendix B - Map 1) using GIS. The plot shows in the north of the bay the beach contours follow a broadly shore parallel pattern, rising elevation towards the harbour. In the south of the bay the beach contours are more distorted reflecting the sections exposed rocky foreshore in this area.</p> <p>The GIS has also been used to calculate the differences between the current topographic survey DGM (January 2024) and the earlier topographic survey DGM (September 2023), with 5m resolution raster grids (as shown in Appendix B – Map 3), to identify areas of erosion and accretion.</p> <p>The plots shows that overall the bay appears to have experienced a net loss of material as a result of the recent storms. The southern half of the bay, fronting Royal Albert Drive, has been dominated by erosion up to 1.25m in level. Moving North this erosion continues across the upper beach, however the lower beach has experienced a shoreline parallel band of accretion (up to +1.25m in magnitude). This general patterns indicates a movement of material from the south to the north against the usual dominant drift (north to south).</p>

A similar pattern is observed in Scarborough South Bay with a net erosion occurring. The data again suggests that material has been both drawn down the profile from upper to lower beach and also transported from the south to the north, accumulating in the lee of the harbour.

Difference between topographic surveys
 (September 2024 to January 2024)

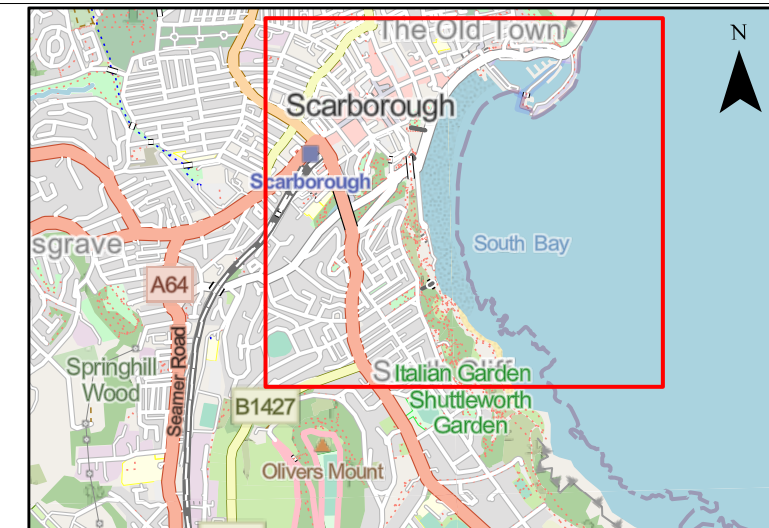
Change in Elevation (mOD)
