North East
Coastal
Observatory

Cell 1 Regional Coastal Monitoring Programme Update Report 16: 'Partial Measures' Survey 2024

South Tyneside Council

South Tyneside Council
April 2024

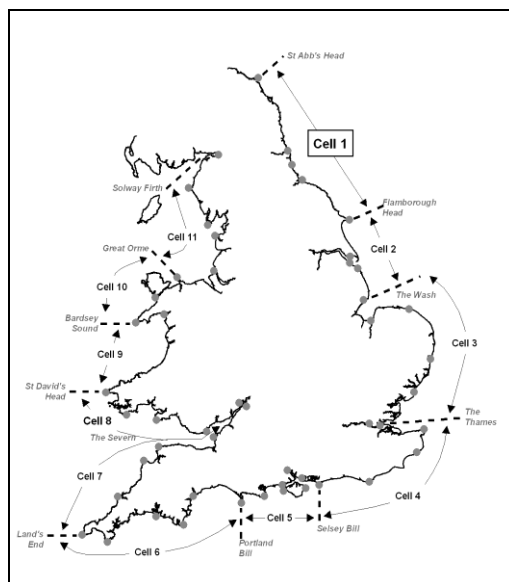
Figure 1 Sediment Cells in England and Wales

The Cell 1 Regional Coastal Monitoring Programme covers approximately 300km of the north east coastline, from the Scottish Border (just south of St. Abb's Head) to Flamborough Head in East Yorkshire. This coastline is often referred to as 'Coastal Sediment Cell 1' in England and Wales (Figure 1). Within this frontage the coastal landforms vary considerably, comprising low-lying tidal flats with fringing salt marshes, hard rock cliffs that are mantled with glacial sediment to varying thicknesses, softer rock cliffs and extensive landslide complexes.

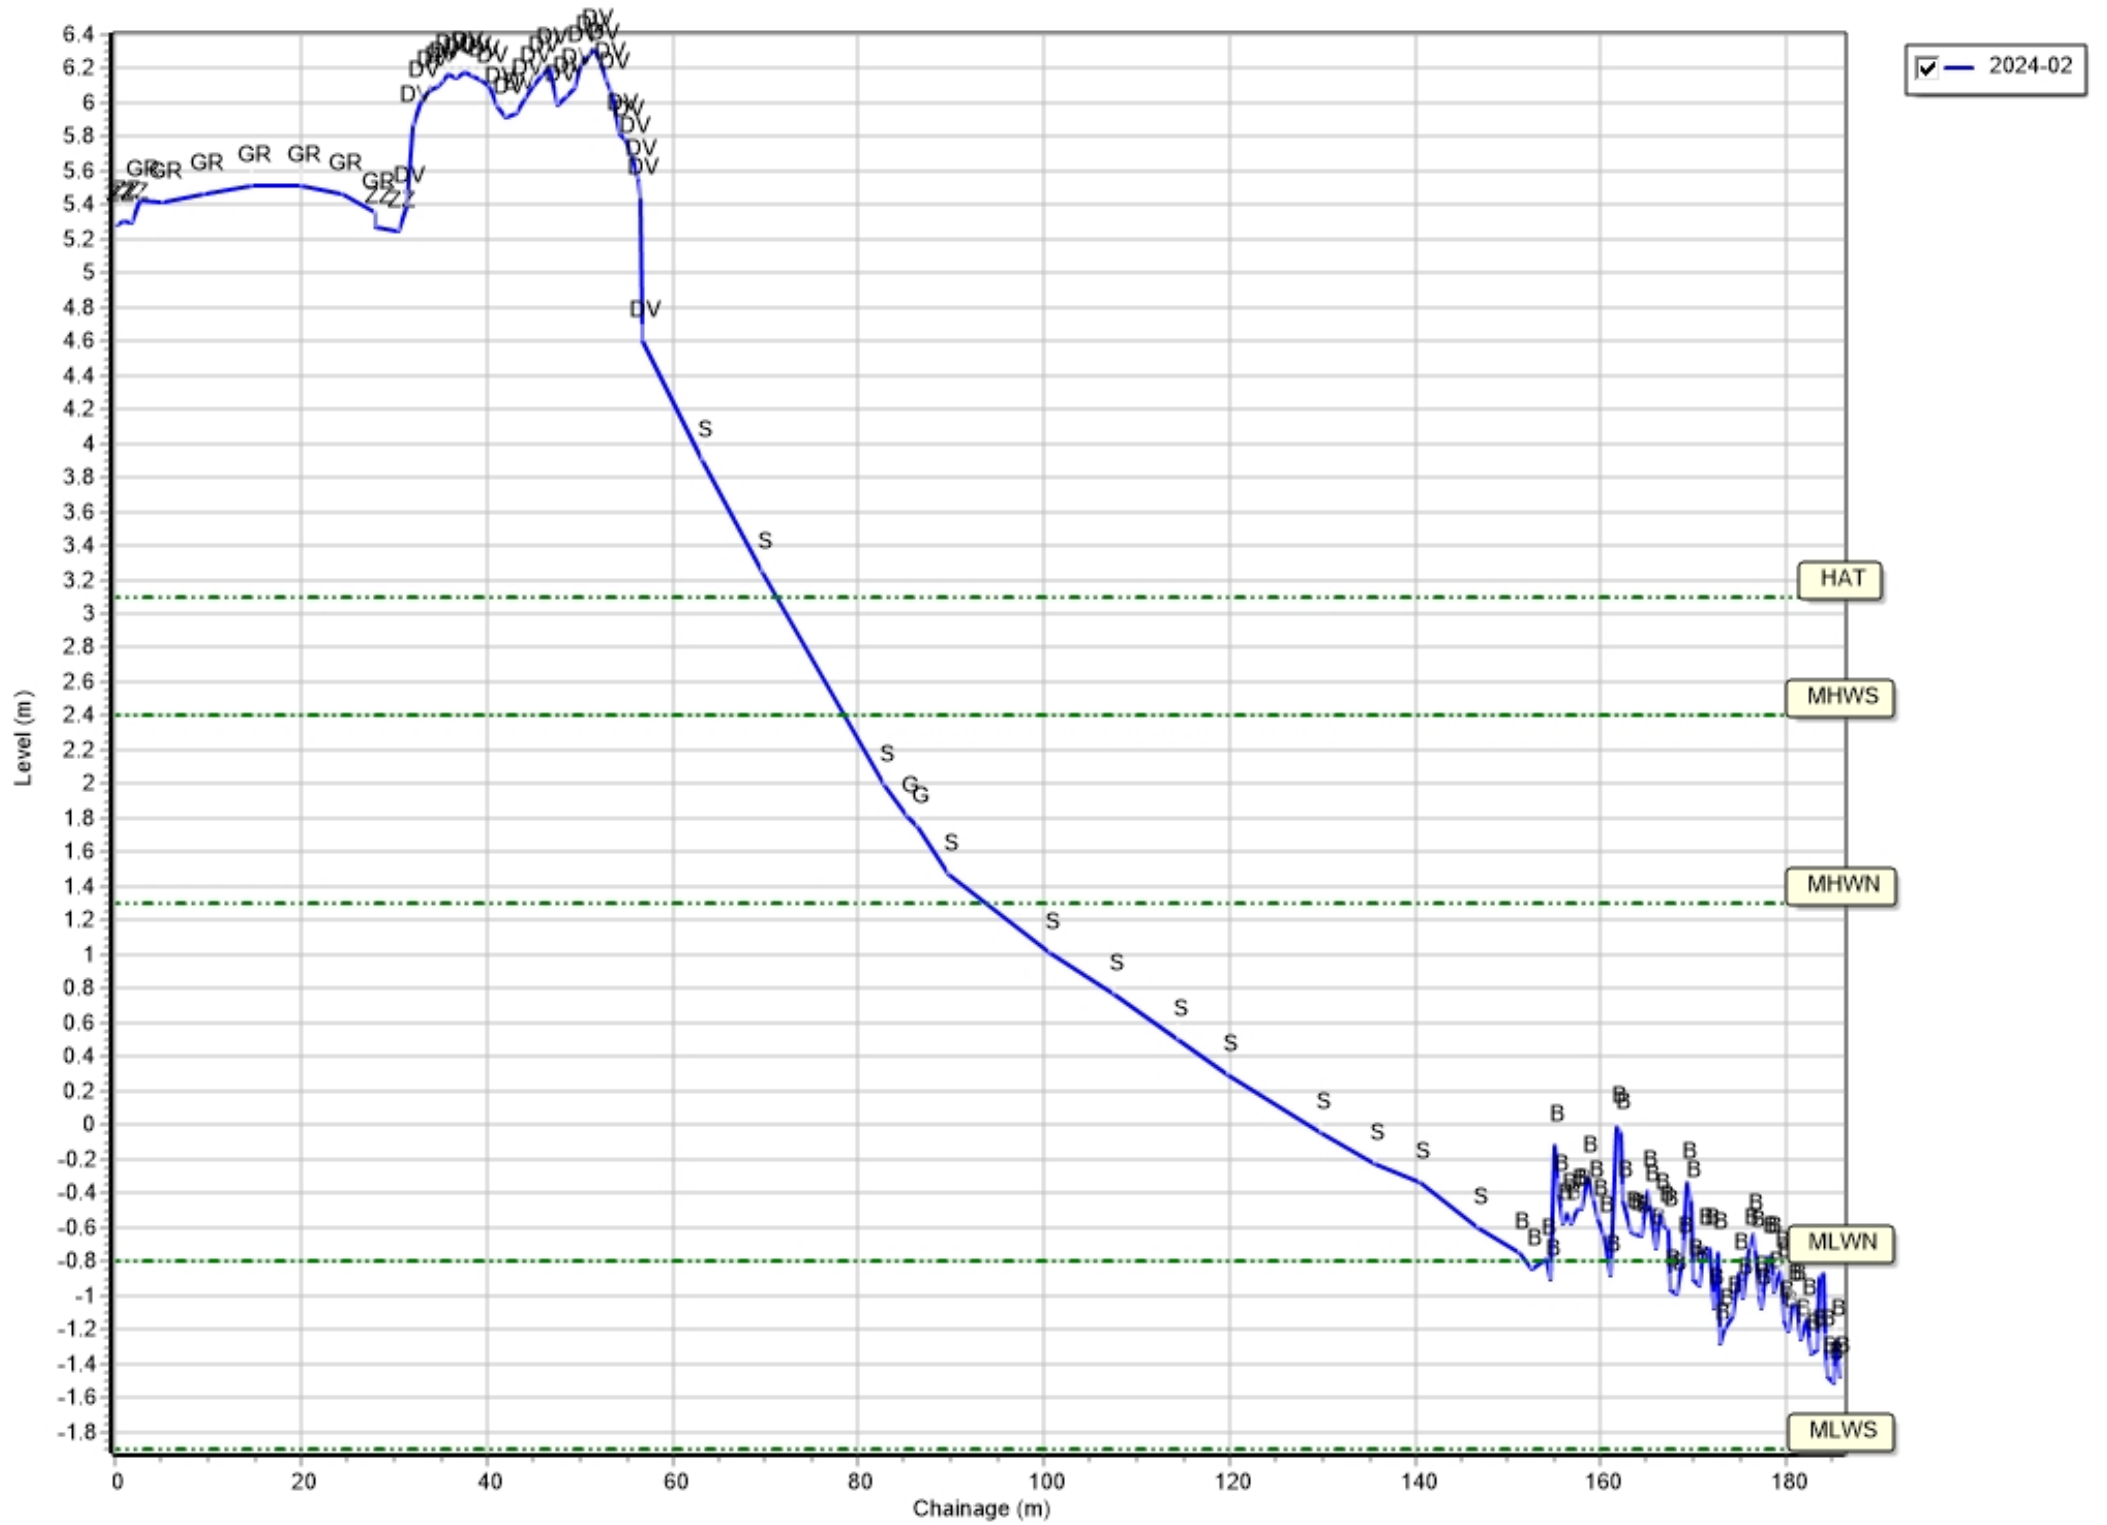
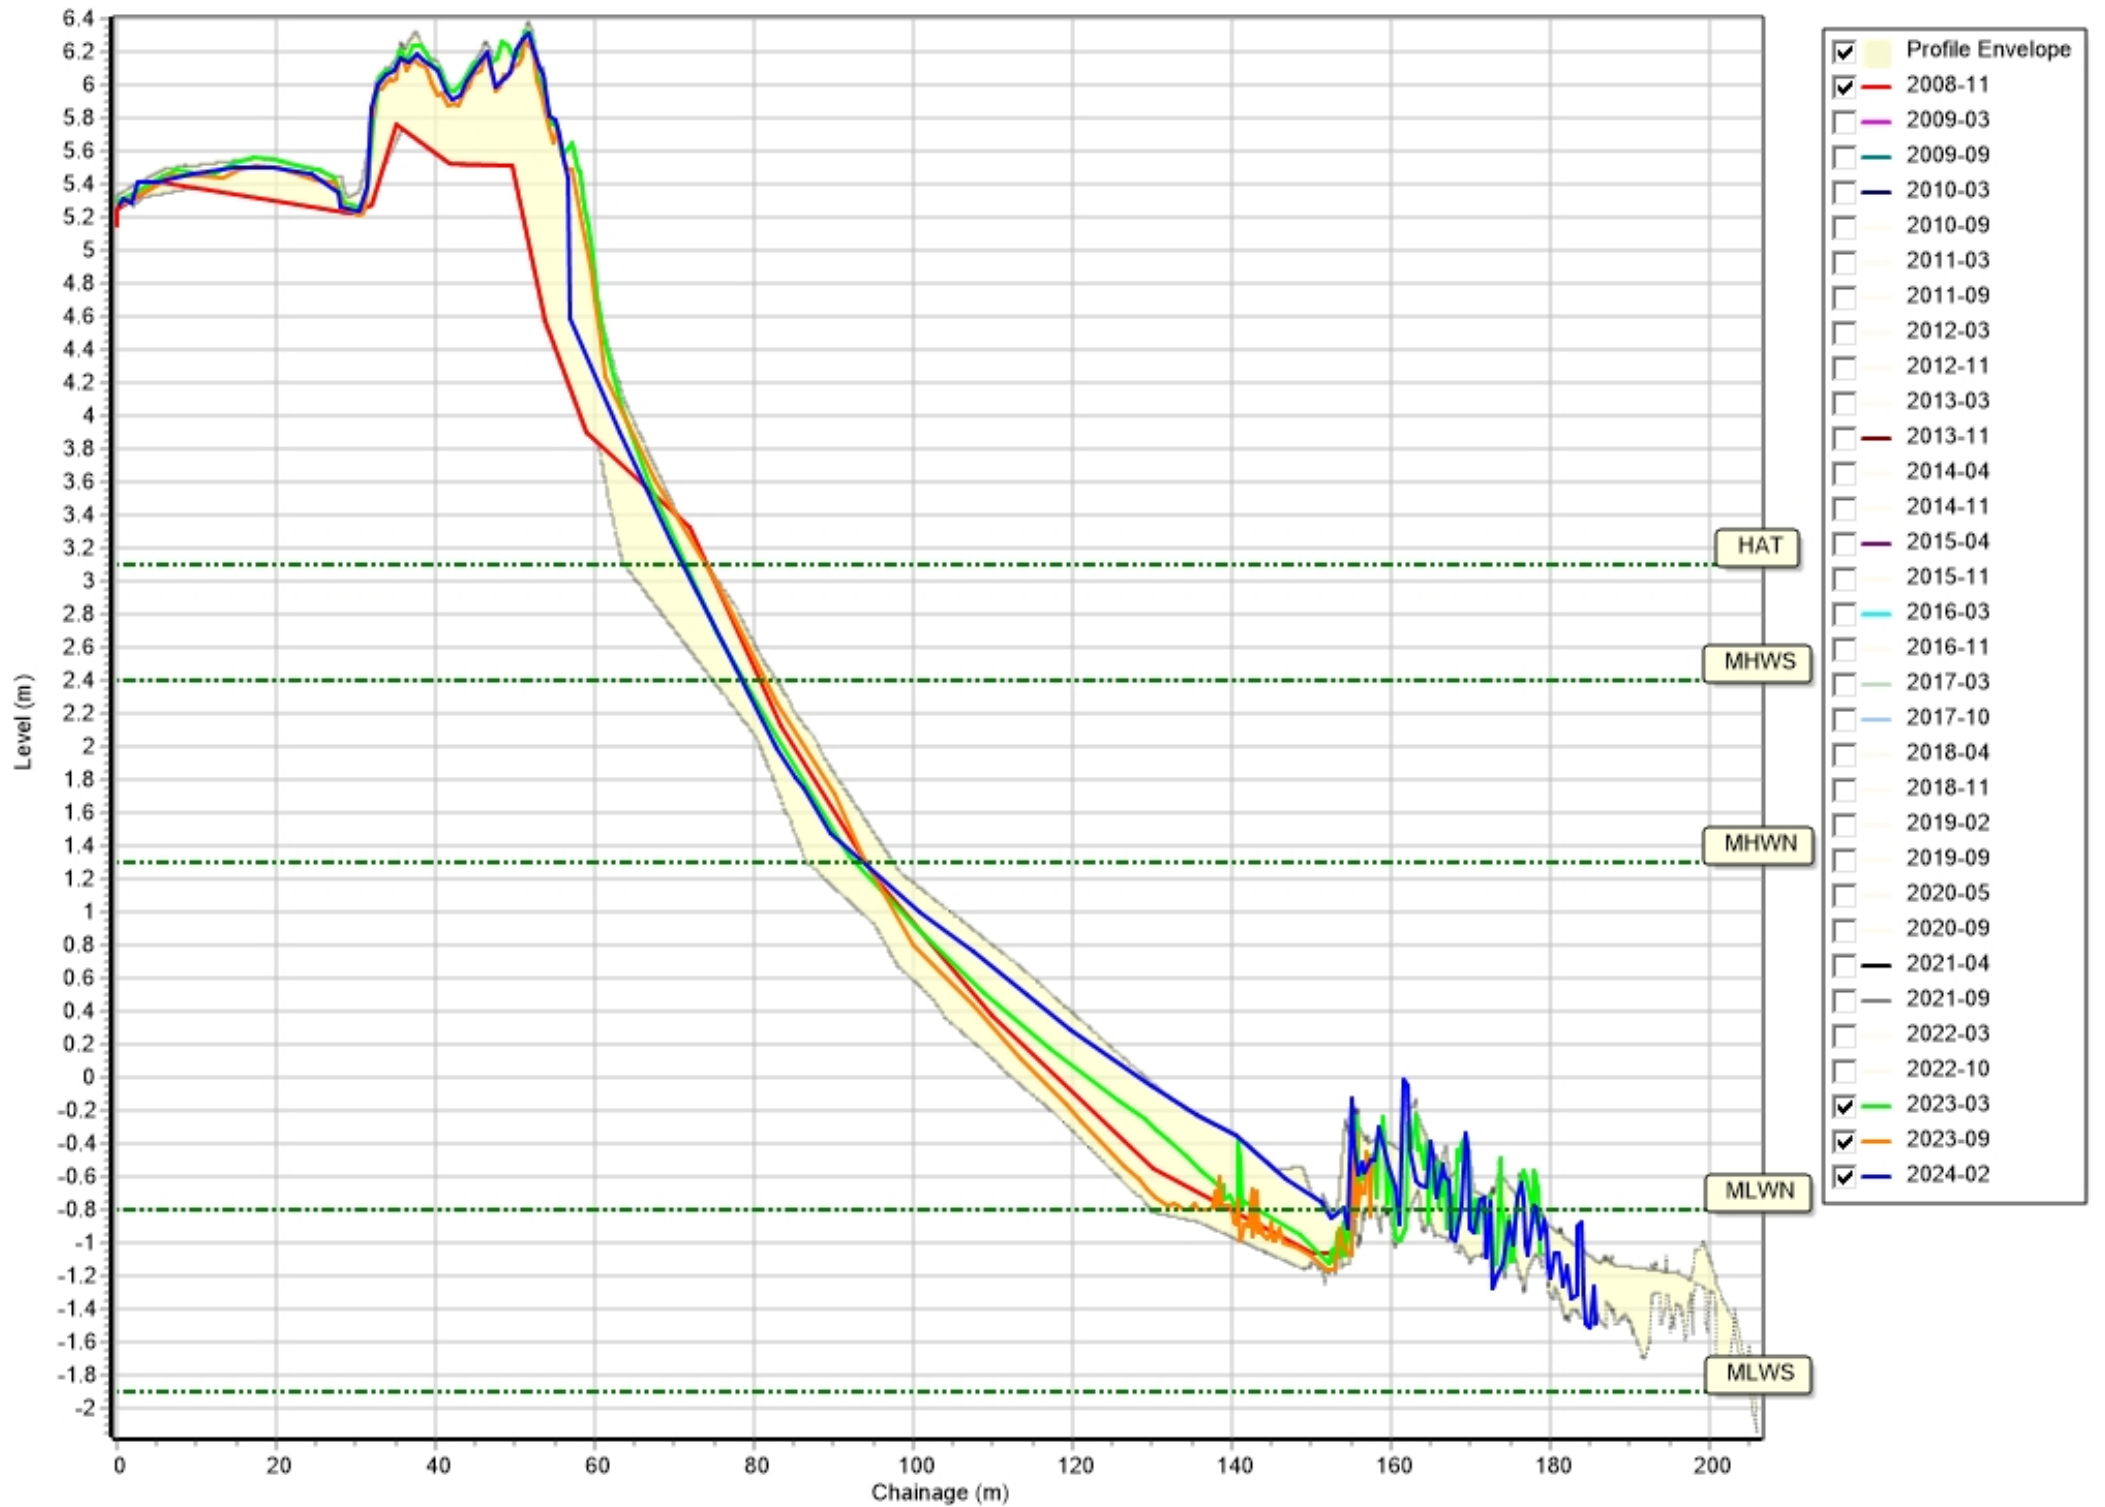
Profiles: 1bSS1

Survey Date	Description of Changes Since Last Survey	Interpretation
<p>29th February 2024</p>	<p>Beach Profiles:</p> <p>Littlehaven Beach is covered by four beach profile lines for the Partial Measures surveys, distributed between South Groyne and South Pier (1bSS1, 1bSS2, 1bSS3 and 1bSS4). All four profiles were last surveyed in September 2023.</p> <p>Profile 1bSS1 is located towards the north of Littlehaven Beach, in the lee of a rocky outcrop and harbour wall. The rear dunes have experience low level accretion limited to +0.2m. At chainage 57m, erosion has caused cliffing, 1m in height, of the foredune. This has retreated the toe of the foredune by 4m. Between chainage 61m and 94m, the beach has dropped in level by up to 0.25m, before alternating to accretion of up to 0.6m to chainage 154m. Seawards of chainage 154m, the rocky foreshore is exposed.</p> <p>Profiles 1bSS2 to 1bSS4 extend seawards from the new sea wall that was completed in 2014.</p> <p>At profile 1bSS2, sediment has overtopped the stepped revetment resulting in accretion up against the rear seawall of 0.2m. Some 0.8m of accretion has occurred at the toe of the stepped revetment, burying all but the top step. This accretion is very local and tapers to no change by chainage 8m. Between chainage 8m and 75m, the beach has undergone significant erosion up to 1.2m. Seawards of chainage 75m, low level accretion has again occurred (+0.3m). When compared to the range of the previous surveys the upper beach is at the highest level on record whilst a section of the mid beach is at the lowest.</p> <p>At profile 1bSS3, sediment has overtopped the stepped revetment resulting in accretion on the promenade of 0.1m. Accretion has also completely submerged the stepped revetment (+0.8m) and continues across the upper beach, tapering to no change by chainage -2m. Between chainage -2m and chainage 54m, significantly erosion has occurred (up to -1m). Seawards of chainage 56m, the change again alternates to accretion, where an increase in level of up to 0.3m has occurred. When compared to the range of the previous surveys the upper beach is at the highest level on record whilst a section of</p>	<p>Since the previous survey in September 2023, Littlehaven Beach has experienced notable change. The three most southern profiles have all demonstrate significant erosion (lowering) in middle of the beach, with the partial re-distribution of this material to the upper and lower sections of the beach. This change has resulted in the profiles extending beyond the envelope of previous surveys, with the middle beach at the lowest level on record and the upper beach at the highest. This beach change is a response to the particularly stormy winter 2023/24. It is expected that the beach levels would start to recover given a period of calmer weather.</p>

- Littlehaven Beach has experienced notable change since the previous survey in September 2023. The three most southern profiles have all demonstrate a pattern of significant lowering in middle of the beach with the partial re-distribution of this material to the upper and lower sections of the beach. This change has resulted in the profiles extending beyond the envelope of previous change, with the middle beach at the lowest level on record and the upper beach at the highest. This beach change is a response to the particularly stormy winter 2023/24. It is expected that the beach levels would start to recover given a period of calmer weather.

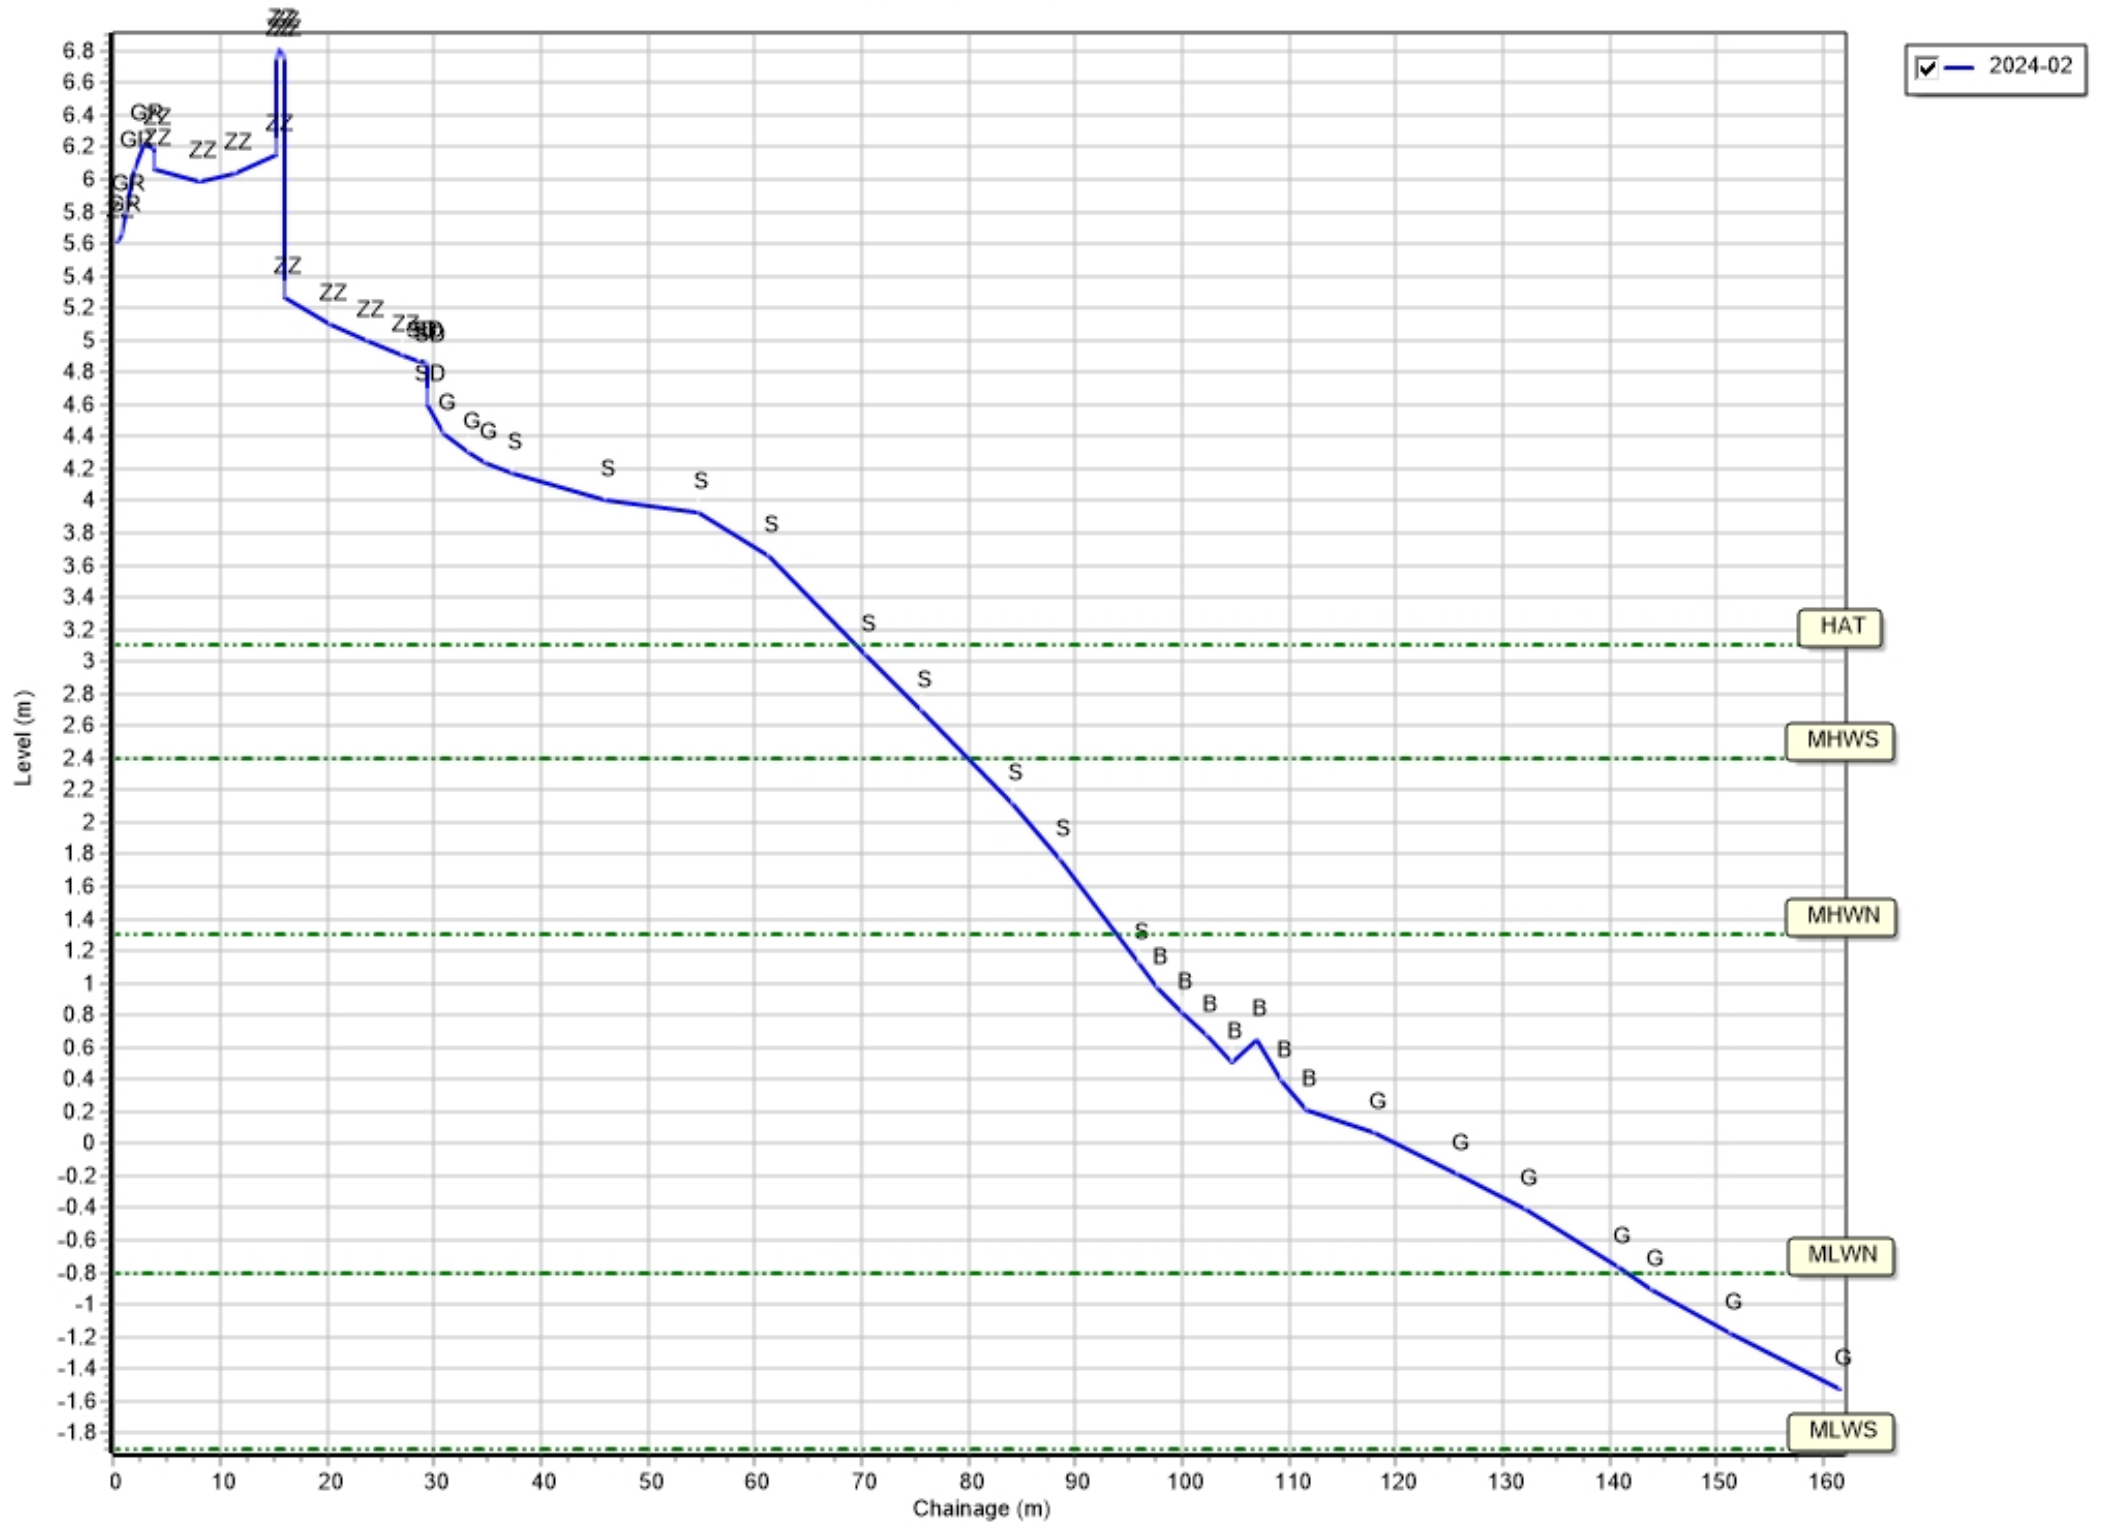
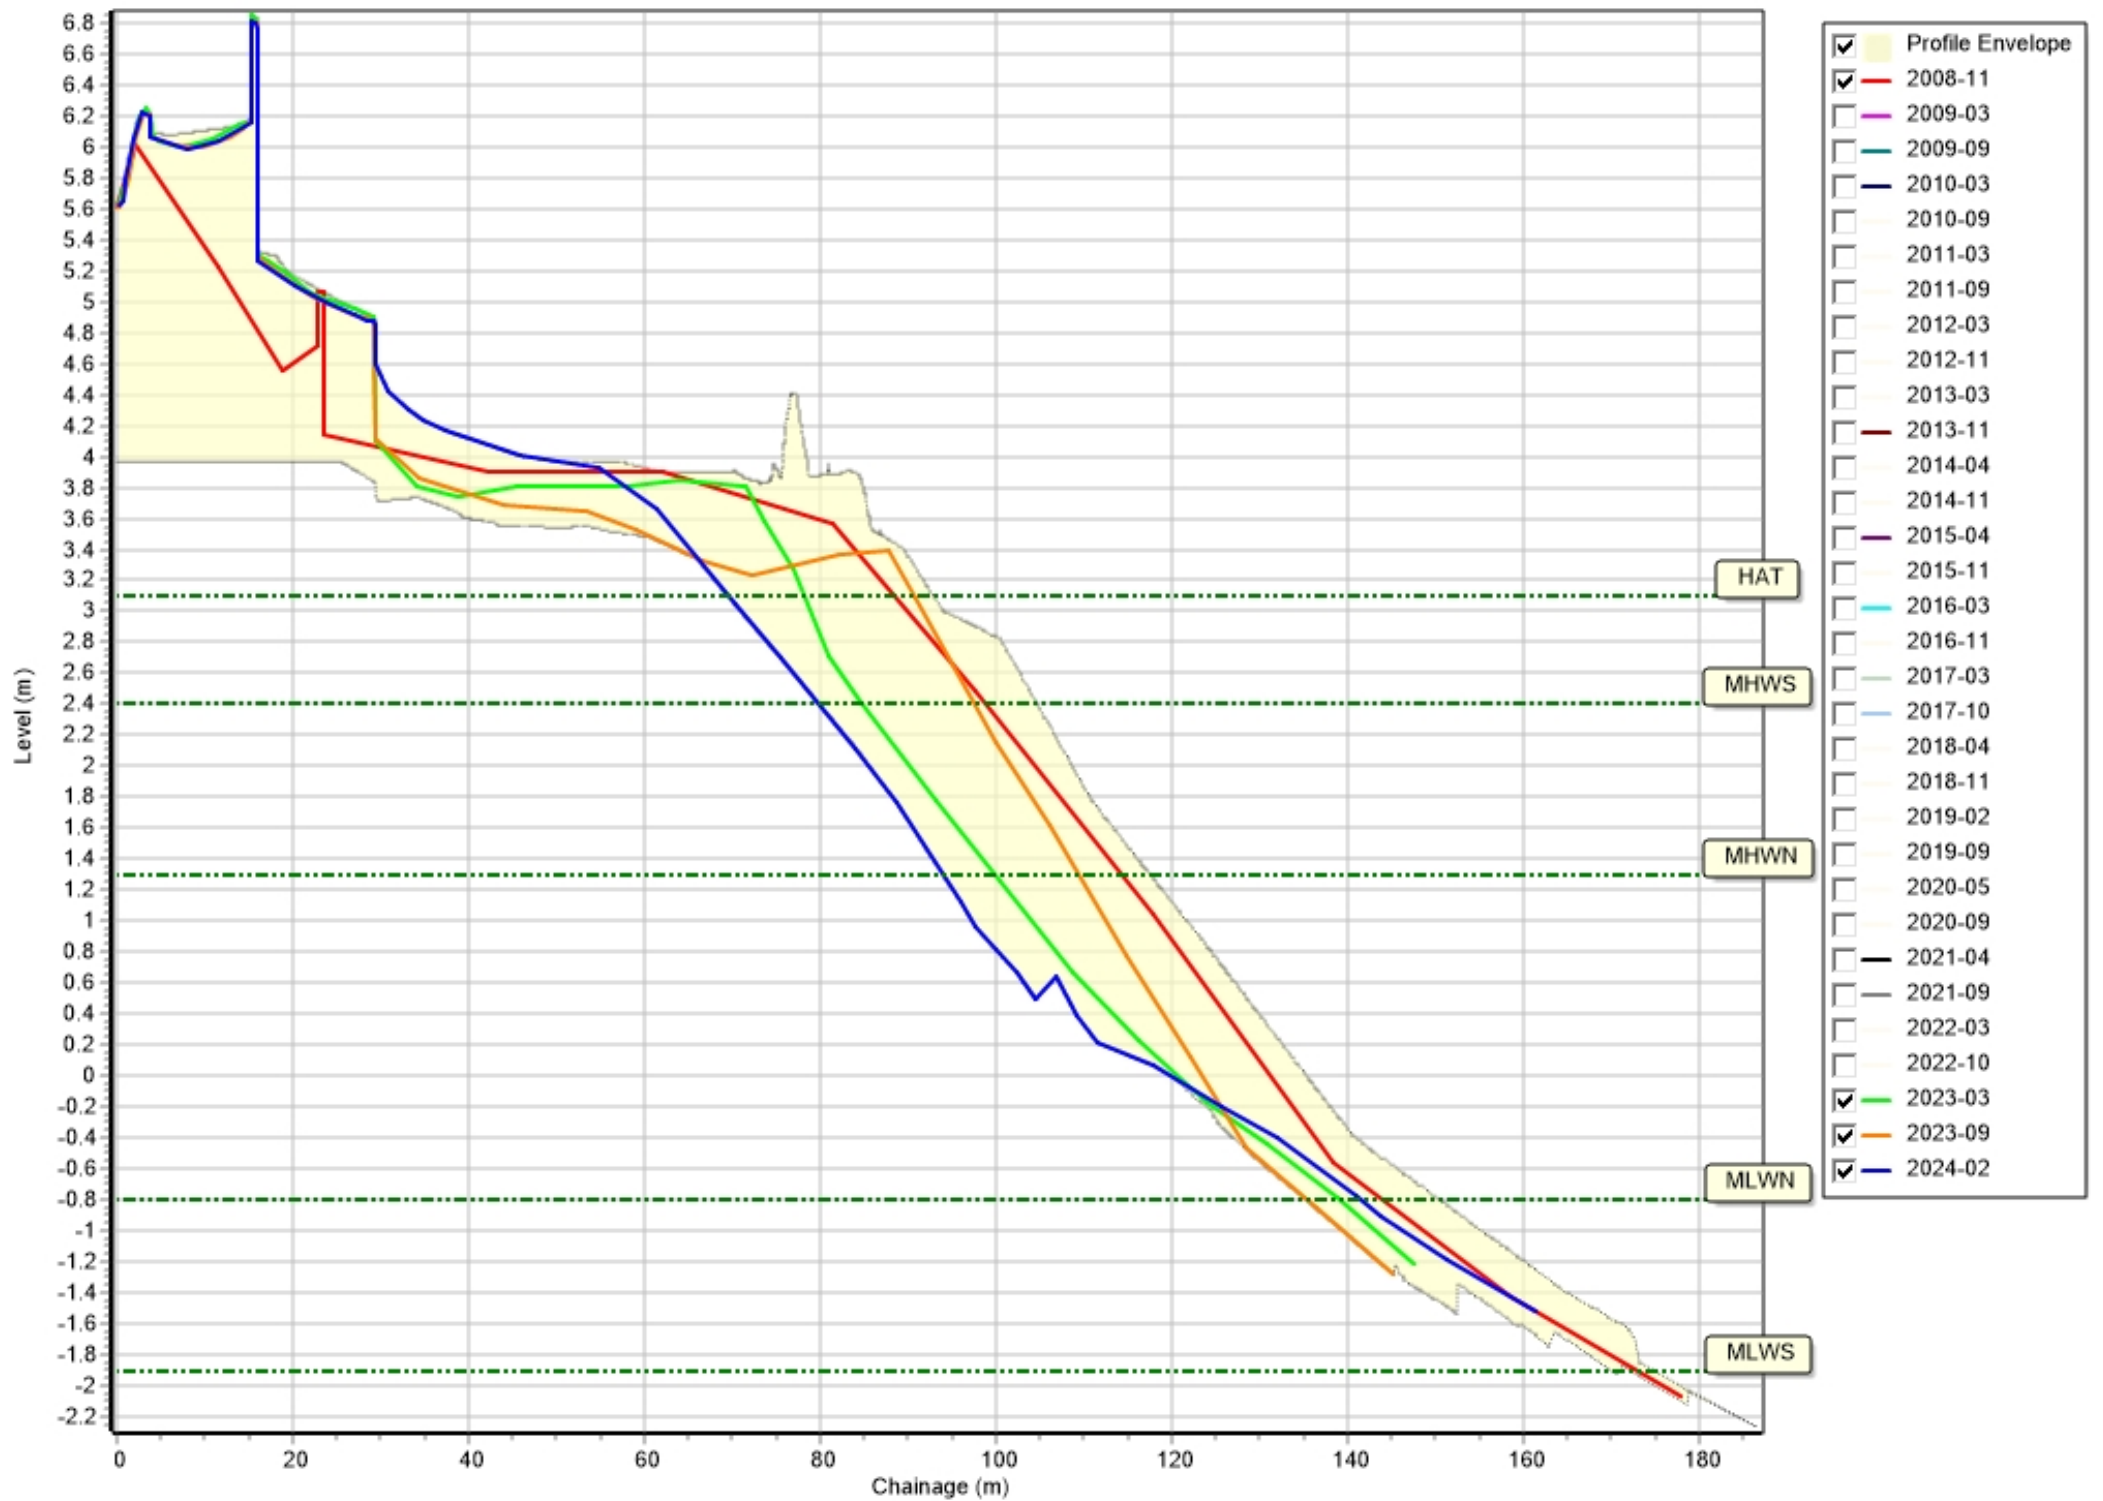
Profiles: 1bSS4

Survey Date	Description of Changes Since Last Survey	Interpretation
	<p>the mid beach is at the lowest.</p> <p>At profile 1bSS4, there has been no change across the promenade and the seawall until chainage 29m. At the toe of the seawall, beach levels have accreted by 0.5m. This accretion extends across the upper beach, tapering to no change by chainage 66m. Between chainage 66m and 125m, the beach has been significantly eroded, dropping in level by a maximum of 1.6m (at chainage 88m). Seawards of chainage 125m, minor accretion is again observed. When compared to the range of the previous surveys the upper beach is at the highest level on record whilst the mid beach is at the lowest.</p>	
<p>February 2024</p>	<p>Topographic Survey:</p> <p>Littlehaven Beach has been covered by bi-annual topographic surveys between the South Groyne and the South Pier since March 2010.</p> <p>Data from the most recent topographic survey (Partial Measures, February 2024) has been used to create a DGM using a Geographical Information System (GIS). This DGM has been compared against the DGM from the previous survey (Full Measures, September 2023) to create a difference plot (Appendix B – Map 2).</p> <p>The figure shows an intense, well defined, shoreline parallel band of erosion extending across the middle of the beach. The magnitude of change is greater in the centre and south of the bay (-1.75m) compared to the north (-0.5m). The band of erosion is abutted on both sides by a band of, comparably, low magnitude accretion.</p>	<p>The pattern of change indicated by the difference plot highlights an overall net loss of material from the bay since Sept 2023. This is not surprising given the number and severity of storms over winter 2023/2024.</p>
