North East
Coastal
Observatory

Cell 1 Regional Coastal Monitoring Programme Update Report 16: 'Partial Measures' Survey 2024

South Tyneside Council

South Tyneside Council
April 2024

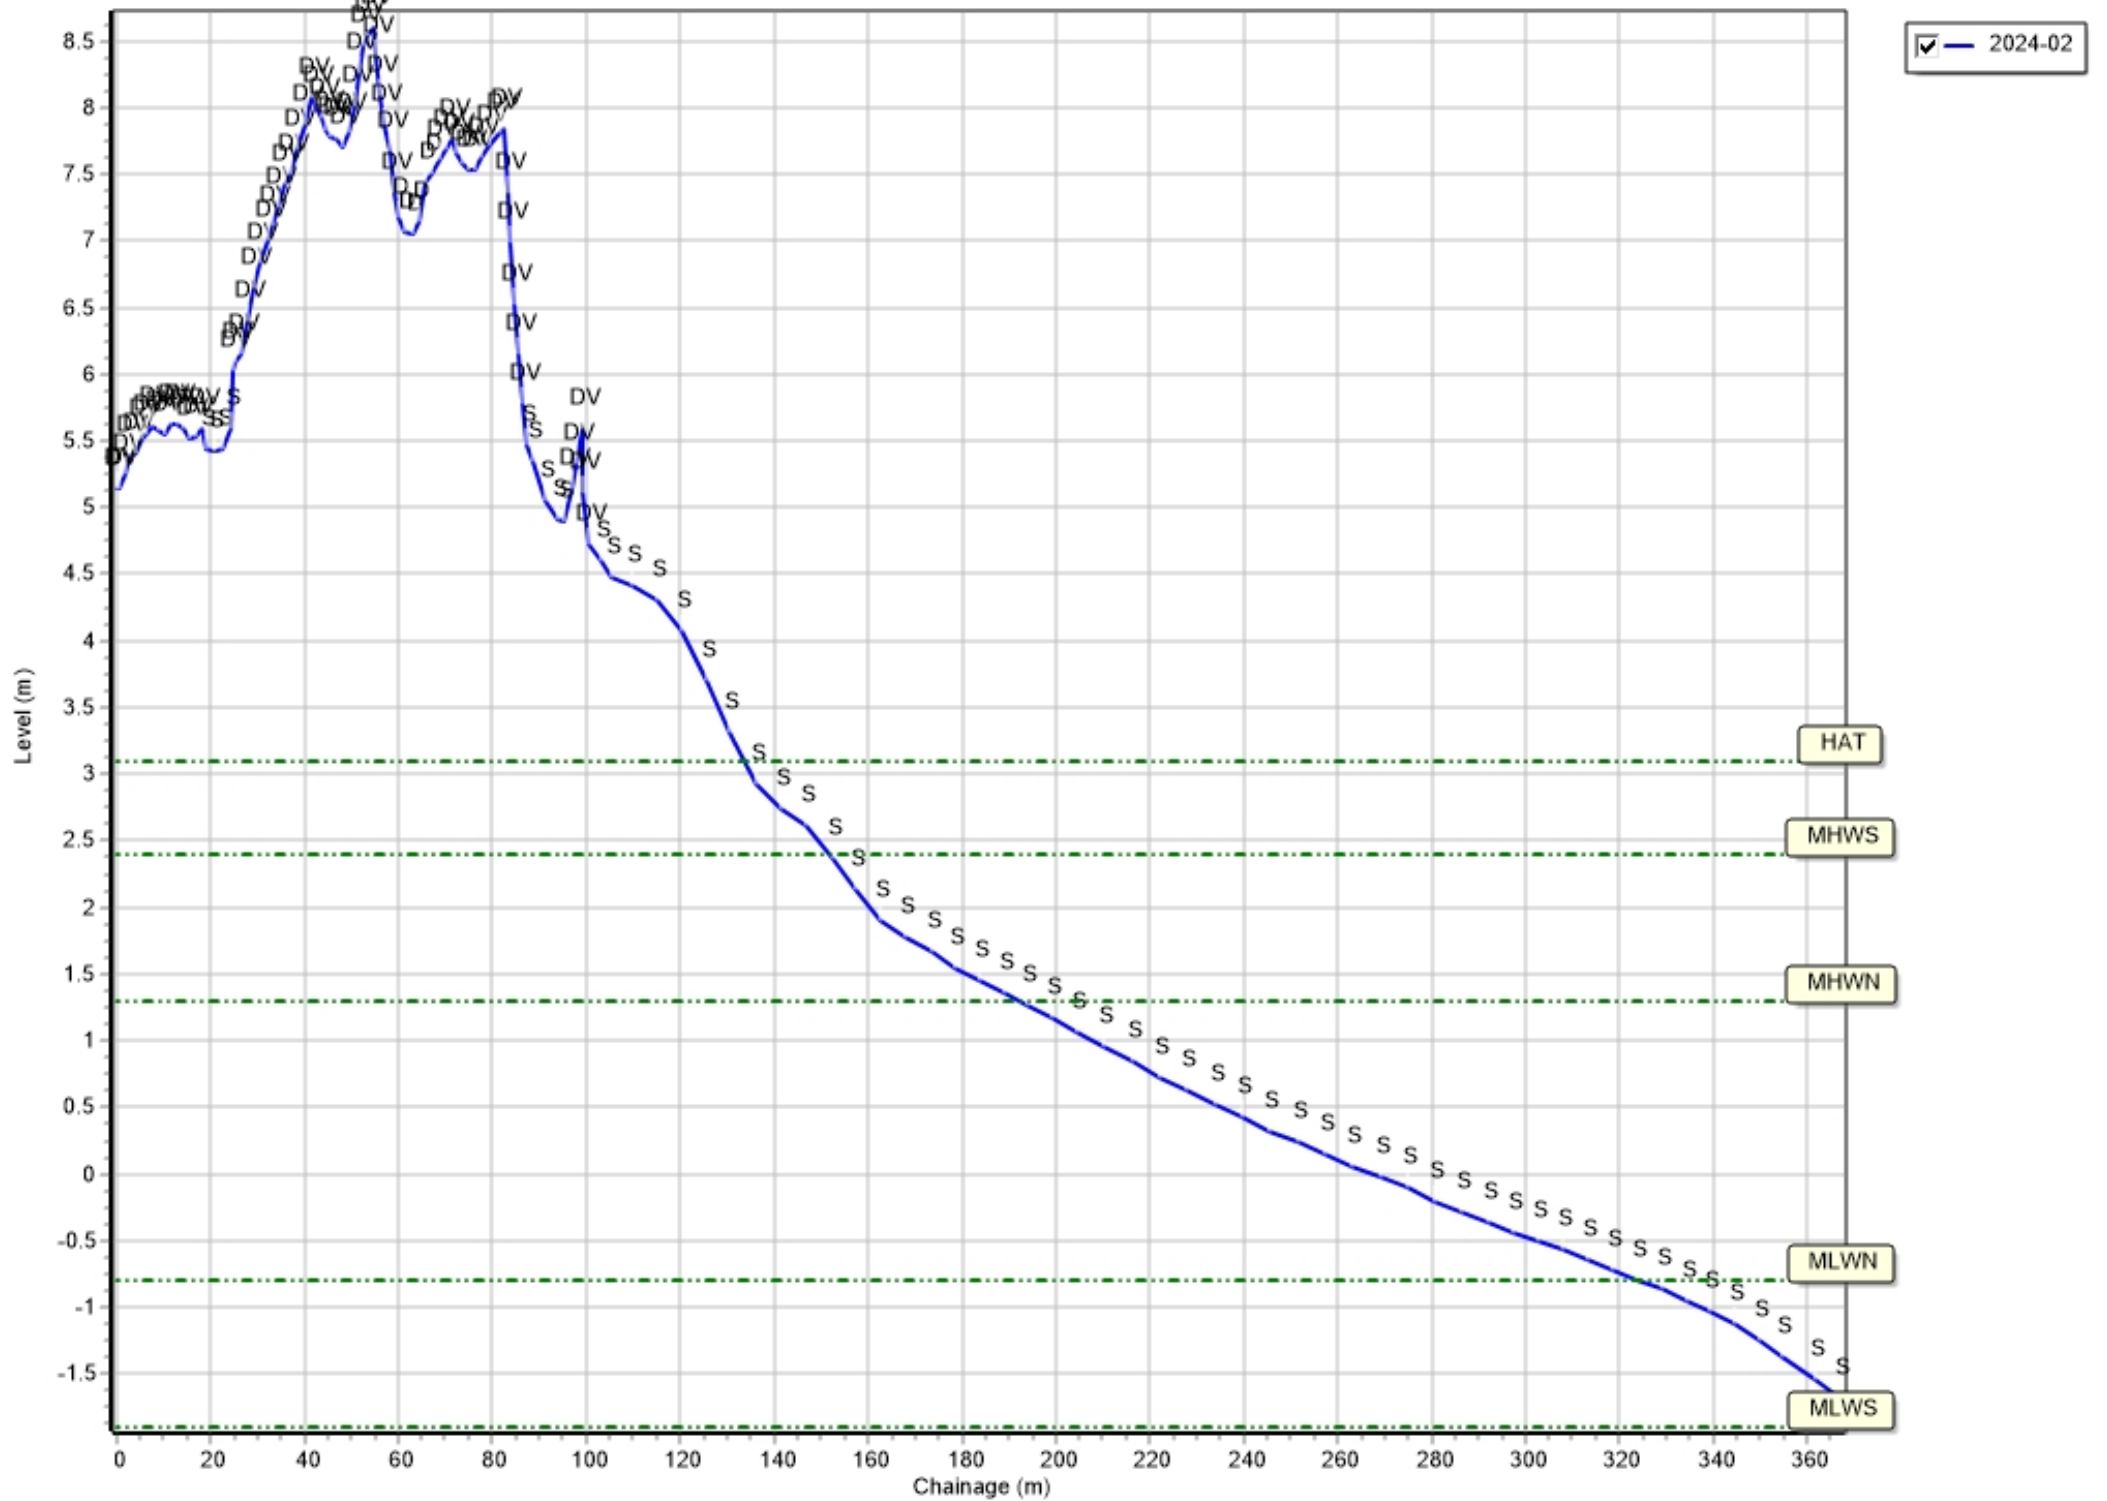
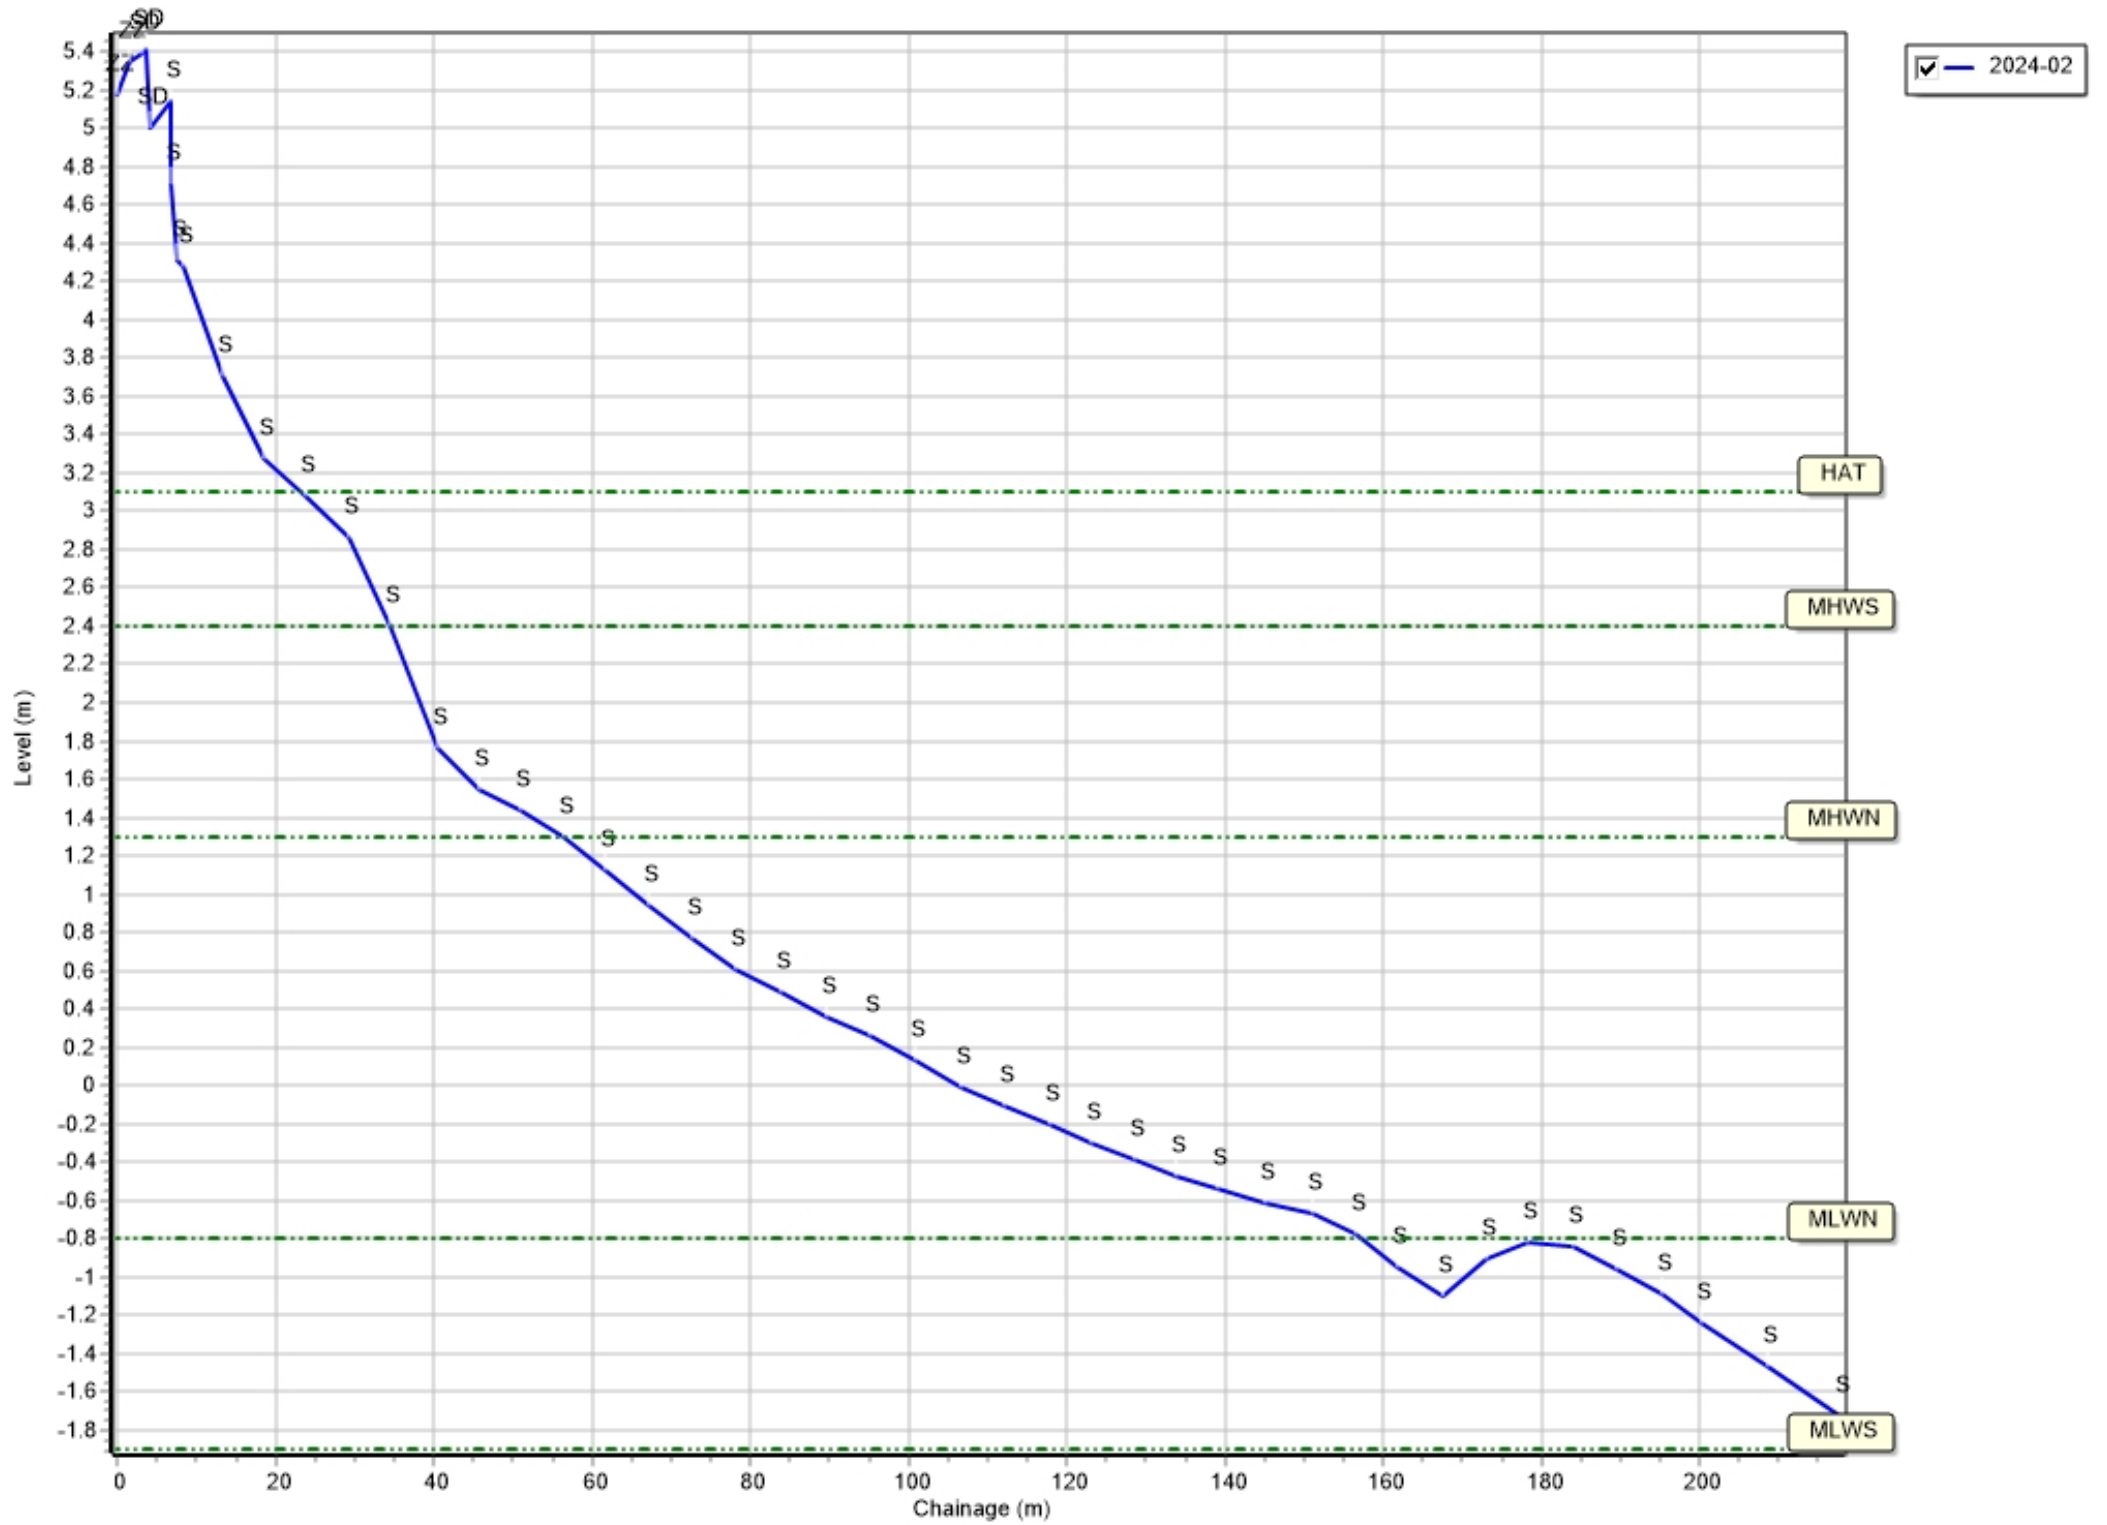
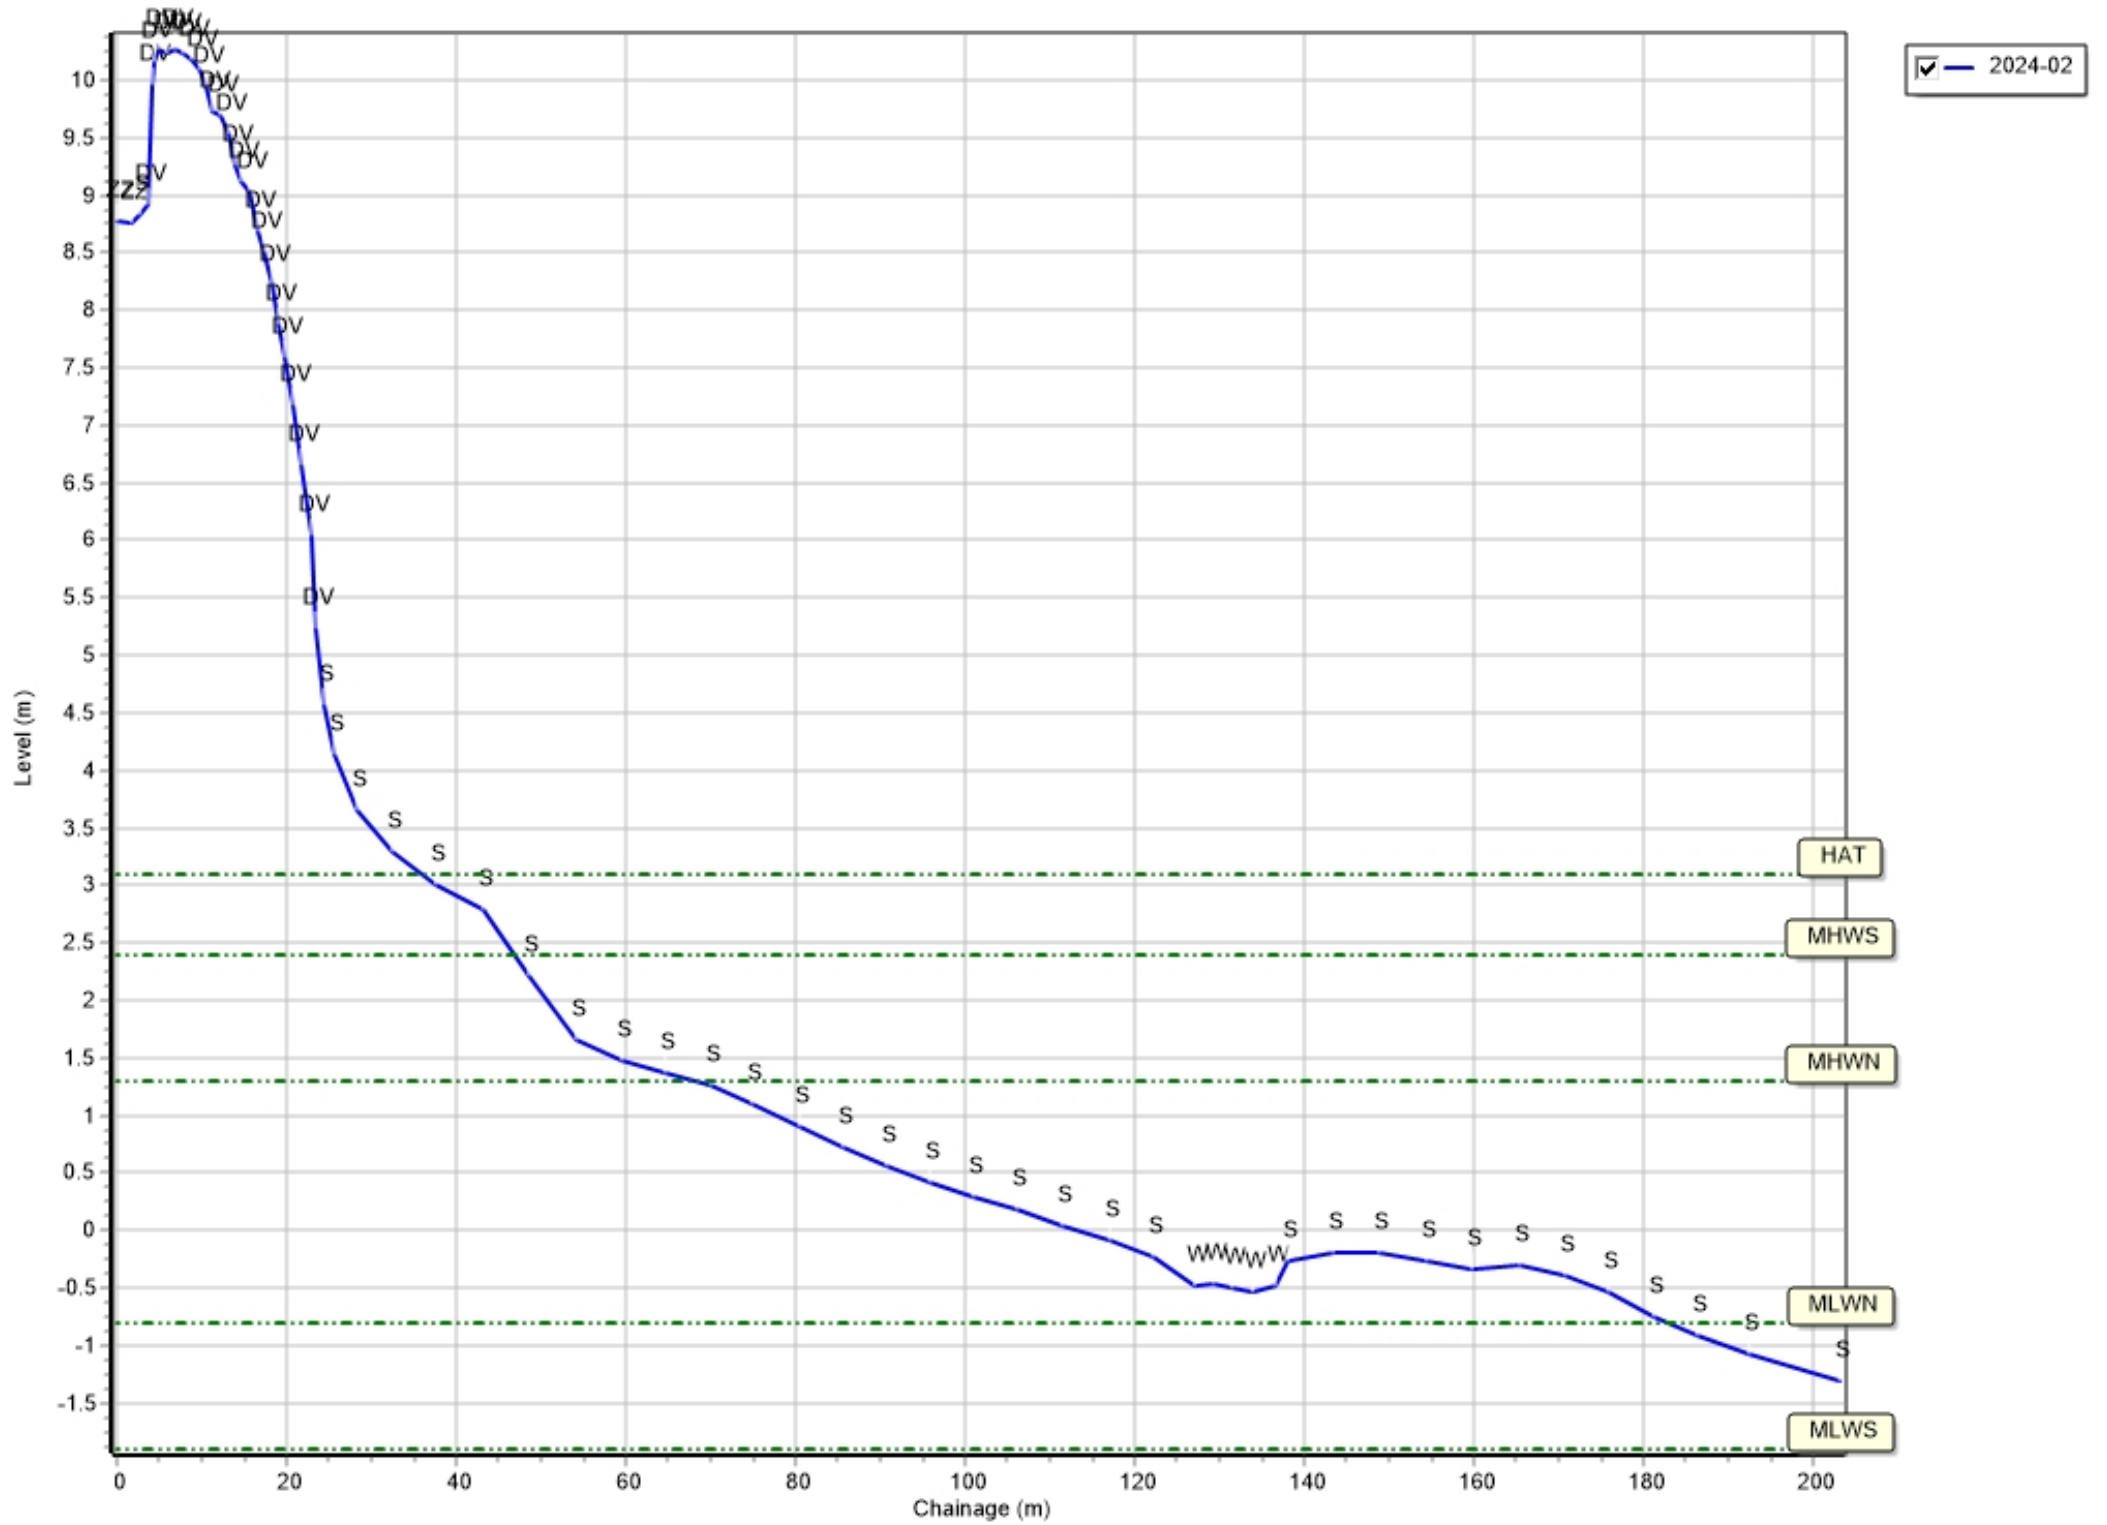
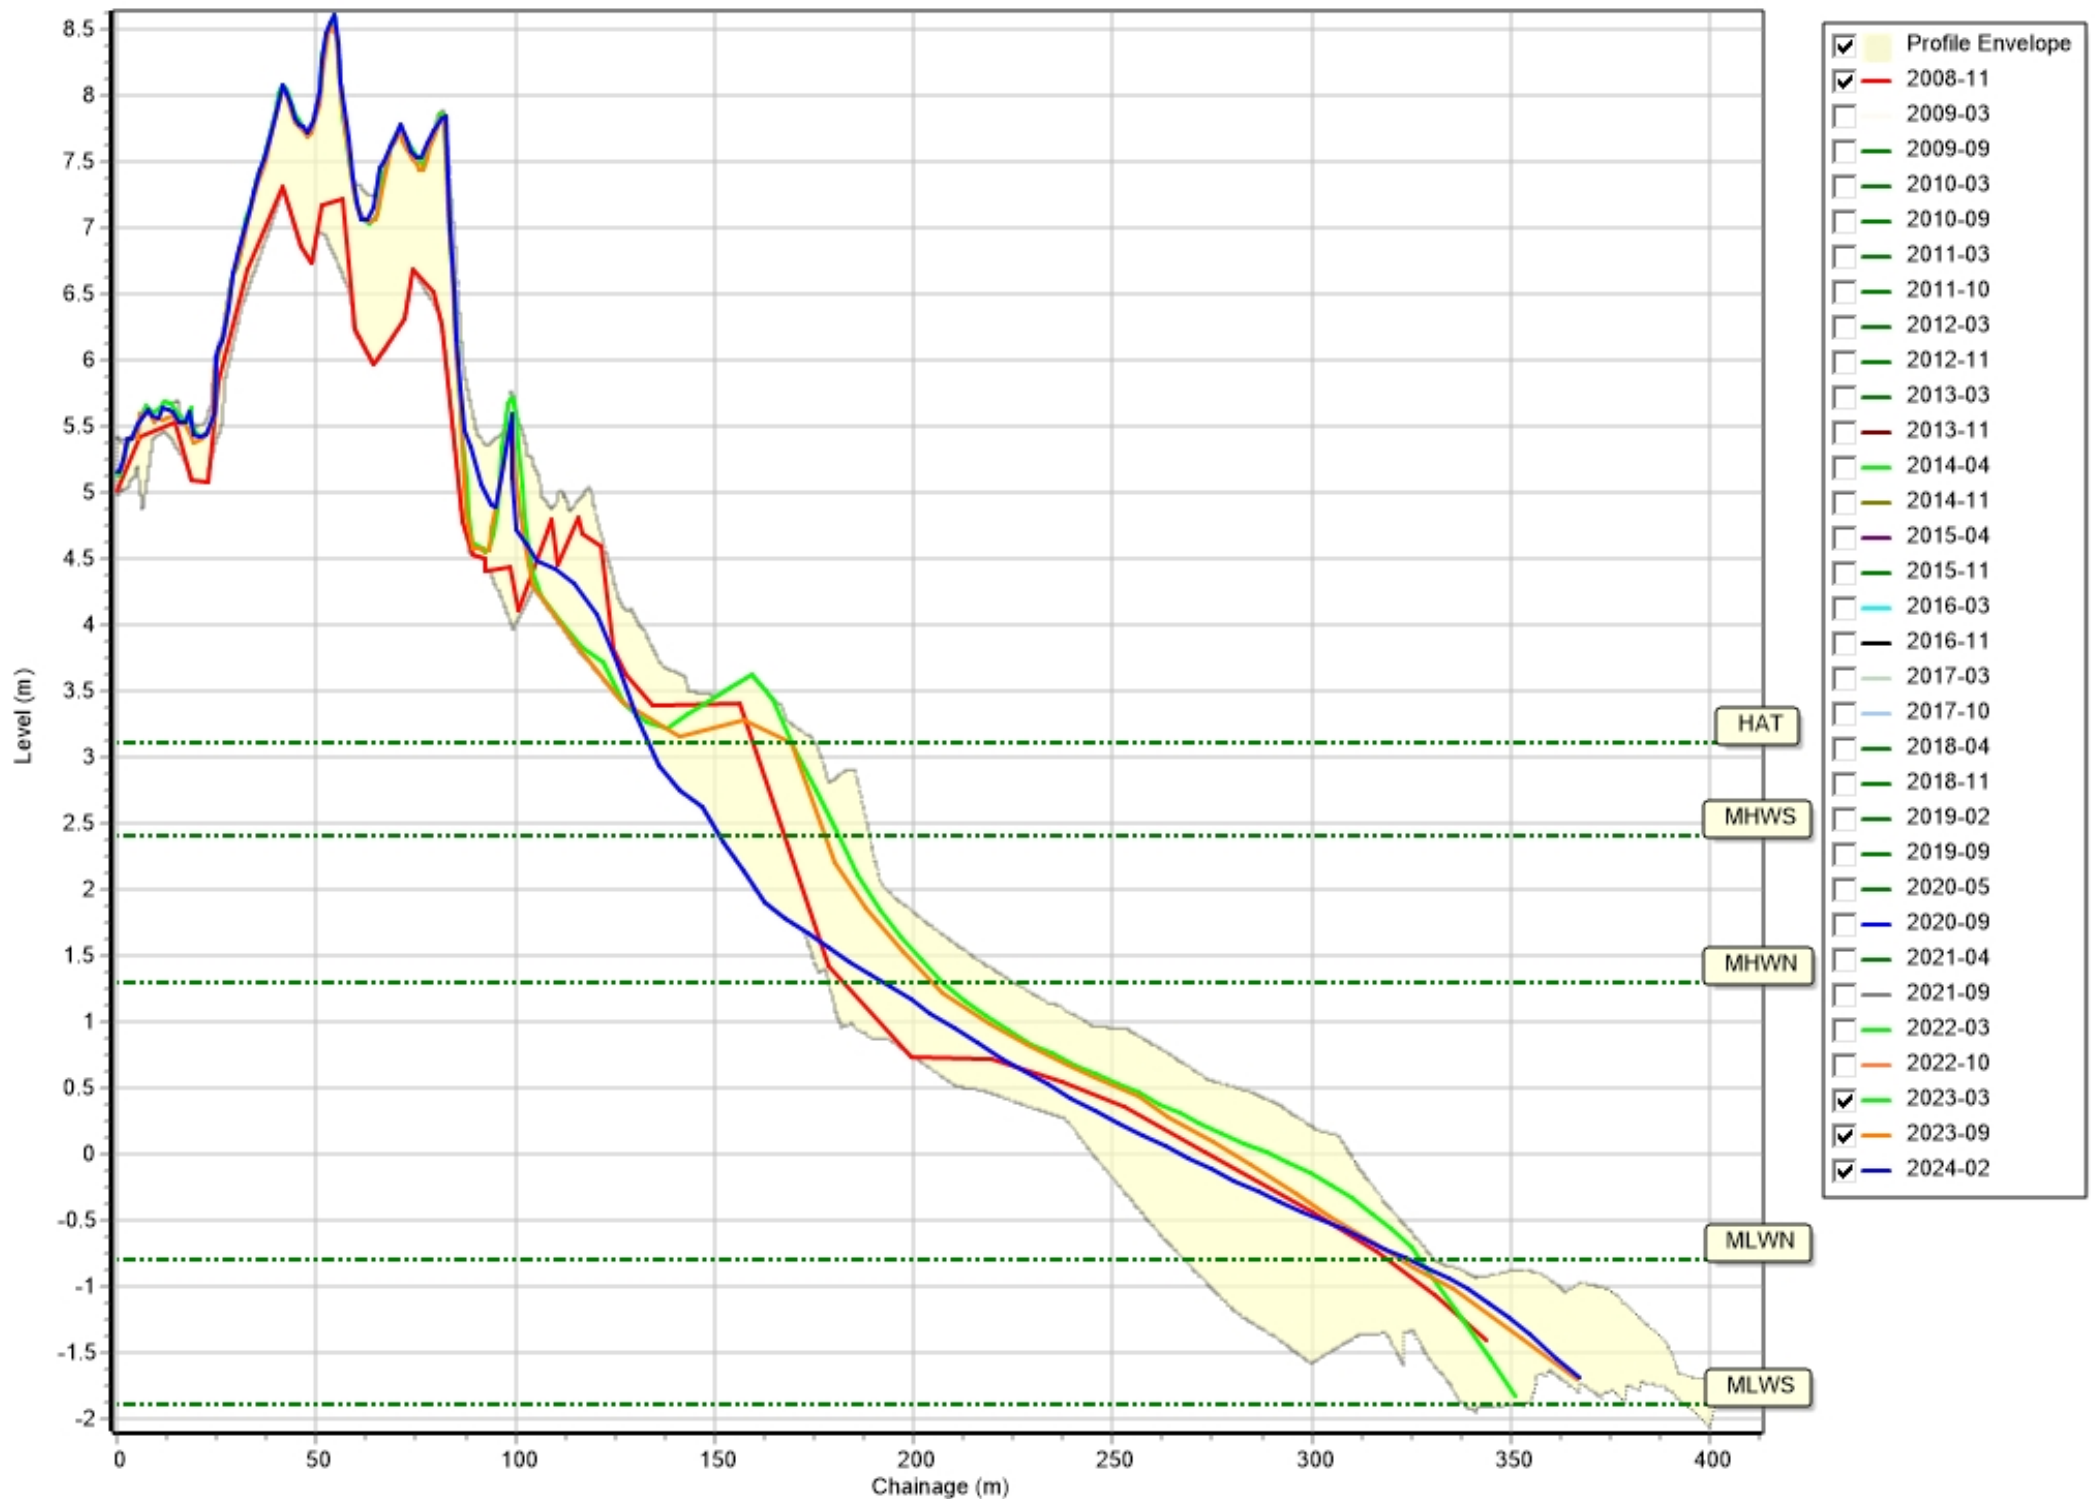
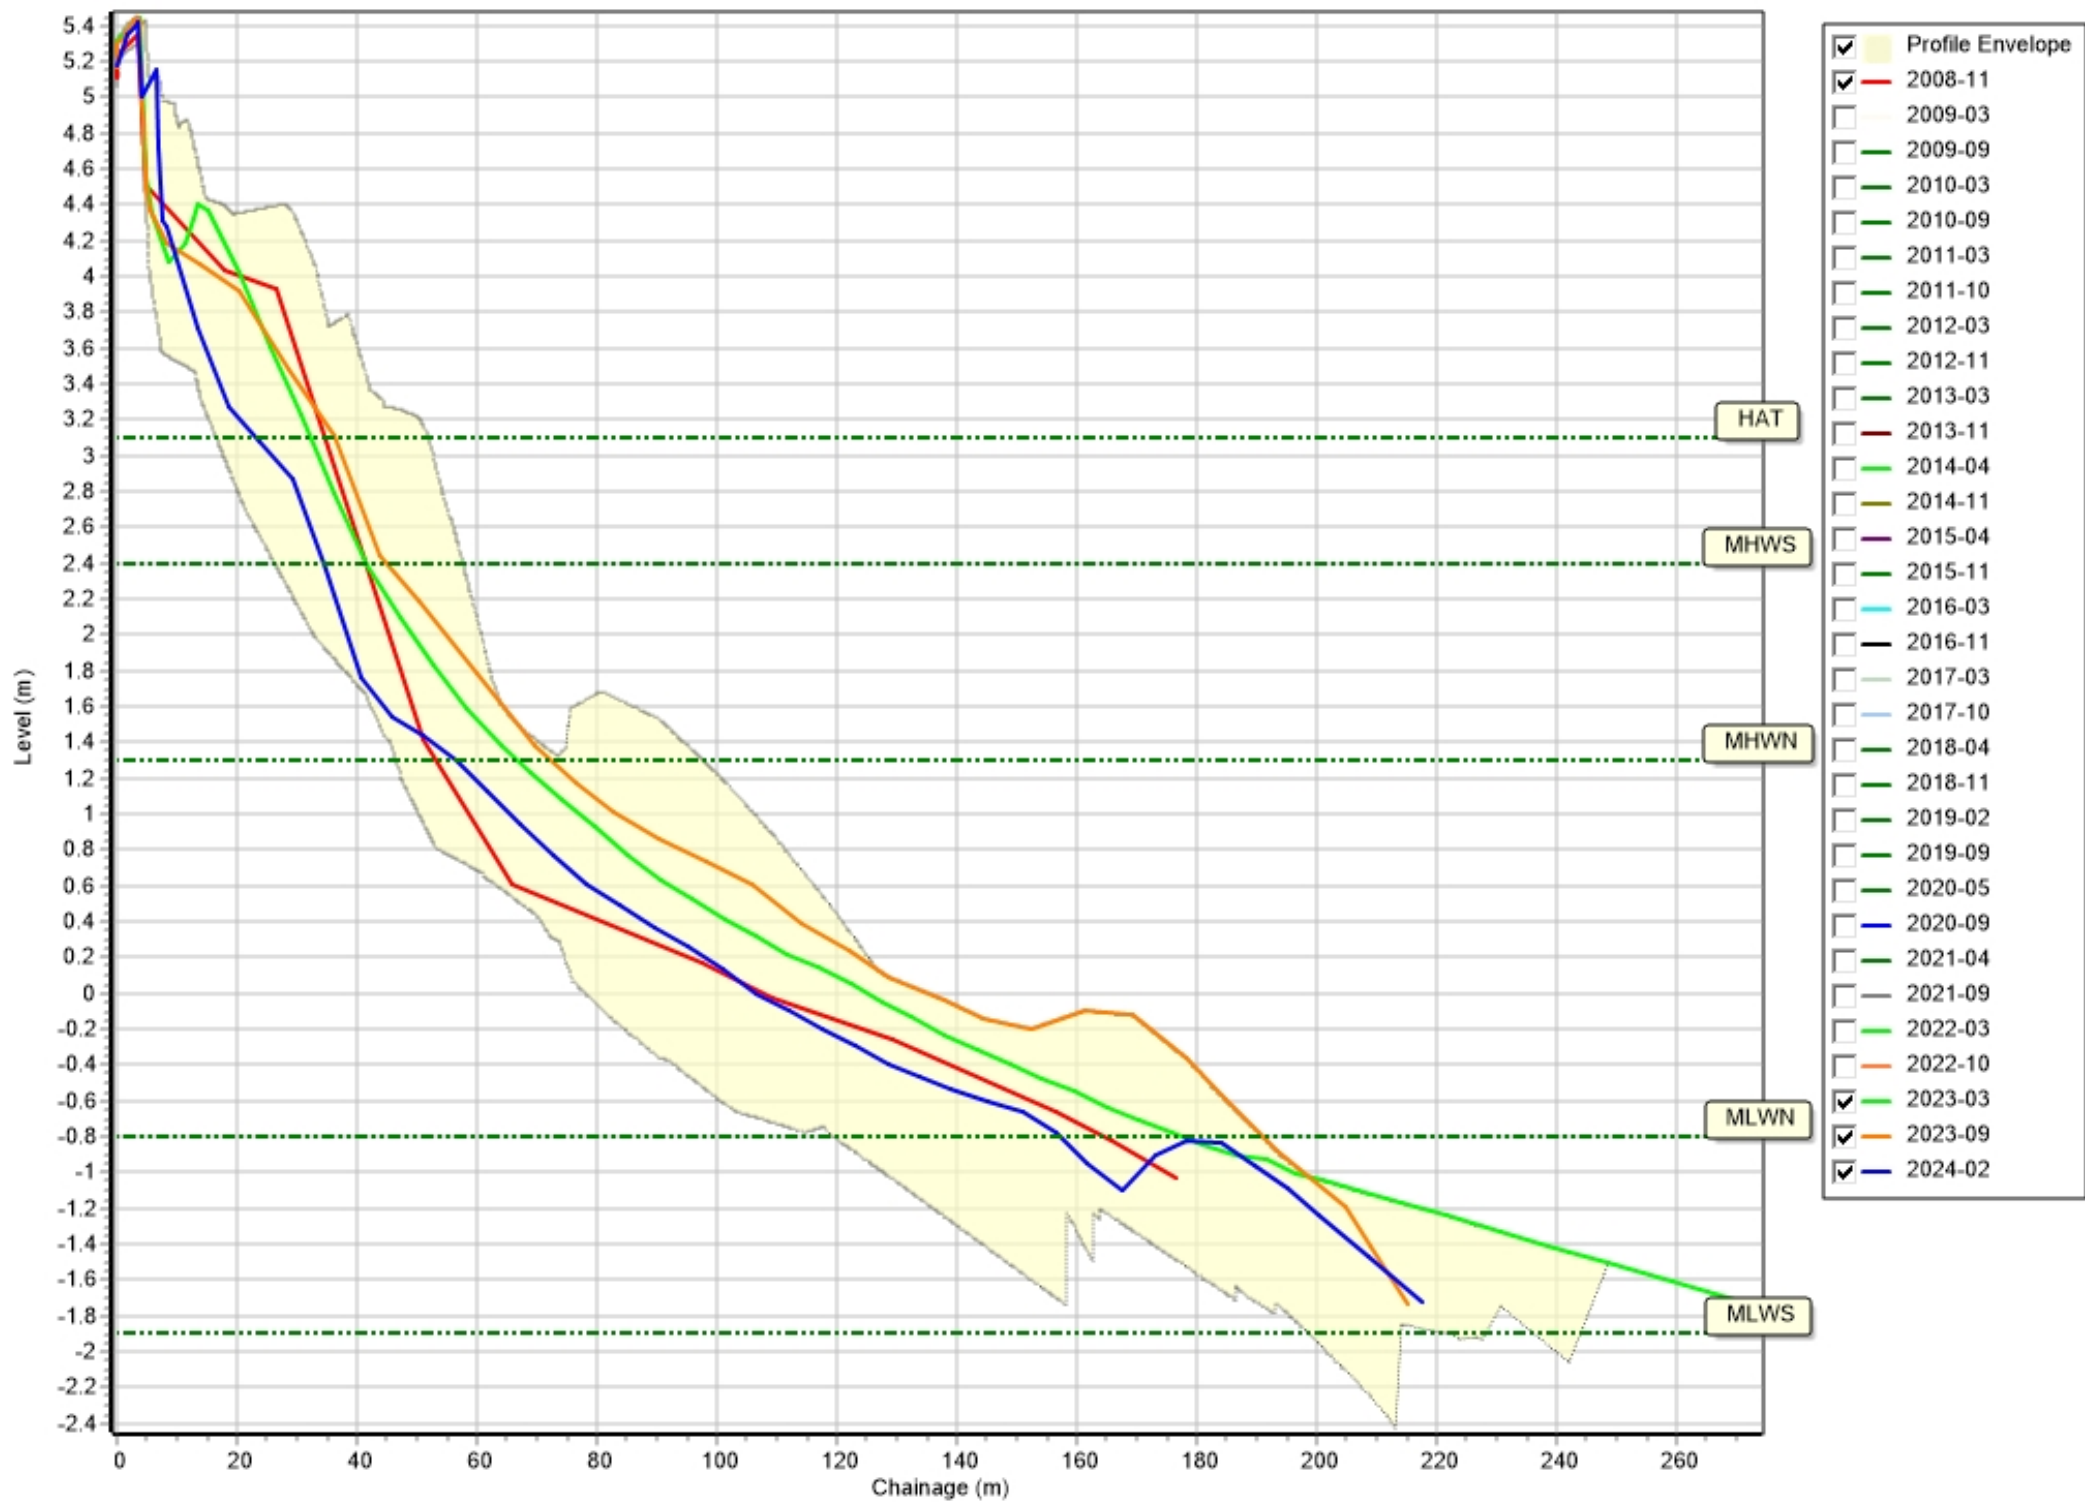
Profiles: 1bSS5

Survey Date	Description of Changes Since Last Survey	Interpretation
29 th February 2024	<p>Beach Profiles:</p> <p>Herd Sands is covered by three beach profile lines for the Partial Measures survey (Appendix A). The previous survey was the Full Measures survey undertaken in autumn 2023.</p> <p>Profile 1bSS5 is located towards the northern end of Herd Sands, in the lee of the breakwater. Sand fences were constructed on the dunes in 2012 to encourage accretion and stabilisation. Since the previous survey the dune system has largely remained stable, with change limited to low level accretion (+0.1m). Between chainage 82m and 96m, on the access track, beach levels have risen by 0.65m. Accretion (of up to 0.45m) has also occurred fronting the foredune, between chainages 102m and 130m. Seawards of chainage 130m, the profile has been dominated by lowering. This is initially by up to 1.2m, where a berm previously observed has been removed, before gradually reducing in magnitude towards the seaward end of the profile. Between chainage 130m and 175m, the profile is at the lowest level on record when compared to the range of the previous surveys.</p> <p>Profile 1bSS8 is located to the south of Herd Sands, adjacent to South Shields Surf School. At the toe of the seawall, between chainage 4m and 7m, beach levels have accreted by up to 0.7m. It is clear when interrogating the surveying photos that this is as a result of sand that has overtopped onto the promenade being swept back onto the beach. Seawards of this artificial accretion, the profile has been dominated in its entirety by lowering. The magnitude of lowering peaks at 1m at chainage 167m. When compared the range of the previous surveys, the upper beach is at a low level whilst the lower beach is at a medium level.</p> <p>Profile 1bSS9 is most southernly profile on Herd Sands and is located fronting the Water's Edge Car Park near Trow Quarry. The start of the profile, between chainage 4m and 23m, is covered by a narrow dune system. Since the previous survey, the dunes have remained stable. At the toe of the dunes, beach levels have dropped by up to 1m, creating a small cliff in the foredune toe. This erosion continues across the profile up to chainage 140m. Between chainage 143m and 178m, a shallow berm has formed resulting in increase in level of up to 0.25m. When compared to the range of the previous surveys, the upper beach is at a low level whilst the lower beach is at a medium level.</p>	<p>Over winter 2023/24, the profiles show that Herd Sands beach has experienced notable lowering. This is particularly evident on the upper beach, where a drop in level of up to 1.2m is observed. It is apparent that a small portion of this material has been drawn down the profile, with Profile 1bSS9 experiencing minor accretion on the lower beach.</p> <p>Despite this change in the fronting beach, the dunes have largely remained stable except the drop of level at the toe of the foredune.</p> <p>This loss of beach material is a typical profile response (lowering) to storm conditions. The recovery of material in calmer summer months should be monitored closely.</p> <p>Longer term trends:</p> <p>The dunes backing Herd Sands in the North have been gradually accreting since the interventions in 2012. The narrow dunes in the south have also accreted since the monitoring began in 2010, albeit at a smaller magnitude. Beach levels show more variance, with no clear long term pattern of either accretion or erosion. The profile appears to be modified by seasonal fluctuations.</p>

- Over winter 2023/24, the profiles show that Herd Sands beach has experienced notable lowering. This is particularly evident on the upper beach, where a drop in level of up to 1.2m is observed. It is apparent that a small portion of this material has been drawn down the profile, with Profile 1bSS9 experiencing minor accretion on the lower beach. Despite this beach lowering, the backing dunes (where present in the north and south of the bay) have largely remained stable except the drop of level at the toe of the foredune. The lowering of the fronting beach is a typical response to storm conditions. The recovery of material in calmer summer months should be monitored closely.
