North East
Coastal
Observatory

Cell 1 Regional Coastal Monitoring Programme Update Report 16: 'Partial Measures' Survey 2024

South Tyneside Council

South Tyneside Council
April 2024

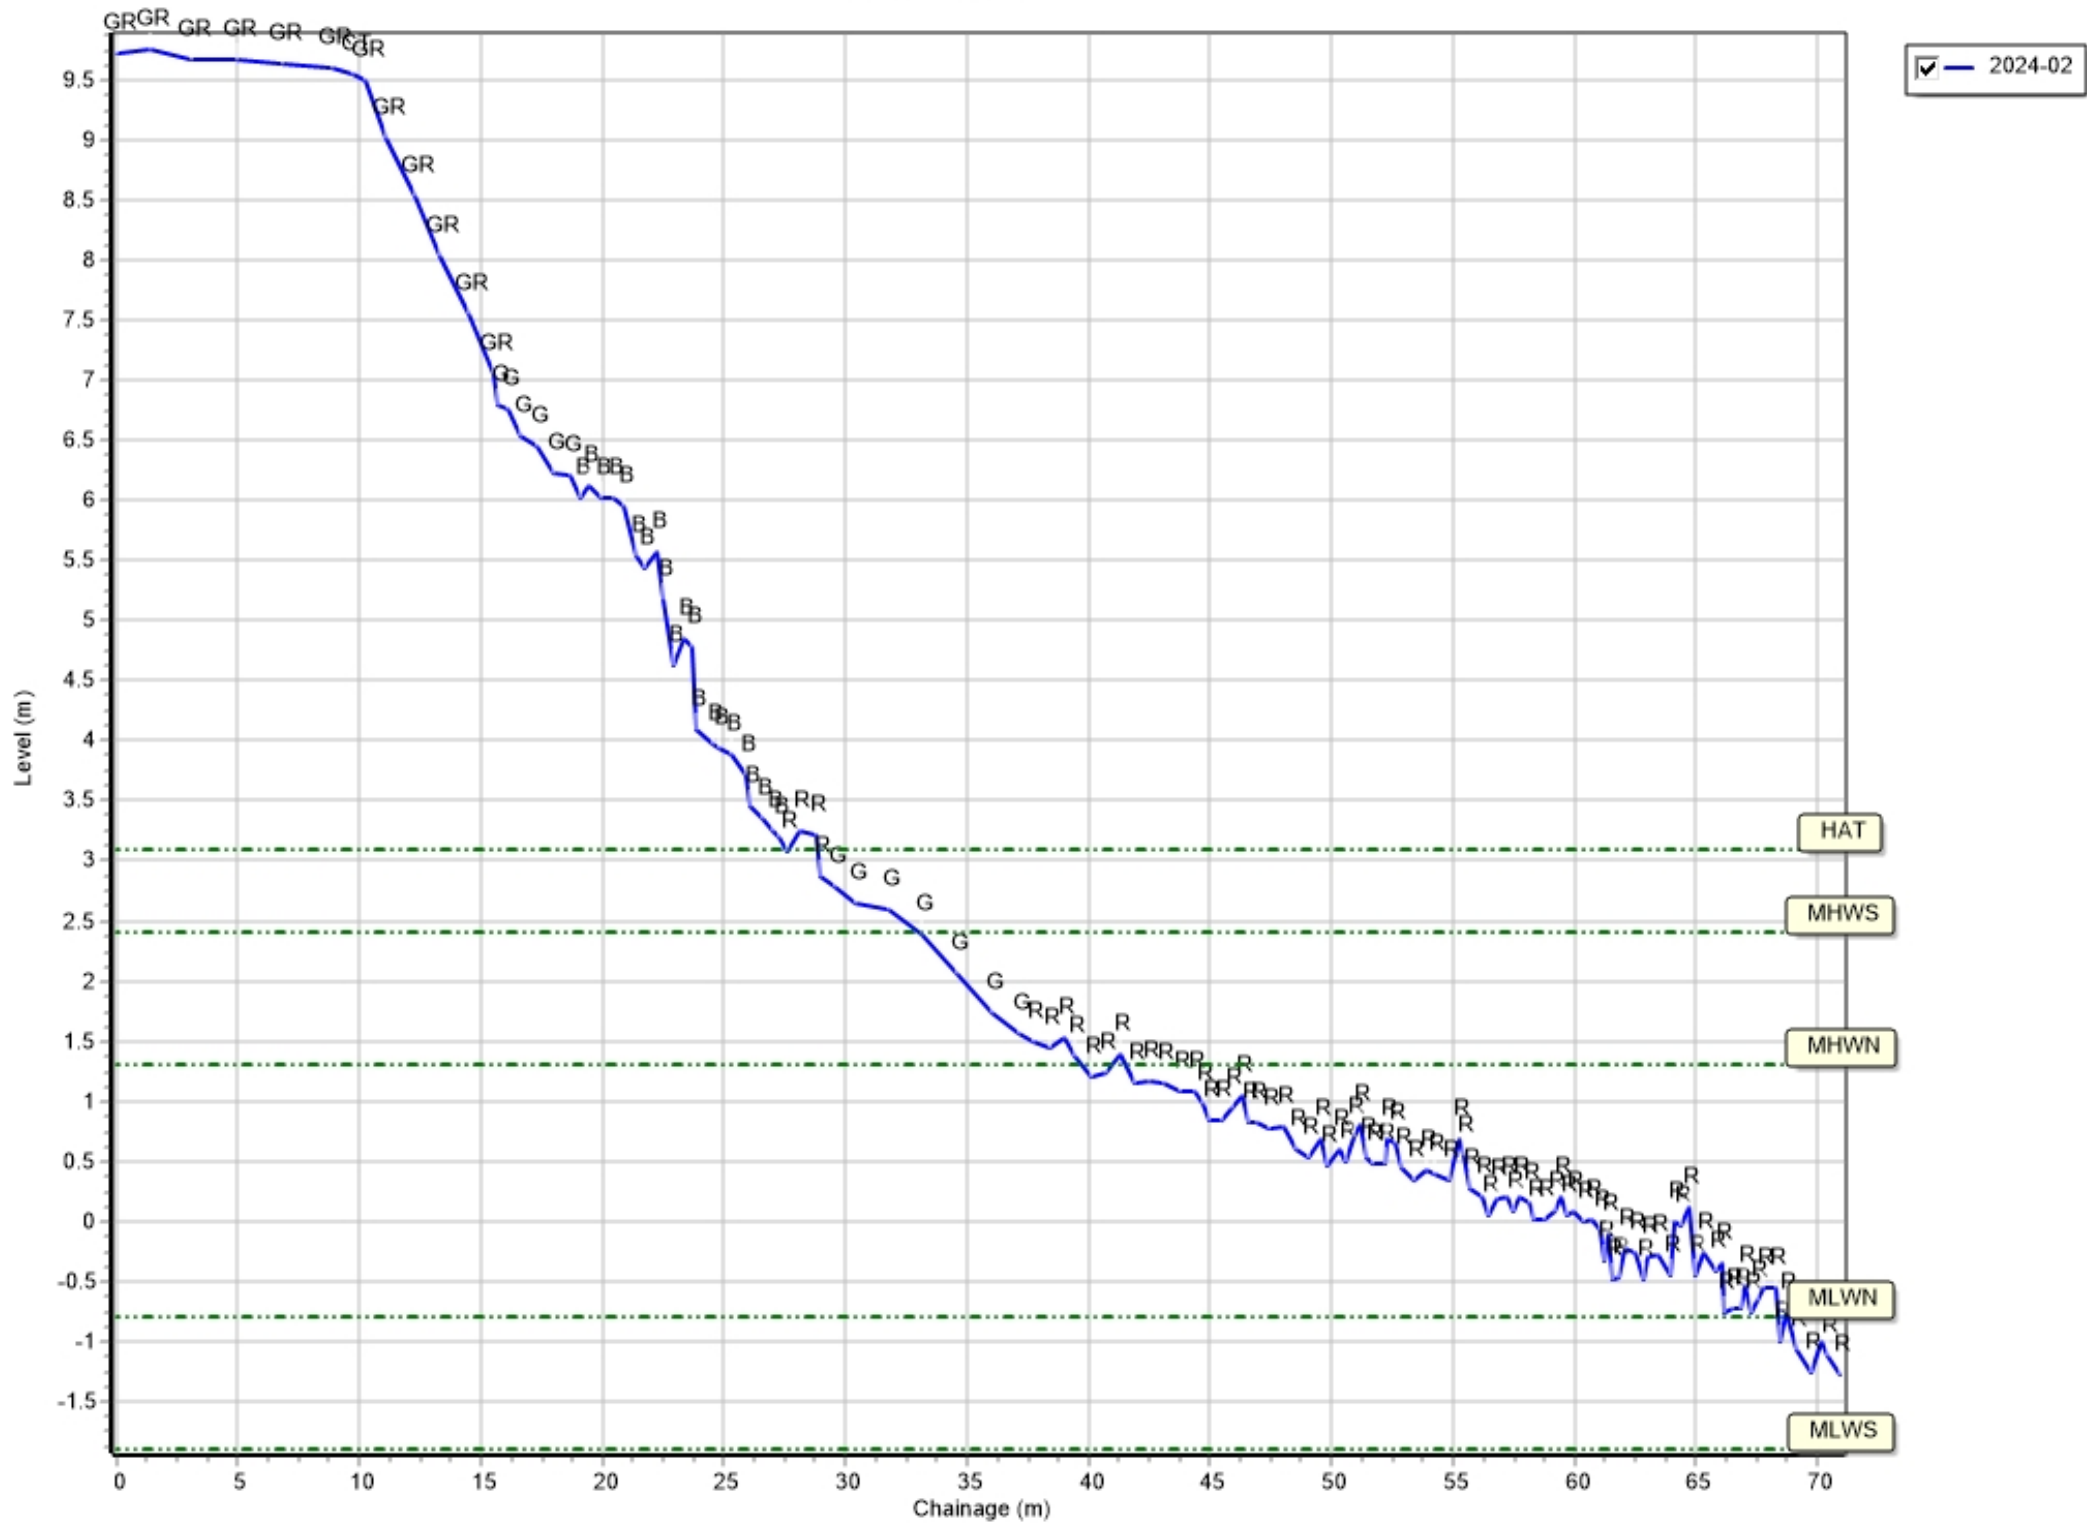
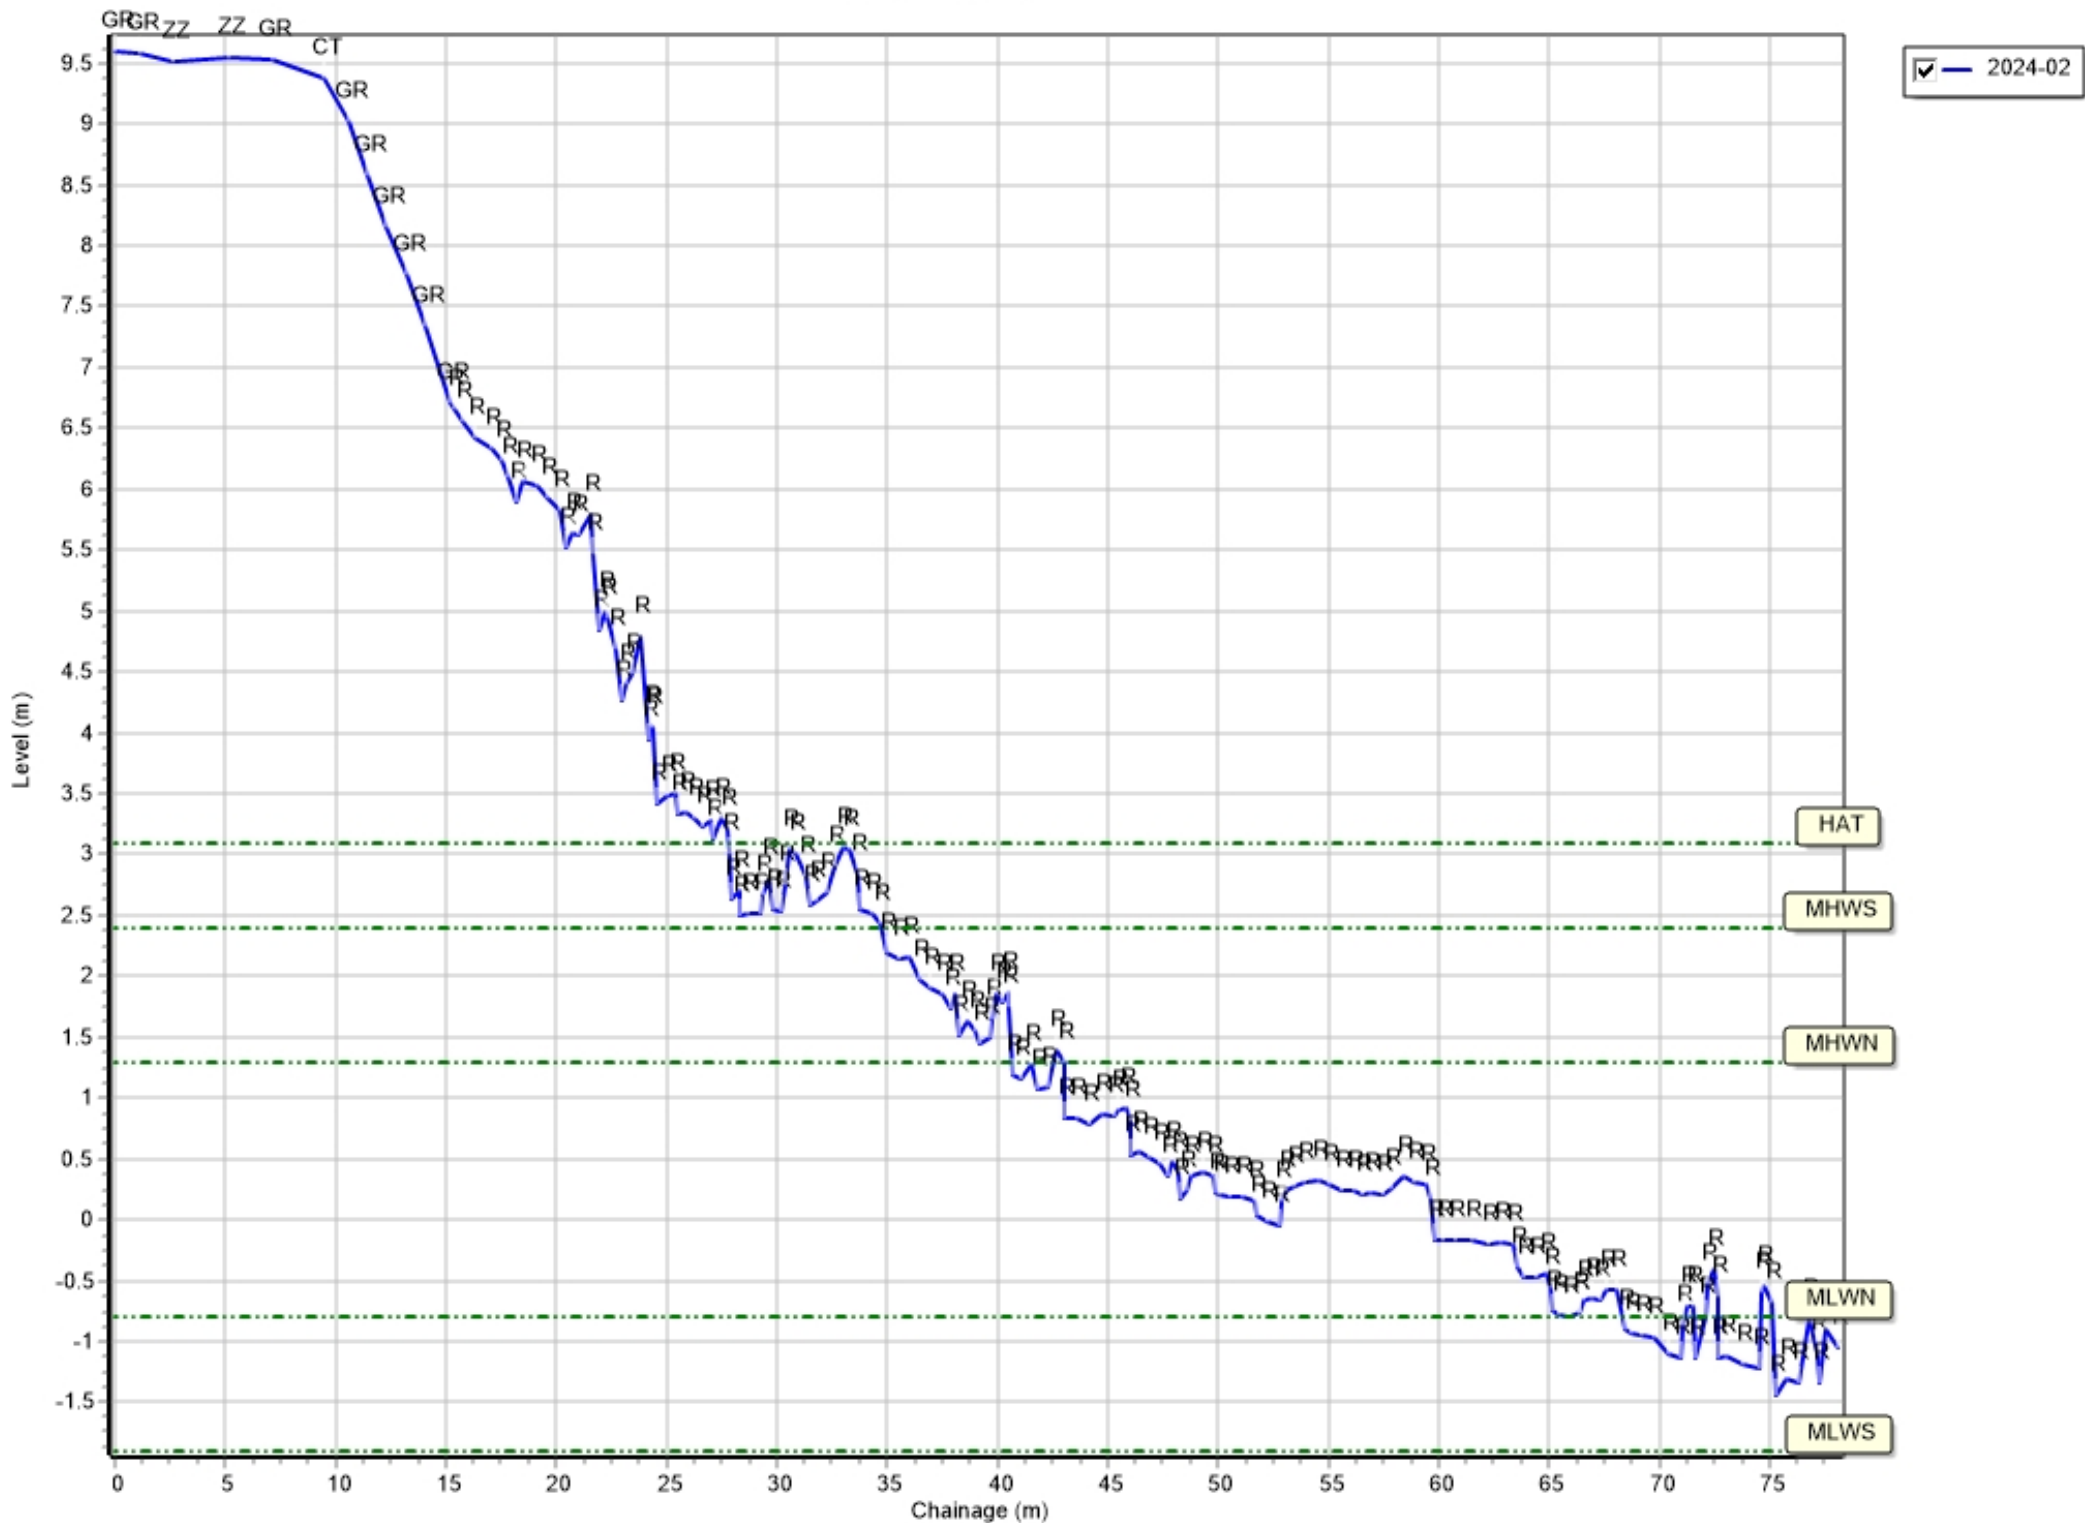
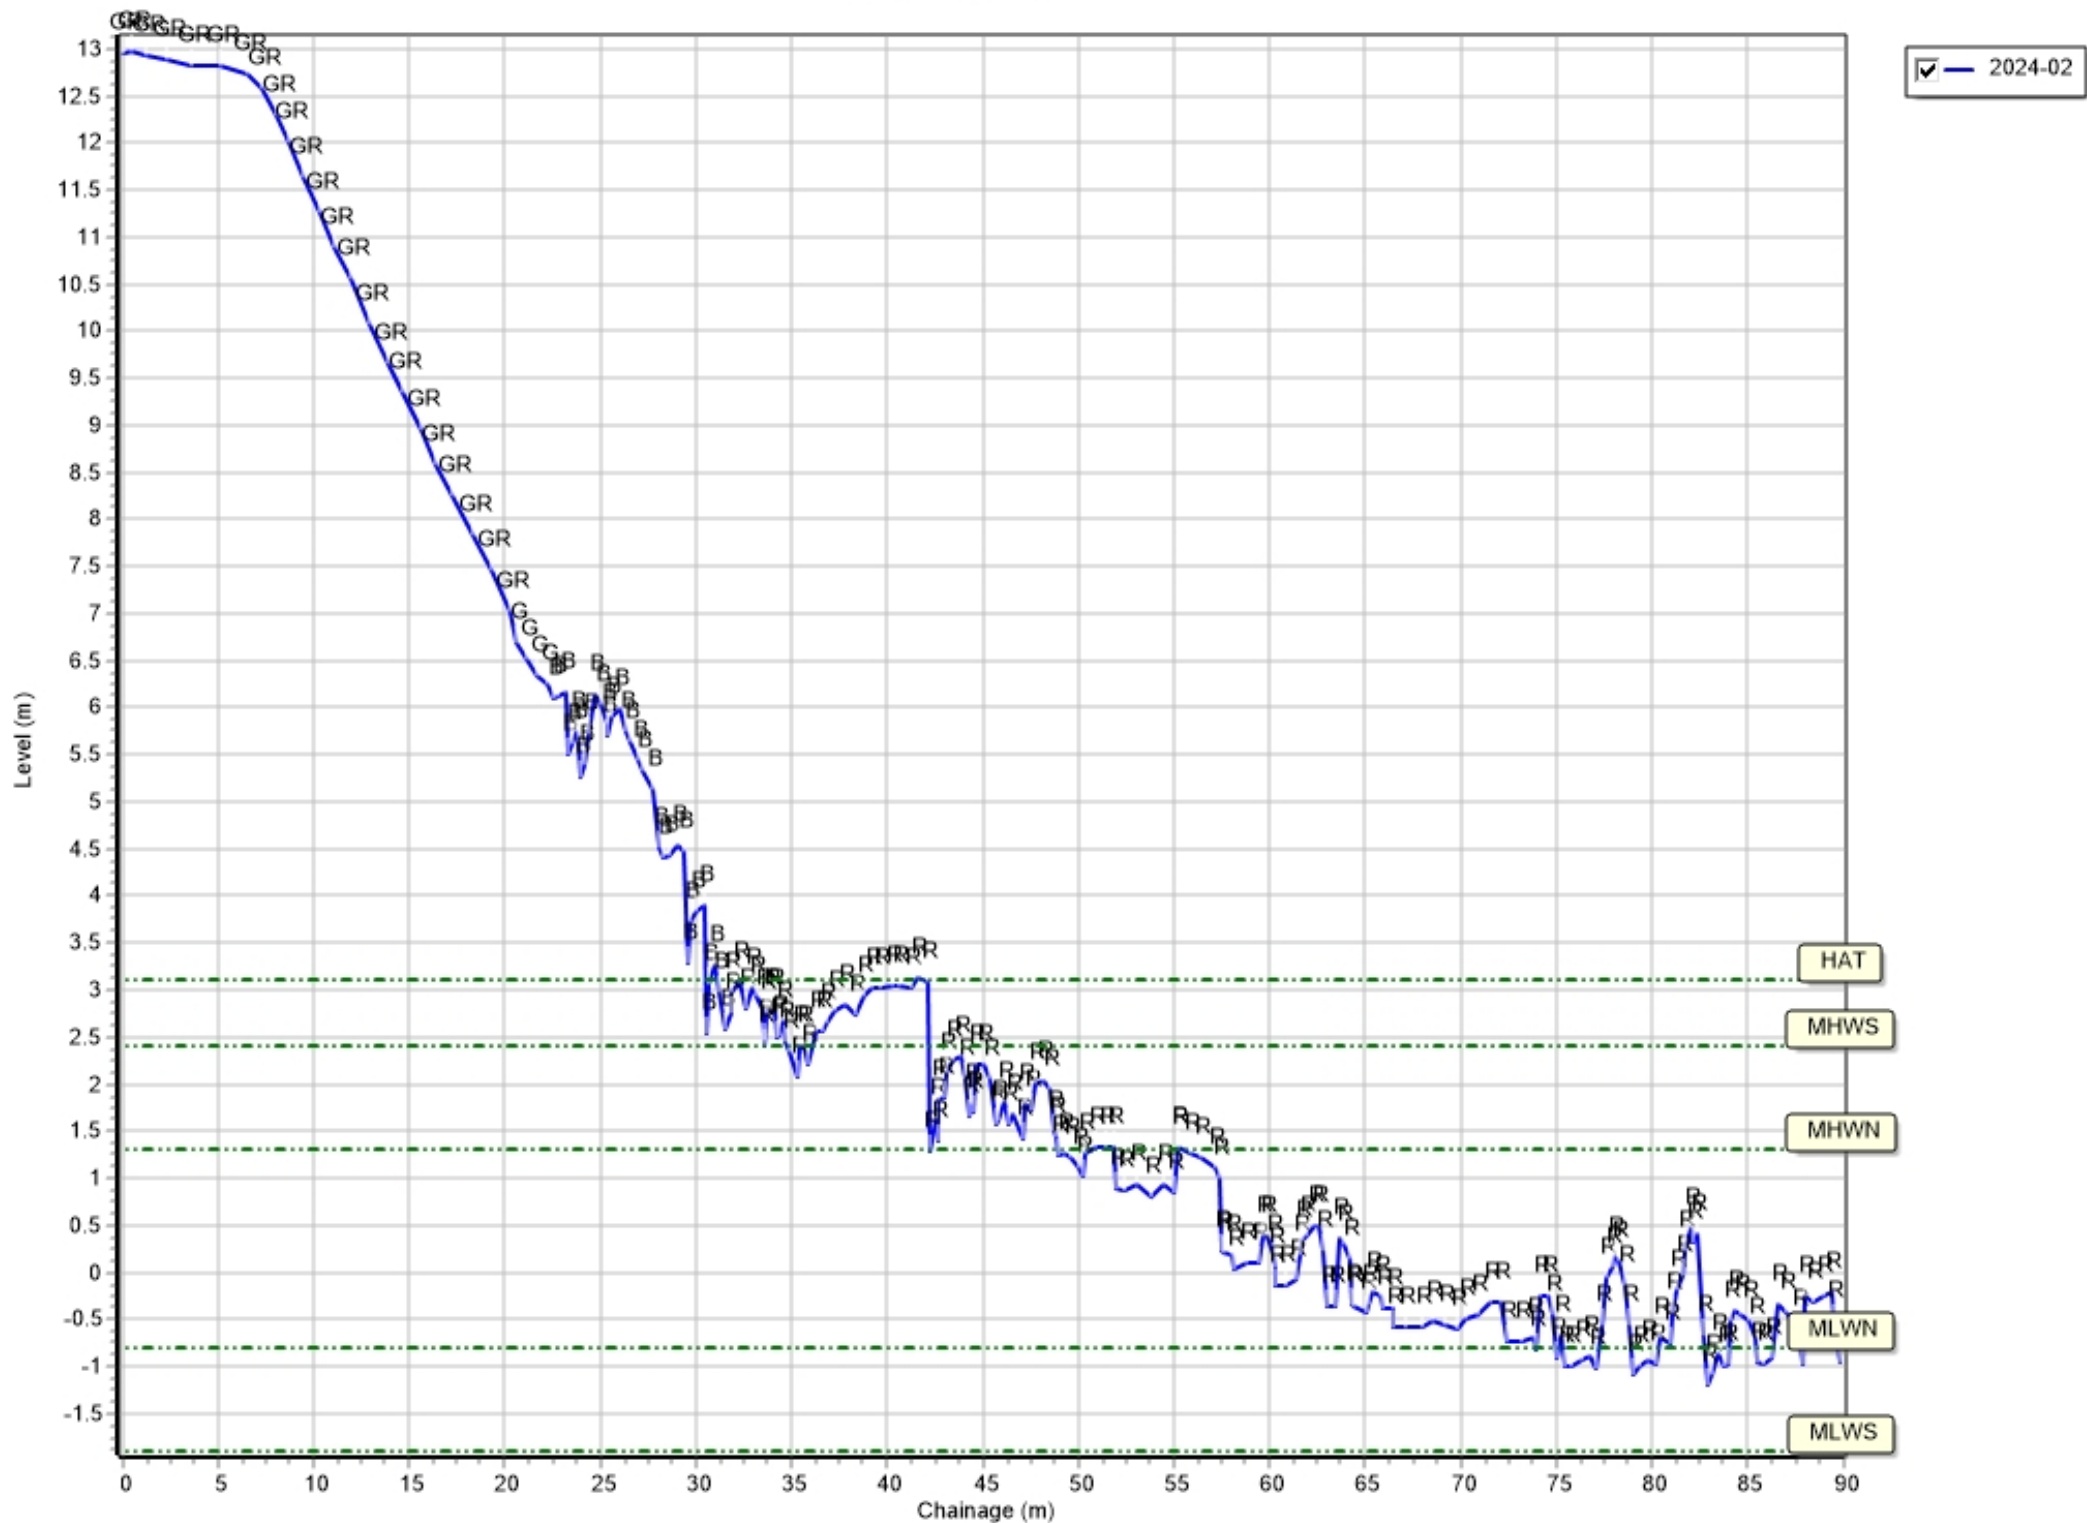
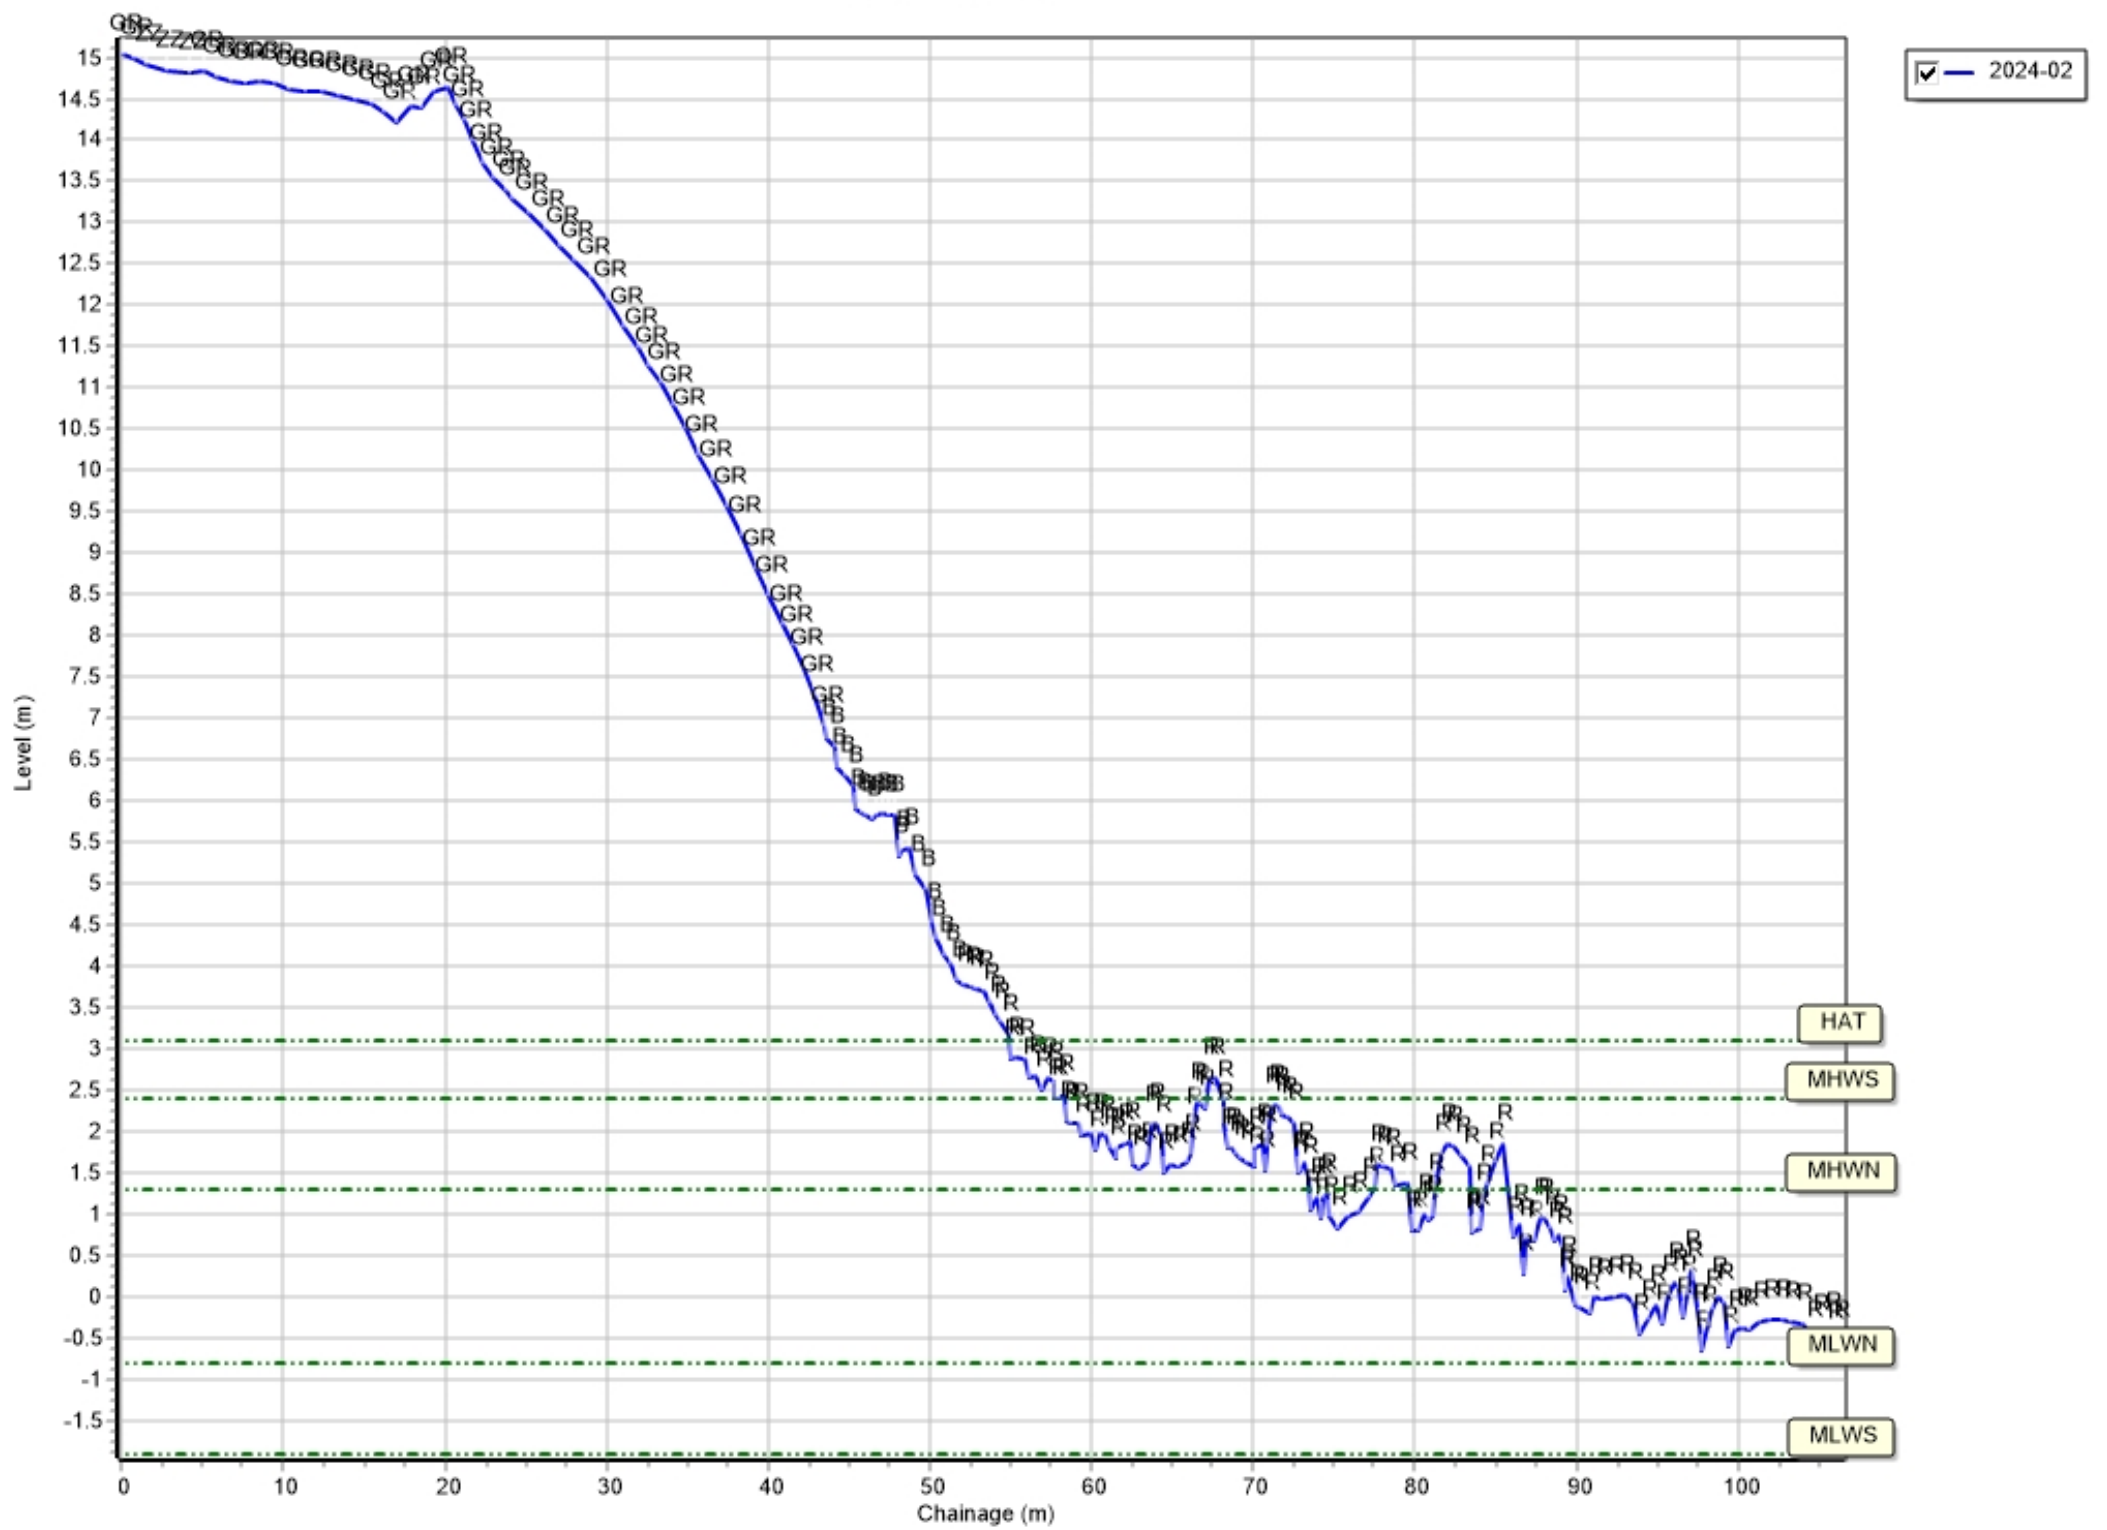
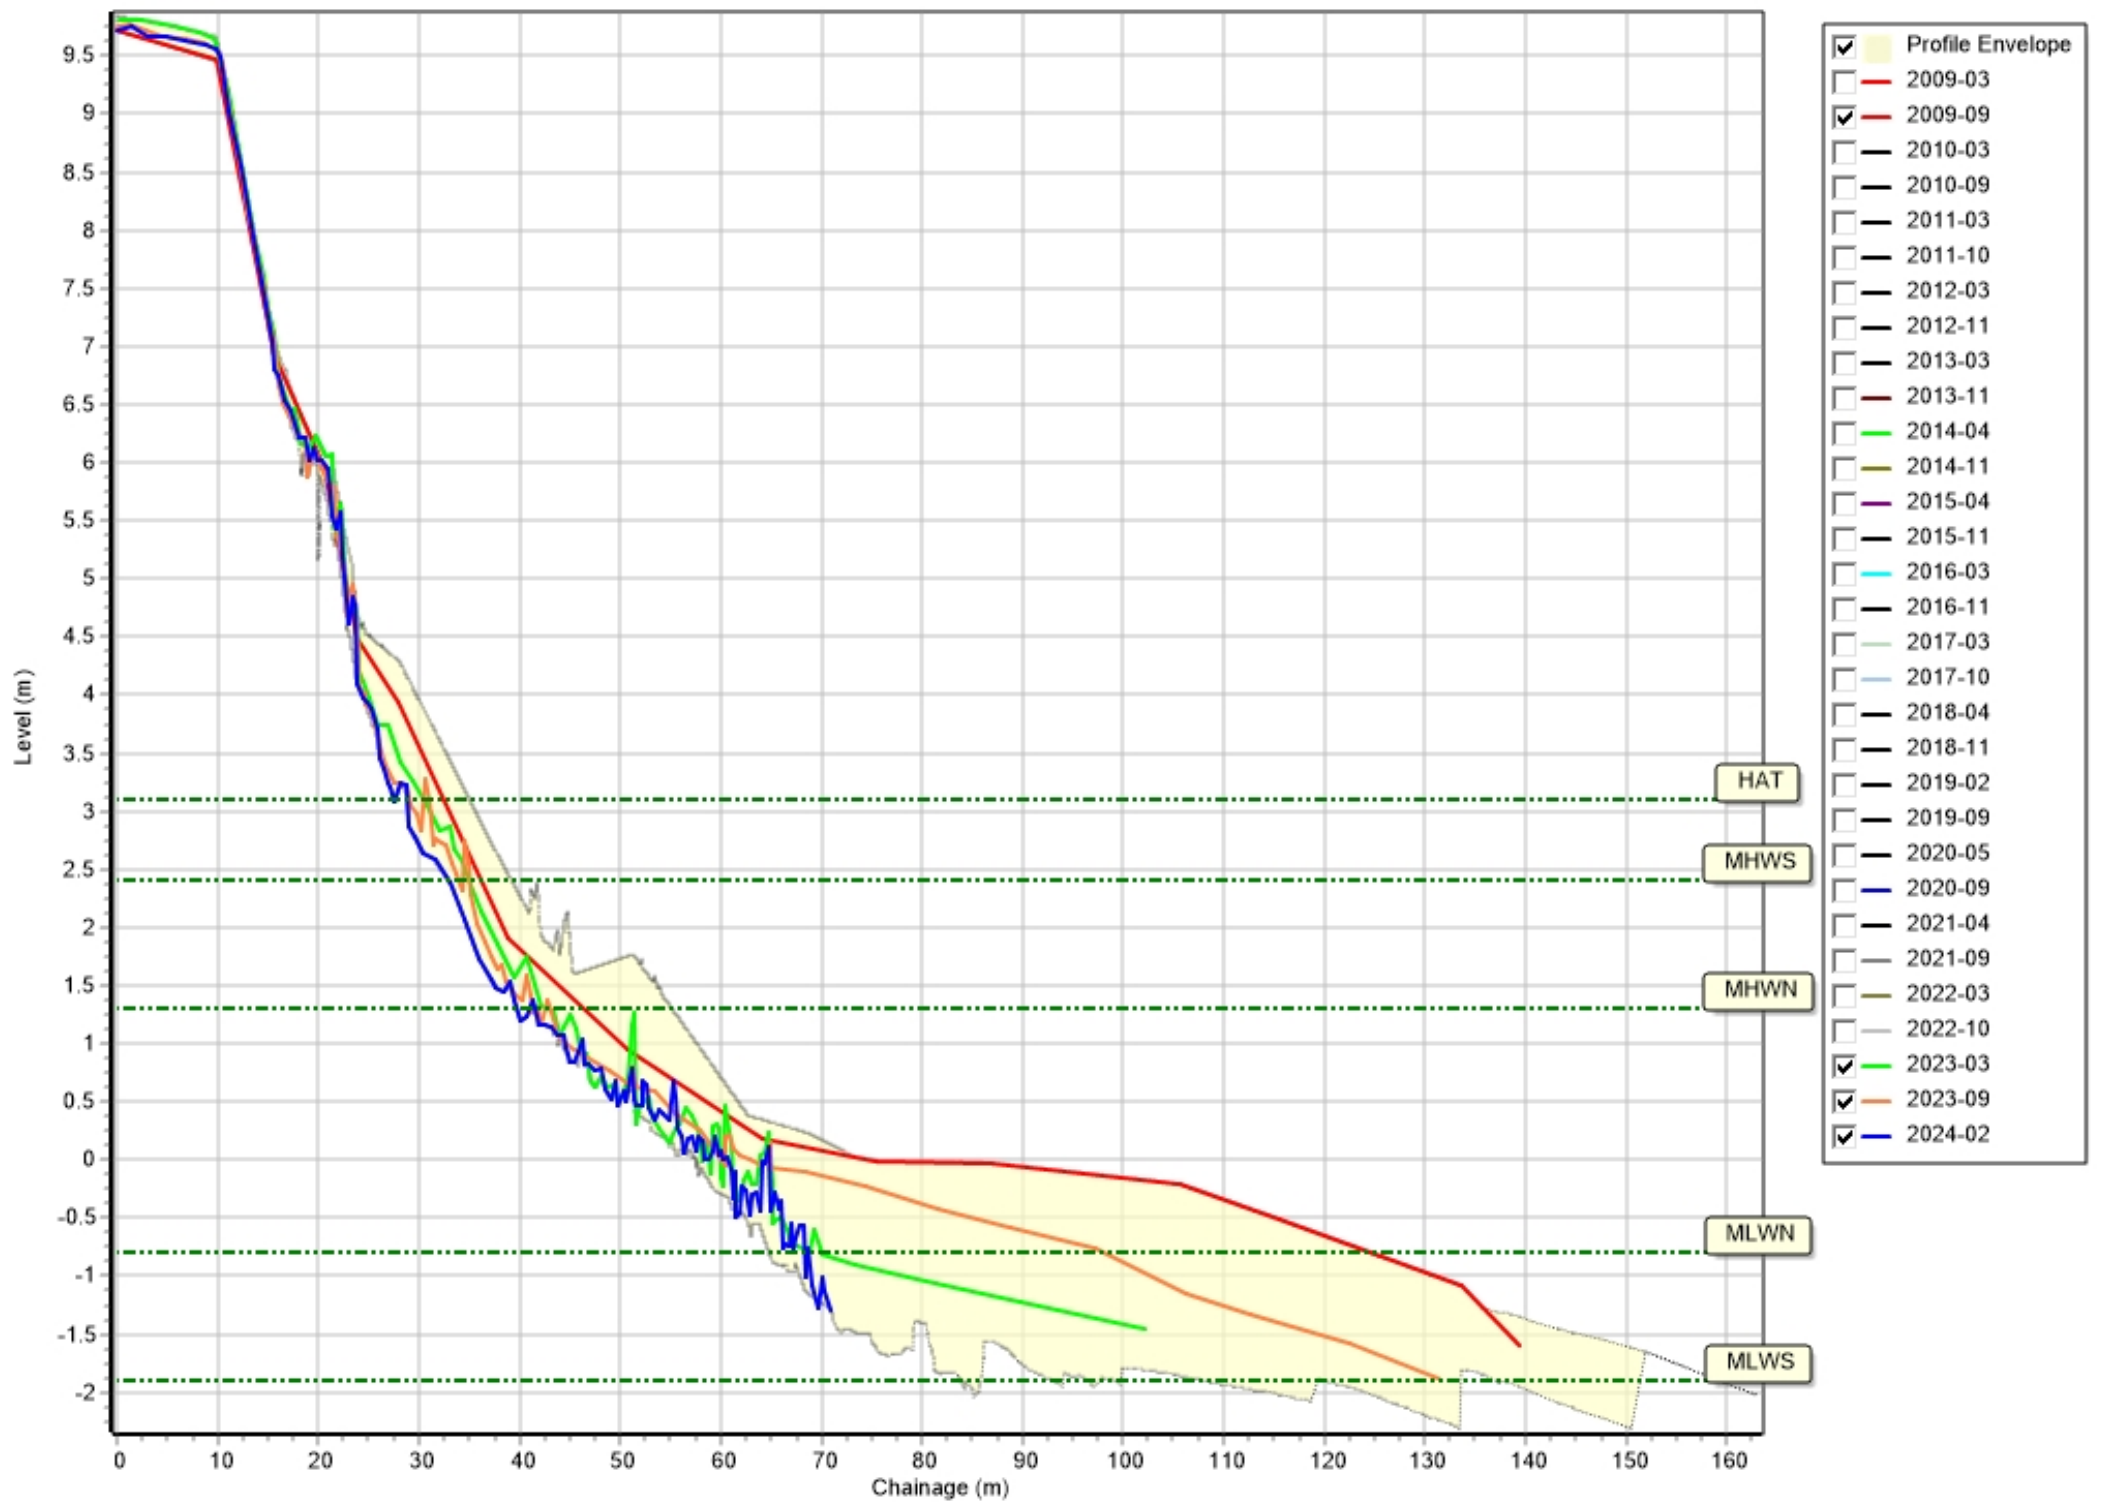
Profiles: 1bSS10

Survey Date	Description of Changes Since Last Survey	Interpretation
29 th February 2024	<p>Beach Profiles:</p> <p>Trow Quarry is covered by four beach profile lines for the Partial Measures survey (Appendix A), two in Graham’s Sand and two in Southern Bay. The previous survey was the Full Measures survey undertaken in autumn 2022.</p> <p>Profiles 1bSS10 and 1bSS11 are located in Graham’s Bay.</p> <p>Profile 1bSS10 has remained stable until the toe of the rock revetment at chainage 26m. Seawards of this point, beach levels have dropped. Initially this lowering is modest (up to 0.2m until chainage 60m), before increasing in magnitude to a drop in level of 1m at the seaward end of the profile at chainage 71m. As a result of the erosion, the rocky foreshore / boulder field has been exposed over a greater length than in the previous survey. At the crest of the revetment (chainage 15m), minor erosion of the coastal slope has exposed a geotextile. The beach profile is at a very low level when compared to the range of the previous surveys and, in places, at the lowest on record.</p> <p>Profile 1bSS11, is located in the southern half of Graham’s Bay. Since the previous survey, the profile has remained stable with change limited to the local movement of larger cobbled material, particularly between chainages 24m and 32m. The profile remains at a very low level when compared to the range of the previous surveys.</p> <p>Profiles 1bSS12 and 1bSS13 are located in Southern Bay. As per Graham’s Bay, the profiles consist of a rock revetment protecting an historical landfill site. The rock revetment is fronted by the exposed rocky fore shore with intermittent large cobbles. At both locations the beach profile has remained stable since the previous survey, with change limited to the movement of cobbles on the foreshore.</p>	<p>The profiles at Grahams Bay and southern Bay have remained stable across the backing hinterland and protecting rock revetment since the previous survey. Where beach material was present, it has dropped in level, exposing a greater length of rocky foreshore.</p>

- The profiles at Graham’s Bay and Southern Bay at Trow Quarry have remained stable across the backing hinterland and protecting rock revetment since the previous survey. Where beach material was present, it has dropped in level, exposing a greater length of rocky foreshore.
