North East
Coastal
Observatory

Cell 1 Regional Coastal Monitoring Programme Update Report 16: 'Partial Measures' Survey 2024

South Tyneside Council

South Tyneside Council
April 2024

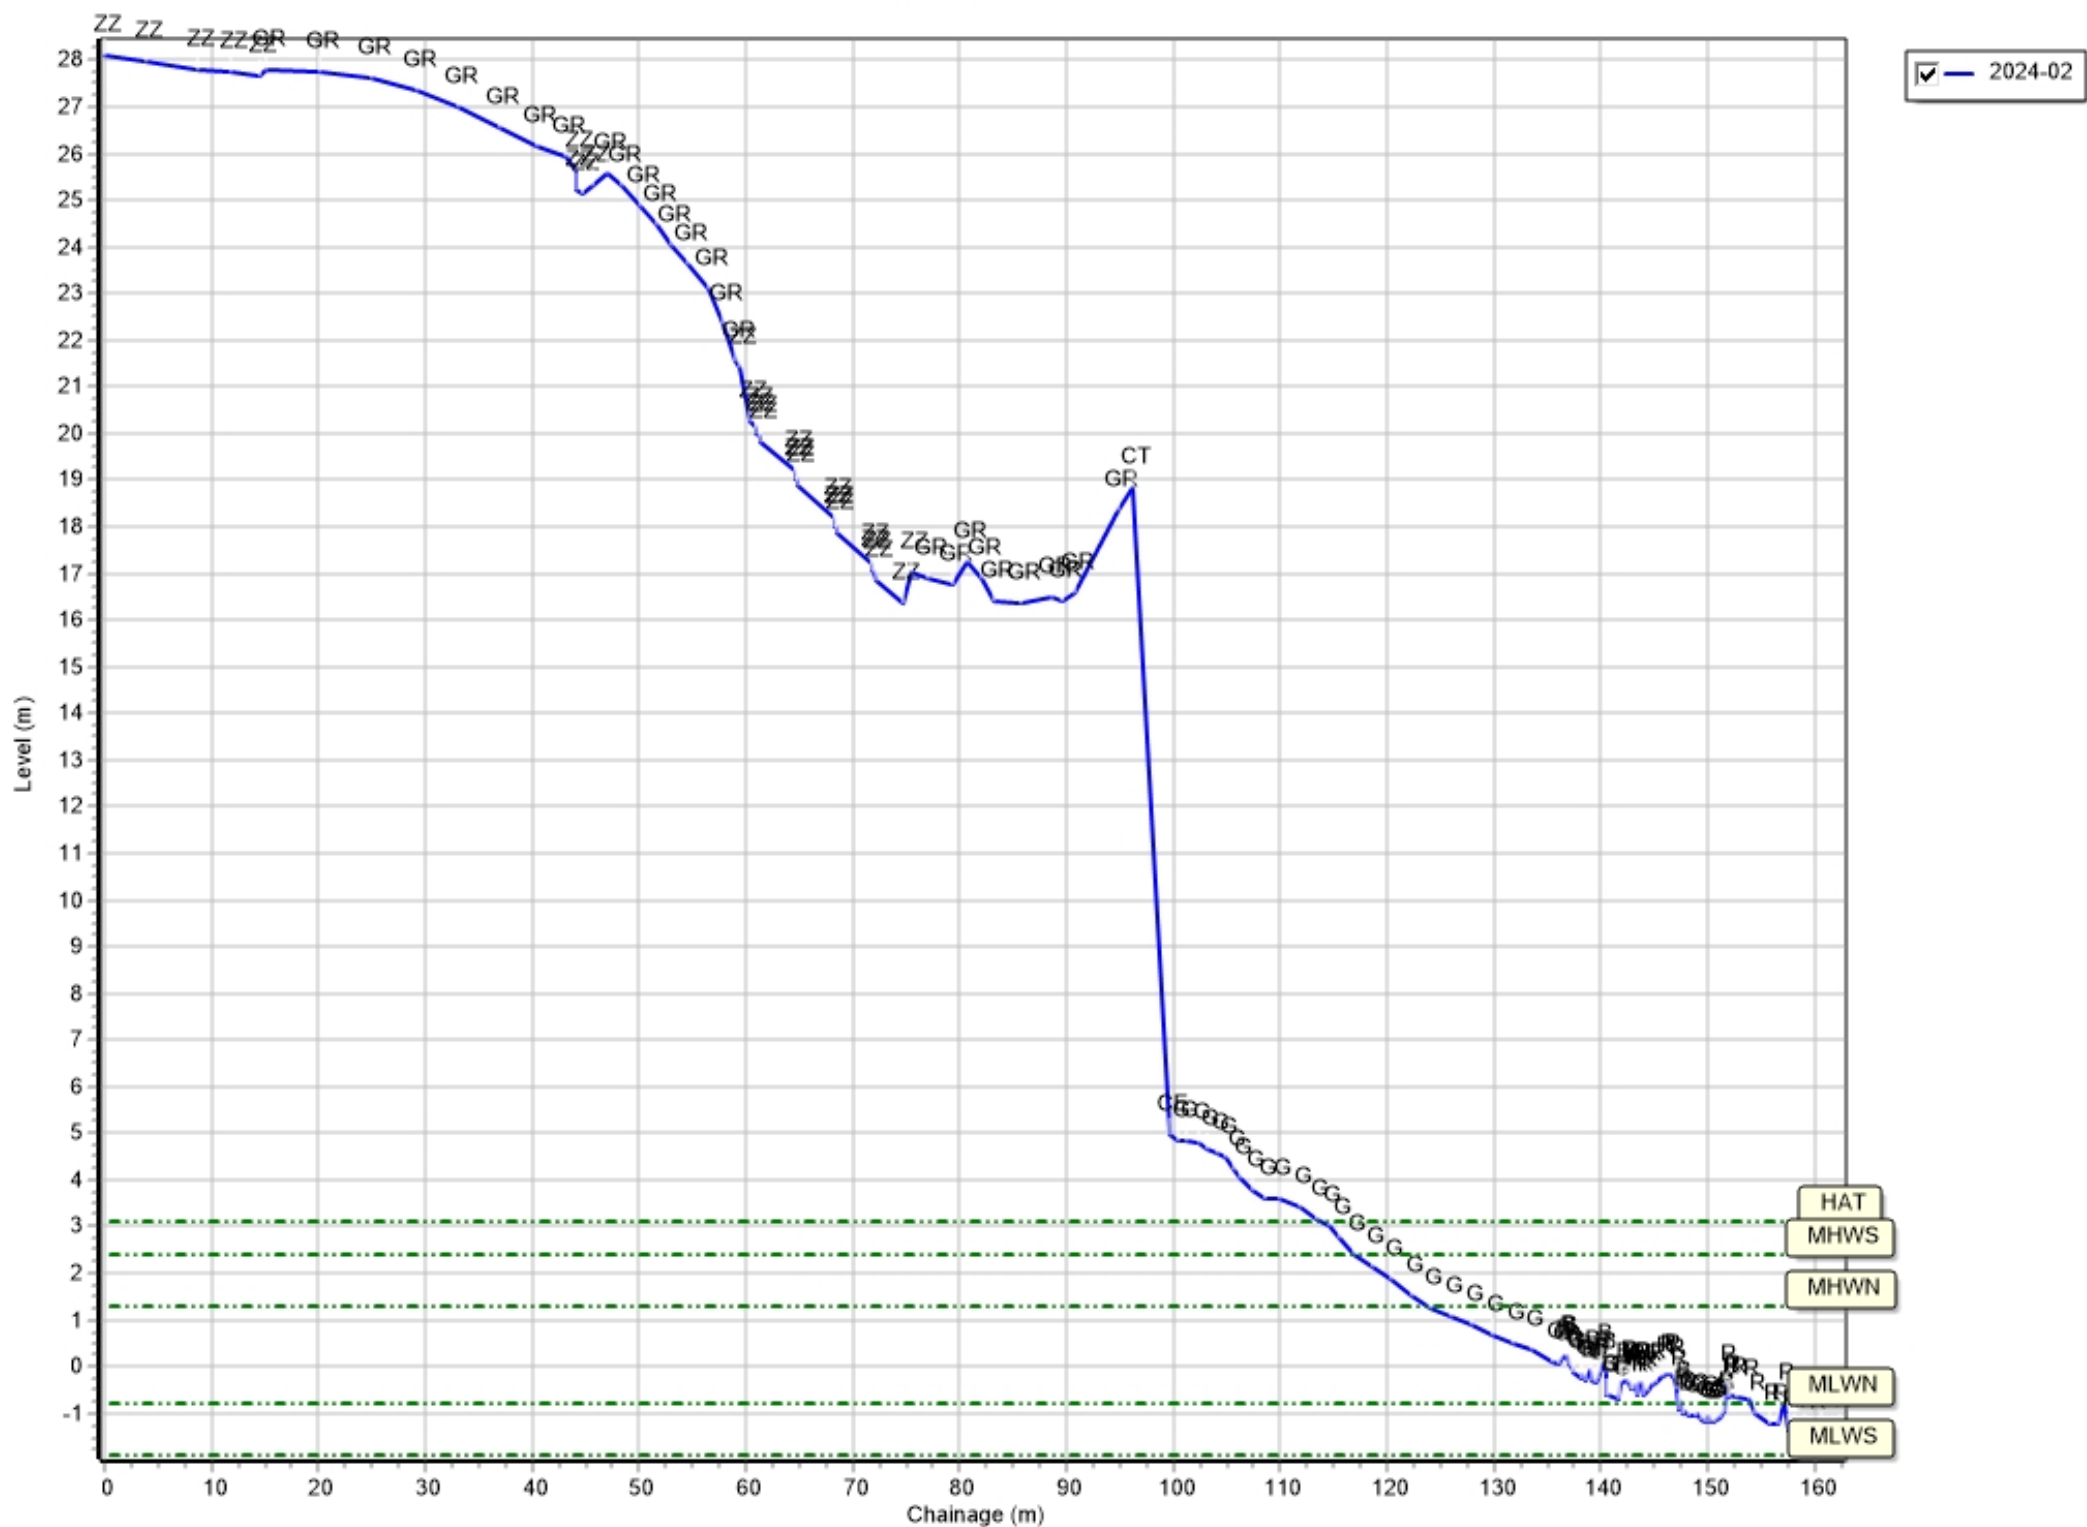
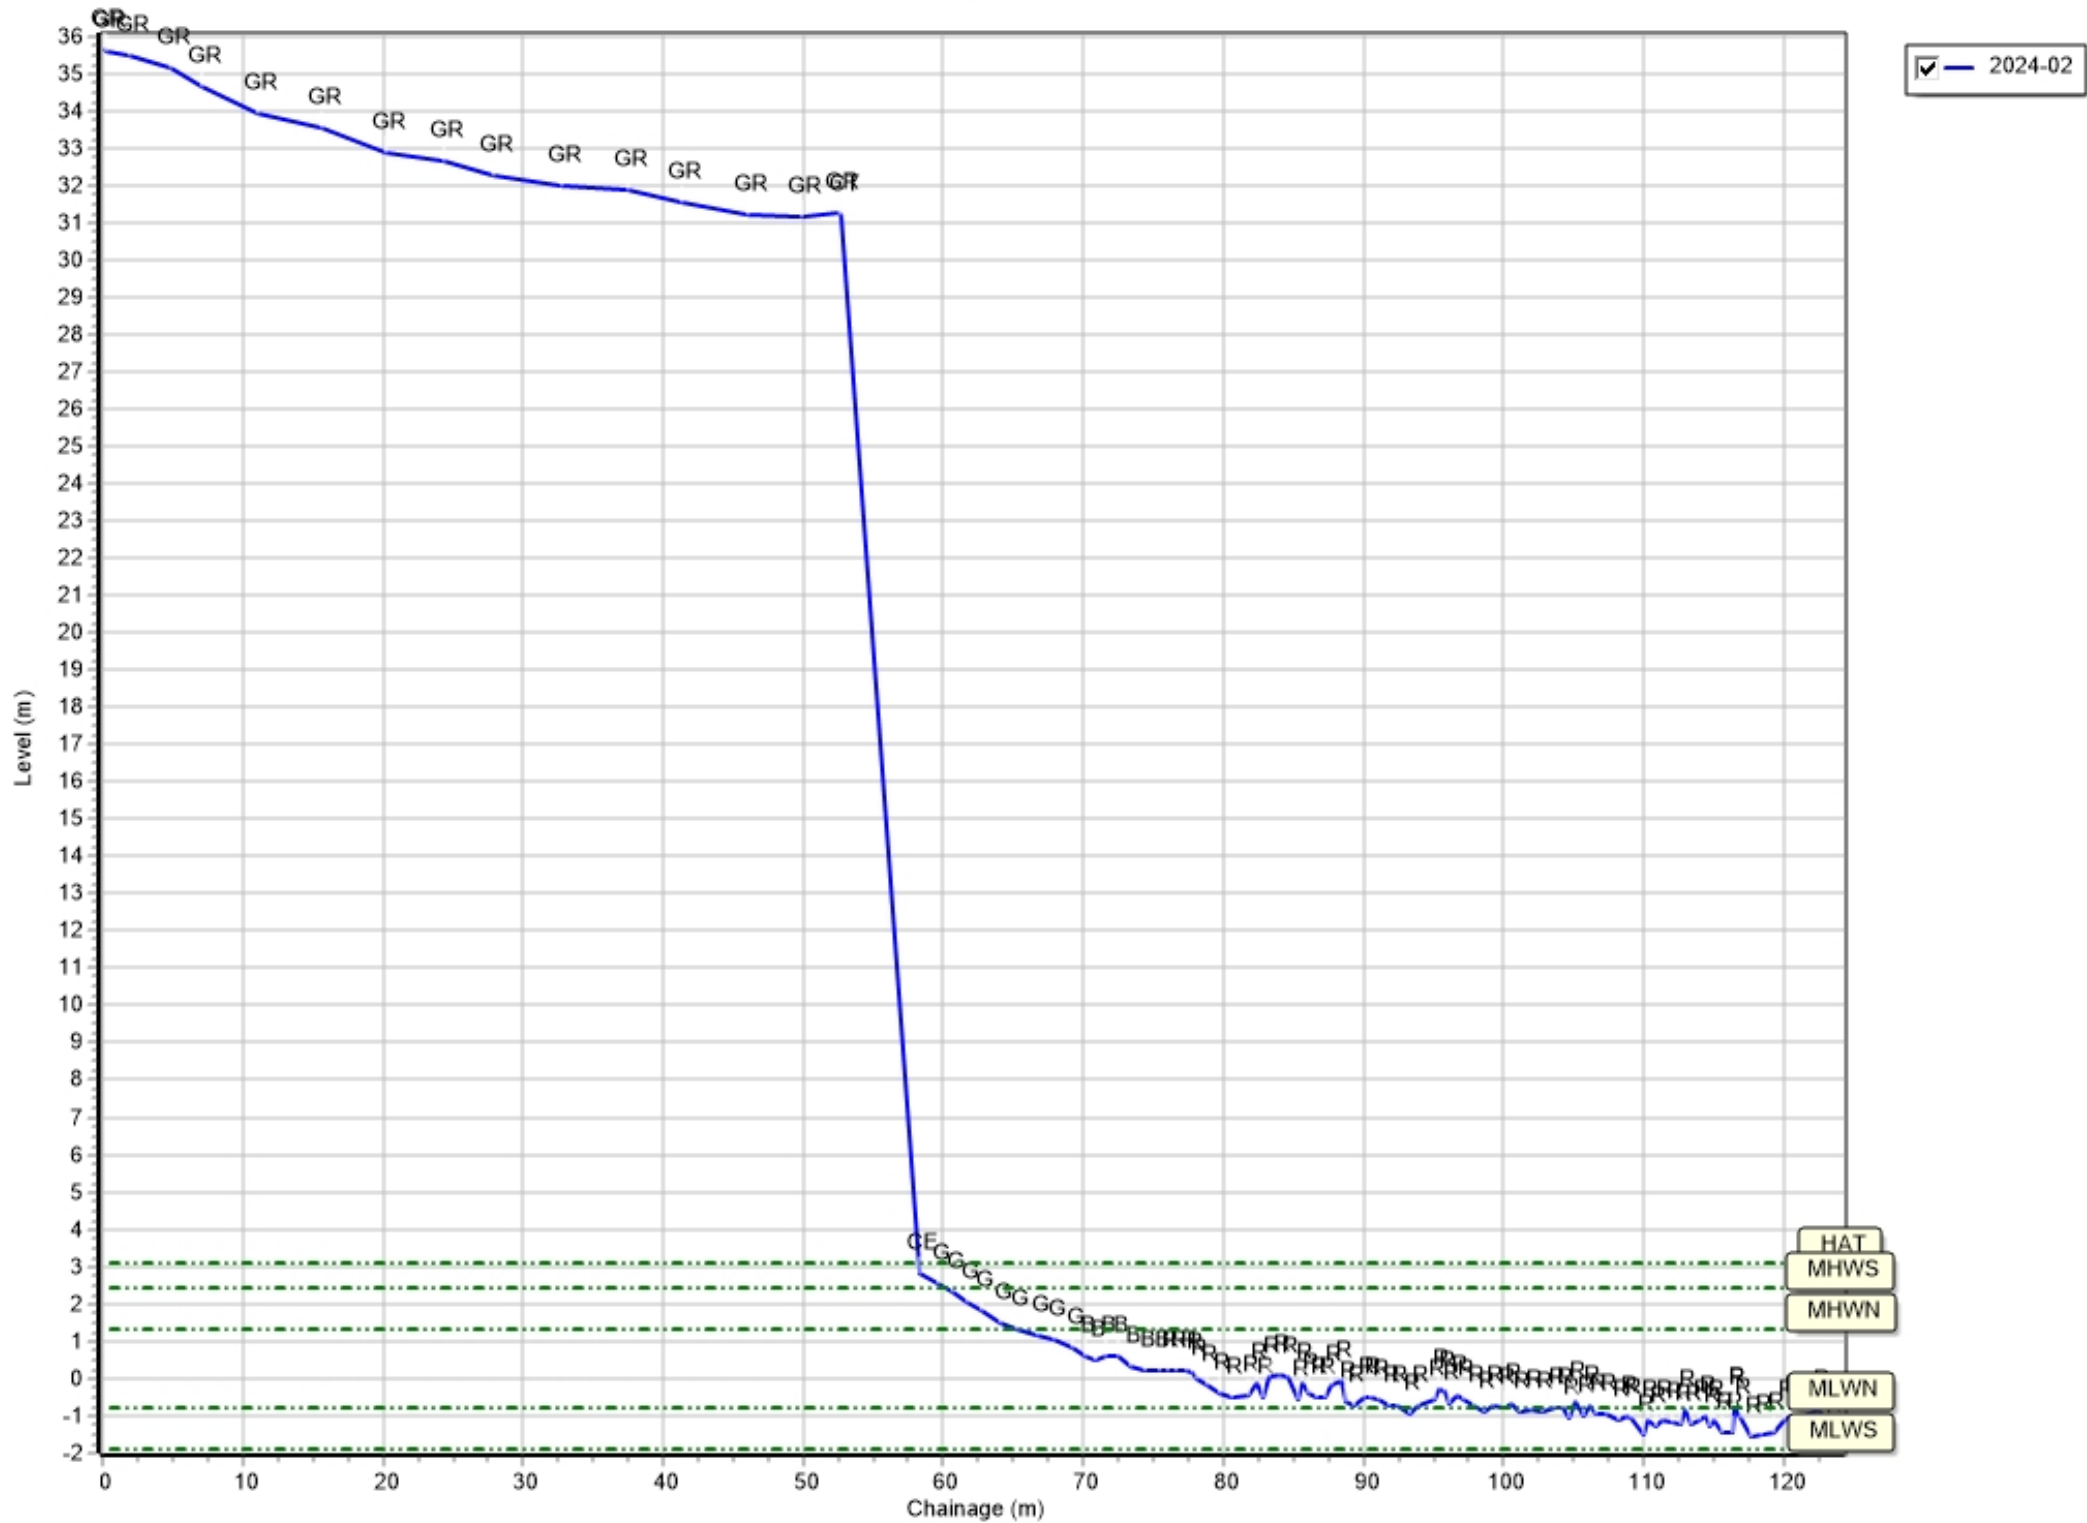
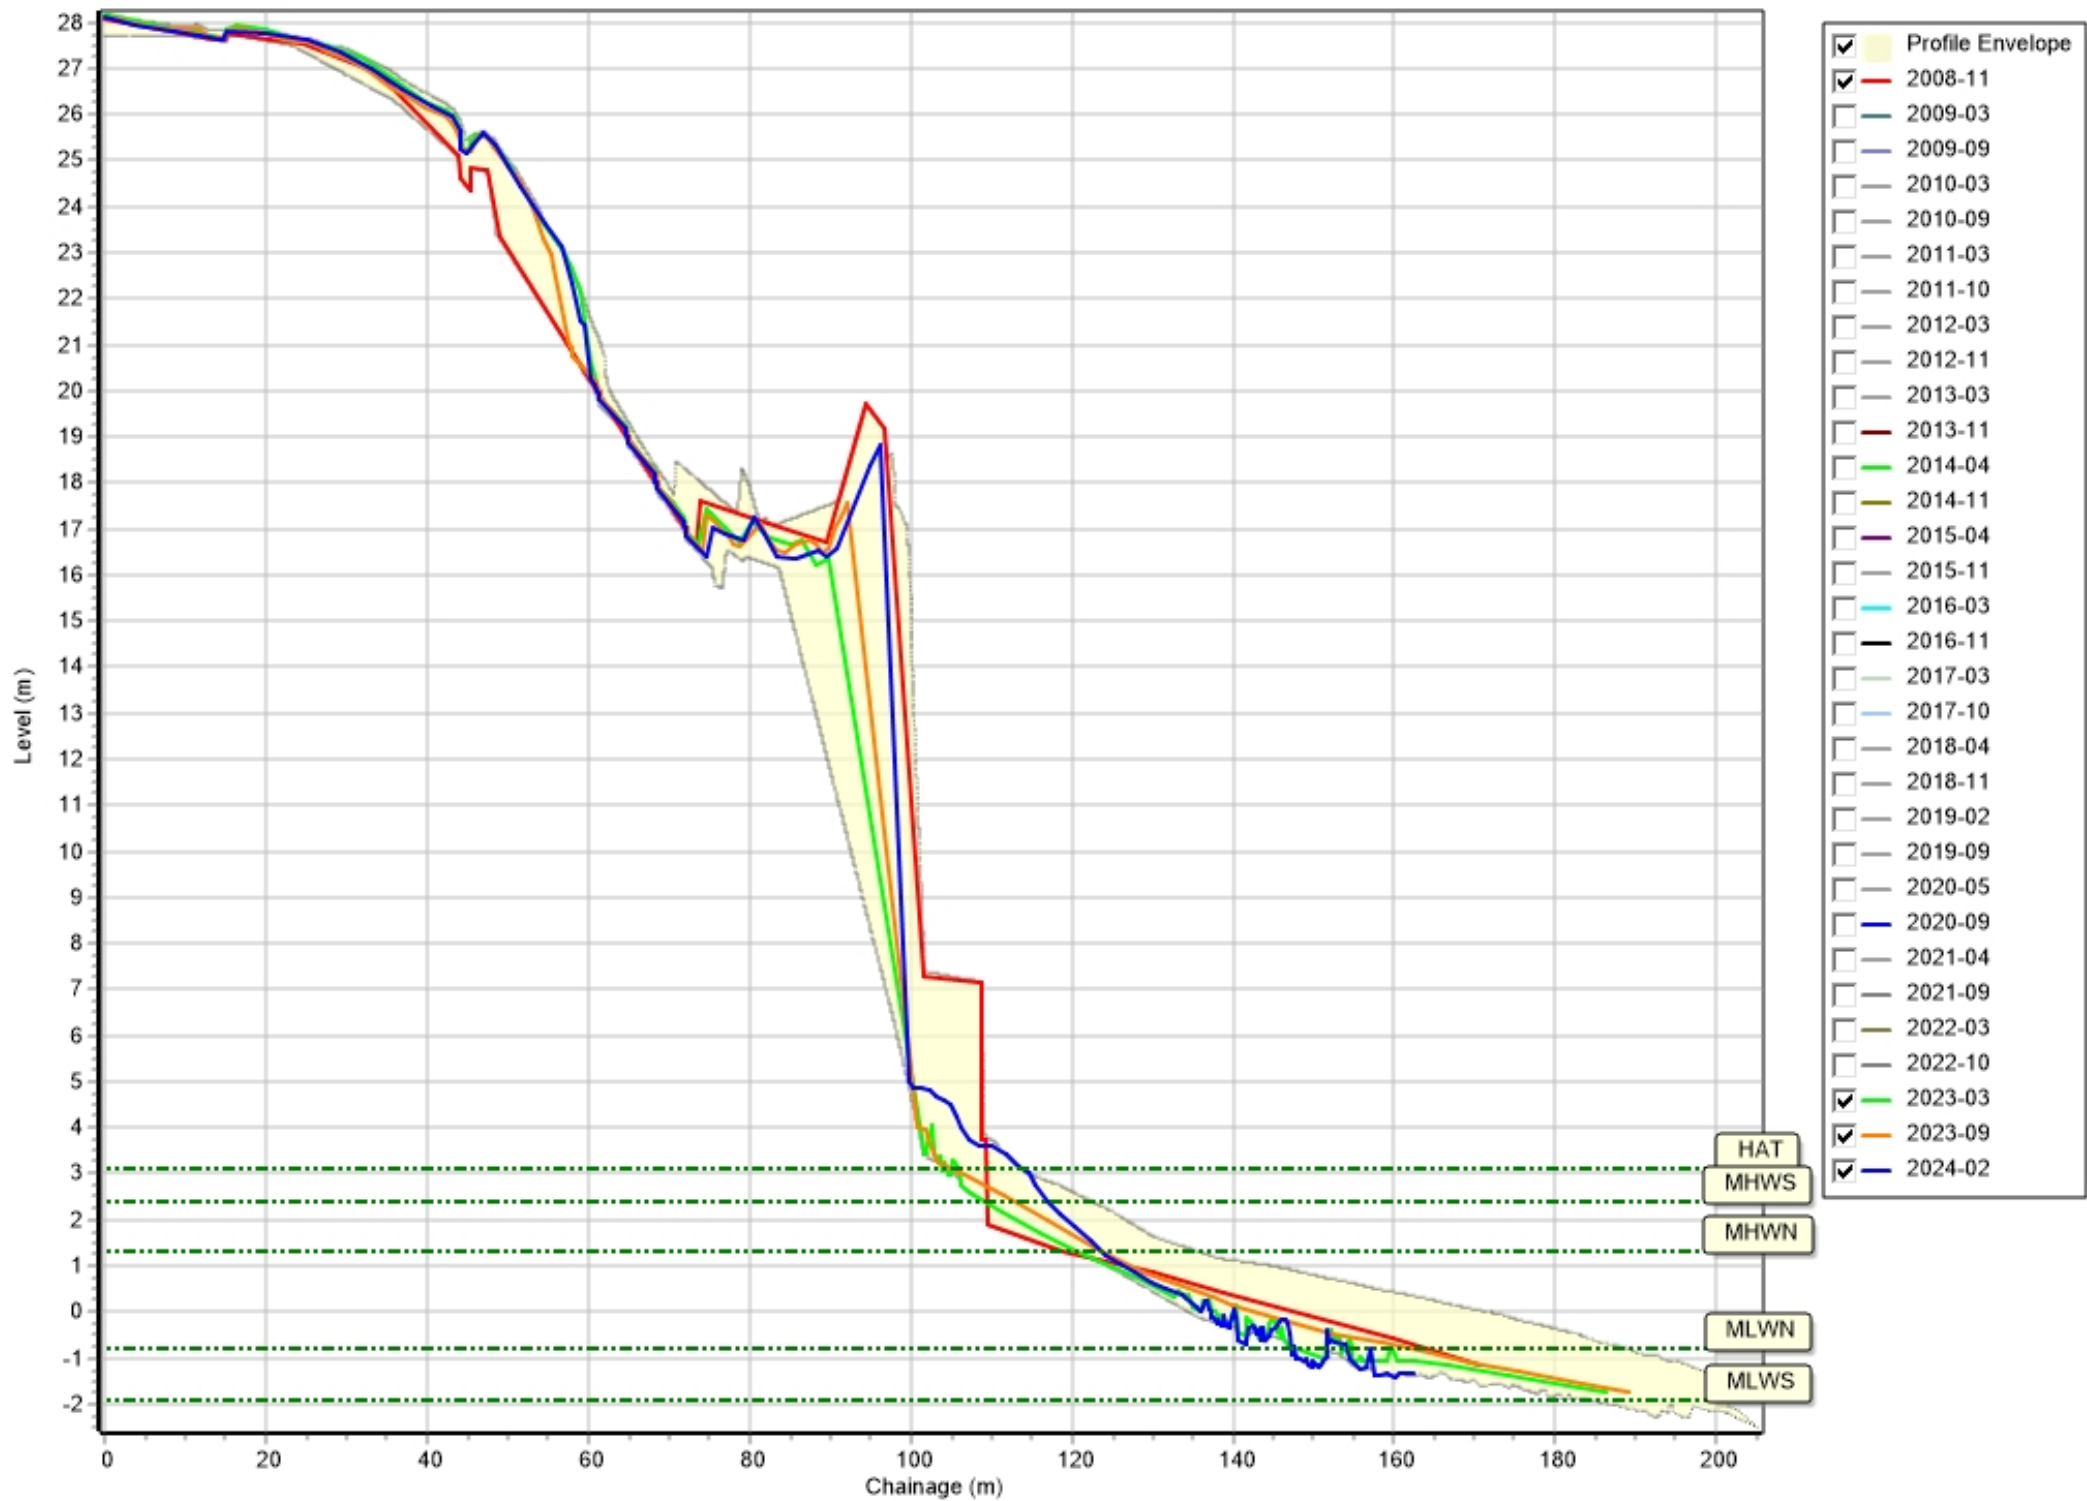
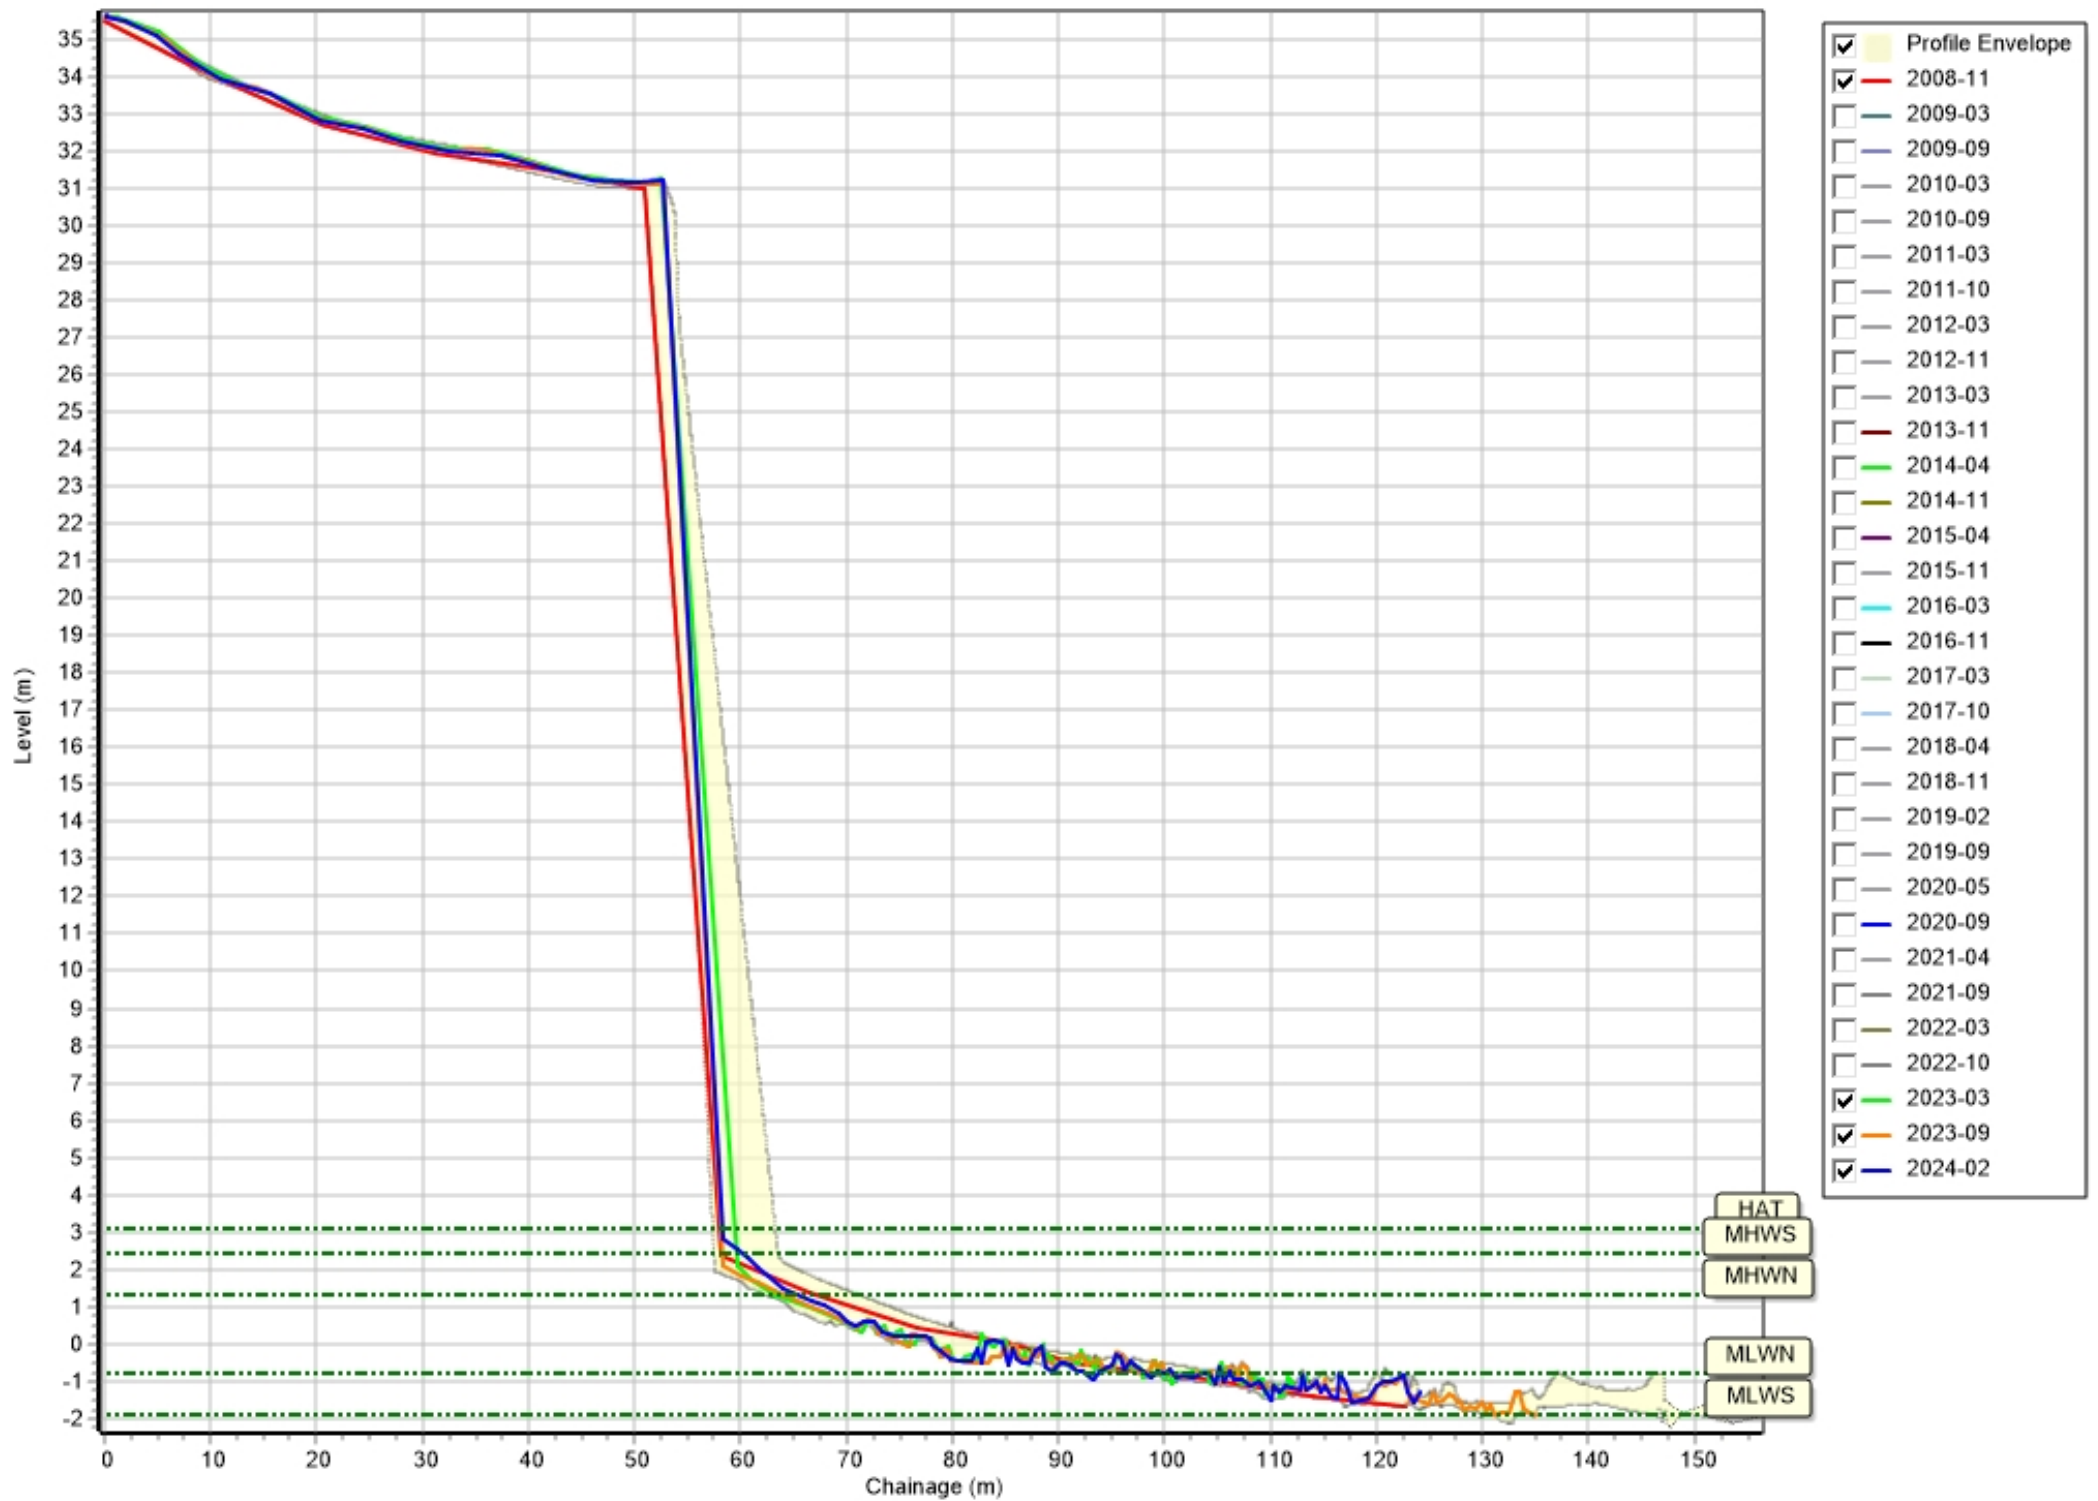
Profiles: 1bSS14

Survey Date	Description of Changes Since Last Survey	Interpretation
<p>29th February 2024</p>	<p>Beach Profiles:</p> <p>Marsden Bay is covered by two beach profile lines for the Partial Measures survey (Appendix A). The previous survey was the Full Measures survey undertaken in September 2023.</p> <p>Profile 1bSS14 is located to the north of the bay and covers the cliffs and former lifeguard station adjacent to the Redwell Steps. The survey report again notes that '<i>a section of cliff face could not be measured due to ground conditions being unsafe</i>' which explains the discrepancies the cliff face. At the toe of the cliff, at chainage 100m, the upper beach has accreted by up to 1.4m in level tapering to no change by chainage 123m. Seawards of chainage 123m, the change alternates to lowering gradually increasing in magnitude down the profile (limited to -0.7m) . Between chainage 130m and 162m, the erosion has exposed the rocky foreshore. Compared to the range of the survey, the upper beach is at a very high level whereas the lower beach is at the lowest level on record.</p> <p>Profile 1bSS17 is located to the south of the bay. There is no change across the profile up to the toe of the cliff at chainage 58m. Beach levels at the toe of the cliff have accreted by 0.7m, this accretion tapers to no change at chainage 71m. Seawards of chainage 71m, the rocky foreshore remains exposed. Beach levels at the toe of the cliff are at a relatively high level when compared to the range of the previous survey, with the exposed rocky foreshore naturally at a low level.</p>	<p>Both profiles at Marsden Bay highlight notable accretion of cobbly material at the toe of the cliffs This build of larger material above the HAT water mark is a typical response to severe storm condition where liberated material is deposited above the normal elevation.</p>

- As reported previously, a section of cliff face could not be surveyed at profile 1bSS14 due to ground conditions being unsafe.

- At Marsden Bay, both profiles highlight notable accretion of cobbly material at the toe of the cliffs. This build of larger material above the HAT water mark is again a typical response to severe storm conditions where liberated material is deposited above the normal elevation.

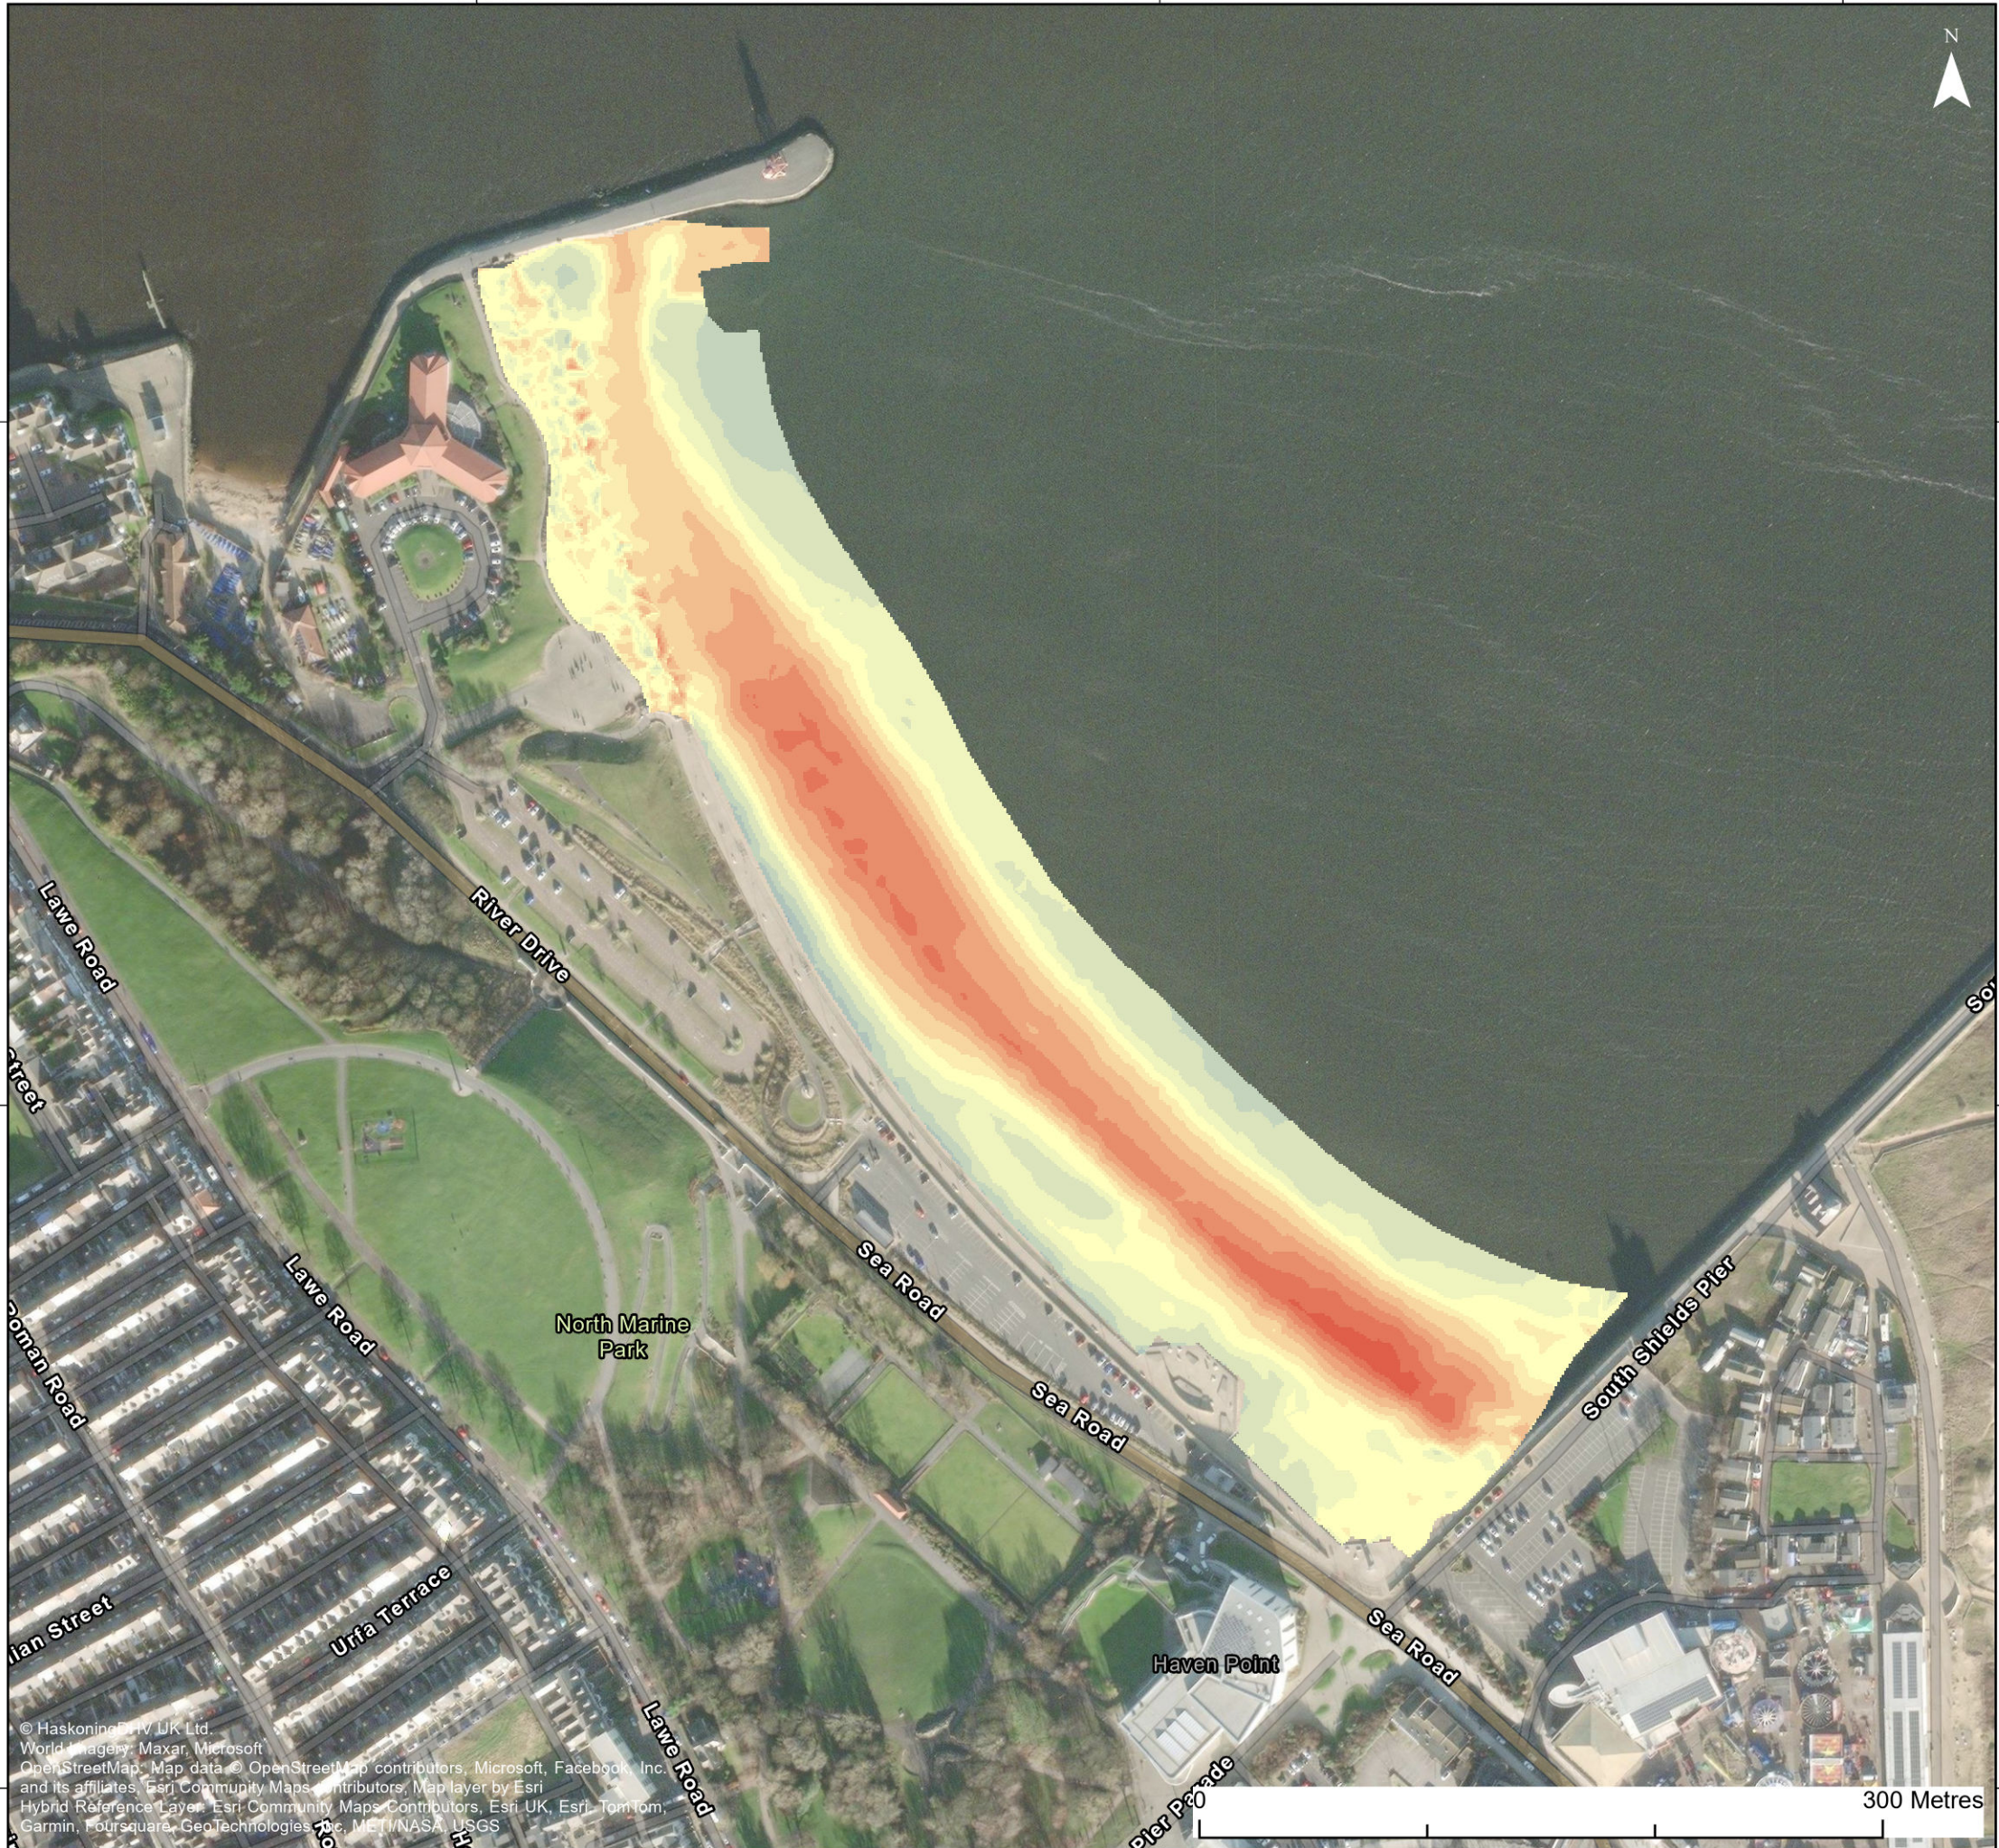
Appendix B - Map 2

Difference between topographic surveys
(Sept 2023 to Feb 2024)

Change in Elevation (mOD)

LITTLEHAVEN BEACH
