Scarborough Borough Council
Filey Bay Coastal Defence Strategy Study
Strategy Report (Final)
October 2002

Filey Bay Coastal Defence Strategy Study

Strategy Report (Final)

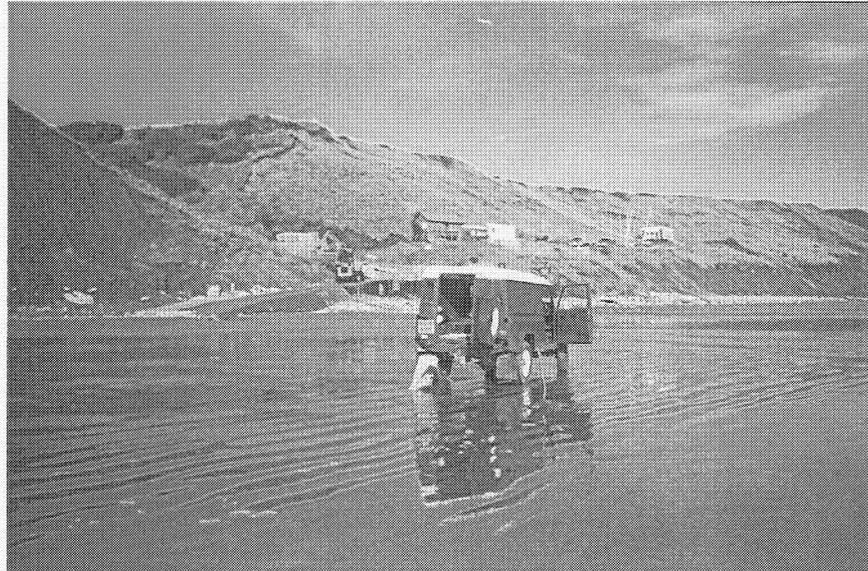
Figure 7.1 Filey Sailing Club

The Sailing Club to the north of Filey Town is located within the cliffs. It is protected by sheet piles and rock contained by timber breastwork. These defences have an estimated residual life of 5-10 years. Beyond that time it is likely that the defences will be outflanked as erosion and land slippage continues on both sides.

It is anticipated that the Sailing Club will not be sustainable during the lifetime of the strategy, and will require to be relocated, and it is therefore unlikely that these defences will require significant maintenance.

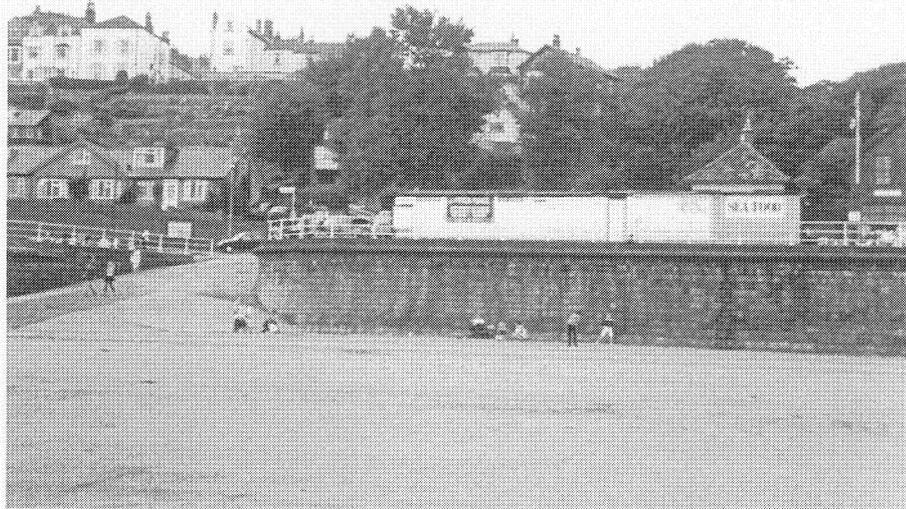
Figure 7.2 Filey Town seawall

A near-vertical concrete seawall extends along the developed frontage at Filey (Figure 7.2). The wall, faced with stone, incorporates a wave recurve section at its crest to deflect overtopping waves seaward. At the northern end, the seawall incorporates the Coble Landing slipway, used by local fishing boats and the lifeboat. A second slipway exists at the southern end of the seawall, at Royal Parade.

The seawall is in fair condition, though there are certain aspects that should be monitored and maintained to prolong the asset life of the structure. Some wave return copings are suffering from calcitic crystalline expansion which causes the coping to crack and parts of the overhang to break off. These should be periodically inspected and replaced. There are definite movement cracks evident in numerous places along the wall. These could be caused by a change in pore water pressure behind the seawall.

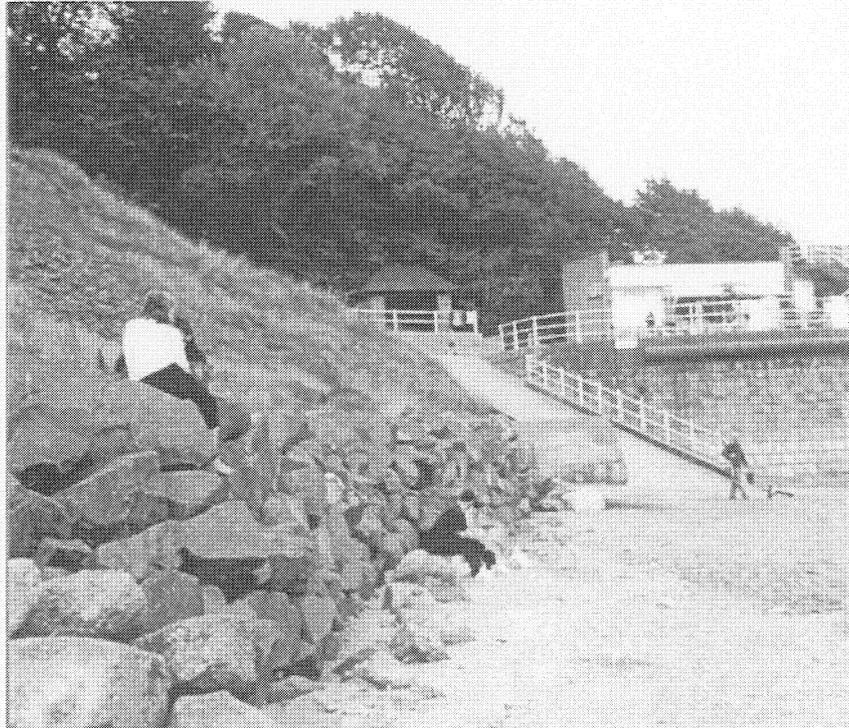
Figure 7.3 Rock protection adjacent to Martin's Ravine to south of Filey Town

There is evidence of outflanking at both the northern and southern ends of the seawall. Rock protection has been placed immediately to the south of the seawall (Figure 7.3), at Martin's Ravine, to protect against this outflanking. Gabions were initially used, reinforced later by small pieces of granite gabbro rock (less than 1 tonne). These have been placed in front and on top of the gabion baskets at a very steep slope. It is doubtful that this structure would be effective during a significant storm event. The section may present a safety hazard to beach users, particularly if the landslip behind is reactivated. It is assumed that the gabions and rock were placed to limit outflanking of Royal Parade and the access way through Martin's Ravine. There is also an active landslip on the cliffs immediately behind the gabion/ rock wall, adjacent to the access way. This slip is partly resisted by the rock defence, but any further slope movement could overwhelm the gabion structure.

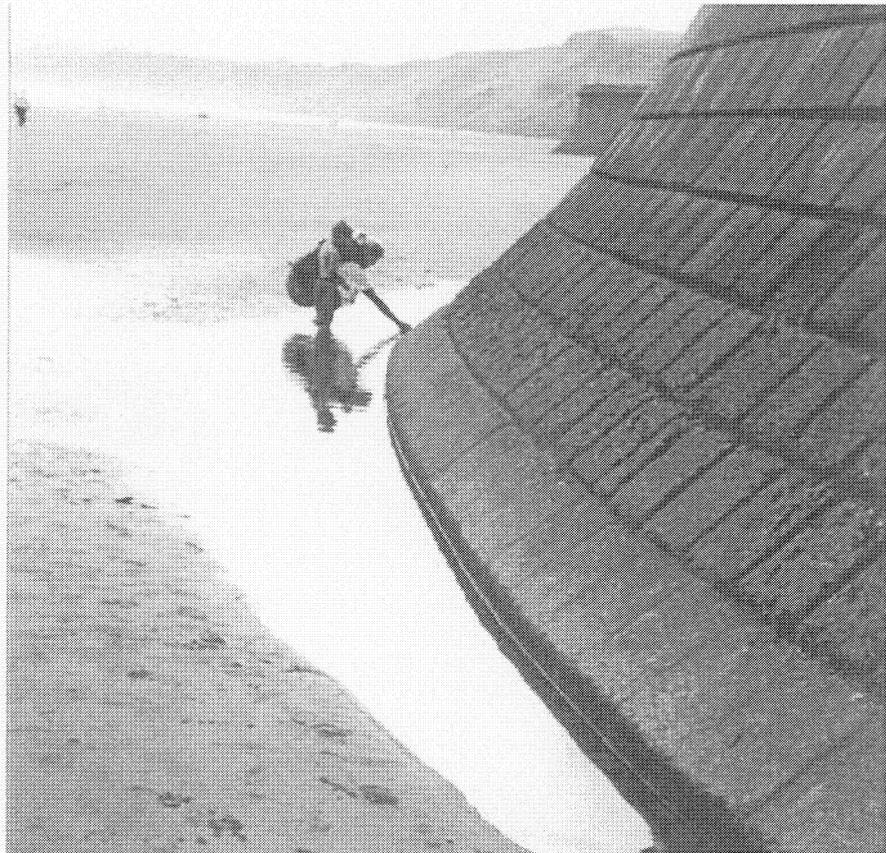
Figure 7.4 Scour at base of Filey seawall

Scour is evident in places along the base of the seawall. Exposure of the lower wall blocks is greater at changes of alignment and at the slipway interfaces. Scour effects are particularly evident on the northern roundhead of Royal Parade, where exposure of the top of the foundation block was observed during inspection (Figure 7.4). Along the length of the wall the variations in beach levels could be seen during walkover inspection, although these variations were of no more than 150mm, based on the block dimensions. On occasions, following storm conditions, beach levels have dropped significantly at the wall, exposing a concrete apron that forms the toe, Figure 7.5. This is considered in more detail in Chapter 5, where the effects of storm conditions and sea level rise on beach levels are discussed.

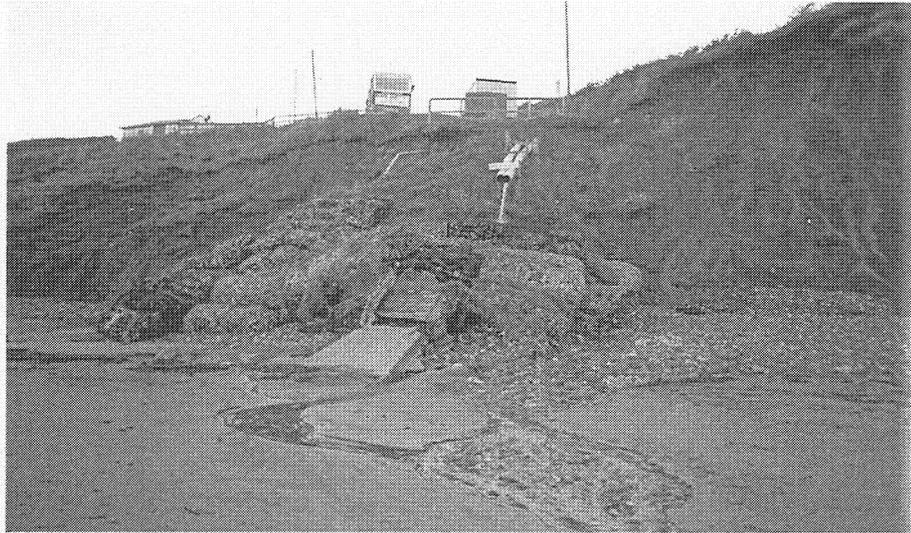
Figure 7.7 Gabions at Hunmanby Gap

There are some gabions protecting the toe of the cliff at Hunmanby Gap (Figure 7.7). These appear to have originally been placed to protect beach access, which has since been relocated. The gabions therefore currently have limited function and are gradually being outflanked as erosion and land slippage continues on both sides.

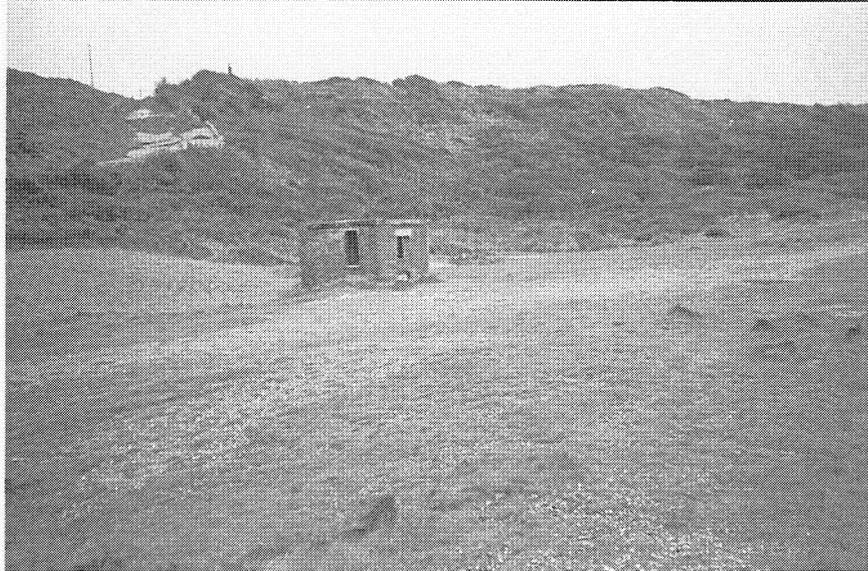
Figure 7.8 Cliffs at Reighton [note damaged access at top left of photo]

While there are no formal defences at Reighton, public access down to the beach is by means of a concrete track that is badly damaged (Figure 7.8), and in its present state poses a safety hazard to beach users. Along the beach, there is concrete debris, presumably from structures that have collapsed as the cliff has eroded (Figure 7.8).

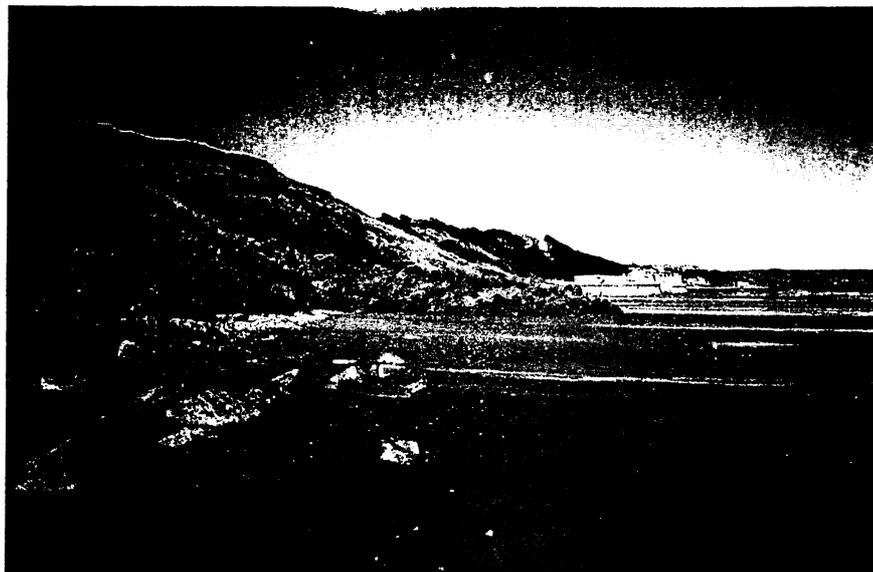
Figure 9.4 Muston Sands

The frontage to the south of Filey Town is fairly undeveloped and comprises glacial till overlying Jurassic bedrock. There is evidence of active coastal erosion and landsliding and of outflanking at the southern end of Filey Town Wall.

A golf club is located on the cliff top here and could suffer some land loss. However, the sediment supply to the Filey frontage is inherent to its stability and the ongoing natural processes should be allowed to prevail as far as is practical.

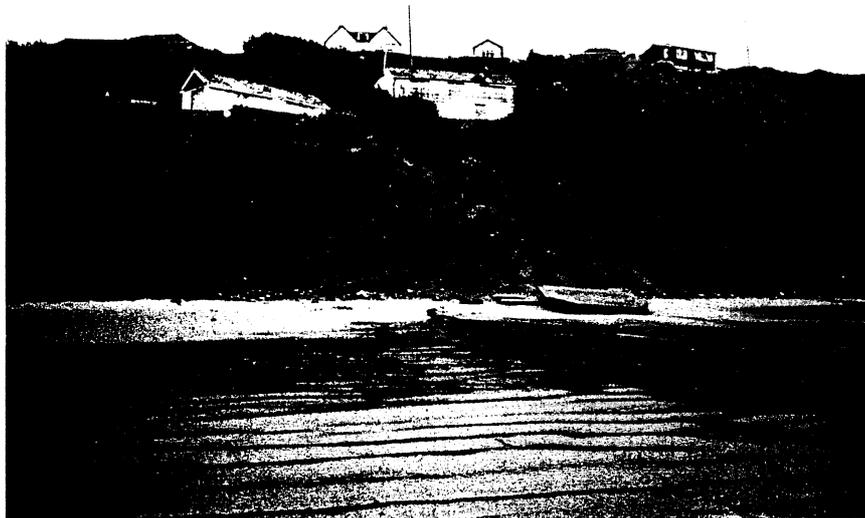
Figure 9.5 Flat Cliffs

Early field observations as part of the strategy study identified the potential risk to the Flat Cliffs properties due to land instability. Ground investigation works were therefore undertaken to inform stability analysis of the coastal slopes (see Annex F). This gives an indication of the sensitivity of the coastal landslides to basal erosion and ground water level, suggesting failure of the slopes upon which the properties are located within 10 to 20 years.

It is not considered that the Flat Cliffs community will be sustainable beyond 50 years. Any intervention to prevent erosion of the cliffs will have some effect on processes within the Bay as the cliffs contribute material into the system.

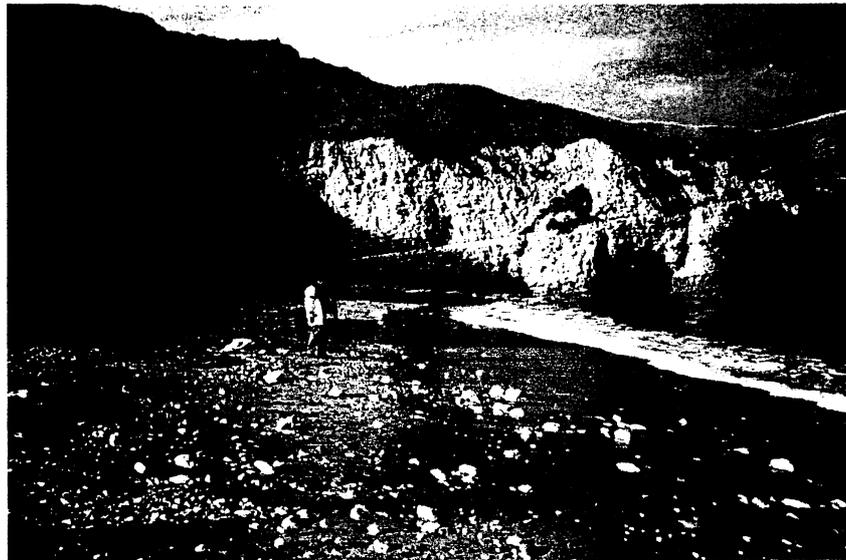
Figure 9.10 North Landing

With the exception of North Landing (Unit 31D), the policy for these units is **no active intervention**, in accordance with the SMP recommendation of **do nothing**. Due to the infrastructure at North Landing, a policy of **limited intervention** is recommended to maintain the existing boat launch facilities, compared with an SMP recommendation of **retreat the existing line of defence**.

The limited intervention will comprise inspection and maintenance of the defences at North Landing. Beach levels should also be monitored, with the survey undertaken in November 2000 providing a baseline.
