**Cell 1 Regional Coastal Monitoring Programme
Update Report 6: 'Partial Measures' Survey 2014**

**Scarborough Council
Final Report**

July 2014

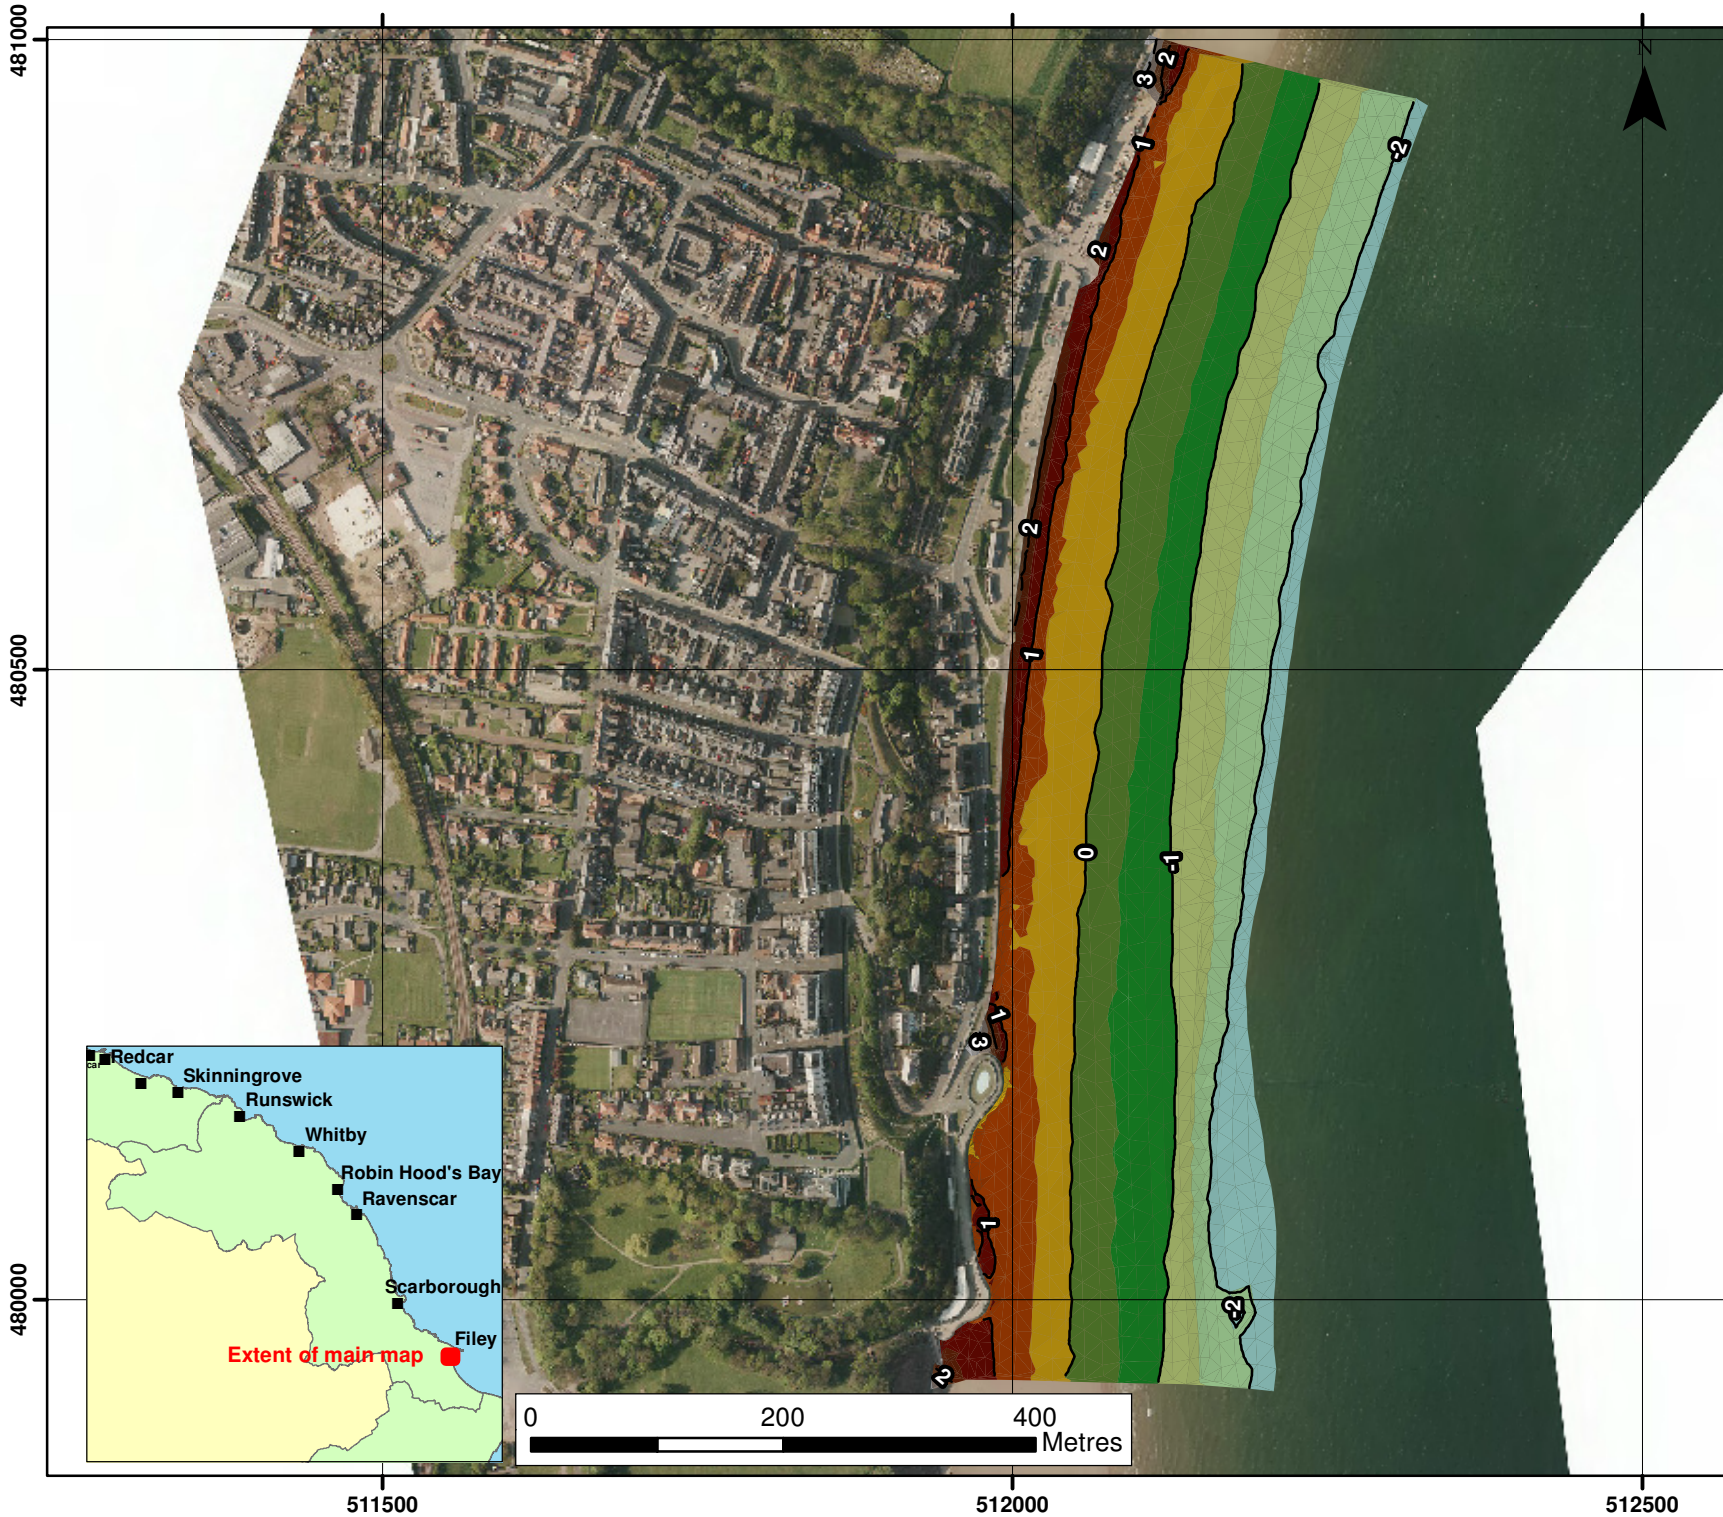
Elevation difference
is between bespoke
Pre-Sediment
Recycling Survey
06 May 2014 and
bespoke Post-Sediment
Recycling Survey
20/05/2014

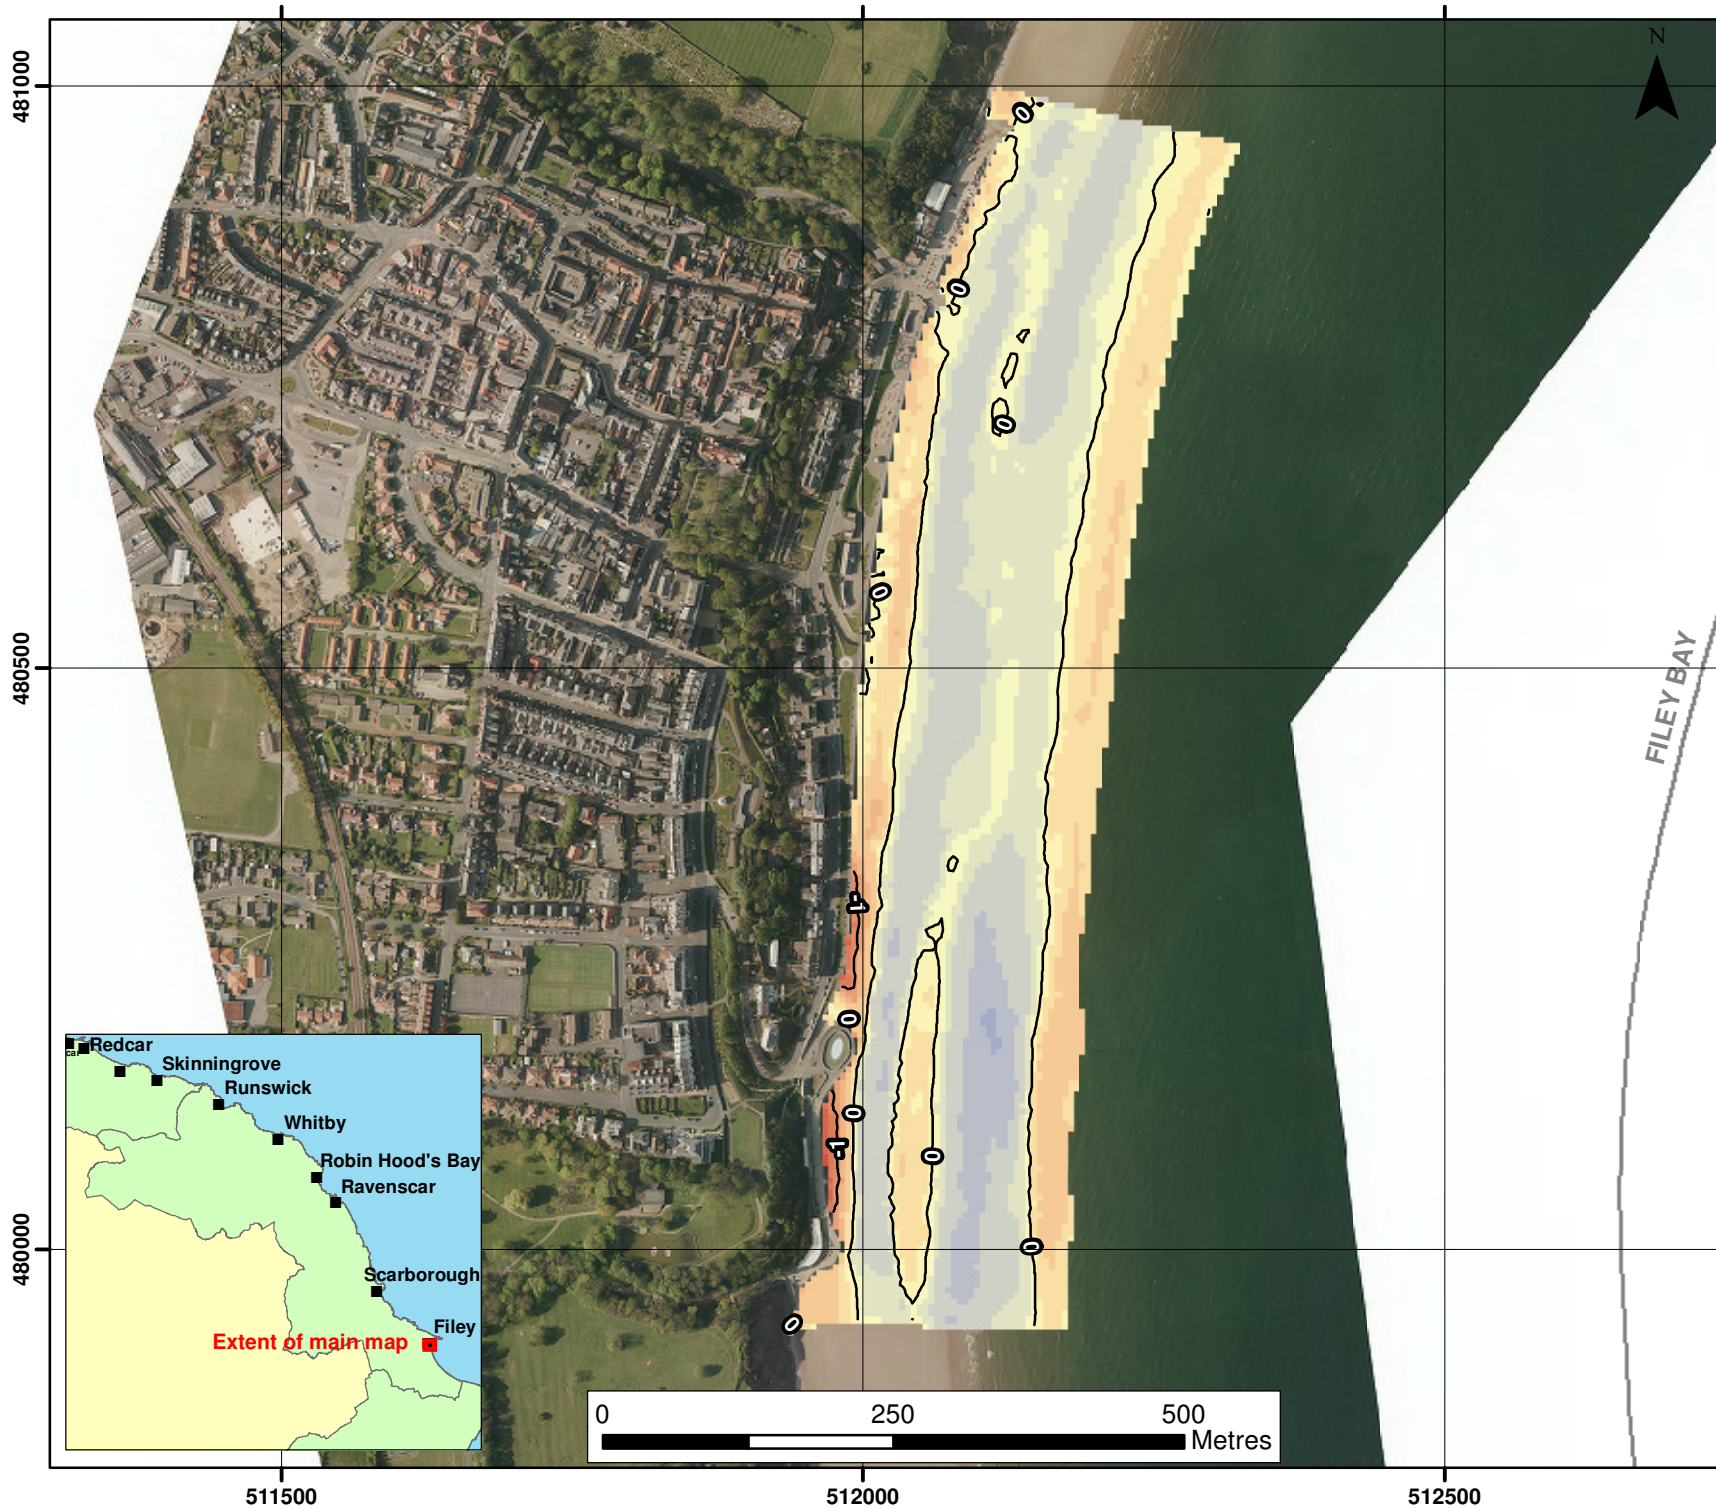
KEY Autumn 2013 and Spring 2014
Change in elevation (m)
