**Cell 1 Regional Coastal Monitoring Programme
Coastal Walkover Inspections 2010**

South Tyneside Council

**South Tyneside Council
Final Report**

June 2010

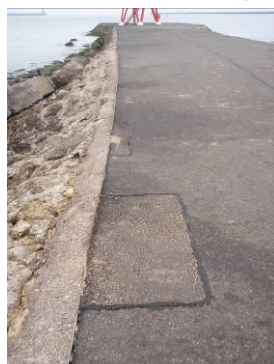
Along the northern (river-facing) side of the South Groyne there was evidence of previous concrete and asphalt repairs (below left). In one area the concrete repairs have become slightly damaged and the asphalt deck immediately behind is showing signs of cracking. This zone requires some routine remedial attention. Elsewhere along the river-facing side, there is occasional missing stonework and in one location armour stone placed on the river bed in front of the structure has been displaced.

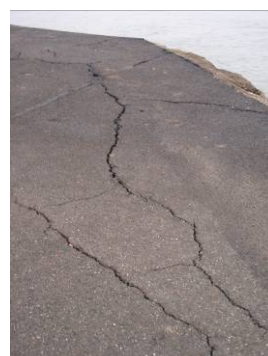
At the seaward tip of the structure, there remains evidence of cracking in the asphalt deck (below right). The pattern of this cracking appears similar to that recorded in 2008 and recent discussions with the Port of Tyne reveal that they are aware of this area and believe it to be surface cracking and not a consequence of structural settlement.

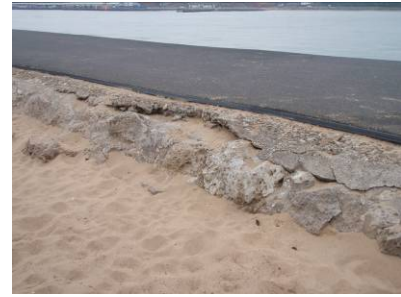
Near the landward root, however, there is evidence of cracking and the onset of voiding in the concrete near the asphalt deck (right).

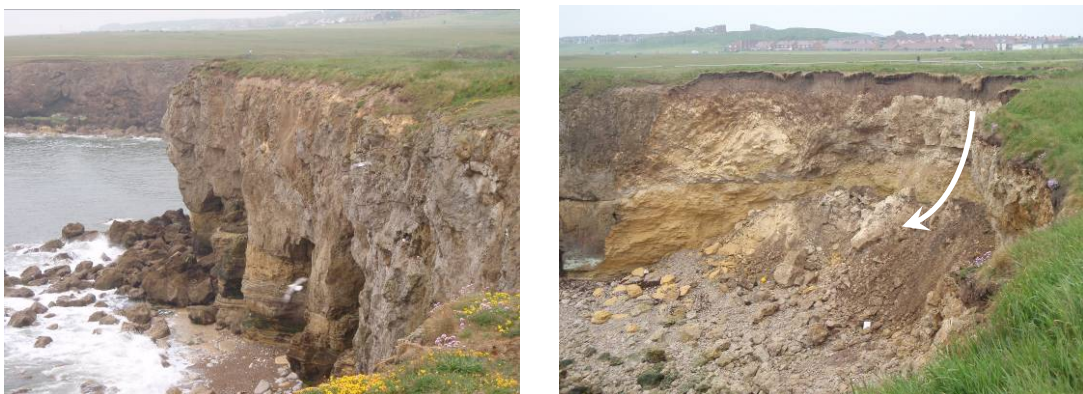
Just to the south of Frenchman's Point, the cliffs have a number of arches formed at their toe (below left) and within the main section of Frenchman's Bay a dramatic rock fall occurred on 21st March 2010 resulting in the collapse of around a 50m section of frontage (below right).

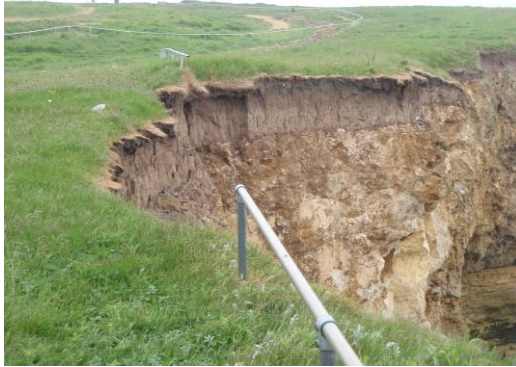
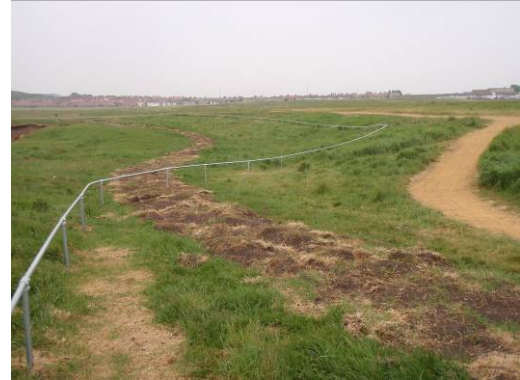
This cut the cliff top back by around 20m, sufficient to affect a length of approximately 15m of the footpath and low-level barrier (below left), both of which have now been re-diverted inland by The National Trust (below right). Following the collapse an emergency response plan was swiftly implemented and a temporary safety fence was initially installed along with new warning signs. The National Trust's policy is to realign the path and barrier to more landward positions as future erosion occurs.

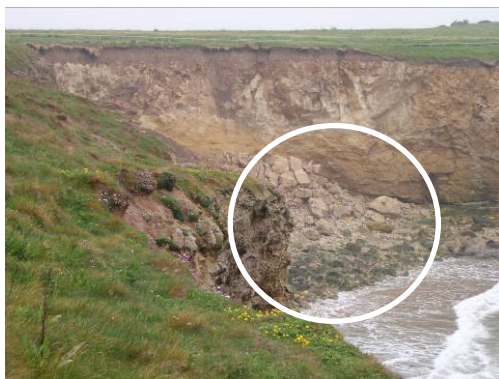
The rock debris at the toe of the cliffs (left) will now provide a degree of protection to the cliff toe until the material becomes moved away by marine action and the process occurs again.

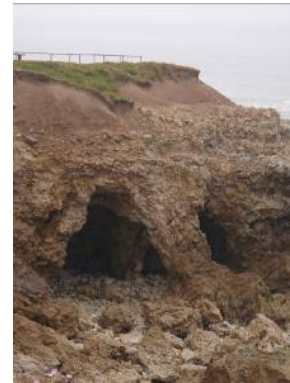
Within Man Haven Bay, and within the northern most of the three mini-bays between here and Camel Island, there appears to be evidence of debris flow (below left). This may have occurred over the harsh winter of 2009/2010 when snow melt may have mobilised some of the sediments within the softer overlying cliff material and washed it away down the cliff face. At Man Haven, one section of rock cliff underlying the debris flow also has a large vertical crack. Elsewhere between Man Haven and Camel Island, the frontage is heavily affected by cave and arch formation at the toe of the cliffs (below right).

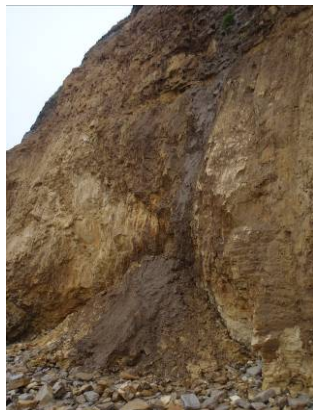
At the northern end of Marsden Bay, the cliff and arch formation at the toe of the cliffs continues and there is evidence of relatively recent rock falls (below left) and residual rock overhangs (below right). The National Trust has re-aligned the public footpath at the top of the cliffs landwards in response to some recent, localised, failures.

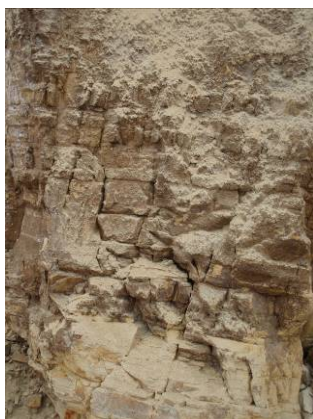
In other places the rock structure has become fractured (below left) and one area of cliff in particular has cracked (below right) with a failure due to this likely to occur.

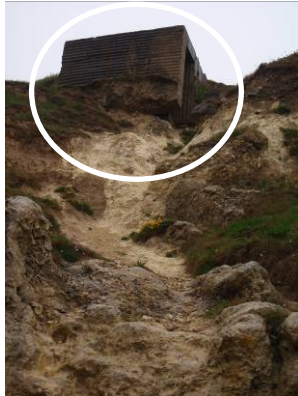
Also within the northern end of Marsden Bay there are three structures; all of which are in very poor condition. Along the access ramp to the northern end of Marsden Bay (by Camel Island) there is a concrete bunker located high up the cliff. This is perilously perched on the cliff face with previous cliff failures leaving a corner section of the bunker overhanging. There is also a stone-faced wall at the base of the disused Lifeboat Station which is now undermined and failing at its northern corner (below right). It appears that previous damage to the (former) stone-facing at this section has previously been repaired by brickwork, but this patch-up is now failing. Along the stone-faced section of this wall, there are numerous notable gaps between the stone-work and the coping.

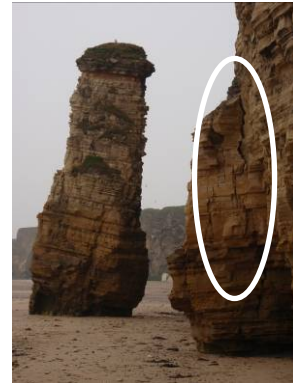
Between the Redwell Steps and the Grotto Public House, the cliffs have small arches and caves along their base in places (below left) and there is one cracked rock near Lot's Wife which is likely to fail due to toppling (below right).

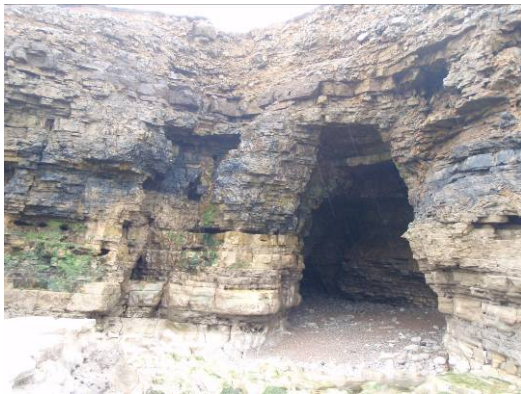
Whitburn Coastal Park covers the area of the former Old Harbour Quarry, which has been subsequently infilled with waste material. At the headland separating Byer's Hole from Potter's Hole, cave formation (below left) has breached the limestone ridge that was left at the seaward edge of the former quarry, causing the wash-out of the fill material and, in one location, creating a sink hole to open in the backing ground (below right).

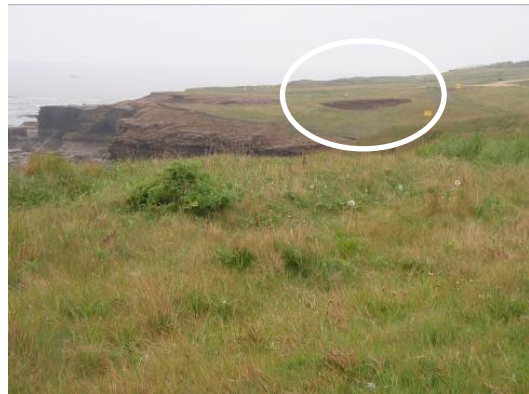
The National Trust has now fenced off this area, placed warning signs and diverted the public footpath and a scheme development remains ongoing. Since a previous scheme-specific survey in August 2009 the cave formation does not appear to have increased and the adjacent caves still have not yet breached through the limestone ridge. The existing concrete defences, previously used to 'plug' two of the nearby caves at this headland, are continuing to become undermined.
