**Cell 1 Regional Coastal Monitoring Programme:
Walkover Visual Inspections of Assets**

**South Tyneside Council
Final Report**

September 2012

Walkover Visual Inspection of Assets

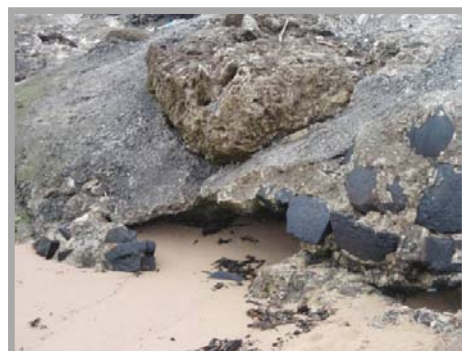
Photo of same location as above taken from 2010 inspection report

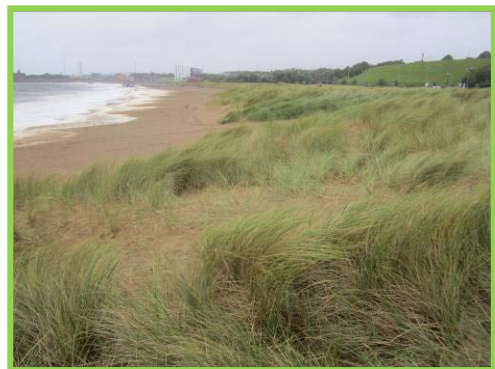
Well vegetated dunes with no sign of erosion along the toe.

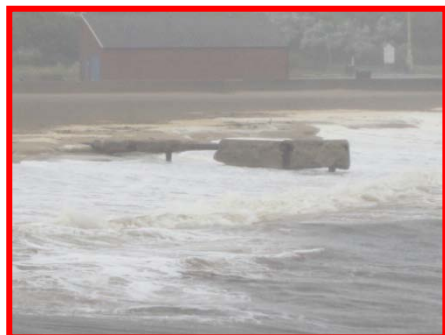
The assumed obsolete outfall that is seaward of the beach at this location is still in very poor condition and in need of removal, below right.

Obsolete outfall at Littlehaven

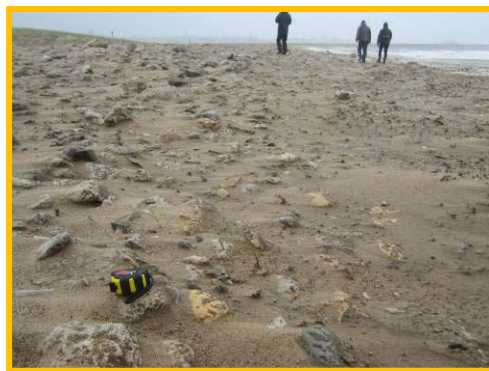
Wide cobble berm across beach at South Groyne.

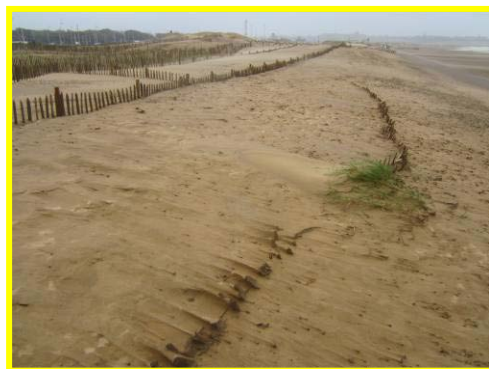
Dune fencing well buried in places with some signs of new vegetation growth.

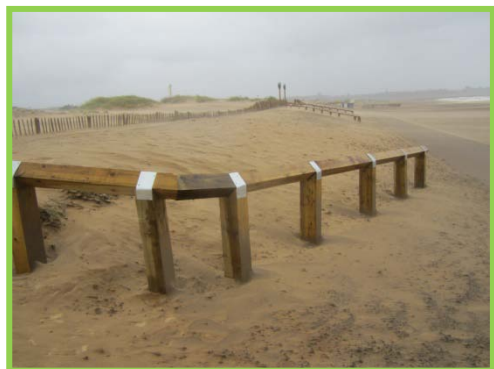
New pedestrian zoning barriers at access points in good condition.

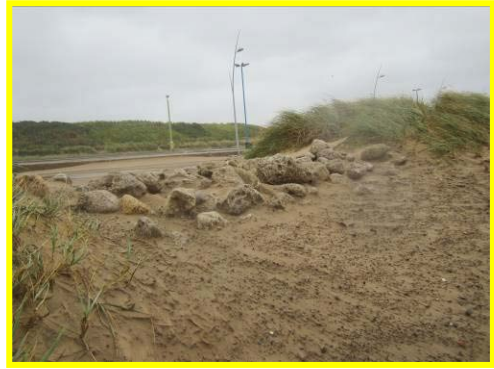
Placement of cobbles at the blowouts in the dune crest

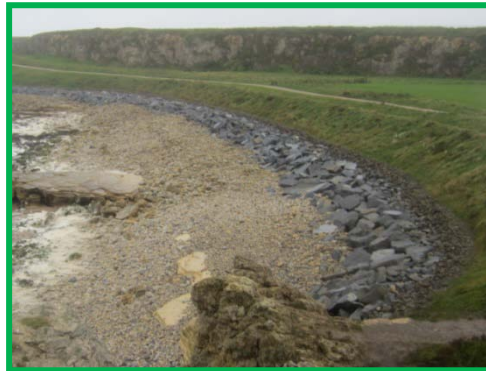
Rock revetment and grass slope at Graham's Bay in very good condition.

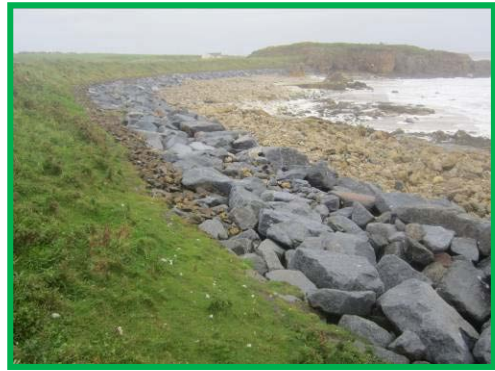
Rock armour well interlocked with no signs of settlement or movement.

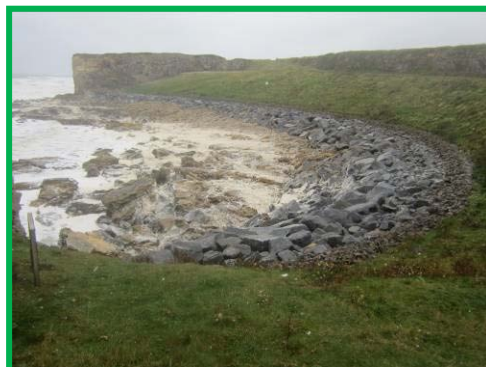
Rock revetment in Southern Bay in good condition.

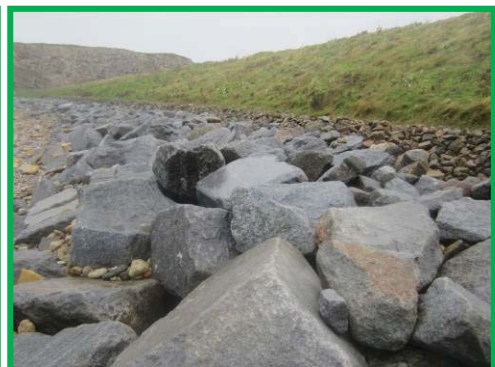
Rock armour stable and well interlocked with no erosion evident in earth slopes.

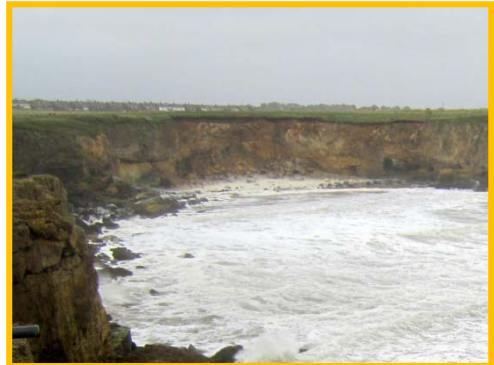
Historic collapse of cliff at centre of bay has not worsened.

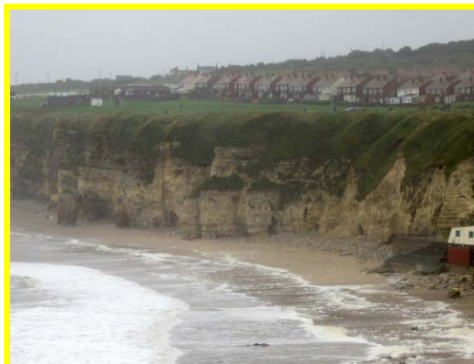
Small arches and caves in the base of the cliff south of the Lifeboat Stn.

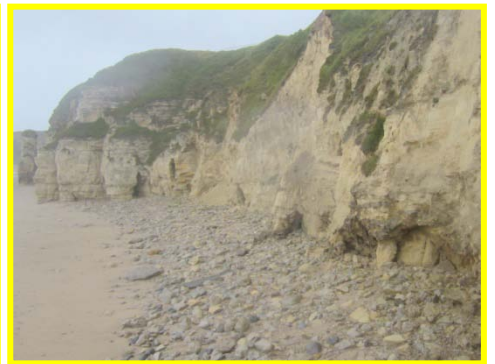
Small arches and caves in the base of the cliff south of the Lifeboat Stn.

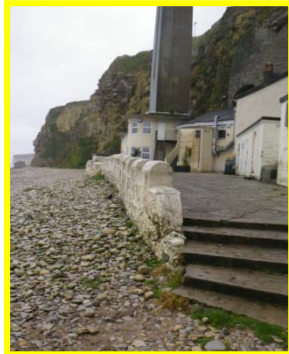
Masonry wall at Marsden Grotto protected by cobble berm.

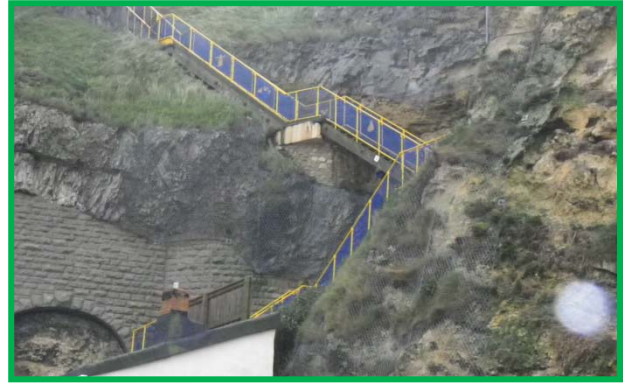
Rockfall protection netting at Marsden Grotto stairs.

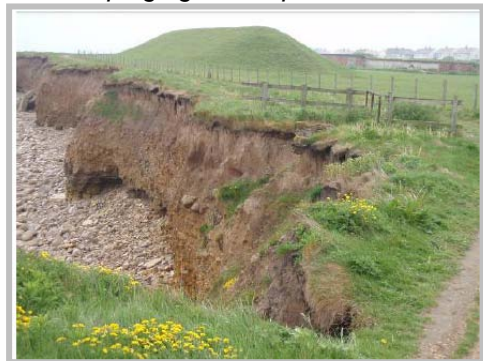
Photo from 2010 inspection report
