**Cell 1 Regional Coastal Monitoring Programme:  
Walkover Visual Inspections of Assets**

**South Tyneside Council  
Final Report**

**August 2014**

## Walkover Visual Inspection of Assets

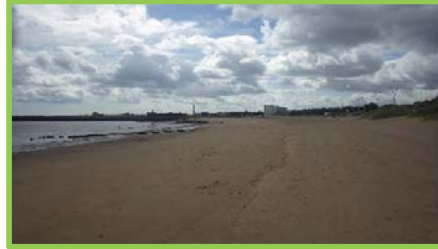
The strand line at the Littlehaven dunes was a reasonable distance down the foreshore, indicating a wide and healthy beach at this location. The beach width increases in the lee of the South Groyne. There was no evidence of dune erosion and sand levels were very good. The vegetation was well established and some

informal access tracks have been created by visitors. Fencing and more replanting would prove beneficial. Beach profile data and inspection of this area suggests that the area is accreting with sediment, showing effectiveness of the South Groyne in preventing material from entering the navigation channel of the River Tyne estuary.

*Wide healthy beach at Littlehaven Dunes*

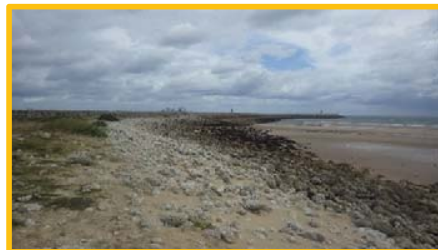
The northern section of Sandhaven between South Pier and the children's play area has a cobble berm in front of the dunes at its northern end which narrows and thins with progression south. At the previous inspection reference was made to the 'donkey track' which extends from the South Pier, initially behind the dunes then switching to seaward of the dunes to meet the Lifeguard Station. Work was being carried out at that time to protect and enhance the dune system. In addition to this, works have been carried out on the provision of boardwalk areas, improved walls and improved access to the beach. The 'donkey track' has been re-surfaced and is now in good condition, although still covered by sand in places. The dunes north of the Lifeguard Station have accumulated large amounts of sand but have areas barren of vegetation and there is evidence of recreational activity. They provide a good buffer in front of the promenade and the backing amenity assets. The brushwood fencing is proving to be successful and a replanting programme should be increased to stabilise the dune system.

*Cobble berm at northern section of Sandhaven.*

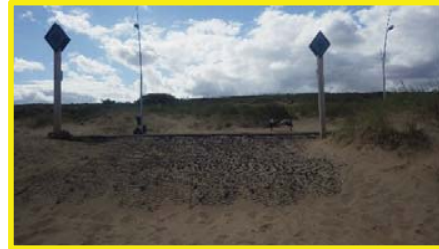
*Exposed gabions at access points across dunes.*

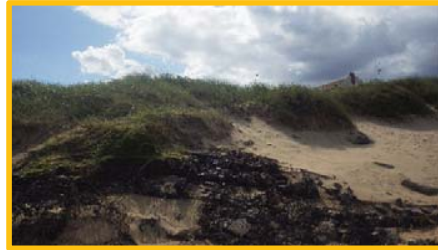
*Breaking up of gabions adjacent to ramp at south end of dunes.*

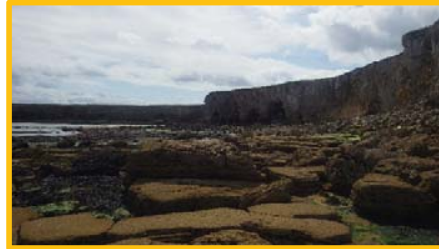
Just to the south of Frenchman's Point, the cliffs have a number of arches formed at their toe and there is evidence of major rock falls. This has resulted in the cliff face moving closer to the coastal path. The National Trust are active in monitoring the area and react by realigning the fencing and installing new warning signs. The rock debris at the toe of the cliffs will now provide a degree of protection to the cliff toe until the material is moved away by marine action and the process will start again.

Arches formed in the toe of cliffs south of Frenchman's Point.
