**Cell 1 Regional Coastal Monitoring Programme
Walk-over Visual Inspections of Assets**

**Sunderland City Council
Final Report**

May 2013

Walk-over Visual Inspections of Assets

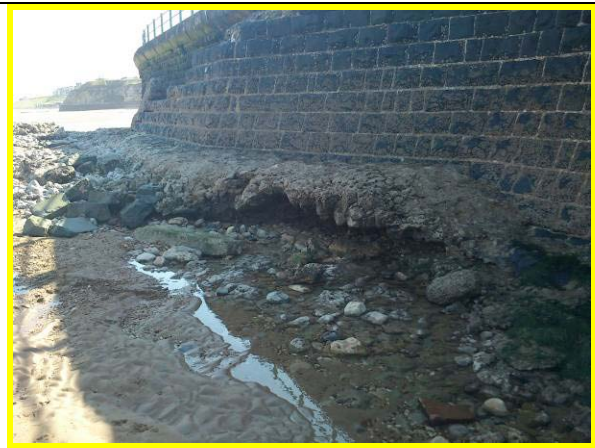
Undercut toe apron at disused set of steps
(Asset ref. No. 121AB901B0604C02)

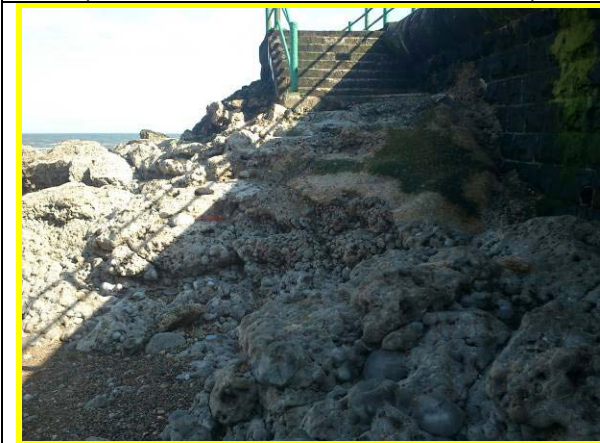
Eroded natural / grouted rock at access steps
to Parsons Rocks
(Asset ref. No. 121AB901B0604C02)

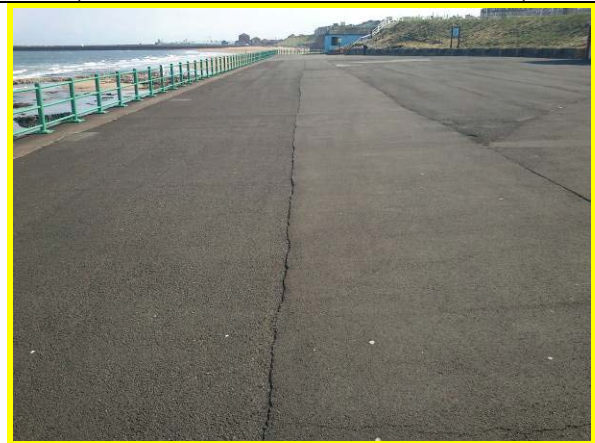
Promenade surface joints need resealing at
Parsons Rocks
(Asset ref. No. 121AB901B0604C02)

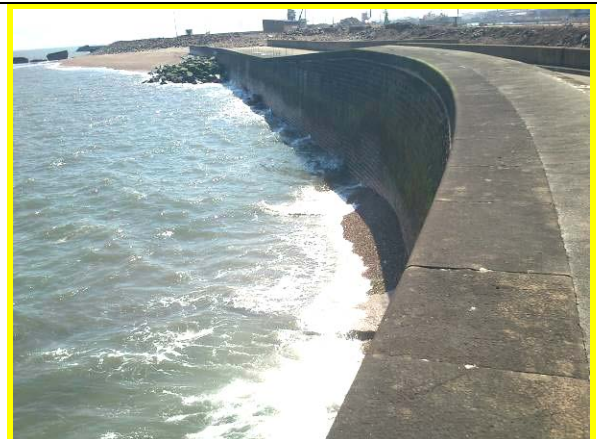
View of front face of wall 16.05.2013
(Asset ref. No. 121AB901B0801C03)

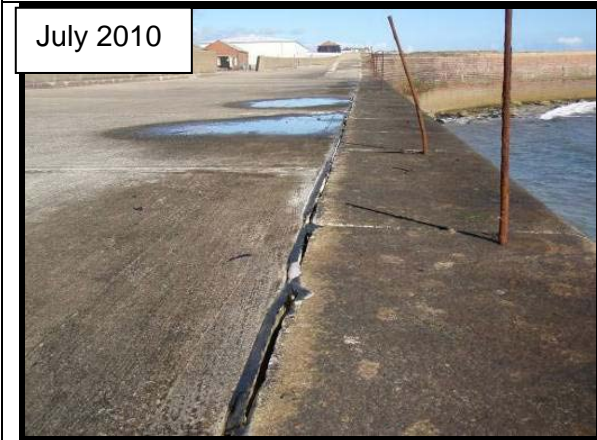
Deck slab above void – Photo from 2010 report
(Asset ref. No. 121AB901B0801C03)

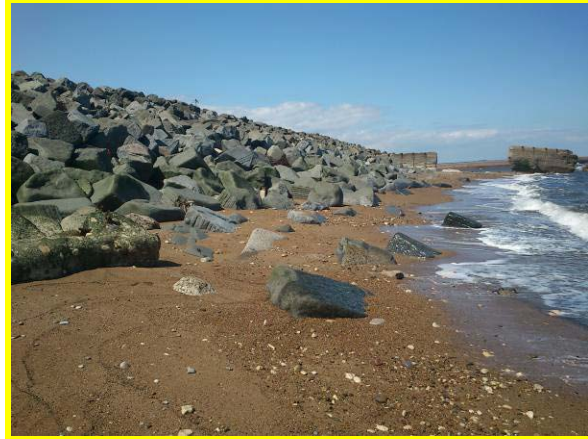
Southern section of rock armour
(Asset ref. No. 121AB901B0801C06)

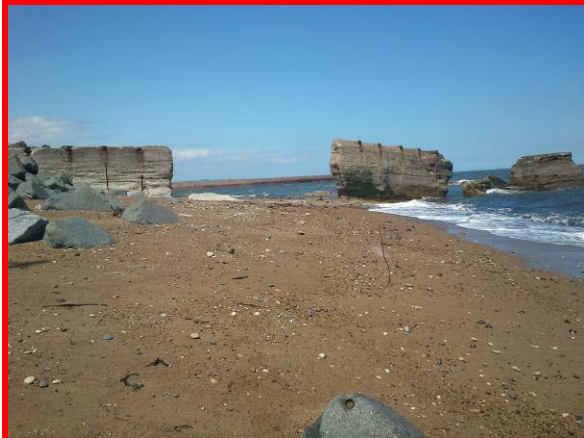
Remains of derelict concrete groyne from
south (Asset ref. No. 121AB901B0801C01)

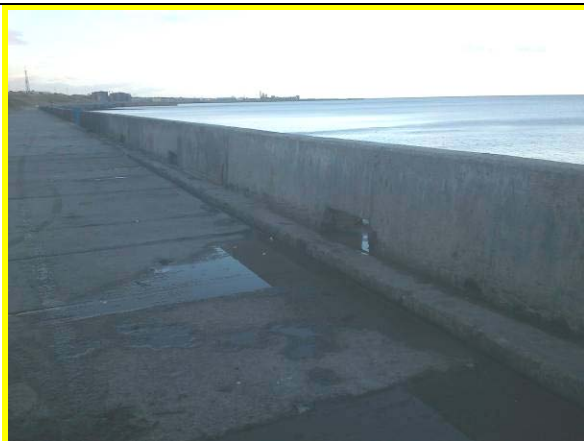
Crest wall with enlarged drainage holes
towards southern end of defence.
(Asset ref. No. 121AB901B0803C02)

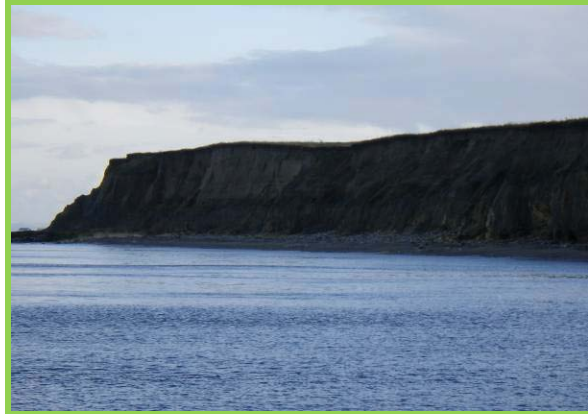
Cliffs south of Hendon are afforded a degree of natural protection by rubble at toe
(Asset ref. No. 121AB901B0803C01)

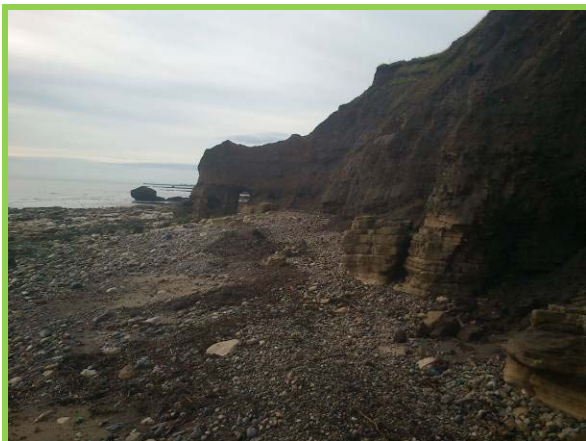
Multiple local mud slides in upper till slopes and arch formation south of Ryhope Nook.
(Asset ref. No. 121AB901B0804C03)

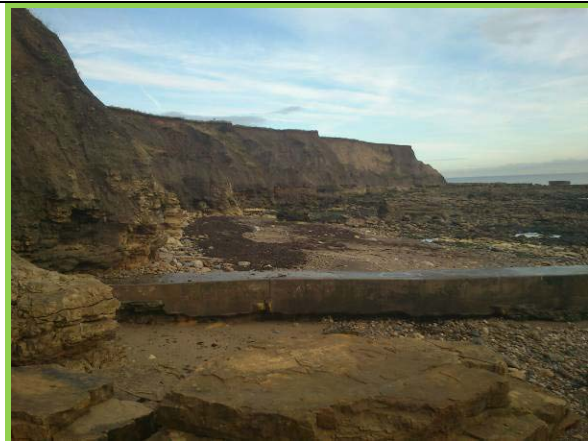
Mud slides in upper till cliff.
(Asset ref. No. 121AB901B0804C03)
Also shows undermined concrete cladding on outfall structure at Ryhope Nook.

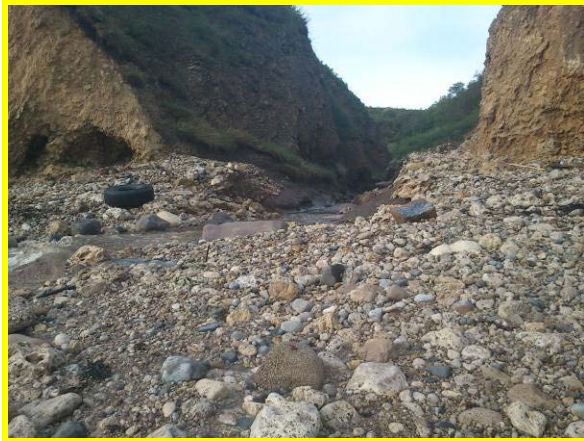
Erosion of beach crest by flow from beck at Ryhope Dene. (Locally active)
(Asset ref. No. 121AB901B0804C02)
