**Cell 1 Regional Coastal Monitoring Programme
Walk-over Visual Inspections of Assets**

**Sunderland City Council
Final Report**

September 2014

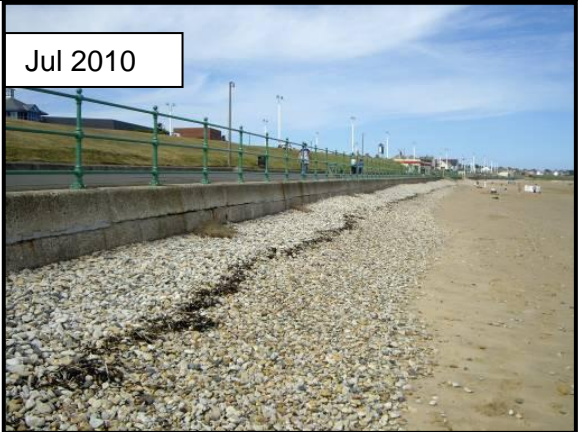
<p>Jul 2010</p> <p>Shingle upper beach present in July 2010. (Asset Ref. No. 121AB901B0603C01)</p>

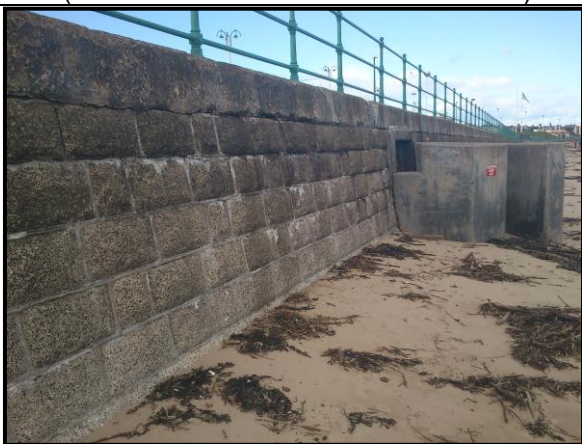
Photo from 2012 report.
(Asset Ref. No. 121AB901B0603C02)

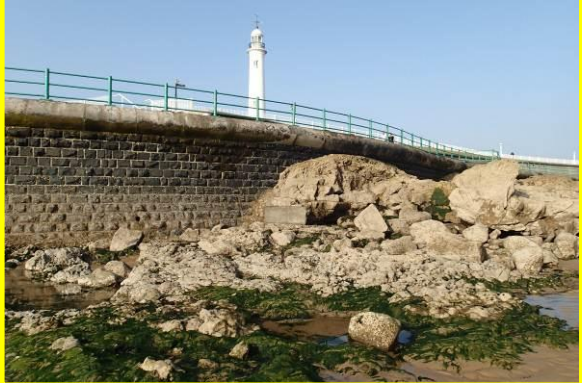
The masonry seawall backing Parson's Rocks is in fair to good condition (below left). The masonry structure ties in with the elevated natural limestone rock outcrop, which is abrading and eroding in places, for example at the old access steps just north of the point and on the southern

<p>Masonry wall at Parsons Rocks. (Asset Ref. No. 121AB901B0604C02)</p>

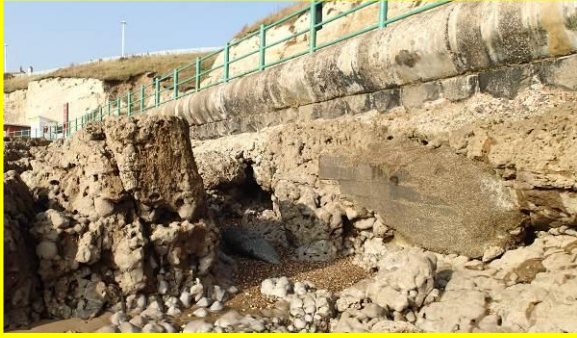
flank where there is a void starting to extent below the promenade, see photo below lower right, and maintenance repairs are recommended to prevent the damage escalating. The condition of the coping deteriorates towards the south end of the wall with cracking and missing mortar in some joints in the masonry blocks.

<p>Eroded limestone outcrop with void beneath promenade at south of Parsons Rocks. (Asset Ref. No. 121AB901B0604C02)</p>

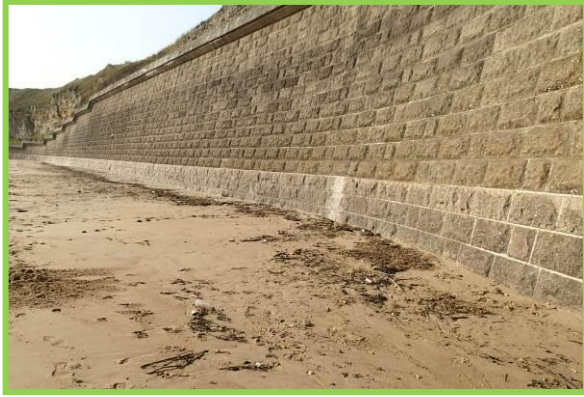
South of Parson's Rocks, the high masonry wall around the headland extending south to the ravine at Roker Park (Asset Ref. No. 121AB901B0605C01) was in generally good condition (below left) with local minor loss of mortar and spalling noted in a few places. The natural cliff above appeared to be relatively stable. At the most exposed section where the wall is most seaward, before the return to Roker Park, there was a single facing block missing from the wall, see photograph below right. This should be repaired before the damages spreads.

High masonry wall in good overall condition.
(Asset Ref. No. 121AB901B0605C01)

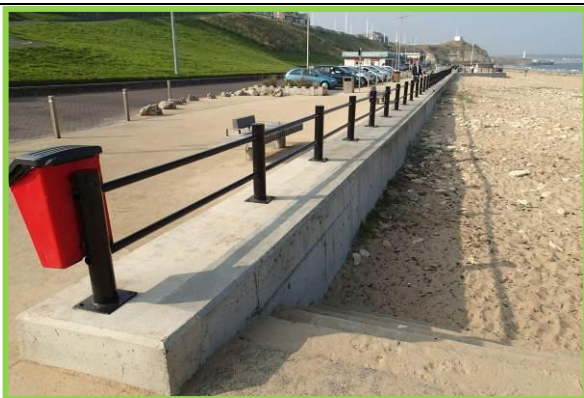
The low level concrete wall fronting Marine Walk was in good condition (below left) following improvement works a few years ago. Vertical cracks in the encasing concrete of the northern section were noted in a couple of locations. Some of the handrail fixings were showing corrosion stains. Improvements were being undertaken to the promenade as part of the seafront regeneration scheme at the time of the September 2012 inspections and the promenade was in good condition.

Low concrete encased wall at Marine Walk in
good overall condition.
(Asset Ref. No. 121AB901B0605C02)

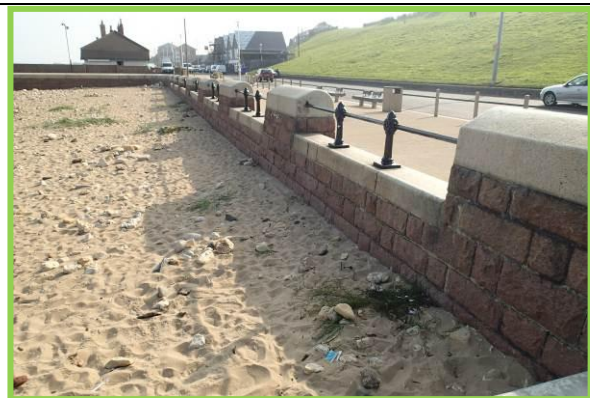
Southern section of wall protected by wide
beach in good overall condition.
(Asset Ref. No. 121AB901B0605C02)

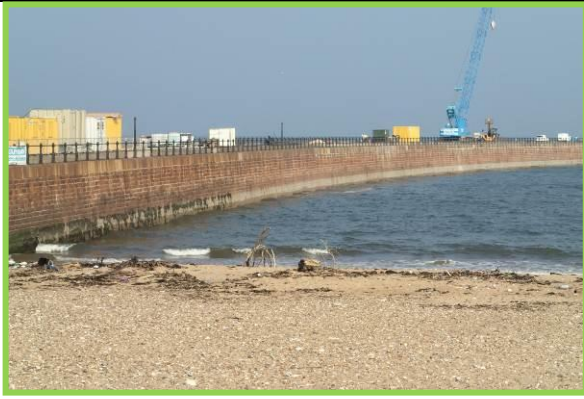
At the time of the inspection Roker Pier was closed to the public as major refurbishment and repair works were underway. The pier was only inspected from the shoreline. The work underway appeared to be undertaking repairs to the pier below the waterline on the seaward side and resurfacing the deck. The overall condition assigned was good as it is assumed that any significant defect to the pier will be dealt with as part of the ongoing refurbishment.

Works underway to refurbish Roker Pier.
(Asset Ref. No. 121AB901B0702C04)

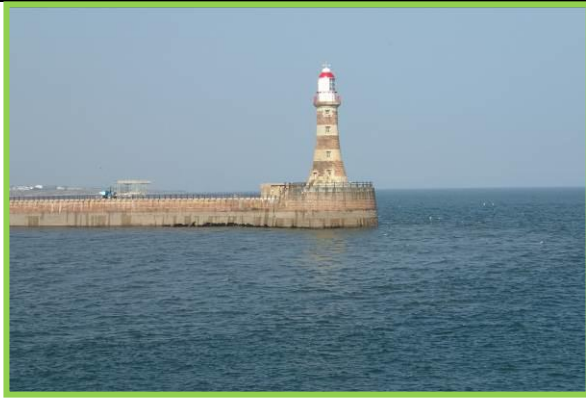
Seaward end of Roker Pier viewed from New South Pier.
(Asset Ref. No. 121AB901B0702C04)

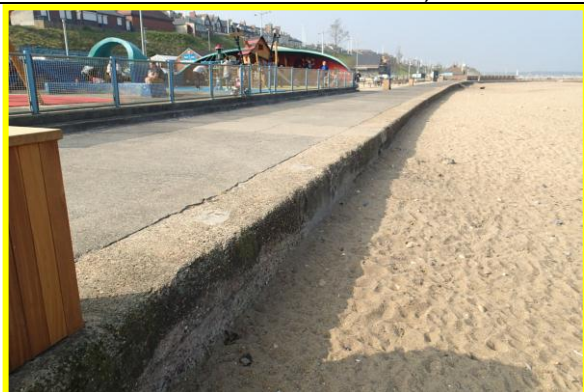
High beach levels at Roker Beach.
(Asset Ref. No. 121AB901B0702C01)

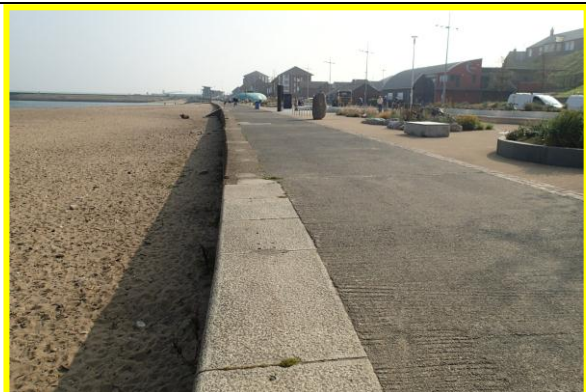
Roker beach promenade in fair condition. Area to rear has been resurfaced under regeneration scheme.

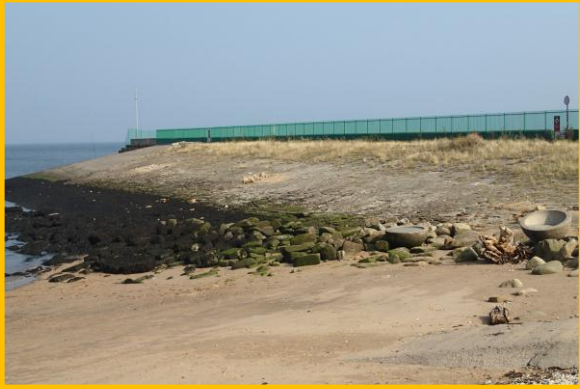
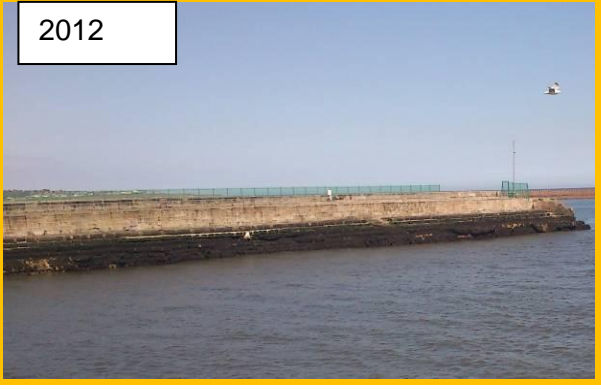
<div data-bbox="823 203 979 259" style="border: 1px solid black; padding: 2px; display: inline-block;">2012</div>

The structure remains fenced off to members of the public (below left) with signs describing the structure as unsafe and therefore assessment was not possible. From the landward end, the structure appeared in similar condition to that reported in previous inspections with missing concrete and masonry from both the grouted revetment forming the northern face and the masonry wall forming the southern face (below right). Viewed from the south bank of the River Wear it was clear that there are significant voids in the masonry wall and apron to south side.

<p>Old North Pier revetment armoring on northern side. (Asset Ref. No. 121AB901B0702C03)</p>	<p>Voids in apron and undercutting of Old North Pier (photo from 2012). (Asset Ref. No. 121AB901B0702C03)</p>

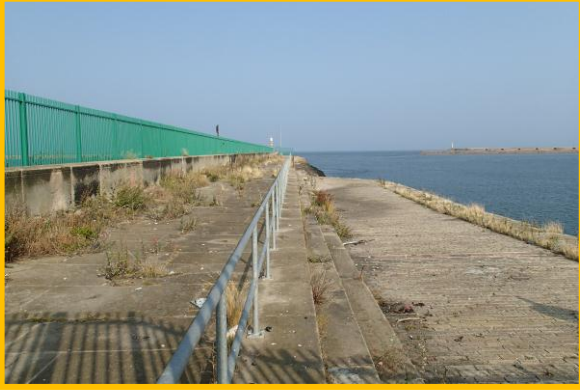
<p>View of Old North Pier deck slab through barrier fence. (Pier closed to public due to unsafe condition). (Asset Ref. No. 121AB901B0702C03)</p>

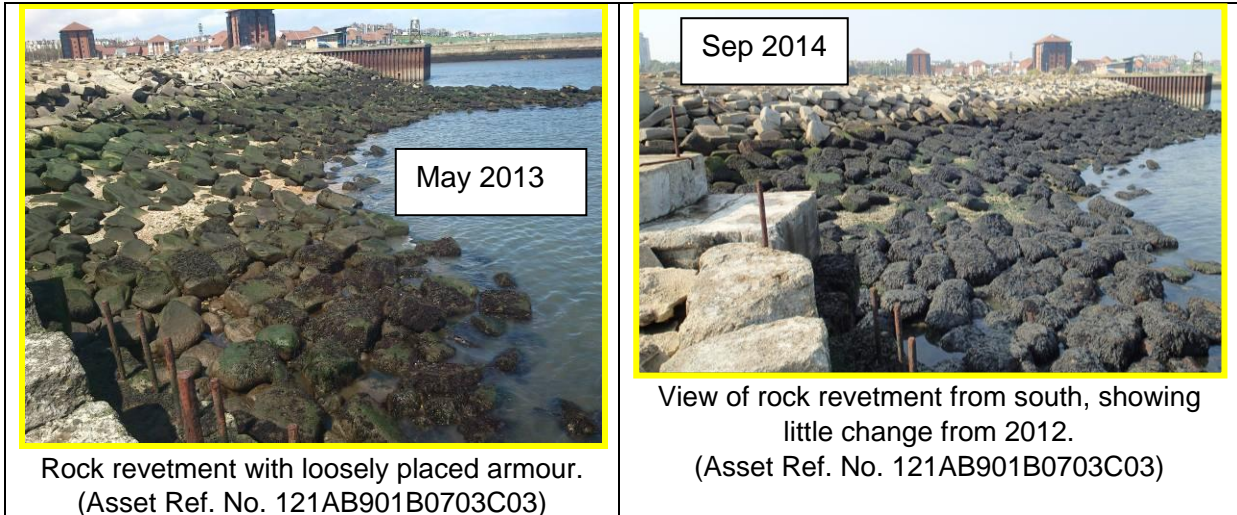
The northernmost structure consists of a rock armour revetment which is in fair overall condition. The rock armour loosely placed with some gaps towards toe and lacks interlock. The crest section of rock is grouted with concrete and is in good condition. The revetment ties into a sheet piled river / navigational wall to the north and a masonry seawall with a precast concrete recurve crest to the south, which extends to the rear as a secondary wall, see below right. The rear wall was inspected only at the seaward end, and is in good condition, with minor spalling and cracking of the concrete and spalling to the surface of the concrete walkway to the rear. The very seaward end, see below left, has reinforcement bars standing vertically from the top of the concrete wall and it appears these were placed to allow the continuation to form a boundary wall which was not completed. There appeared to have been little change to the condition of the asset since the previous inspection in May 2013.

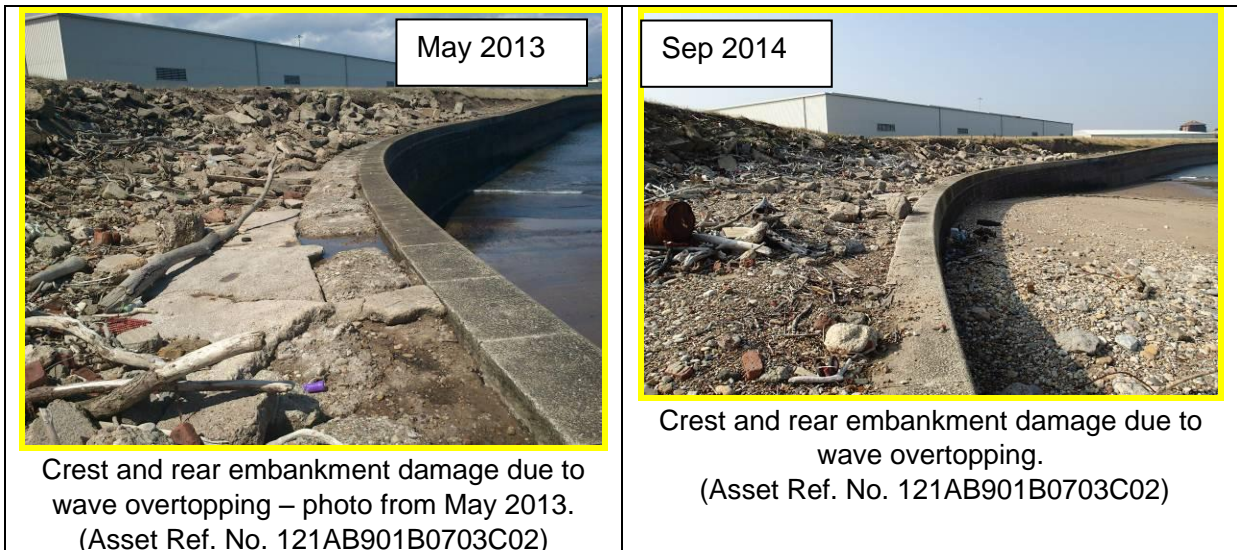
The masonry and concrete seawall to the south, which links into the north face of New South Pier is in fair overall condition. There is evidence of minor impact damage and spalling to the seaward face. There are missing blocks at the northern end, where there is risk of outflanking causing the wall to start unravelling, although the situation in 2014 looks very similar to the photographs from 2010 and 2013. As noted in the 2012/13 report, the concrete apron to the rear of the wall (south part only) has experienced a significant deterioration due to wave overtopping with sections missing. The rubble embankment landward of the seawall has been further eroded on the seaward face by wave overtopping. As recommended in the previous report the surfacing to the rear should be repaired / replaced and voids in the rubble surface immediately behind the wall should be filled in order to avoid wave overtopping causing further erosion and pooling behind the wall destabilising the structure.

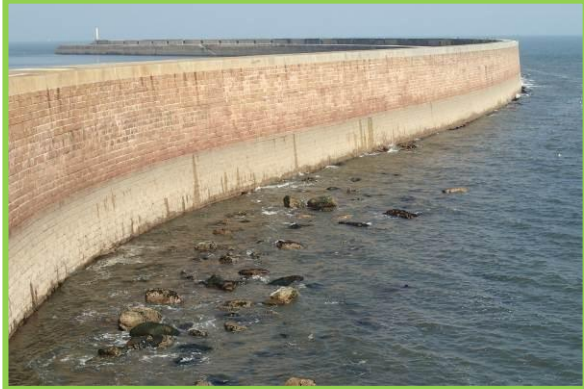
<p>View of south face of wall from land. (Asset Ref. No. 121AB901B0703C01)</p>

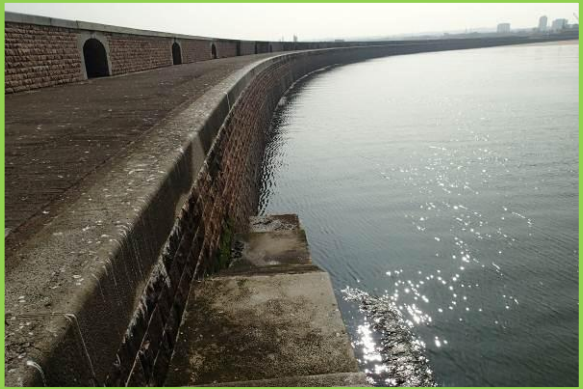
<p>View of north face and lower deck level of New South Pier from seaward end. (Asset Ref. No. 121AB901B0703C01)</p>

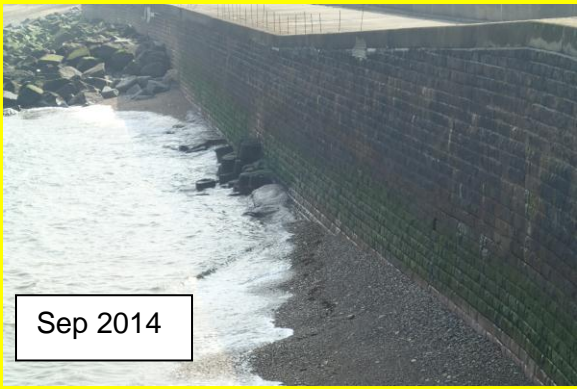
<p>Sep 2014</p> <p>View of front face of wall 11.09.2014. (Asset Ref. No. 121AB901B0801C03)</p>

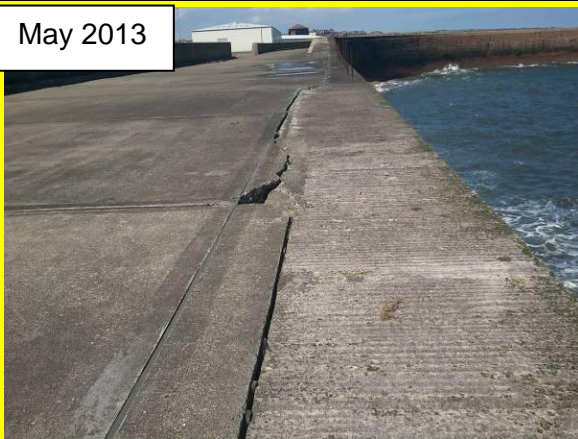
<p>May 2013</p> <p>Deck slab above void – Photo from 2010 report. (Asset Ref. No. 121AB901B0801C03)</p>

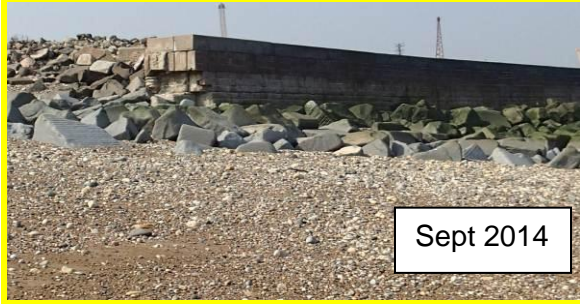
<p style="text-align: center;">Sept 2014</p> <p>Low beach level in September 2014, similar to 2010 inspection. (Asset Ref. No. 121AB901B0801C03)</p>

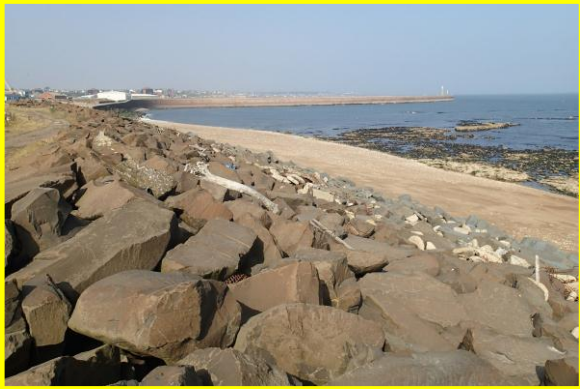
South of the seawall, there are two lengths of rock armour sea defence (121AB901B0801C02 and 121AB901B0801C06) with the remains of a collapsed concrete groyne (121AB901B0801C01) between. The rock revetment (with some concrete blocks) was in fair condition with minor displacement of material and local slumping of the crest.

<p>Northern section of rock armour. (Asset Ref. No. 121AB901B0801C02)</p>

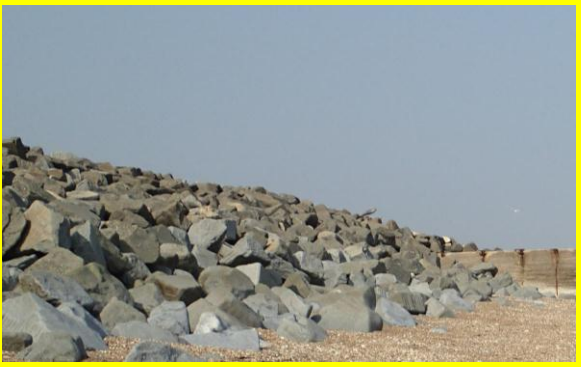
<p>Southern section of rock armour. (Asset Ref. No. 121AB901B0801C06)</p>
---	--

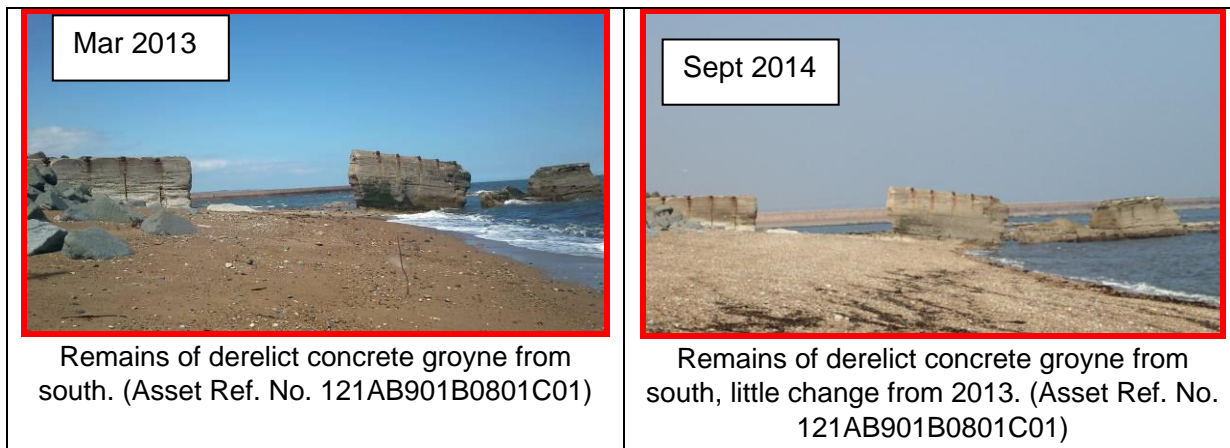
The groyne appeared in a similar condition to that reported in 2008 and 2010 and 2013, suggesting minimal change. The remains do not appear to have adverse effects on the surrounding rock armour and although, the beach has accreted since 2010, the groyne is considered to have a negligible effect on wave energy and sediment transport along the frontage. A degree of protection will be provided by the South Rocks outcrop, erosion of which is possibly the source of the shingle accumulation on the northern part of the beach.

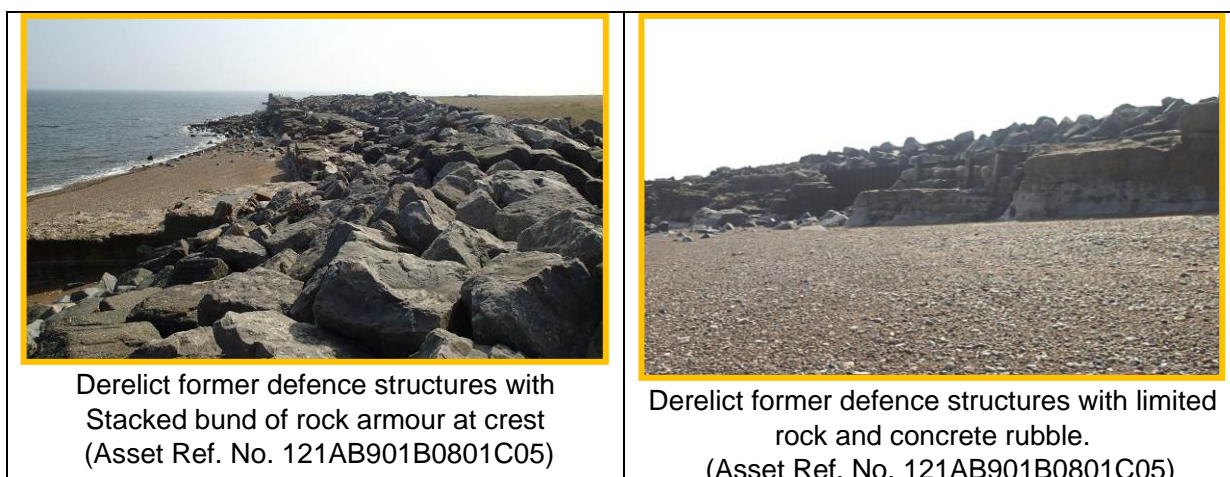
The North East Pier is split into 3 asset lengths in the NFCDD. The seaward section of defence to the north is asset 121AB901B0801C05, consisting of a variety of derelict concrete, masonry and sheet pile structures, with limited armouring with mixed rock and concrete blocks, supplemented by a bund of stacked rock and demolition waste at the crest. This is in poor condition, see below, and if the vacant land to the rear is to be redeveloped it is recommended that additional rock armour is placed to improve the standard of defence

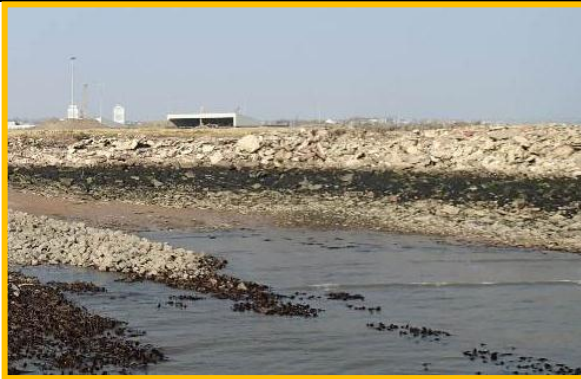
The asset inner face, asset 121AB901B0801C07 is protected by demolition waste rubble armour and rated with a slightly better condition, below left. The concrete block abutment walls were generally intact although the concrete was extensively abraded with spalling and rust staining present throughout.

Tipped rubble at landward end of North East Pier protecting inner face of defence.
(Asset Ref. No. 121AB901B0801C07)

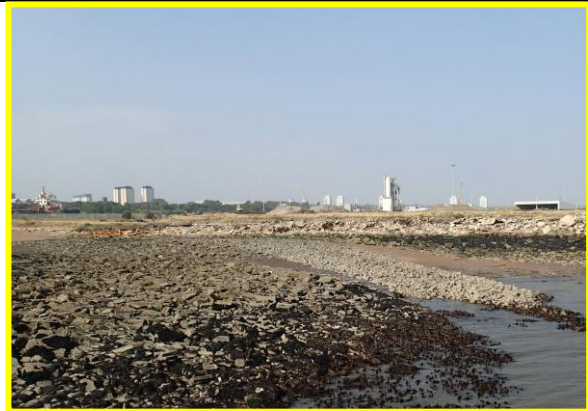
Random demolition rubble tipped into old dock
(Asset Ref. No. 121AB901B0801C08)

The south outlet basin has been partly filled and protected with tipped rubble which appears to be a variety of broken sections of concrete slabs, masonry and rock, see above right and below left and right. This affords a degree of protection, but is not a formal defence and is assessed as poor condition. There are three asset lengths in NFCDD, which are from north to south 121AB901B0801C08 (above right), 121AB901B0802C07 (below left) and 121AB901B0802C06 (below right).

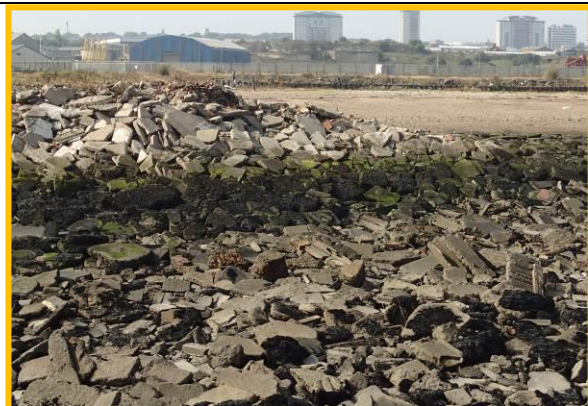
Random demolition rubble tipped into old dock to rear of South West breakwater.
(Asset Ref. No. 121AB901B0802C06)

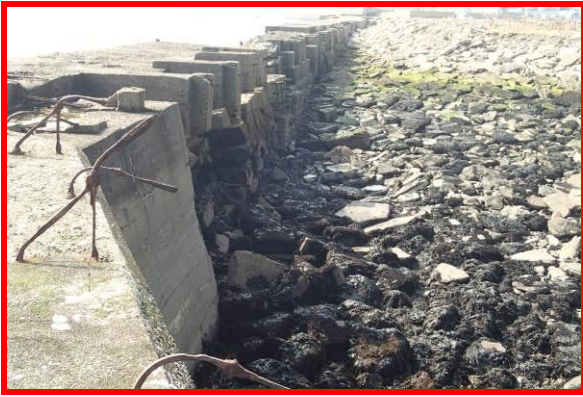
As described in the 2010 and 2012/13 reports the South West Breakwater is in a derelict condition, with significant damage to and loss of deck sections, displaced core blocks to the north side, missing sections of concrete blockwork and damage and undercutting at the roundhead.

<p>South West Breakwater – inner face 11.09.2014. (Asset Ref. No. 121AB901B0801C07)</p>

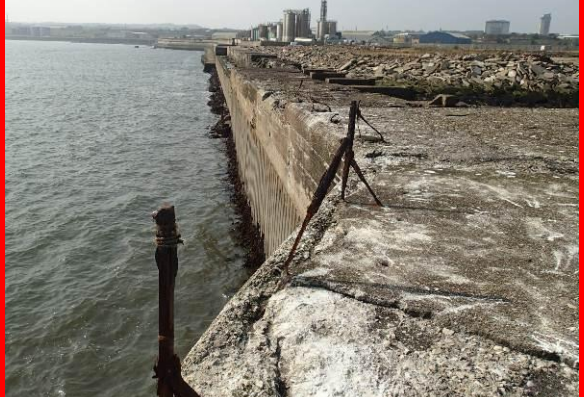
<p>South West Breakwater – seaward face and deck 11.09.2014. (Asset Ref. No. 121AB901B0801C07)</p>

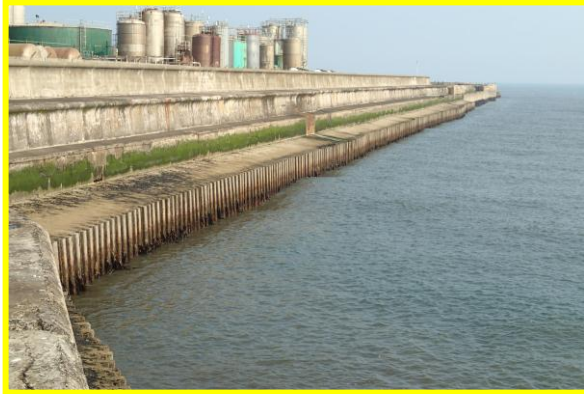
Located to the south of the South West Breakwater is a large concrete seawall with sheet piled toe and set back crest wall, asset 121AB901B0802C04, of about 500m length, terminating at the north end of the sewage works. The asset was in fair overall condition, with localised damage and cracking to concrete and missing sealant in some construction joints. The toe piles appear corroded although they could only be viewed from a distance, see below left, and an underwater inspection is recommended as voids through the piles could lead to loss of fill material and destabilisation of the wall. The flood boards at the access point near mid-length of the wall that were missing in the 2012/13 report have been replaced, see below right.

Spur barrier wall.
(Asset Ref. No. 121AB901B0802C04)

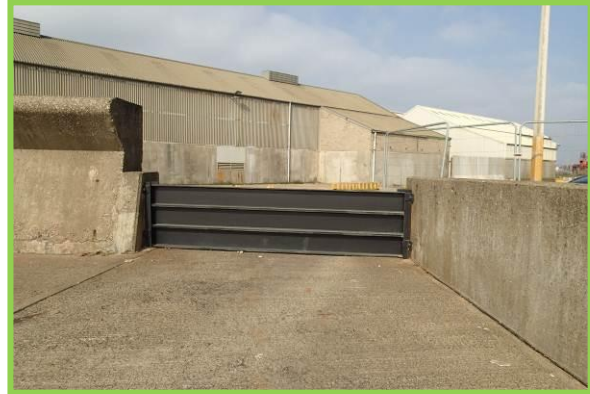
New flood boards at access point in crest wall.
(Asset Ref. No. 121AB901B0802C04)

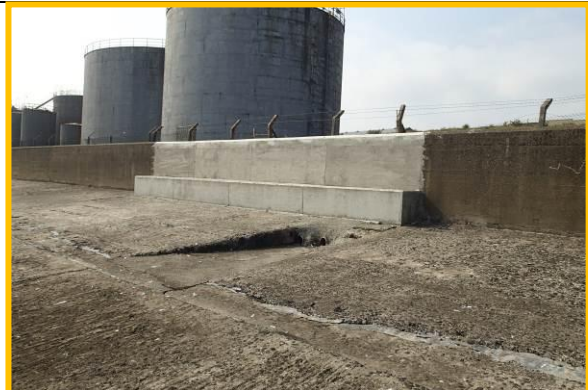
The most southerly defence within the port area is asset 121AB901B0802C01, which has been downgraded from fair to poor overall condition. The 2012/13 report noted that a single section of the rear flood wall had failed, presumably during storm wave impact, see photo below left. The failed section had been repaired and some others reinforced. The toe piles are badly corroded and abraded with holes through. A length of coping beam has been lost and further south more has been displaced. Cracking between crest slab and cope indicates that further sections of coping may be lost soon. It is recommended that rock armour reinforcement is considered for this length of wall.

Repaired section of crest wall.
(Asset Ref. No. 121AB901B0802C01)

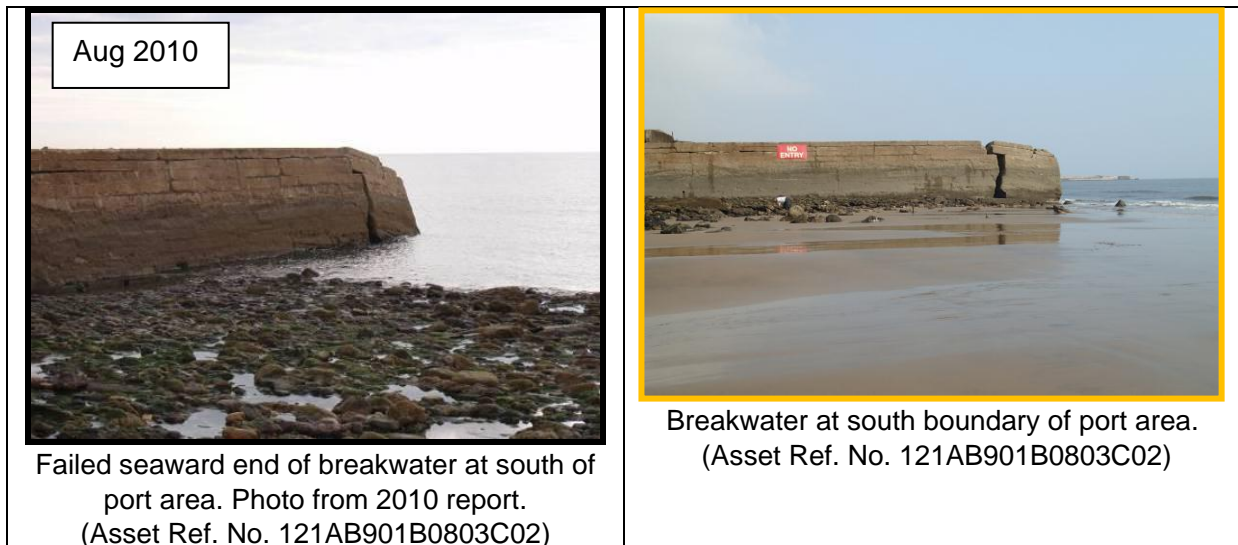
The breakwater marking the southern extent of the Port of Sunderland has failed at the seaward end, below (left and right), but was in a similar condition to that reported in 2008, 2010 and 2012. In NFCDD this structure forms part of the asset length to the south, 121AB901B0803C02.

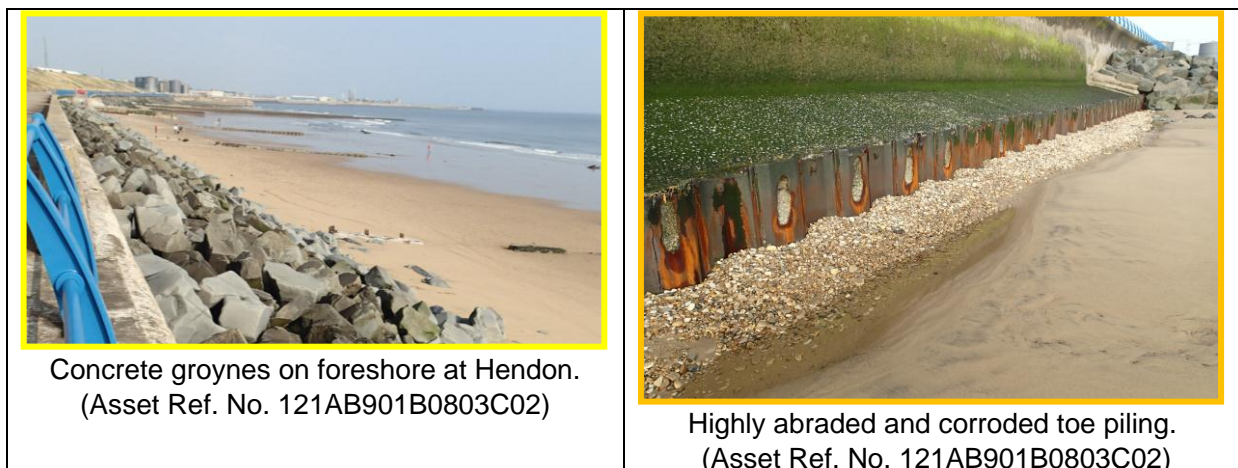
South of the port boundary the concrete Hendon Seawall, Asset Ref. No. 121AB901B0803C02, was in fair overall condition. Rock armour protection has been placed in front of the wall in several sections and this was in good condition with appropriate voids and interlock between units. There are about ten concrete groynes on the foreshore which appear to be having limited impact on the control of sediment movement, although the large gaps at access points through the groynes will not help, see below left. Steel toe piling was visible along significant lengths of the wall where it is not protected by rock armour, but the piles were heavily corroded and abraded with limited remaining life, see below right.

Sealant was missing from construction joints in the concrete slabs in a number of locations. Minor spalling was evident around drainage holes with exposed reinforcement in the crest wall to the southern part of the defence, below lower left. There was also abrasion evident to the front face of the wall in places. Additional rock armour to protect the failing piles and abraded wall should be considered in future.

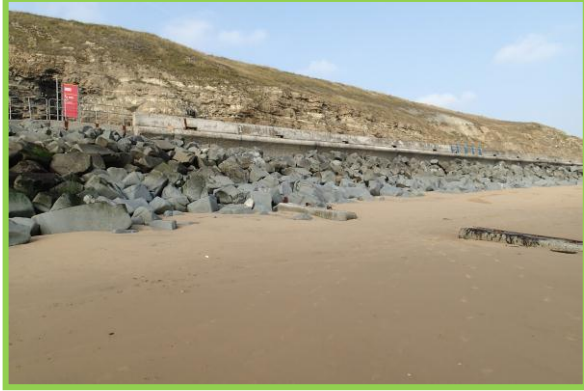
Rock armour in good condition.
(Asset Ref. No. 121AB901B0803C02)

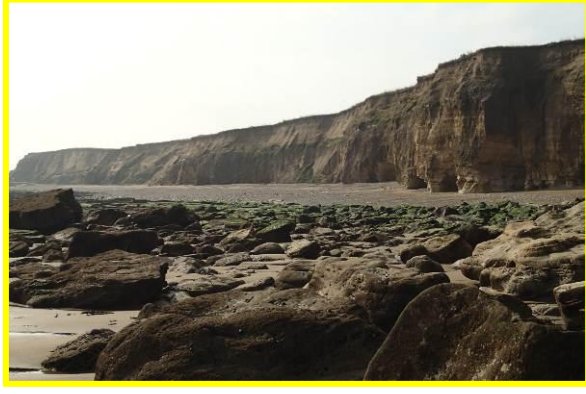
Cliffs south of Hendon are afforded a degree of natural protection by rubble and small beach at toe. (Asset Ref. No. 121AB901B0803C01)

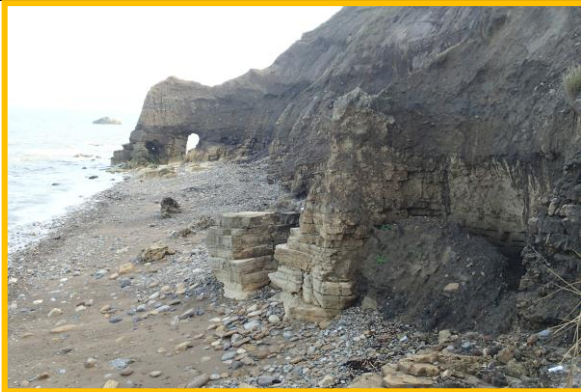
Multiple local mud slides in upper till slopes and active erosion of lower cliffs with arch formation south of Ryhope Nook.
(Asset Ref. No. 121AB901B0804C02)

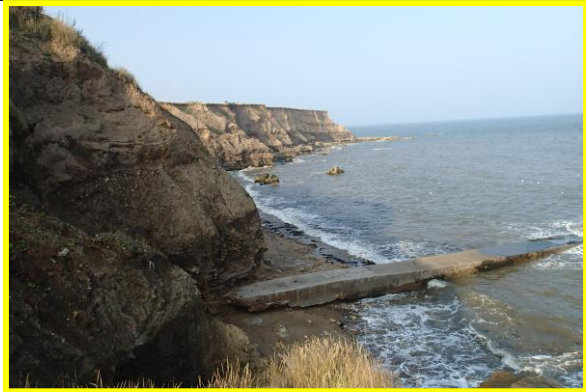
Mud slides and active erosion in upper till cliff. Also shows undermined concrete cladding on outfall structure at Ryhope Nook.
(Asset Ref. No. 121AB901B0804C03)

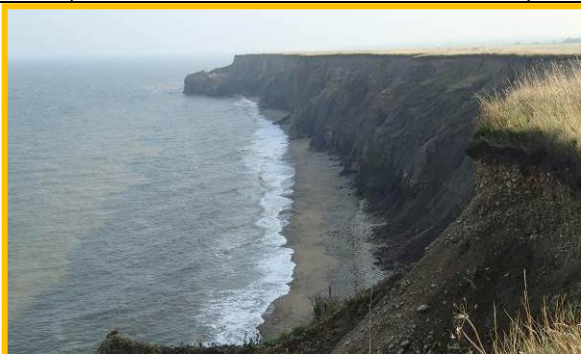
Eroding cliffs at Halliwell Banks. (Partly active)
(Asset Ref. No. 121AB901B0804C02)

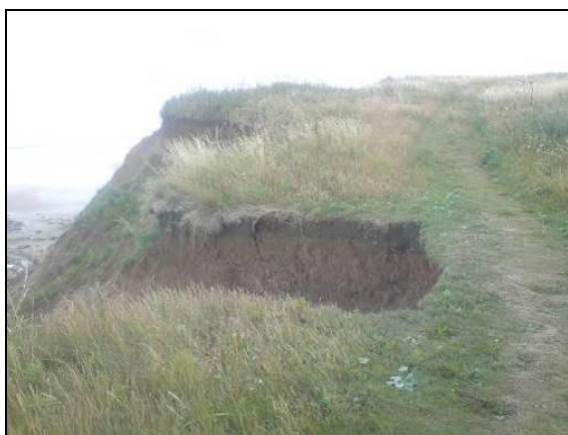
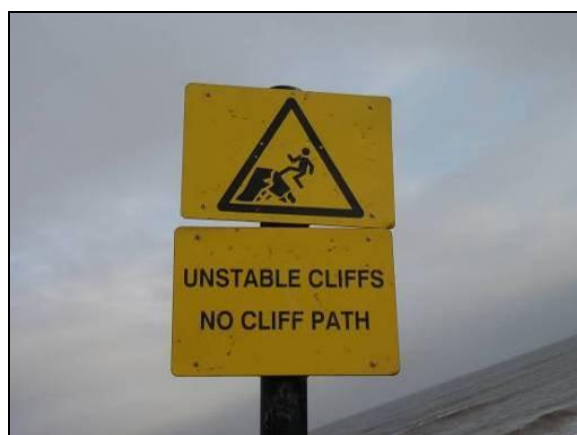
The 2010 and 2012/13 reports noted that there were slope failures in close proximity to the cliff top footpath, particularly at Halliwell Banks, see photos below from the 2010 report. This remains the case. Although signs are present to warn members of the public that the cliffs are unstable, there is a public footpath along the cliff edge on the Ordnance Survey mapping and the track

appeared to still be well worn. The proximity of the retreating cliff edge to the footpath therefore remains an ongoing public health and safety concern.
